PERFORMANCE AUDIT OF THE PUBLIC UTILITIES DEPARTMENT'S WATER METER COVER REPLACEMENT PROGRAM

A Lack of Management Oversight and
Accountability—Along with Process
Inefficiencies and Limited Staffing
Resources—Significantly Delay Box and
Lid Replacement

Office of the
City Auditor

City of San Diego

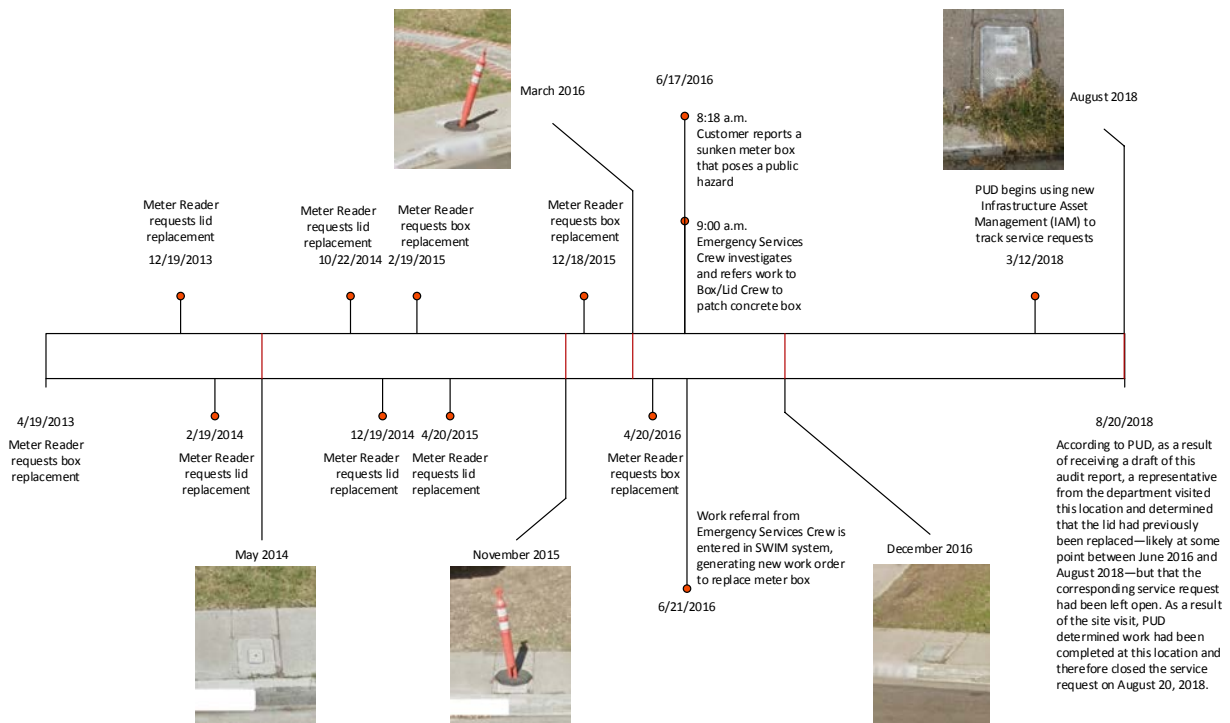
Exhibit 10

In one extreme example, since 2013, PUD has received multiple reports of a box/lid problem at a location—and at one point sent an emergency services work crew to investigate the problem—but did not complete the necessary repairs for at least three years after receiving the first report of a problem. Noteworthy here is that meter readers diagnosed the problem differently on different occasions, sometimes reporting a box in need of replacement and sometimes a lid. As explained previously, this increases the risk that the box/lid crew is not prepared to address the actual problem when they arrive at the site. Also noteworthy is that PUD quickly responded when a customer requested service—on the same day in fact. However, PUD’s response to the customer’s request did not fix the reported problem. Instead, the responding emergency services crew referred the problem to the Box and Lid Group for repair, essentially replicating previous meter readers’ reports and wasting a trip to the site. The timeline in **Exhibit 10** illustrates this extreme case where process inefficiencies have contributed to a box/lid replacement time of at least three years.

In One Extreme Example, Process Inefficiencies Contributed to a Replacement Timeline of at Least Three Years
