Master Storm Water System Maintenance Program Annual Report

Transportation & Storm Water Department
Storm Water Division

SEPTEMBER 2016

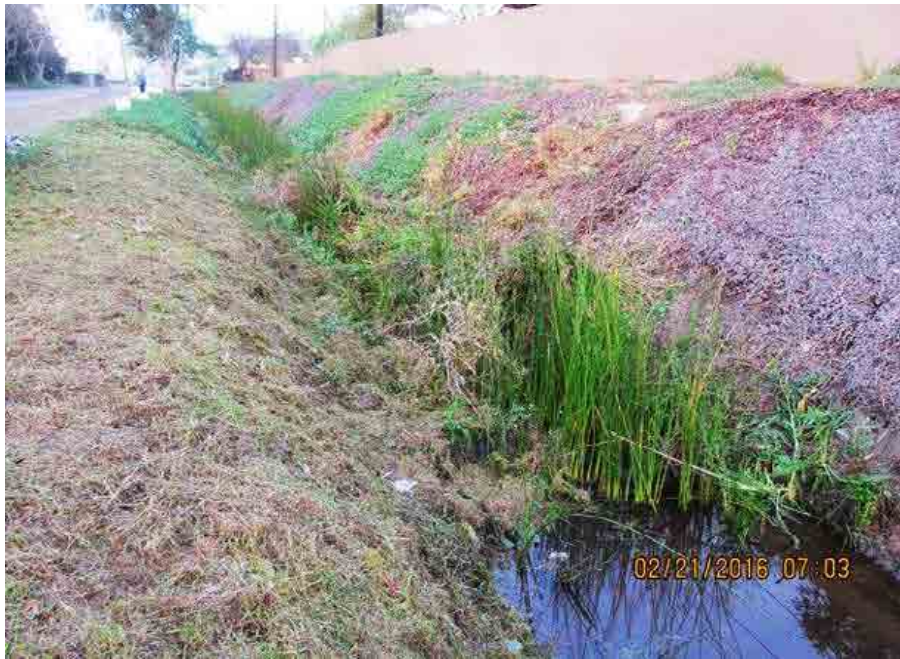
Photo 1. Pacific Beach Dr/Olney Street Channel Map 37 Pre-Maintenance 2/21/2016

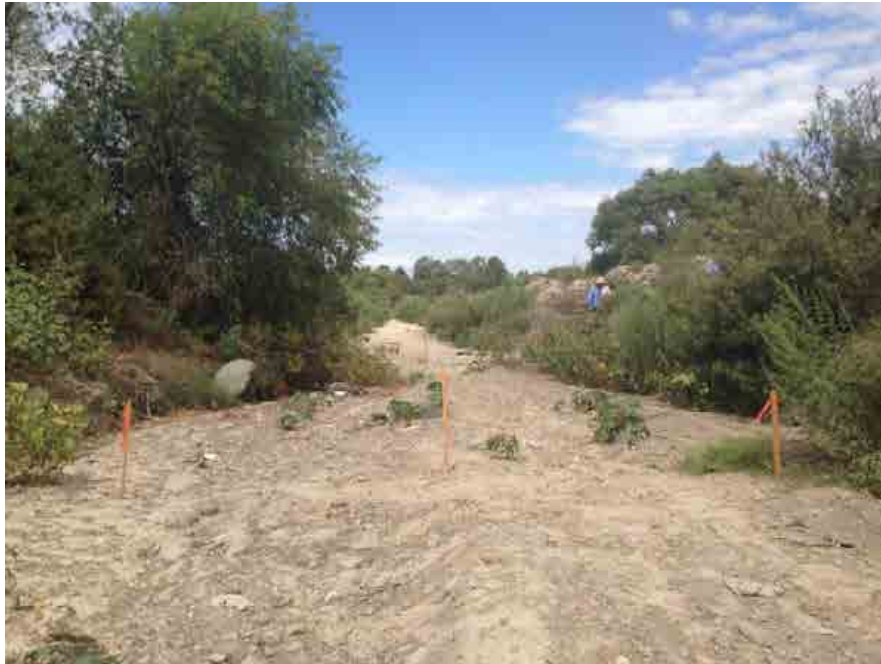
The pre-project IHHA results indicated that, in the pre-project condition, the Pilot channel was at 5% of its calculated design capacity and could contain less than a 2-year storm event flow within its banks. With the sediment and vegetation removed, the conveyance capacity of the Pilot channel would increase from approximately 10 cubic feet per second (cfs) to approximately 200 cfs, although the channel would still contain less than a 2-year storm.

The IHHA results indicated that, in the pre-project condition, Smuggler's Gulch channel was at 89% of its calculated design capacity and could contain the 2-year storm event flow within its banks. With the sediment and vegetation removed, the conveyance capacity of Smuggler's Gulch channel would increase from 800 cfs to 900 cfs and convey the 2-year storm.

Photo 3. Tijuana River Valley Pilot Channel and Smuggler's Gulch Pre-Maintenance 9/14/15

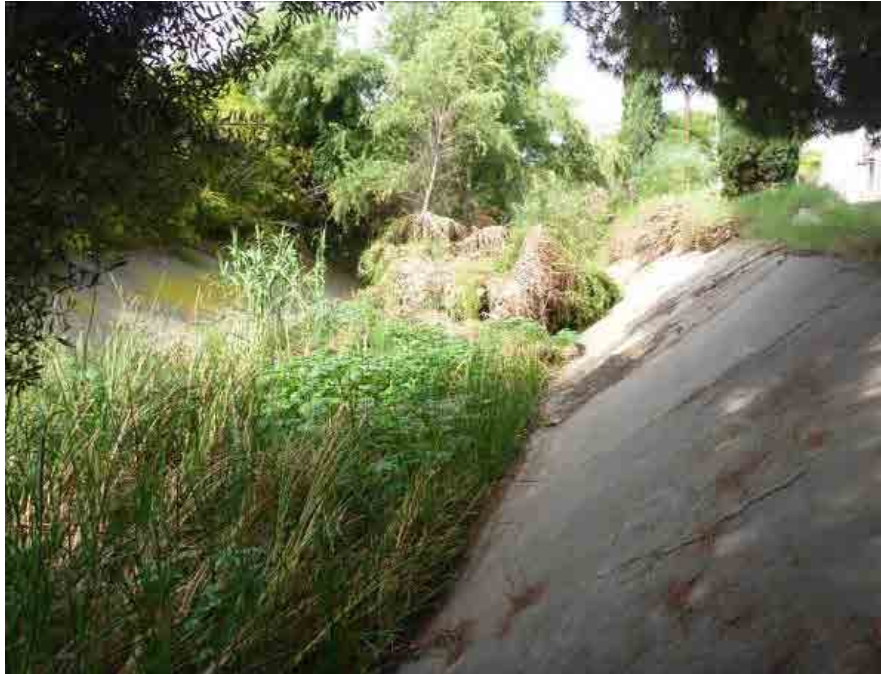
In Upper Alvarado (the portion near SDSU), reach 2 (Upper Reach 2, or UR2) was maintained (Figures 9 and 10). In the pre-project condition, UR2 was able to convey approximately the 5- to 10-year storm event flow. With the sediment and vegetation removed, the conveyance capacity is estimated to increase to a 10- to 35-year storm. As part of maintenance, a temporary check dam was installed to comply with MMP requirements, as UR2 experiences erosive velocities during larger storms. The check dam reduces the conveyance capacity of the channel after maintenance to approximately a 5- to 10-year storm. The check dam will remain in place until the establishment of new vegetation, but

Photo 5. Alvarado Channel (MMP Maps 59, 60, 64) Pre-Maintenance 8/18/15

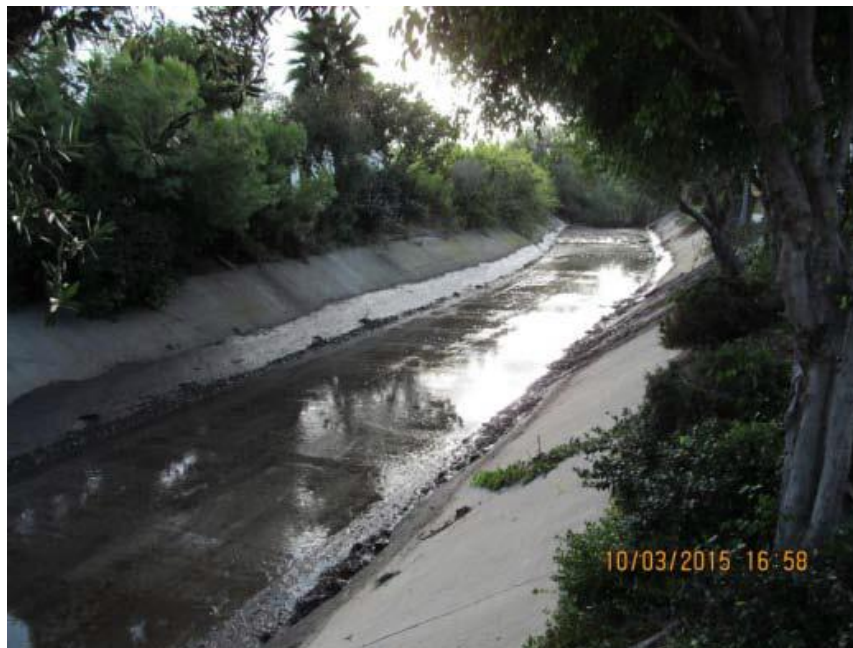
Photo 6. Alvarado Channel (MMP Maps 59, 60, 64) Post-Maintenance 10/03/15

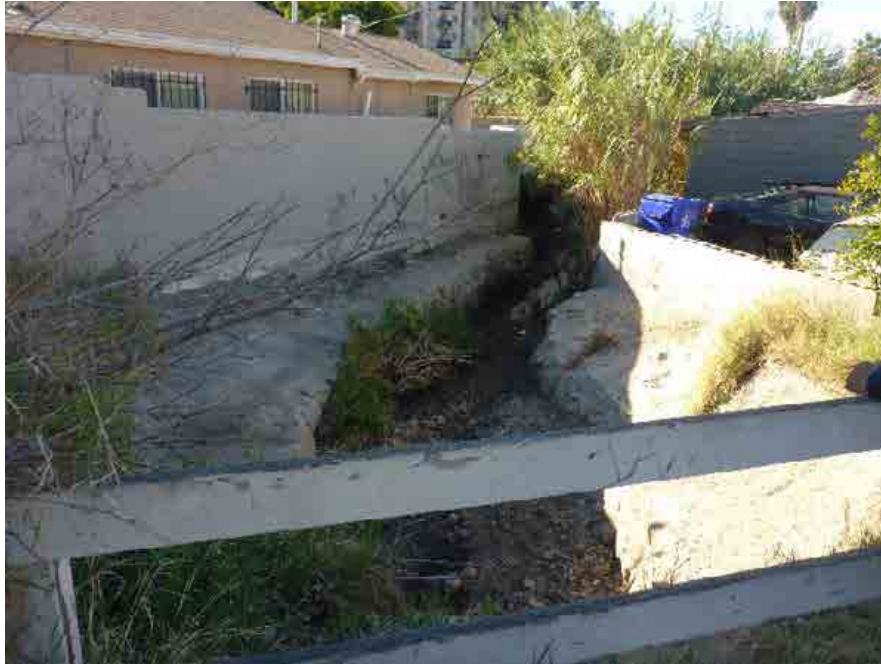
Photo 7. Auburn Creek Channel (MMP Maps 67 & 68) Pre-Maintenance 11/11/15

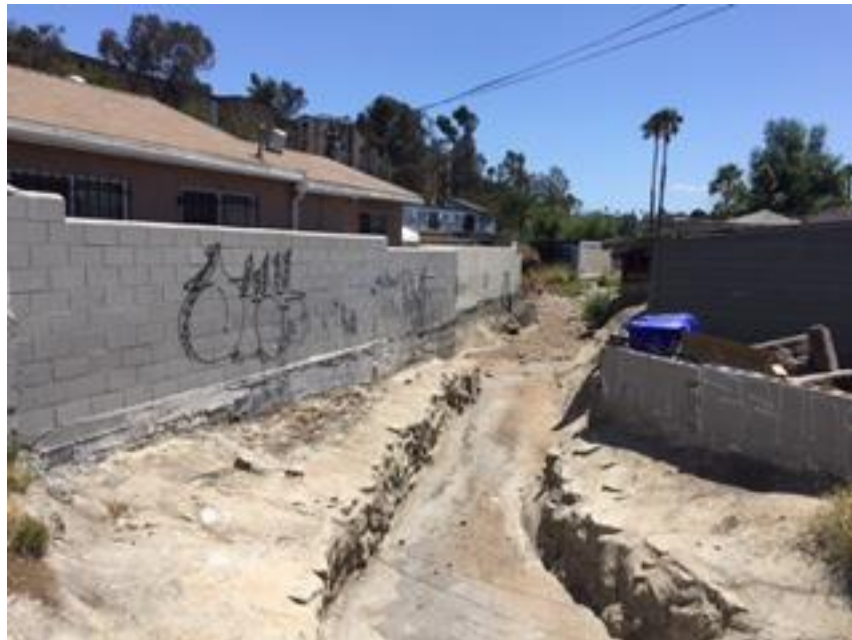
Photo 8. Auburn Creek Channel (MMP Maps 67 & 68) Post-Maintenance 06/13/16

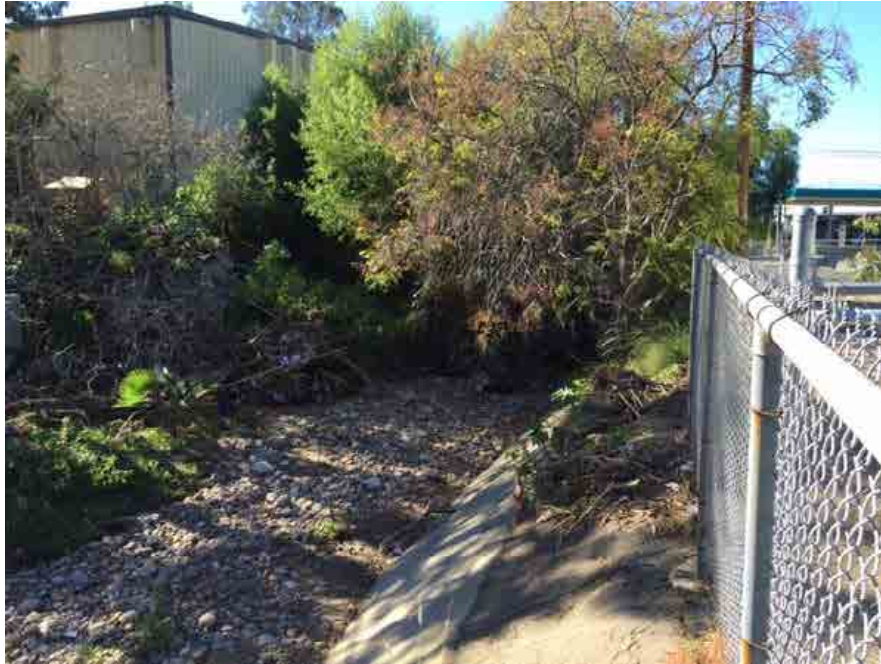
The Auburn Creek emergency maintenance project included the mechanized removal of sediment, vegetation, trash and debris in MMP Map 70. Assessments by City staff conducted on November 11, 2015 determined that sediment, cobble, and vegetation had densely and unevenly accumulated upstream and was reducing channel capacity (Figures 15 and 16). Further, adjacent property owners indicated to City staff that the adjacent properties had flooded during recent rain events. The City determined the residential properties adjacent to the channel were under imminent threat of damage from storm flows, given the channel's condition. The channel conditions prior to emergency maintenance combined with the prediction of an ongoing El Niño weather pattern and heavy winter storms constituted an emergency situation requiring immediate action to reduce flood risk to adjacent public and private property within City jurisdiction.

The date of the last maintenance event is unknown. Based on pre-project conditions, the channel was covered approximately 25% with vegetation growing in unevenly accumulated sediment.

Photo 9. Auburn Creek Channel (MMP Map 70) Pre-Maintenance 11/11/15

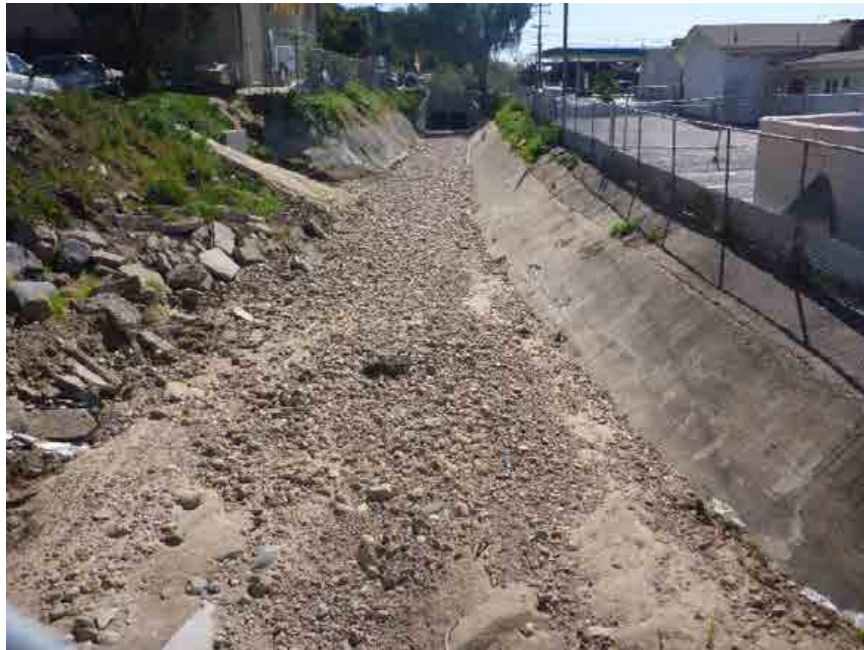
Photo 10. Auburn Creek Channel (MMP Map 70) Post-Maintenance 3/24/16

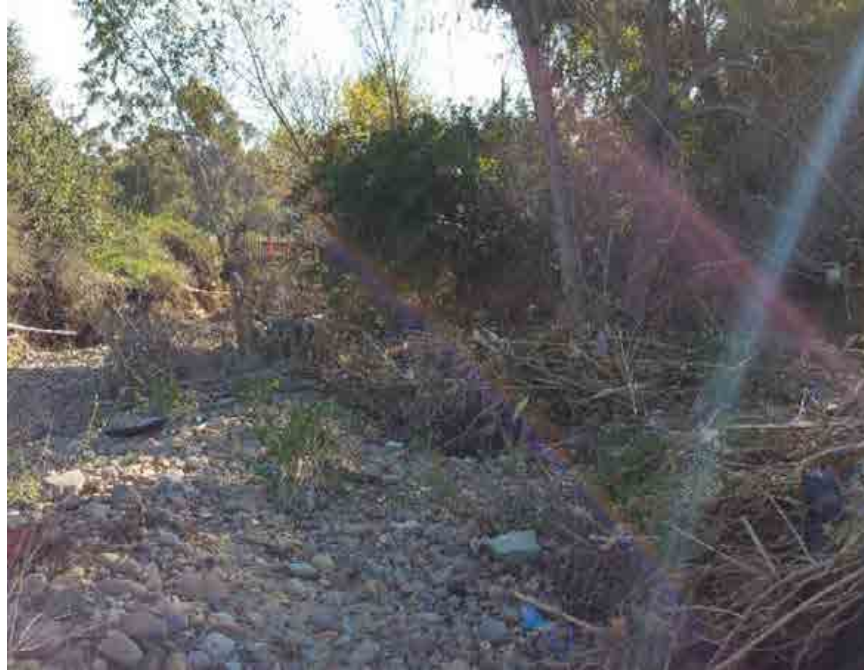
The Auburn Creek emergency maintenance project included the repair and stabilization of creek bank and mechanized removal of sediment, vegetation, trash and debris a section of MMP Map 77 (Figures 17 and 18). Assessments by City staff conducted on February 19, 2016, in response to a complaint of a sidewalk failure, determined that repair to the eroded eastern bank of the channel was necessary. The repair work was necessary to prevent further erosion and undermining of Federal Boulevard and associated sidewalk and direct flows away from the bank and toward the concrete box culvert. Excavation and removal of vegetation, sediment, and debris that had unevenly accumulated and likely caused the bank erosion was also required. It was understood that these activities would reduce flood risk to adjacent roads and property but would not increase overall channel capacity.

The date of the last maintenance event is unknown. Based on pre-project conditions, the channel was covered approximately 25% with vegetation growing unevenly.

Photo 11. Auburn Creek Channel (MMP Map 77) Pre-Maintenance 03/21/16

Emergency work consisted of 3 components along a total length of approximately 270 linear feet. A slope repair of the eastern bank of the channel occurred from the Federal Boulevard culvert inlet to 125 linear feet upstream. This segment of the channel, along with an additional 110 linear feet upstream of the slope repair, was cleared (sediment and vegetation removal) as part of this emergency maintenance within the full approximately 23-foot channel bed width. Within an additional 35 linear feet upstream of the channel maintenance area, debris and two large uprooted trees were accessed and removed (no sediment or living vegetation was removed).

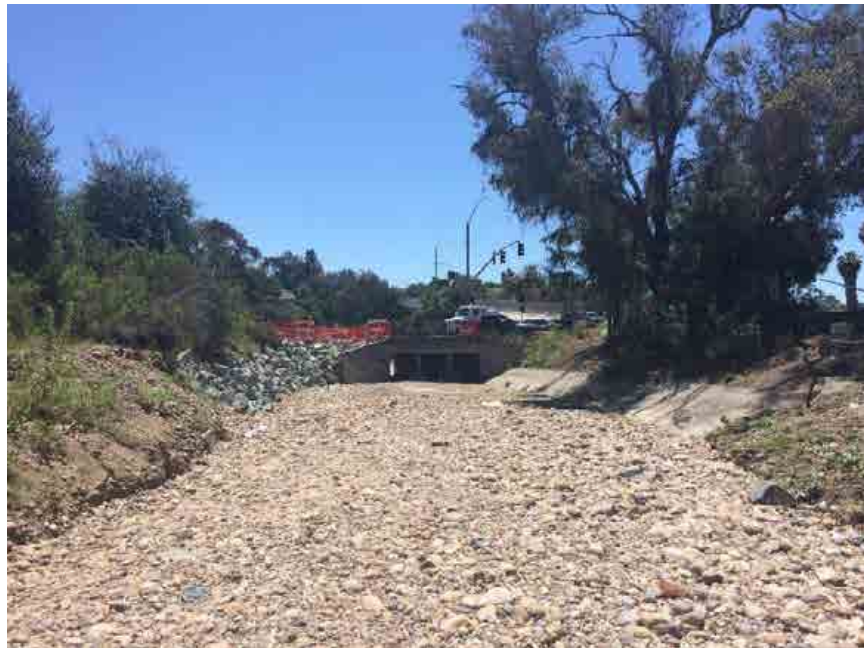
Subsequent to the emergency maintenance, conveyance capacity of the Auburn Creek channel identified in MMP map 77 was estimated by City staff. The maintenance activities were estimated to provide only a nominal increase channel capacity, approximately a 2.4% increase. No change in capacity was expected for the repair work on the eroded eastern bank. As described above, the purpose of the sediment, debris and vegetation removal was to direct flows away from the eastern bank and toward the concrete box culvert to prevent bank erosion.

Photo 12. Auburn Creek Channel (MMP Map 77) Post-Maintenance 4/18/16

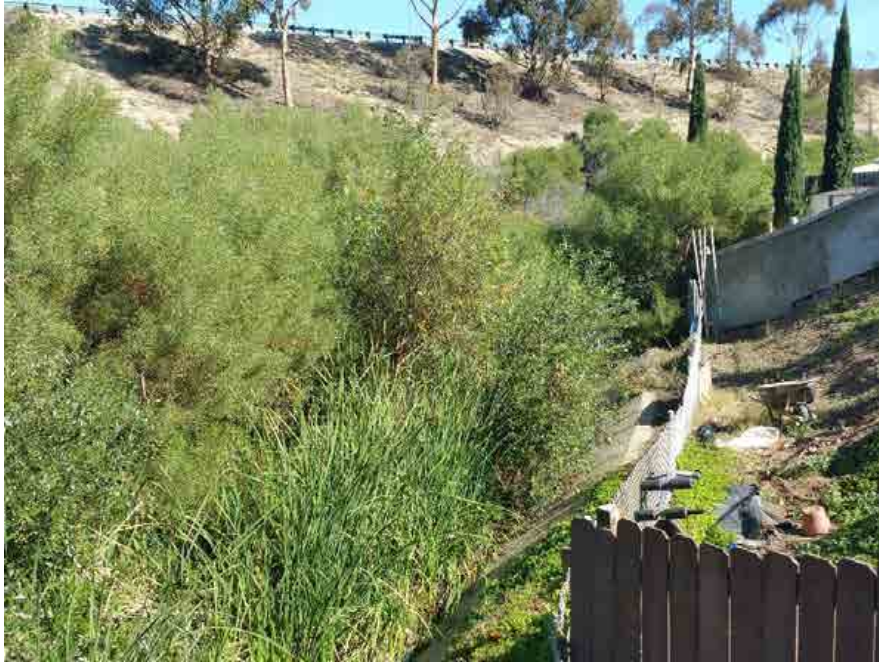
Photo 13. Via de la Bandola Channel (MMP Map 130a) Pre-Maintenance 11/5/15

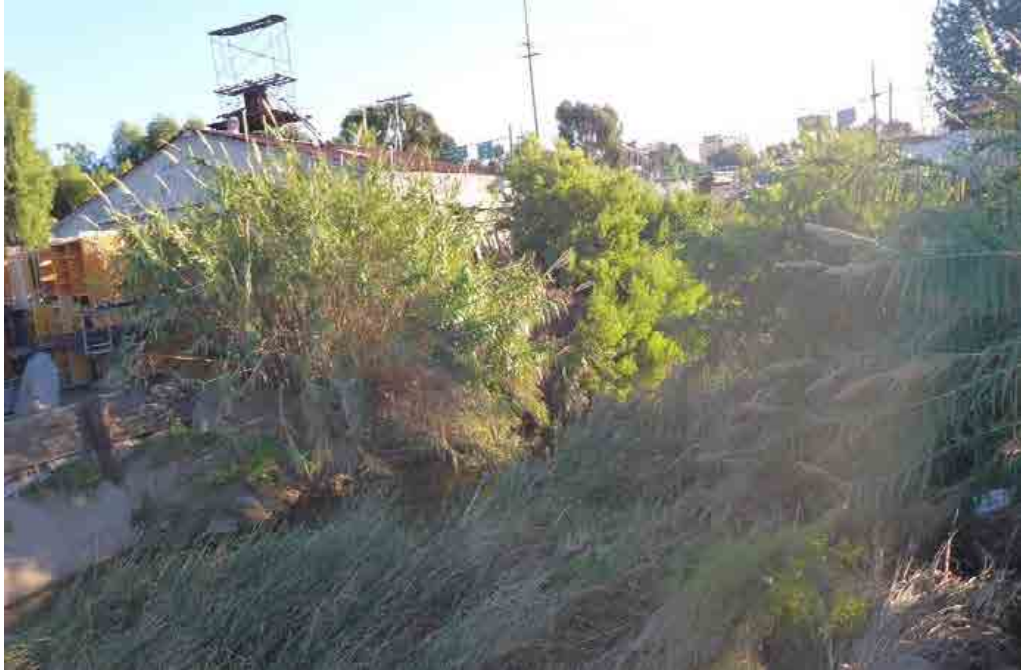
Photo 15. Chollas Creek Channel (MMP Map 91) Pre-Maintenance 12/2/15

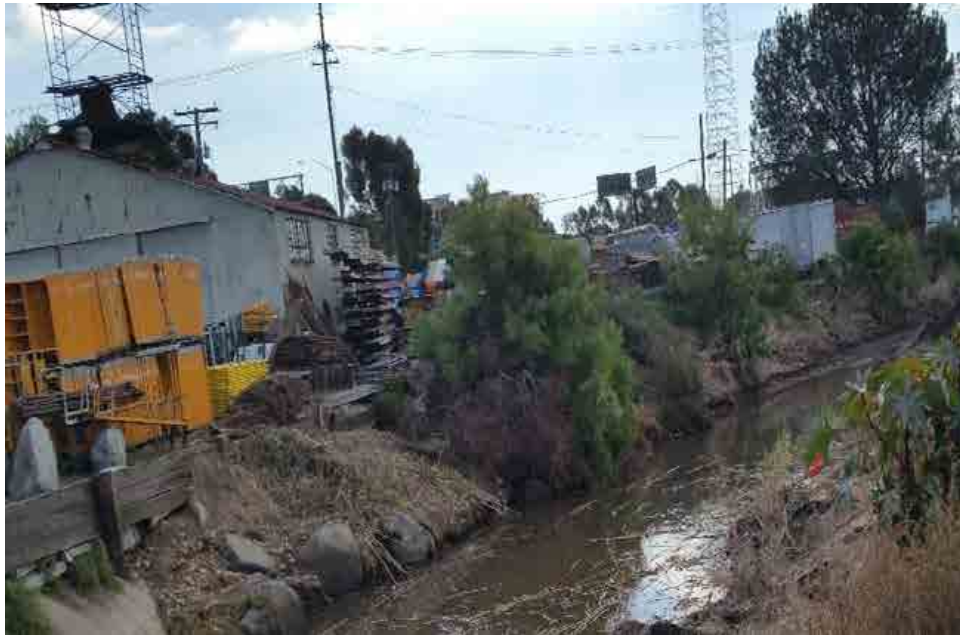
Photo 16. Chollas Creek Channel (MMP Map 91) Post-Maintenance 01/16/16

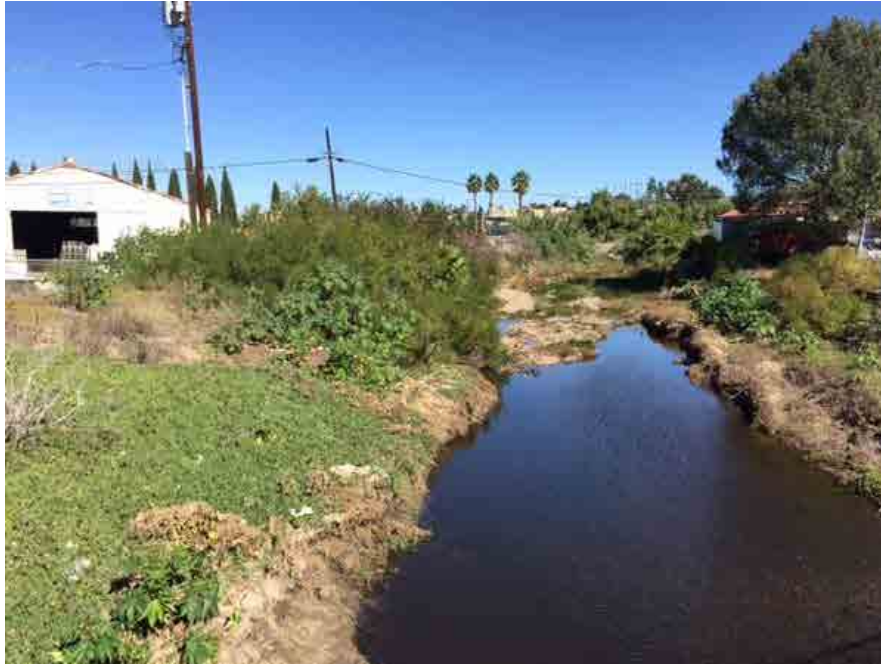
Photo 17. Chollas Creek Channel (MMP Map 93) Pre-Maintenance 11/12/15

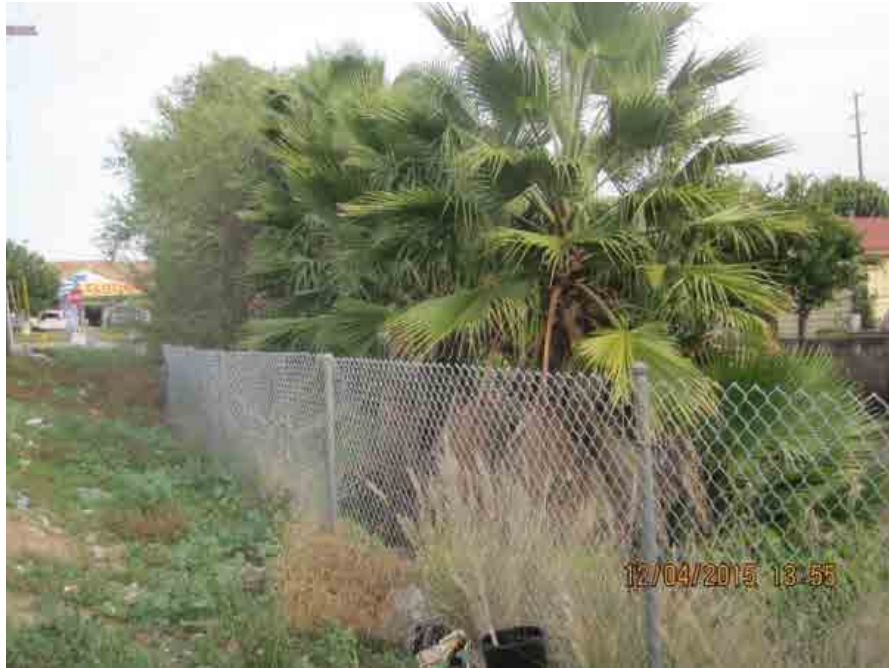
Photo 19. Cottonwood Channel (MMP Maps 120-121) Pre-Maintenance 12/4/15

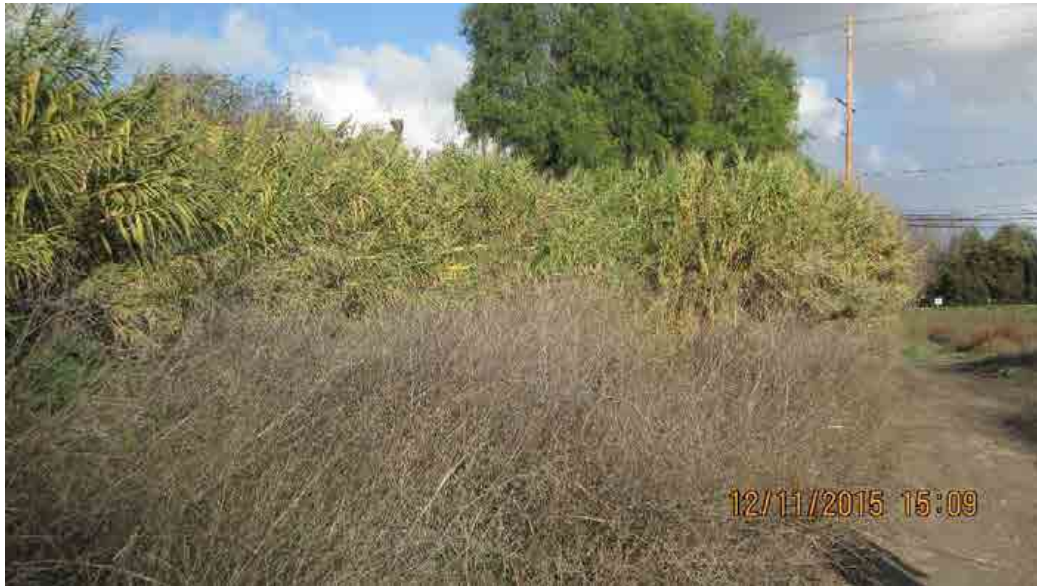
Photo 21. Jamacha Channel (MMP Map 115) Pre-Maintenance 12/11/15

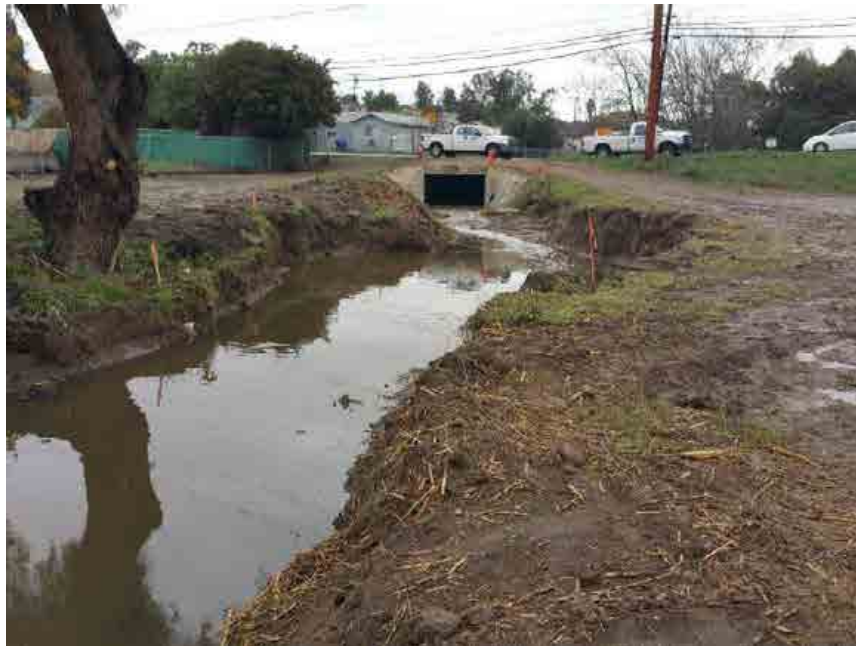
Photo 22. Jamacha Channel (MMP Map 115) Post-Maintenance 1/5/16

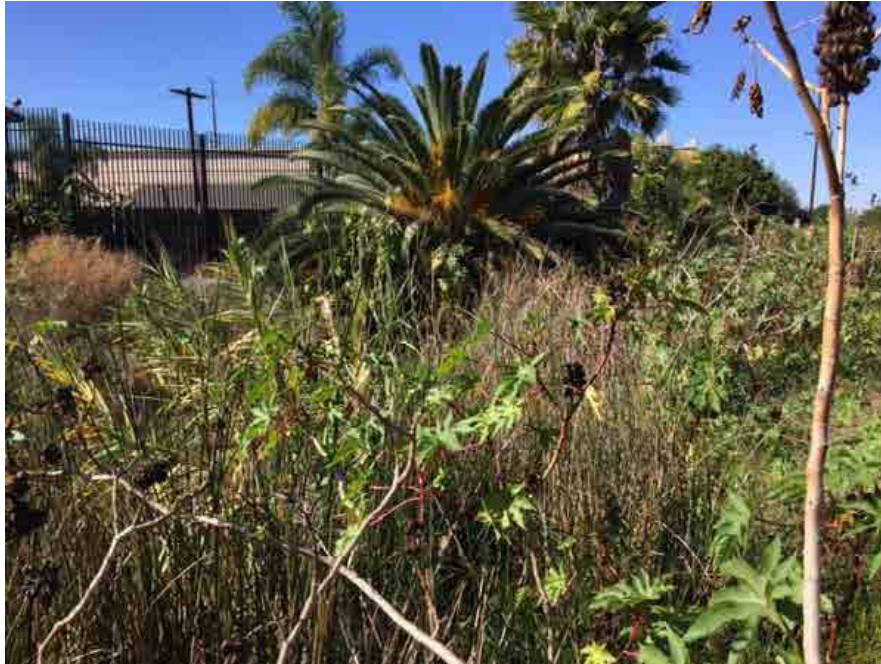
Photo 23. Nestor Creek Channel (MMP Map 134) Pre-Maintenance 11/13/16

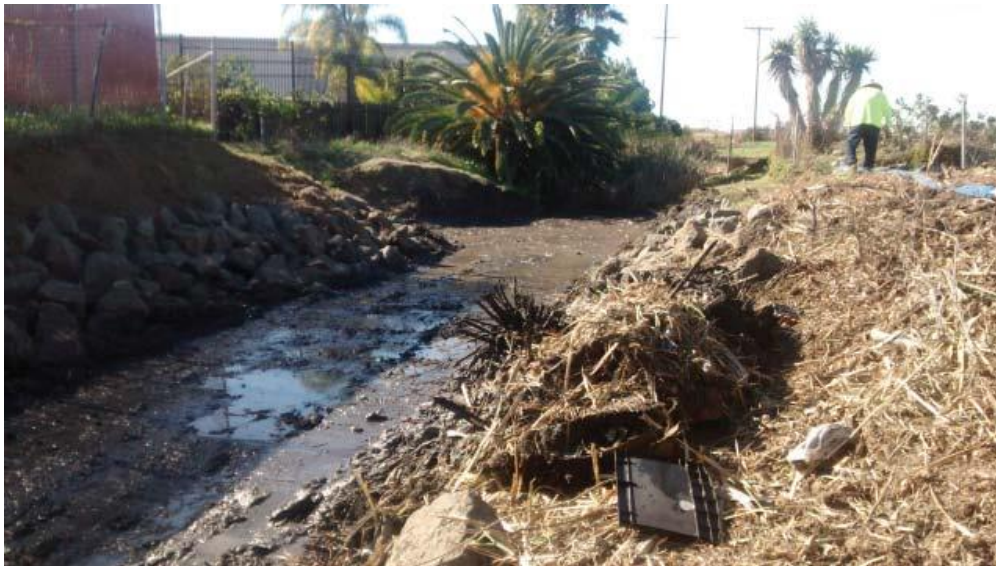
Photo 24. Nestor Creek Channel (MMP Map 134) Post-Maintenance 2/5/16

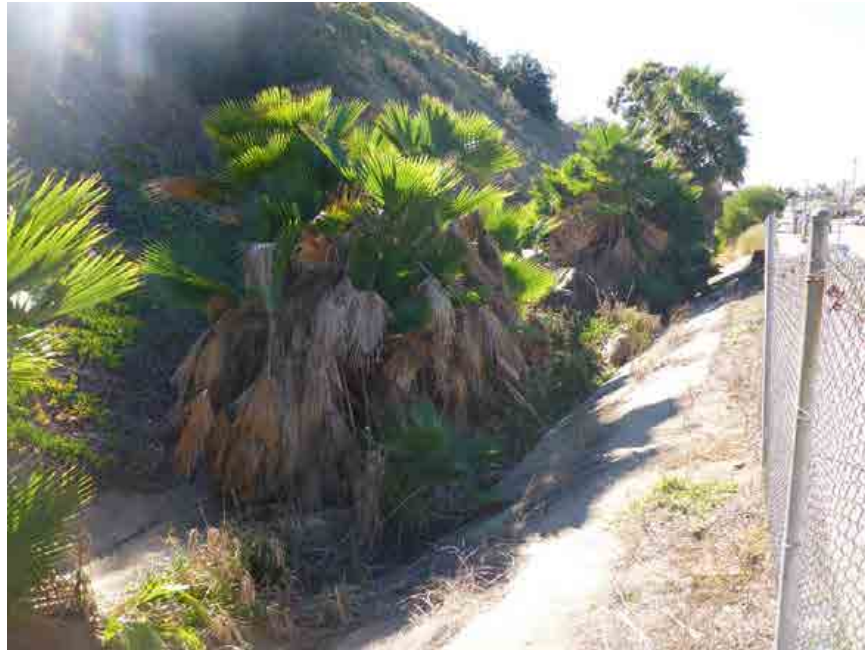
Photo 25. Parkside Channel Pre-Maintenance 12/4/15

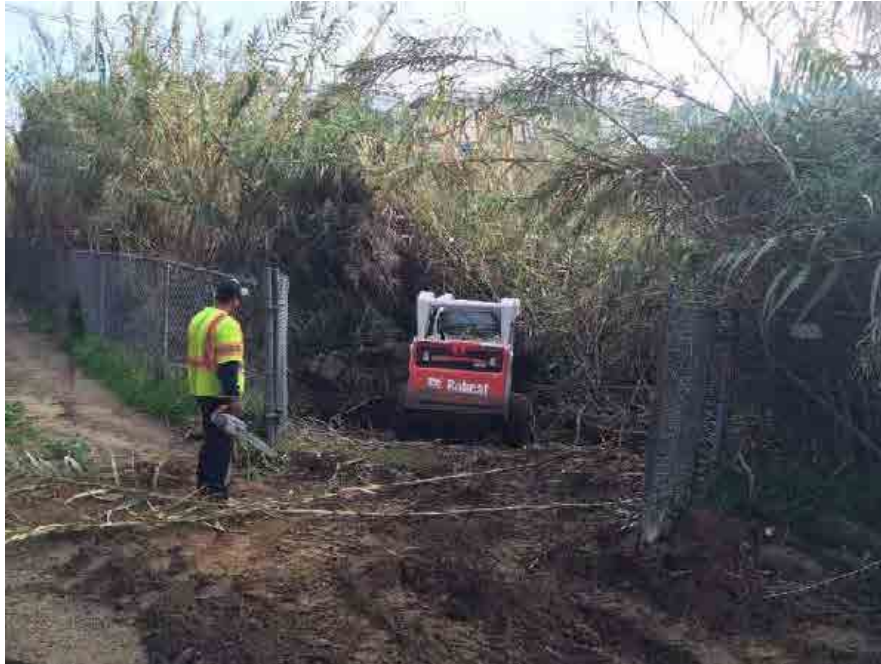
Photo 27. Washington Channel Pre-Maintenance 1/20/16

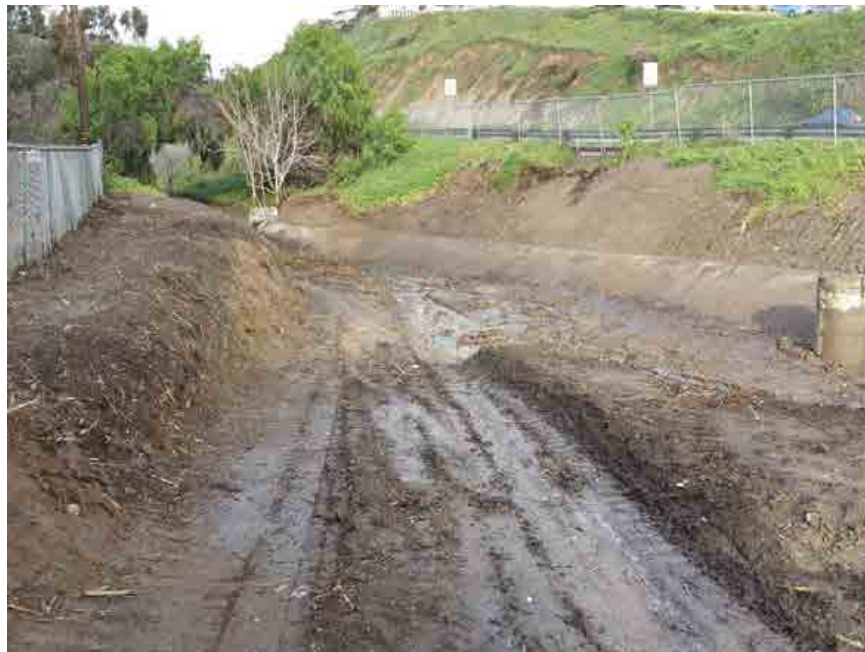
Photo 28. Washington Channel Post-Maintenance 2/1/16

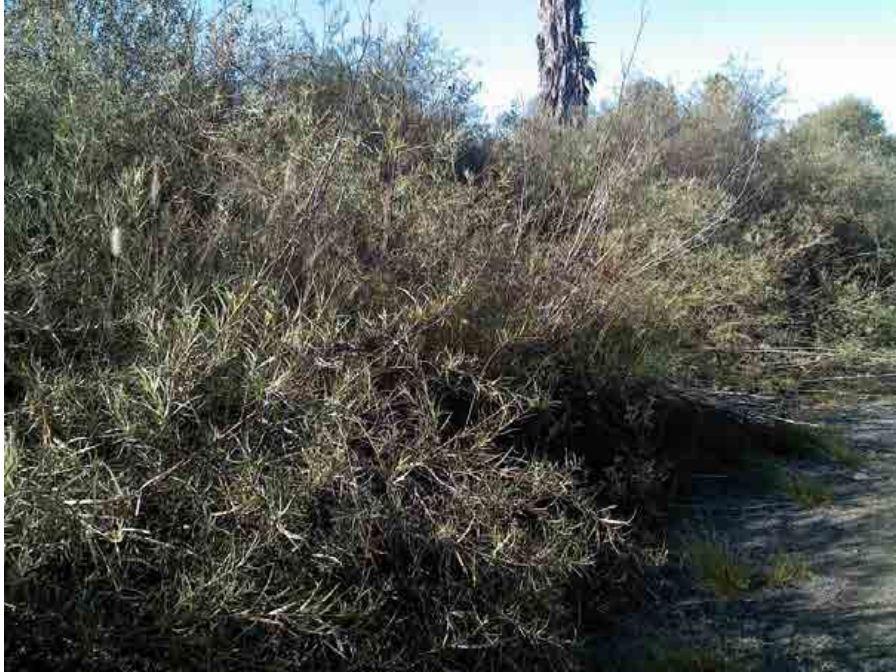
Photo 29. Smythe Channel (MMP Map 130) Pre-Maintenance 1/7/16

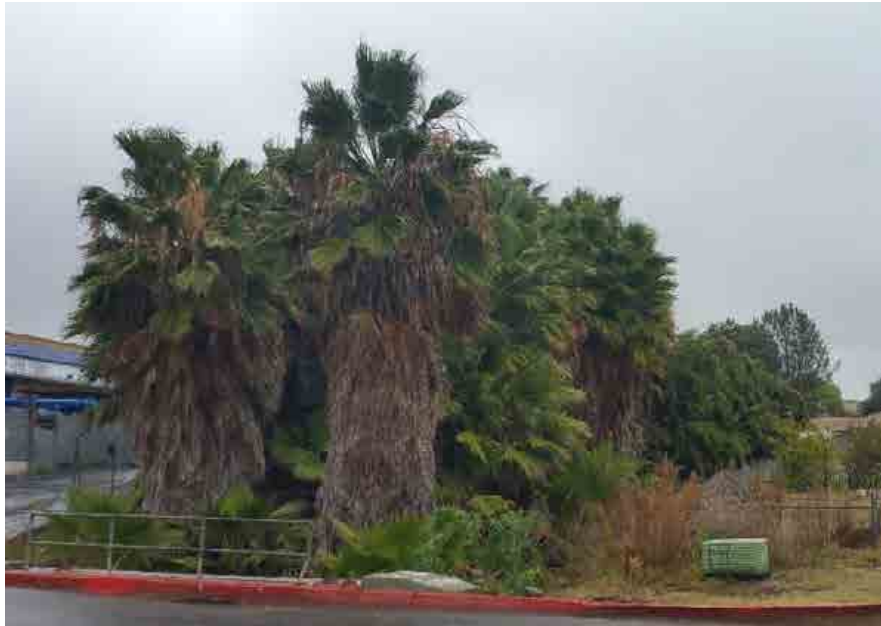
Photo 31. Chollas Creek Channel (MMP Map 71) Pre-Maintenance 12/22/15

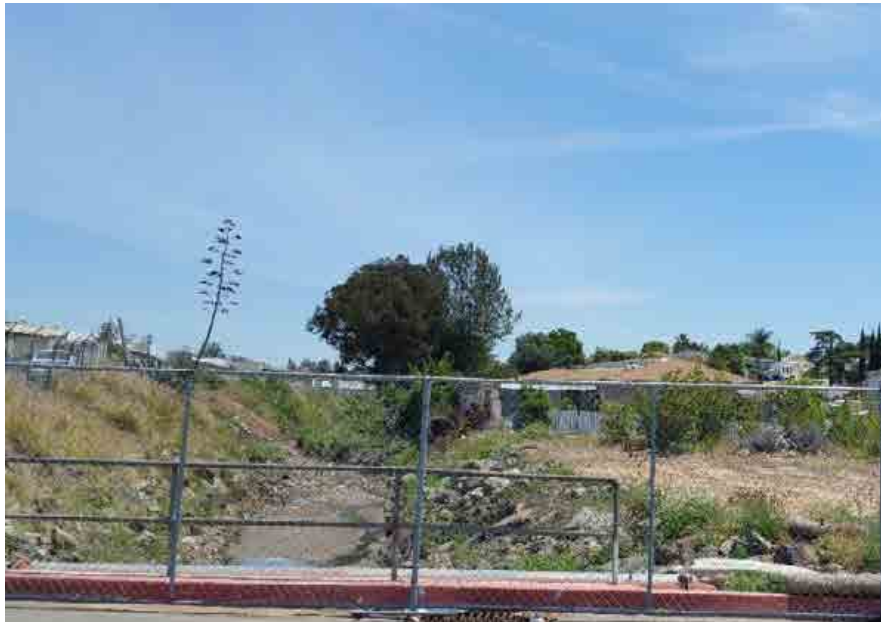
Photo 32. Chollas Creek Channel (MMP Map 71) Post-Maintenance 5/11/16

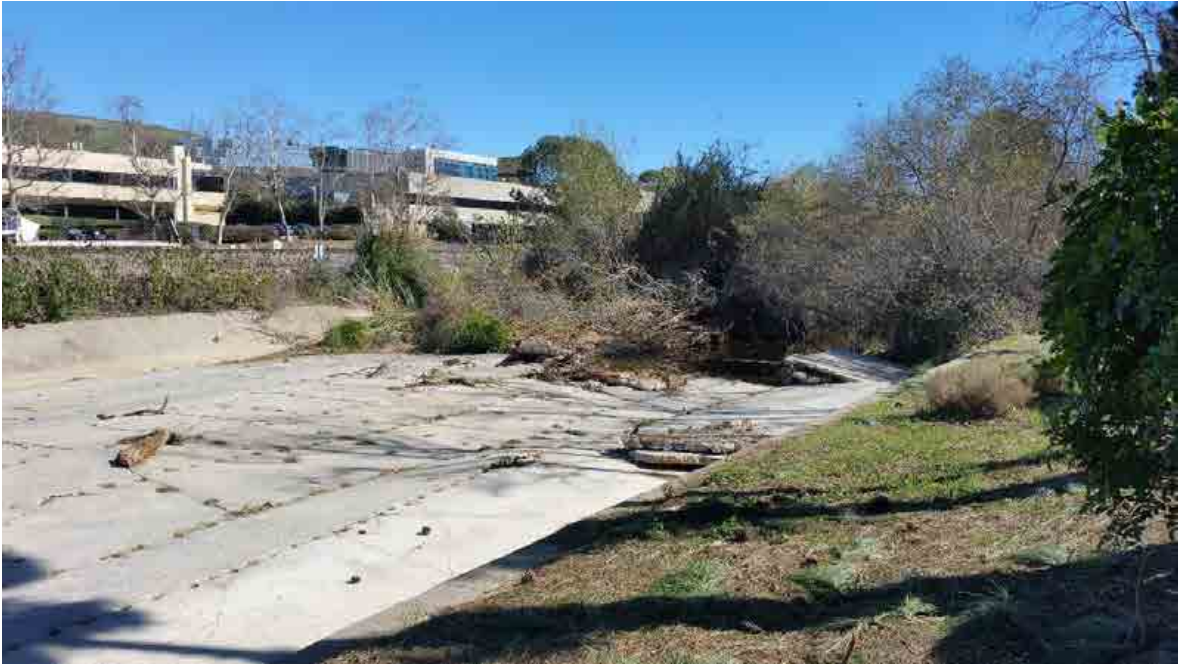
Photo 35. Sorrento Valley (Soledad Creek) Map 12 Emergency Concrete Repair Pre-Maintenance 2/5/16

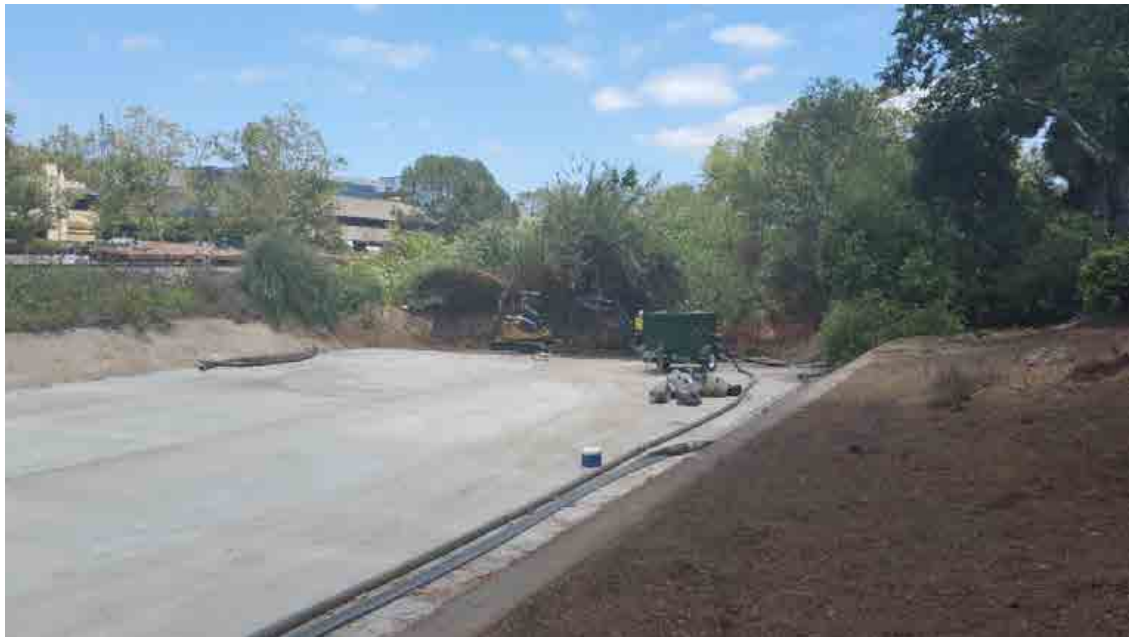
Photo 36. Sorrento Valley (Soledad Creek) Map 12 Emergency Concrete Repair During/
Post-Maintenance 6/13/16
