CHAPTER 3 – SOLIDS TREATMENT FACILITIES

3.1 Solids Process Facilities

3.2.1 Condition Assessment -“Capacity Limiters”

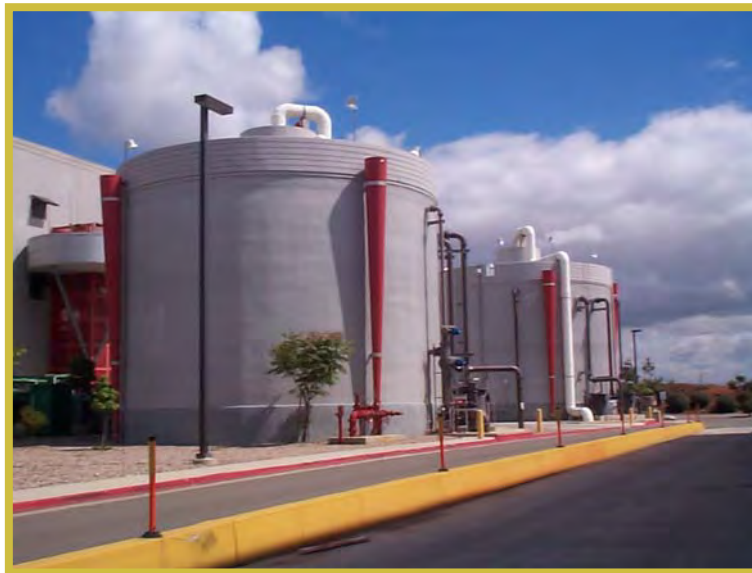
RAW SOLIDS RECEIVING TANKS

1. *Clogging of suction piping:* The long suction piping header from the duty receiving tank to the raw solids transfer pumps is prone to clogging and the flushing connections provided are too small.
2. *Lack of isolation valves at the tank outlet pipes.* The receiving tanks are fitted with flexible rubber connectors adjacent to the wall connections. When the connectors inevitably develop leaks or rupture, there will be no means to isolate the leak from the tank and the contents of the tank may spill.

1. Provide isolation valves and larger connections to facilitate flushing and draining the long header suction pipe to remove accumulated solids.
2. Install isolation valves between the tank walls and flexible pipe connectors to prevent emptying of a tank in the event that a connector possibly ruptures during a seismic or abnormal hydraulic surge event.
3. Have NCWRP implement a periodic schedule for pigging the raw sludge pipeline.

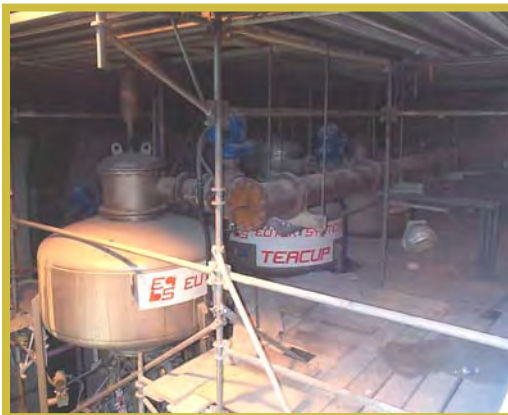
TEACUP DEGRITTERS

1. *Inaccessible teacup valves:* The teacups, associated valves and accessories are very difficult if not impossible to access for repair and maintenance without putting plant staff at safety risk. This results in reduced reliability due to inability of plant staff to perform needed maintenance.

3. Review and tune the control strategy so that the degritters function automatically under a wide range of operating conditions.
4. Included in the Brown & Caldwell Odor Control Facility Evaluation done in 2003 are alternatives for enclosing the snails and grit/screenings bins. These alternatives should be revised and the most feasible alternative should be selected for implementation.

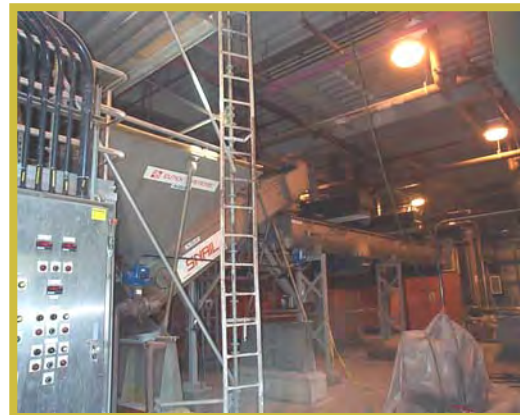
GRIT DEWATERING UNIT AND
SCREW CONVEYOR

2. *Inadequately-designed grit hoses:* Lack of vertical separation between the grit teacups and the dewatering units result in minimally sloped 3-inch diameter discharge hoses. These hoses develop low spots that collect grit and cause frequent plugging. In addition, the utility water connection to these grit hoses is too small to provide the needed flushing action.

When replacing the snails in the future, evaluate the feasibility of installing longer and steeper units that could be mounted directly on the floor. This would provide more slope for the grit hoses and would eliminate low spots. This would also allow the hoses to be run below the access platform and would eliminate tripping hazard.

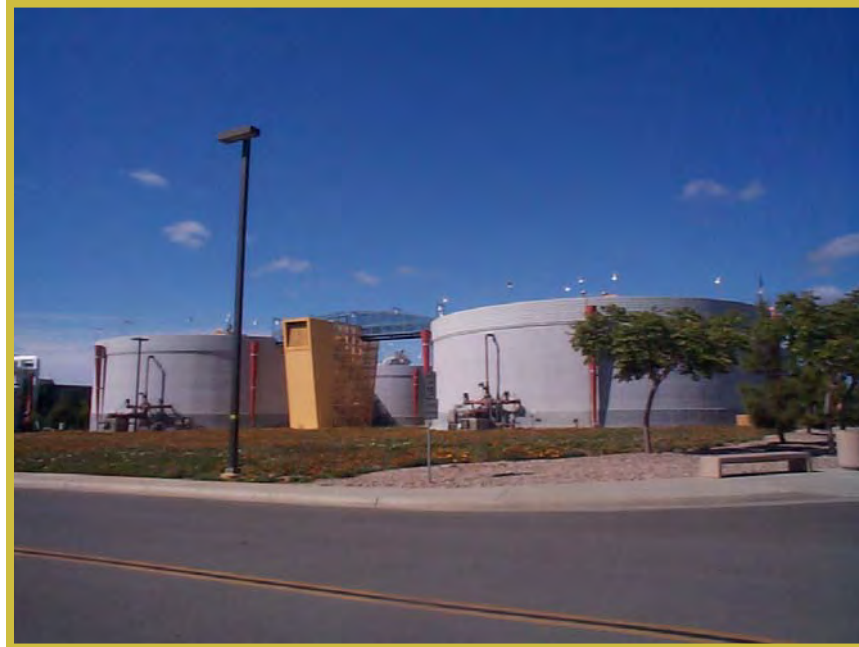
ANAEROBIC DIGESTERS

1. *Poor design of the ferric chloride (FC) system:*
 - a. The FC injectors are mounted in steel pipe sleeves that penetrate the digester side walls near the base of the digesters. These pipe sleeves are subject to FC concentrations that can corrode the sleeve and cause a digester spill.

- b. The actuators provided are too large for the size of the PVC piping in the FC system. These oversized actuators can exert too much torque on the valve operators and can break the valves. A valve breakage will cause a chemical spill.

2. *Undersized overflow pipe:* The common overflow pipe from the 3 digesters to the Digested Biosolids Storage Tanks (DBST) has insufficient capacity when the receiving DBST is near its high operating level. In addition, this common overflow pipe is inadequately sized to handle flows generated during digester transfer operations and in the past resulted in overfilling the digester and spilling from the digester overflow boxes.

3. *High overflow weir level.* The Digester Emergency Overflow Weir Level is too high: This has caused the digester liquid to rise above the digester's roof level before it can overflow to the emergency overflow system. This could result in hydraulic uplift force that can potentially damage the roof structure. This was of great concern after construction to the plant's designer.
4. *Unstable gas and foaming operations:* These occur due to excessive digester mixing (to prevent solids accumulation). MBC O&M staff has alleviated the gas foaming problem by reducing the axial mixing pumps operating duration to 2 days per week.

1. Recommended corrective measures for the FC feed piping /valves problems:
 - a. On one of the digesters, MBC O&M staff has capped the ferric chloride injection pipes (at 3 locations) and instead extended the FC feed pipe up to roof level and into a roof-mounted injector so that the corrosive chemical is dripped down onto the digester liquid eliminating risk of corroding any ferrous digester material. Modify the FC injector piping for the other digesters similarly.

It is recommended that a hole be cored through the wall between the overflow boxes and the emergency overflow box to avoid submerging the digester roof.

3. The emergency overflow weir level needs to be lowered to eliminate this risk of structural damage to the digester roof. Core a hole through the wall between the overflow box and the emergency overflow box to avoid submerging the digester roof.
4. It is recommended that the current 2 days per week operation of the mixing pumps be maintained.

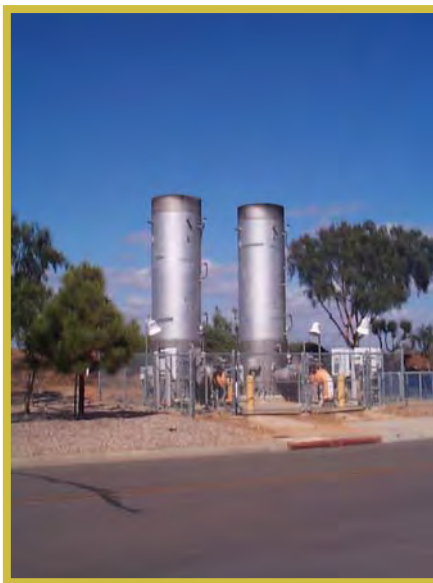
WASTE BIOGAS FLARES

1. *No emergency power to the gas flares:* During a plant power outage, the gas flares shut off and fail to reignite as they are not connected to any emergency power supply. Flares become inoperative during an outage.

2. *Condensate accumulation:* Problems associated with condensate accumulation in the biogas piping are present.
 - a. Condensate accumulates at condensate traps installed in valve pits. Each trap (total of 6) is at the terminus of a branch pipe connected to a low point of the gas collection header (low pressure). At each trap, the occasional failure of the automatic (motorized) drain valve combined with gas pressure transients resulting from sudden increase in flows from PLWTP have caused the water in the trap to be blown out and resulted in occasional hazardous biogas emissions. Because of this, operators have opted to close the upstream manual isolation valve and perform the daily task of manually draining any accumulated condensate in the gas header. The installed condensate trap device itself has thus become, manually-operated instead of automatic.

1. A recommendation to provide emergency power from Area 76 diesel engine-generator sets to the flares and its biogas motorized valves is under review for implementation.
2. a. In 4 of the 6 condensate traps, plant staff installed a water U-trap with a utility water connection. The upstream manual isolation valve operator was fitted with an extended shaft to allow manual operation from ground level. These modifications need to be done on the two remaining traps.

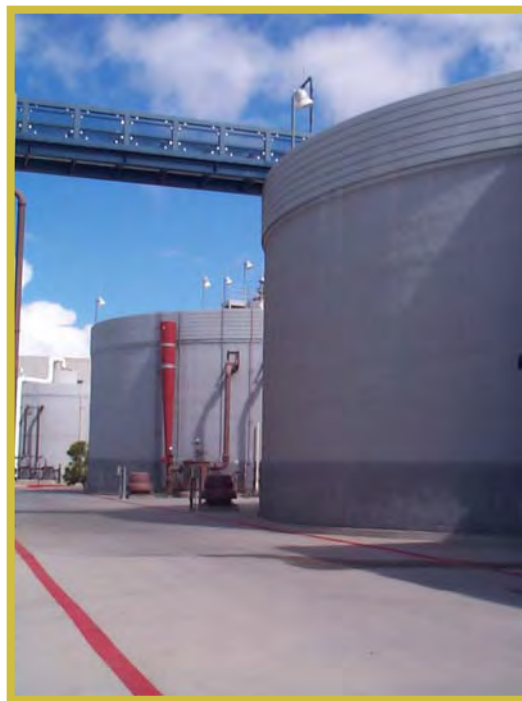
DIGESTED BIOSOLIDS STORAGE TANKS

1. *Gas venting at PLWTP sludge feed pipeline:* Small increases in flow from PLWTP result in unstable inflows into the DBSTs. These abnormal flow spikes are observed for a period of 15-20 minutes after PLWTP varies its flow. This is of particular concern when restarting the sludge flow in the PLWTP forcemain. At a minimum starting sludge flow of 350 gpm from PLWTP, MBC can see peak inflows exceeding the PLWTP flow by a factor of 5. During these spike events, upsurge can cause the biogas to be vented from the DBSTs. (See problem #4 in previous Biosolids Storage section). This problem is believed to be caused by “gas binding” at a high point in the incoming pipeline. Although an air-vacuum and air-relief (AVAR) was provided at this high point, it has been isolated from the pipeline to avoid continuous venting of methane gas immediately upwind of the Area 19 Main Plant Switchgear (MPSG) air intake. The continuous venting is a result of the AVAR being at an elevation higher than the DBST low operating level. MBC O&M resorted to periodic manual venting of the pipeline. This practice was discontinued due to compliance concerns with the APCD and due to safety concerns.

2. *Incorrectly located pressure relief device:* A rupture disc installed to protect the PLWTP sludge pipeline from abnormal high pressures is incorrectly located. This pressure relief device was installed on a piping section near the DBST’s area which has the lowest pressure rating at 150 psig. Plugging of the pipeline at the intermediate upstream pipe section (250 psig rated) can potentially result in higher pressures (up to 405 psig). This pipe clog could rupture this important pipeline.

4. *Too much grit in PLWTP inflow:* On inspection of the DBSTs, the PLWTP inflow was found to have a large amount of grit. This abnormal grit volume causes plugging of the dewatering transfer pumps, its suction piping, and results in more frequent cleaning of the storage tanks. These problems are magnified anytime PLWTP draws down one of its digesters for maintenance.

5. *Risk of biosolids tank wall punch-through:* One of two overflow pipes between the biosolids storage tank and the emergency storage tank is hard-piped. This rigid piping is not recommended by the tank designer. Rubber expansion joints are provided at the wall connection to one tank but not on the overflow piping tank connection. Without the expansion joint, even a moderate seismic event could cause this hard piping to punch through a tank wall, damaging the tank and risking a spill.

1. Investigate the cause of the unstable inflows and develop a corrective plan.
2. A technically feasible solution is to install a new pressure relief device or relocate the existing device on the intermediate pressure section of the pipeline. The exact location of this new pressure relief device will be further investigated.

3. Install pumps with the necessary flow and head capacities. A project to reestablish the intended design flows and redundancies and to simplify the control strategy has already been designed and bid. Completion of this project is recommended.

- c. All of PLWTP's digester sludge screens are now on-line and should help reduce the grit amount in the MBC inflow. Continued operation of the PLWTP screens is recommended.

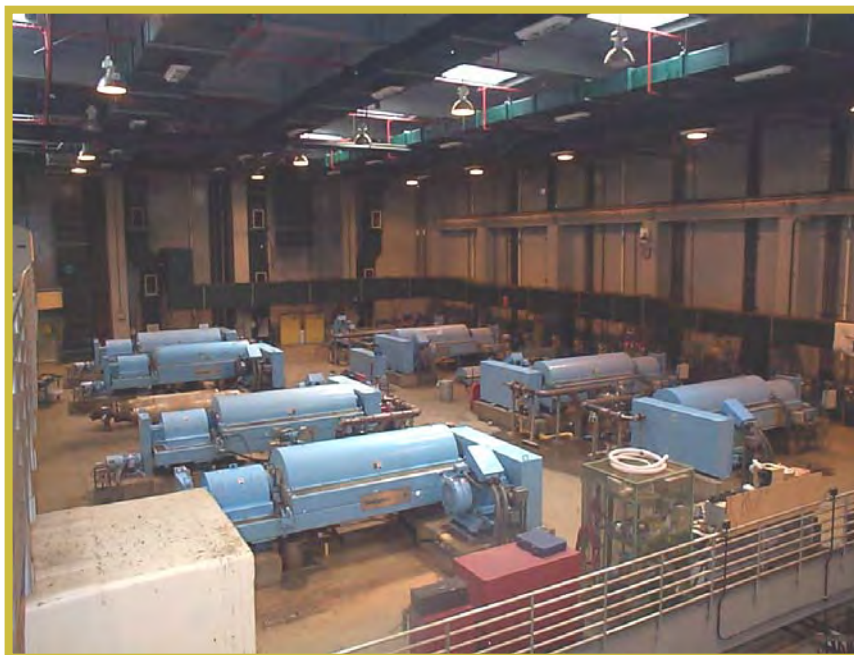
DEWATERING CENTRIFUGES

1. *Standby capability deficiency:* Presently, there are 8 dewatering centrifuges and 8 dedicated sludge feed pumps. If a pump goes out of service, then the corresponding centrifuge also is put out of service or vice-versa. Centrifuge units #1 and #8, including their paired feed pumps, are designated for standby service only for centrifuge units #3/#5/#7 and #2/ #4/ #6, respectively. Due to this present control strategy, all auxiliary equipment of the centrifuge (sludge feed pump and chemical feed pump included) are routed and controlled via the centrifuge controls. Feed pumps #1 and #8 by themselves cannot provide standby service if a pump in its group is put out of service. As the shutdowns for repair and maintenance of the centrifuges become more frequent, standby pair units #1 and #8 are called to duty more often and for longer periods than intended. On occasions when a standby pair is on duty and an auxiliary equipment of a regular duty centrifuge fails, that whole unit will have to be shutdown as the control strategy dictates, decreasing the dewatering process output.

2. *Inadequately-designed centrate collection pipe system:* Existing undersized and inadequately designed centrate (CN) collection headers result in centrate surcharging at the centrate discharge chutes and causes centrate to overflow into the foul air duct connections. The surcharging is caused by flow interruption at the CN header tees (instead of lateral wyes) and insufficient slope of the centrate collection headers. Centrate in the odor collection ducting eventually gets to and damages the odor fans and scrubbers in Area 60. The presence of centrate in the foul air ducts reduces their exhaust capacities. O&M staff has thus connected drain piping on the odor headers and routed these drains to the area floor drains for centrate removal. The large amount of drained centrate overflows at the floor drains creating a safety hazard for the operators.

The centrate-loaded foul air duct header in the pipe gallery also runs the risk of collapsing if its hanger supports fail from the extra weight. With a failed foul air duct header, safety of O&M personnel is at risk.

3. *Scaling of centrate pipe headers:* Significant scaling is observed in the centrifuge's centrate (CN) discharge chutes and in the two existing CN collection headers directly under the centrifuges. These CN collection headers must be cleaned with high pressure water every 3 months via flushing ports installed at the header ends. Similar scale build-up due to the centrate's high pH is suspected in the inaccessible 36-inch diameter main centrate collection header in the pipe gallery. With no access means into this 36-inch pipe, its condition has not been verified nor can it be addressed.

4. *Cake hopper level sensor problem:* Centrifuge cake pump operation is controlled by a level sensor mounted on a 5-ft tall cake hopper. With the cake's tendency to "cone up," a requirement for a minimum of 2 feet sensor distance above the cake, and lower water level (LWL) at 6 inches above the hopper bottom, an actual hopper operating range of no more than 2 feet (vs. 3.5 ft design) is only available. The cake spatters in the hopper and also on the level sensor result in erroneous level readings. Worse, this short sensor operating height causes intermittent operation of the centrifuge, bin screws and cake pumps. This causes the bin screw motors to trip out due to high amperage when the bin level exceeds 1 foot (design was for 4 feet). This in turn causes excessive wear on the cake pumps when they ramp up from zero to full speed in short time. This problem also occurs with the cake pumps in the truck loadout area.

6. *Capacity limitation of centrifuges:* Average flows to the dewatering centrifuges are within the design flows set for the Consumer's Alternatives Phase 1 year 2010 figures. However, due to operational conditions, MBC's experience shows the need for an extra unit available for standby service or the need for larger capacity centrifuge units. Several factors contribute to this need:

With the MBC mass balance model runs performed by Brown and Caldwell (see Appendix C), it has been determined that the addition of one of two more centrifuge units or replacement with larger units to provide more dewatering capacity (Problem P-10.6) will not be required until 2025. In the interim period, due to increasing wear and tear, the existing centrifuges will be replaced with new same size units. The centrifuge capacity and redundancy problems will be addressed with the implementation of a number of projects (See recommendation #6). Among these, the addition of the 5th sludge and 5th polymer feed pumps for each of the 2 sets of dewatering centrifuges (4 units each set) will alleviate the redundancy problem. This project has been approved for implementation in FY 2007-2010.

2. To address centrate header overflow problems, a project was recently completed in 2005 that installed a U-pipe trap at the CN's 36-inch tee connection to prevent centrate overflows into the odor control exhaust ducting. A phase 2 construction will replace the odor header ducting with ductile iron piping with wye connections and with steeper pipe slope. This will provide a second header for added centrate withdrawal capacity while the header also serves as a foul air conduit. A final third phase is planned to address future larger units or additional centrifuge units. This phase consists of replacing the two existing original centrate headers under the dewatering centrifuges with larger size headers.
