CABRILLO BRIDGE Rehab/Retrofit Project

Description of work

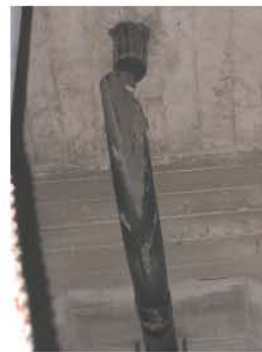
Photo of Bent 6 - interior broken down drain before repairs were made.

Repair existing drainage systems to prevent further water damage.
