SUNSET CLIFFS NATURAL PARK

Final Drainage Study

**SUNSET CLIFFS NATURAL PARK
DRAINAGE STUDY**

MAY 2012

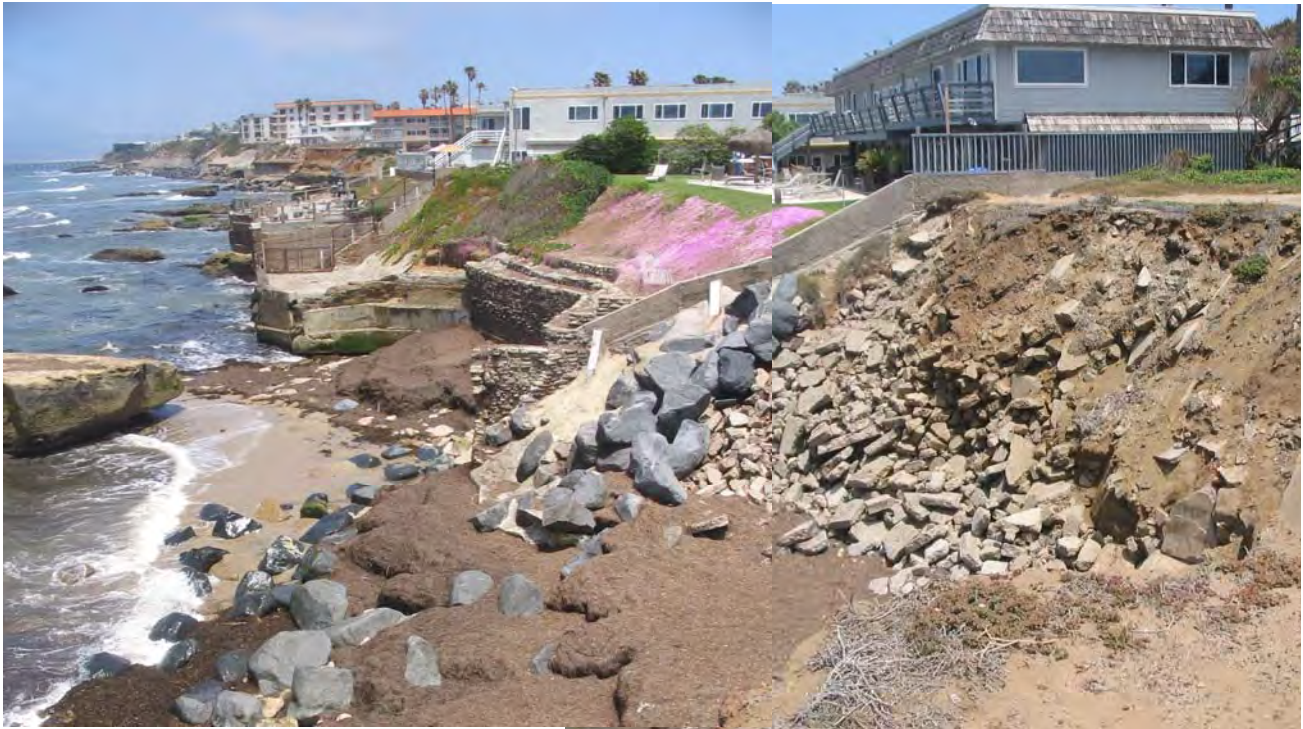
Photo 1 –Looking north at the Adair Street street end rubble, Site 10.

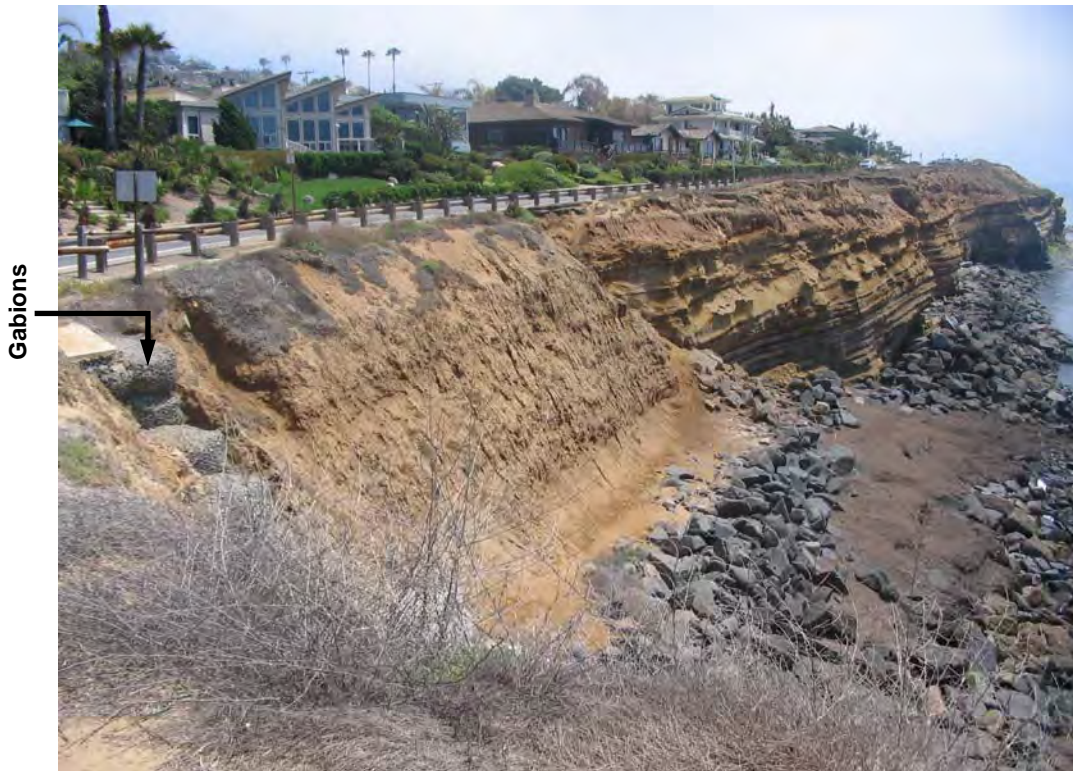
Photo 12 – Site 4 view south of Monaco Street

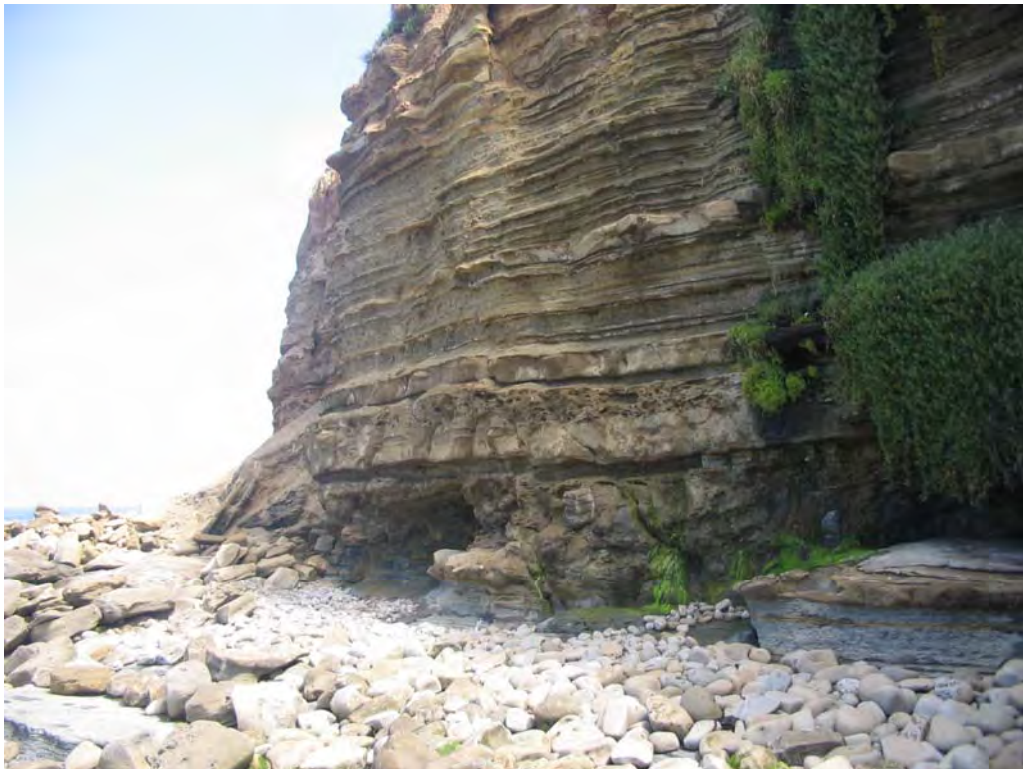
Photo 13 – Site 3 view north from Ladera Street Stairway

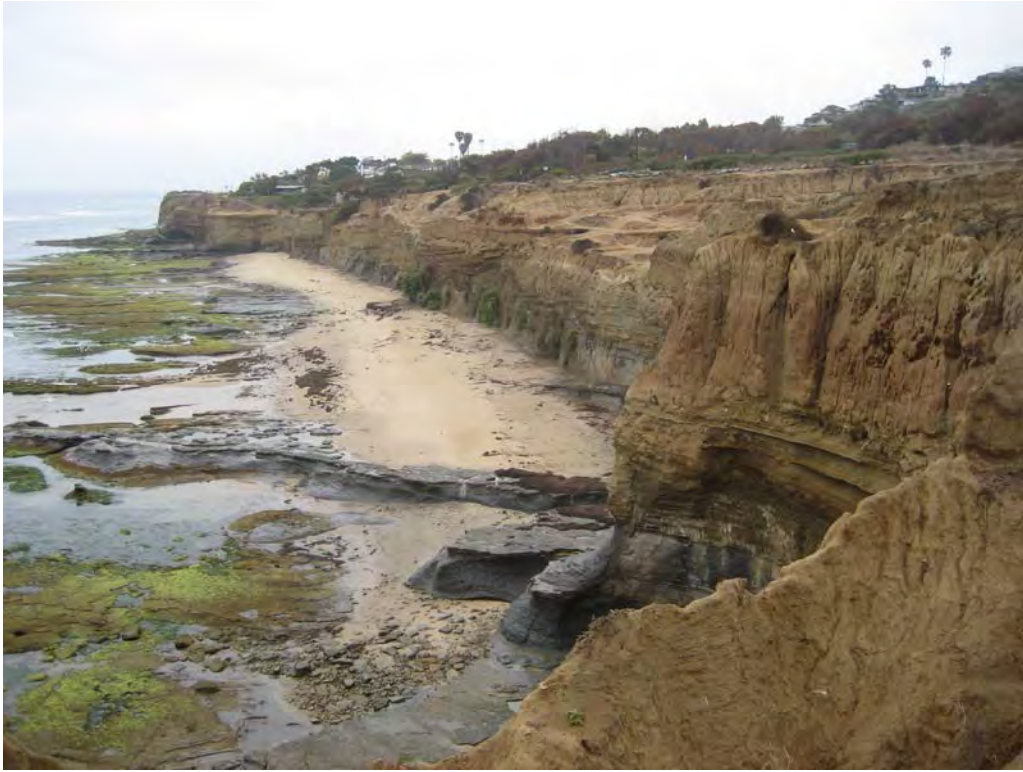
Photo 15 - View North at Garbage Beach, Site 1.

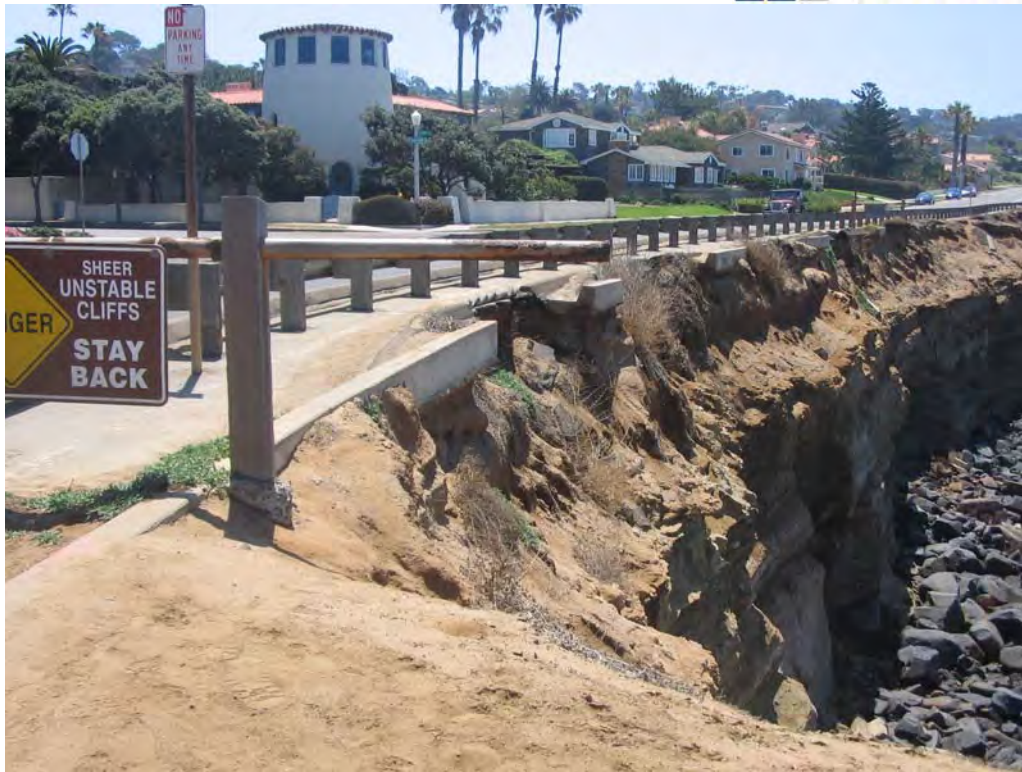
PH4: Bluff Failure caused by 2 caves joining on both sides of bluff protrusion and water impact through these formations.

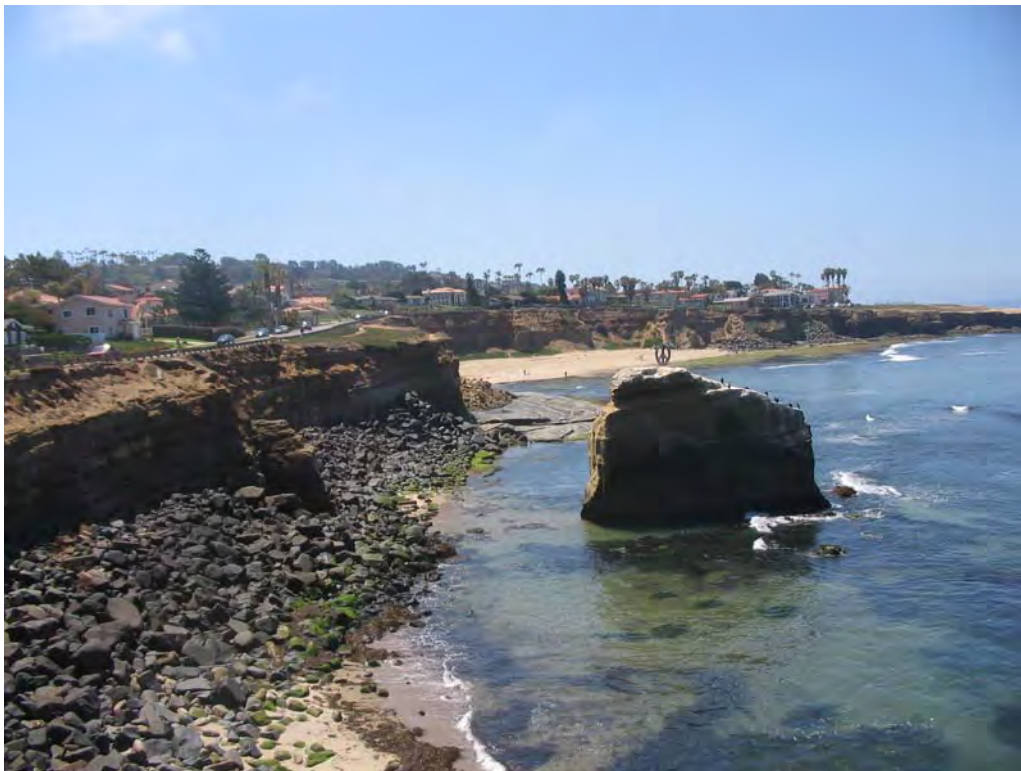
PH5: Site of the April 2007 Bluff failure fronting Dedi's house.

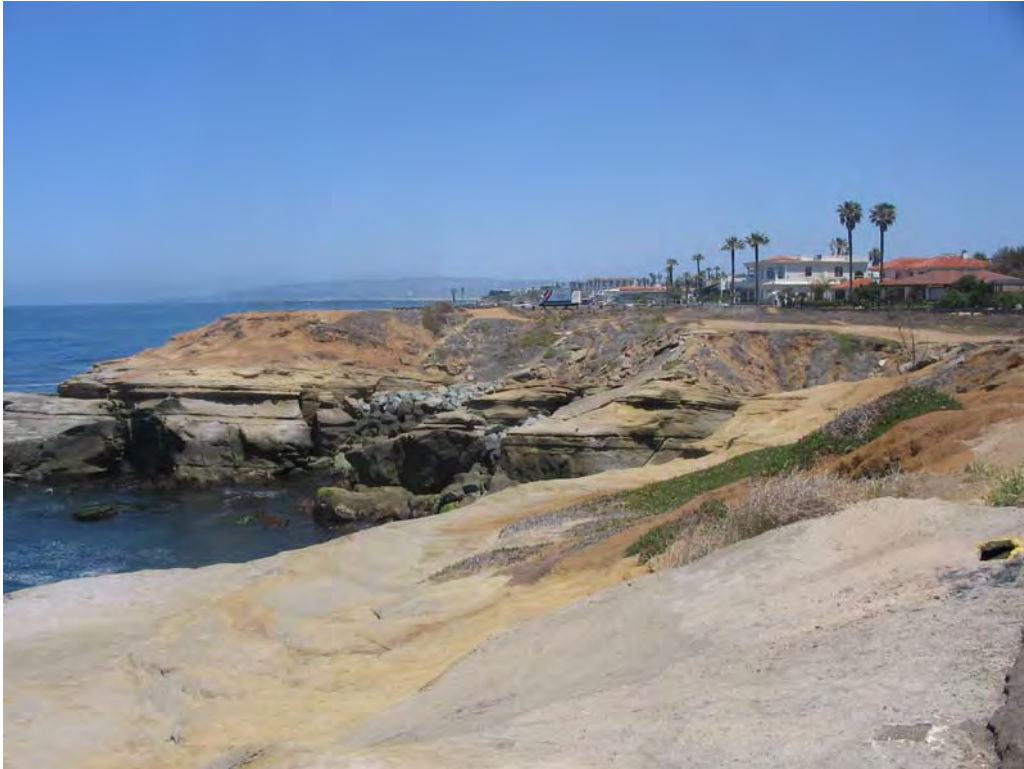
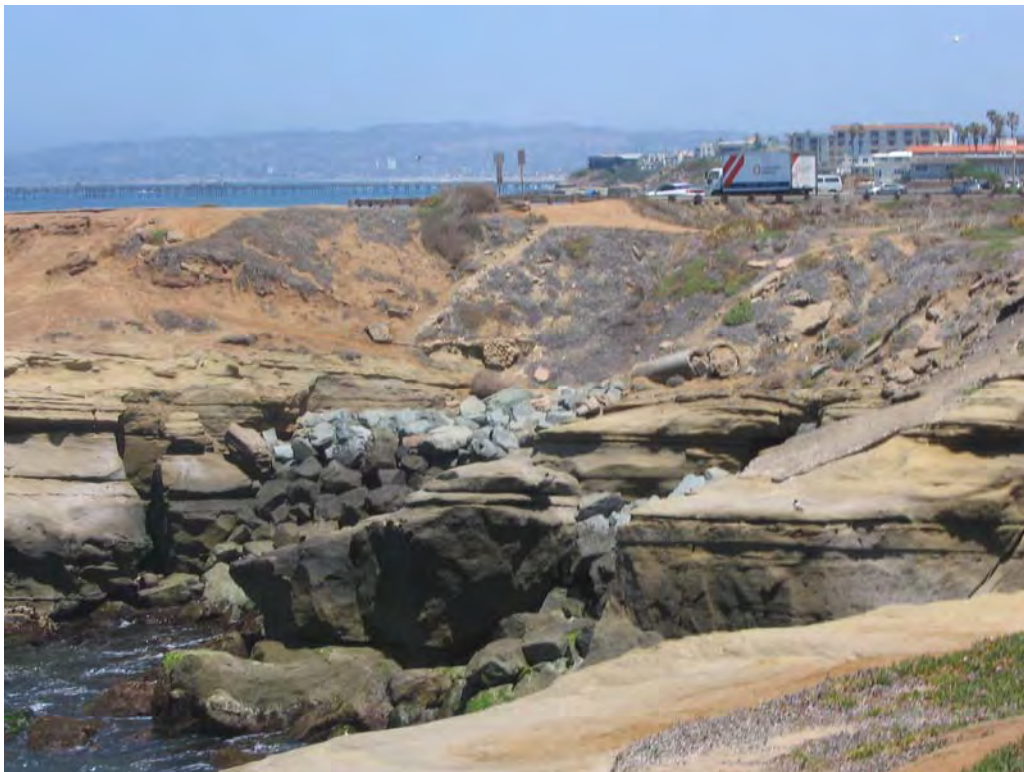
PH17/18: Fill on cliff face the end of Osprey.

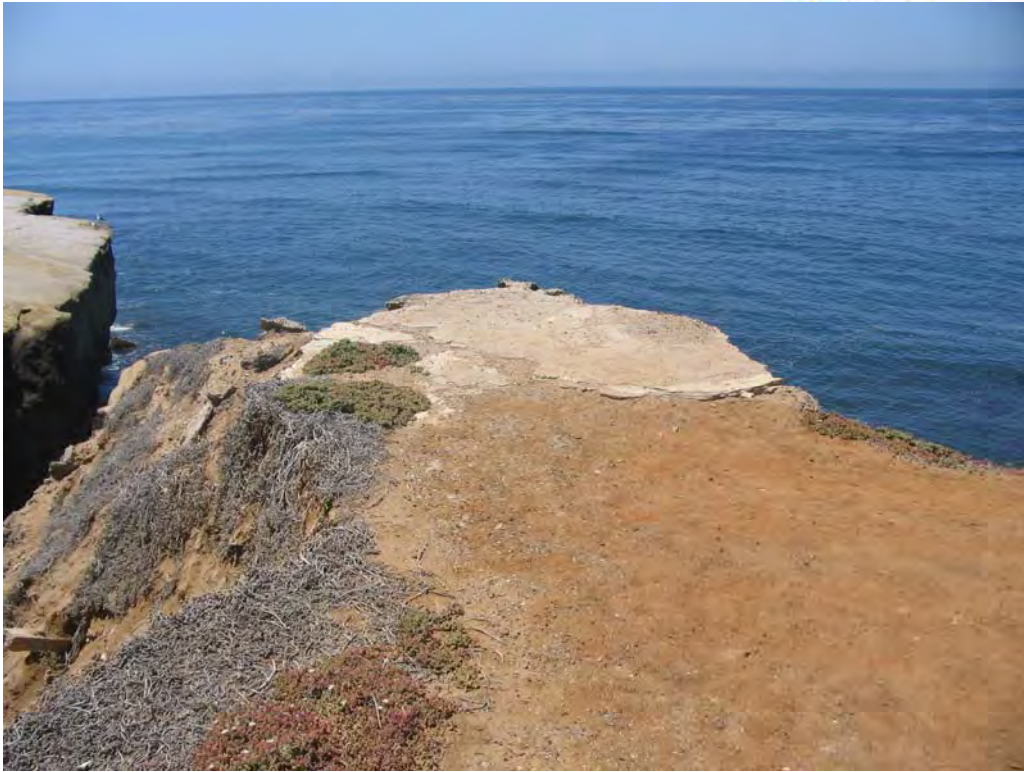
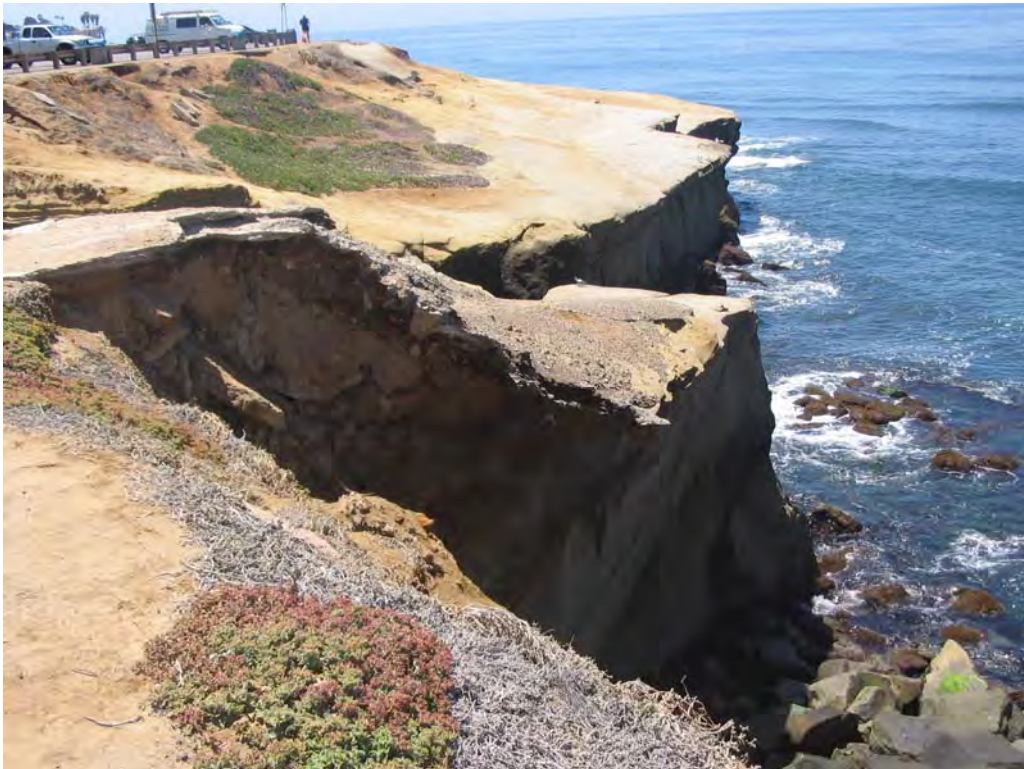
PH21/22: Another “failed” attempt to control runoff erosion of bluff, by pouring a concrete slab over the top of the point. These things need to be removed.

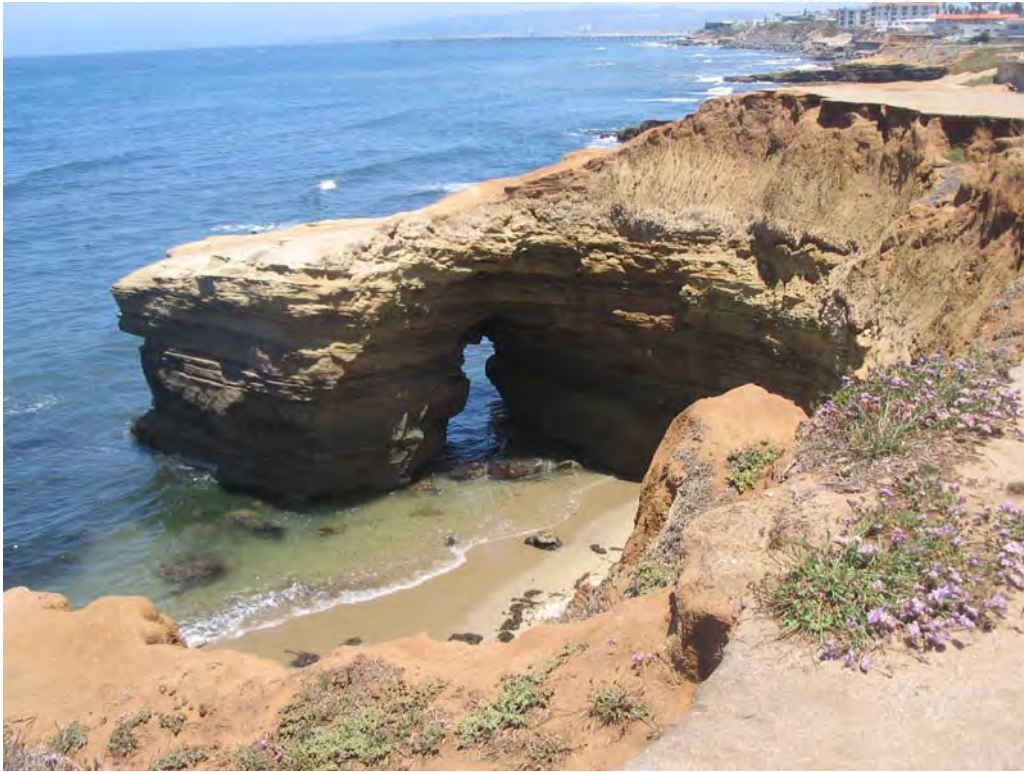
PH23: sea arch formed over last >20 years; caused by natural erosion (waves, wind).

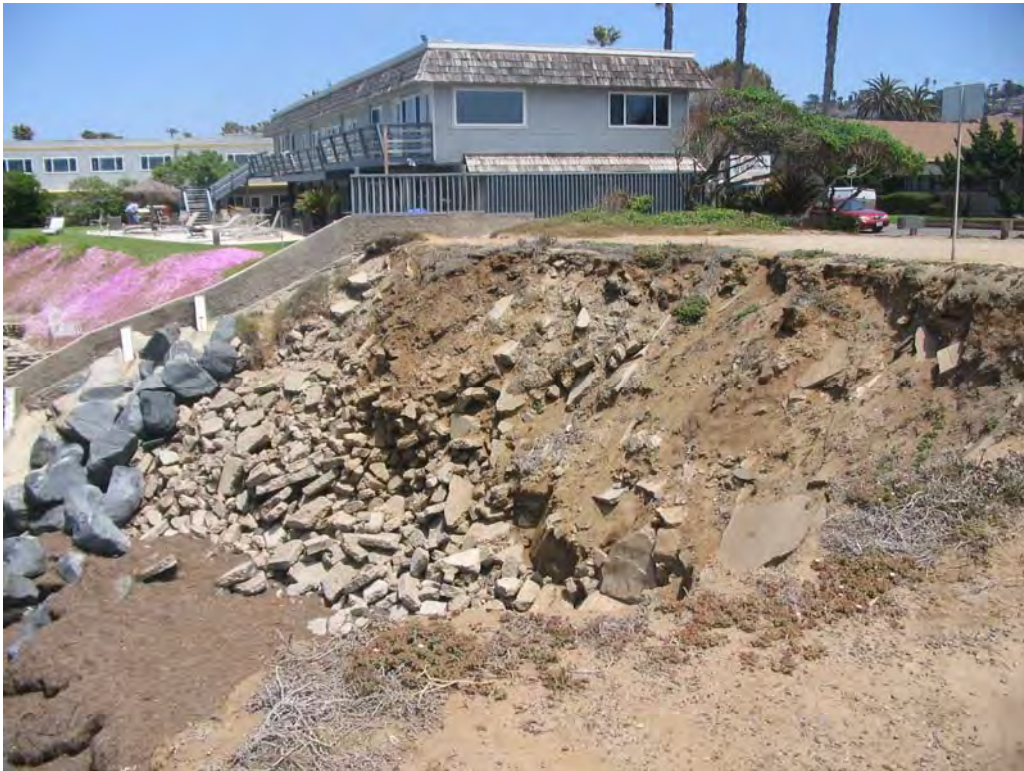
PH28: construction fill, concrete rubble. 1930 whole caved in and rubble fill was placed.

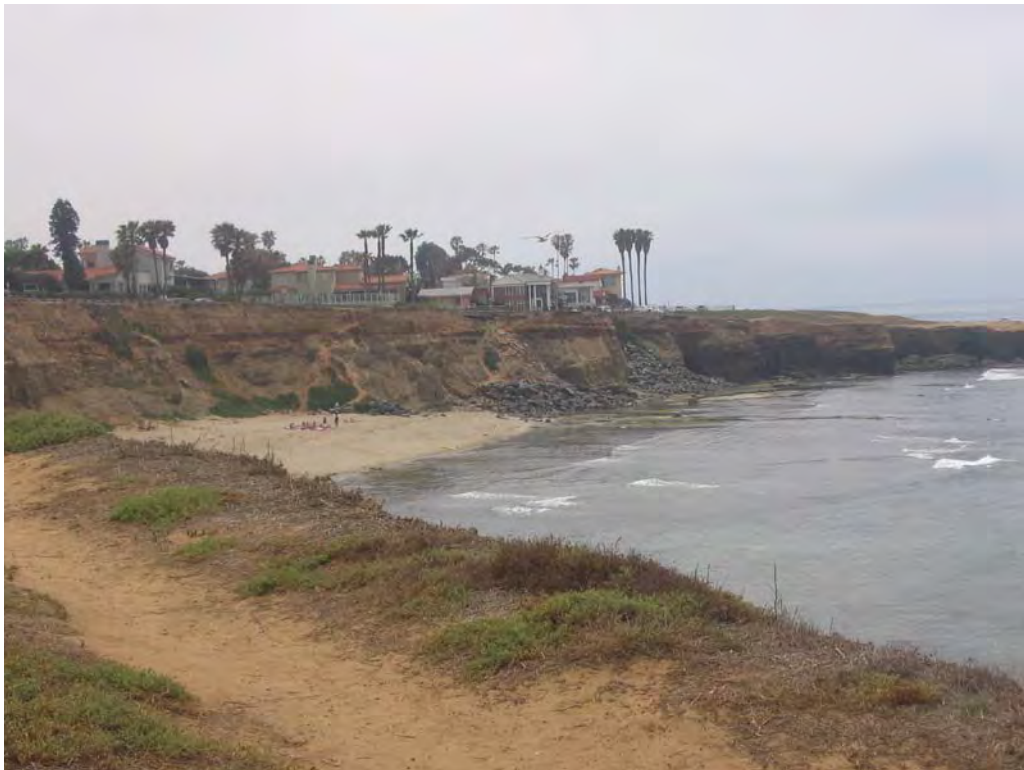
P33: No surf beach, no recommendations for beach access (no parking/restrooms/etc.) in Master Plan. However, it is a popular spot and foot traffic is causing erosion via paths and seeping water.

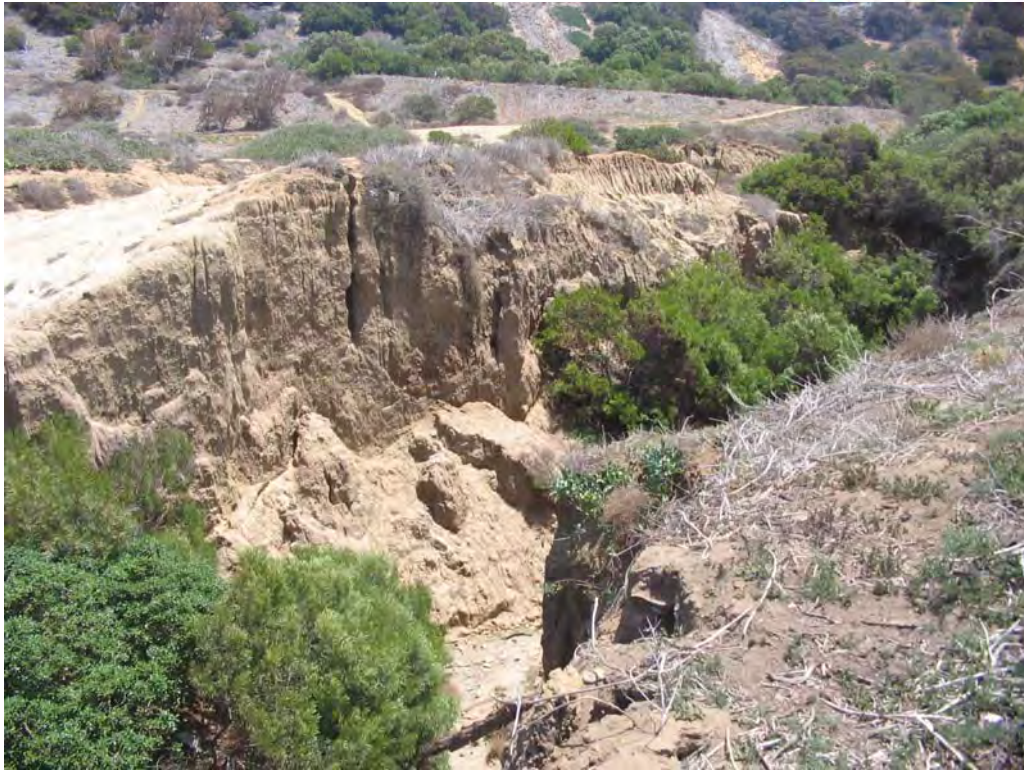
Grand Canyon (No man's Land). How to repair this erosion so park can be restored after new pipe is layed in the crevice?

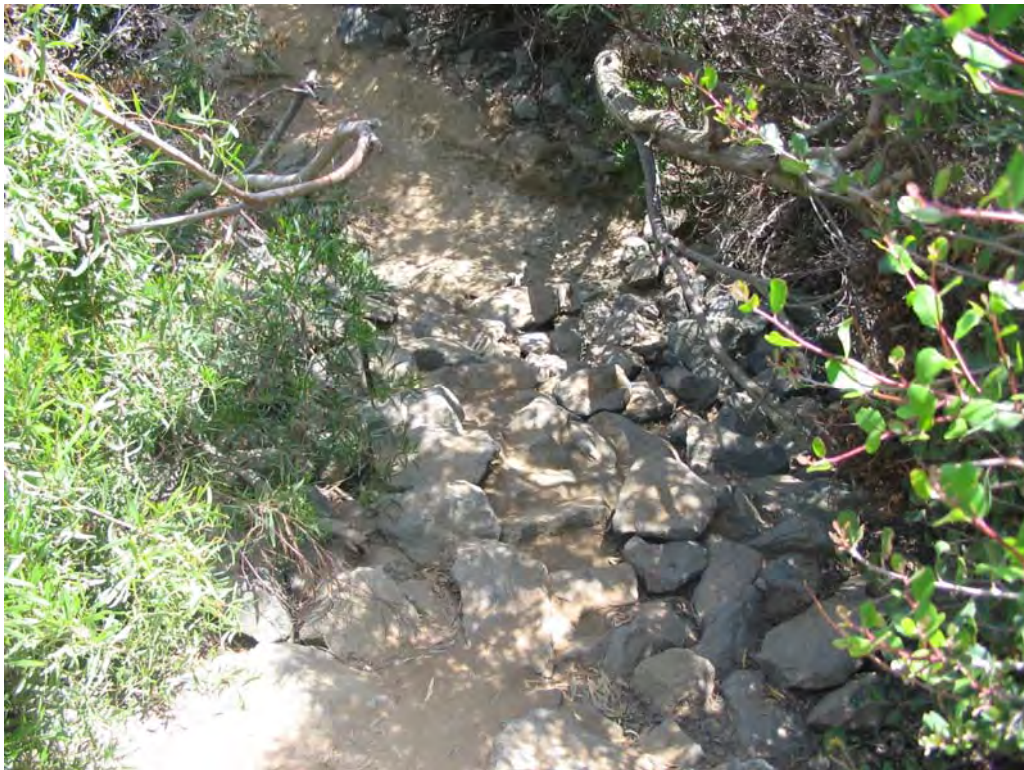
This is the sink hole described on Page 4 of this memo.

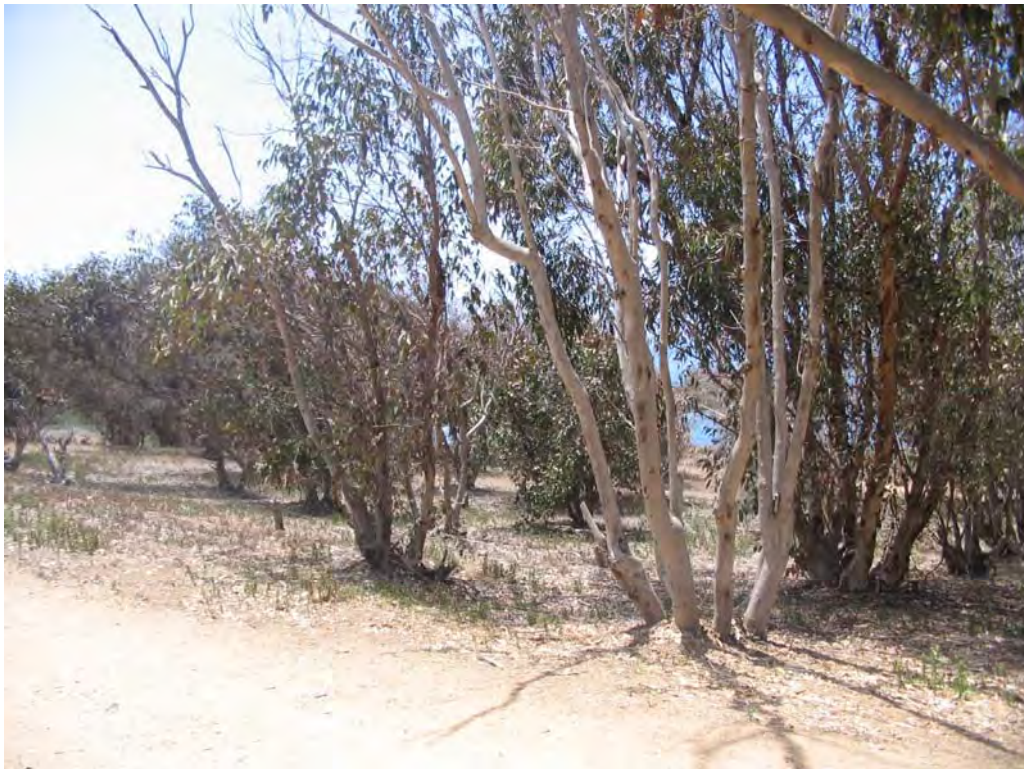
These eucalyptus trees were planted long ago. Need to be removed and replaced with natural vegetation.

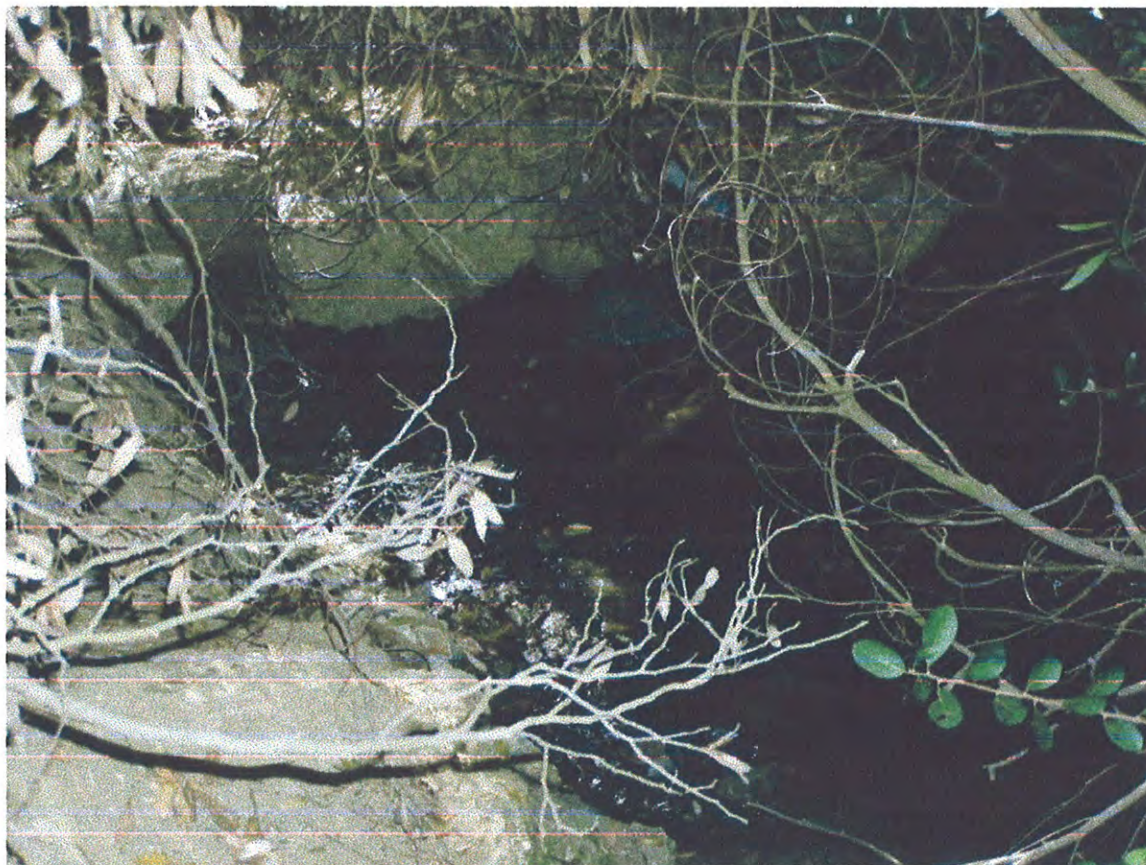
During periods of heavy rain, the 24 inch diameter outfall pipe, that is located where the white piece of pipe can be seen in the picture below, discharges over the pond and into the non-native shrubbery below that should be removed per the Master Plan.

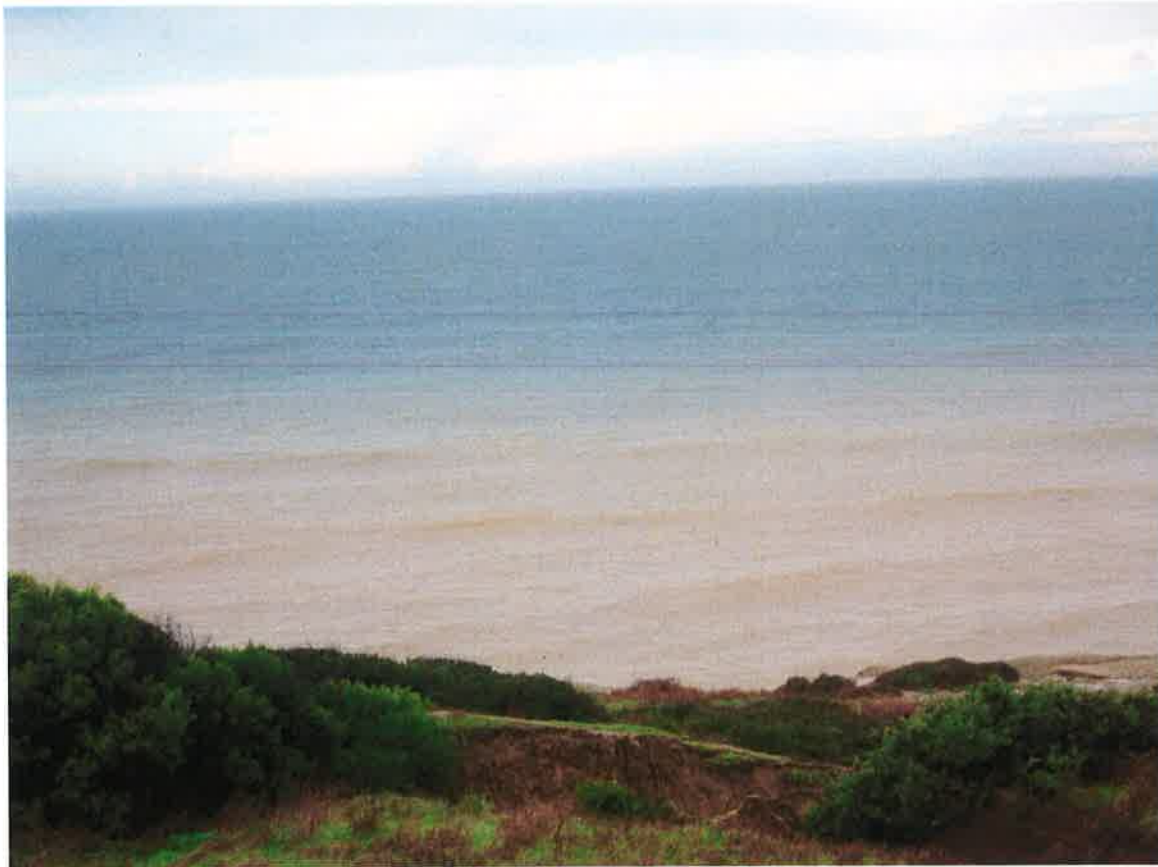
Figure 1. Turbid nearshore waters adjacent to the Sunset Cliffs Natural Park December 22, 2010 visually alerts the public to the contaminants and massive erosion from the Park. Turbid waters, due to erosion from the Park, can be seen off the Park after every storm.

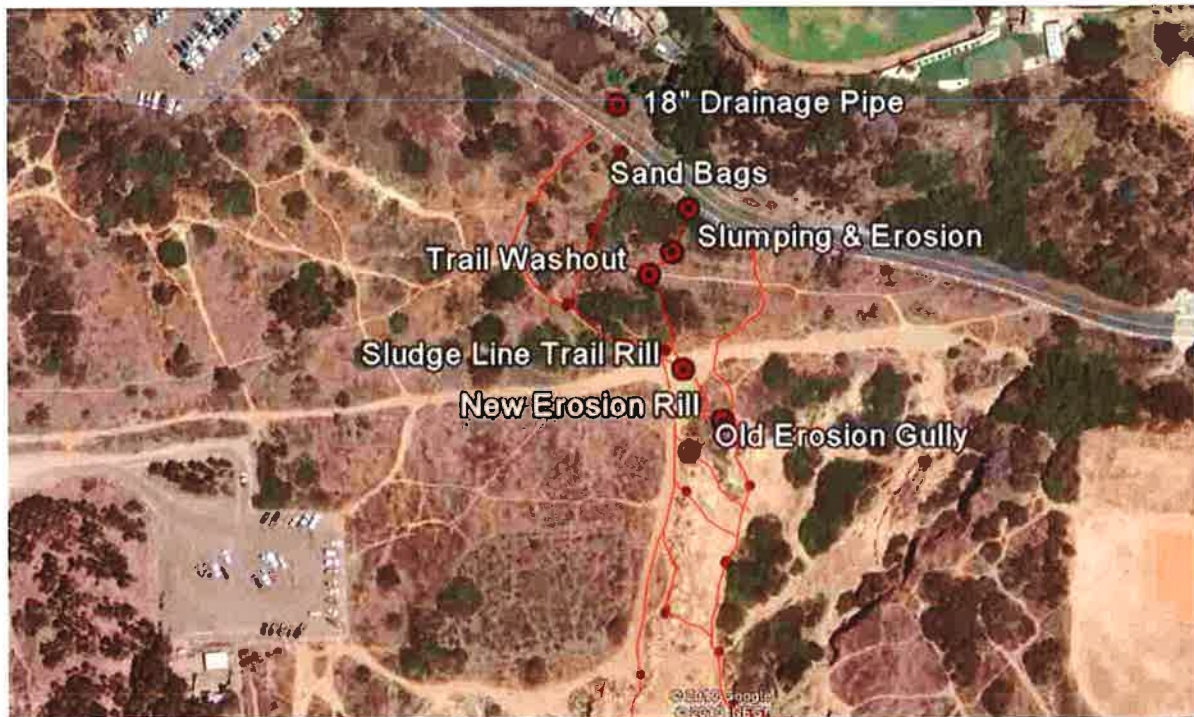
Figure 6. Runoff and erosion features associated with the 18" PLNU drainage pipe that discharges onto the Loop Road at the marked location. The large red dots show the location of features, and the small dots and streamlines show where evidence of watercourses transporting runoff that ponds on the Loop Road due to discharges from the 18" pipe can be seen after major rainfall events.

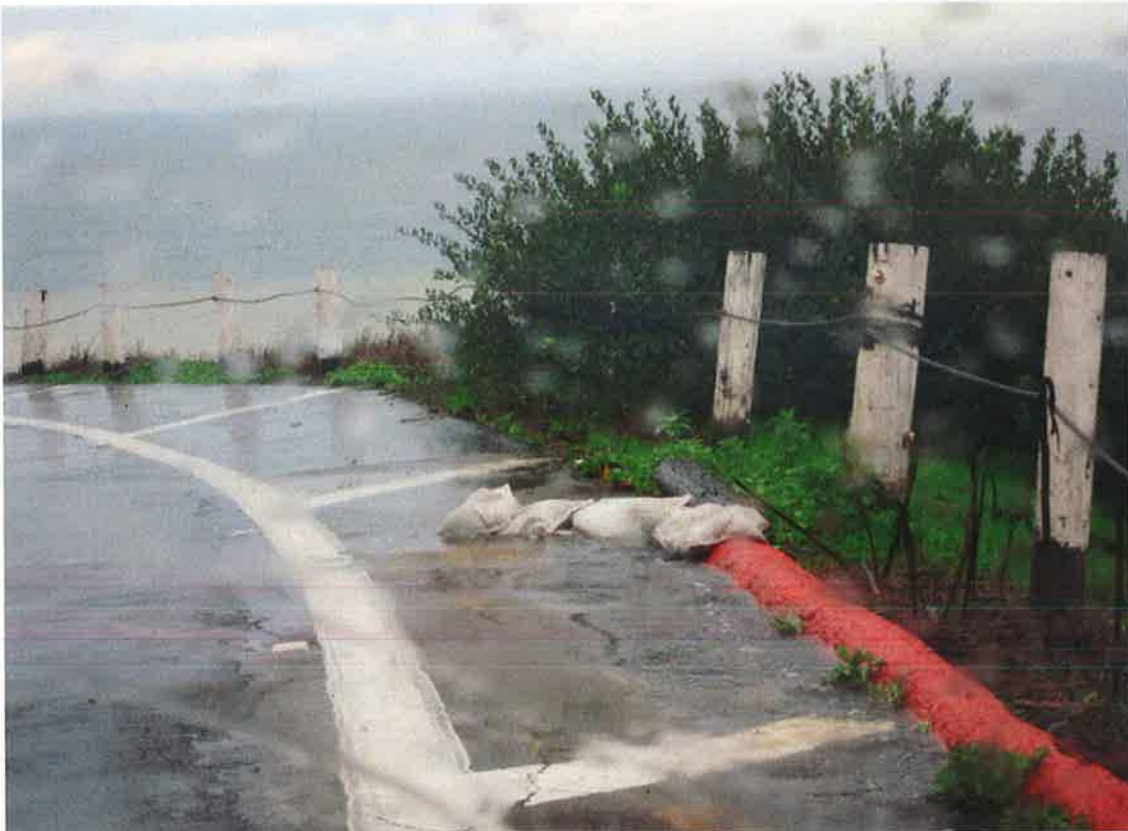
Figure 8. The curb down slope from the 18" storm water discharge pipe is only about 3" high in places, and ends at the sand bags. Runoff flows over the 3" curb and the area without a curb. It should be built up to 6". The runoff to this point does not include runoff from the PLNU 24" storm drain. The few sand bags seen, demarcate the location where there is no longer a curb on the western edge of the road, but the water flows off the road starting where the curb height is reduced to 3". A consistent 6" high curb placed along the western edge of the Loop Road would minimize water going off the road and onto parkland. Potholes and cracks are developing along the loop road, and these should be resealed to minimize seepage under the roadbed.

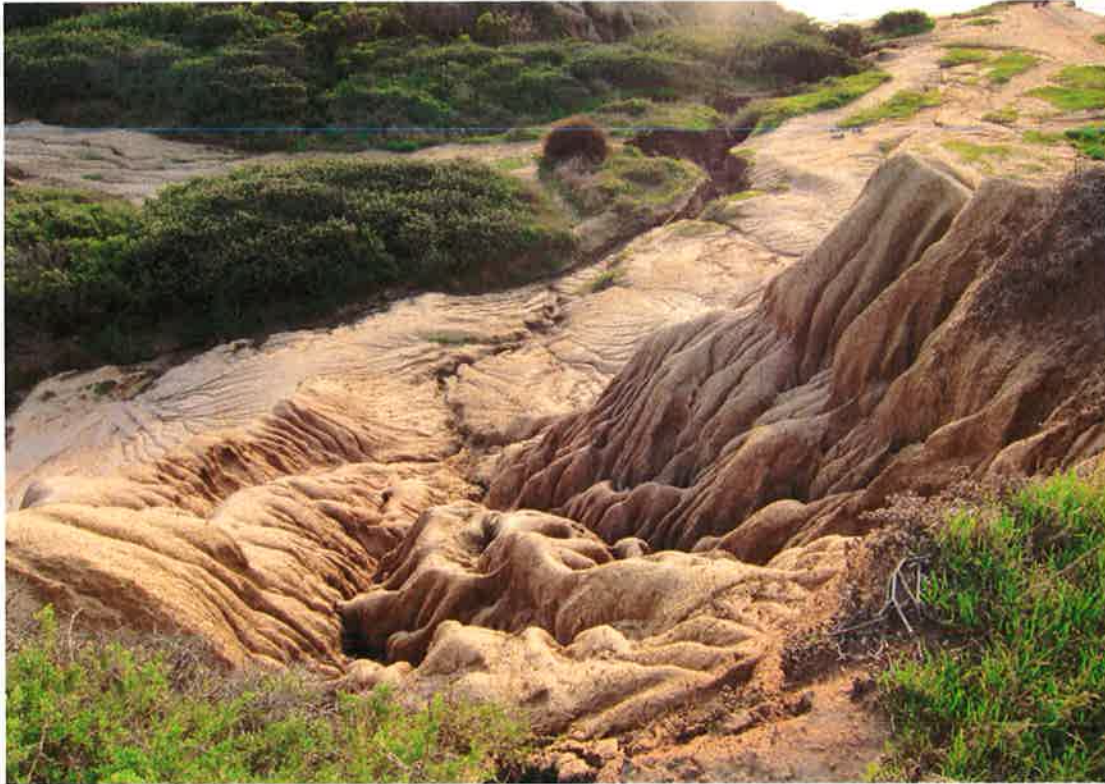
Figure 18. Further erosion on the western portion of the Badlands due to runoff from the 18" pipe. The runoff joins the erosion gully in the bottom which joins the runoff from Culvert Canyon before it exits over the cliffs. This damage to the park would not occur if curbs were added all along the Loop Road.

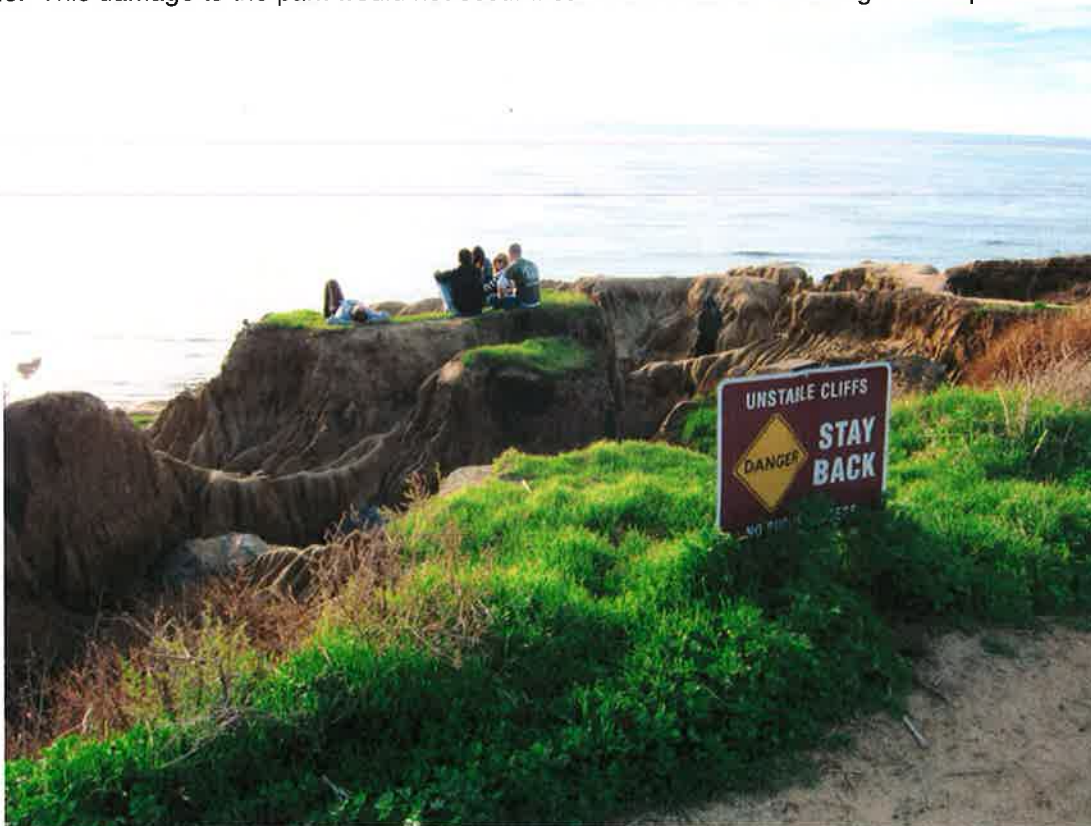
Figure 19. Runoff from both the 18" pipe and the Upper Parking Lot are likely responsible for this massive loss of cliff.

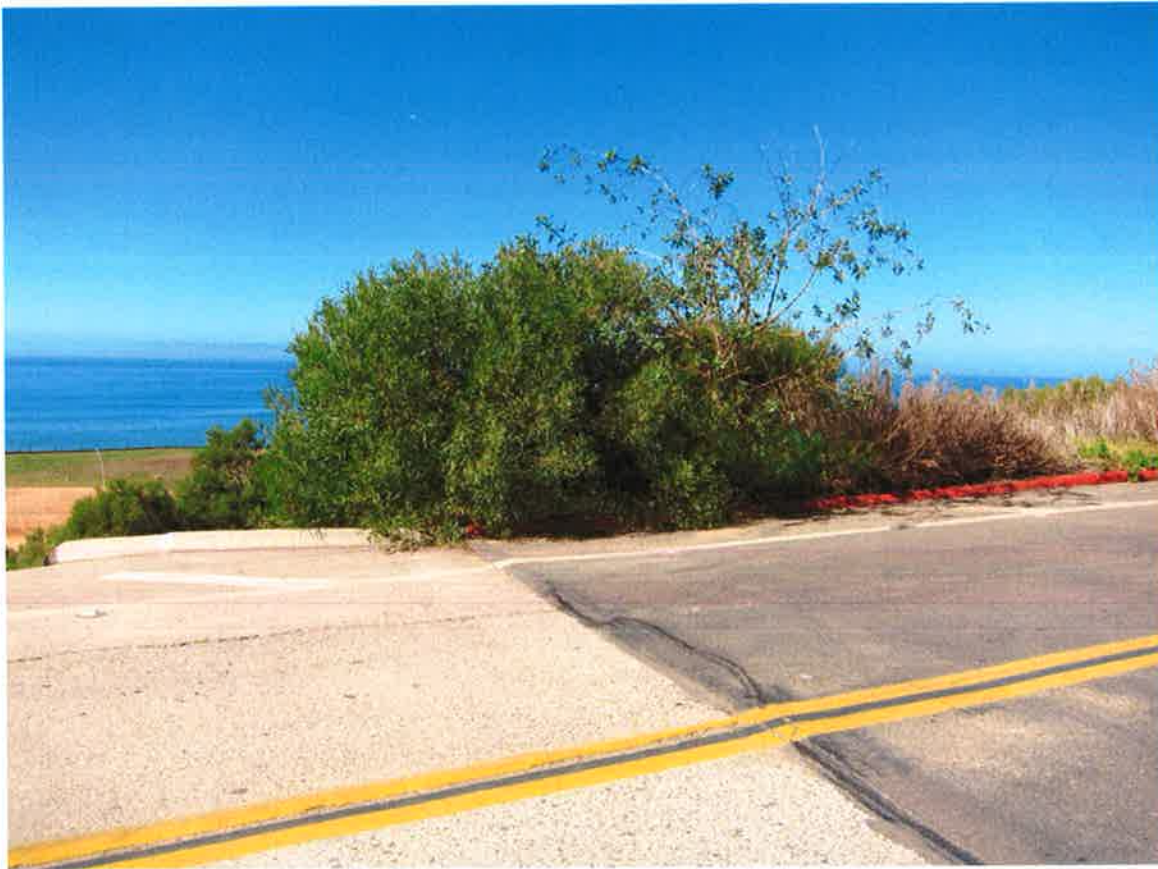
Figure 24. Due to low curb height at the northern edge of the Loop Road Arizona Crossing, runoff during moderate to high flow periods tends to flow around the northern edge of the Arizona Crossing apron and undermine it. The black Acacia branches cover the point where the runoff goes off the road.

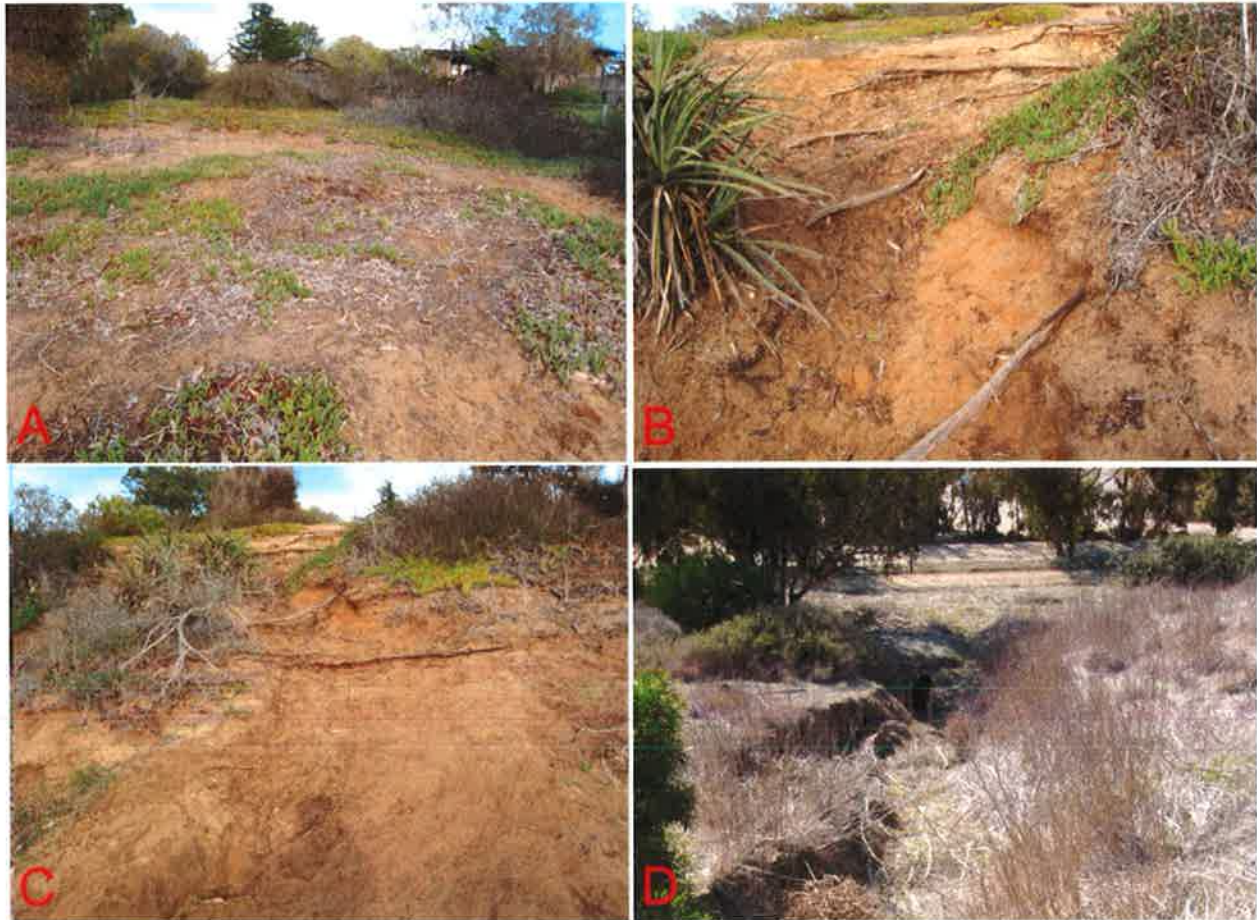
Figure 27. Area of Park where pedestrian traffic appears to have denuded the hillside (see A, B and C). Without a good cover of native plants, rainfall doesn't sink into the ground resulting in runoff generation that is causing erosion down slope, just before the runoff enters the Lower Parking Lot (see D).

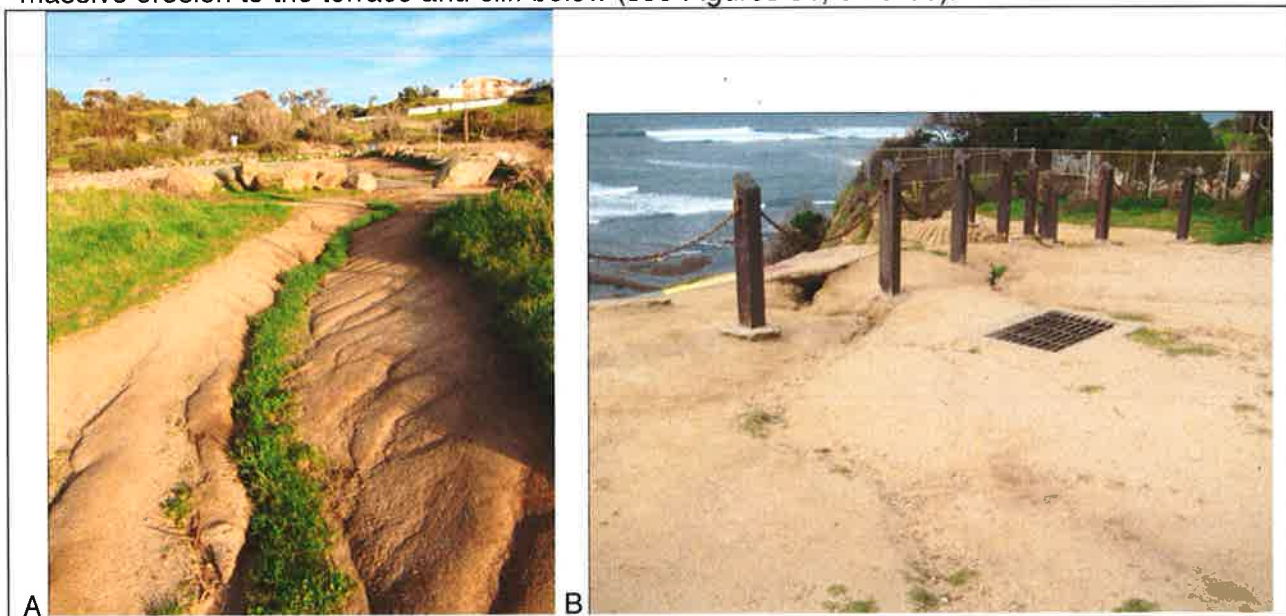
Figure 29A & B. Runoff gully from the southwest corner of the Lower Parking Lot leading an inlet on the bluff above the Gunite swale. The inlet and swale are higher than the erosion gullies cut around them, therefore the runoff continues to bypass the drainage system and is undermining the Gunite drainage swale. These maintenance problems should be addressed before the system is irreparably damaged.
