SUNSET CLIFFS NATURAL PARK

Final Drainage Study

**SUNSET CLIFFS NATURAL PARK
DRAINAGE STUDY**

MAY 2012

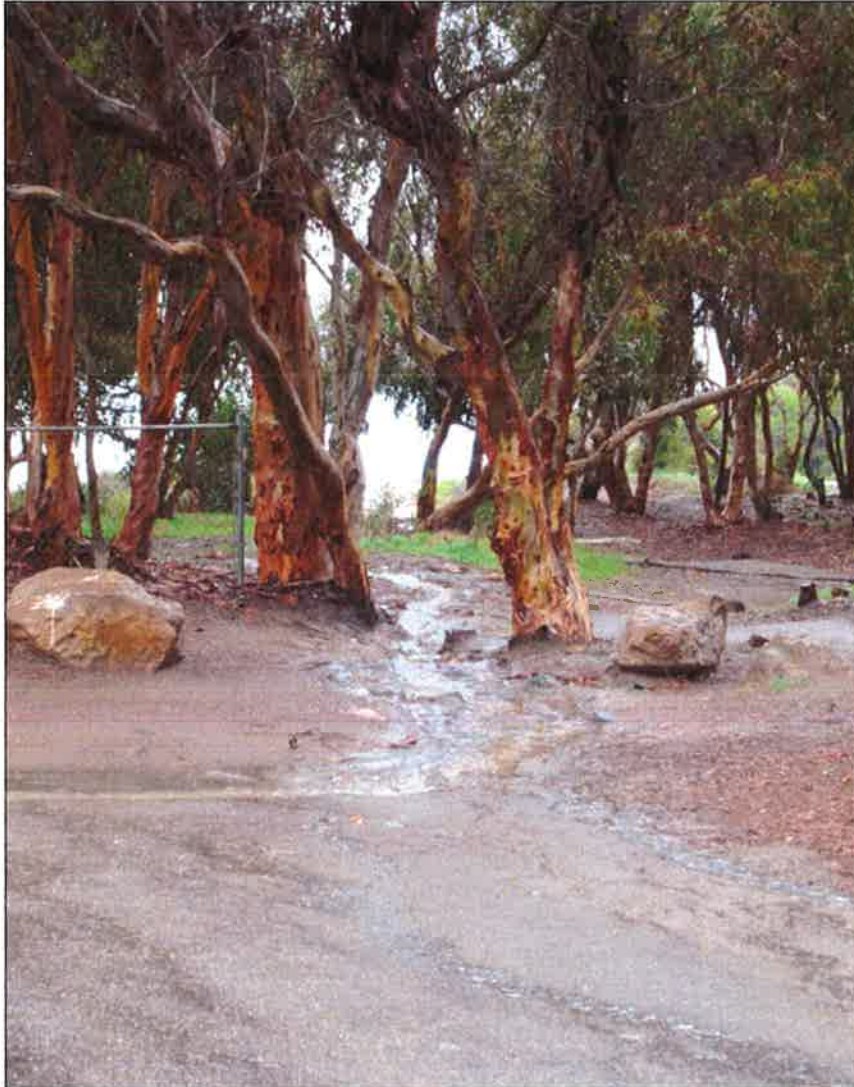
Figure 34. Runoff exiting the northwest corner of the Lower Parking Lot.
