THE CITY OF SAN DIEGO

REPORT TO THE PLANNING COMMISSION

SUBJECT: 2137 BRANT STREET TENTATIVE MAP
PROJECT NO. 105413 - PROCESS FOUR

Property Inspection Report
2137-45 Brant St.
San Diego, CA 92101

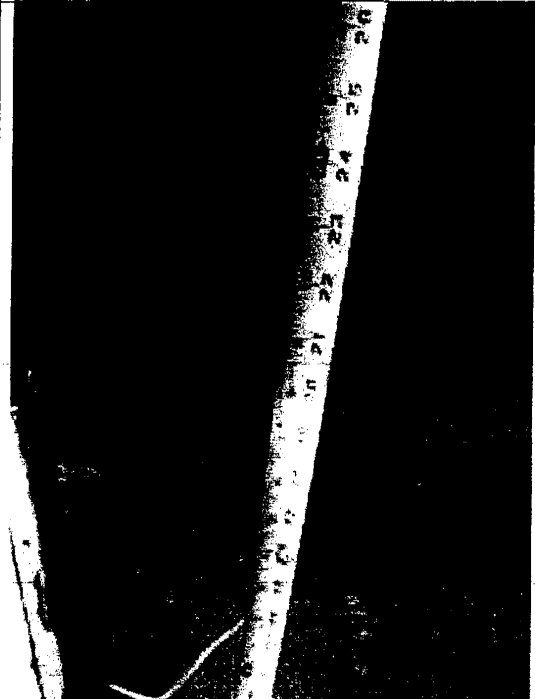
Incorrect sensor height
