Building Conditions Report

Park Diplomat Apartments

1707 Essex Street
San Diego, San Diego County, California 92103-3647

Project No. 08-C-2221
August, 2007

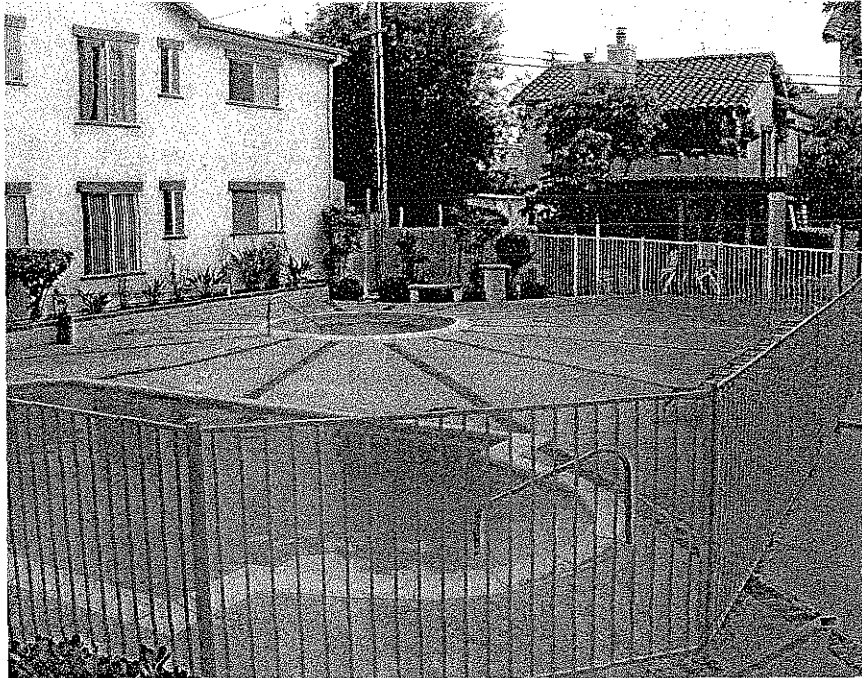
We understand that surfaces of the swimming pool and spa have not been re-plastered in years. And the concrete deck around the pool and spa appeared worn. It is recommended that the surfaces of swimming pool and spa be re-plastered, and the associated concrete deck be up-graded.

PHOTO 7. The fenced swimming pool and the spa.

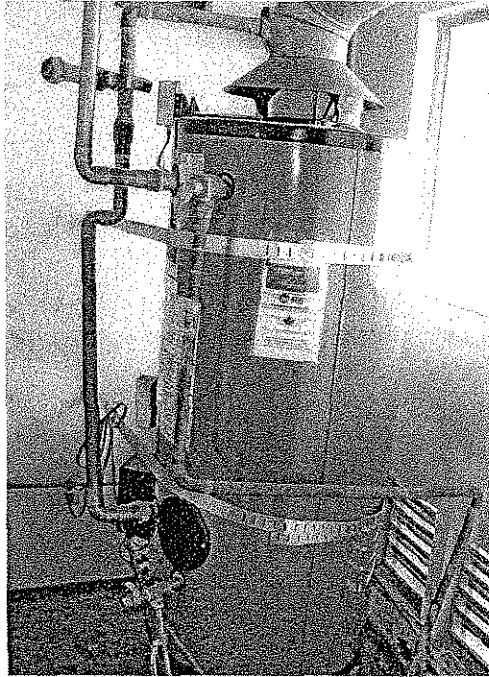
The two central gas-fired hot water heaters are observed to be strapped to the adjacent walls for seismic safety. Generally, plumbing system of the subject property was observed in good condition, and appeared adequately maintained.

PHOTO 11. Properly strapped hot water heater.

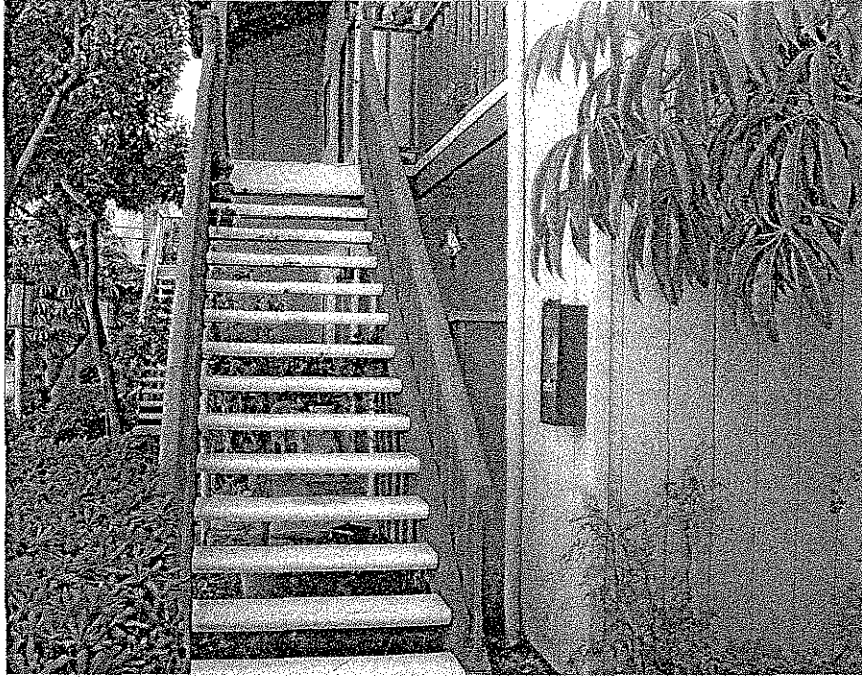
Observations/Comments: JCEP/Huang noted that the inspection tags of the fire extinguishers were just expired (8/16/06). Management is aware of the situation and will have the fire extinguishers inspected soon.

PHOTO 13. Typical stairs accessing upper level flats.

Note: The fire extinguisher.

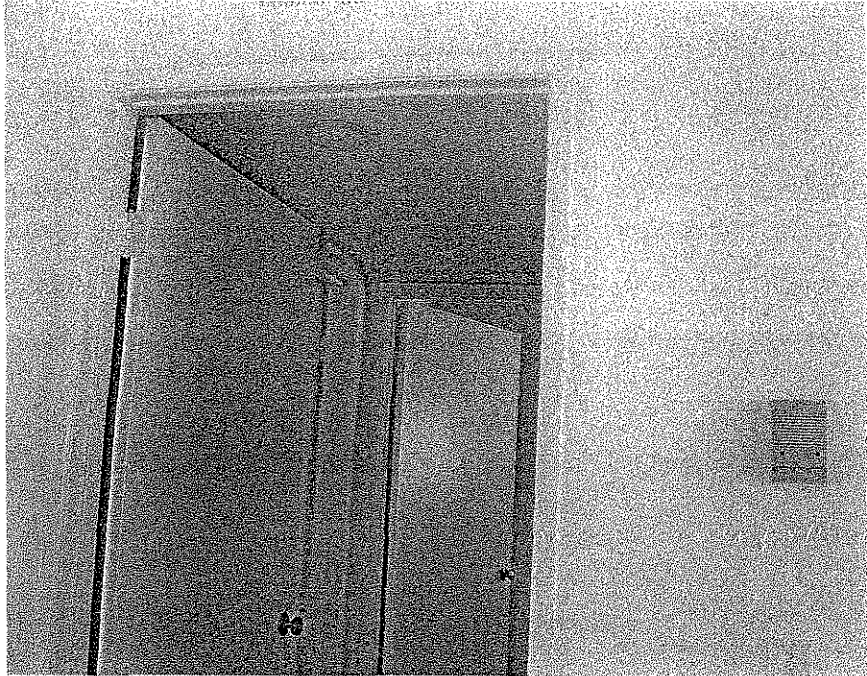
Smoke detectors are provided for the apartments. However, they are not in conformance with the requirement of the San Diego Municipal Code Section 1440507. It is recommended that each bedroom of the apartments be provided with a hardwired and battery backed smoke detector. And the smoke detectors shall be interconnected, and shall include a visual notification device for the hearing impaired occupants. JCEP/Huang further recommends that a fire alarm system be installed in the apartment complex. The system should be monitored 24/7 by a professional fire life safety company.

PHOTO 17. Typical ceiling hung smoke detector.

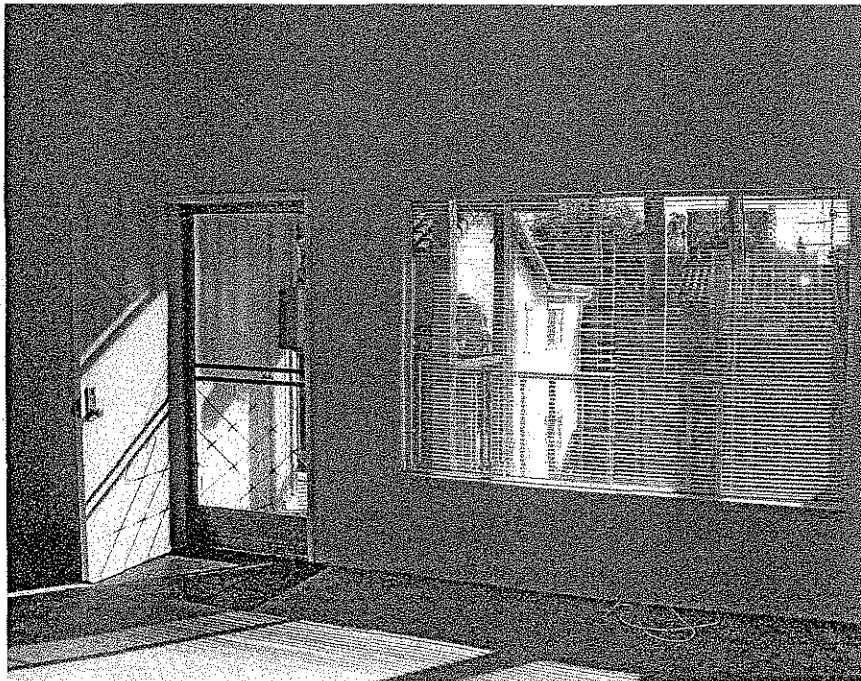
Windows in upper level flats are of sliding units with opening typically of 70 x 33 inches (accessible opening 35 x 33 inches) which is larger than the 22 x 22 inches opening required by the emergency egress provisions of the current California Building Code Section 310.4. However, the window sills are typically measured at 47 inches above the finished floor, which is higher than the 44 inches allowed by the above Code. JCEP/Huang recommends that the windows be properly modified in order to comply with the current California Building Code Section 310.4 (San Diego Municipal Code 144.0507).

PHOTO 18. Sliding window in the living room, and apartment unit entry door.

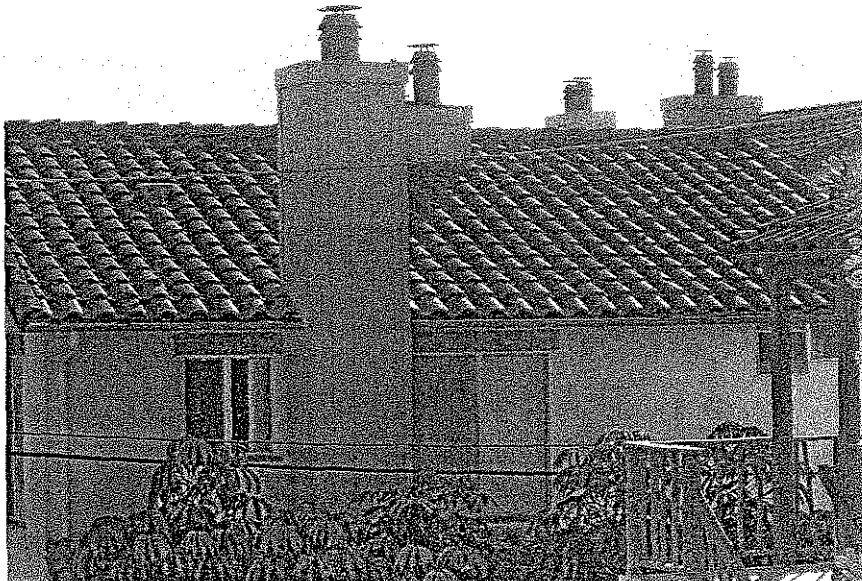
The roofing systems appeared adequately maintained and in good to fair condition. However, due to aging, the roofing system should be replaced within the next 2 to 3 years. Re-roofing can be incorporated with the planned Renovation Program.

PHOTO 24. Typical roofing system and the chimneys.

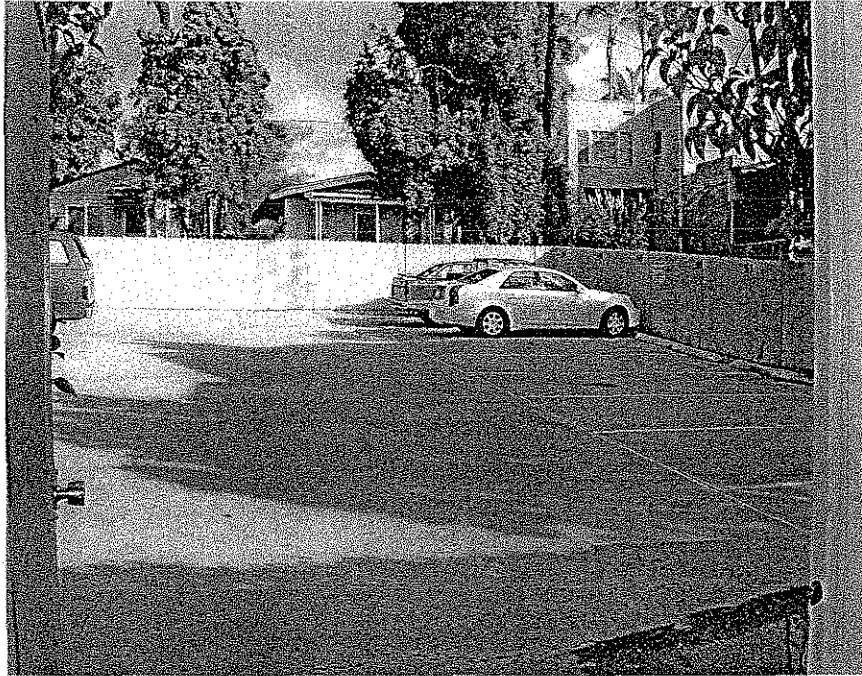
- The asphalt paved parking lot appeared fairly maintained and in fair condition. JCEP/Huang recommends that the asphalt pavement be seal-coated and restriped following necessary localized repair/replacement.

PHOTO 27. Parking lot by Essex Street and Park Boulevard.

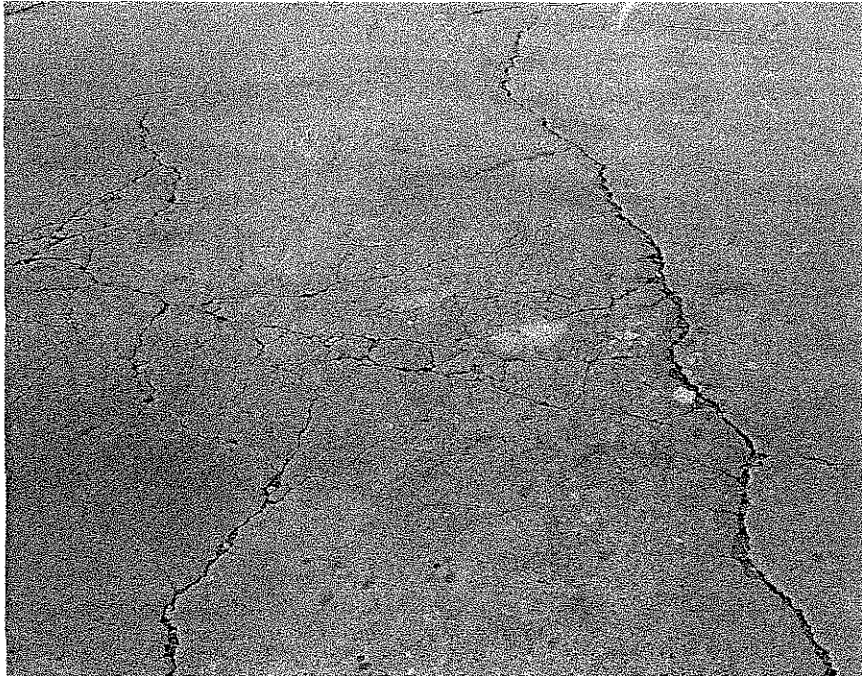
- Cracking on the concrete driveway between Buildings 2 & 3 were noted. Some cracks appeared large enough to be considered as a potential tripping hazard.

PHOTO 29. Cracked concrete parking lot that should be replaced immediately.

It is recommended that the cracked areas of the concrete pavement be replaced immediately.
