THE CITY OF SAN DIEGO

DATE ISSUED: July 16, 2009 REPORT NO. HRB-09-037

SUBJECT: **ITEM #14 – 155 19th Street, Sherman Heights District Contributor**

RE: 155 Nineteenth Street - Exterior Siding Assessment

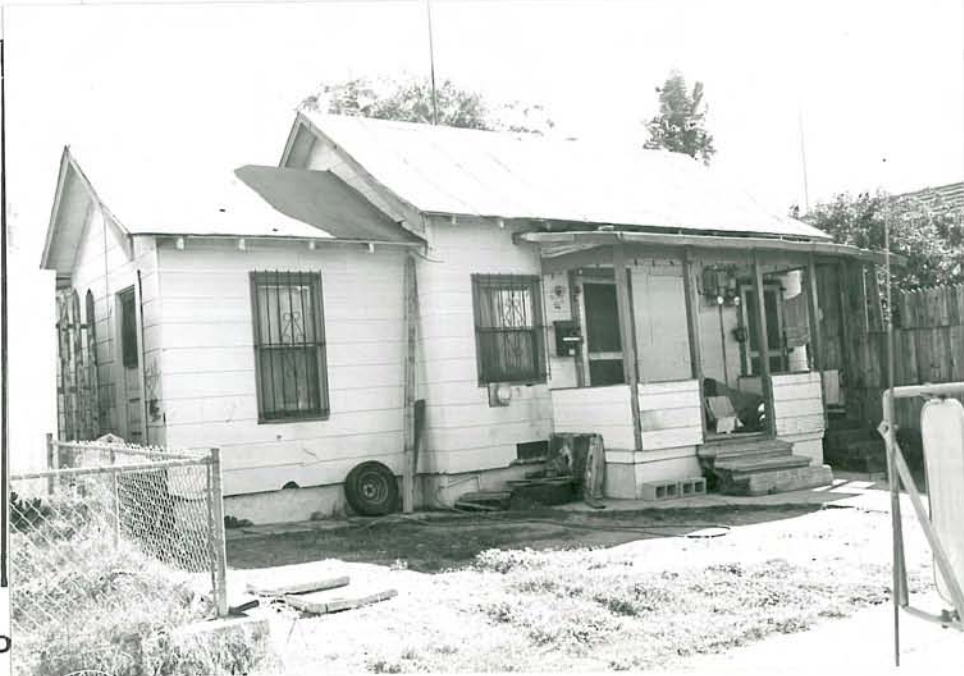
This is a small one story side gabled house with asbestos shingles. The roof has exposed rafters and fascia boards. The windows are 1/1 double hung sash with moulded trim. The porch has a shed roof and partially covers the front facade. The porch posts are thin and square. The foundation is concrete. The house suffers from neglect and poor maintenance. The roofing material, front door and perhaps the porch are all alterations. A window has been blocked in and another entrance has been added.

13. Condition: Excellent ___ Good ___ Fair XX Deteriorated XX No longer in existence ___
14. Alterations: additional entrys, roofing material, asbestos shingle siding
15. Surroundings: (Check more than one if necessary) Open land ___ Scattered buildings ___ Densely built-up XX
Residential XX Industrial ___ Commercial ___ Other: _____
16. Threats to site: None known ___ Private development ___ Zoning XX Vandalism XX
Public Works project ___ Other: _____
17. Is the structure: On its original site? XX Moved? ___ Unknown? ___
18. Related features: _____

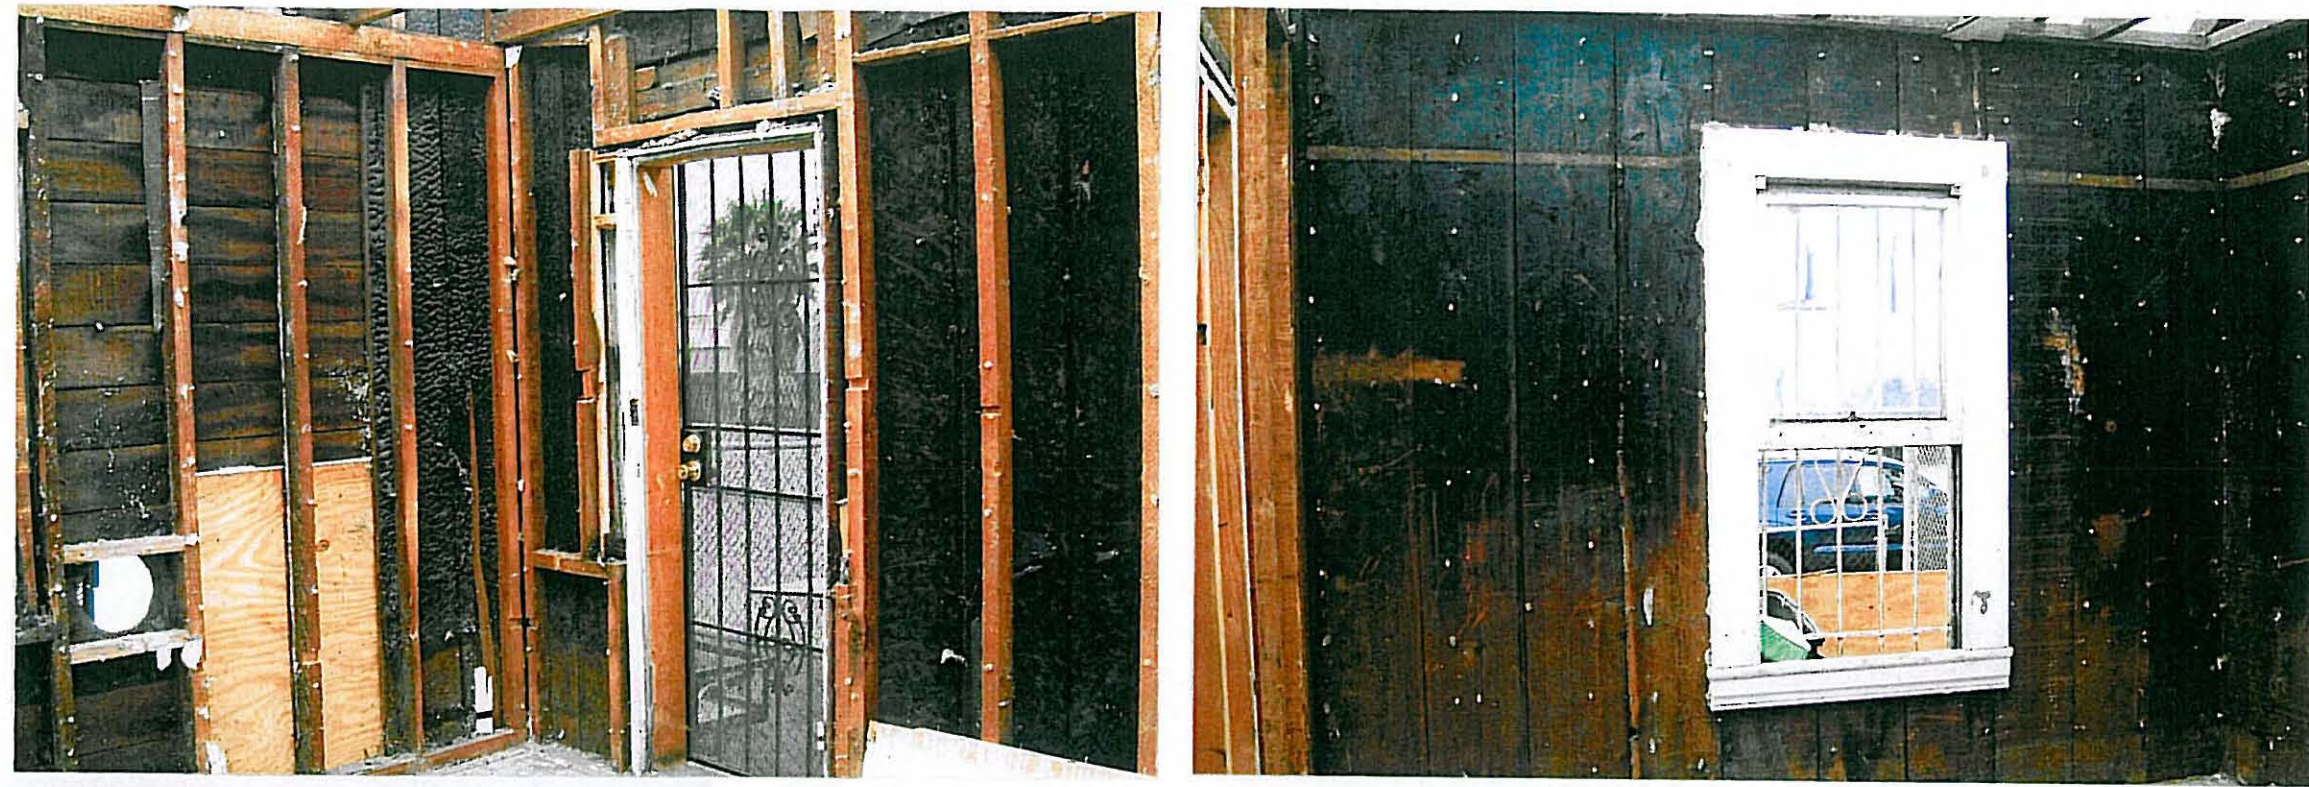
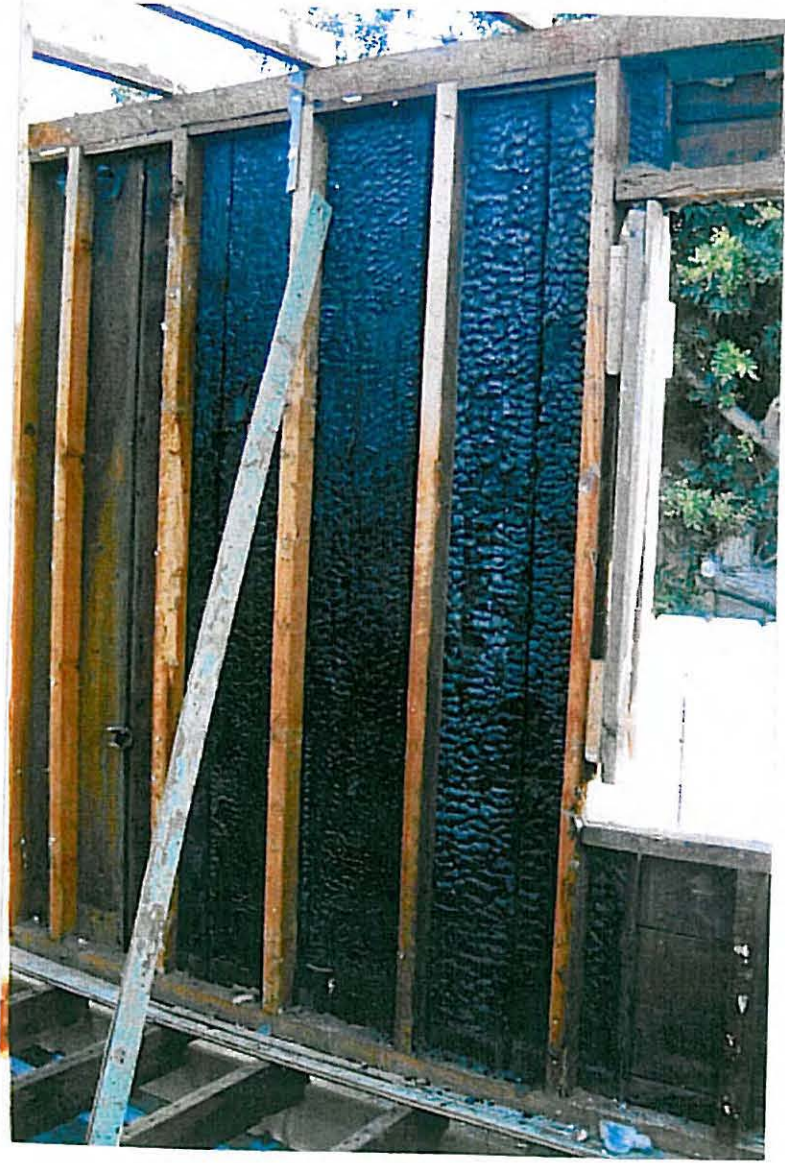
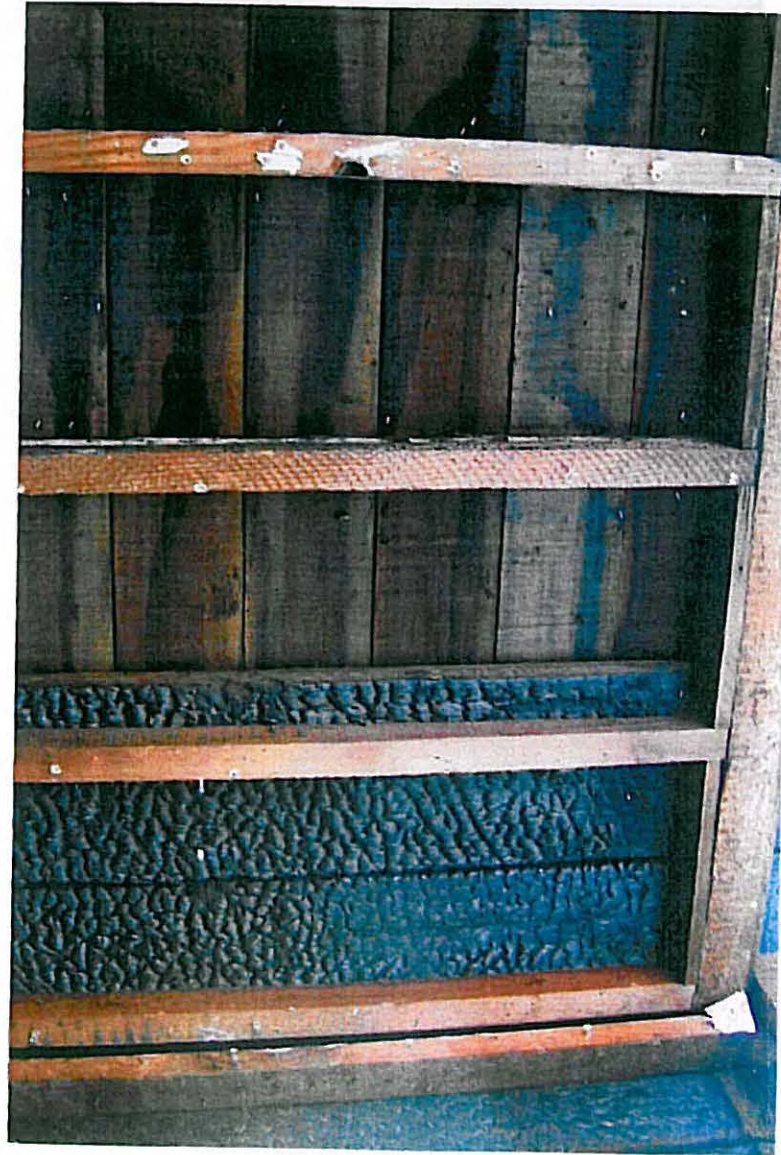
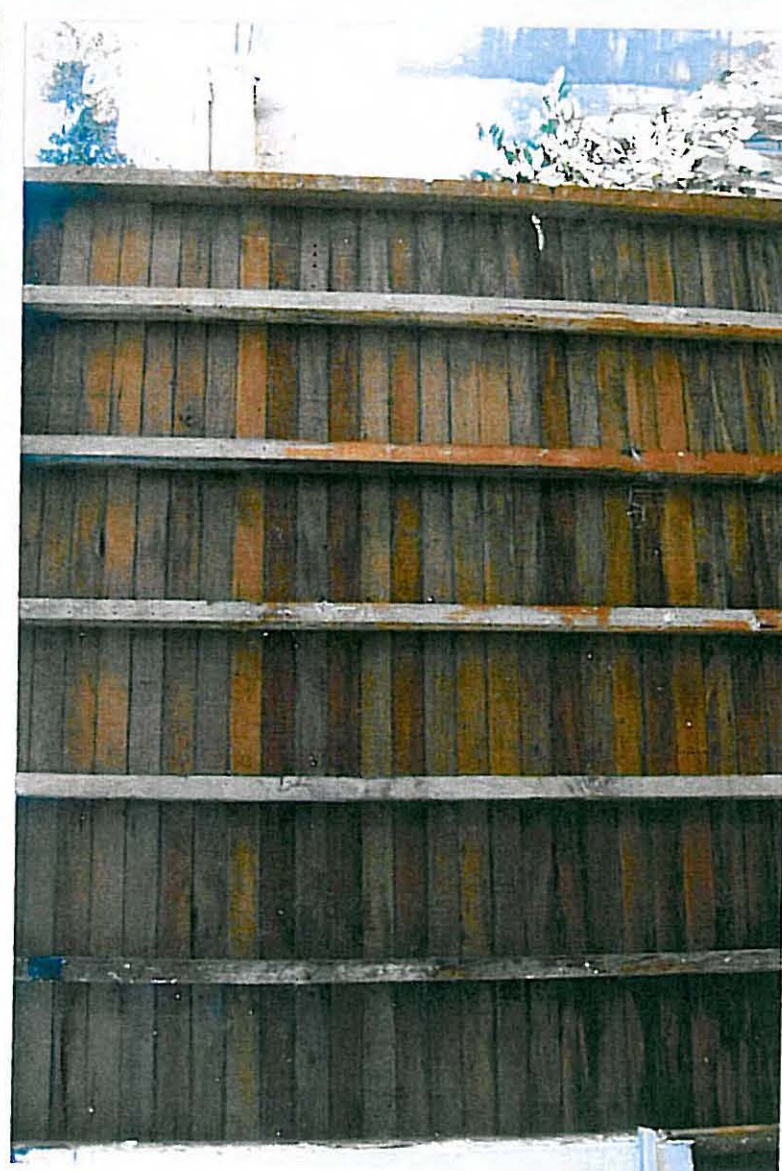
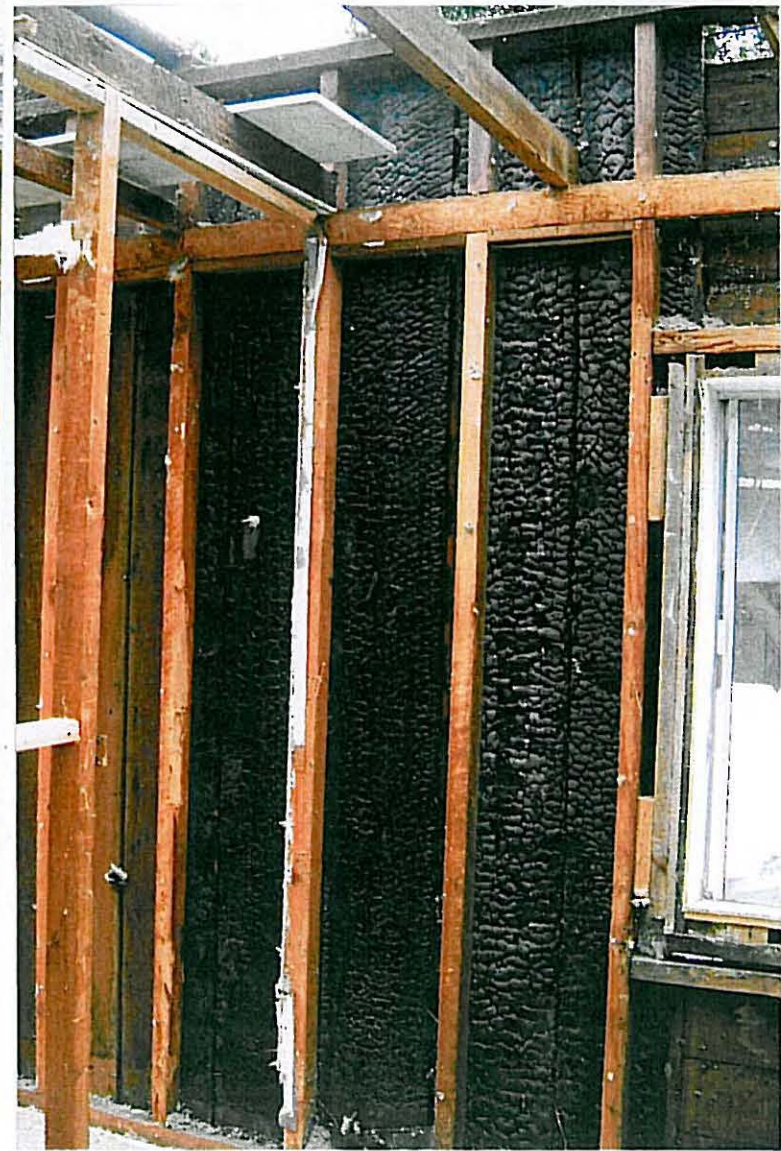
After work began on the property, the owner and his contractor discovered that, like many buildings of this type and era, the house was built using single wall construction. In addition, the single wall construction had been severely damaged by an earlier fire and reinforced with sub-standard framing. Photos submitted to staff during this stage of the project have been included as Attachment 2.

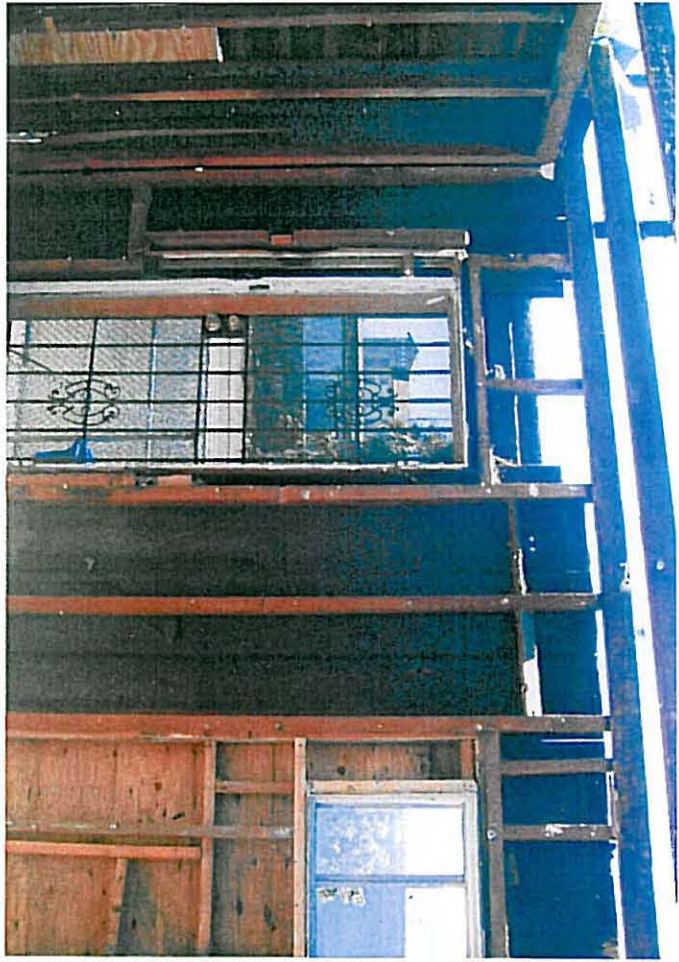
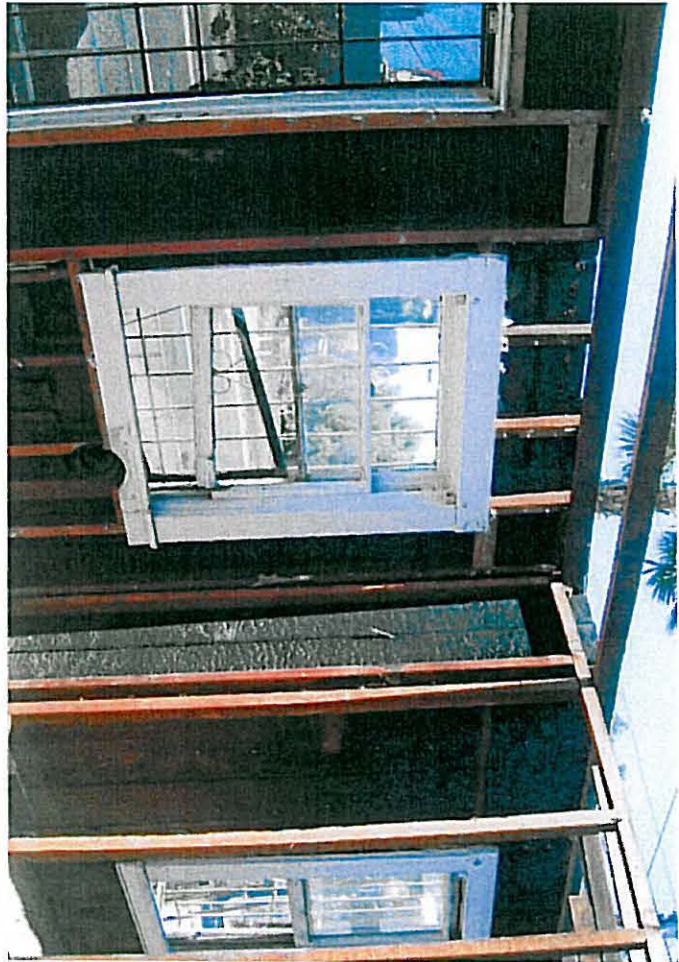
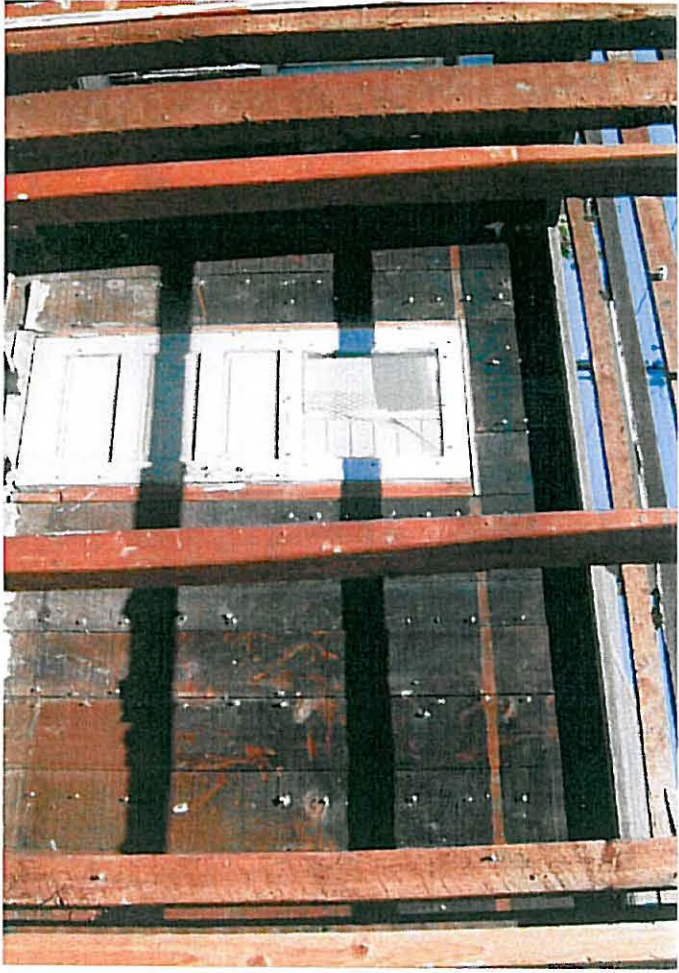
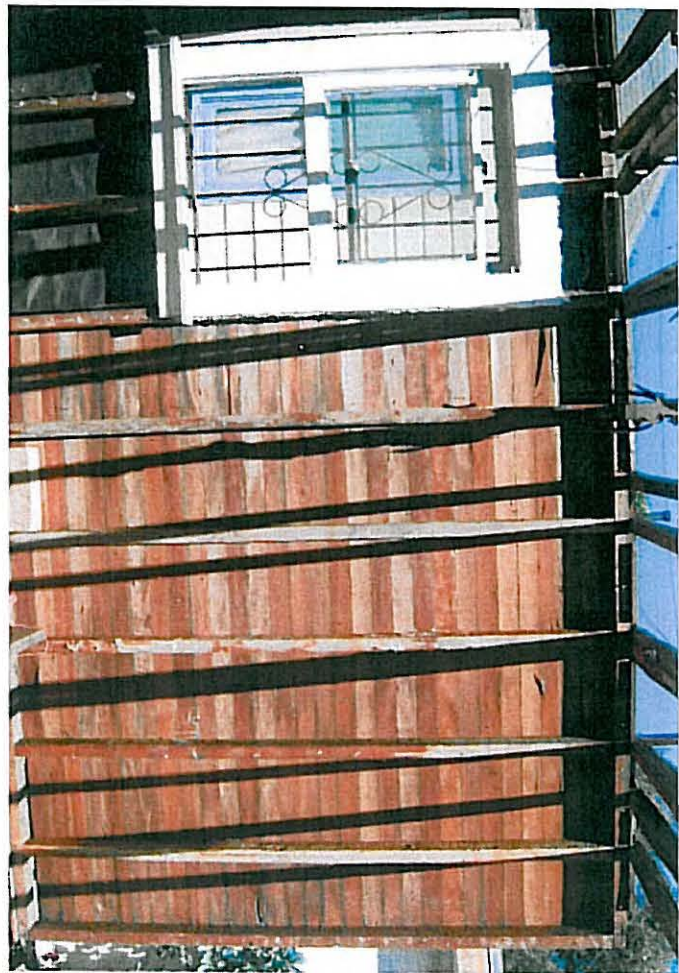
1. The clapboard siding is uniform, straight, and well attached to the structure.
2. All three exposures north, west, and south appear uniform in condition. The east wall has been demolished per plan and contains no siding.
3. Previous siding nailing has not destroyed the overall condition of the siding.
4. All later siding on top of the horizontal siding has been removed.
5. There is no visible evidence of termite damage to the siding, only to the stud framing.
6. The horizontal siding is triple lap in a 7" board width, probably redwood.

1. The horizontal siding is not the original siding as it was applied over older 1x12 vertical siding with battens.
2. Only the west (front) wall and the front portion of the north wall have remnants of the vertical siding.
3. Portions of the 1" vertical siding on the south wall were burned in a fire and were removed except for strips left on the studs to support the siding. It appears that the current horizontal siding was added at the time of fire repairs, likely prior to 1940.
4. The house had a rear addition and the north siding is not uniform. The rear portion of the north side is individual 3" lapped siding.

1. The house is jacked up, new foundations placed under, roof gone, interior finishes all removed. Original wood windows remain in place.
2. The NW corner of the house lacks any stud framing. Vertical siding spans from sill to top plate and window hung within.
3. Most walls lack consistent top plates with splices.
4. The remaining horizontal siding appears to be good enough to be removed and reinstalled along the front elevation.

These recommendations follow *The Secretary of the Interior's Standards for Rehabilitation*. Based on the lack of framing integrity of the walls, as well as evidence that this siding is not original to the building, Heritage recommends the removal and reinstallation of most of the existing horizontal siding in the most publicly visible locations. Reinstallation should occur on the west (street) facing wall and as much of the west end of the south wall as is possible. Siding damaged beyond repair can be discarded; approximately 20%. Nail holes and cracks should be filled prior to new primer and paint. The remainder of the house should be clad with wood siding matching the historic profile, exposure, and wood species.

Regarding the original wood windows, they should be restored and reused. If they are damaged beyond repair, they can be replaced with wood replicas that match their appearance and detailing. Below are two potential window repair and replication sub-contractors who have worked on historic buildings. Heritage Architecture & Planning makes no representation as to the listed firms capabilities, contractor license status, or quality of work.

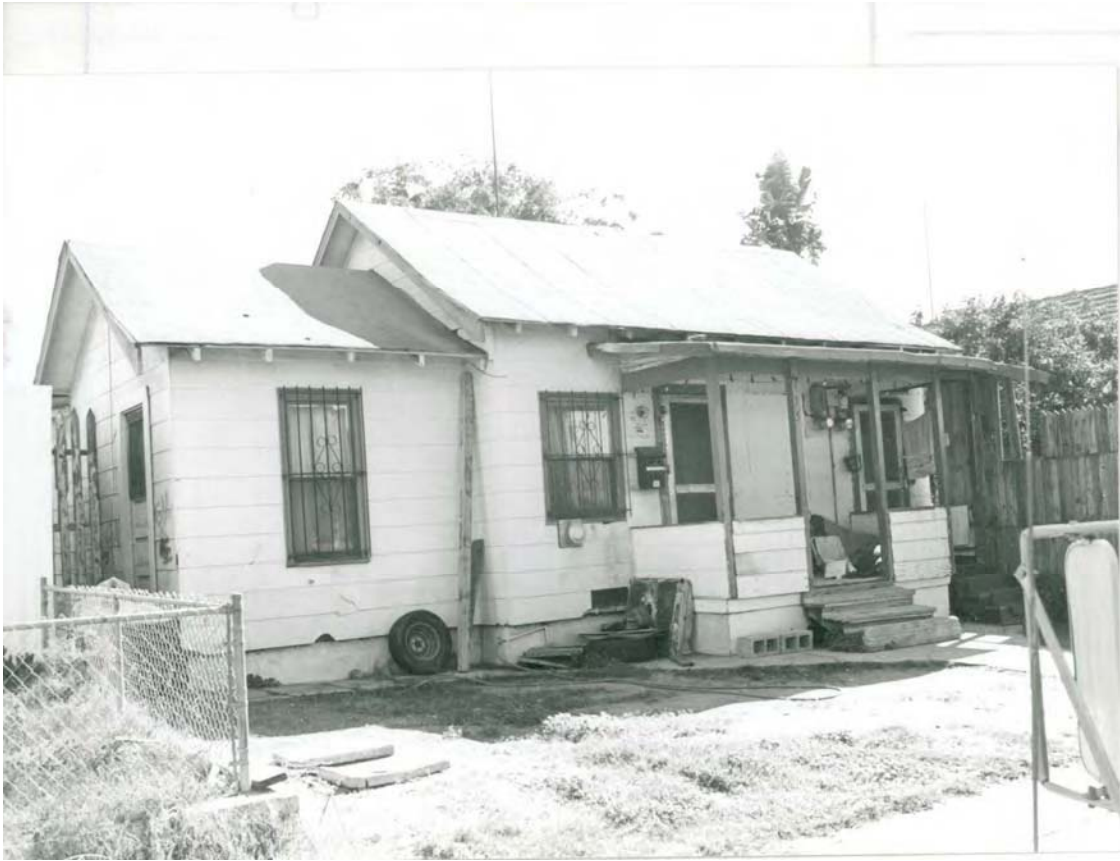
In early 2009, the owner contacted staff and requested a Mills Act contract for the property, which was now being assessed by the County as a new structure. In response to this request, staff conducted a site visit with the original 1987 survey form in-hand and found that the newly constructed house differed significantly from the original dimensions and proportions. A side-by-side photo comparison of the house as it was designated in 1987 and as it stands today has been included as Attachment 4. Significant differences include the roof pitch; the relationship between the eave-line and the eave-line of the smaller wing to the north; window size and placement; and the bulk of the porch posts and supports. Staff informed the property owner that due to the inaccurate reconstruction, staff would not issue a Mills Act agreement and would take the property forward to the Board to have the designation removed.

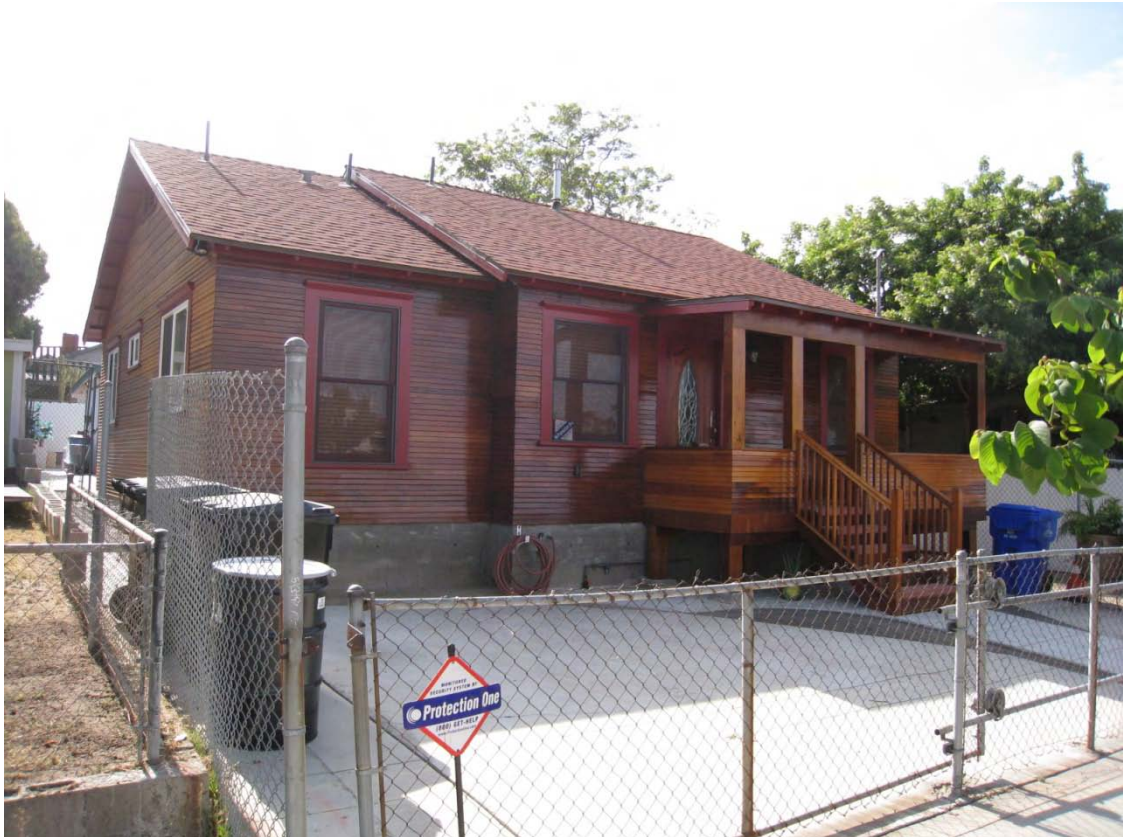
2009

Since the designation of the property at 155 19th Street as a contributing resource to the Sherman Heights Historic District, there has been a change in circumstances surrounding the designation. The deteriorated and fire-damaged condition of the resource led to the reconstruction of the building, which was not completed in a manner consistent with the U.S. Secretary of the Interior’s Standards, despite attempts to ensure its accurate reconstruction. The new building differs significantly from the original house in regard to the roof pitch; the relationship between the eave-line and the eave-line of the smaller wing to the north; window size and placement; and the bulk of the porch posts and supports. The house no longer reflects its original design, proportions and spatial relationships; and the integrity of the resource and its ability to convey the significance of the district has been lost. Therefore, staff recommends that the Board rescind the designation of the property at 155 19th Street and reclassify the property from a contributing to a non-contributing resource within the district. As a non-contributing resource, the property would be regulated under the City’s Historical Resources Regulations and the Sherman Heights and Grant Hill Park Historic District Design Guidelines and Criteria as they relate to non-contributing resources and new development, and any future improvements at this site would be subject to review and approval by historic resources staff.

Based on the information submitted and staff’s field check, it is recommended that the Board rescind the designation of the property at 155 19th Street, designated as HRB Site #208-003, due to a loss of integrity. The property would be reclassified as a non-contributing resource to the Sherman Heights Historic District, and would be subject to the regulations for non-contributing resources and new development.
