PROPERTY CONDITION REPORT

SKATEWORLD
6905 – 6921 Linda Vista Drive
San Diego, CA 92111

AEC Project No. 08-047SD
September 26, 2008

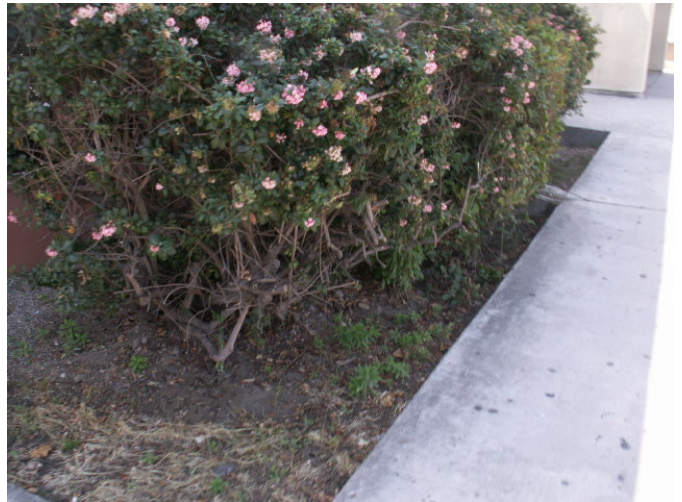
Landscaping is sparse.

The landscaping was observed to be sparse and unkempt at the time of the site visit. It did not appear that it was serviced by regular maintenance. AEC recommends that this can be rejuvenated as an immediate need after the exterior have been repainted. Funds for this have been allocated.

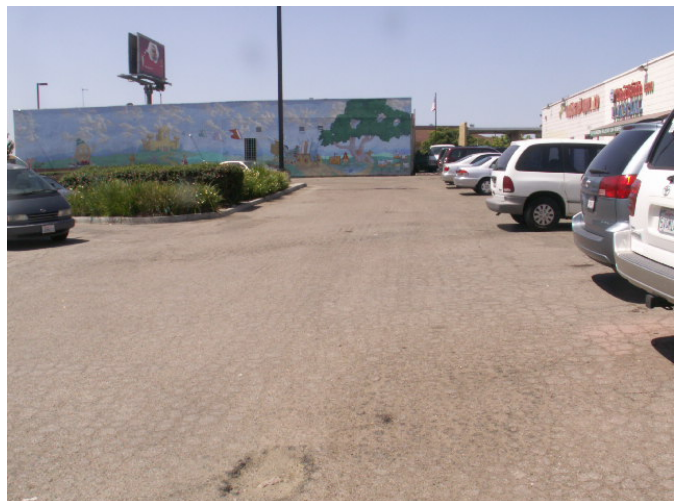
View of the west side asphalt paving. Note pothole in foreground.

AEC observed approximately 5,600 square feet of asphalt that has potholes and is alligating. It is recommended that this area be repaired. Funds for this have been allocated in the immediate needs section of this report. In conjunction with this, AEC has allocated a lump sum to reseal and re-stripe the affected area. AEC recommends that the asphalt surface be sealed periodically during the term and has allocated funding for this in the replacement reserve section of this report.

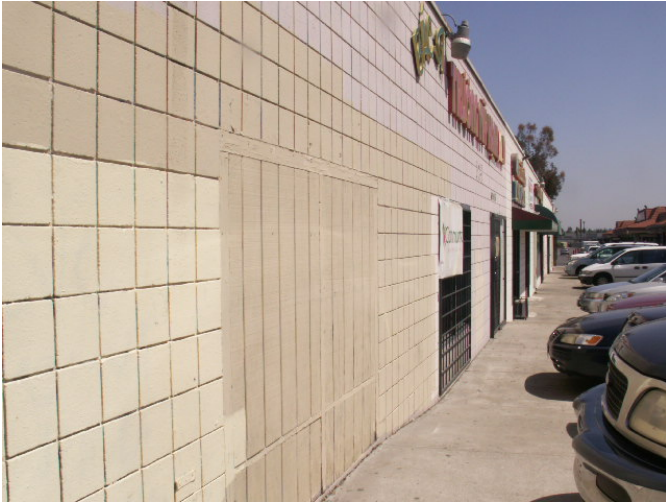
The concrete block wall at the east side of the Building has different colors of paint.

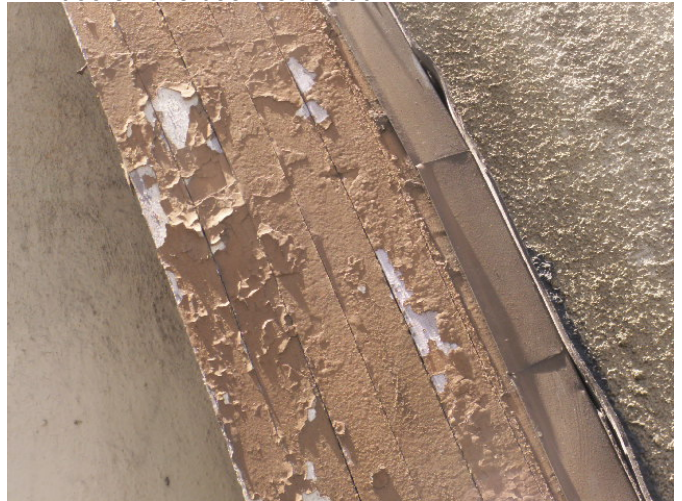
Detail of the glue-lam. Note the need for paint.

- **Exterior Painting:** Exterior paint was observed to be flaky and peeling. AEC recommends that the exterior of the Building be prepped, primed and painted as an immediate need to bring the building up to acceptable standards.

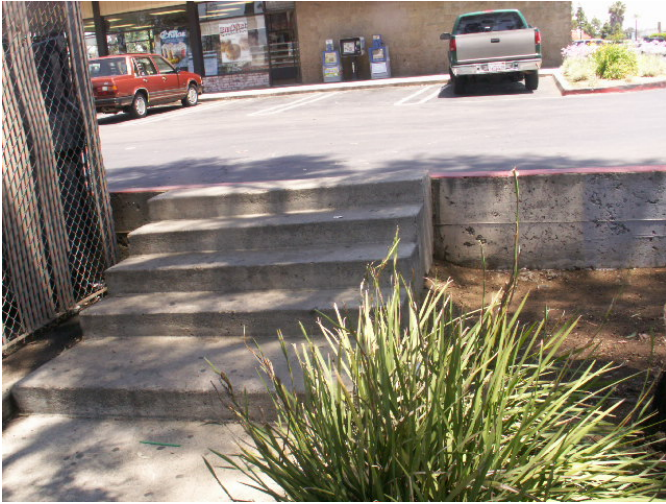
Concrete steps from the finish grade at the Subject Property connect to the property at the north. Note the lack of a handrail.

The steps do not have a handrail. All steps with more than 3 risers are required to have a handrail for safety reasons. AEC recommends that a metal handrail be installed and has allocated funds for this in the immediate needs section of this report.

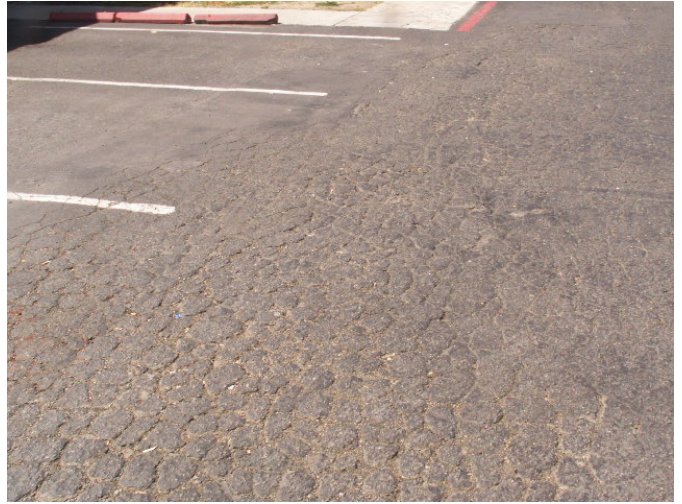
The asphalt is alligator at the west parking lot.

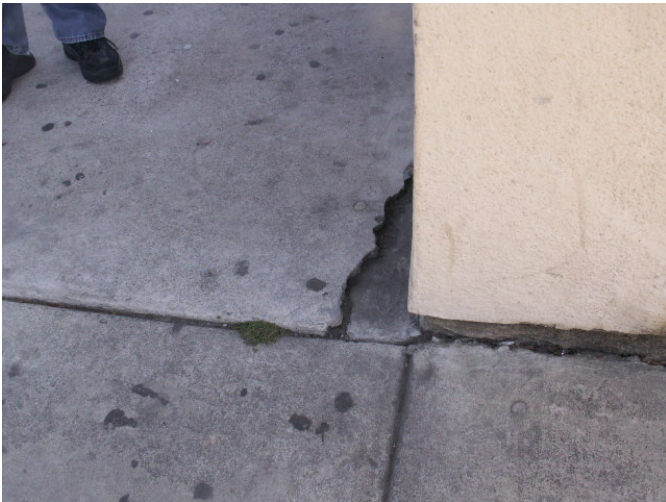
The concrete walkway at the north side of the Subject Property was cracking and has numerous trip hazards. An additional trip hazard was observed at the southwest corner of the Building.

Uneven pavement at the southwest corner of the Building.

- **Trip Hazards:** Trip hazard were observed at the concrete walkway at the north end of the Site and at the southwest corner of the Building. It appears that a newer layer of concrete has been poured over an existing layer of concrete. Trees adjacent to these areas (some appear to have been recently removed) have roots that are growing above the finish grade and forcing the concrete to crack and in some areas, raising areas of the concrete. AEC recommends the concrete be ground at the uplifted sections and re-poured in those areas that have cracked beyond the ability to repair. Since this is a safety item, AEC recommends that this be accomplished as an immediate need.

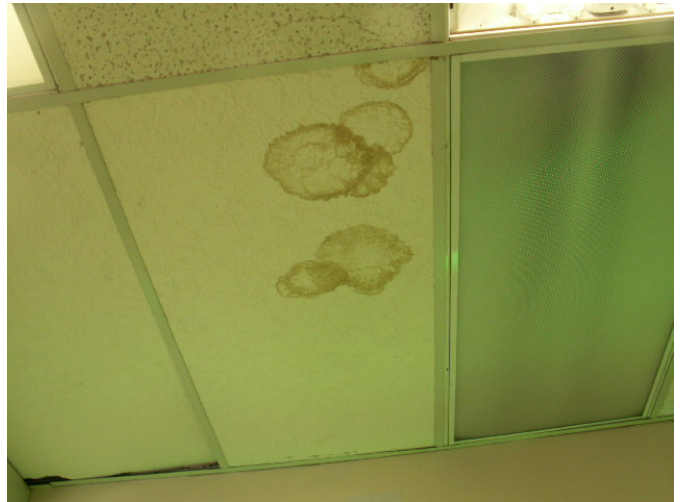
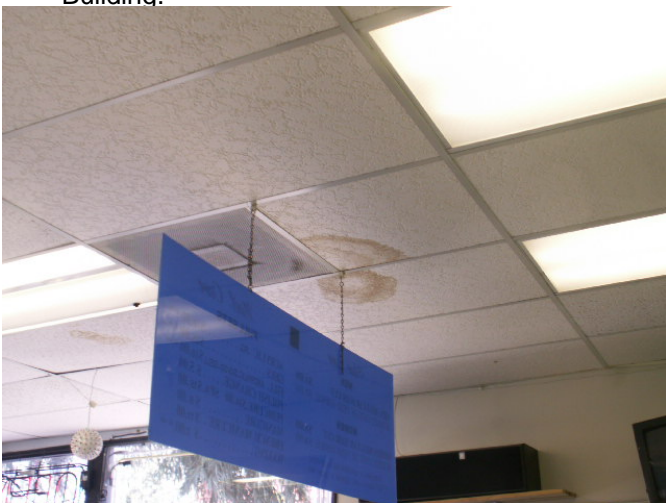
Typical staining caused by a leaky roof.

- **Roof Replacement:** The roofs on the building were last replaced or originally installed 20 to 25 years ago. That exceeds the expected useful life for both types of roofs used on the Building. Evidence of leaks, confirmed by tenants during the site visit, is evident by the many water-damaged acoustical tile ceilings that were observed. Since replacement of the roofing material is necessary, AEC is listing this normally capitalized improvement as an immediate need. It should be noted that no evidence of mold in conjunction with the damaged ceiling tiles was observed or noted.

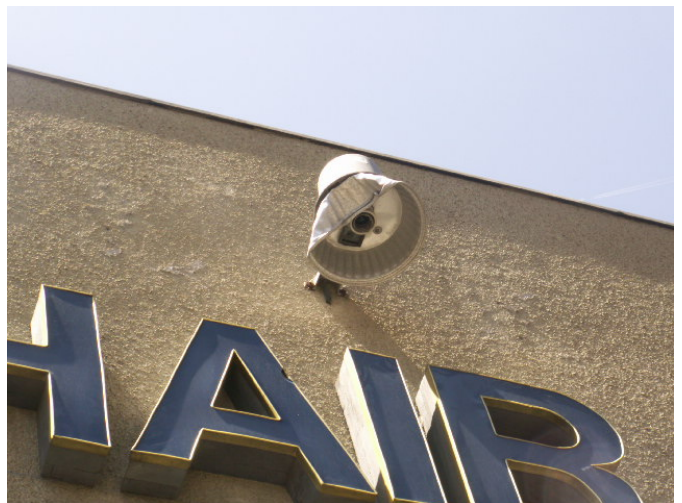
A typical scone lamp requires repair/replacement.

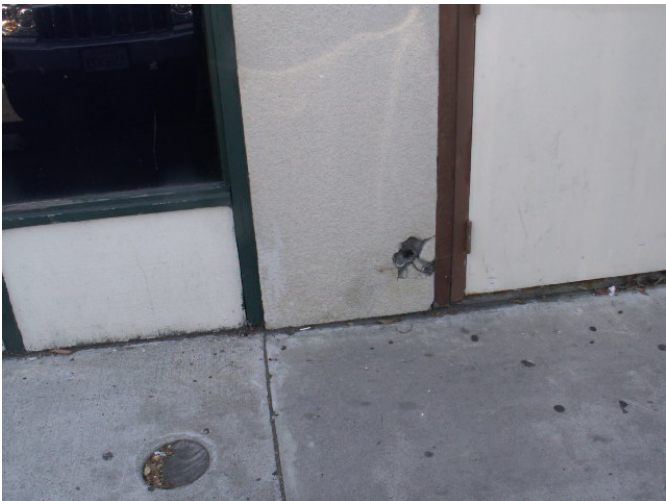
A hole was observed at the base of the stucco on the west side of the Building.

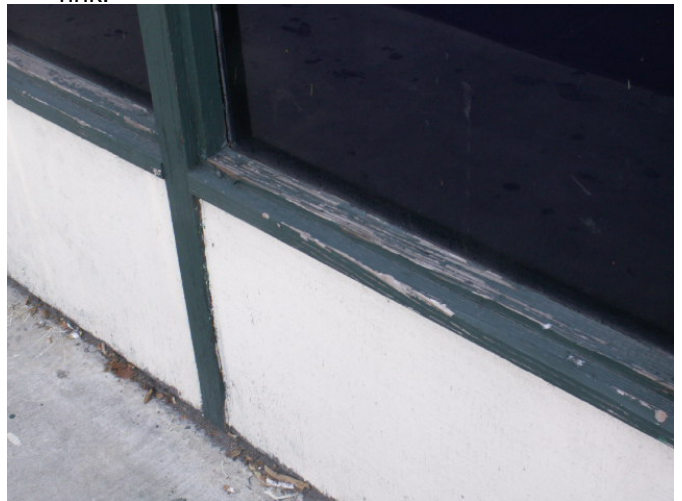
The paint around the windows is flaking.

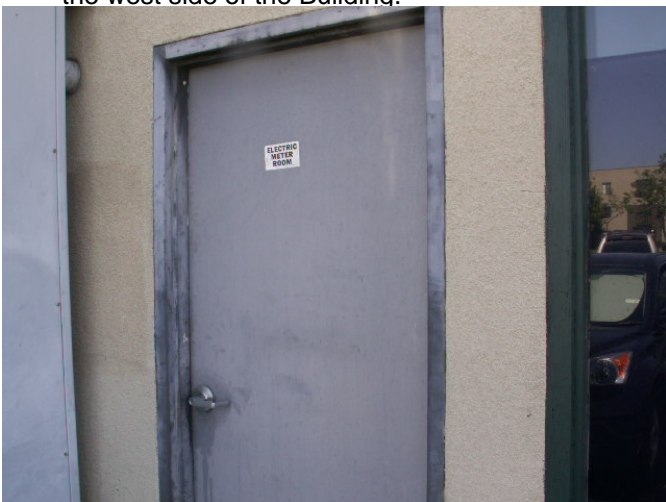
The door to the electrical room requires paint.

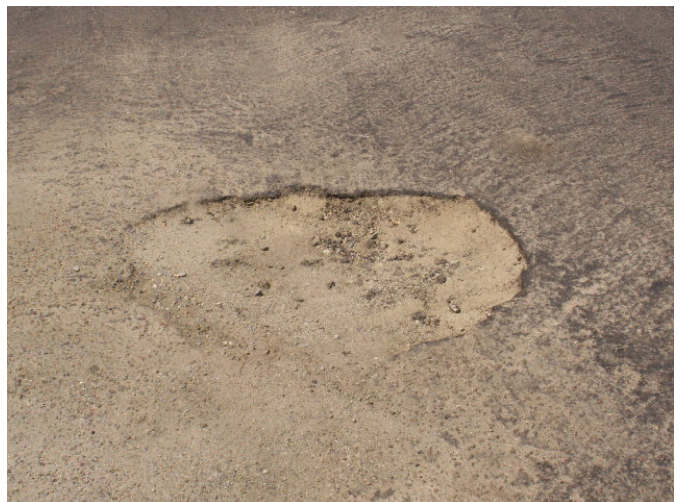
Typical pothole.

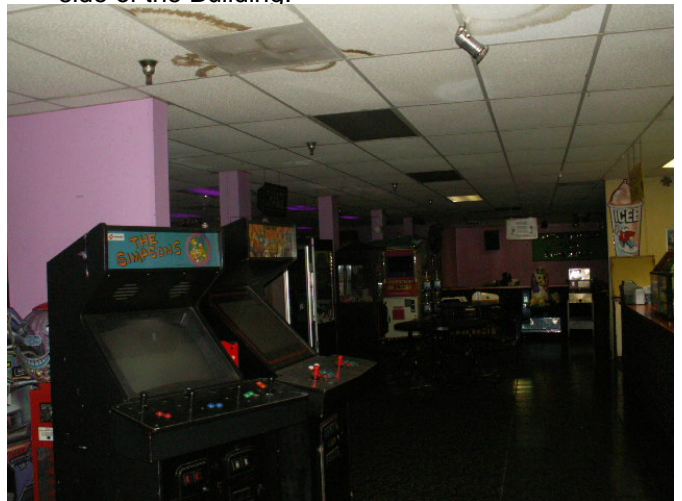
Interior at the skating rink. Not the soiled ceiling tile.
