**DESKTOP
GEOTECHNICAL INVESTIGATION
BEYER COMMUNITY PARK
BEYER BOULEVARD AND ENRIGHT DRIVE
SAN DIEGO, CALIFORNIA**

(K2 Engineering Job No. G2017001-1)

March 22, 2017

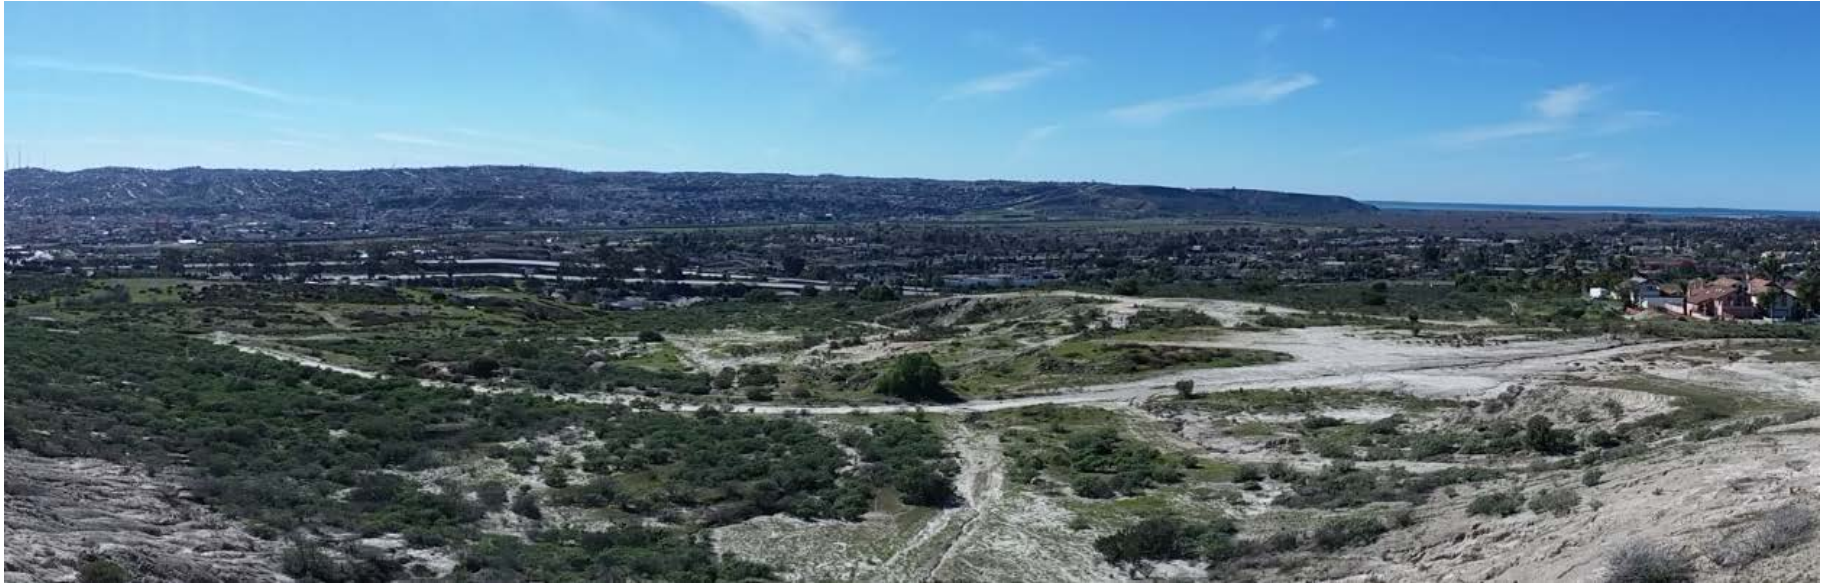
Looking Southwest at Beyer Park Site

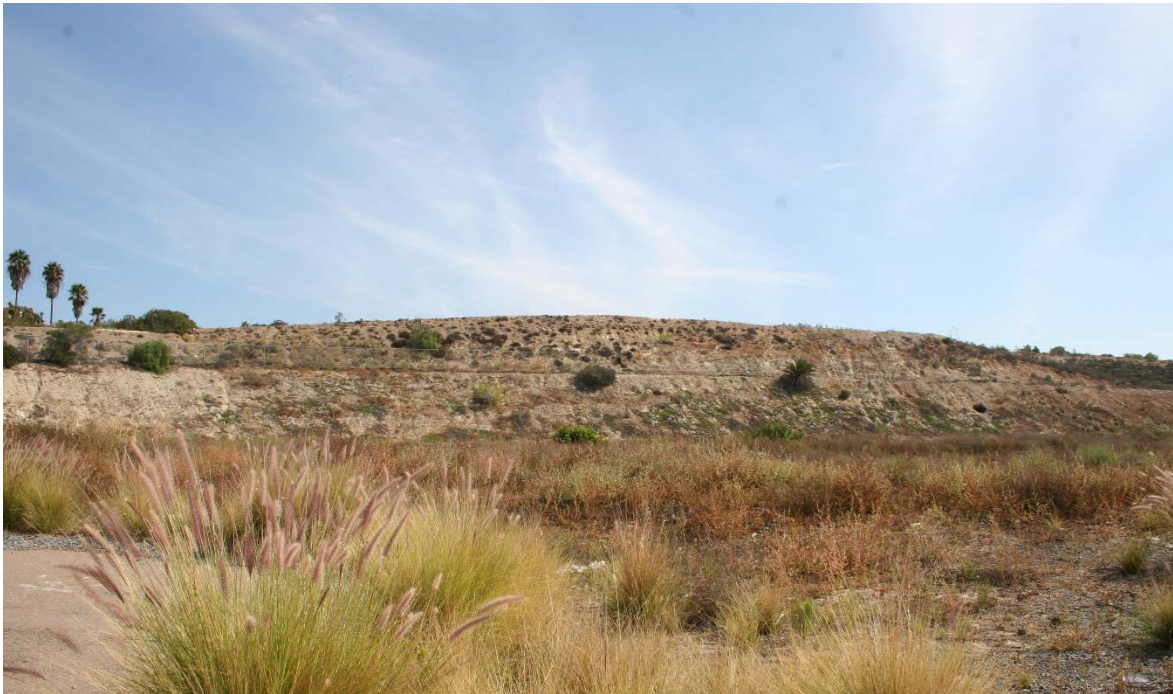
Looking east at Beyer School slope

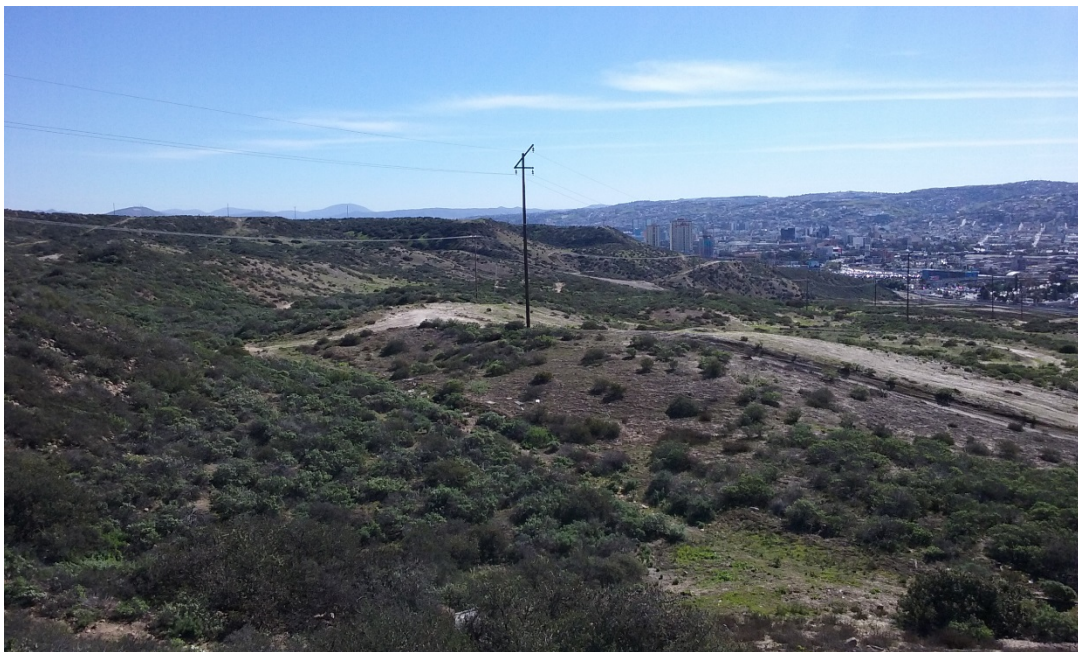
San Ysidro Landslide – Looking South

Two major landslides have been documented in the vicinity of the site, the Moody Canyon landslide to the north (off-site) and the San Ysidro landslide to the south and east. Based on available information, the limits of the San Ysidro landslide east of the La Nacion fault the northeast site boundary could be confirmed but not the southern boundary. Furthermore, the area east of the La Nacion Fault has been described as being part of the OMLS, however, we observed no evidence of this in the reviewed geotechnical reports.

Additional field explorations are recommended to confirm the landslide boundaries and to evaluate the stability of proposed. The approximate location of the landslides and of the proposed field explorations is presented in Plate 2, Site Plan and Geologic Map.

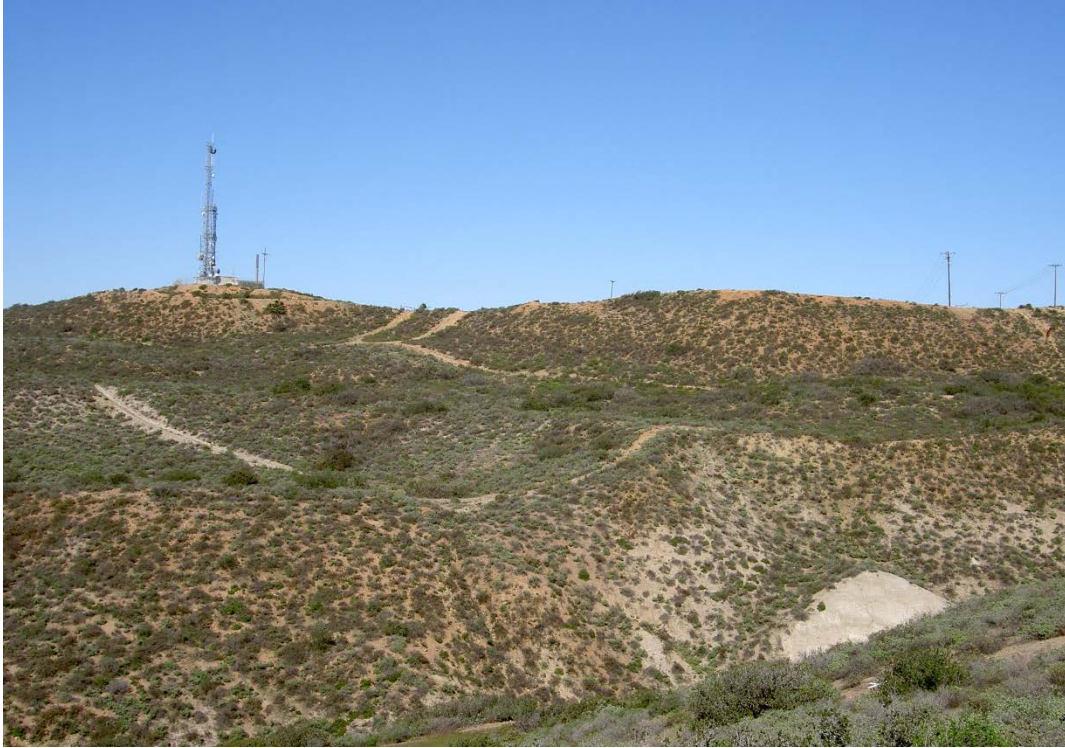
Moody Canyon Landslide – Looking North

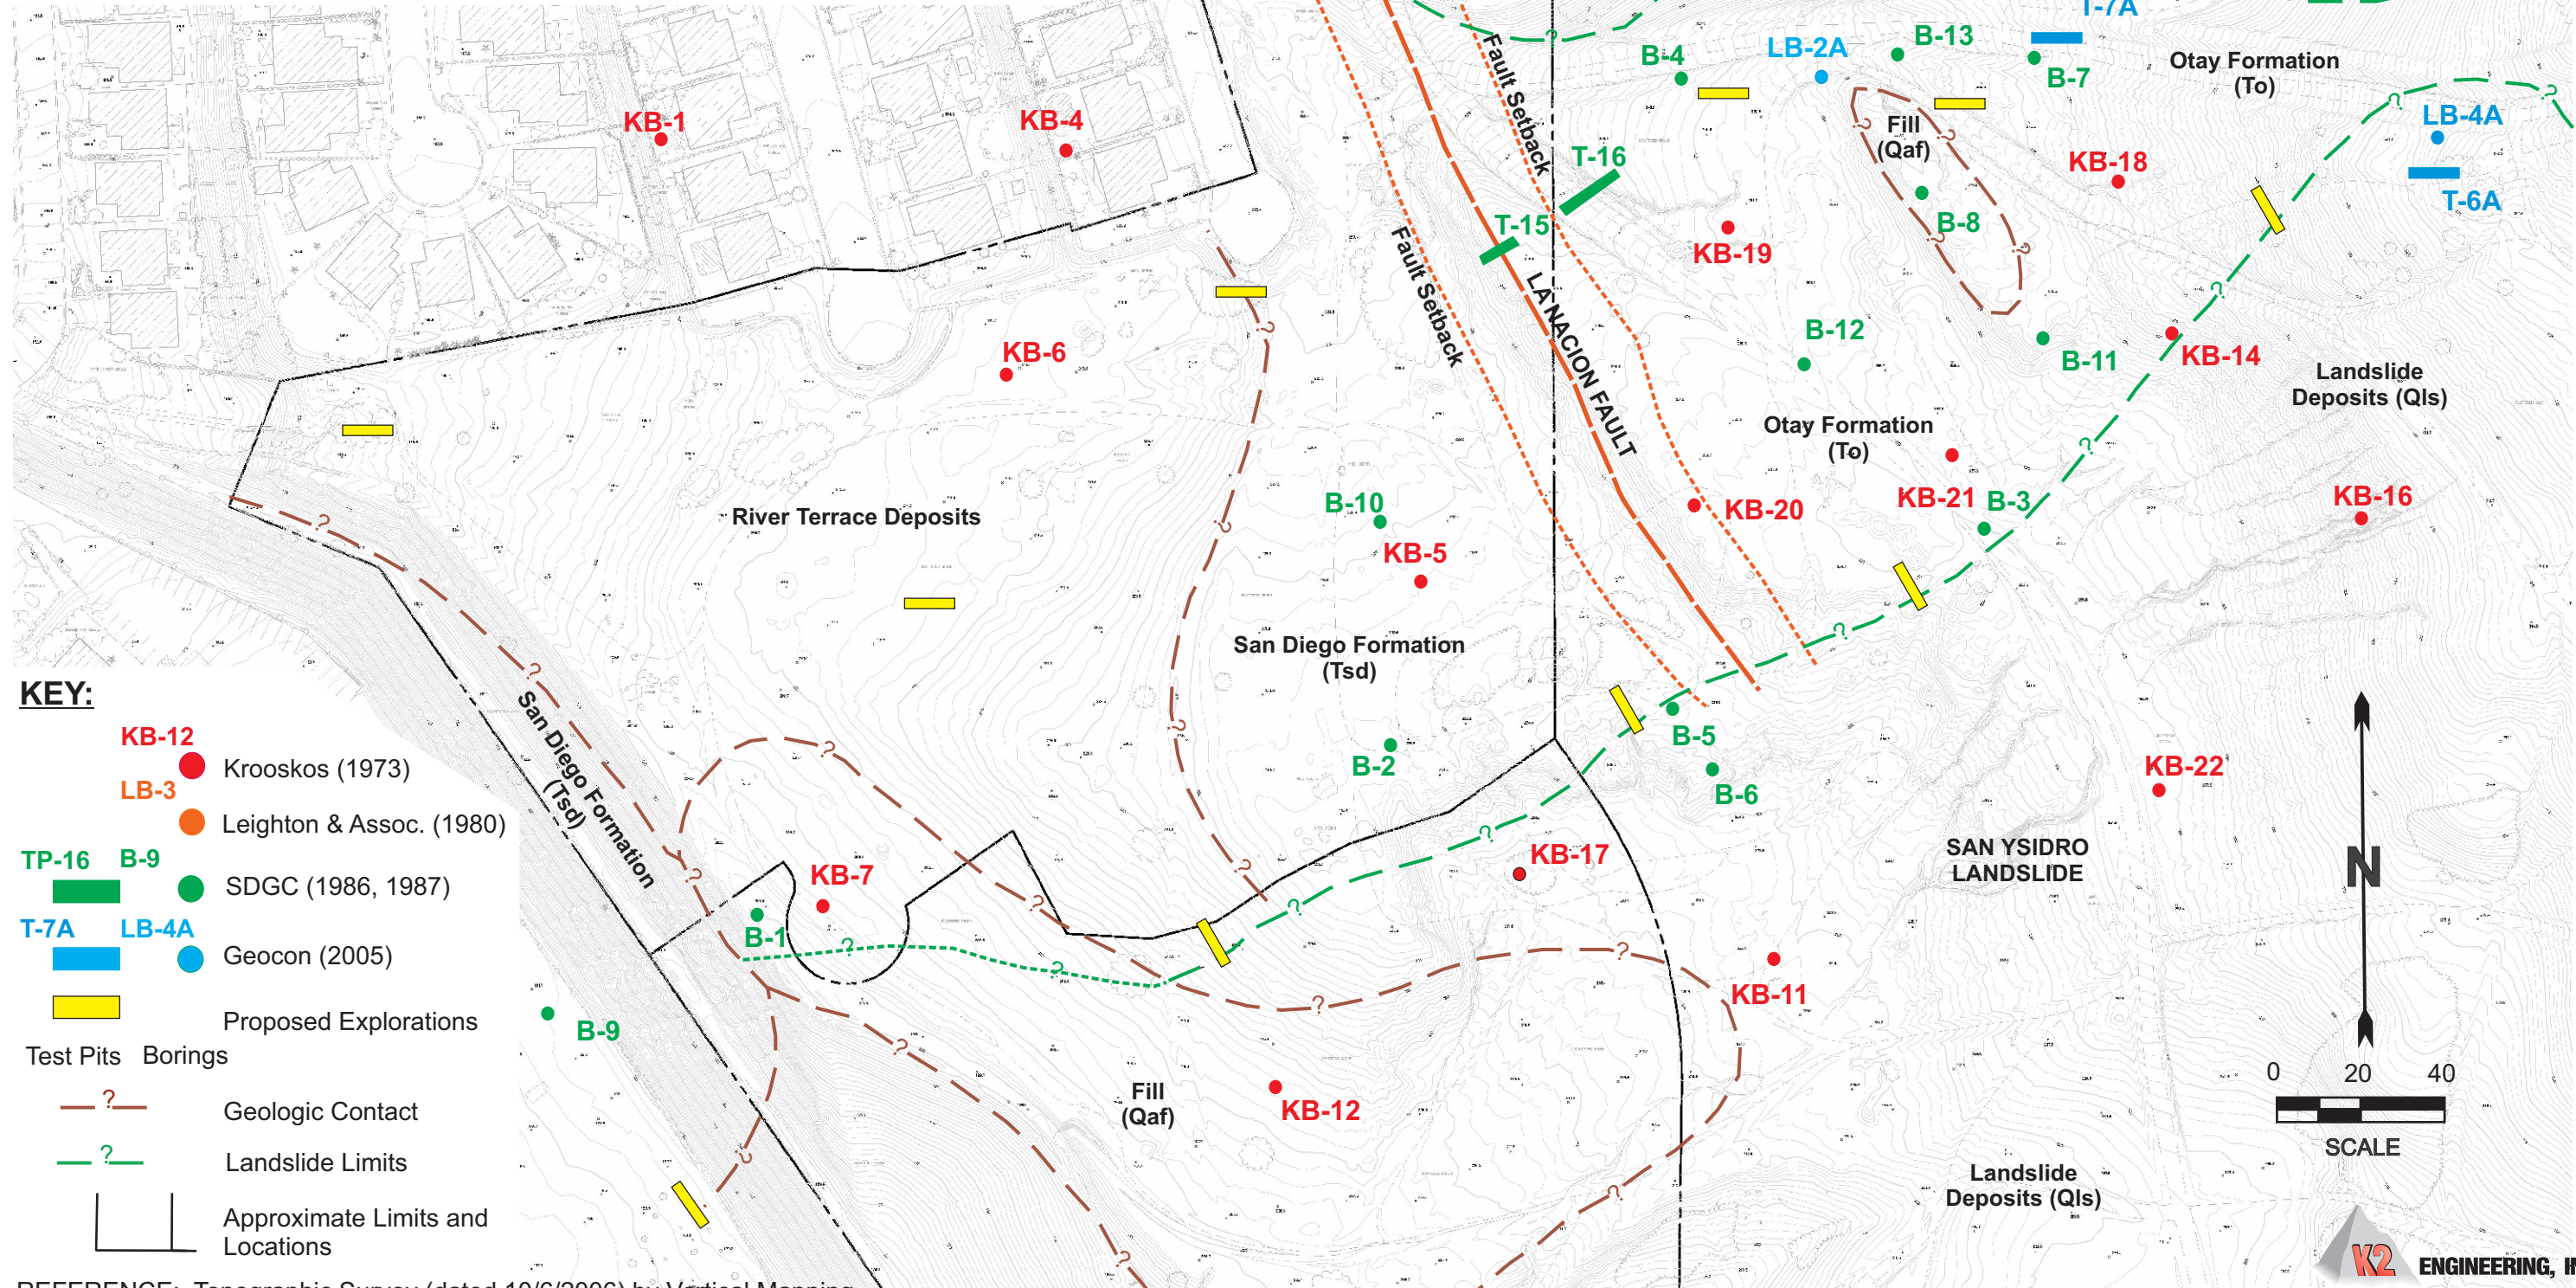
The La Nacion Fault zone was mapped as crossing the site in a northwest to southeast direction, east of the terminus of Beyer Boulevard. It was described as trending “through the center of the site in a northwest direction (N20W to N40W).” (SDGC, 1988). Vertical offsets, fractures, slicks and remolded zones associated with faulting were reported in the exploratory excavations.

River Terrace Deposits: Late Pleistocene age river terrace deposits occur in the central portion of the property as shown on the Geologic Map, Plate 2. This unit consists of massively bedded, light reddish- brown to light orange-brown, medium to fine grained sandstone and cobble to boulder conglomerate. This unit likely originated in an ancient floodplain of the ancestral Tijuana River. The eastern limit of this unit is formed by the La Nacion Fault where the fault has juxtaposed orange brown river terrace beds and light grey sandstone of the Otay Formation. To the west, this unit is well exposed at the top of the cut slope that forms the western boundary of the proposed park property.

We recommend that future field investigations include geologic mapping of the exposed slopes and test pits to confirm the landslide boundaries. The test pits should extend to depths of 10 to 15 feet. Their final dimensions would be determined in the field as the investigation progresses. The locations of the proposed exploratory excavations are presented in Plate 2, Site Plan and Geologic Map.
