Rain Barrel Downspout Disconnect Best Management Practice Effectiveness Monitoring and Operations Program

Final Report

June 11, 2010

**Weston Solutions, Inc.
2433 Impala Drive
Carlsbad, California 92010**

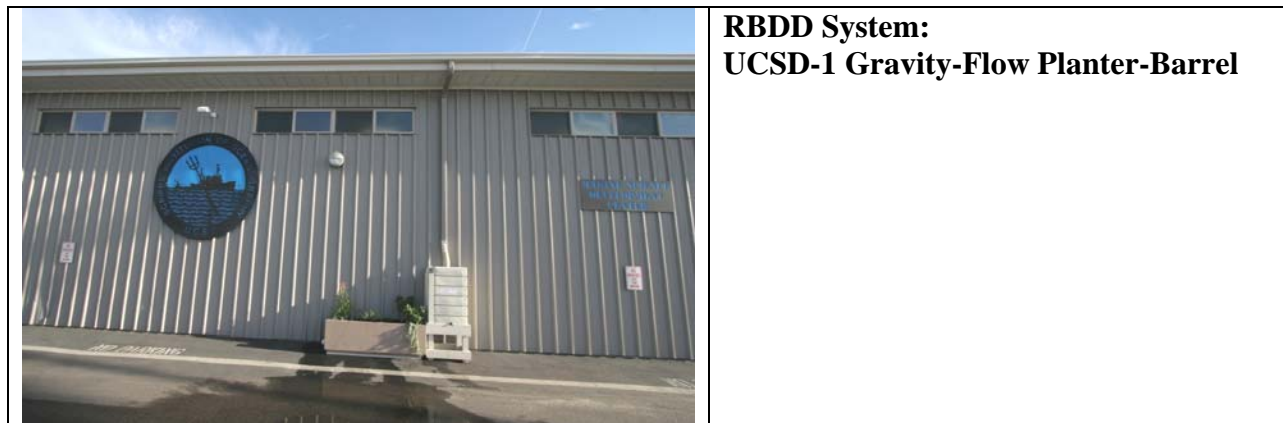
Figure 2-5. Scripps Institution of Oceanography Metalshop Building Downspout Disconnect Installation Photograph(s)

**RBDD System:
UCSD-1 Gravity-Flow Planter-Barrel**

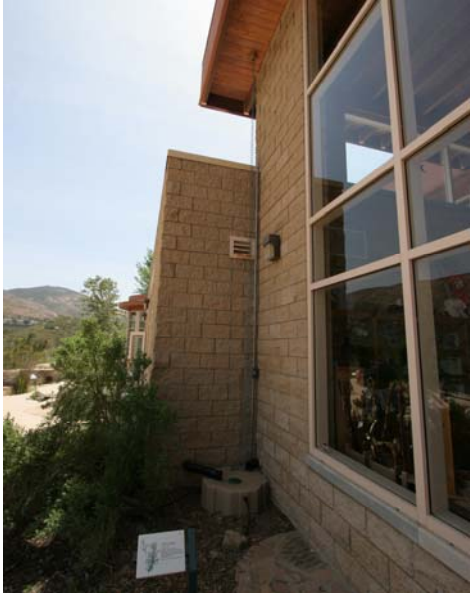
<p>RBDD System: MT-1 Automated Barrels Discharging to Existing Landscaping (12-volt solar electrical service with manual turn timer)</p> <p>Rain Chain and Solar Powered Pump (see photo)</p>

During the December inspection, the barrel system near the patio entrance at Mission Trails Regional Park Nature and Visitor Center (MT-1) showed no evidence of receiving flow. After speaking with the site contact and photo-documenting flow conditions during the storm event on January 18, 2010, it was determined that the roof drain configuration does not regularly discharge to the RBDD system. The roof drainage system is configured in a paired configuration with a main downspout and an overflow. The main downspout conveys flow during all storms and the overflow drain is functional if the main drain is plugged and non operation or if the capacity of the main drain has been exceeded due to intense rainfall. The main roof drains discharge to an untraceable underground conveyance system according to as built drawings. The facility maintenance staff has determined that reconfiguring the roof drains will create a flow condition where the barrels are receiving runoff and have received a work order to reconfigure the drains. Irrigation tubing at Mission Trails (system MT-2) had been vandalized. New tubing had to be connected to the pump. In order to maintain the existing electrical connections to the pump, maintenance activities had to be conducted inside the barrel, in algae-filled water.² Once tubing was re-connected, the solar panel powered pump and timer system operated as designed.

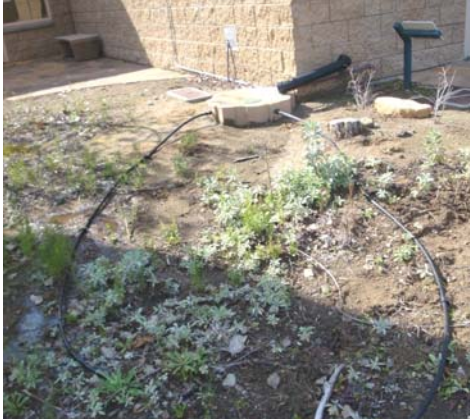
Figure 2-6. Mission Trails Regional Park Nature and Visitors Center Downspout Disconnect Installation Photograph(s)

<p>RBDD System: MT-2 Automated Barrel Discharging to Existing Landscaping (12-volt solar electrical service with manual turn timer)</p>

Vandalism was repaired at the Mission Trails Regional Park Nature and Visitor Center (MT-2). Additional instances of vandalism were not recorded at this site once the initial repairs were completed (in addition to the maintenance repair work, the Center undergrounded the irrigation tubing, making it inaccessible at the ground surface).

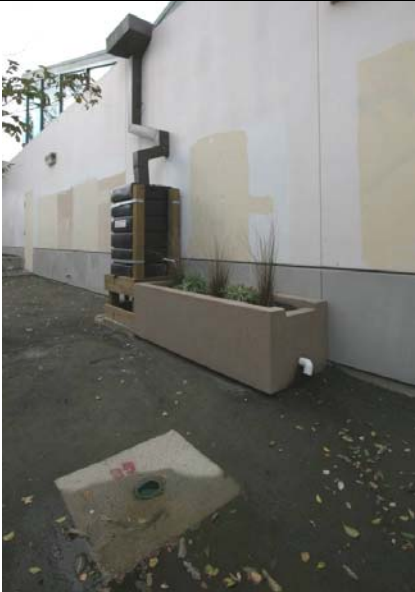
Figure 2-7. Mira Mesa Library Downspout Disconnect Installation Photograph(s)

<p>RBDD System: MM-1 Gravity-Flow Planter-Barrel</p>
 	<p>RBDD System: MM-2 Multiple Gravity-Flow Barrels in Series Discharging to Existing Landscaping</p>

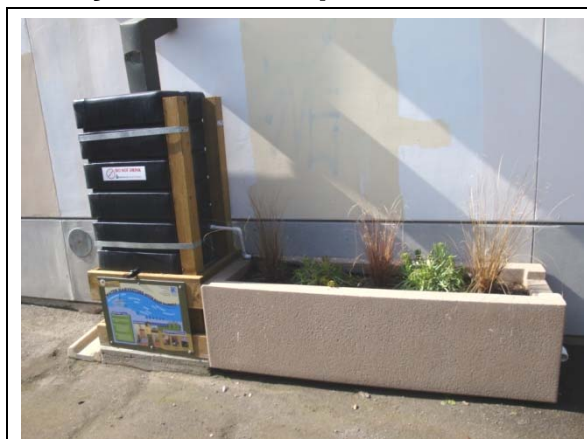
Figure 5-1. Complete Planter-Barrel System Ready for Operation

During the startup evaluation, all systems were determined to be operational and ready for use. Figure 5-1 provides an example of a complete planter-barrel installation.
