Phase III Draft Final Report District 3 Sidewalk Study

March 21, 2006

Prepared for:
City of San Diego

Prepared by:
Kimley-Horn and Associates, Inc.

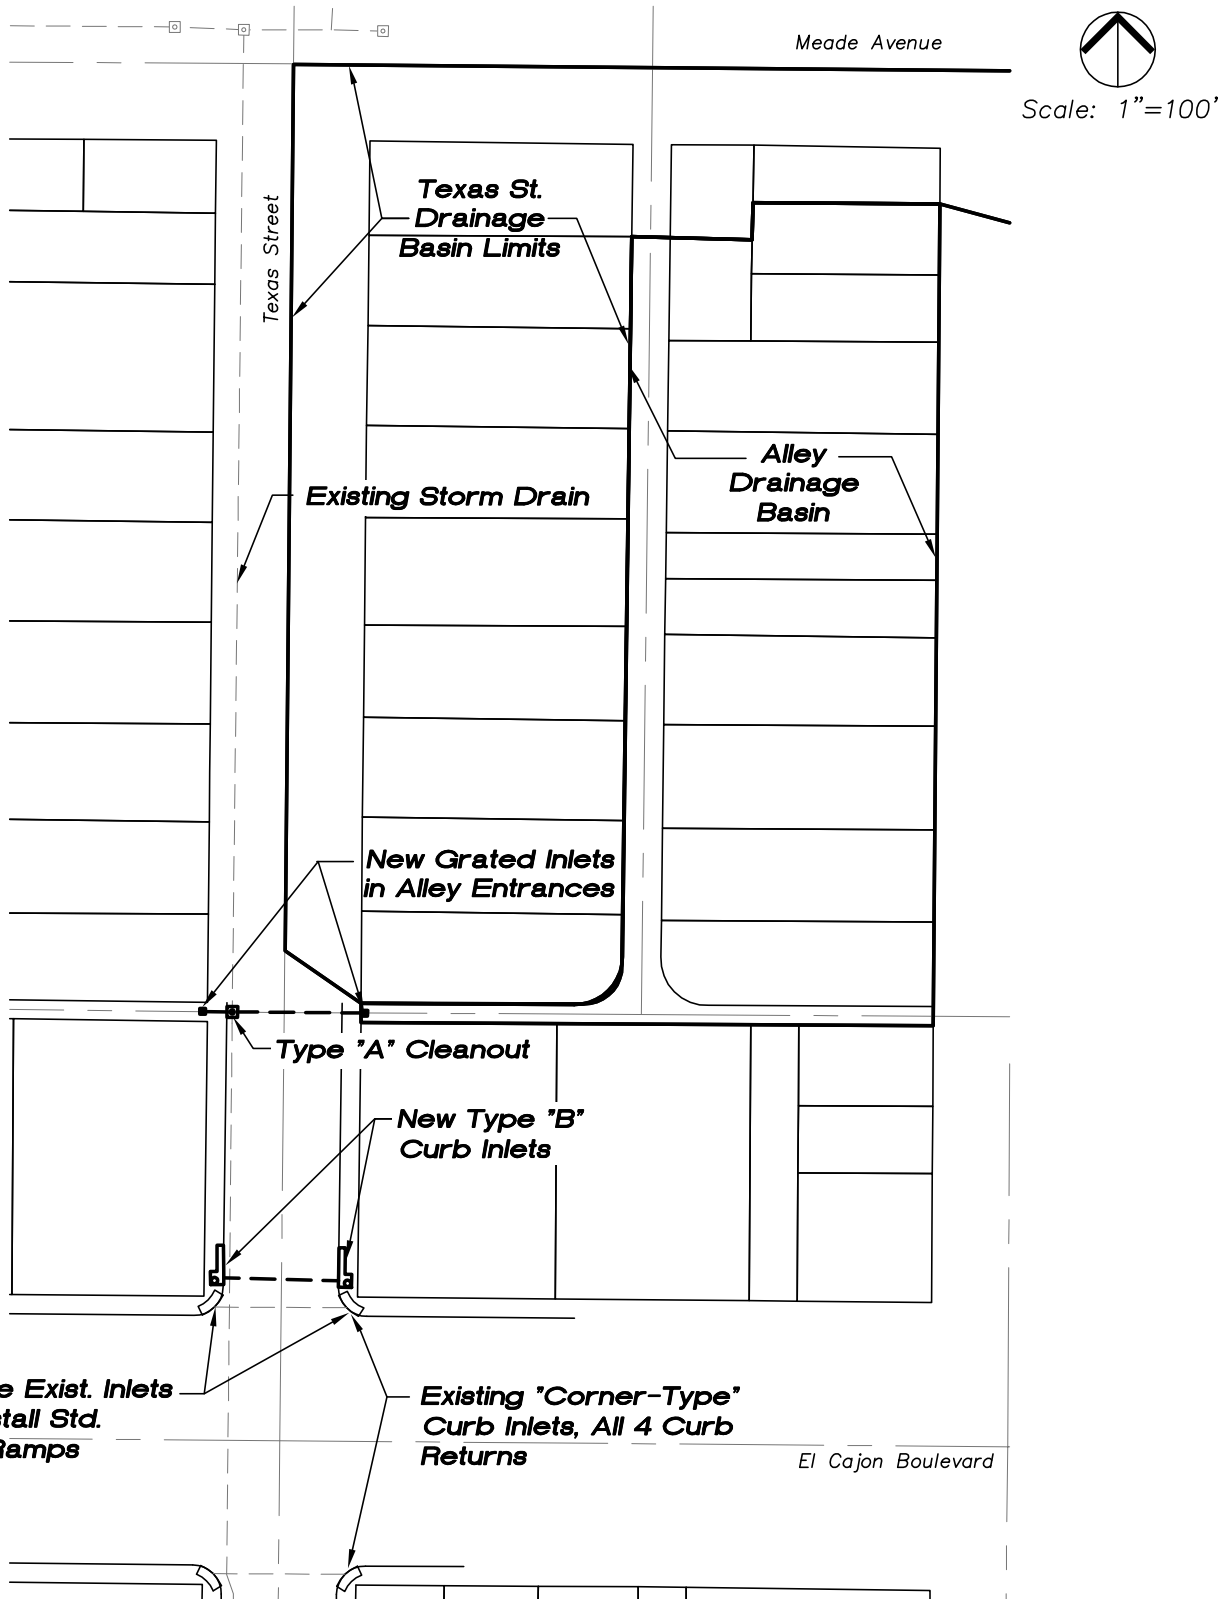
Figure 5

On the west side of Texas Street, the upstream flows are not as great, but surface grades are defective, resulting in permanent ponding in the alley entrance which partially blocks pedestrian movement. The City's GIS storm drain mapping indicates a pair of inlets along Meade Avenue just west of Texas, which appear to provide protection to this segment. Field investigation revealed that the inlet on the south side of Meade does not exist, and only a small grated inlet exists on the north side.

Installation of storm drain inlets here could provide two benefits: a curb inlet along the east side of Texas Street could capture the significant upstream flows, reducing the likelihood of flows topping the curb, and a grated inlet in the alley just upstream of the sidewalk could capture the alley flows, so that pedestrians would not need to walk through the stream of runoff from the alley. A connection point for such a system is available about 200 feet away at the intersection of El Cajon Blvd. See **Figure 5, Texas Street Drainage Improvement**.
