TORREY PINES ROAD PRELIMINARY ENGINEERING STUDY

TECHNICAL MEMORANDUM FOR

FENCE CONSIDERATIONS

TRAN CONSULTING ENGINEERS

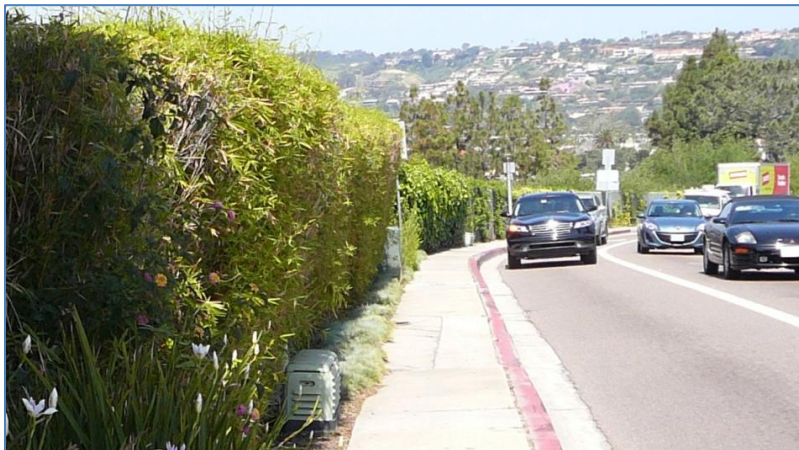
The fence in the scenic view area between Prospect Place and Coast Walk Station 12+00 to 16+00 will be approximately 400 feet long, replacing the current chain link fence overgrown with plant materials – see Pictures 2752 and 3959 below. The slope in this area will be modified to accommodate a wider sidewalk and an 18 inch parkway with plants and/or trees. It is suggested that this fence be a 72 inch high fence, high enough to prevent access down the slope and limiting the amount of litter that is tossed down the slope, which is a problem according to residents. A shorter 42 inch fence could increase unwanted trespassers and litter problems. A steep embankment is located here and therefore a retaining wall will also be required. Additionally the corridor study had recommended a guardrail barrier to prevent cars from running off the road. Therefore part of this fence could be integrated into a decorative guardrail/parapet with a high Plexiglas wall to open this area as a view corridor to travelers. Retaining walls, view corridors and guardrail are the topics of other technical memoranda; please see these technical memoranda for additional recommendations and details.

Picture 2752 - Overgrown Fence near Prospect Place

If retaining walls can be avoided in some portions of this location and shrubs can be placed down the embankment another suggested alternative is that this fence be a 72 inch high wood with metal fabric fence that is set down the slope approximately 4 feet so the view is not obstructed.

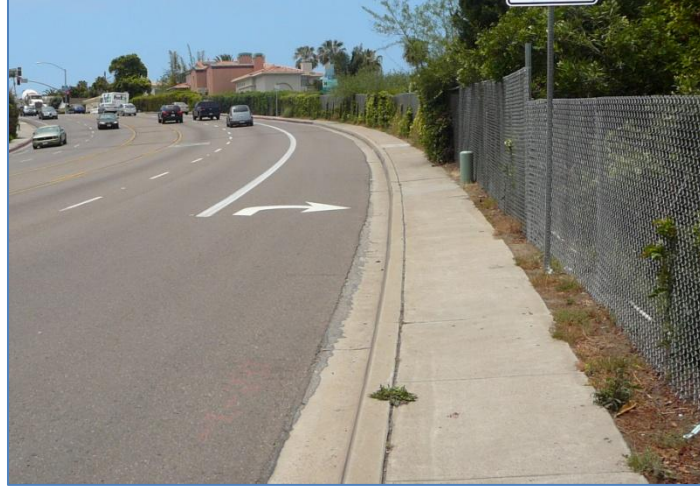
Picture 3959 - Fence Looking Southwest

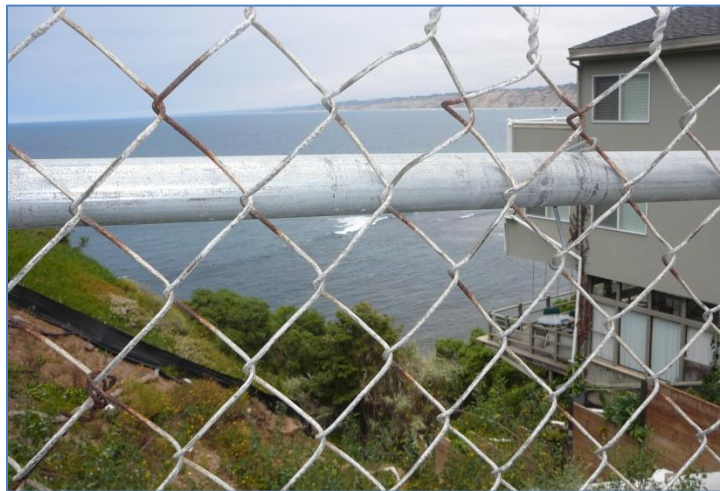
Between Station 17+20 and 18+20 an existing retaining wall supports the sidewalk and road. There is a drop of at least 10 feet over the retaining wall. Currently, a chain link fence is mounted on the retaining wall with a green plastic woven cover as shown on Pictures 3957, 2742 & 2741. This is a view corridor, so the fence should be replaced. If a wood and steel wire fabric is utilized here, steel posts may be needed instead of wooden post for structural reasons, depending on how the posts are to be installed in the retaining wall. It would be unsafe to install a shorter fence here. At this location, a concrete parapet with Plexiglas material that reaches a total height of 72-inches could be integrated into the existing retaining wall.

Picture 3957- View through Opening in Fence

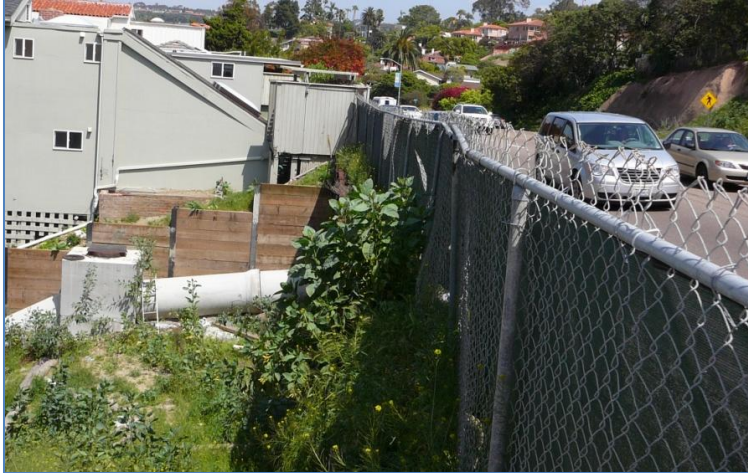
Picture 2742 - Behind the Chain Link Fence Looking East

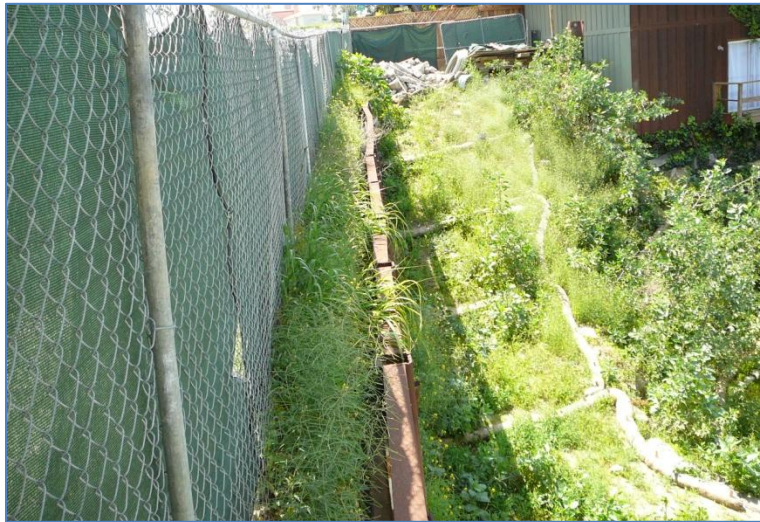
Picture 2741 - Behind the Chain Link Fence Looking West

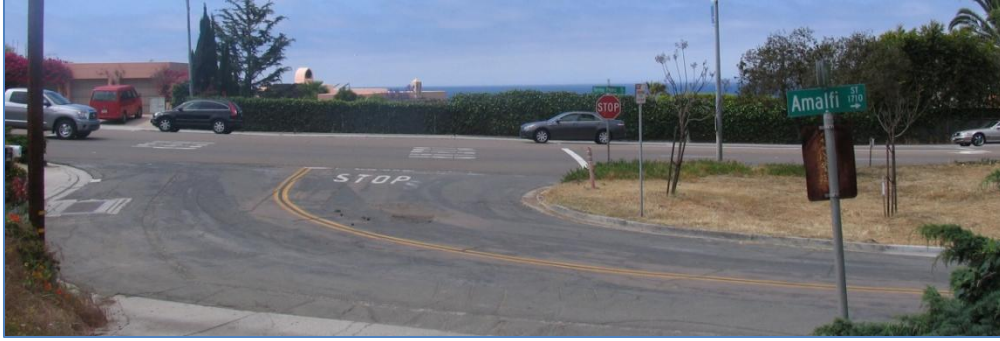
Another special fencing case between Station 21+40 to 22+70 (Charlotte Street, a paper street) across from Amalfi St. where there is a concrete retaining wall with a chain link fence constructed on top, along the edge of the sidewalk as shown in pictures 3398, 3399, 2735 & 3951 below. The existing chain link fence is overgrown with ivy and the ocean view is not visible from the sidewalk or the road. The corridor study recommends a guardrail across from Amalfi to prevent cars from running off the road. A 72-inch fence is recommended for safety in this area because there is more than a 10-foot drop. It would be dangerous to install a shorter fence here. A parapet with a Plexiglas top is recommended here to provide a proper barrier while providing a view through the Plexiglas.

Picture 3398 - Charlotte Street Fence

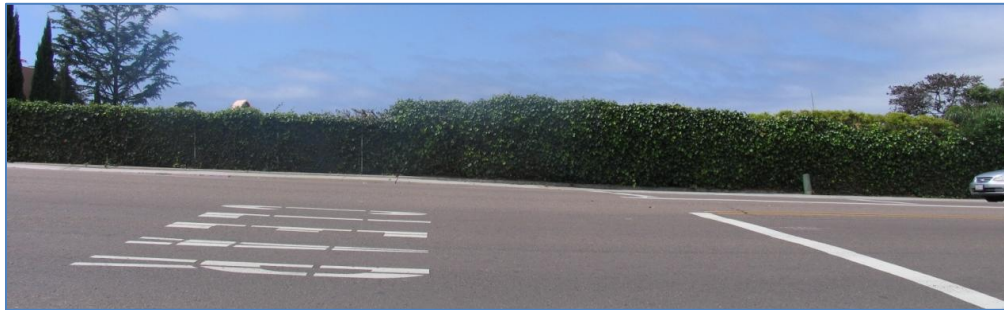
Picture 3399 - Charlotte Street Fence Overgrown with Ivy

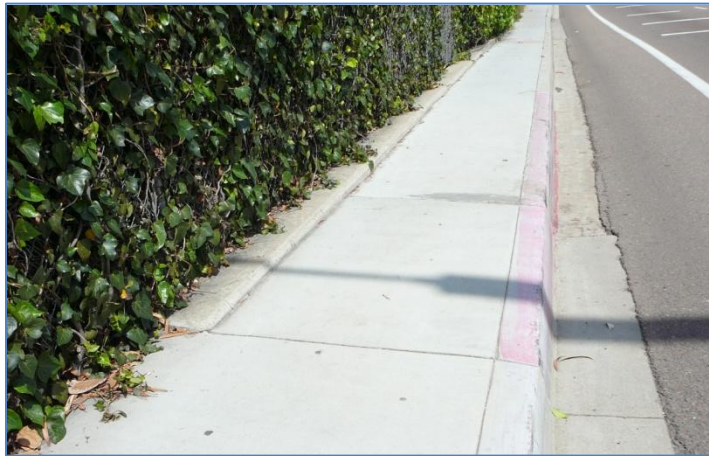
Picture 2735 - Charlotte Street Fence, Top of Retaining Wall and Sidewalk

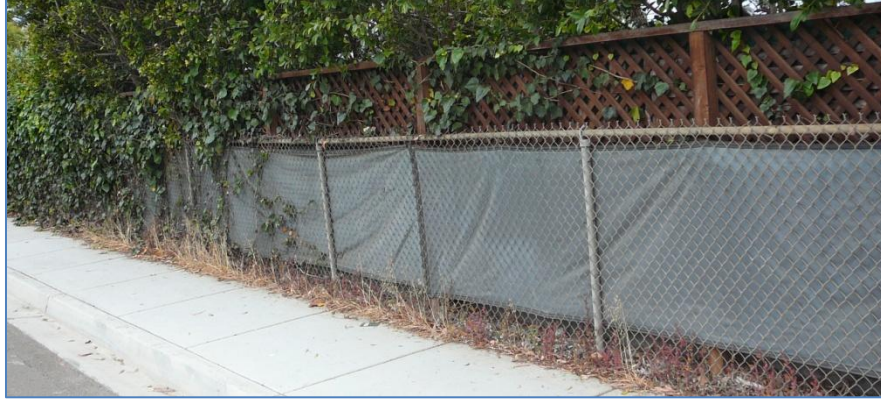
The Charlotte Street chain link fence continues to the east and is supplemented with a privately built wood fence directly behind it as shown in the photo below. It is recommended to leave this portion of the fence as-is since it is in good condition, or remove the city's chain link fence, leaving the private fence. If a public fence is required and not a chain link fence for this area, a wood and wire fabric fence is recommended.

Picture 3951 - Continuation of the Charlotte Street Fence

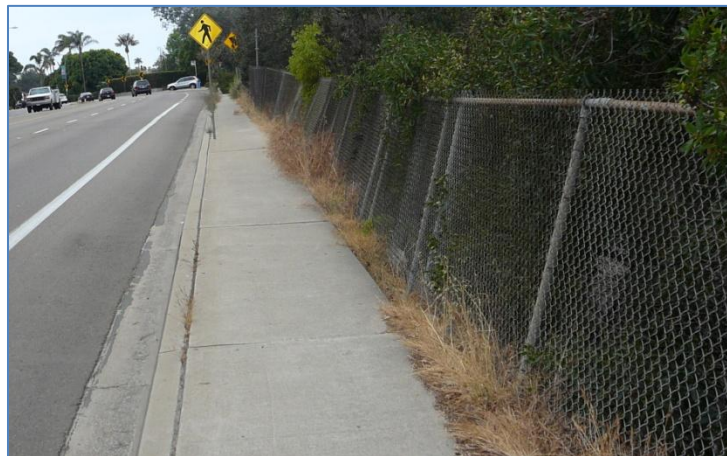
A 300-foot fence from Station 32+50 to 35+50 needs to be replaced. This fence, located above St. Louis Terrace is in poor condition as shown in Pictures 3925 and 3926 below. A 72-inch high wood and wire fabric fence is recommended for this location.

Picture 3925 - Fence above St. Louis Terrace

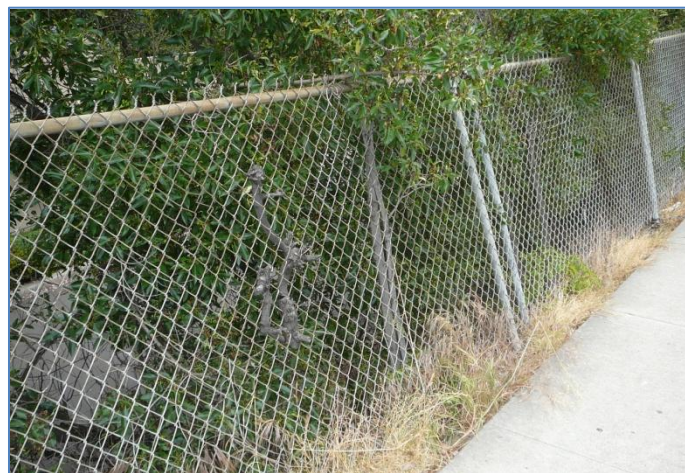
Picture 3926 - Fence above St. Louis Terrace

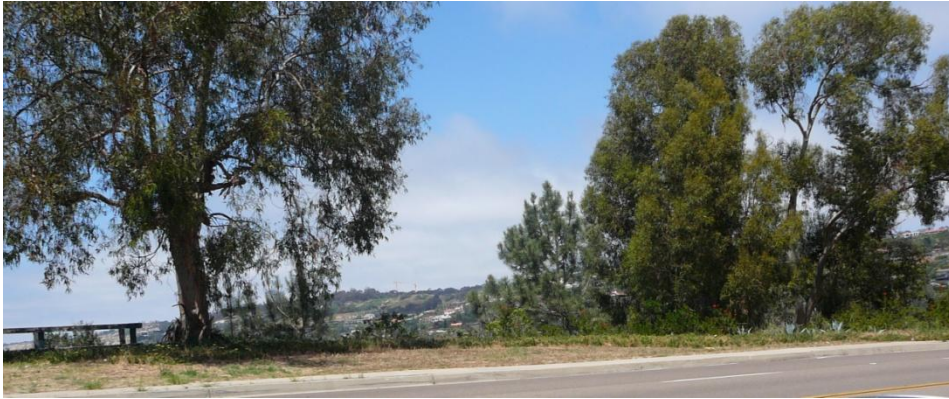
Between Little Street and Roseland Drive, from Station 38+00 to 41+00, there is an area without a fence between the sidewalk and private homes below as shown in Picture 3977 below. This flat unused land area is adjacent to the sidewalk and described in the Corridor Study as being the location for Little Street Park. It is recommended that a fence be installed around the top of the slope. Since this is a view corridor with a partially obstructed view of the ocean and beach area a 42-inch high wood and wire fabric fence is recommended however this should be further discussed in the park development not included in this preliminary design.

Picture 3977 - No Fence near Little Street at Station 40+00

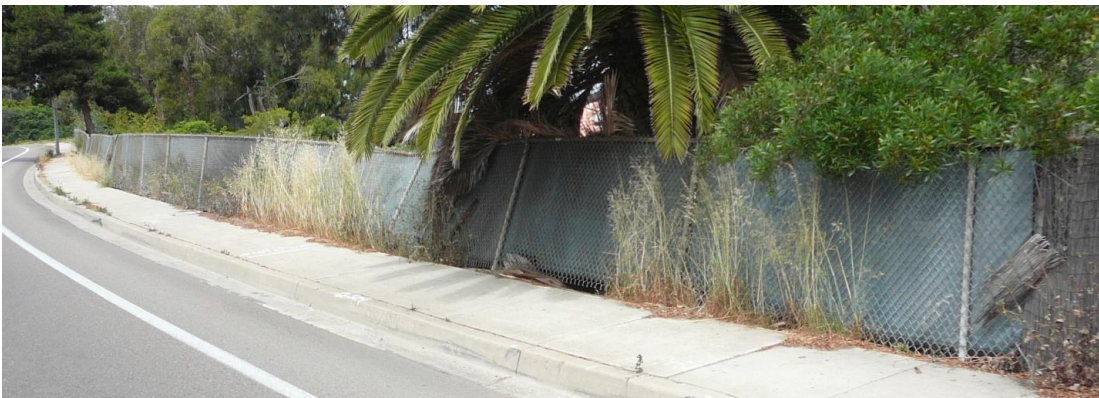
It is recommended that the old 300-foot long fence from Station 41+00 to 44+00, shown in Picture 3915 below, be replaced with a 72-inch high fence. Although this is not a view corridor a view of the ocean over existing homes is provided from this location the 72-inch fence could be set down the hill from the sidewalk to enhance the view. A wood and wire fabric fence could be utilized for this area.

Picture 3915 - Old Existing Fence

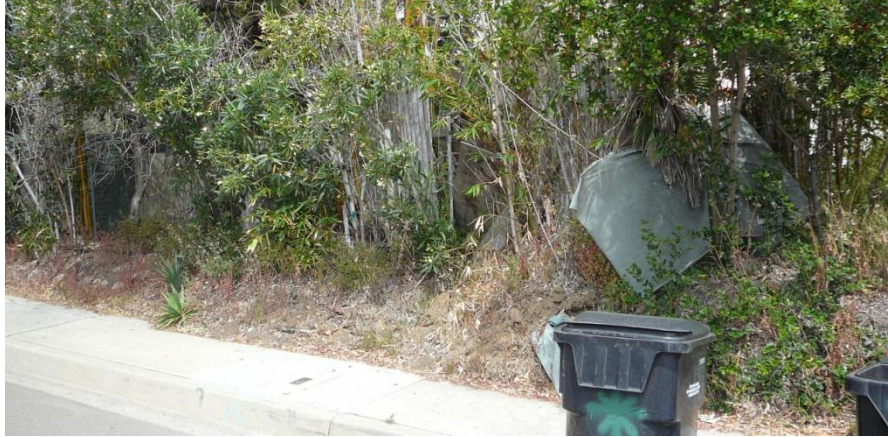
The continuation of the chain link fence above, from Station 44+00 to 44+60, shown in Picture 3914, is also on City Right of Way. It is overgrown with bamboo and plants that should be cleaned up and a new fence installed.

Picture 3914 - Approximate Station 44+ 60 that Needs New Fence
