APPENDIX A

Hydrology and Hydraulics Fact Sheets

Hydrology and Hydraulics Fact Sheet

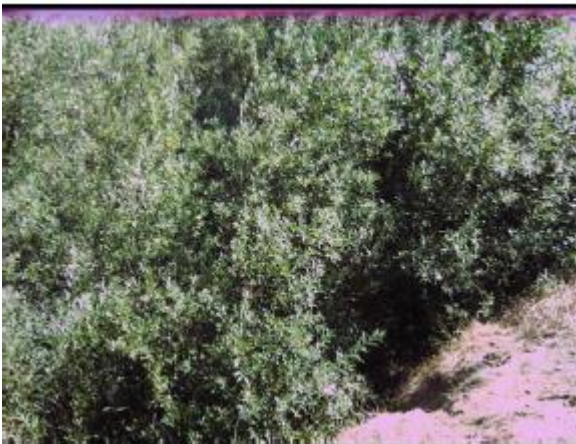
IHHA 1. Sorrento Valley 1: Looking upstream at the vegetation along the banks.

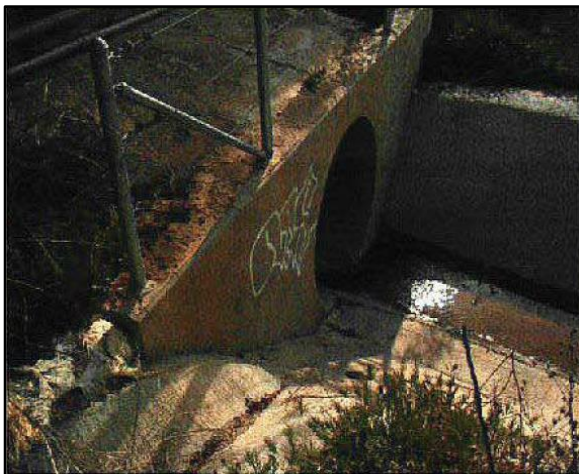
1. IHHA 1. Industrial 1, Reach 3: Looking at 54-inch-diameter RCP outlet at upstream end of facility group.

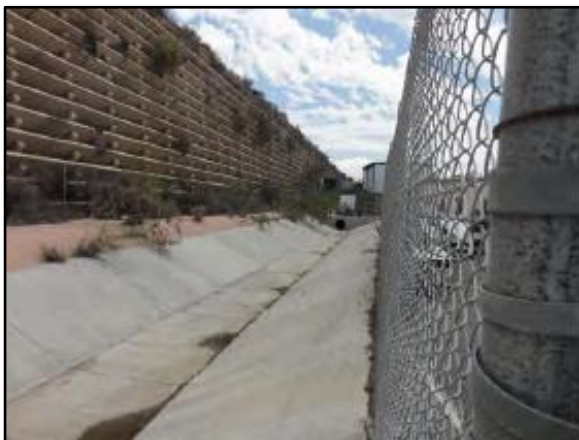
1. IHHA 1. Tripp 1, Reach 4: Looking upstream toward 42-inch RCP outlet.

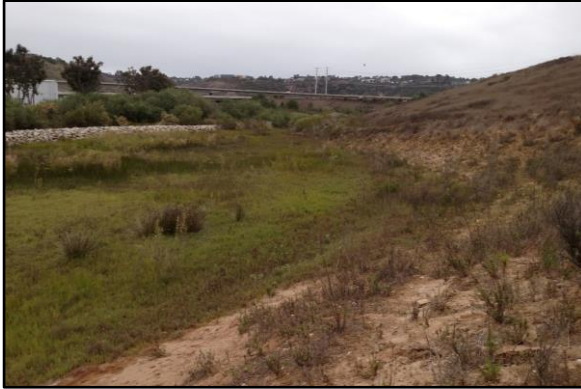
3. 5-805 Basin: Vegetation observed throughout basin.

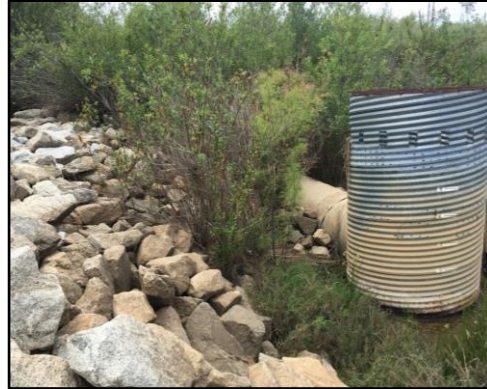
4. 5-805 Basin: Basin outlet structure and rip rap embankment.

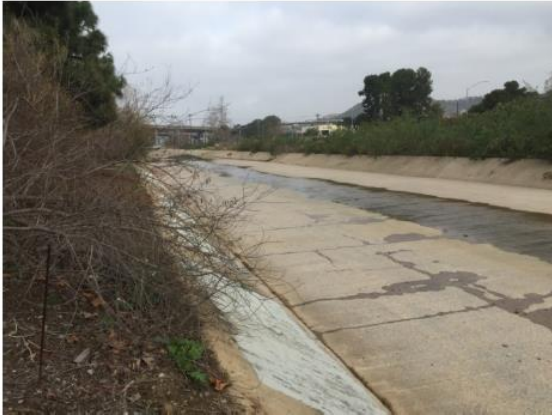
1. Roselle 2: Looking upstream of the I-5 overpass.

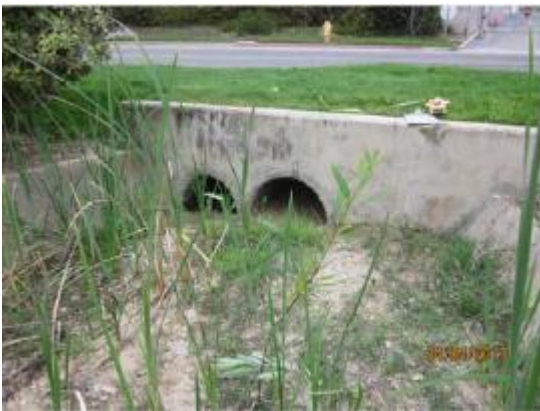
IHHA 62. Flintkote 1: Looking upstream at the 24- and 30-inch RCP outlet.

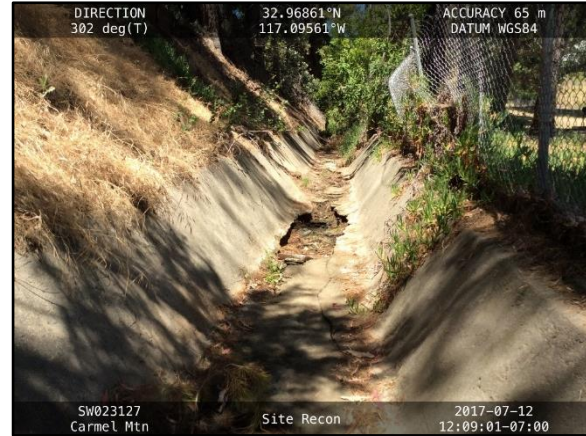
2. Via San Marco 1: Representative of segment showing failure of gunite bottom, looking upstream.

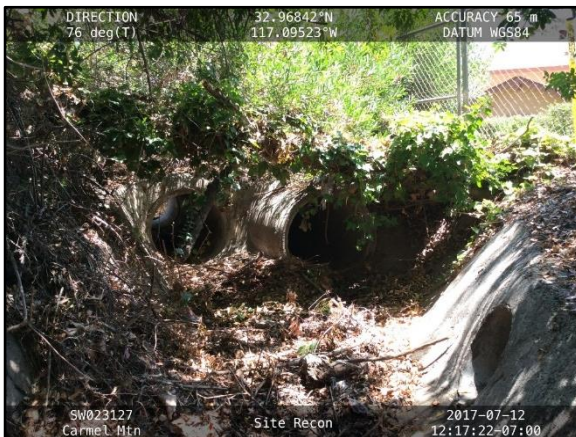
3. Via San Marco 1: Upstream of double pipe culverts, looking downstream (Station 501).

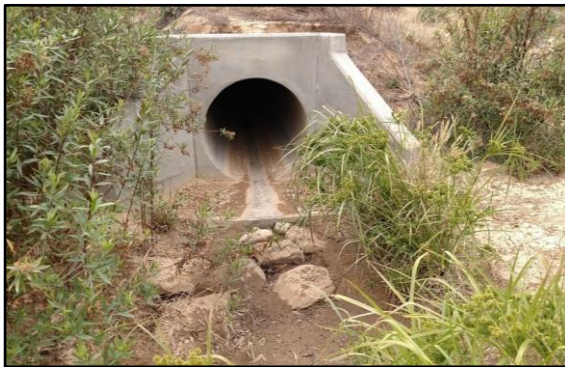
1. Alta La Jolla: Inlet observed to be mostly clear of sediment/debris.

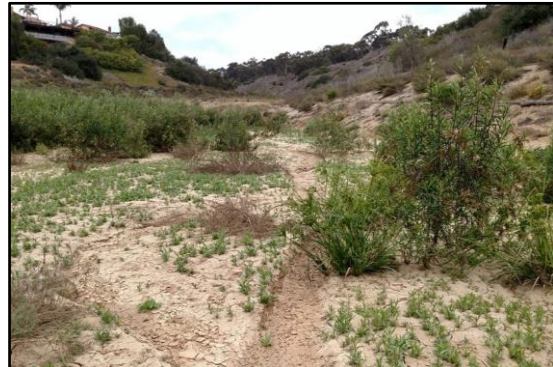
2. Alta La Jolla: Vegetation observed in basin.

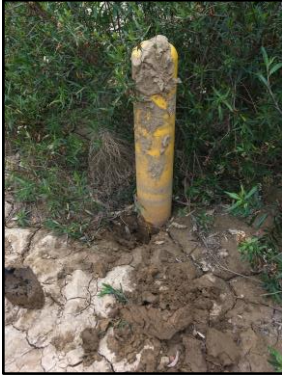
3. Alta La Jolla: Sediment/debris deposition depth is at “red stripe” elevation on monitoring bollard.

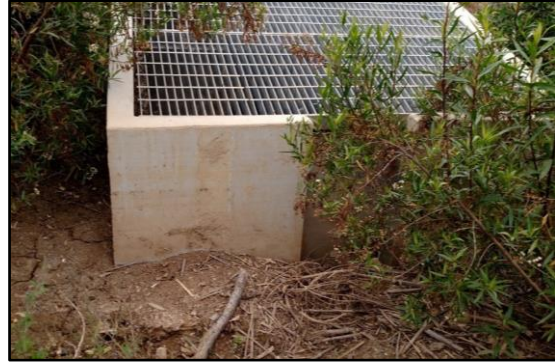
4. Alta La Jolla: Outlet structure observed to be partially blocked with sediment/debris.

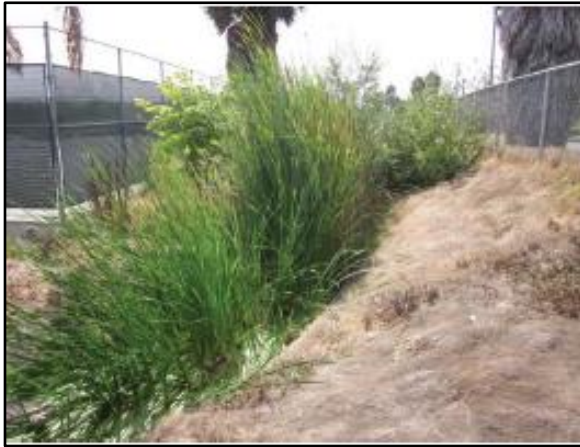
1. IHHA 24. MBHS 1: At upstream end of concrete segment, just downstream of 27-inch-diameter RCP and headwall.

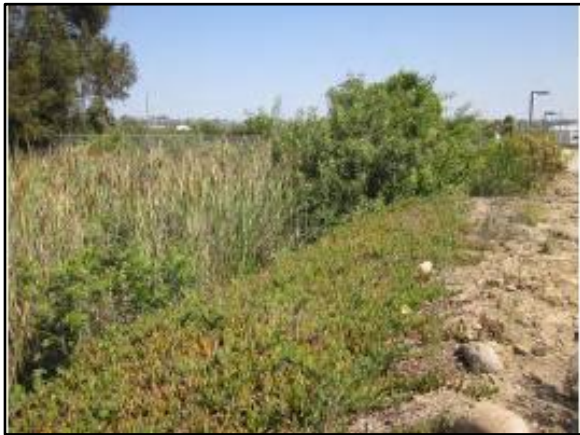
3. IHHA 31. PBO 1: High vegetation density and growth at the upstream end of the earthen channel were observed.

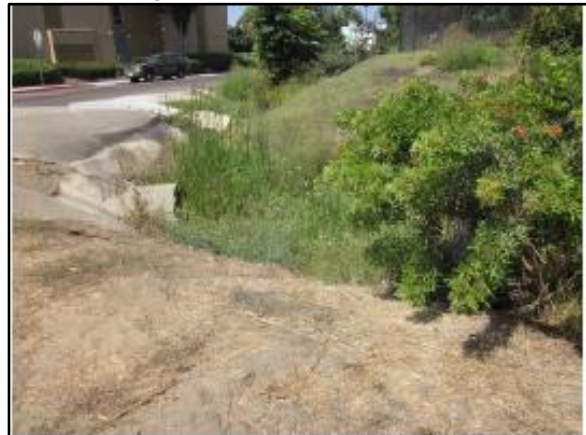
4. 7. IHHA 31. PBO 1: Downstream end looking east. High vegetation density and growth were observed

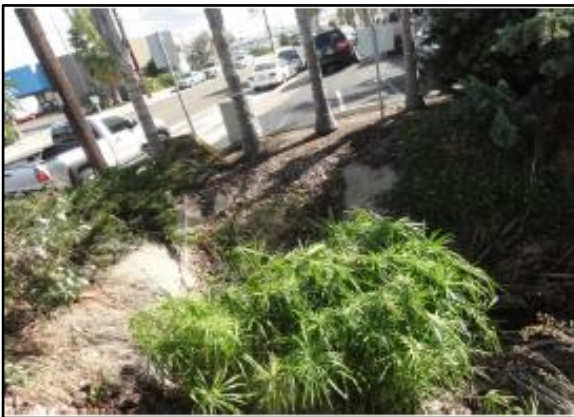
IHHA 1. Engineer 1 (Reach 1): Downstream end of facility group, facing east towards the 36-inch RCP (November 2015).

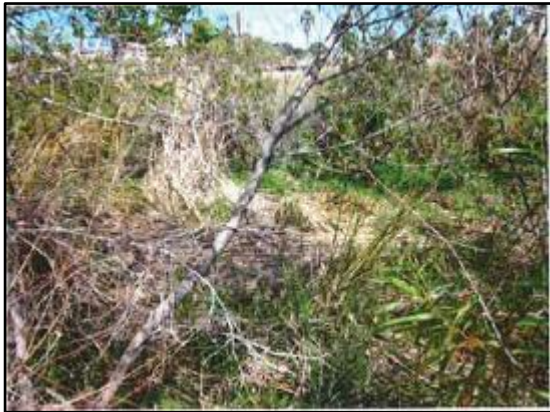
IHHA 8. Stadium 2, Map 1: Looking upstream near area of recommended maintenance (March 2013).

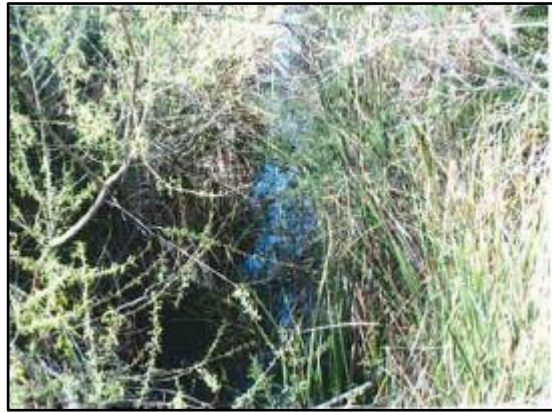
IHHA 13. Stadium 1, Map 1: Heavily vegetated channel bottom near the downstream end of the facility group (March 2013).

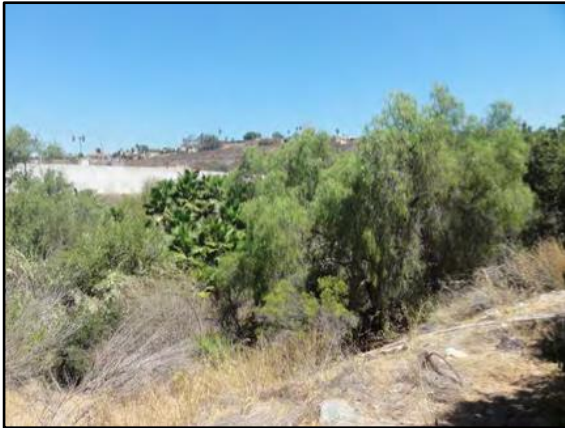
IHHA 1. Alvarado 1, Map 1: From south side of Reach 1 at the downstream end of the Alvarado Channel, upstream of College Avenue, looking upstream.

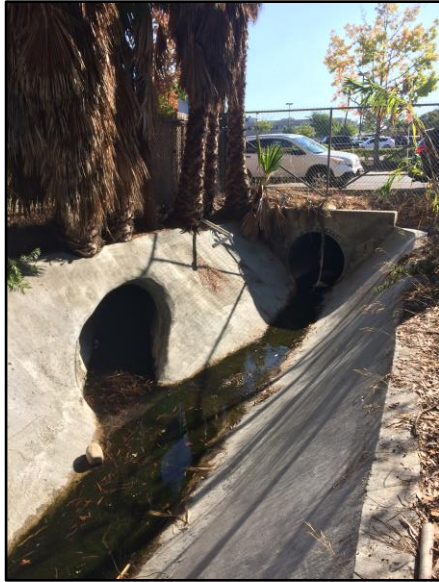
1. Alvarado 3, Map 2: Facing the upstream end of the segment, at the location of the recent concrete lining repair work.

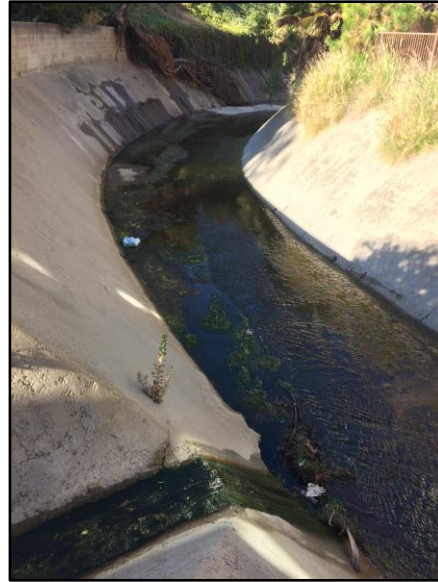
2. Alvarado 3, Map 2: Facing downstream at where the tributary discharges into the Alvarado 2 segment.

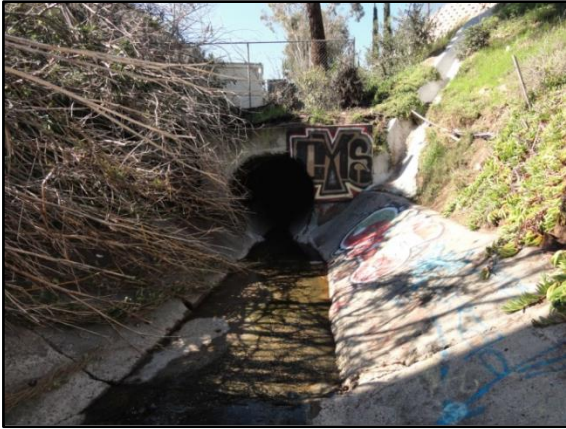
IHHA 1. Baja 1 (Reach 1): Facing downstream end of facility group; towards 60-inch-diameter RCP culvert beneath the Collwood Villas Apartments and Collwood Boulevard.

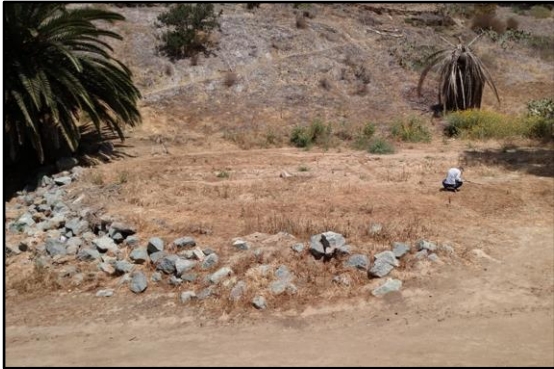
1. Maple Canyon: Sediment deposition observed in basin and minimal vegetation growth within basin.

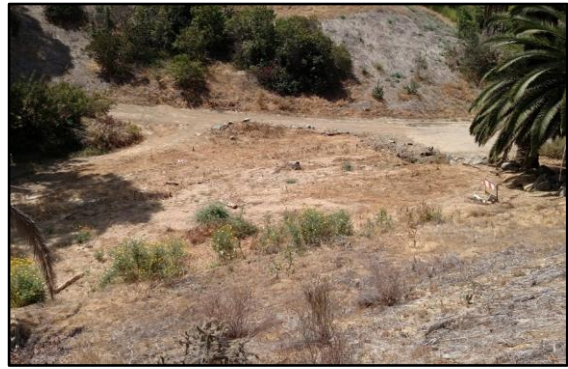
2. Maple Canyon: Looking south onto basin, completely filled with sediment.

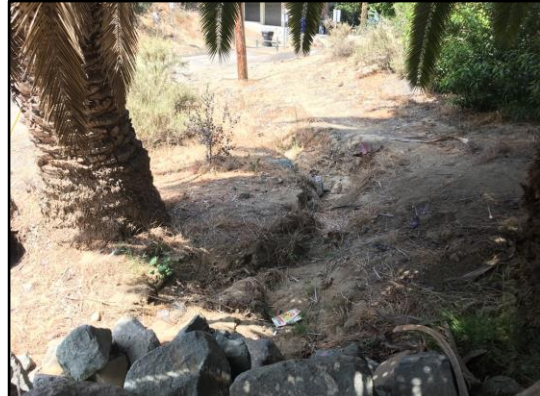
4. Maple Canyon: Uncontrolled drainage channel observed; no outlet control structure observed.

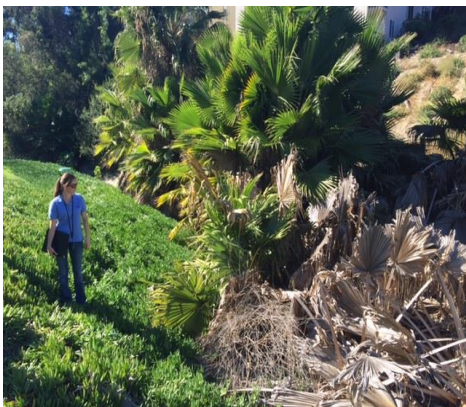
1. Washington 2: Looking downstream at vegetation in concrete ditch in baseline condition (November 2015).

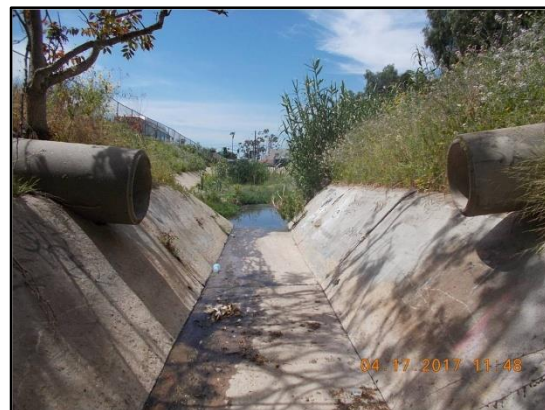
2. Washington 2: Looking downstream at transition to Washington 1 (April 2017).

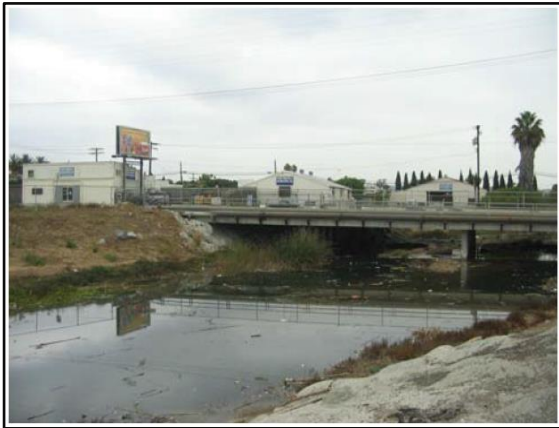
1. IHHA 2. National 1: Looking upstream where the channel crosses under National Avenue, representative of low vegetation.

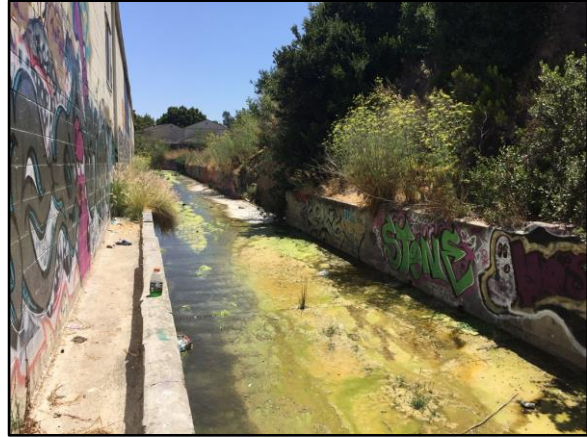
4. Cartagena 1: Looking upstream; missing sidewall and eroded bank at center.

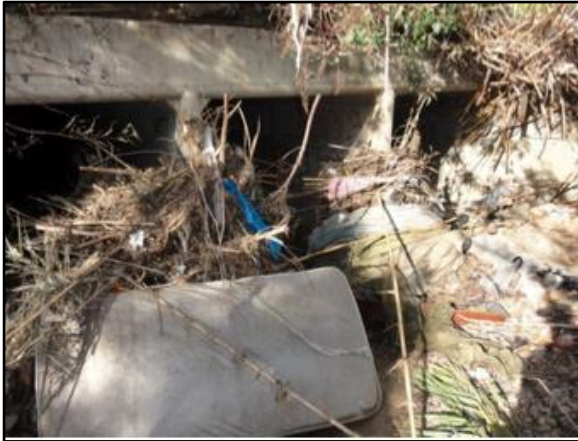
IHHA 1. Home 2, Map 1: Looking downstream at the triple 6-foot wide by 6-foot tall RCB culvert under Spillman Drive. Photo shows 50% clogging of culvert.

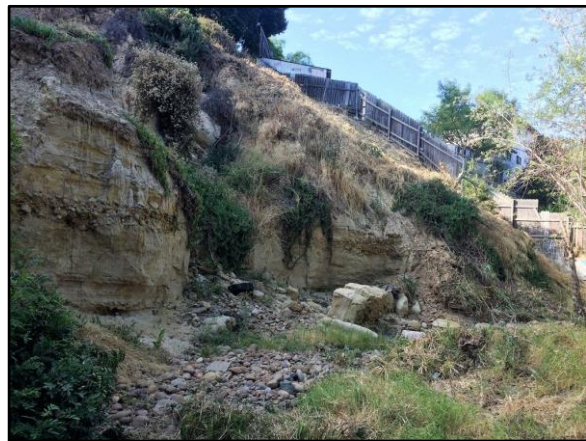
2. Wightman 2: Looking downstream toward channel bank failure/erosion.

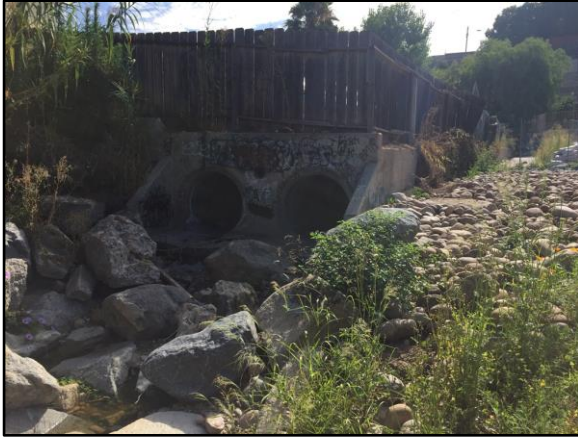
3. Wightman 2: Looking upstream at double 42-inch-diameter RCP; split flow into parking lot seen to the left.

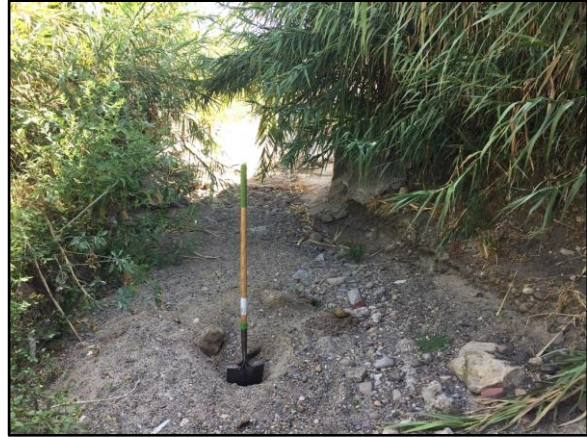
4. Wightman 1: Looking upstream just after transition from concrete to earthen lining; deep sediment observed.

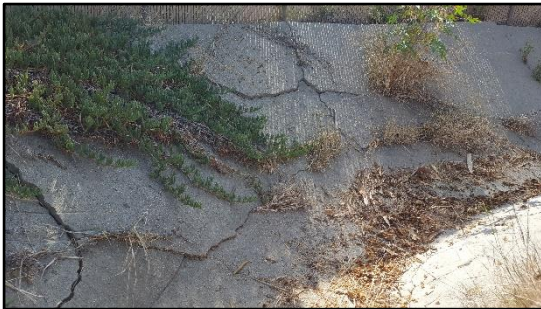
3. Megan 1, Reach 2: Looking downstream at damaged concrete.

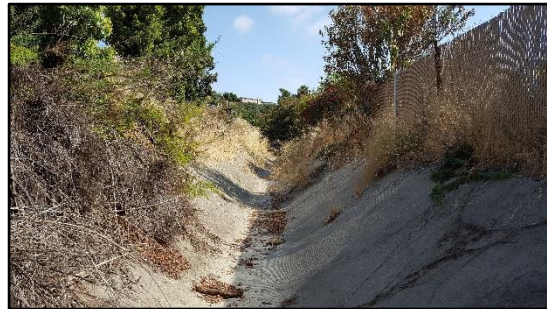
4. Megan 1, Reach 1: looking upstream at concrete ditch.
