# **APPENDIX I**

## ***Hydrology and Hydraulics Technical Report***

## A.1 Green Valley Creek – Pomerado

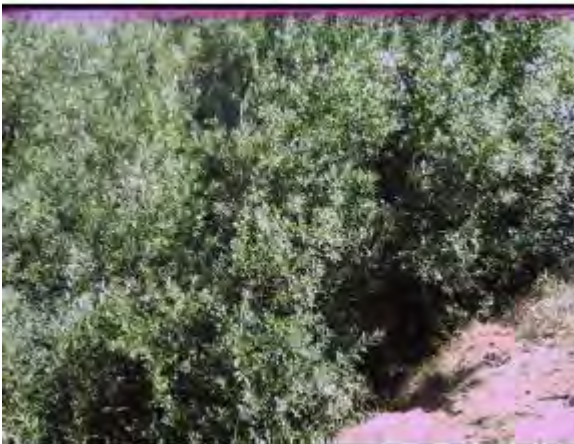
IHHA 1. Sorrento Valley 1: Looking upstream at the vegetation along the banks.

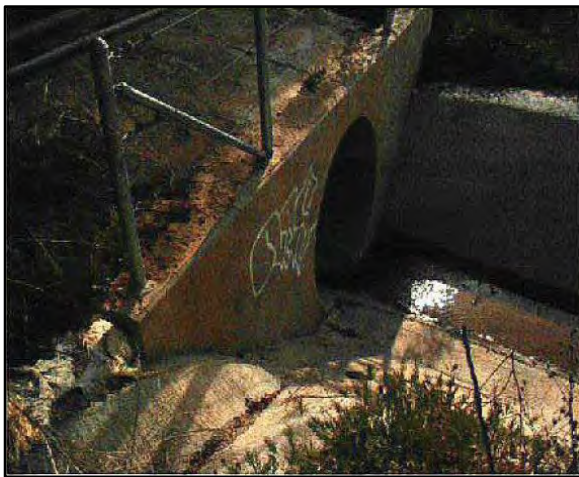
1. IHHA 1. Industrial 1, Reach 3: Looking at 54-inch-diameter RCP outlet at upstream end of facility group.

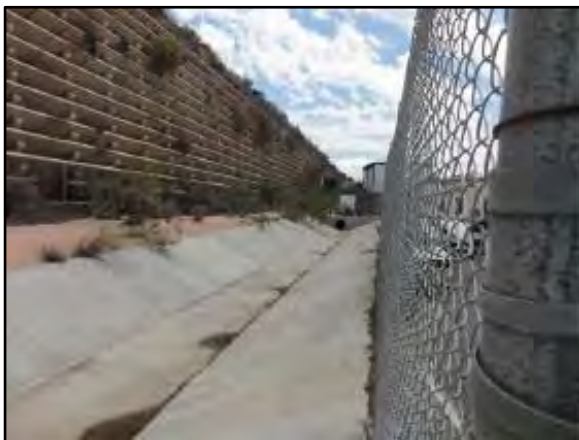
1. IHHA 1. Tripp 1, Reach 4: Looking upstream toward 42-inch RCP outlet.

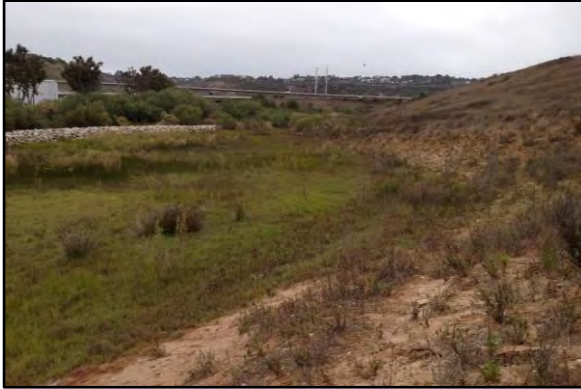
3. 5-805 Basin: Vegetation observed throughout basin.

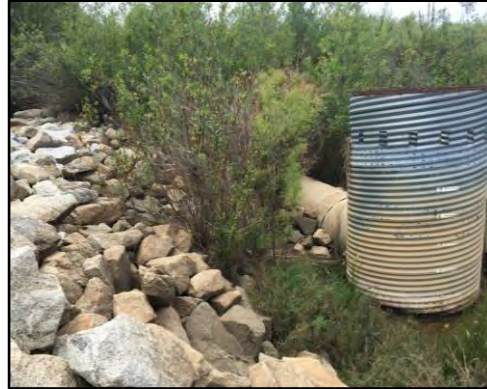
4. 5-805 Basin: Basin outlet structure and rip rap embankment.

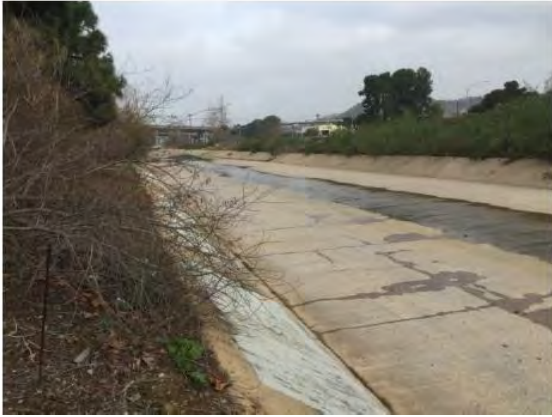
1. Roselle 2: Looking upstream of the I-5 overpass.

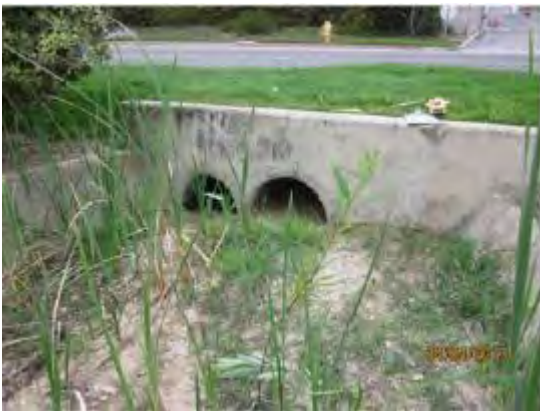
IHHA 62. Flintkote 1: Looking upstream at the 24- and 30-inch RCP outlet.

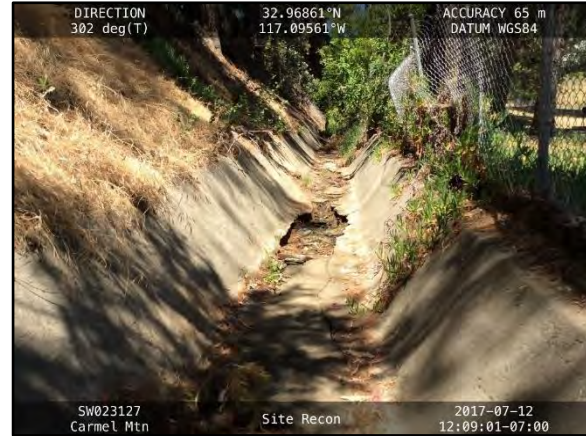
2. Via San Marco 1: Representative of segment showing failure of gunite bottom, looking upstream.

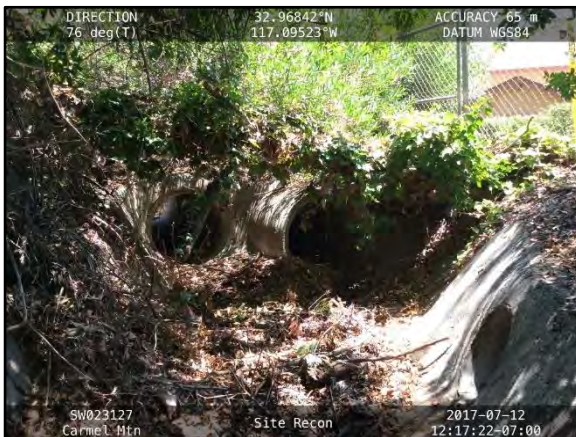
3. Via San Marco 1: Upstream of double pipe culverts, looking downstream (Station 501).

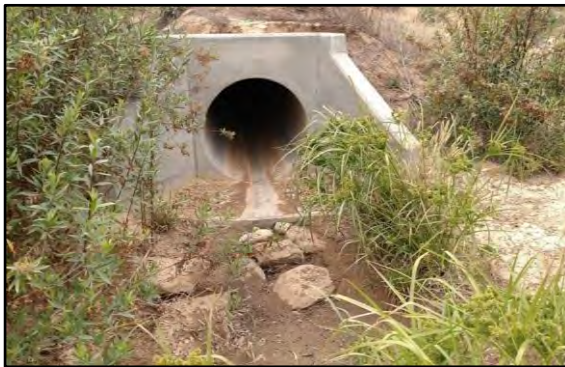
1. Alta La Jolla: Inlet observed to be mostly clear of sediment/debris.

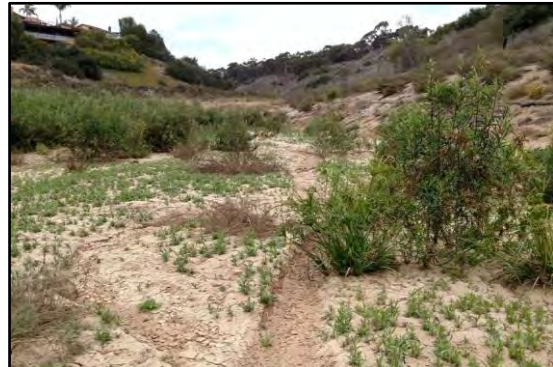
2. Alta La Jolla: Vegetation observed in basin.

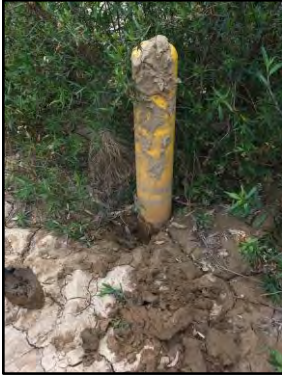
3. Alta La Jolla: Sediment/debris deposition depth is at “red stripe” elevation on monitoring bollard.

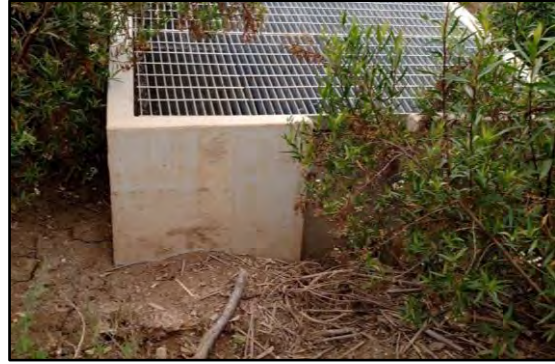
4. Alta La Jolla: Outlet structure observed to be partially blocked with sediment/debris.

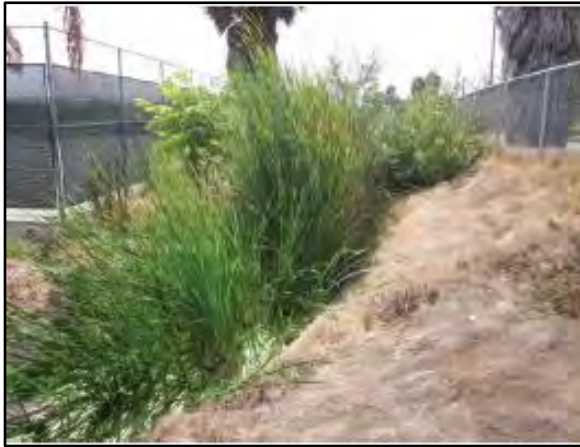
1. IHHA 24. MBHS 1: At upstream end of concrete segment, just downstream of 27-inch-diameter RCP and headwall.

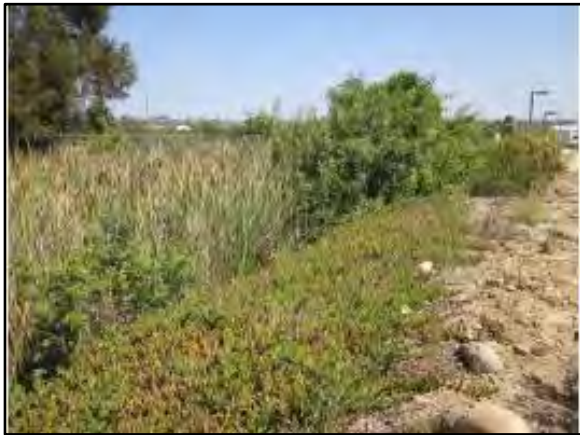
3. IHHA 31. PBO 1: High vegetation density and growth at the upstream end of the earthen channel were observed.

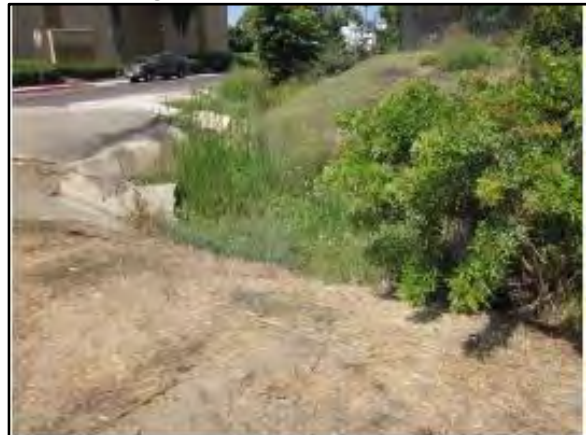
4. 7. IHHA 31. PBO 1: Downstream end looking east. High vegetation density and growth were observed

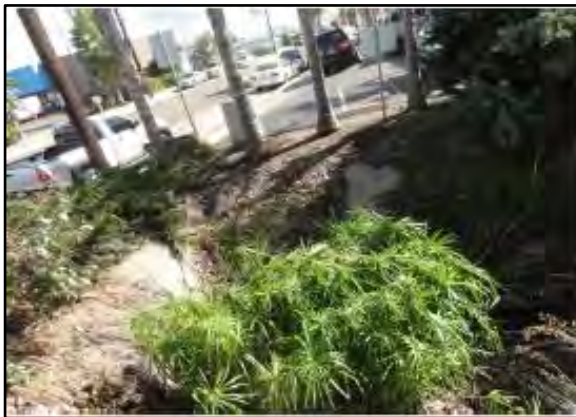
IHHA 1. Engineer 1 (Reach 1): Downstream end of facility group, facing east towards the 36-inch RCP (November 2015).

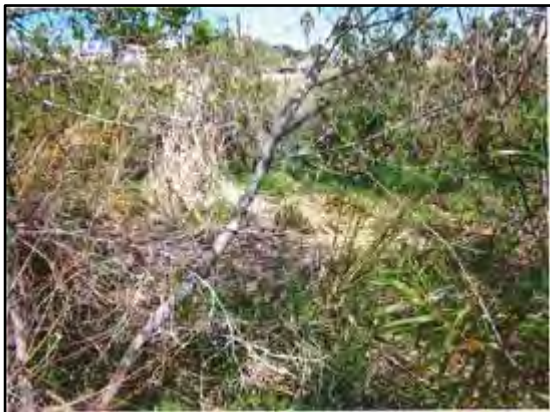
IHHA 8. Stadium 2, Map 1: Looking upstream near area of recommended maintenance (March 2013).

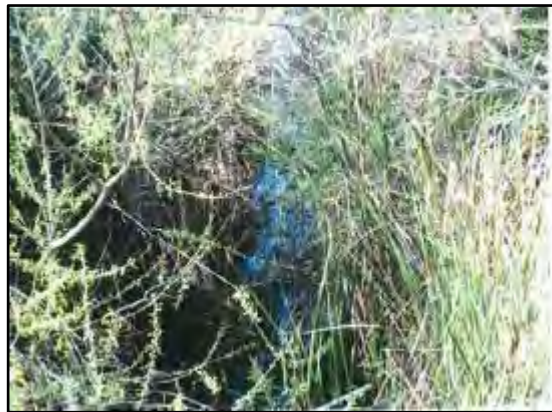
IHHA 13. Stadium 1, Map 1: Heavily vegetated channel bottom near the downstream end of the facility group (March 2013).

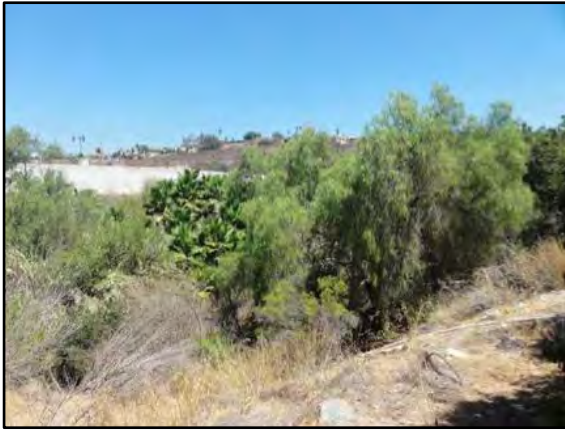
IHHA 1. Alvarado 1, Map 1: From south side of Reach 1 at the downstream end of the Alvarado Channel, upstream of College Avenue, looking upstream.

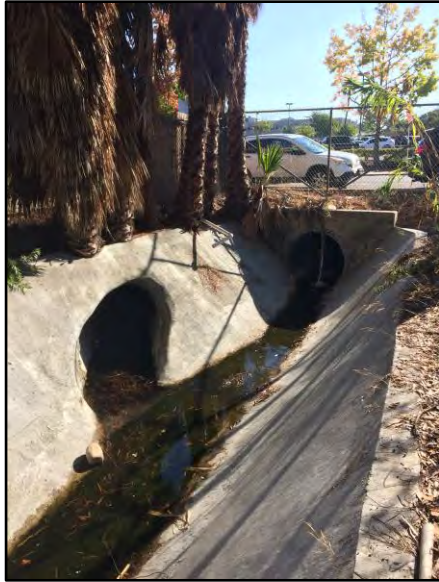
1. Alvarado 3, Map 2: Facing the upstream end of the segment, at the location of the recent concrete lining repair work.

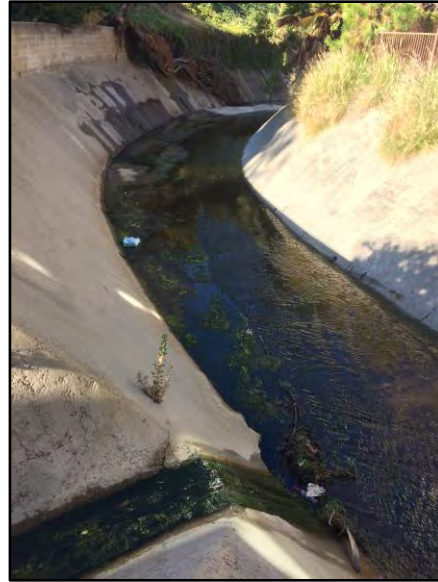
2. Alvarado 3, Map 2: Facing downstream at where the tributary discharges into the Alvarado 2 segment.

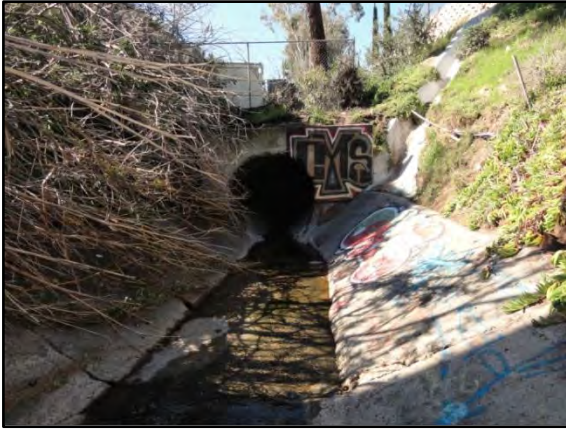
IHHA 1. Baja 1 (Reach 1): Facing downstream end of facility group; towards 60-inch-diameter RCP culvert beneath the Collwood Villas Apartments and Collwood Boulevard.

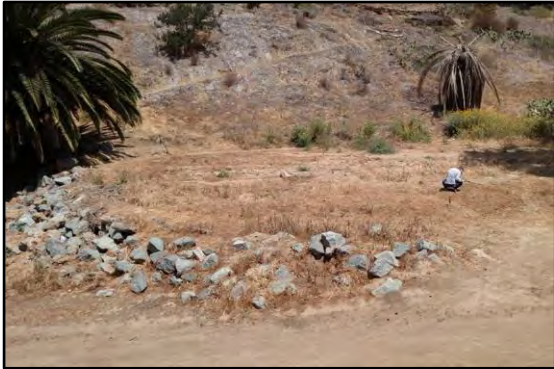
1. Maple Canyon: Sediment deposition observed in basin and minimal vegetation growth within basin.

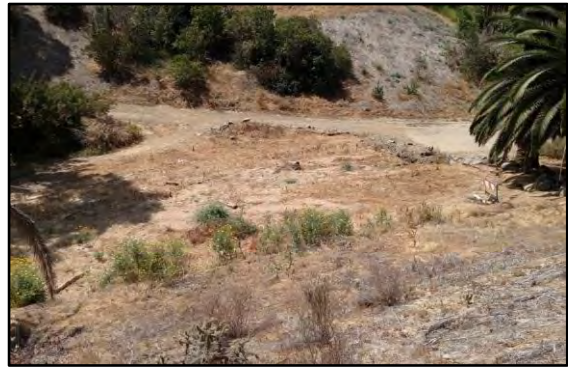
2. Maple Canyon: Looking south onto basin, completely filled with sediment.

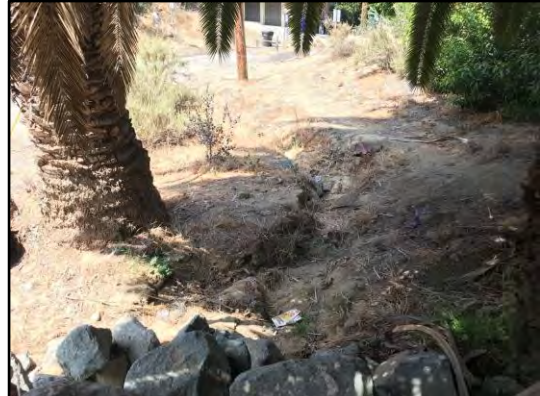
4. Maple Canyon: Uncontrolled drainage channel observed; no outlet control structure observed.

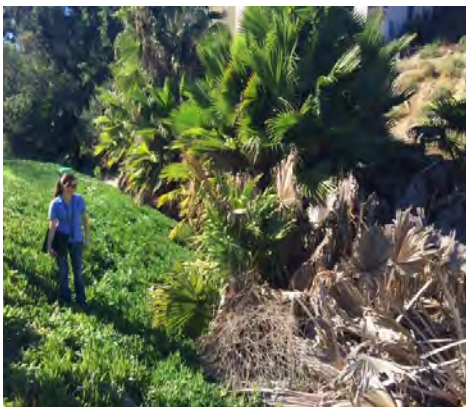
1. Washington 2: Looking downstream at vegetation in concrete ditch in baseline condition (November 2015).

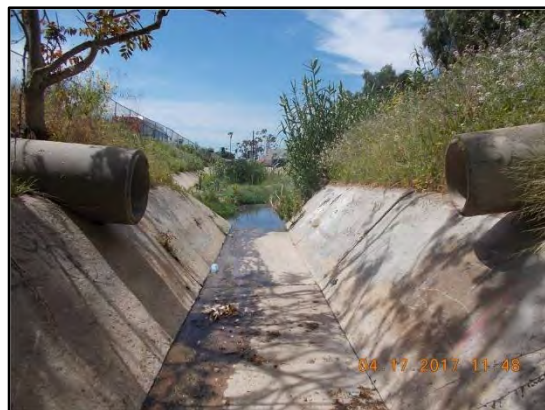
2. Washington 2: Looking downstream at transition to Washington 1 (April 2017).

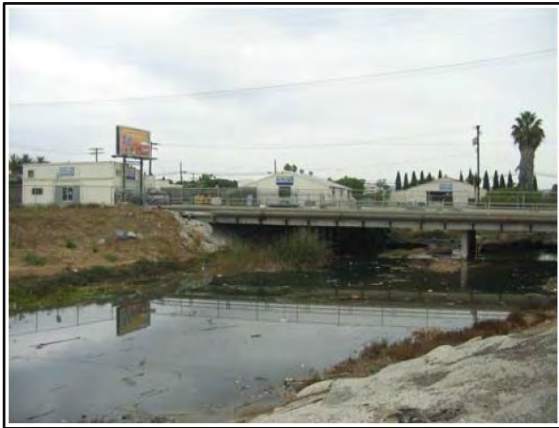
1. IHHA 2. National 1: Looking upstream where the channel crosses under National Avenue, representative of low vegetation.

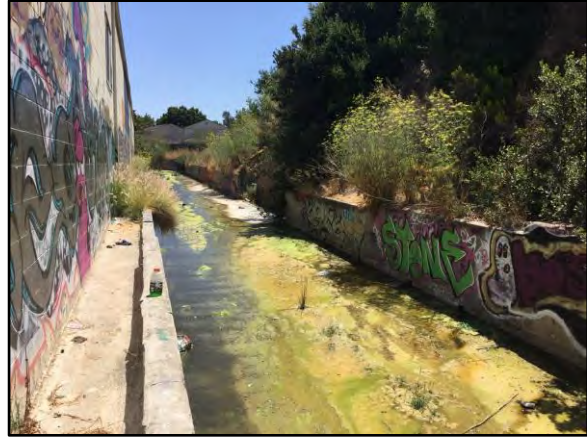
4. Cartagena 1: Looking upstream; missing sidewall and eroded bank at center.

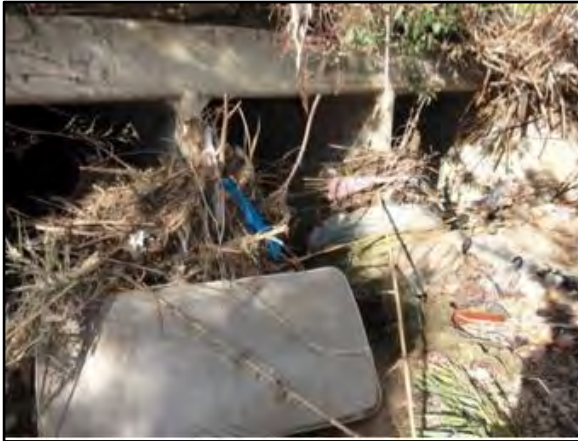
IHHA 1. Home 2, Map 1: Looking downstream at the triple 6-foot wide by 6-foot tall RCB culvert under Spillman Drive. Photo shows 50% clogging of culvert.

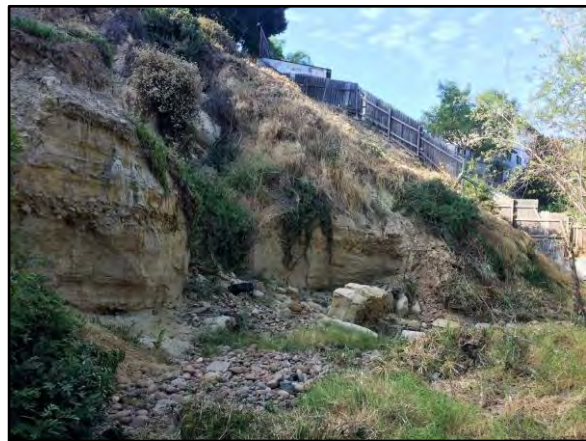
2. Wightman 2: Looking downstream toward channel bank failure/erosion.

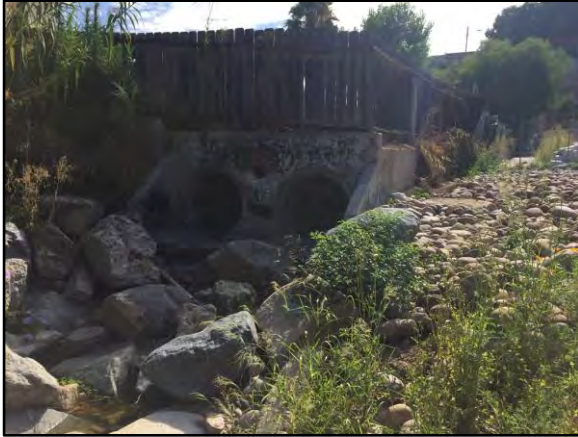
3. Wightman 2: Looking upstream at double 42-inch-diameter RCP; split flow into parking lot seen to the left.

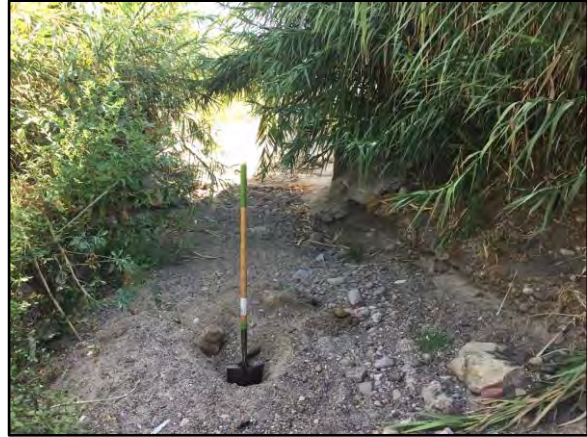
4. Wightman 1: Looking upstream just after transition from concrete to earthen lining; deep sediment observed.

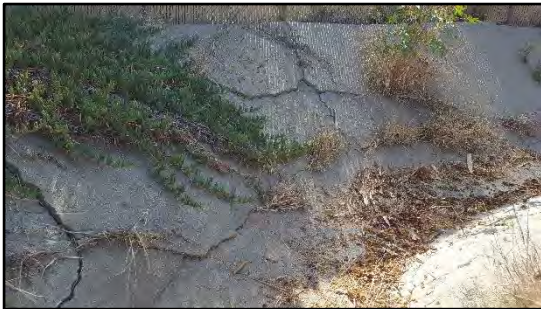
3. Megan 1, Reach 2: Looking downstream at damaged concrete.

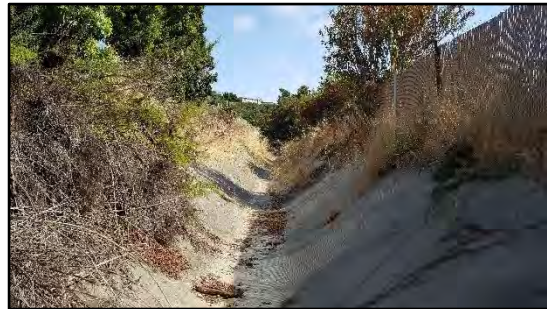
4. Megan 1, Reach 1: looking upstream at concrete ditch.
