## A.44 Chollas Creek – 54th Street (No. 5-04-280)

### Summary of Recommended Maintenance

## Attachment A: Hydrology and Hydraulics Fact Sheets

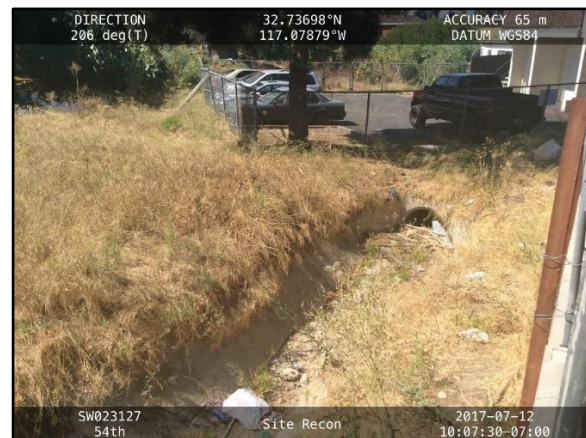
2. 54th St 1: Looking downstream towards the culvert; conveys flows beneath parking lot, then discharges back into ditch.

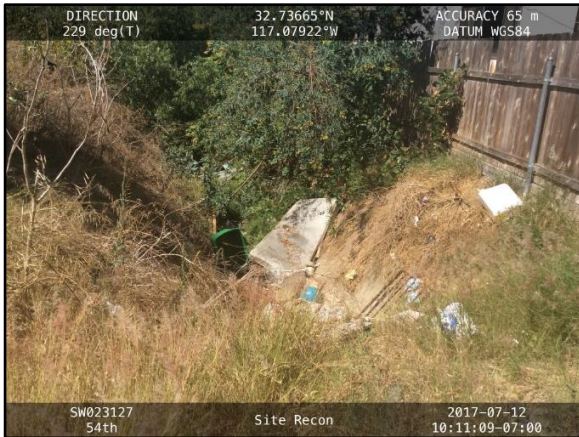
3. 54th St 1: Looking downstream.

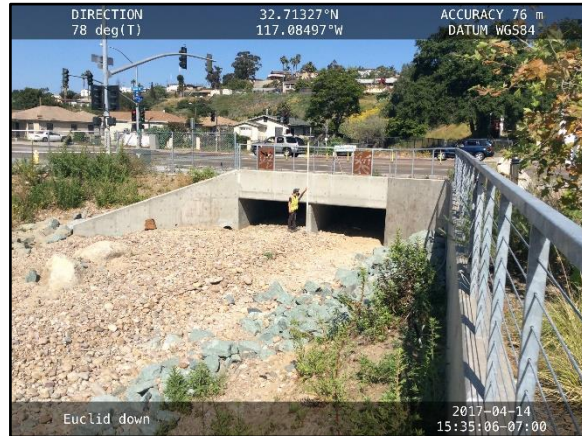
2. Euclid 1: Double box culvert outlet at Euclid Avenue.

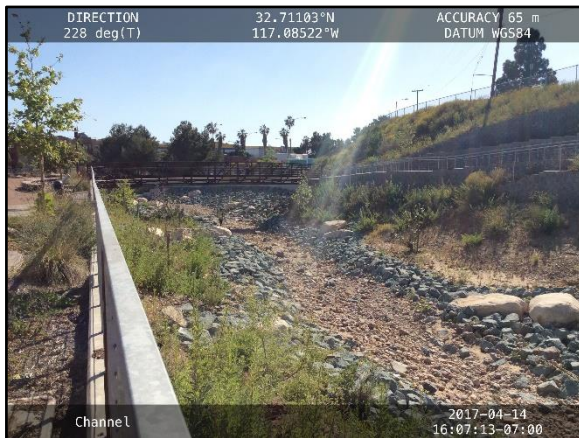
3. Euclid 1: Representative of earthen with cobble portion of channel.

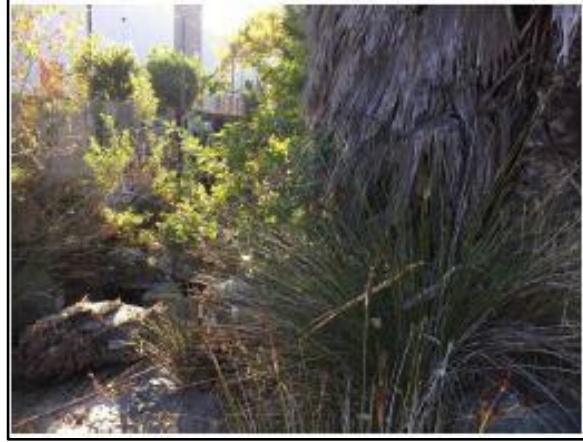
IHHA 14. Federal 1: Upstream portion of Reach 2 looking southwest at the 2-ton riprap channel lining and vegetation within the channel (palm trees and arundo).

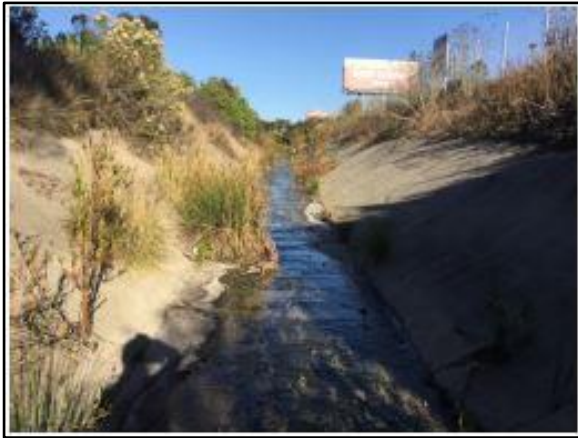
IHHA 15. Federal 2: Downstream portion of Reach 3 looking northeast at the concrete lined channel. Note the minimal vegetation established within the channel.

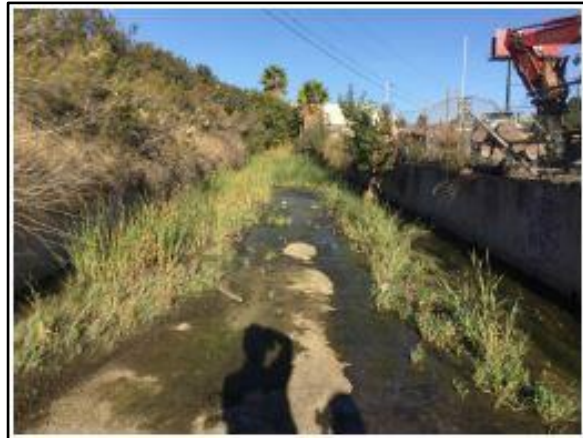
IHHA 19. Federal 2: Upstream portion of Reach 3 looking northeast at the rectangular concrete channel. Note the minimal vegetation established in channel.

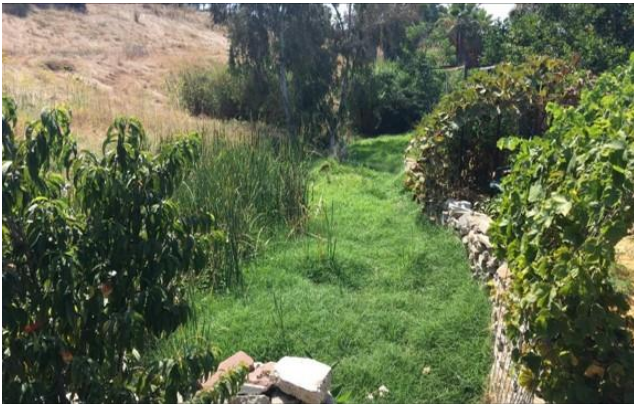
5. Cadman 1: Looking downstream at the dense vegetation present in the channel, facing northwest.

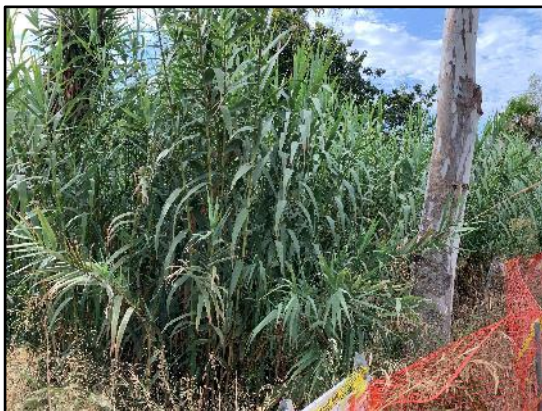
1. Lobrico 1, Reach 2: Dense vegetation present in channel at outlet of 48-inch RCP beneath Lisbon Street, looking southeast (July 2019).

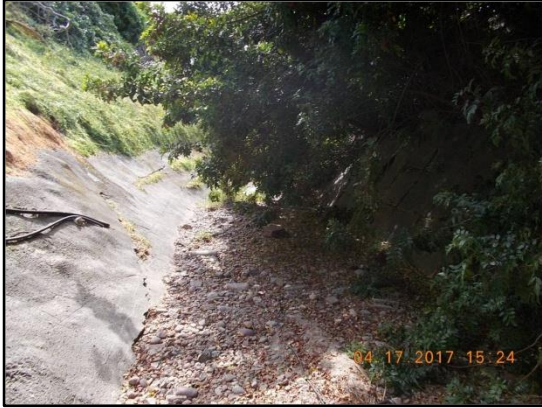
7. Solola 2 (Reach 1): Looking downstream at broken concrete.

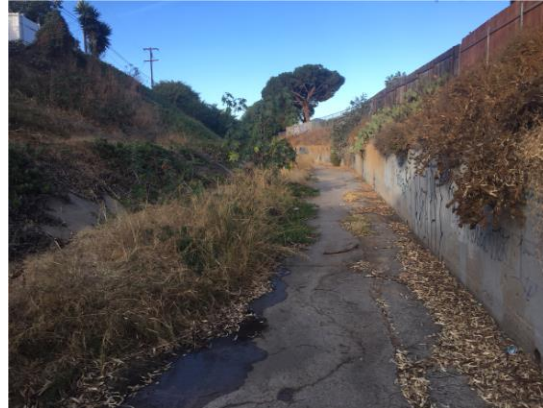
8. Solola 1: Looking downstream at accumulated sediment/debris in concrete channel. (November 2017)

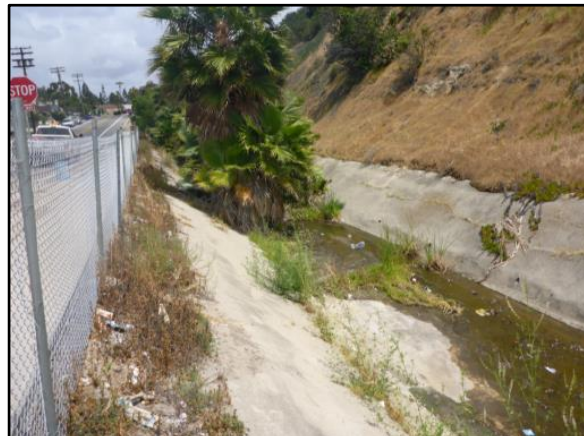
3. Parkside 1: Representative of channel (with dense vegetation), looking upstream.

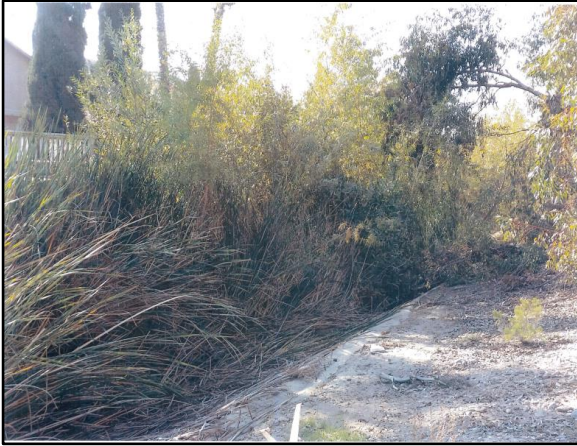
3. Via de La Bandola 1, Map 1: Looking upstream at dense vegetation and sediment/debris within channel.

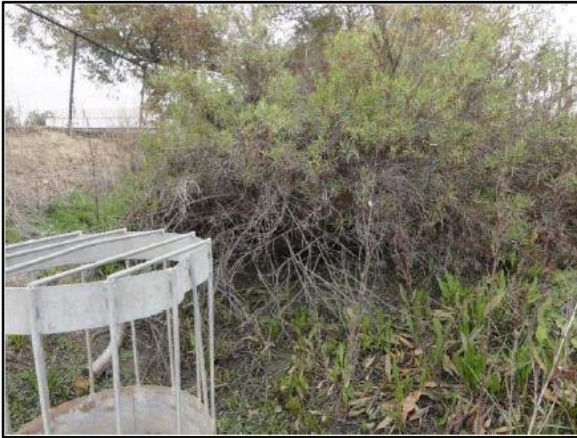
IHHA 3. Siempre Viva 1, Reach 1 (Bristow Channel): looking east towards upstream end of dense vegetation.
