# Technical Memorandum - MWMP Hydrology & Hydraulics Current Conditions Assessment

## 1 Introduction

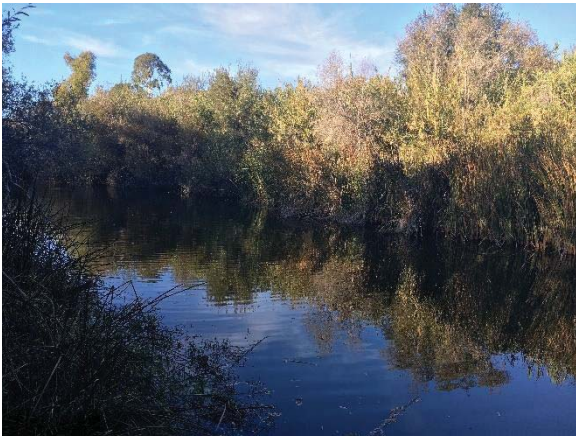
begins. The IHHA for Sorrento Valley 1 was prepared in 2010 by Rick Engineering. In the October 2010 site visit performed by Rick Engineering, the segments condition was described to have moderate to dense vegetation on the banks and bed of the segment. Based on available records, the maintenance activities last occurred in this segment in 1998, prior to the indicated site visits. During the site visit in June 2018, the condition of the segment appeared similar to the conditions discussed and modeled in the IHHA. Vegetation continued to be dense along the banks and minor amounts of vegetation were visible within the bed of the channel. Sediment depth approximation was not feasible due to the presence of water. The condition of this channel appears similar to the previous analysis and it is recommended that the H&H Technical Report for the MWMP recommendations remain unchanged.

Looking downstream from approximately Station 2161.9265 (June 2018).

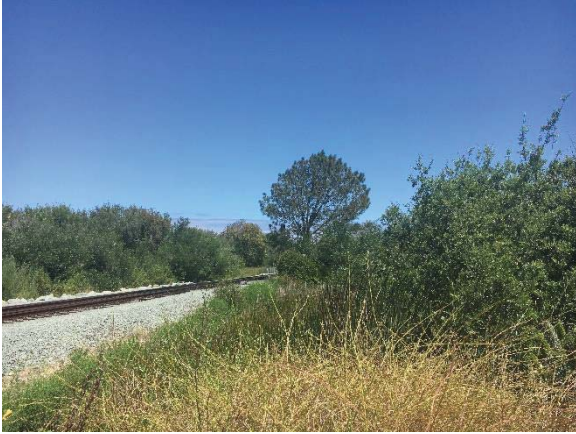
The Industrial 1 segment is in the Los Peñasquitos Watershed Management Area and is tributary to Los Peñasquitos Lagoon. The segment is located in a highly industrialized area and is bound by commercial buildings, warehouses, and parking lots. The segment is located west of the I-5 Local Bypass and south of Carmel Mountain Road. The IHHA for Industrial 1 was initially prepared in 2010 and updated in 2017 by Rick Engineering. During the March 2010 site visit performed by Rick Engineering, the segment conditions in the earthen channel were observed to have dense vegetation and sediment deposition was estimated to be approximately 1 foot deep. No known maintenance activities have occurred in this segment. During the site assessment in June 2018, the vegetation density in the earthen channel appeared to increase slightly since the 2010 site visit however; the limits of maintenance appear to be unchanged from the previous assessment. It is recommended that the H&H Technical Report for the MWMP recommendations remain unchanged.

Looking downstream from the Sorrento Valley Road culvert outlet at approximately Station 620 (June 2018).

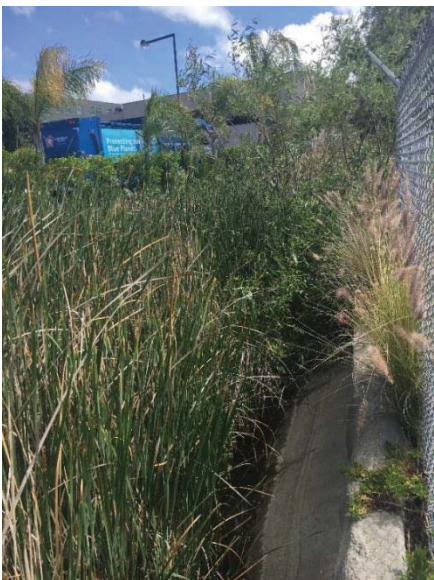
The Industrial 2 segment is in the Los Peñasquitos Watershed Management Area and is tributary to Los Peñasquitos Lagoon. The segment is located in a highly industrialized area and is bound by commercial buildings, warehouses, and parking lots. The segment is located west of the I-5 Local Bypass and south of Carmel Mountain Road. The IHHA for Industrial 2 was initially prepared in 2010 and updated in 2017 by Rick Engineering. During the March 2010 site visit performed by Rick Engineering, the segment conditions were described to have minor vegetation density and sediment deposition in the upstream portion of the segment and in the downstream portion of the concrete segment, the vegetation was observed to be dense. Based on available records, the maintenance activities last occurred in this segment in 2010. During the site assessment in June 2018, the ditch appeared to be similar to the conditions discussed and modeled in the IHHA. The vegetation density in the concrete ditch appeared to increase slightly since the 2010 site visit however; the limits of maintenance appear to be unchanged from the previous assessment. It is recommended that the H&H Technical Report for the MWMP recommendations remain unchanged.

Looking upstream from the Sorrento Valley Road culvert inlet at approximately Station 751.3246 (June 2018).

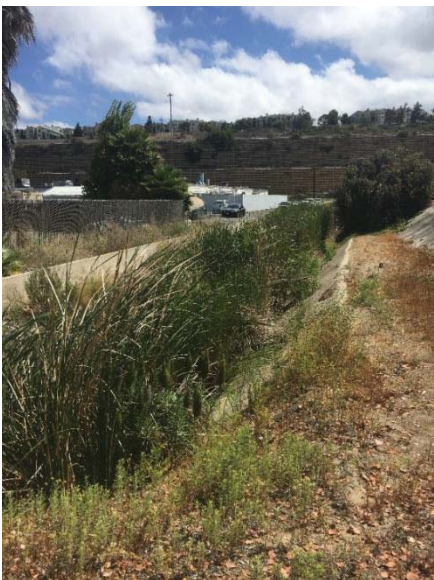
The Tripp 1 segment is located in the Los Peñasquitos Watershed Management Area and is tributary to Los Peñasquitos Lagoon. The concrete lined segment is located west of I-5, east of Sorrento Valley Road, and south of Tripp Court, and is bordered by commercial properties. The IHHA for Tripp 1 was prepared in 2015 by Rick Engineering. During the August 2014 site visit performed by Rick Engineering, the segment conditions were described as moderate vegetation within the segment with approximately 3 feet of sediment at the inlet of the culvert across Sorrento Valley Boulevard. Based on available records, the maintenance activities last occurred in this segment in 2010. During the site assessment in June 2018, the ditch appeared to be similar to the conditions discussed and modeled in the IHHA. The vegetation in the concrete ditch appeared to increase in density since the 2014 site visit near the downstream end of the segment and the sediment deposition could not be observed due to the density of the vegetation however; the limits of maintenance appear to be unchanged from the previous assessment. It is recommended that the H&H Technical Report for the MWMP recommendations remain unchanged.

Looking upstream from the Sorrento Valley  
Road culvert inlet at approximately Station  
679.8481 (June 2018).

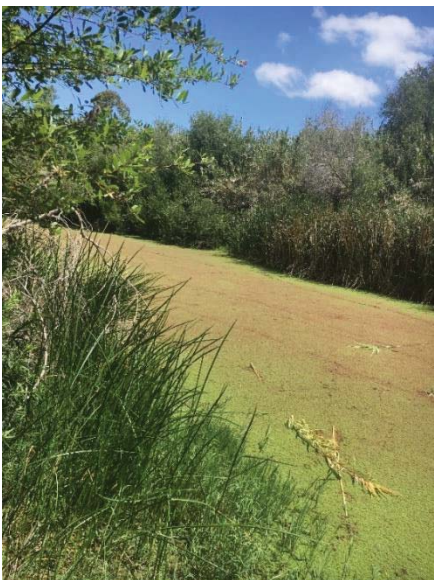
The Roselle 1 segment is located in the Los Peñasquitos Watershed Management Area and is a part of Soledad Canyon Creek. The earthen segment is located near the I-5/I-805 interchange between the railroad tracks and Roselle Street and an industrial development is located along portions of the west side of the facility group. The IHHA for Roselle 1 segment was initially prepared in 2010 by Rick Engineering and was updated in 2016 by a report prepared by ESA. In the January 2016 site visit performed by ESA, the segment conditions were described as moderate to dense vegetation. Based on available records, maintenance activities last occurred in this segment in 2016 in the upstream portion of the segment. During the site assessment in June 2018, the channel appeared to be similar to the downstream channel conditions discussed and modeled in the IHHA. The upstream portion of the channel appeared to be moderately vegetated and appears to be slightly less dense than what was observed during the ESA site visit. Given the history of maintenance, the limits of maintenance are recommended to be unchanged from the previous assessment and it is recommended that the H&H Technical Report for the MWMP recommendations remain unchanged.

Looking downstream from approximately Station 2632.2881 (June 2018).

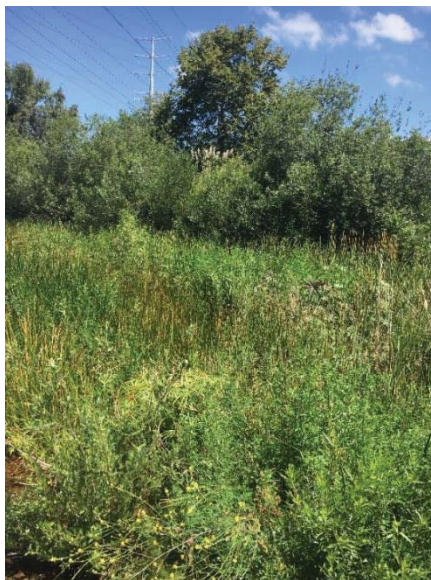
Looking downstream from approximately Station 3930.989 (June 2018).

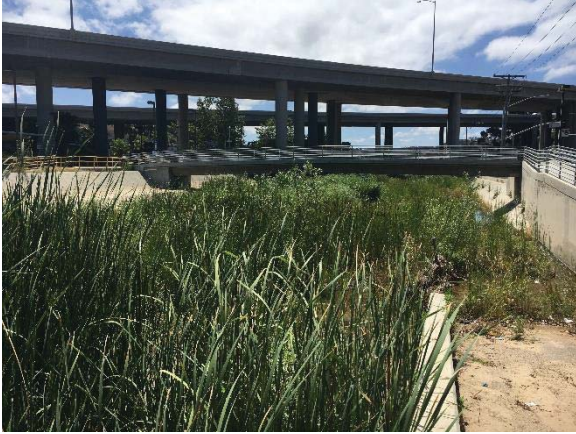
The Roselle 2 segment is located in the Los Peñasquitos Watershed Management Area and is a part of Soledad Canyon Creek. The concrete segment is located near the I-5/I-805 interchange between the railroad tracks and Roselle Street and an industrial development is located along portions of the west side of the facility group. The IHHA for Roselle 2 segment was initially prepared in 2013 by URS Corporation and was updated in 2016 by a report prepared by ESA. In the January 2016 site visit performed by ESA, the segment conditions were described to have up to 18 inches of sediment deposition throughout the segment and the vegetation density varied from light at the upstream end to dense at the downstream end. Based on available records, maintenance activities have occurred multiple times in this segment including in 2011, 2015, 2016, and 2017. During the site assessment in June 2018, the channel appeared to be similar to the conditions discussed and modeled in the ESA report. Given the history of maintenance, the limits of maintenance are recommended to be unchanged from the previous assessment and it is recommended that the H&H Technical Report for the MWMP recommendations remain unchanged.

Looking upstream from approximately Station 3930.989 (June 2018).

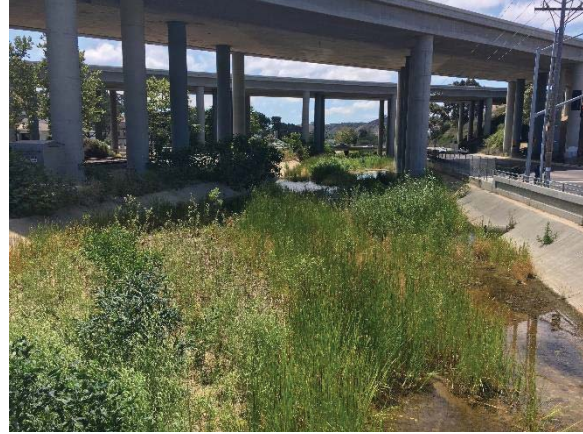
Looking upstream from approximately Station 4067.9646 (June 2018).

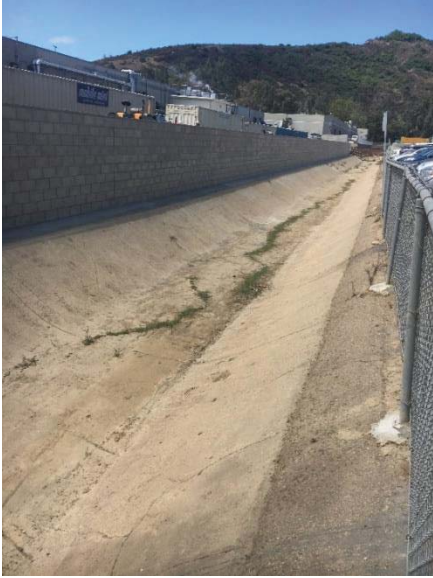
The Flintkote segment is located in the Los Peñasquitos Watershed Management Area and is a tributary to Soledad Canyon Creek. The concrete segment is bound by Flintkote Avenue to the south, commercial/industrial facilities to the east and west, and Soledad Canyon Creek to the north. The IHHA for the Flintkote segment was prepared in 2013 by URS Corporation. In the April 2013 site visit performed by URS Corporation, the segment conditions were described to have up to 1.25 feet of sediment deposition within the segment and varying vegetation from relatively clean concrete at the upstream end to dense vegetation at the downstream end. Based on available records, maintenance activities have occurred multiple times in this segment including in 2011, 2014, and 2017. During the site assessment in June 2018, the channel appeared to be mostly clean with some minor sediment deposition and vegetation growth at the downstream end and minor sediment deposition at the upstream end. Given the history of maintenance, the limits of maintenance are recommended to be unchanged from the previous assessment and it is recommended that the H&H Technical Report for the MWMP recommendations remain unchanged.

Looking upstream from approximately Station 400.82 (June 2018).

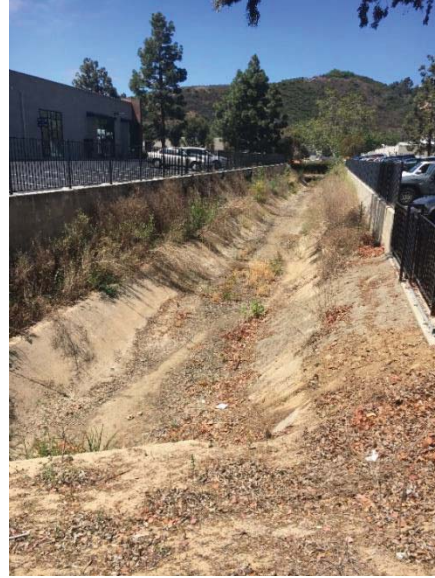
Looking upstream from approximately Station 49.81 (June 2018).

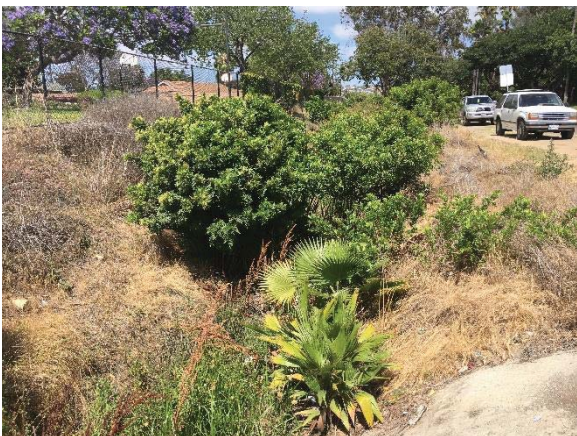
The Pacific Beach/Olney 1 segment is located in the Mission Bay/La Jolla Watershed Management Area and is in a relatively flat area in close proximity to Mission Bay. The earthen segment is bound by the Mission Bay High School/residential area to the north and Pacific Beach Drive to the south. The IHHA for the Pacific Beach/Olney 1 segment was prepared in 2014 by URS Corporation. In the September 2013 site visit performed by URS Corporation, the segment conditions were described as dense vegetation with accumulated sediment throughout the earthen ditch and a greater density of vegetation was observed in the upstream section. Sediment deposition in this segment was estimated to be 6 to 8 inches. Based on available records, maintenance activities last occurred in this segment in 2015. During the site assessment in June 2018, the ditch was observed to have light to medium density vegetation and a minor amount of sediment accumulation. Given the history of maintenance, the limits of maintenance are recommended to be unchanged from the previous assessment and it is recommended that the H&H Technical Report for the MWMP recommendations remain unchanged.

Looking upstream from approximately Station 1 (June 2018).

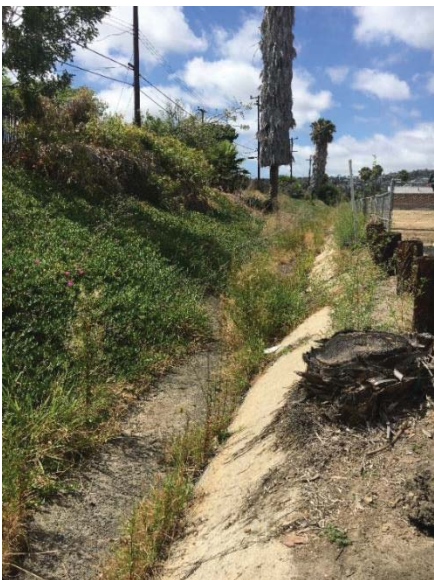
The Mission Bay High School 1 segment is located in the Mission Bay/La Jolla Watershed Management Area and is in a relatively flat area in close proximity to Mission Bay. The concrete segment is bound by the Mission Bay High School bus loading zone to the north and Pacific Beach Drive to the south. The IHHA for the Mission Bay High School 1 segment was prepared in 2014 by URS Corporation. In the September 2013 site visit performed by URS Corporation, the segment conditions were described to be very close to its vegetation growth capacity. Dense vegetation and sediment deposition estimated to be 3 to 4 inches was observed. Based on available records, maintenance activities last occurred in this segment in 2015. During the site assessment in June 2018, the concrete ditch was observed to have a 2 to 3 inches of sediment deposition and light to medium density vegetation. Given the history of maintenance, the limits of maintenance are recommended to be unchanged from the previous assessment and it is recommended that the recommended that the H&H Technical Report for the MWMP recommendations remain unchanged.

Looking upstream from approximately Station 12 (June 2018).

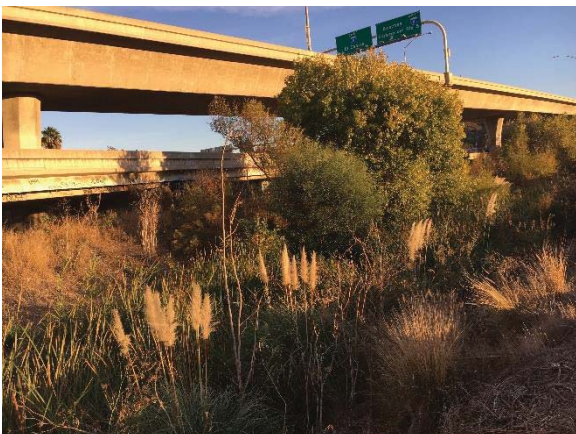
The Stadium 1 segment is located in the San Diego River Watershed Management Area and is a part of Murphy Canyon Creek. The earthen segment is bound by the stadium parking lot to the west and I-15 to the east and is located north of I-8. The IHHA for the Stadium 1 segment was prepared in 2013 by URS Corporation. During the March 2013 site visit performed by URS Corporation, the segment conditions were described as dense vegetation and the sediment deposition was estimated to be 1 to 3 feet. Based on available records, maintenance activities last occurred in this segment in 2015. During the site assessment in June 2018, the earthen channel was observed as light to medium vegetation. Given the history of maintenance, the limits of maintenance are recommended to be unchanged from the previous assessment and it is recommended that the H&H Technical Report for the MWMP recommendations remain unchanged.

Looking downstream from Station 628.163  
(June 2018).

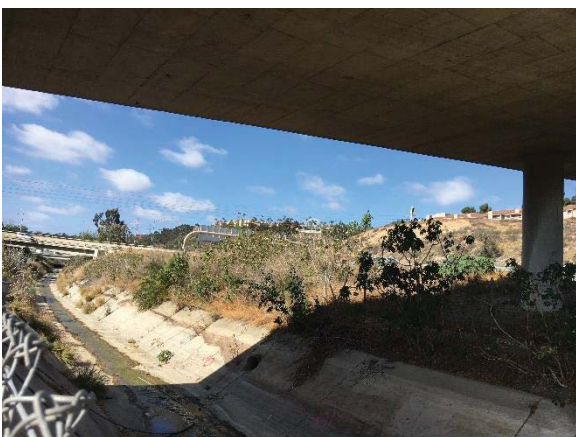
The Stadium 2 segment is located in the San Diego River Watershed Management Area and is a part of Murphy Canyon Creek. The concrete segment is bound by the stadium parking lot to the west and I-15 to the east and is located north of I-8. The IHHA for the Stadium 2 segment was prepared in 2013 by URS Corporation. During the March 2013 site visit performed by URS Corporation, the segment conditions were described as dense vegetation and the sediment deposition was estimated to be 1 foot. Based on available records, maintenance activities last occurred in this segment in 2015. During the site assessment in June 2018, the concrete channel was observed to be mostly clean and light vegetation growth on the side slopes. Given the history of maintenance, the limits of maintenance are recommended to be unchanged from the previous assessment and it is recommended that the H&H Technical Report for the MWMP recommendations remain unchanged.

Looking upstream from approximately Station  
1847.267 (June 2018).

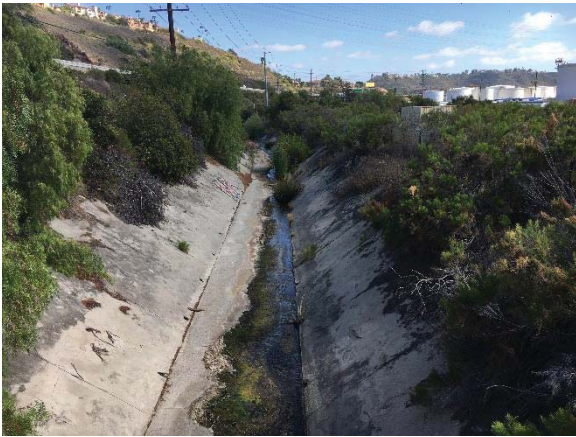
The Murphy Canyon 1 segment is located in the San Diego River Watershed Management Area and is a part of Murphy Canyon Creek. The concrete segment is bound by industrial development and golf facilities to the west and I-15 to the east. The IHHA for the Murphy Canyon 1 segment was prepared in 2013 by URS Corporation. The downstream portion of the Stonecrest segment was originally included in the IHHA analysis however, the Stonecrest segment was analyzed separately as part of the MWMP and is not included in this current conditions assessment. During the March 2013 site visit performed by URS Corporation, the segment conditions were described as mostly clean with light vegetation growth on the side slopes. No known maintenance activities have occurred in this segment. During the site assessment in June 2018, the concrete channel was observed to be the same with slightly more vegetation growth along the side slopes. It is recommended that the H&H Technical Report for the MWMP recommendations remain unchanged.

Looking upstream from approximately Station 530.489 (June 2018).

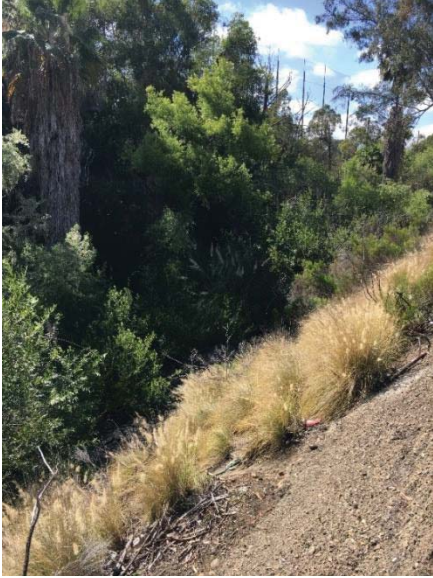
The Murphy Canyon 2 segment is located in the San Diego River Watershed Management Area and is a part of Murphy Canyon Creek. The earthen segment is bound by industrial development and golf facilities to the west and I-15 to the east. The IHHA for the Murphy Canyon 2 segment was prepared in 2013 by URS Corporation. During the March 2013 site visit performed by URS Corporation, the segment conditions were described as to be densely vegetated with mature trees and shrubs was considered to be in its ultimate vegetated condition. No known maintenance activities have occurred in this segment. During the site assessment in June 2018, the earthen channel was observed to be the same condition. It is recommended that the H&H Technical Report for the MWMP recommendations remain unchanged.

Looking upstream from approximately Station 942.369 (June 2018).

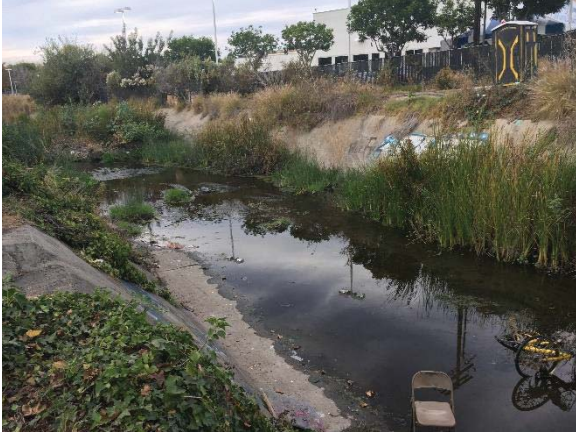
The Mission Gorge 1 segment is located in the San Diego River Watershed Management Area. The segment is bordered by commercial developments along the north side of I-8. The IHHA for the Mission Gorge 1 segment was prepared in 2015 by Rick Engineering. During the August 2014 site visit performed by Rick Engineering, the segment conditions were described as moderate to dense vegetation and the sediment deposition was estimated to be 0.2 to 0.9 feet deep. Based on available records, maintenance activities last occurred in this segment in 2015/2016. During the site assessment in November 2018, the concrete channel was observed to have small patches of light to moderate vegetation and 4 to 6 inches of sediment deposition along the north edge of the segment. Given the history of maintenance, the limits of maintenance are recommended to be unchanged from the previous assessment and it is recommended that H&H Technical Report for the MWMP recommendations remain unchanged.

Looking downstream from the Fairmount Avenue culvert outlet at approximately Station 1155.562 (November 2018).

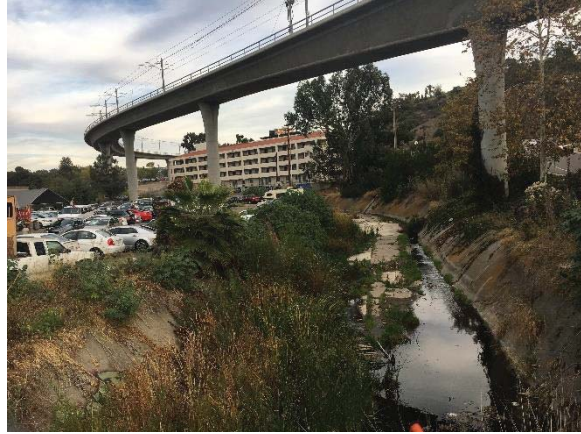
Looking upstream from Fairmount Avenue at approximately Station 1305.414 (November 2018).

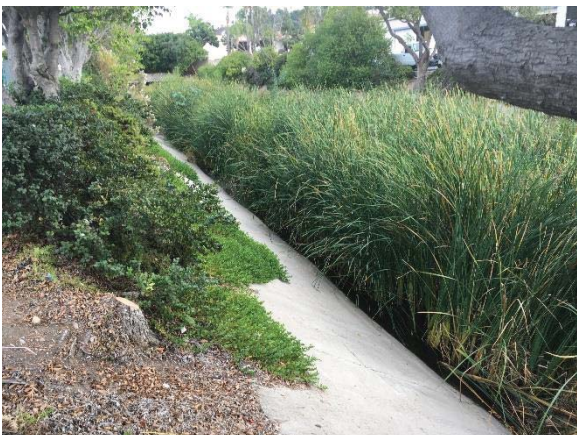
The Mission Gorge 2 segment is located in the San Diego River Watershed Management Area. The segment is bordered by commercial developments along the north side of I-8. The IHHA for the Mission Gorge 2 segment was prepared in 2015 by Rick Engineering. During the August 2014 site visit performed by Rick Engineering, the segment conditions were described as dense vegetation including several trees and the sediment deposition was estimated to be 0.5 to 1.1 feet deep. Based on available records, maintenance activities last occurred in this segment in 2015/2016. During the site assessment in November 2018, the concrete channel was observed to have light to moderate vegetation and sediment deposition was estimated to be 0.5 to 1 foot deep. Given the history of maintenance, the limits of maintenance are recommended to be unchanged from the previous assessment and it is recommended that H&H Technical Report for the MWMP recommendations remain unchanged.

Looking upstream from approximately Station 3171.452 (November 2018).

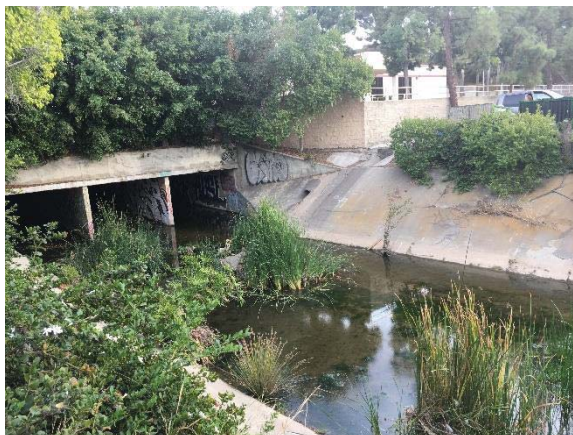
Looking upstream at the box culvert outlet at approximately Station 3519.105 (November 2018).

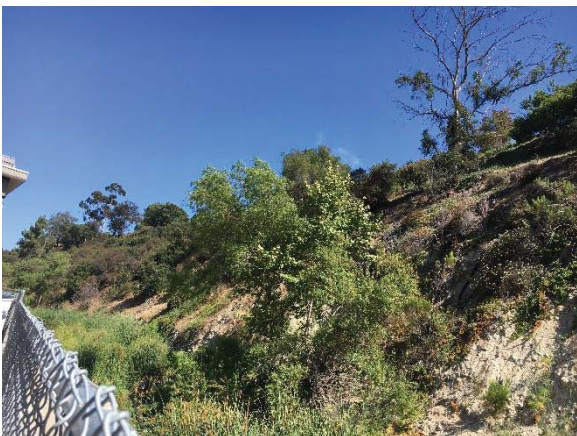
The Alvarado 1 segment is located in the San Diego River Watershed Management Area. The segment is bordered by Alvarado Hospital to the east and by commercial and residential development to the north and south. The IHHA for the Alvarado 1 segment was prepared in 2015 by Rick Engineering. During the August 2014 site visit performed by Rick Engineering, the segment conditions were described as light to moderate vegetation and the sediment deposition was estimated to be 0.2 to 1.7 feet deep. Based on available records, maintenance activities last occurred in this segment in 2015/2016. During the site assessment in June 2018, the earthen channel was observed to have light to moderate vegetation and sediment deposition along a portion of the segment. Given the history of maintenance, the limits of maintenance are recommended to be unchanged from the previous assessment and it is recommended that H&H Technical Report for the MWMP recommendations remain unchanged.

Looking upstream from approximately Station 2873.24 (June 2018).

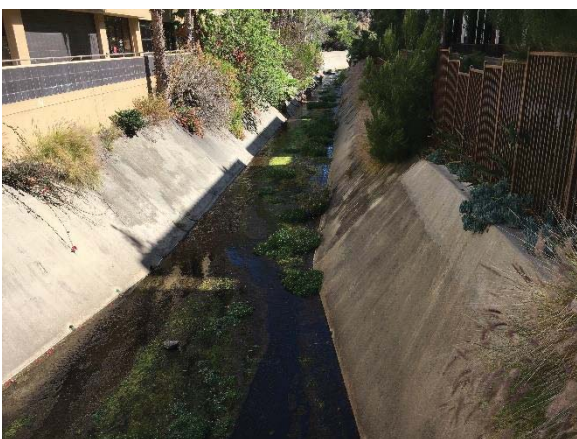
The Alvarado 2 segment is located in the San Diego River Watershed Management Area. The segment is bordered by Alvarado Hospital to the east and by commercial and residential development to the north and south. The IHHA for the Alvarado 2 segment was prepared in 2015 by Rick Engineering. During the August 2014 site visit performed by Rick Engineering, the segment conditions were described as mostly clean with light vegetation growth on the side slopes. No known maintenance activities have occurred in this segment. During the site assessment in June 2018, the concrete channel was observed to be the same. It is recommended that the H&H Technical Report for the MWMP recommendations remain unchanged.

Looking downstream from the pedestrian bridge at approximately Station 4502.213 (June 2018).

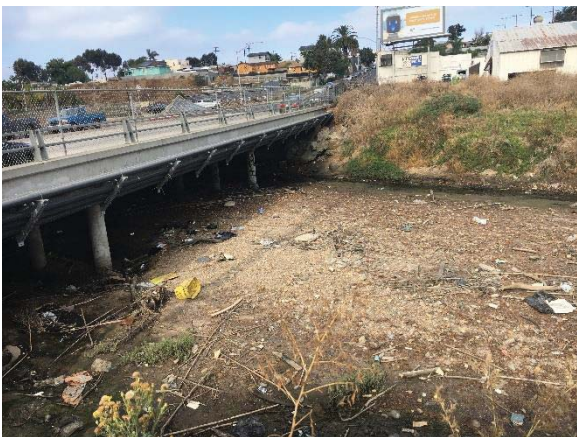
The National 1 segment is located in the Pueblo San Diego Watershed Management Area. The segment extends south from Logan Avenue and flows parallel to I-15 along its western side, before the channel crosses underneath I-5 and ends just upstream of where Chollas Creek conflues with South Las Chollas Creek. The IHHA for the National 1 segment was initially prepared in 2010 by Rick Engineering. During the October 2009 site visit performed by Rick Engineering, the segment conditions were described to have low vegetation and sediment deposition was estimated to be from 0.5 to 3 feet deep. Based on available records, maintenance activities last occurred in this segment in 2015/2016. During the site assessment in August 2019, the earthen channel was observed to have light vegetation and sediment & debris deposition along the segment bottom. Given the history of maintenance, the limits of maintenance are recommended to be unchanged from the previous assessment and it is recommended that H&H Technical Report for the MWMP recommendations remain unchanged.

Looking downstream toward the National Avenue bridge at approximately Station 1745.9117 (August 2019).

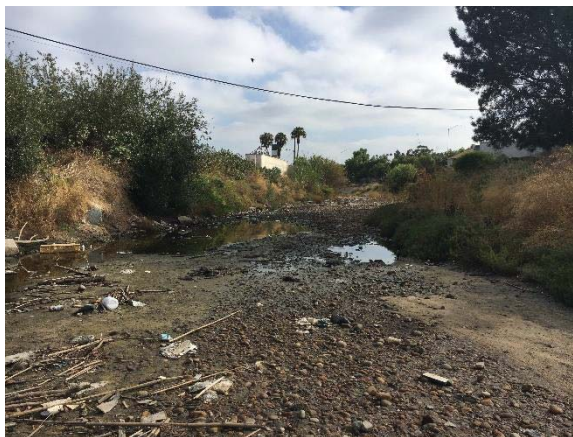
Looking upstream from approximately Station 1745.9117 (August 2019).

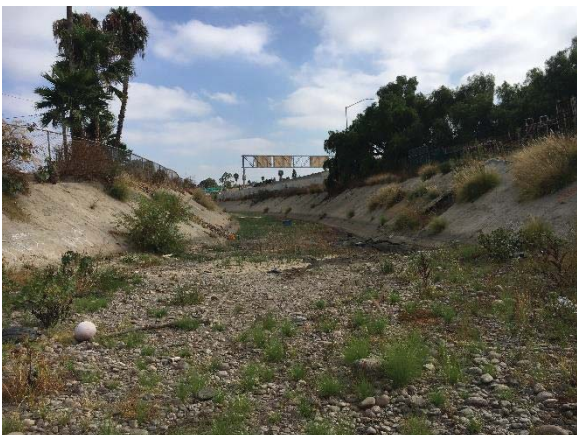
channel was observed to have light vegetation and sediment deposition along the segment bottom at the downstream end and mostly clean concrete at the upstream end. One area of concrete bank repair was also noted. Given the history of maintenance, the limits of maintenance are recommended to be unchanged from the previous assessment and it is recommended that H&H Technical Report for the MWMP recommendations remain unchanged.

Looking upstream from approximately Station 2065.8479 (August 2019).

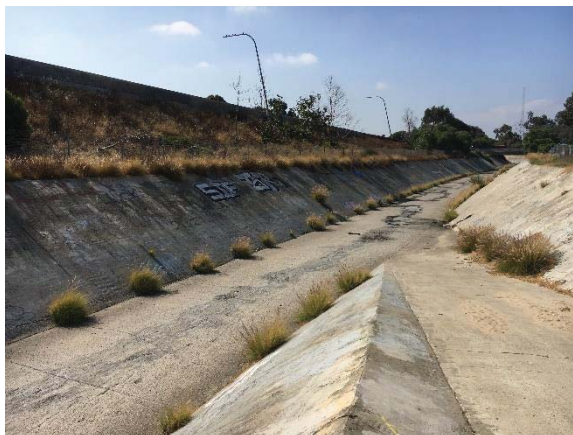
Looking downstream from approximately Station 4774.1509 (August 2019).

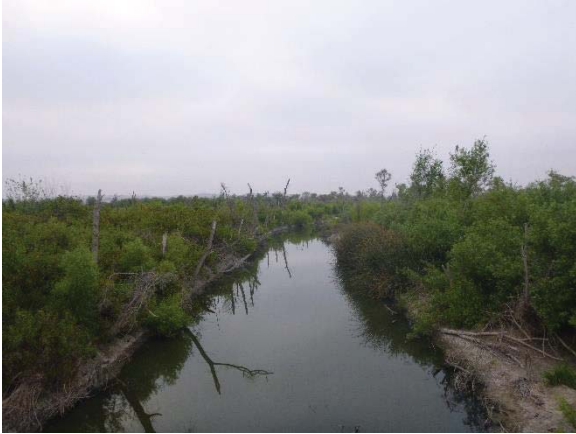
direction. During the site assessment in May 2017, prior to the latest maintenance activity, the earthen channel was observed to have 3 to 5 feet of sediment, trash and other debris deposited in the channel. Given the history of maintenance, the length of maintenance and the width of maintenance are recommended to be unchanged from the previous assessment. The depth of maintenance will vary based on the amount of deposition of sediment that occurs prior to maintenance activities. It is recommended that the H&H Technical Report for the MWMP recommendations remain unchanged as the area of maintenance will remain unchanged.

Looking upstream from the Hollister Street bridge at approximately Station 14856 (May 2017).

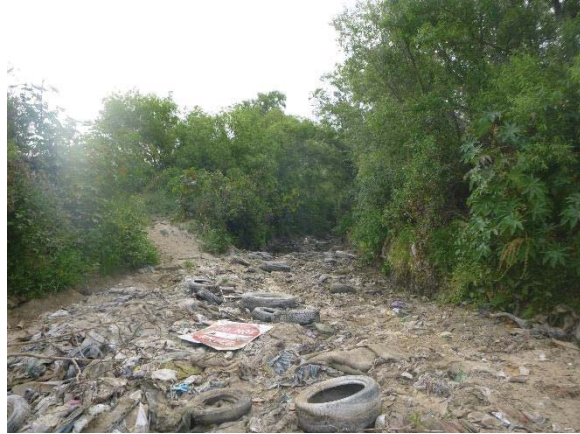
Looking upstream from approximately Station 131 (May 2017).

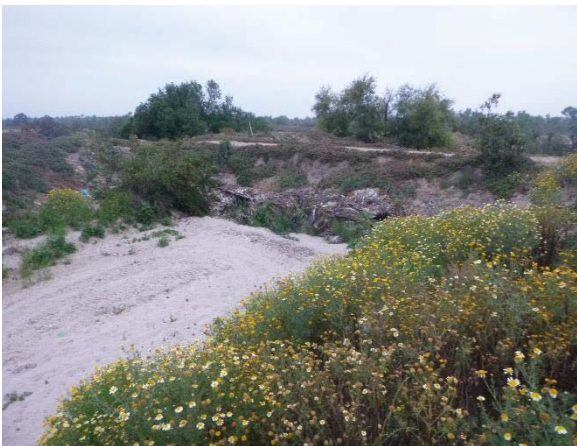
utilized in a manner that maximizes positive drainage flow condition in a downstream direction. During the site assessment in May 2017, prior to the latest maintenance activity, the earthen channel was observed to have accumulated 3 to 10 feet of sediment, trash and other debris deposited in the channel. Given the history of maintenance, the length of maintenance and the width of maintenance are recommended to be unchanged from the previous assessment. The depth of maintenance will vary based on the amount of deposition of sediment that occurs prior to maintenance activities. It is recommended that the H&H Technical Report for the MWMP recommendations remain unchanged as the area of maintenance will remain unchanged.

Looking at the culvert inlet at approximately Station 2549.85 (May 2017).

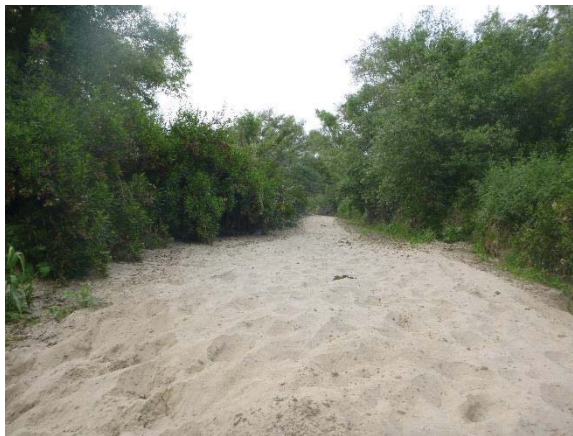
Looking upstream from the confluence with the Pilot Channel (May 2017).
