UPDATED HAZARDOUS MATERIAL TECHNICAL STUDY

Otay Mesa Community Plan Update San Diego, California

GEOCON PROJECT NO. 09721-06-02

OCTOBER 2012

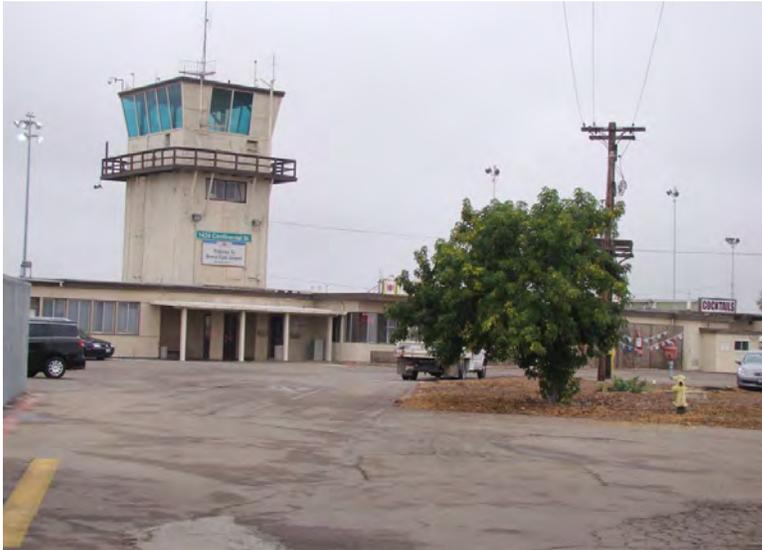
Photo No. 1 Area 1 - Administration and control tower building at 1424 Continental Street in the central portion of the Brown Field operations area (Map ID 2)

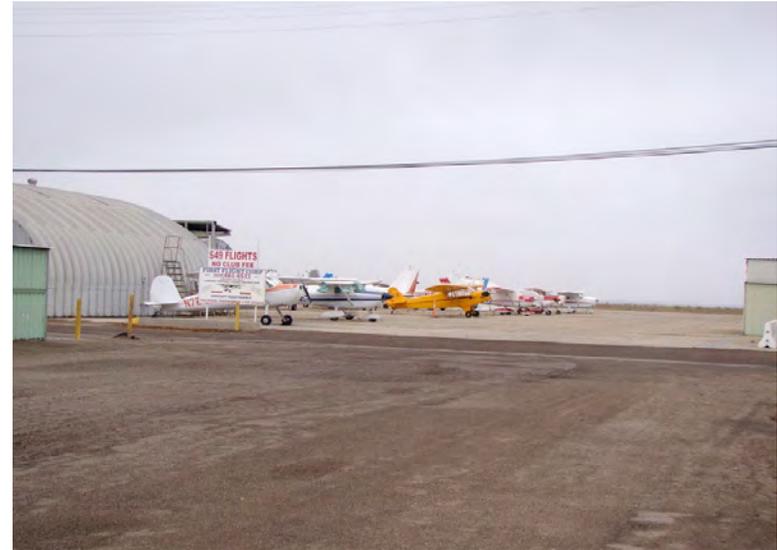
Photo No. 2 Area 1 - Hangars and private planes in northwestern portion of the Brown Field operations area (Map ID 2)

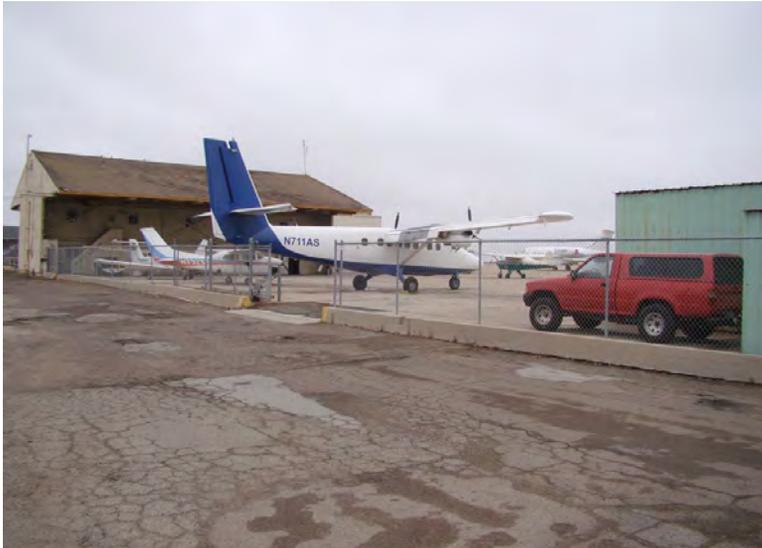
Photo No. 3 Area 1 - Hangar in northern portion of the Brown Field operations area (Map ID 2)

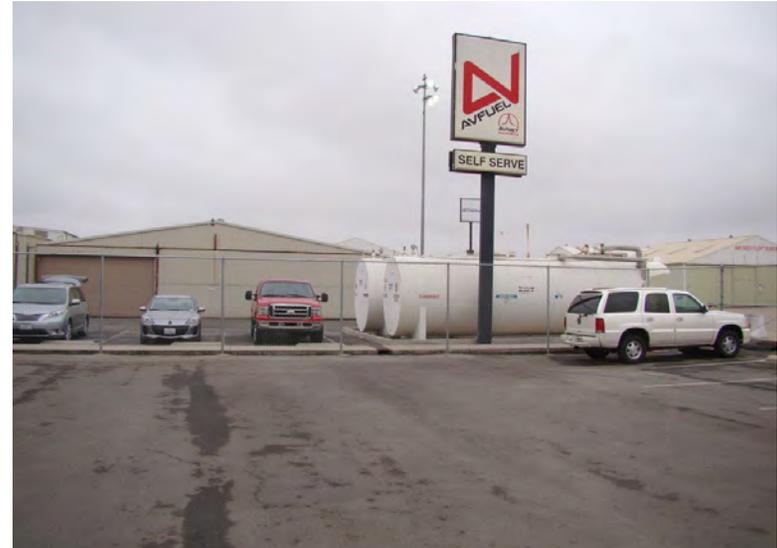
Photo No. 4 Area 1 - ASTs containing jet fuel north of the administration and control tower building in the Brown Field operations area (Map ID 2)

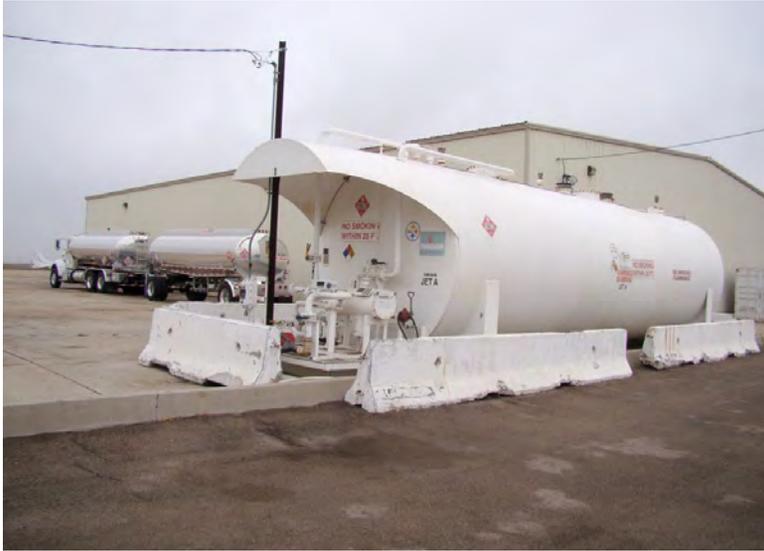
Photo No. 5 Area 1- ASTs containing jet fuel south of the hangars in the Brown Field operations area (Map ID 2)

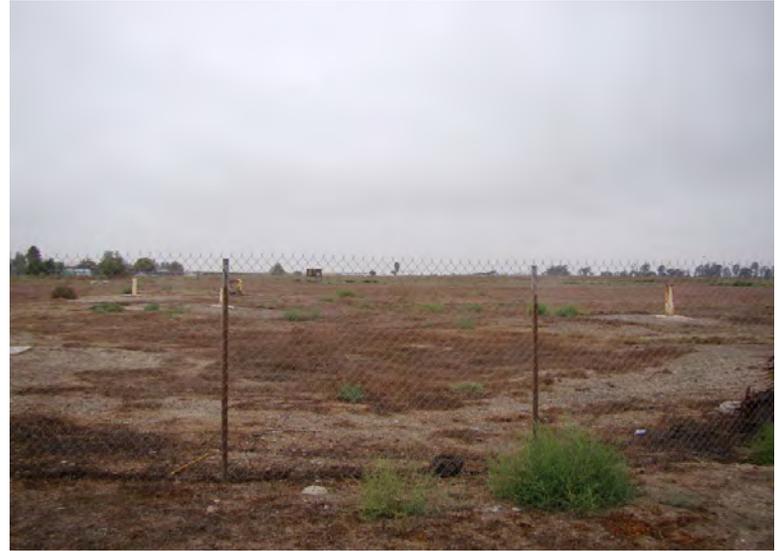
Photo No. 6 Area 1 - Former fuel farm west of the Brown Field operations area (Map ID 2)

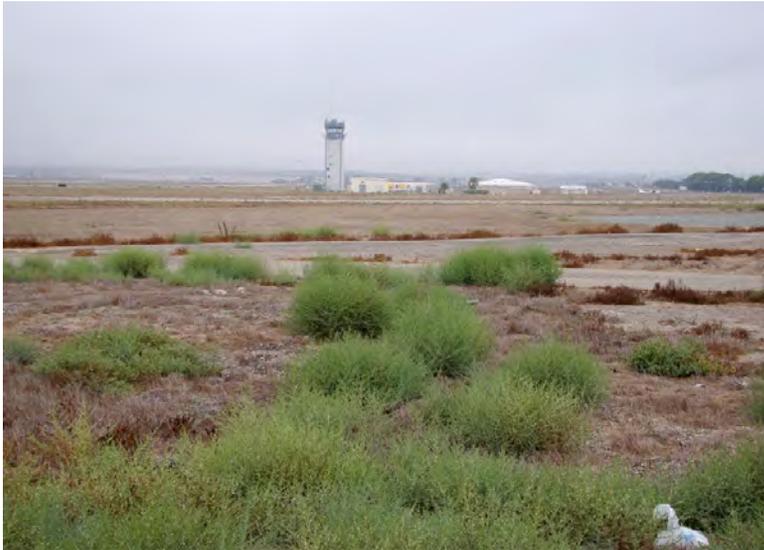
Photo No. 7 Area 1 - Runways and control tower east of the Brown Field operations area (Map ID 2)

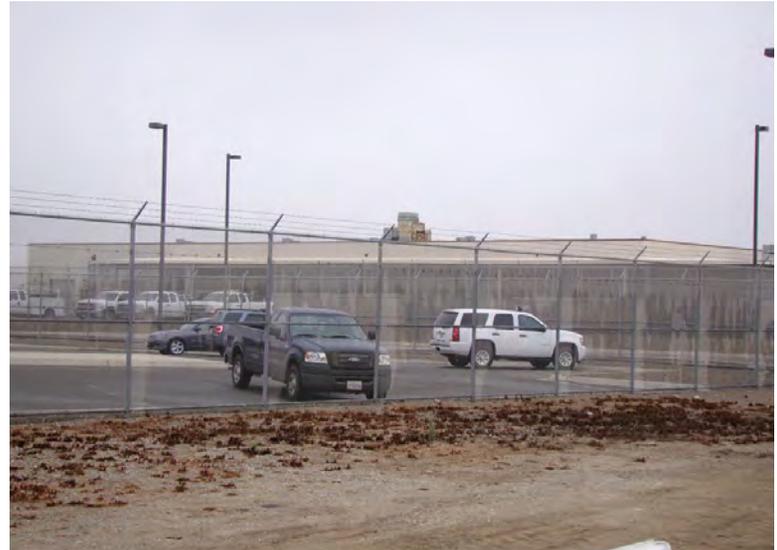
DEH records reviewed for our 2007 HMTS regarding Case No. H37776-001 indicated that an assessment conducted in 1998 identified 3,000 cubic yards of lead-containing soil at this facility. Additional assessment in 2000 found that at least 3,500 cubic meters of soil at the three firing ranges contained high concentrations of lead, antimony, arsenic, copper, molybdenum, and zinc. Excavation, characterization, and disposal of the impacted soil were recommended to mitigate the former facility.

Photo No. 8 Area 1 - U.S. Border Patrol Maintenance Facility north of Pogo Row that currently occupies the western portion of the former U.S. Border Patrol Pistol Range (Map ID 3)

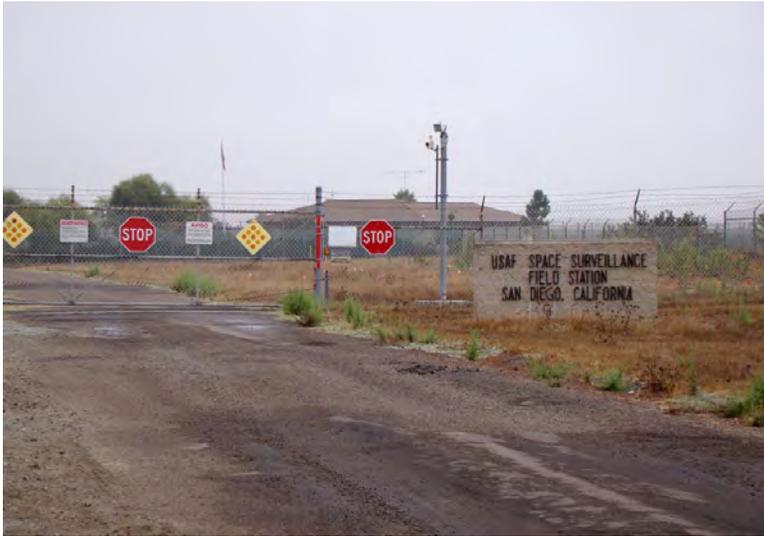
Information available on EnviroStor indicates that the eastern portion of this facility is currently occupied by the San Diego Space Surveillance Station (SDSSS) and that assessment is ongoing to evaluate former munitions installations that were operated by the U.S. Navy, prior to use of the facility by the U.S. Border Patrol. A Remedial Investigation/Feasibility Study (RI/FS) Workplan was prepared

Photo No. 9 Area 1 – San Diego Space Surveillance Station north of Pogo Row that currently occupies the eastern portion of the former U.S. Border Patrol Pistol Range (Map ID 3)

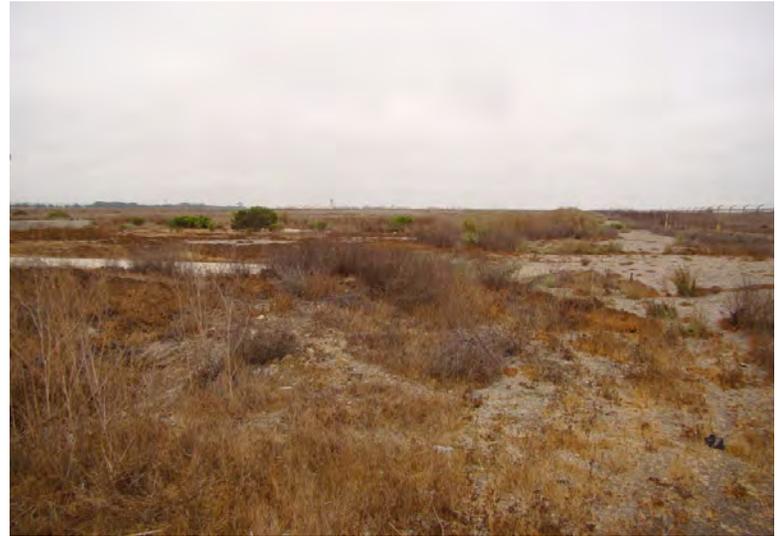
Photo No. 10 Area 1 – Former Organic Recycling West property at 1202 La Media Road (Map ID 5)

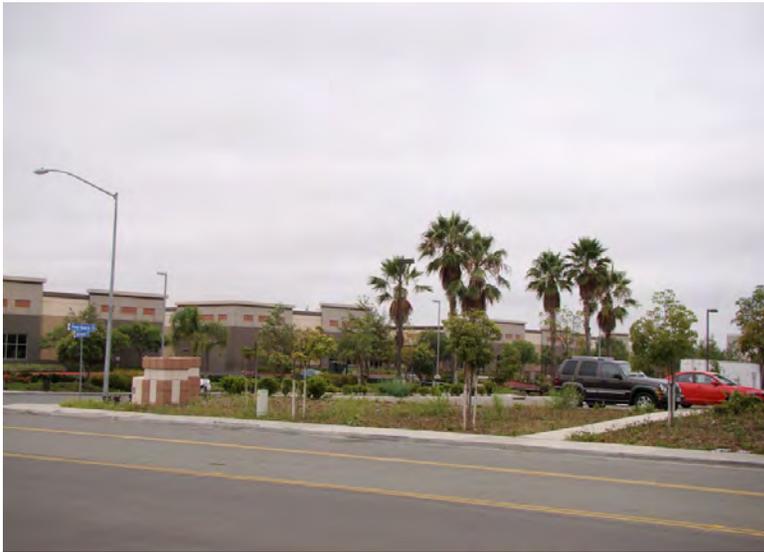
Photo No. 11 Area 1 – Former Piper Ranch property west of Piper Ranch Road that has been redeveloped as a business park (Map ID 6)

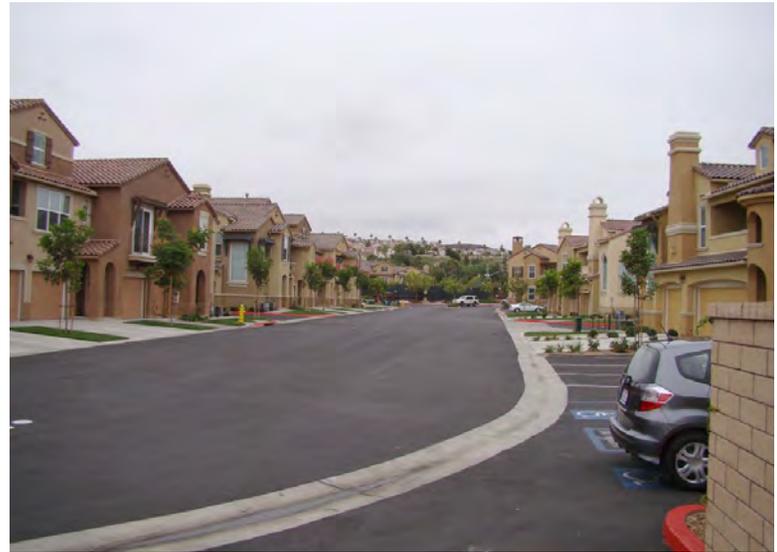
Documents that we reviewed at the County LEA as part of our 2007 HMTS indicate that this property is located north of the intersection of Dennery Road and Red Fin Lane. Reportedly, approximately 5,000 cubic yards of burn ash deposits, originating from the Shinohara II Burn Site (Map ID 9 and adjacent to the north of this property), are present over an approximately 0.5-acre area in the northwestern portion of this property. In a letter dated October 25, 2006, the County LEA approved a plan to construct a 2-foot-thick vegetative soil cap over the areal extent of the burn ash deposits.

Information available on EnviroStor indicates that Pardee Homes entered into a Voluntary Cleanup Agreement (VCA) with the DTSC in 2005 for review and opinion on potential health risks to future occupants of a proposed residential community due to the proximity of the Shinohara II Burn Site. Based on a health risk assessment prepared in 2005, the DTSC indicated that the Shinohara II Burn Site does not pose a significant health threat to future residents of the proposed residential community provided the following conditions are met:

Photo No. 12 Area 1 – Former Dennery Ranch property north of the intersection of Dennery Road and Red Fin Lane that has been redeveloped with single-family homes (Map ID 7)

- 1) The Shinohara II Burn Site will continue to remain undisturbed and covered with vegetation.
- 2) The DEH or other appropriate regulatory agency will provide oversight of any future disturbance to the burn site soils to ensure that potential dust migration will be controlled to protect the health of residents in the adjacent residential community.

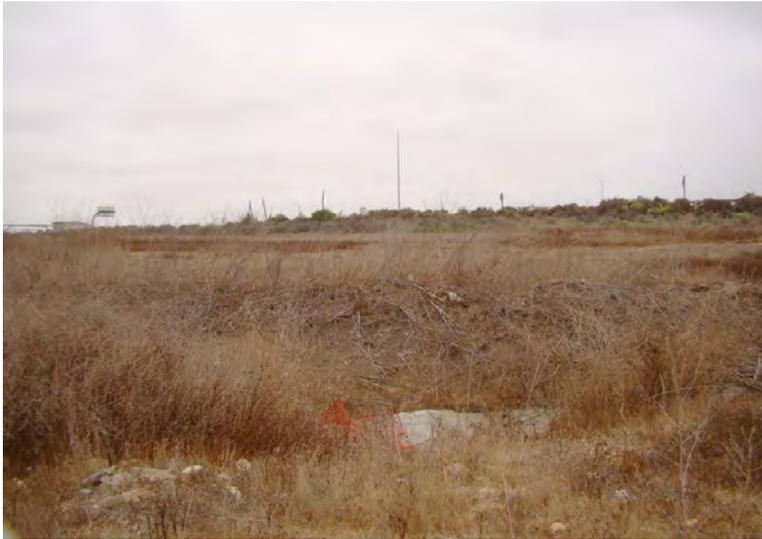
Photo No. 13 Area 1 – Vacant property southeast of the Southbay Expressway Operations Center at 1129 La Media Road (Map ID 10). An abandoned underground storage tank was encountered and removed during grading of this property in 2007

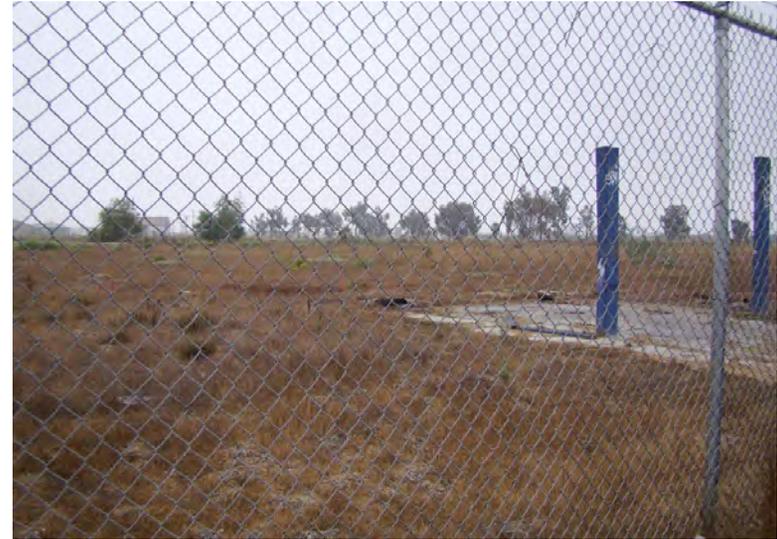
Photo No. 14 Area 1 - Vacant land west of the former fuel farm at Brown Field previously occupied by auto sales lots and Rohr Engine Test Facility (Map ID 11)

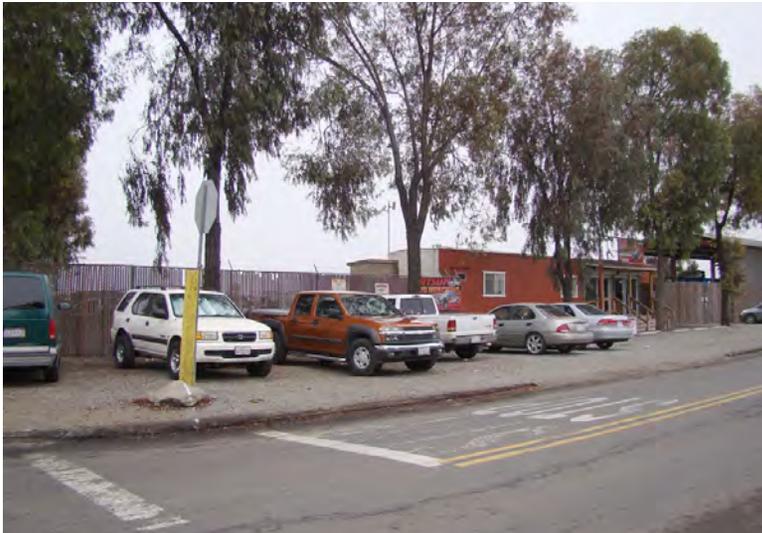
Photo No. 15 Area 1 – Auto Recycling facility at 980 Otay Valley Road (Map ID 12)

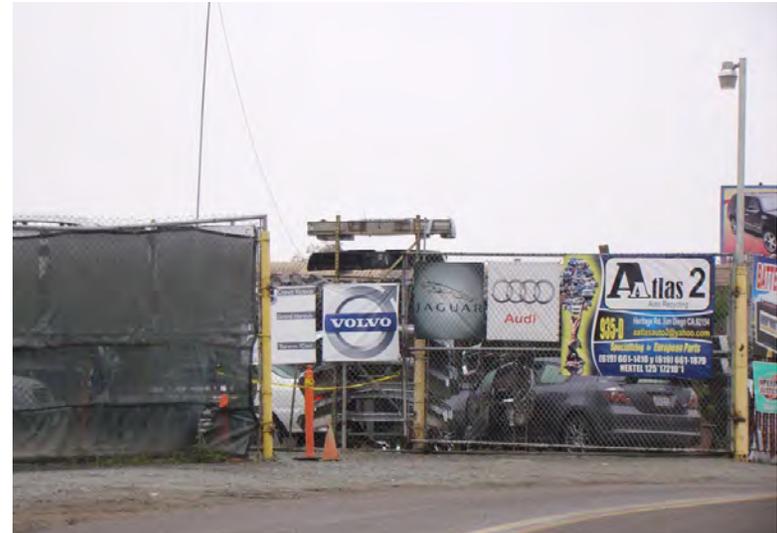
Photo No. 16 OLA Imports and Exports at 935 Heritage Road (Map ID 14)

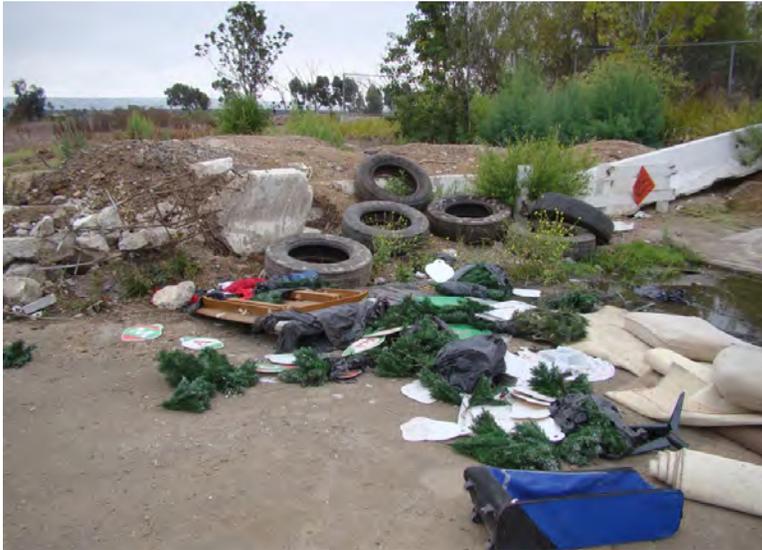
Photo No. 17 Area 2 – Various debris observed at the northern entrance to the Dillons Trail Site (Map ID 15) at the southern termination of Caliente Avenue

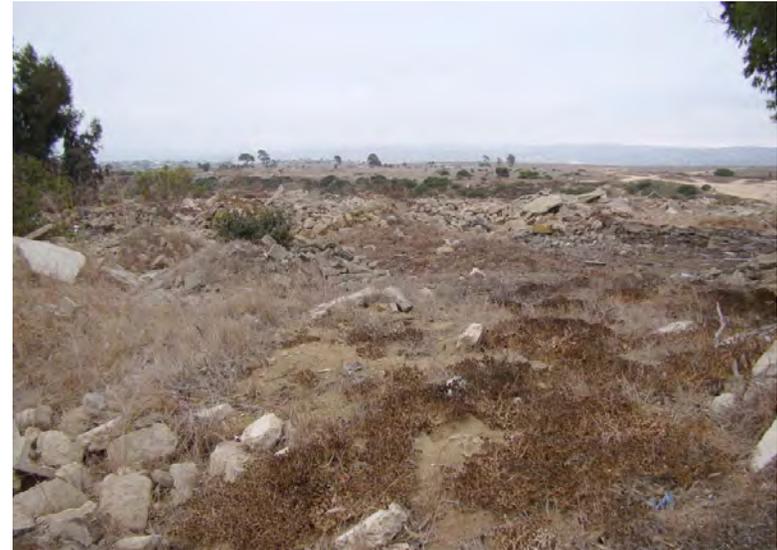
Photo No. 18 Area 2 – Concrete debris observed in the central portion of the Dillons Trail Site (Map ID 15)

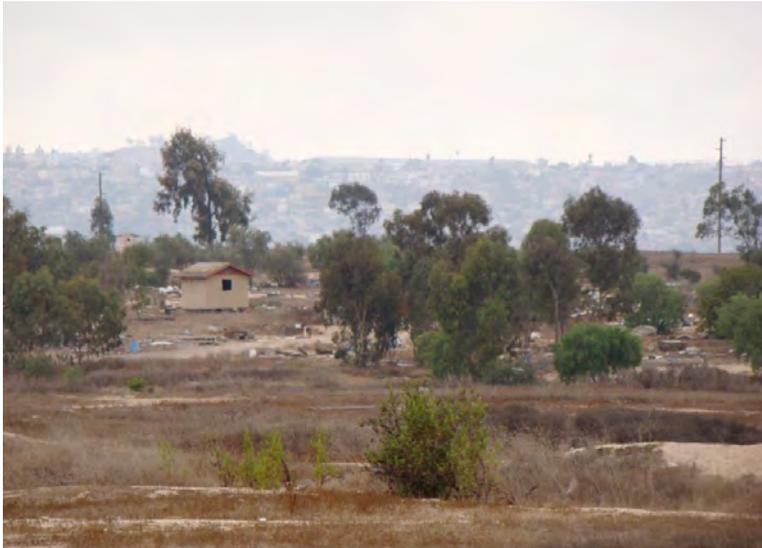
Photo No. 19 Area 2 – Abandoned structures and debris observed southwest of the main trail through the Dillons Trail Site (Map ID 15)

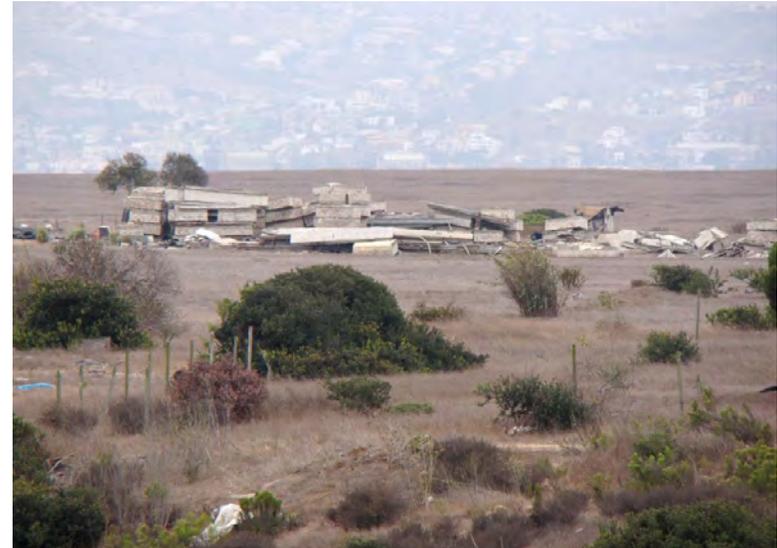
Photo No. 20 Area 2 – Abandoned structures and debris observed southeast of the main trail through the Dillons Trail Site (Map ID 15)

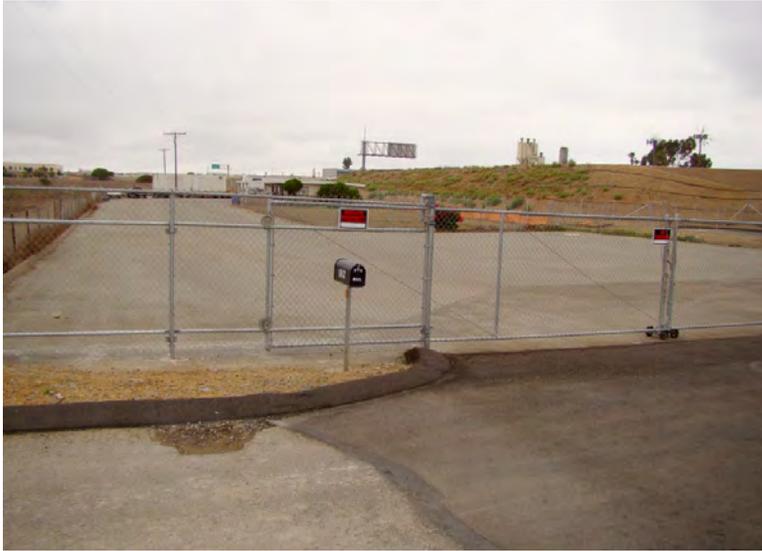
Photo No. 21 Area 3 – Barnhart and Dantzler Property (Map ID 16) located west of the northern termination of Cactus Road

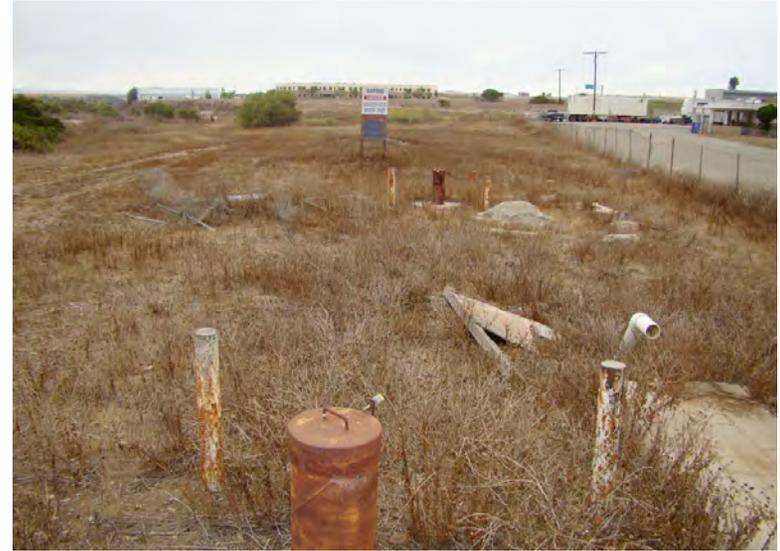
Photo No. 22 Area 3 – Sesi Property (Map ID 17) located adjacent to the south of the Barnhart and Dantzler Property

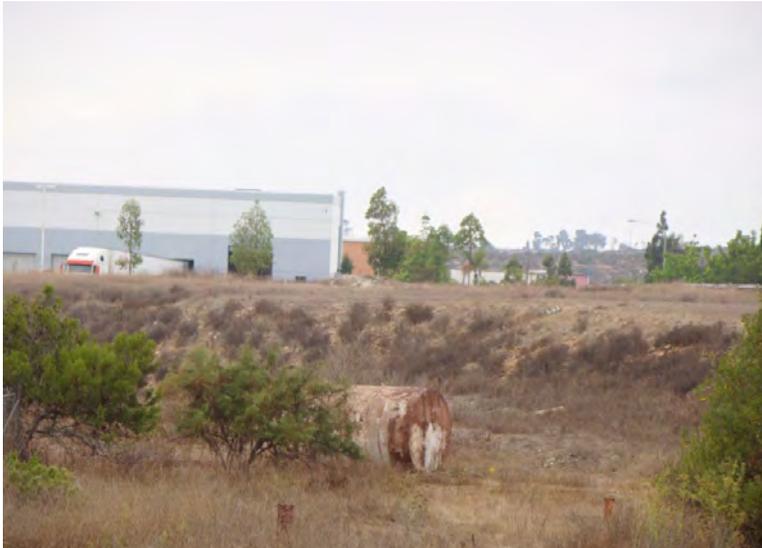
Photo No. 23 Area 3 – Abandoned aboveground storage tank observed in the western portion of the Sesi Property (Map ID 17)

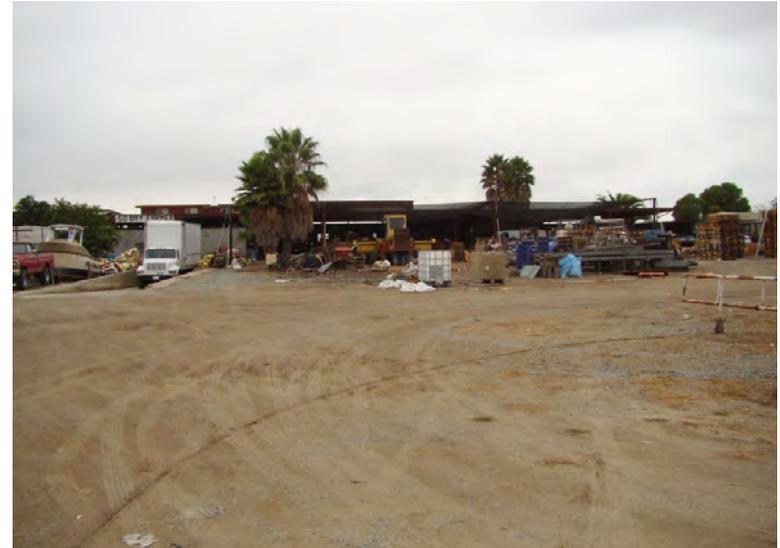
Photo No. 24 Area 3 – Packing and distribution area in the central portion of the Martinez Ranch Compound at 2160 Cactus Road (Map ID 18).

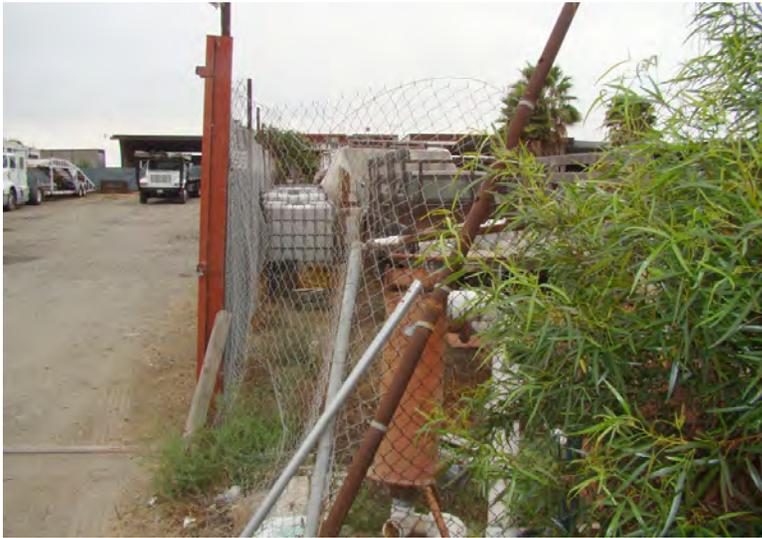
Photo No. 25 Area 3 – Fertilizer storage tanks observed in the packing and distribution area in the central portion of the Martinez Ranch Compound (Map ID 18)

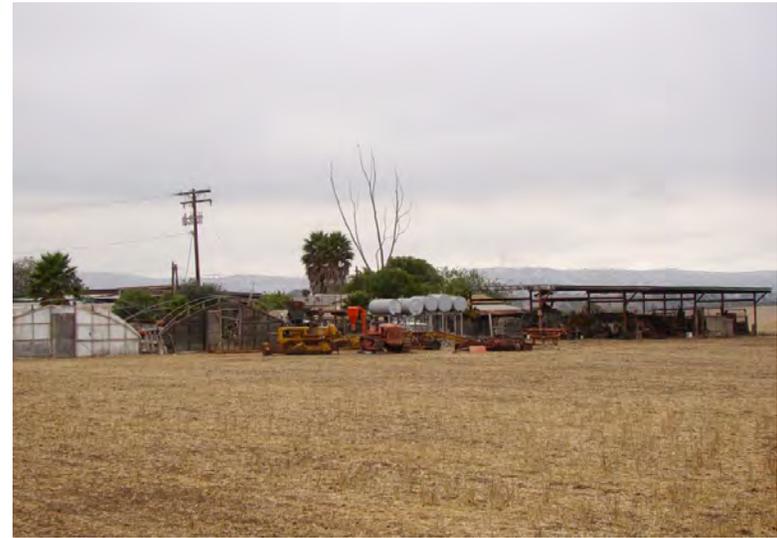
Photo No. 26 Area 3 – Diesel aboveground storage tanks observed in the northern portion of the Martinez Ranch Compound (Map ID 18)

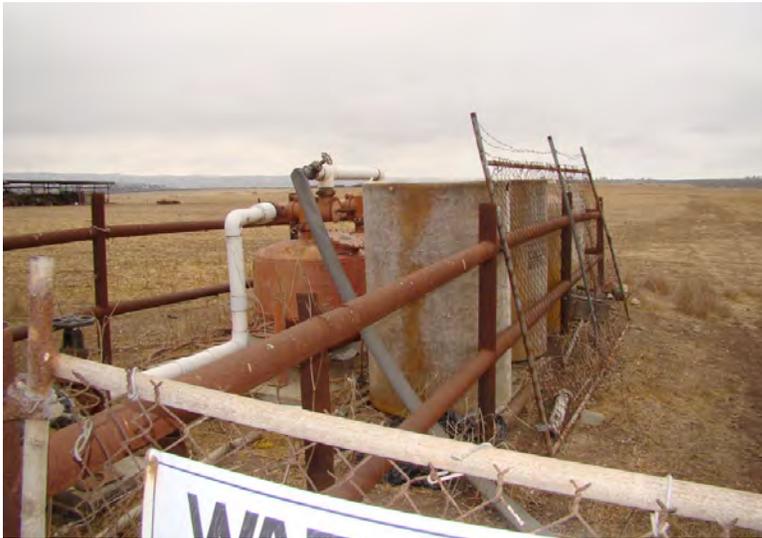
Photo No. 27 Area 3 – Fertilizer aboveground storage tanks observed in the northeastern portion of the Martinez Ranch Compound (Map ID 18)

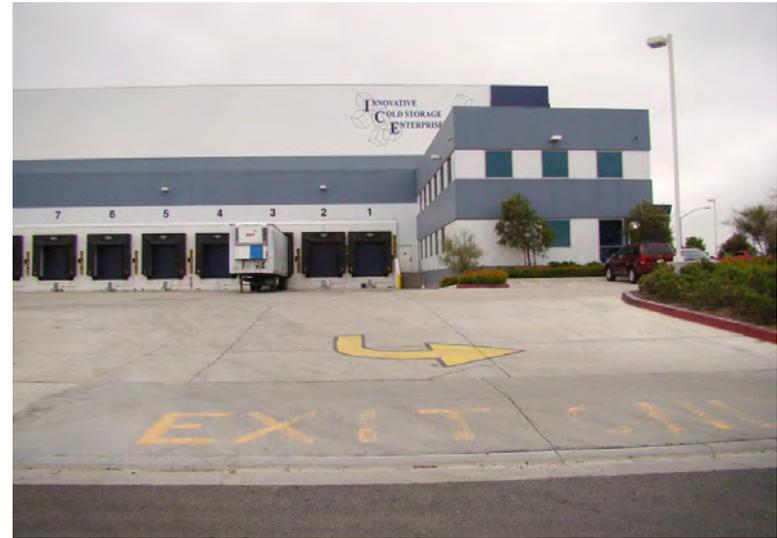
Photo No. 28 Area 3 – Former Martinez Outdoor Storage at 2770 Martinez Ranch Road currently occupied by Innovative Cold Storage Enterprises (Map ID 20)

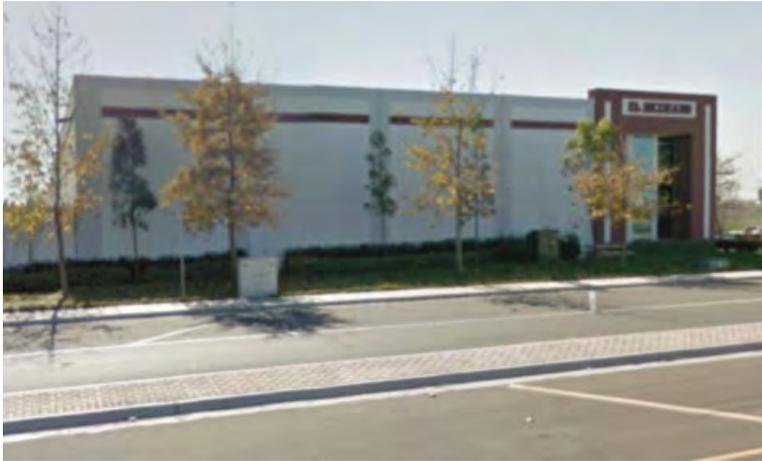
Photo No. 29 Area 4 – Northern portion of Britannia Boulevard Property at 2133 Britannia Boulevard, currently occupied by a business park (Map ID 21)

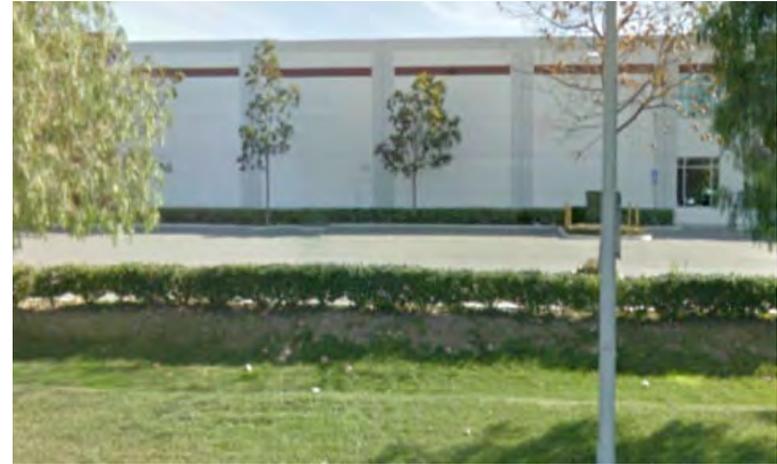
Photo No. 30 Area 4 – Southern portion of Britannia Boulevard Property at 2133 Britannia Boulevard, currently occupied by a business park (Map ID 21)

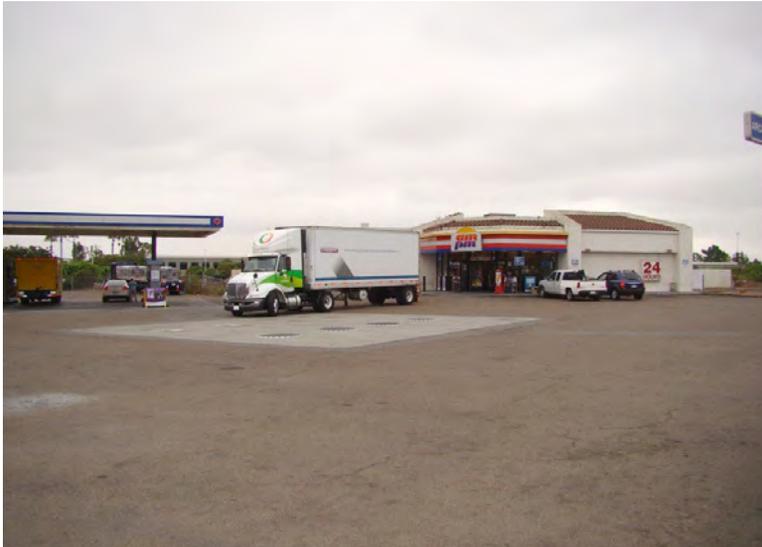
Photo No. 31 Area 5 – Arco Service Station at 2510 Otay Center Road (Map ID 22)

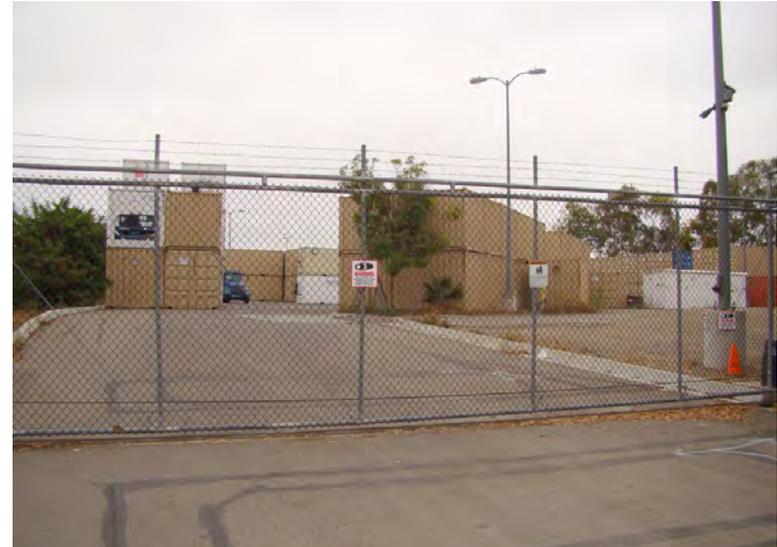
Photo No. 32 Area 6 – Air Liquide Industrial at 9955 Via De La Amistad (Map 23)
