101 ASH STREET

BUILDING CONDITION ASSESSMENT

FINAL REPORT

JULY 28, 2020

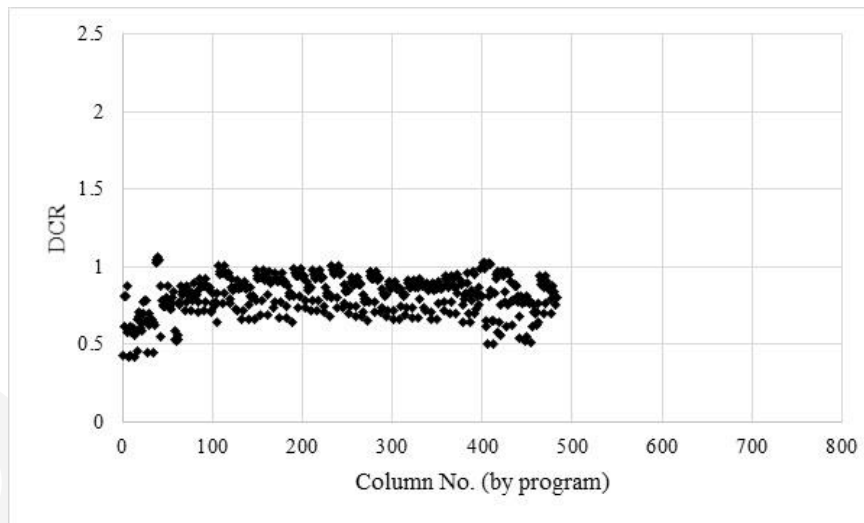
Figure 8. Performance of columns, existing BSE 1E

Figure 8 presents the performance of columns at BSE-1E. Note the following:

- Connections meet ASCE 41-17 requirements
- DCR values are less than or close to unity. In other words, columns remain elastic (damage free).

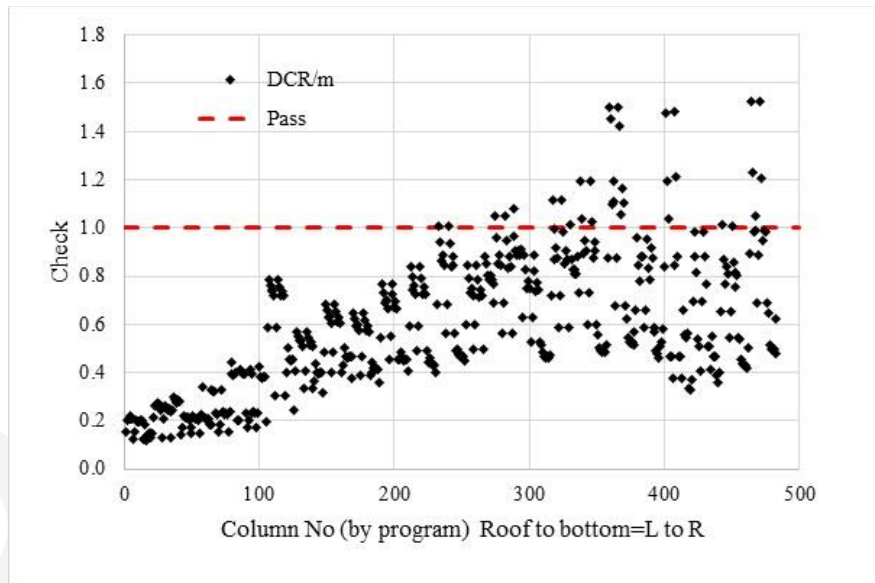
Figure 12. Performance of columns, existing BSE 2E

Figure 12 presents the performance of columns at BSE-2E. Note the following:

- Columns do not meet ASCE 41-17 requirements
