THE CITY OF SAN DIEGO

SUBJECT: Chollas Creek (MMP Map 71) Emergency Maintenance Substantial Conformance Review Submittal

REFERENCE: Emergency Permit PTS #463704 Permit # 1622406; Job Order # **21003732**

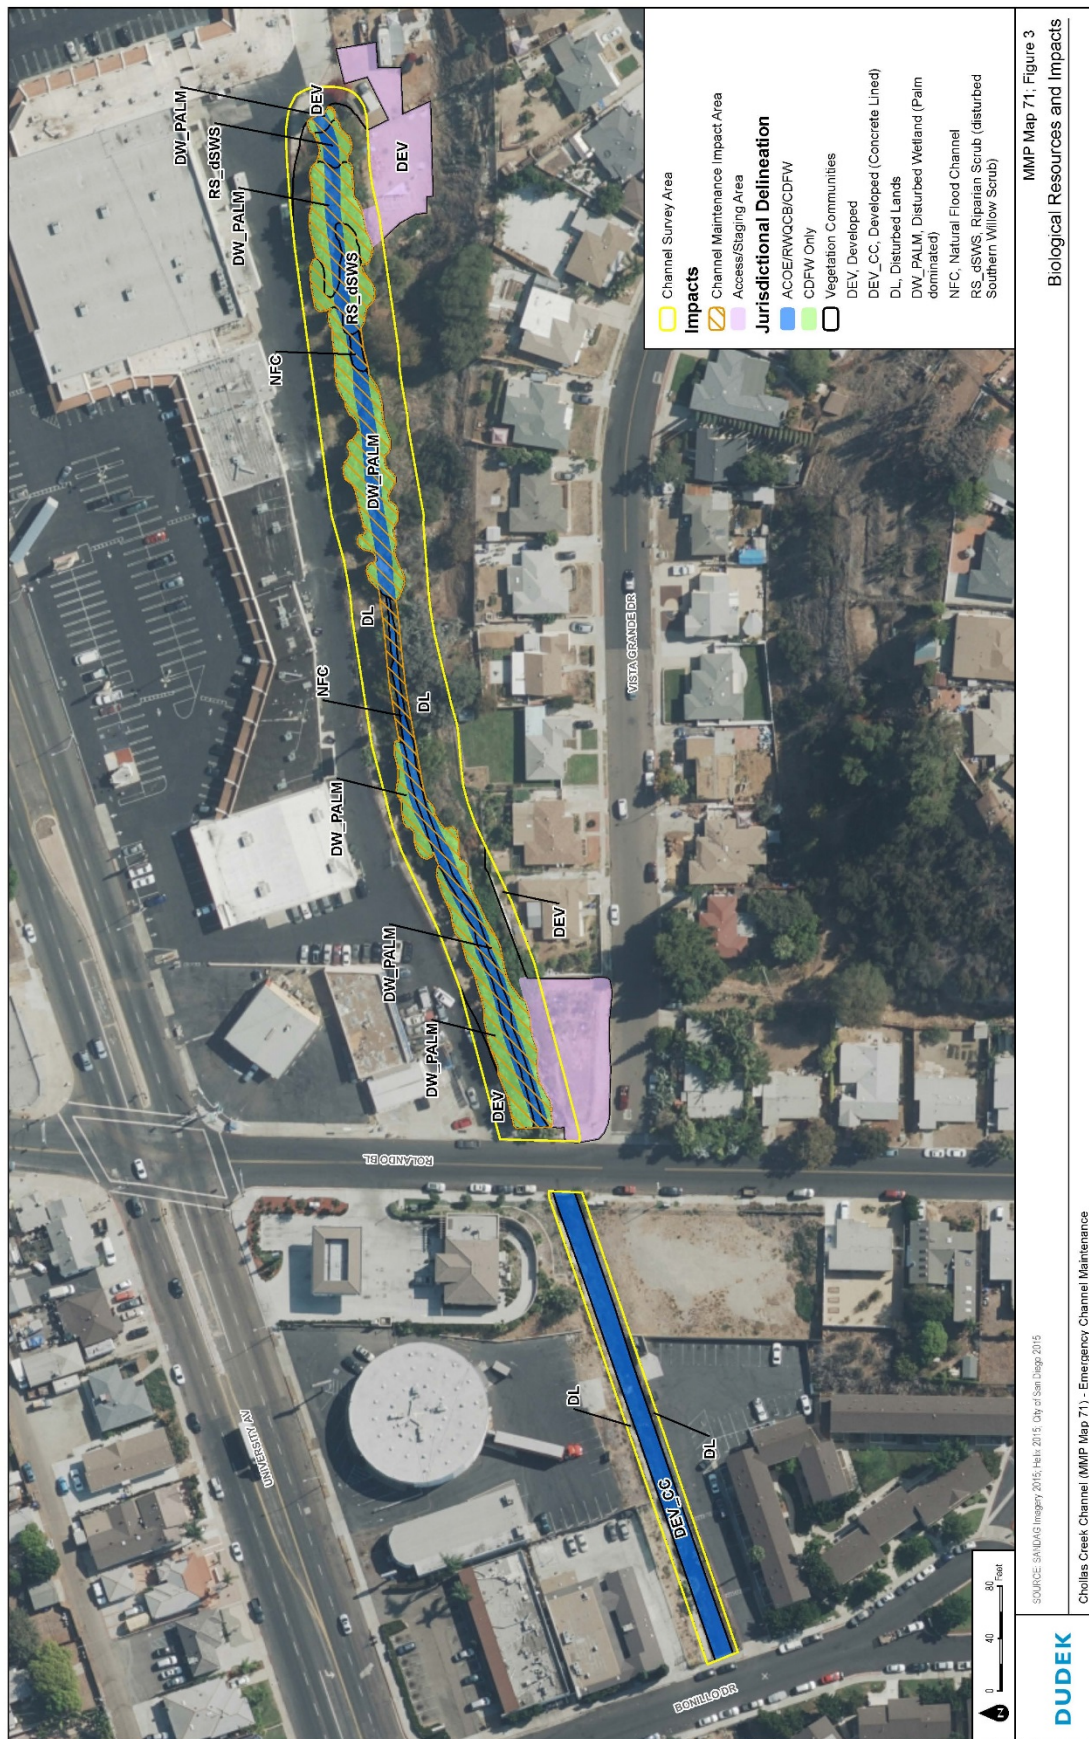
Emergency work consisted of a single earthen channel segment approximately 800 linear feet in length (MMP Map 71; Figure 3). The section west of Rolando Boulevard is concrete-lined and was not included as part of this emergency channel work. The maintenance area began just west of 6523 University Ave and Aragon Drive. Work continued west the entire length of the channel, with an average bottom width of approximately 15 feet, ending at the inlet that carries flows west under Rolando Boulevard (MMP Map 71; Figure 3). Land covers and vegetation communities impacted during maintenance included 0.02 acres of riparian scrub (disturbed southern willow scrub), 0.06 acres of natural flood channel, and 0.11 acres of disturbed wetland (palm dominated). Total impacts to jurisdictional areas are 0.19 acres (800 linear feet) of wetland waters of the U.S. channel. An additional 0.21 acre of disturbed wetland (palm dominated), 0.02 acre of disturbed land and 0.04 acre of riparian scrub (disturbed southern willow scrub) above the Ordinary High Water Mark (OHWM) under CDFW jurisdiction only was also removed.

The emergency maintenance area in Chollas Creek Channel is an earthen channel. The maintenance area begins just west of 6523 University Avenue and continues 800 linear feet west, terminating at the inlet that carries flow under Rolando Boulevard (MMP Map 71; Figure 3). The average bottom width of the channel is approximately 15 feet.
