SOUTH BAY OCEAN OUTFALL ANNUAL INSPECTION REPORT

South Bay Water Reclamation Plant

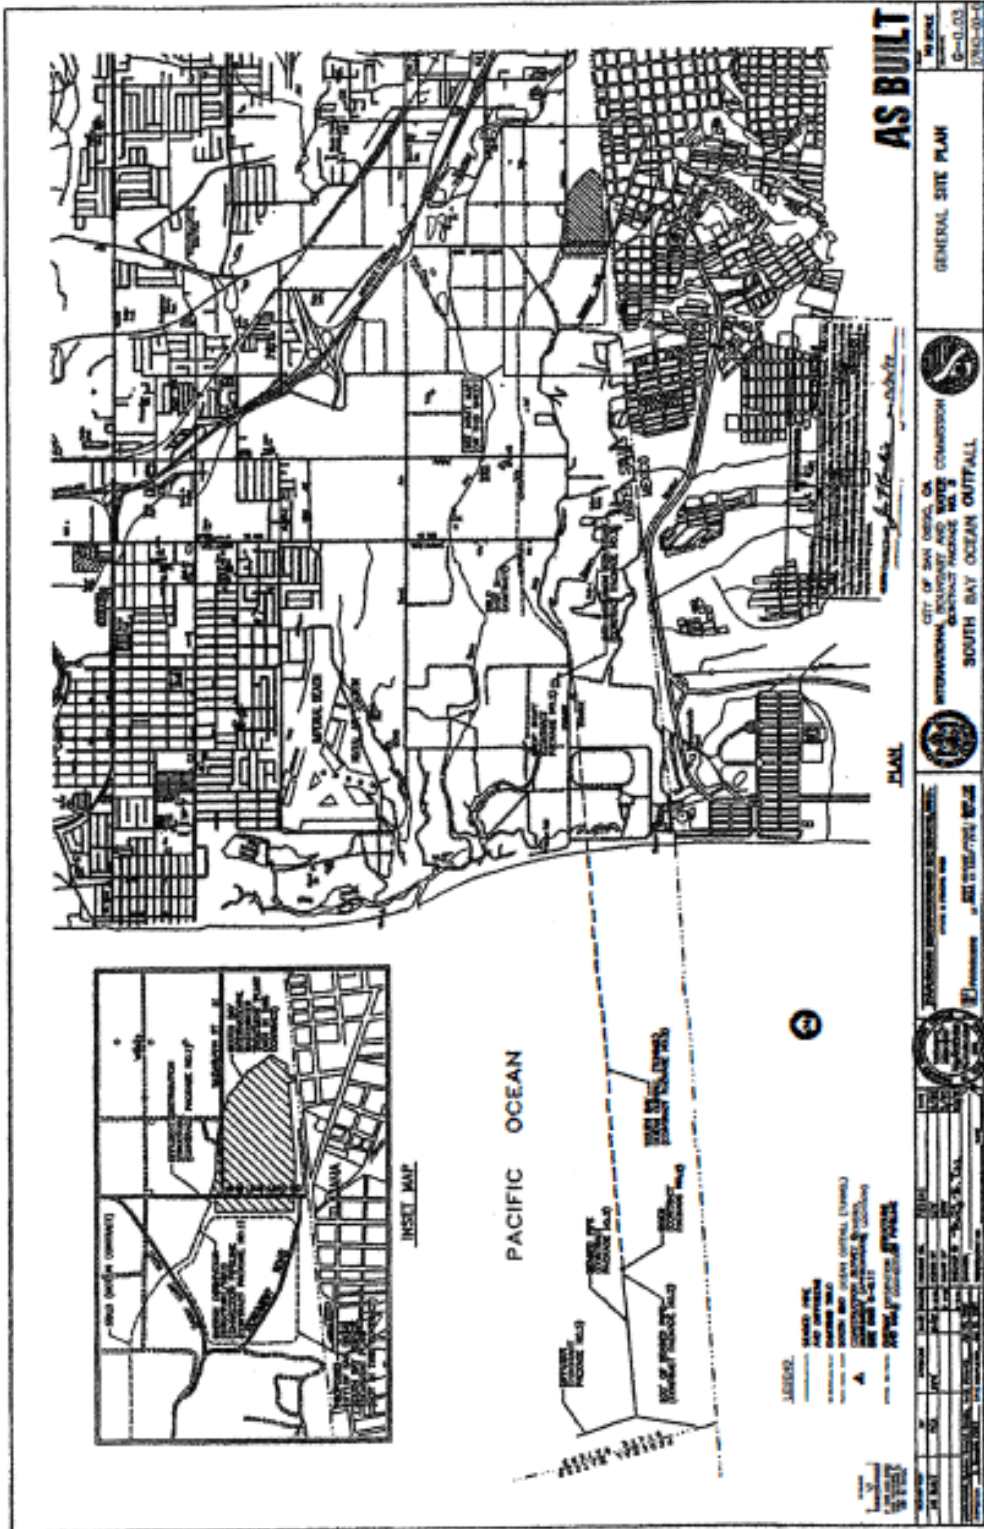
- 6 The upgrade to secondary treatment at the SBIWTP in January 2011 has continued to markedly improve the visible quality of discharged effluent and may have also been responsible for the virtual elimination of the bacterial mats seen near all points of discharge in the years predating the current review period. However, as of Aug 2022, the SBIWTP increased discharged flows to treat excess wastewater from the Tijuana River, which has affected the effluent color and the subsequent water quality in the immediate vicinity of the outfall. The City is assessing the impact and will report our findings in the 2021-2022 Biennial Receiving Waters Monitoring Report.

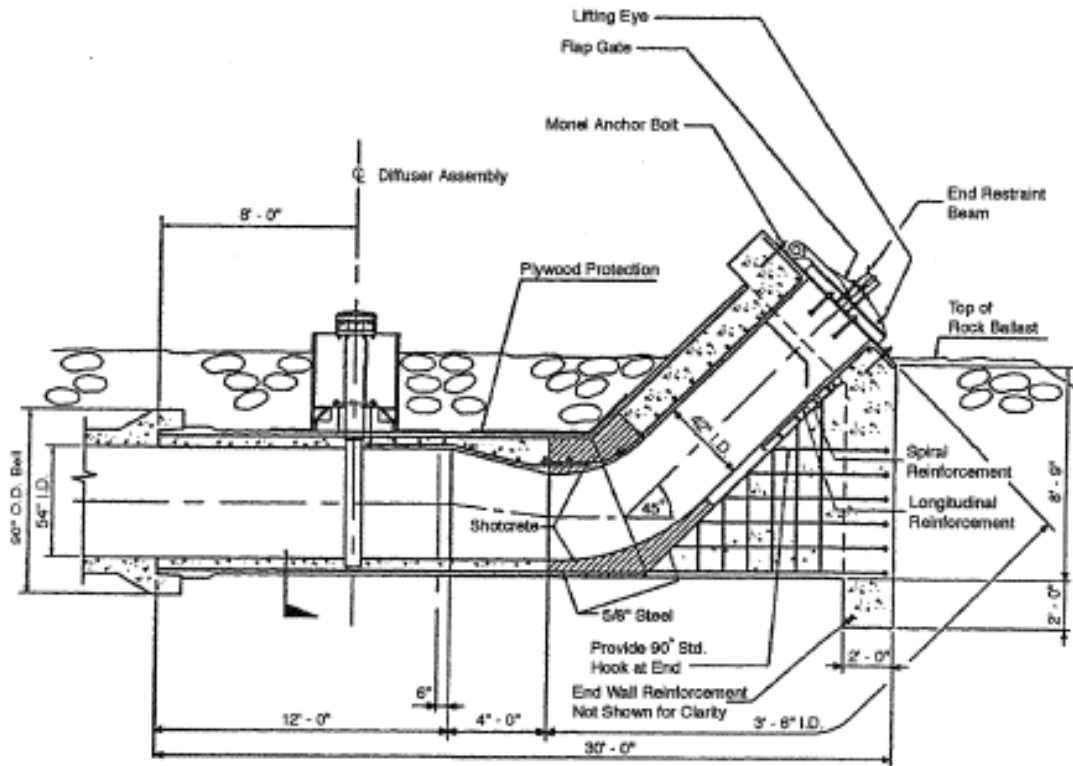
The Diffuser Wye structure for the SBOO.

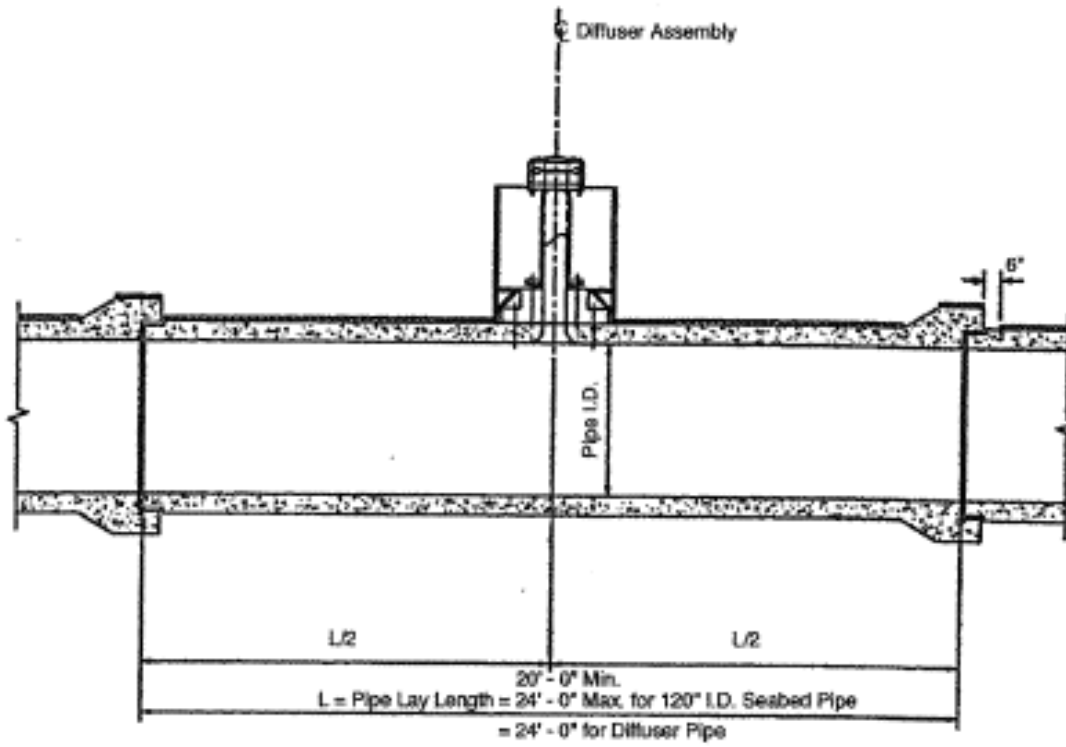
Termination structure found at the end of the SBOO Diffuser Legs.
