## FAULT INVESTIGATION FOR THE MONARCH SCHOOL SAN DIEGO, CALIFORNIA

Centre City Development Corporation  
225 Broadway, Suite 1100  
San Diego, CA 92101

URS Project No. 27663045.00060

April 6, 2007

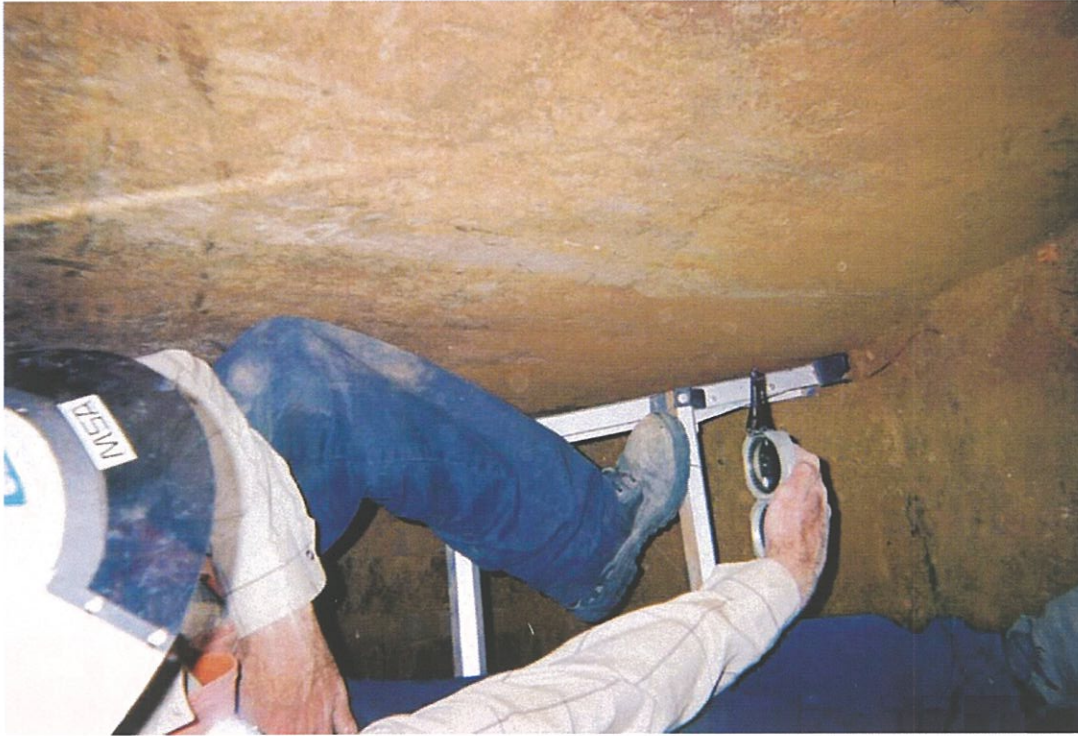
A short trench was excavated in the sidewalk along West Cedar, encompassing the area of CPT-2 and CPT-3. The purpose of the trench was to further investigate the nature of the miss-matched CPTs. We observed what we appeared to be a minor fault-related feature in the trench (Figure 8). However, there were no shears nor offset strata indicated in the trench. It is possible that the feature observed in the trench could simply represent a clay-filled fracture, and may not be a fault-related structure. We inferred that the miss-matched CPTs could represent a fault in the deeper portion of the Bay Point Formation (below the trench). In this case the clay-filled fracture in the trench could be a near surface expression of a deeper fault. We were able to clearly observe that the suspected fault in the trench does not displace the upper portion of the Bay Point Formation (i.e., the suspected fault feature is overlain by and does not displace Trench Unit 2). Within the trench, the fault has a slight northeasterly trend (about North 10 degrees East), and projects towards the northwest corner of the existing Monarch School building (Figure 2 and Figure 7).

As mentioned, the fault observed within the trench was considered a relatively minor feature consisting of a clay-filled fracture about 0.5-inches wide. The fault appeared to be highly weathered without slickensides or shears. As observed in the trench, the fault appeared to terminate upwards and did not extend into the upper portion of the Bay Point Formation (see Figure 8). The overlying unfaulted unit contained manganese and carbonate probably representing the lower portion of a soil profile (weathering profile) developed on the Bay Point Formation. The unfaulted interval of the Bay Point Formation is clearly older than 11,000 years given its degree of induration and oxidation. The unfaulted interval of the Bay Point Formation could be on the order of 80,000 to perhaps 120,000 years old.

THE MEASURED TREND OF THE  
FAULT IS ABOUT N10°E.

At the time of building demolition however, we do recommend trenching. The purpose of trenching at that time would be to confirm the presence or absence of the potentially active fault. If the potentially active fault is not indicated on site, the "Notice of Geologic and Geotechnical Conditions" would not be required. An as-built geologic report should then be submitted to the city that documents the geologic conditions encountered in the excavation.

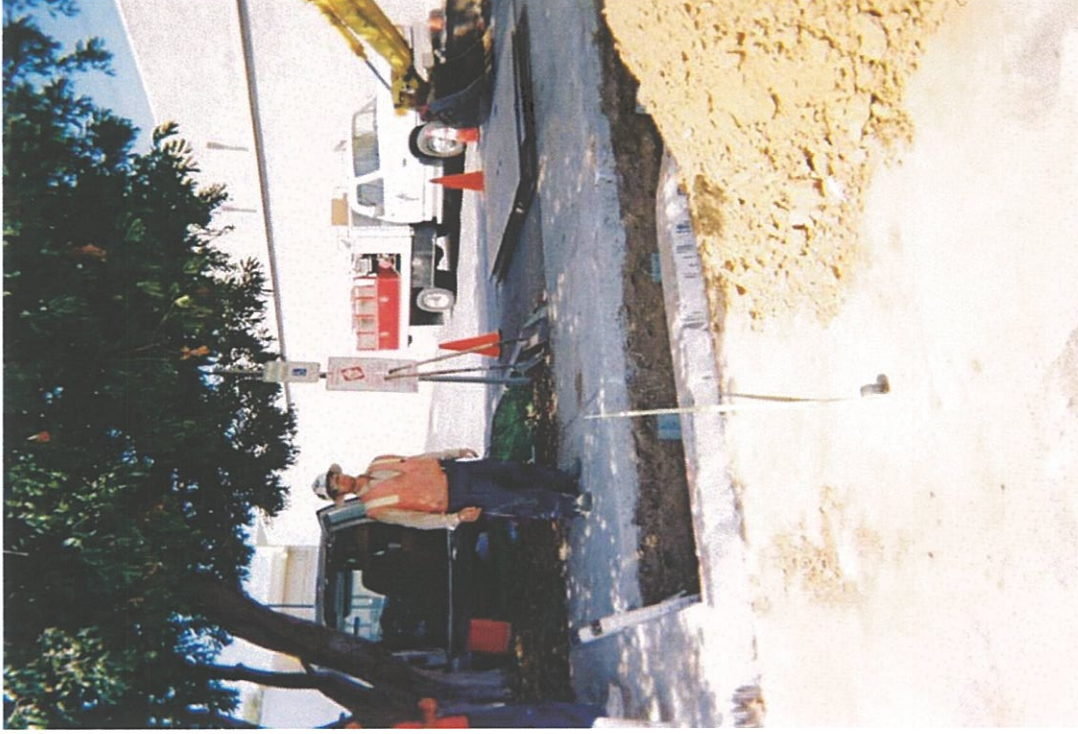
When we excavated the sidewalk trench, we were able to measure the trend of the fault across the width of the trench. From the trench, the fault projects towards the northwest building corner. We considered drilling additional borings within the existing building to help constrain the fault location. The environmental consultant had performed a number of borings with a tripod rig within the building. All of the environmental borings met refusal at shallow depths on buried obstructions. Additional borings would need to be drilled to depths significantly deeper than the environmental borings to locate the fault. Deep borings however, did not appear feasible in the interior of the building. We did not recommend subsurface explorations within the existing building because we were able to confidently determine that the fault was a potentially active fault and set-backs would not be recommended. Therefore, we did not recommend subsurface explorations within the existing building.

TAPE IS ALIGNED WITH THE FAULT  
TREND OBSERVED IN THE TRENCH.

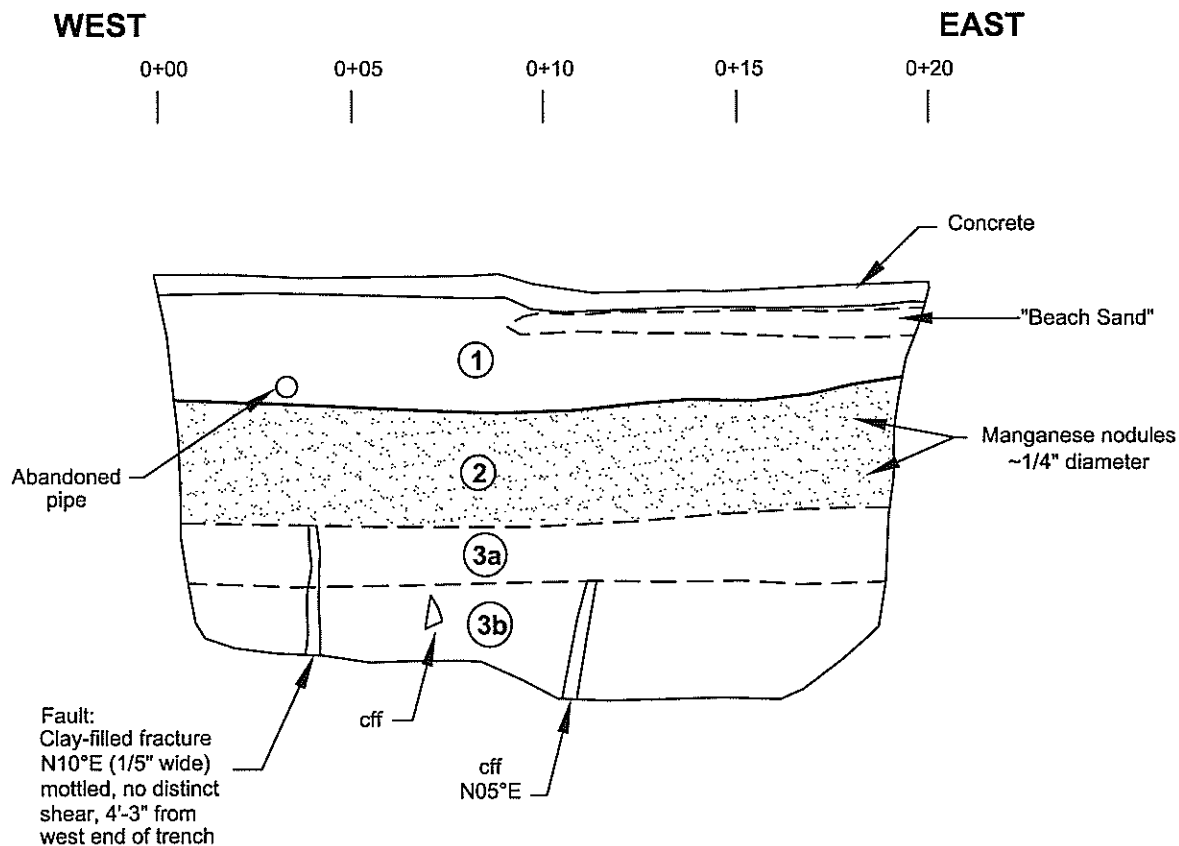
8

- FILL**
- ① Brown, silty sand with concrete and asphalt pieces, broken bottles and other debris
- BAY POINT FORMATION**
- ② Reddish brown, silty clayey medium to coarse sand with carbonate flakes and manganese nodules
- ③a Yellowish brown to brown, sandy CLAY (CL) to clayey SAND (SC)
- ③b Brown, clayey SAND (SC)

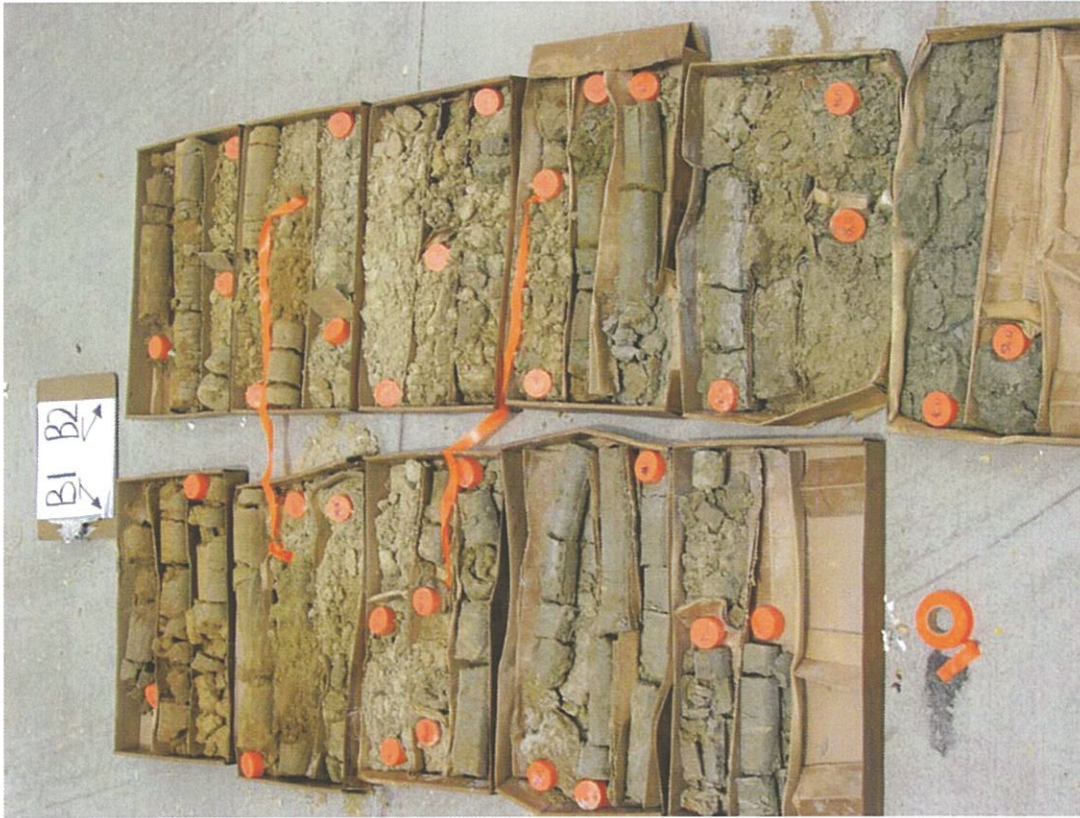
CONTINUOUS CORE SAMPLES, WITH TAPE CONNECTING  
CORRELATIVE UNITS BETWEEN THE TWO BORINGS.

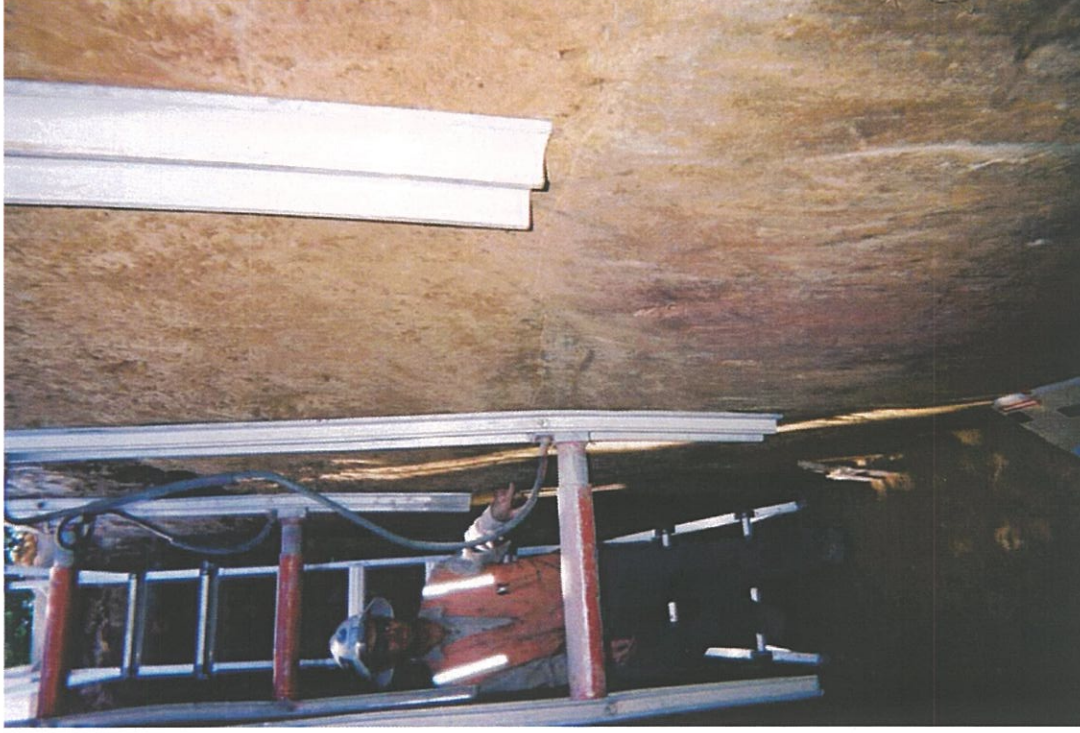
Within the trench, the upper portion of the Bay Point Formation (Trench Unit 2, Figure 8) was a coarse sandy unit containing carbonate and manganese nodules, although pedogenic features (indicative of soil profile formation) were not observed at the trench location. This suggests that previous grading had removed surficial soil horizons typically developed on the Bay Point Formation. The upper portion of the Bay Point Formation appeared weathered and oxidized within Trench Unit 2. The base of this subunit was marked by sharp contact with the underlying sandy clay unit (Unit 3a, also see photo, Figure 9). Therefore the weathered portion of the soil profile is contained within a depositional unit (i.e., Trench Unit 2 is also a depositional unit). We recognized this distinct weathering horizon at similar depths within the two large diameter borings (BH-1 and BH-2) along West Cedar Street. The correlation of this subunit is shown on Figure 10.

GEOLOGIST IS POINTING TO THE BASE OF TRENCH UNIT 2  
WHICH IS NOT OFFSET BY THE FAULT.

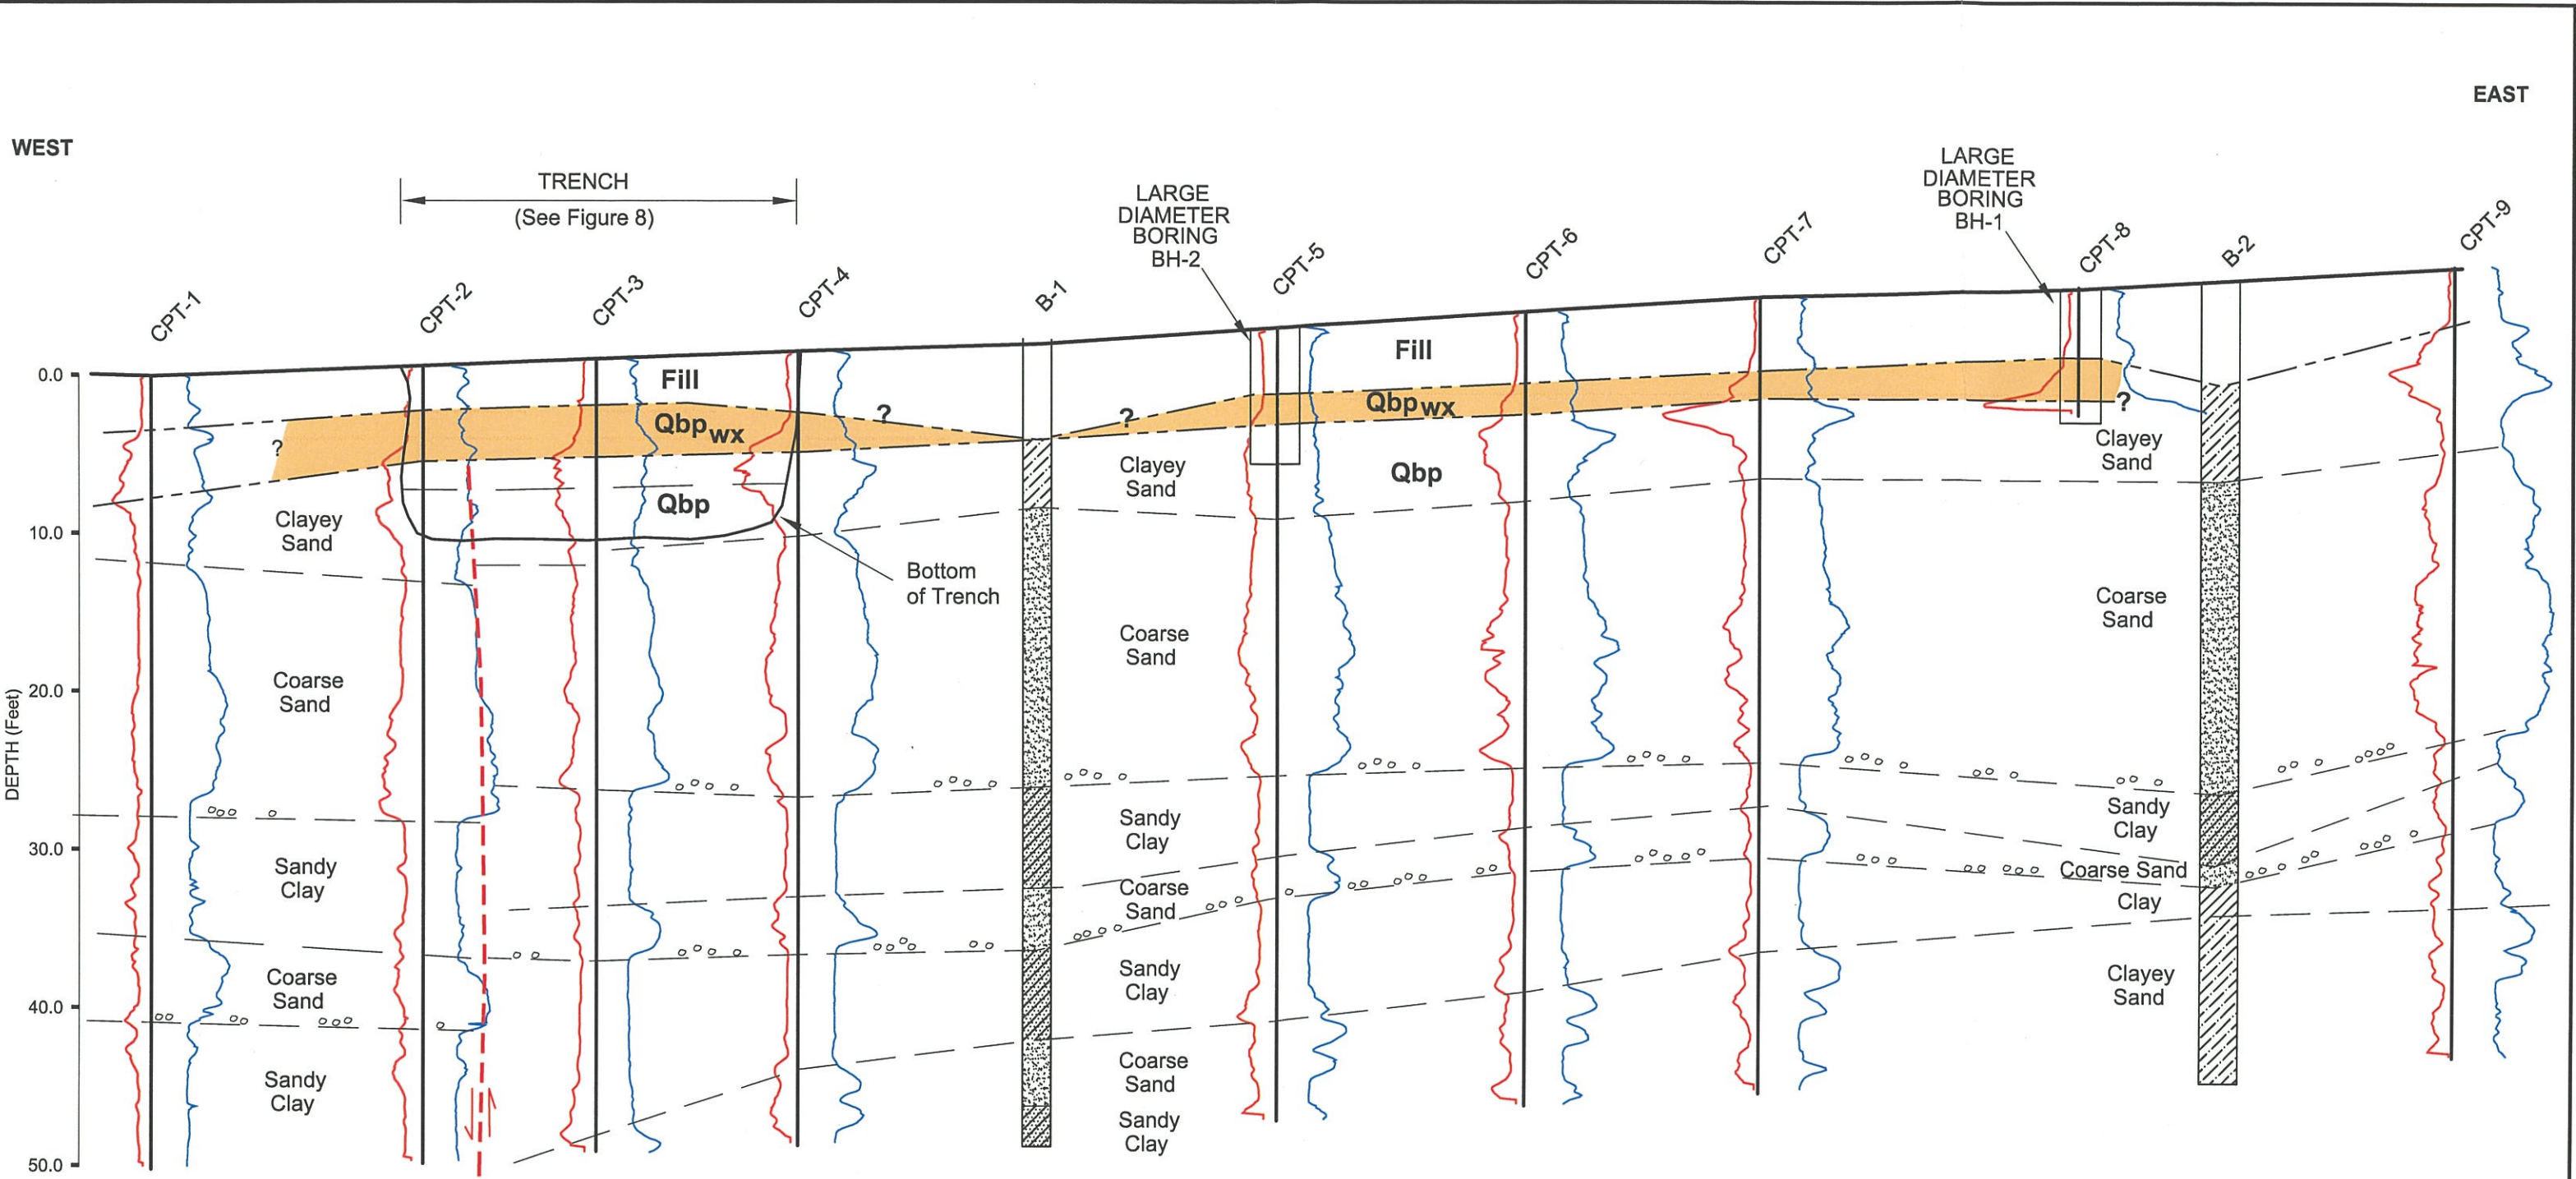
The two large diameter borings were advanced along West Cedar Street in order to visually correlate the geologic units observed in the sidewalk trench with the borings. We observed relatively similar near surface geologic units at relatively constant depths within the large diameter borings and the trench as shown on Figure 10. The occurrence of similar appearing geologic units at roughly consistent depths confirms the absence of faulting in the area between the trench and the large diameter borings.
