**UPDATE REPORT OF PRELIMINARY GEOTECHNICAL  
INVESTIGATION AND COASTAL BLUFF EDGE  
EVALUATION**

Lowenthal Residential Project  
1720 Torrey Pines Road  
La Jolla, California

**JOB NO. 01-8018**  
03 July 2024

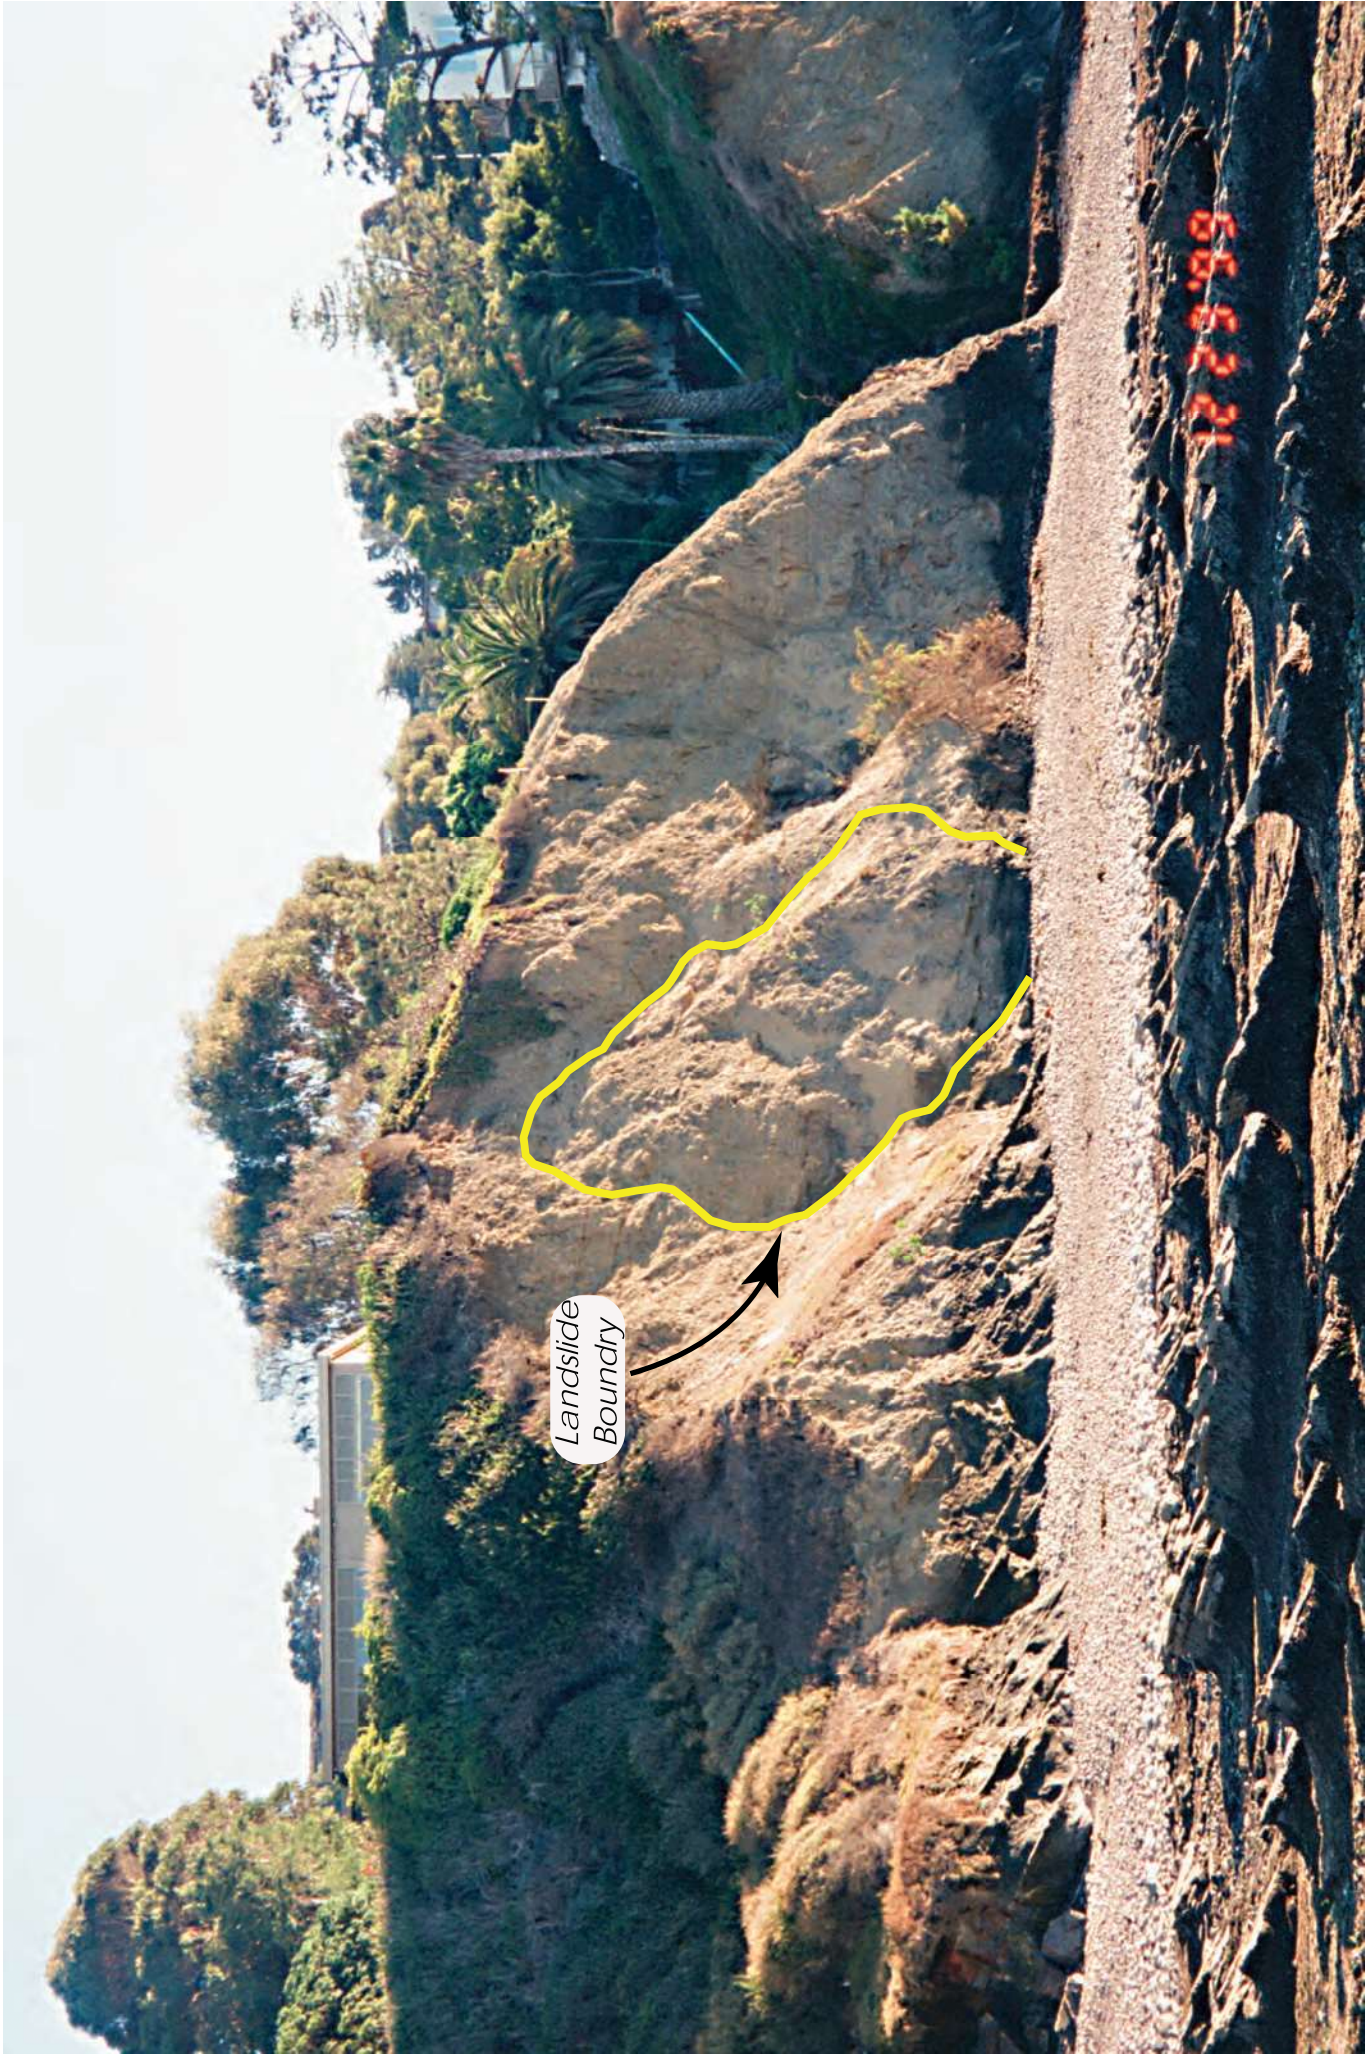
4

**Landslides:** Our site reconnaissance did not reveal indications of landsliding underlying the building pad or areas to receive structures and improvements. Based on our review of the *Geologic Map of San Diego, 30'x60' Quadrangle, CA* by Kennedy and Tan (2008), the *USGS US Landslide Inventory*, the City of San Diego Seismic Safety Study -- Geologic Hazards Map and aerial photographs (4-11-53, AXN-8M-88 and 89), there are no known or suspected large-scale ancient landslides located beneath the site. A small bluff face landslide is mapped on the adjacent property near the northwest corner of the subject property. The failure is limited to the bluff face as shown in Photo Nos. 3, 4, 5, and 6 of Appendix E.

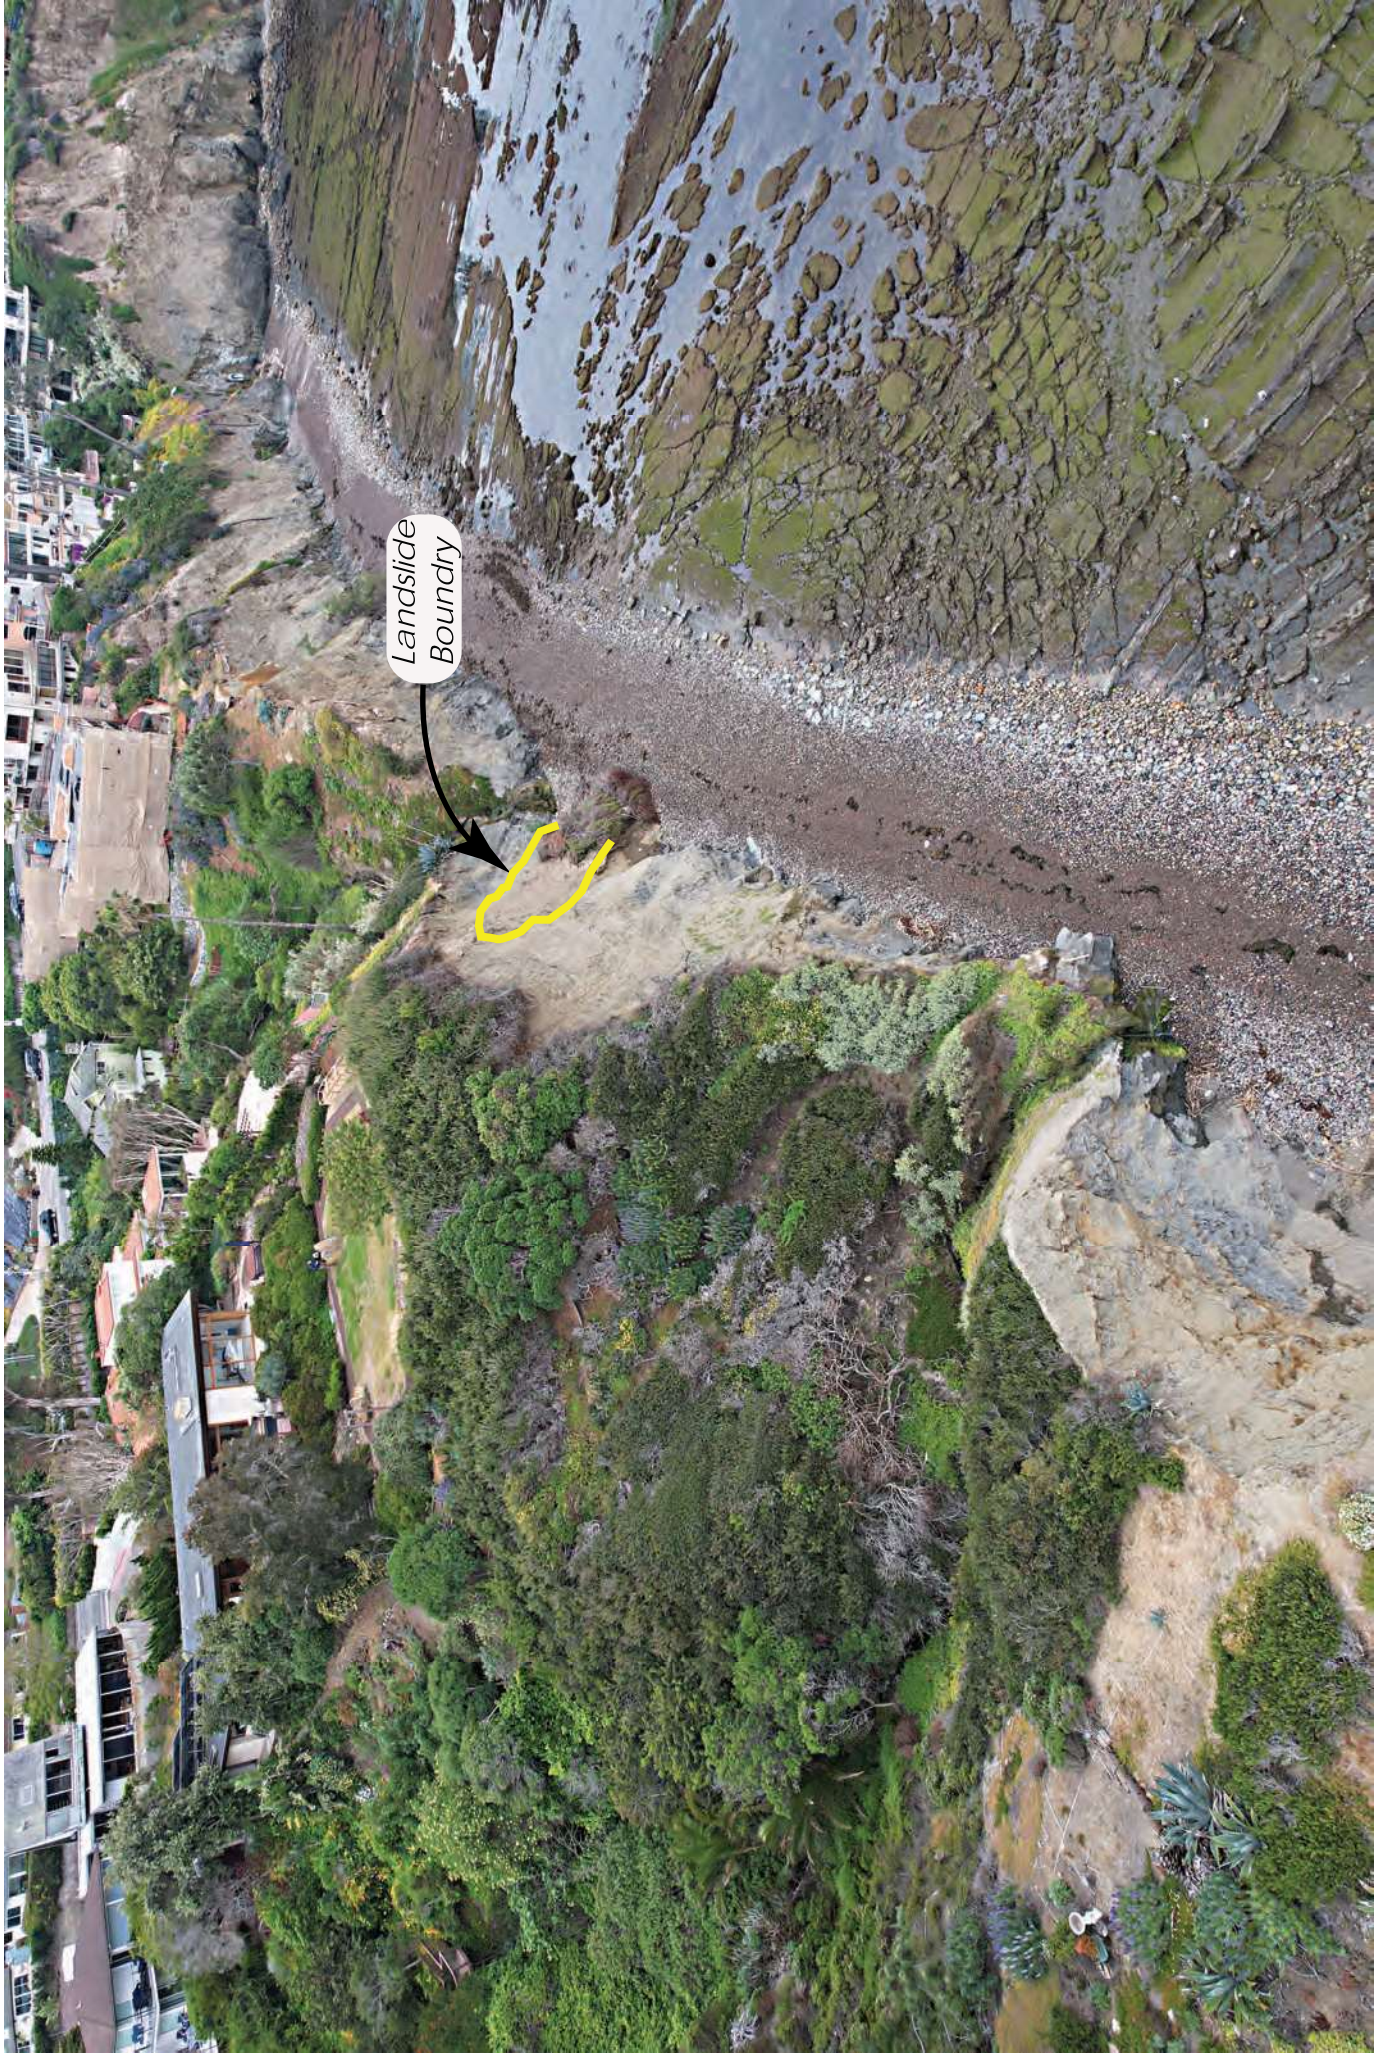
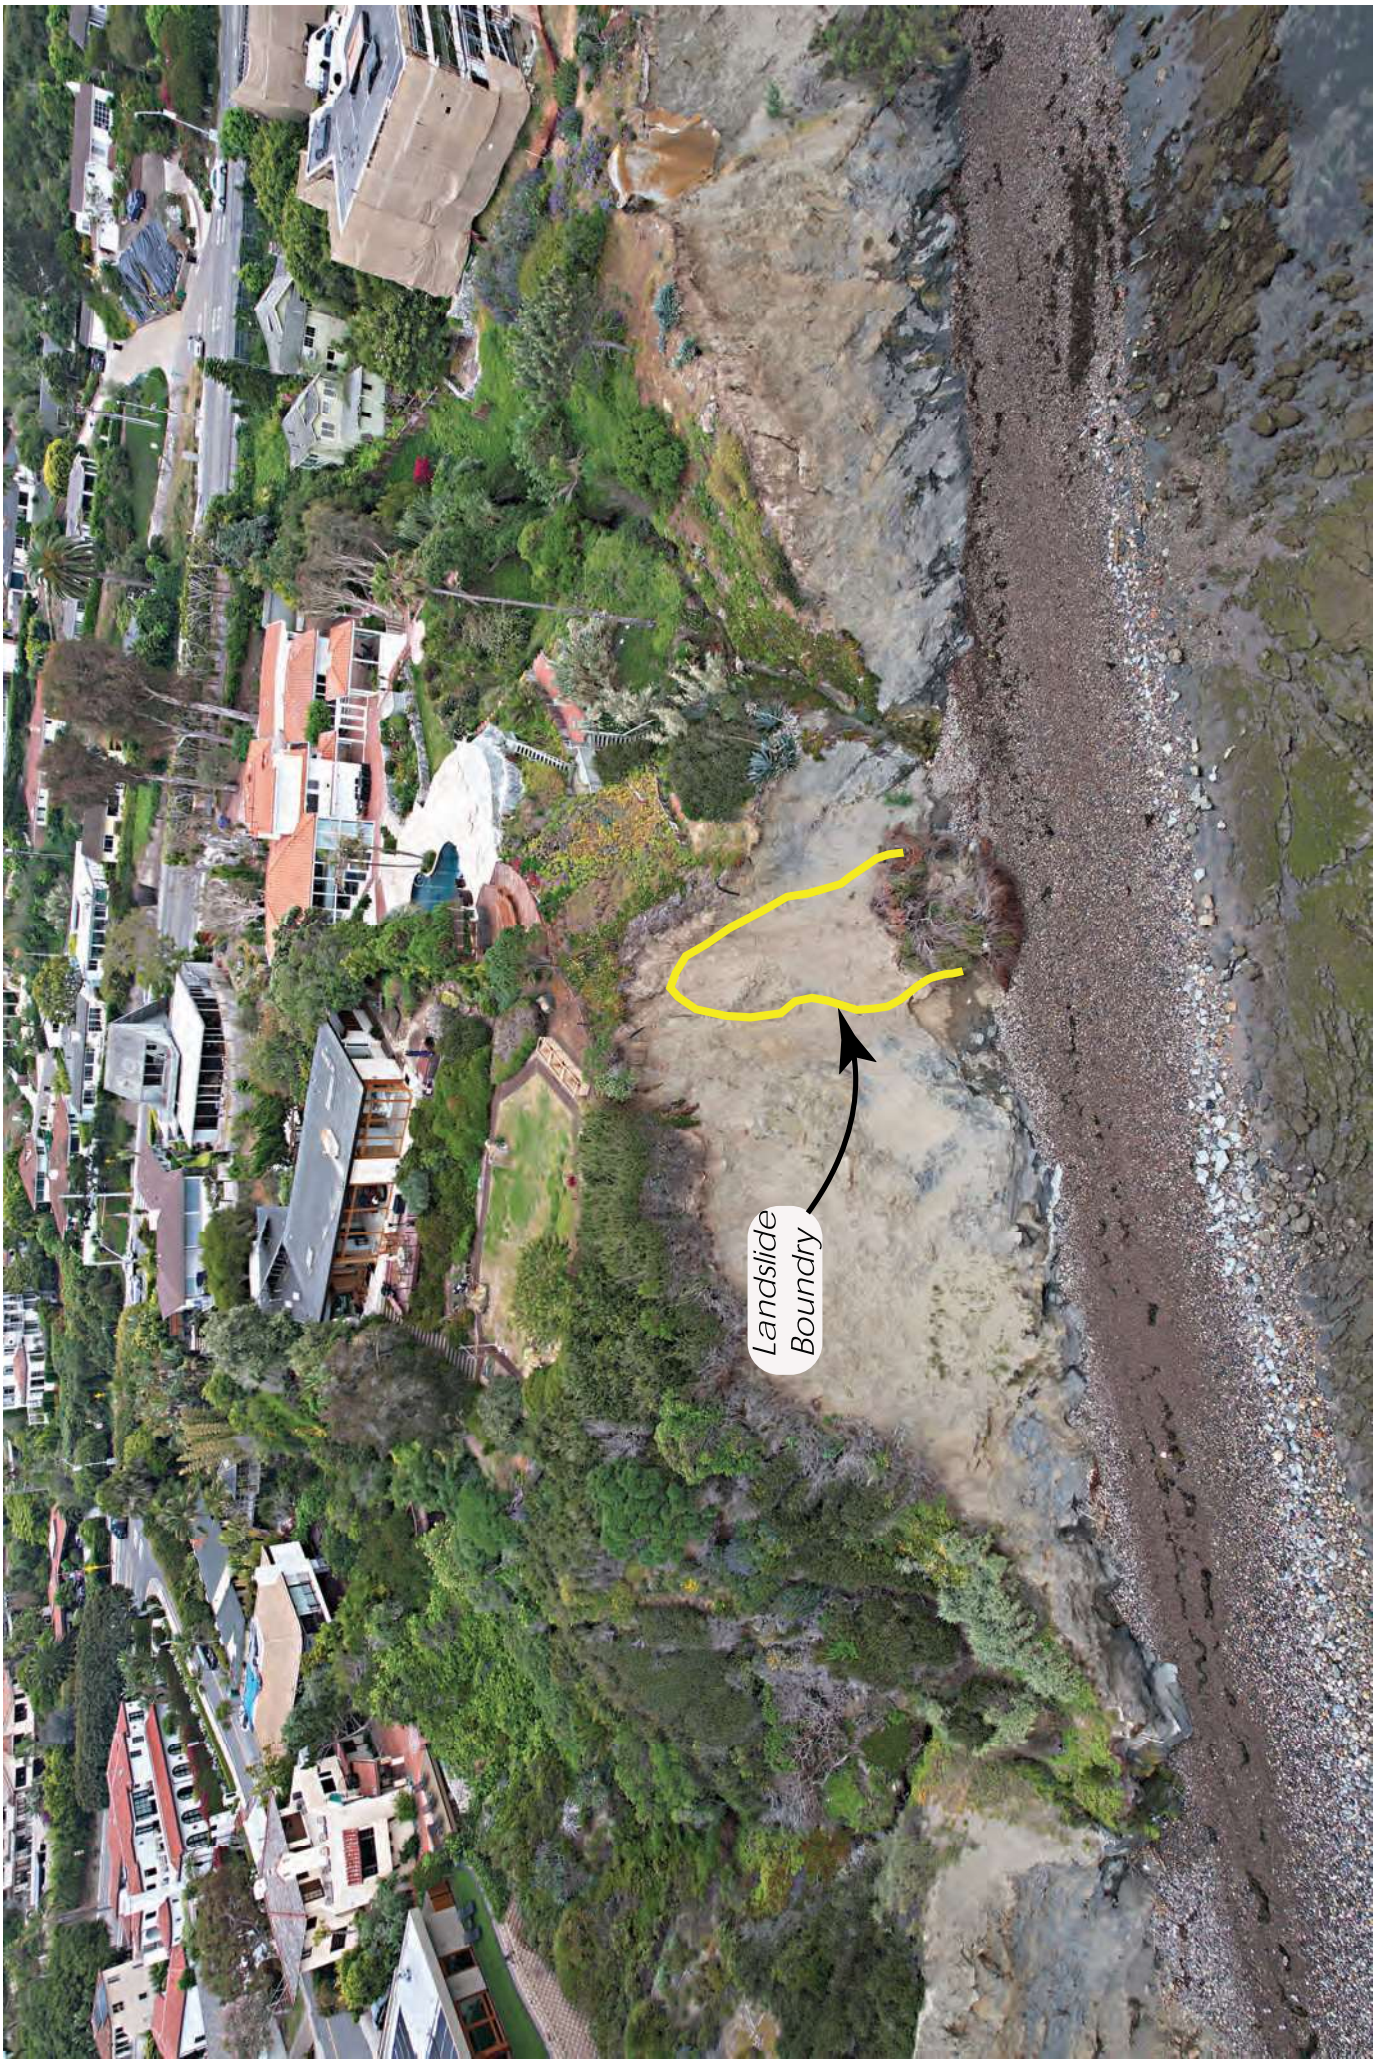
Landslide  
Boundary

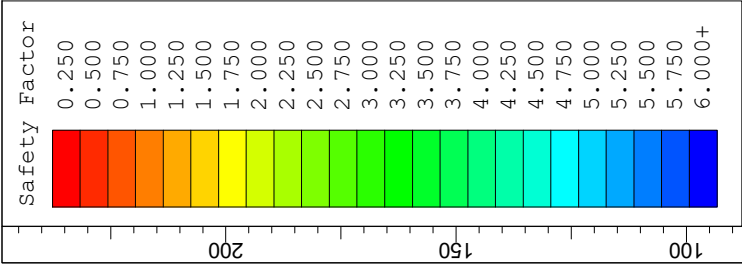
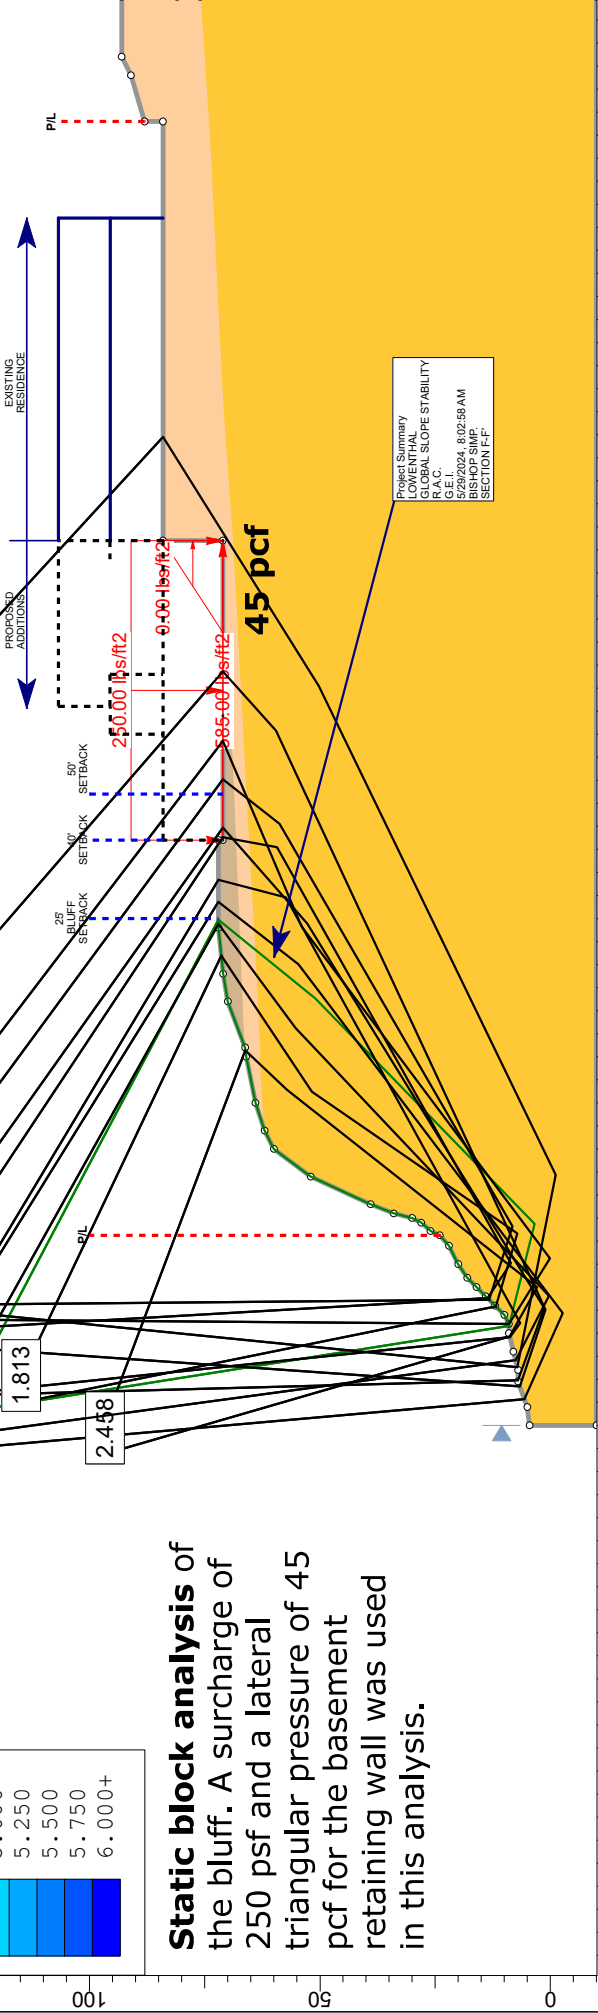
**Static block analysis** of the bluff. A surcharge of 250 psf and a lateral triangular pressure of 45 pcf for the basement retaining wall was used in this analysis.

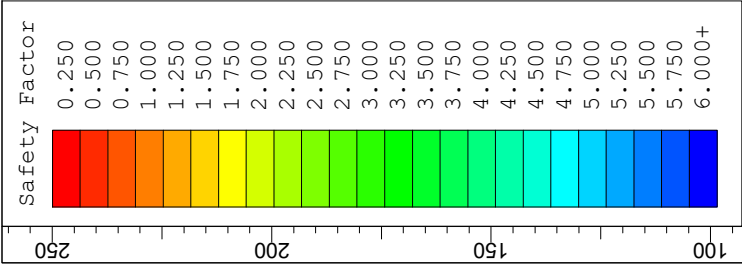
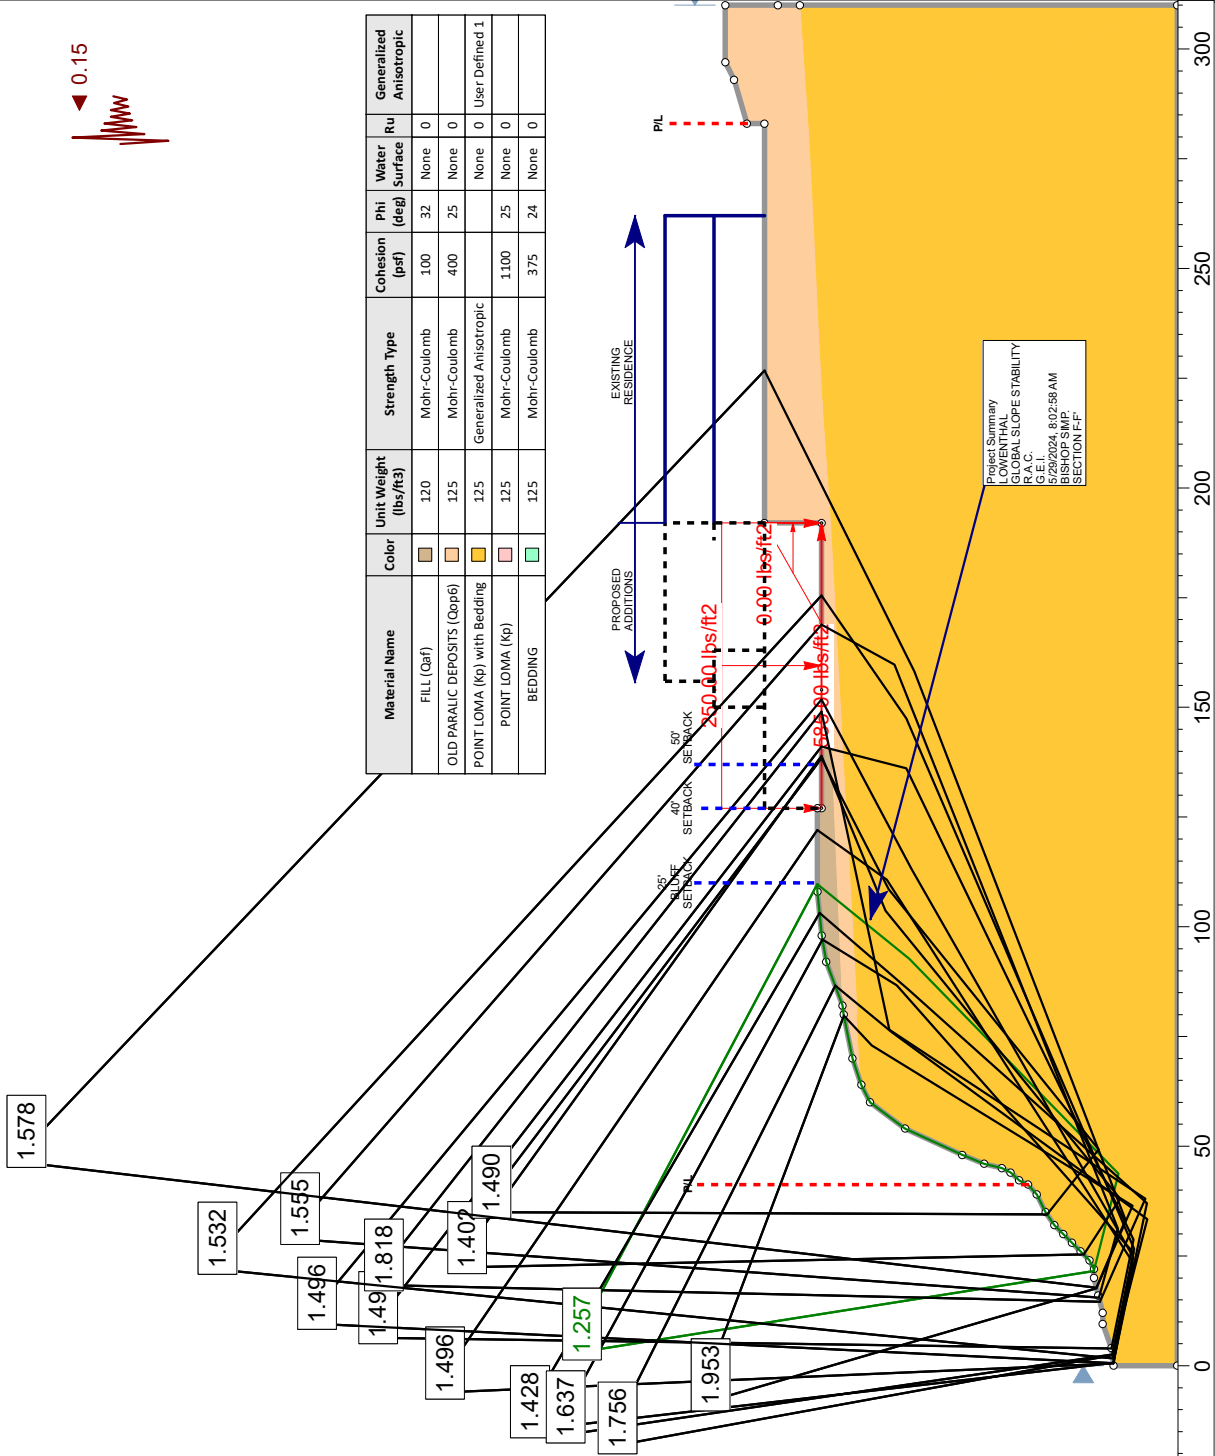
**Seismic block analysis** of the bluff. A surcharge of 250 psf and a lateral triangular pressure of 45 pcf for the basement retaining wall was used in this analysis.

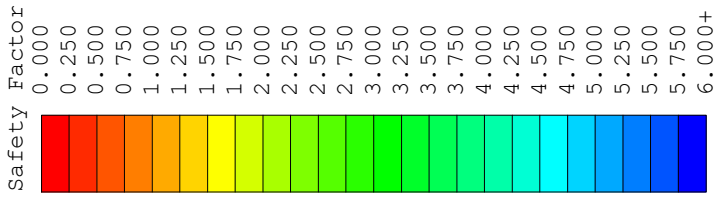
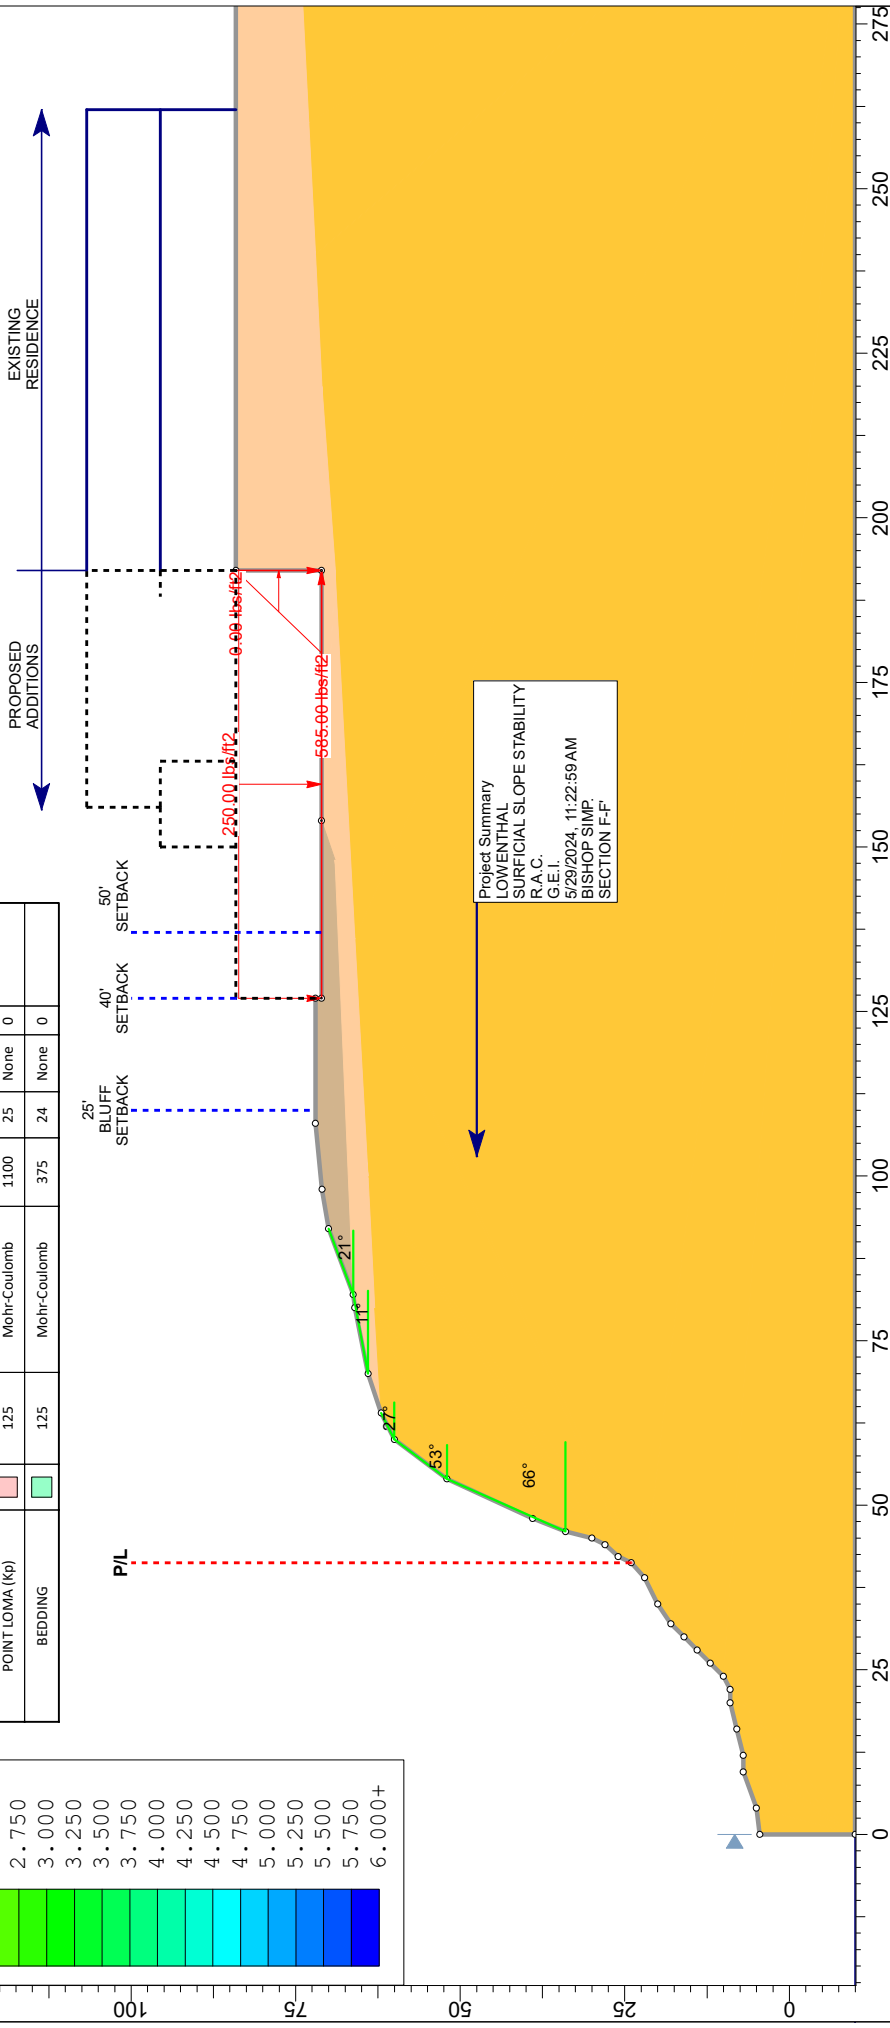
This section shows the analyzed slope inclinations ( $\alpha$ ) used for the surficial slope stability analysis. For the calculated factor of safety, refer to the following spreadsheet.

The Factor of Safety values are **ABOVE** 1.50 and are adequate.

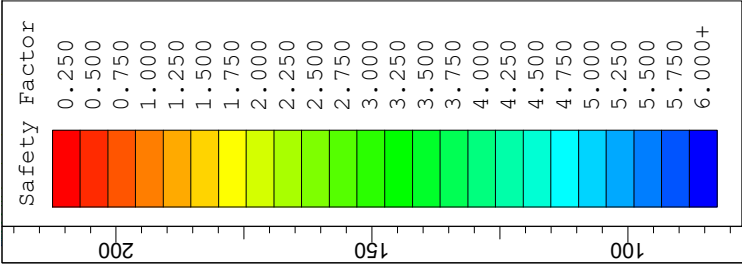
**Static circular analysis**  
of the bluff. A surcharge  
of 250 psf was used in  
this analysis.

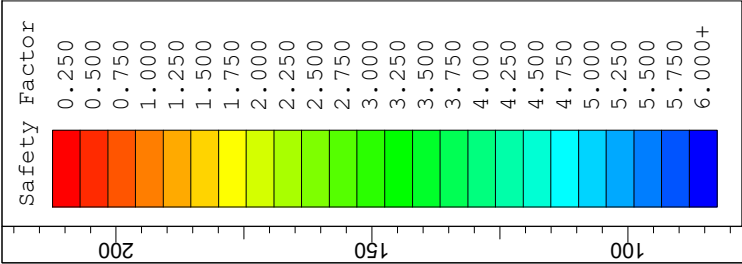
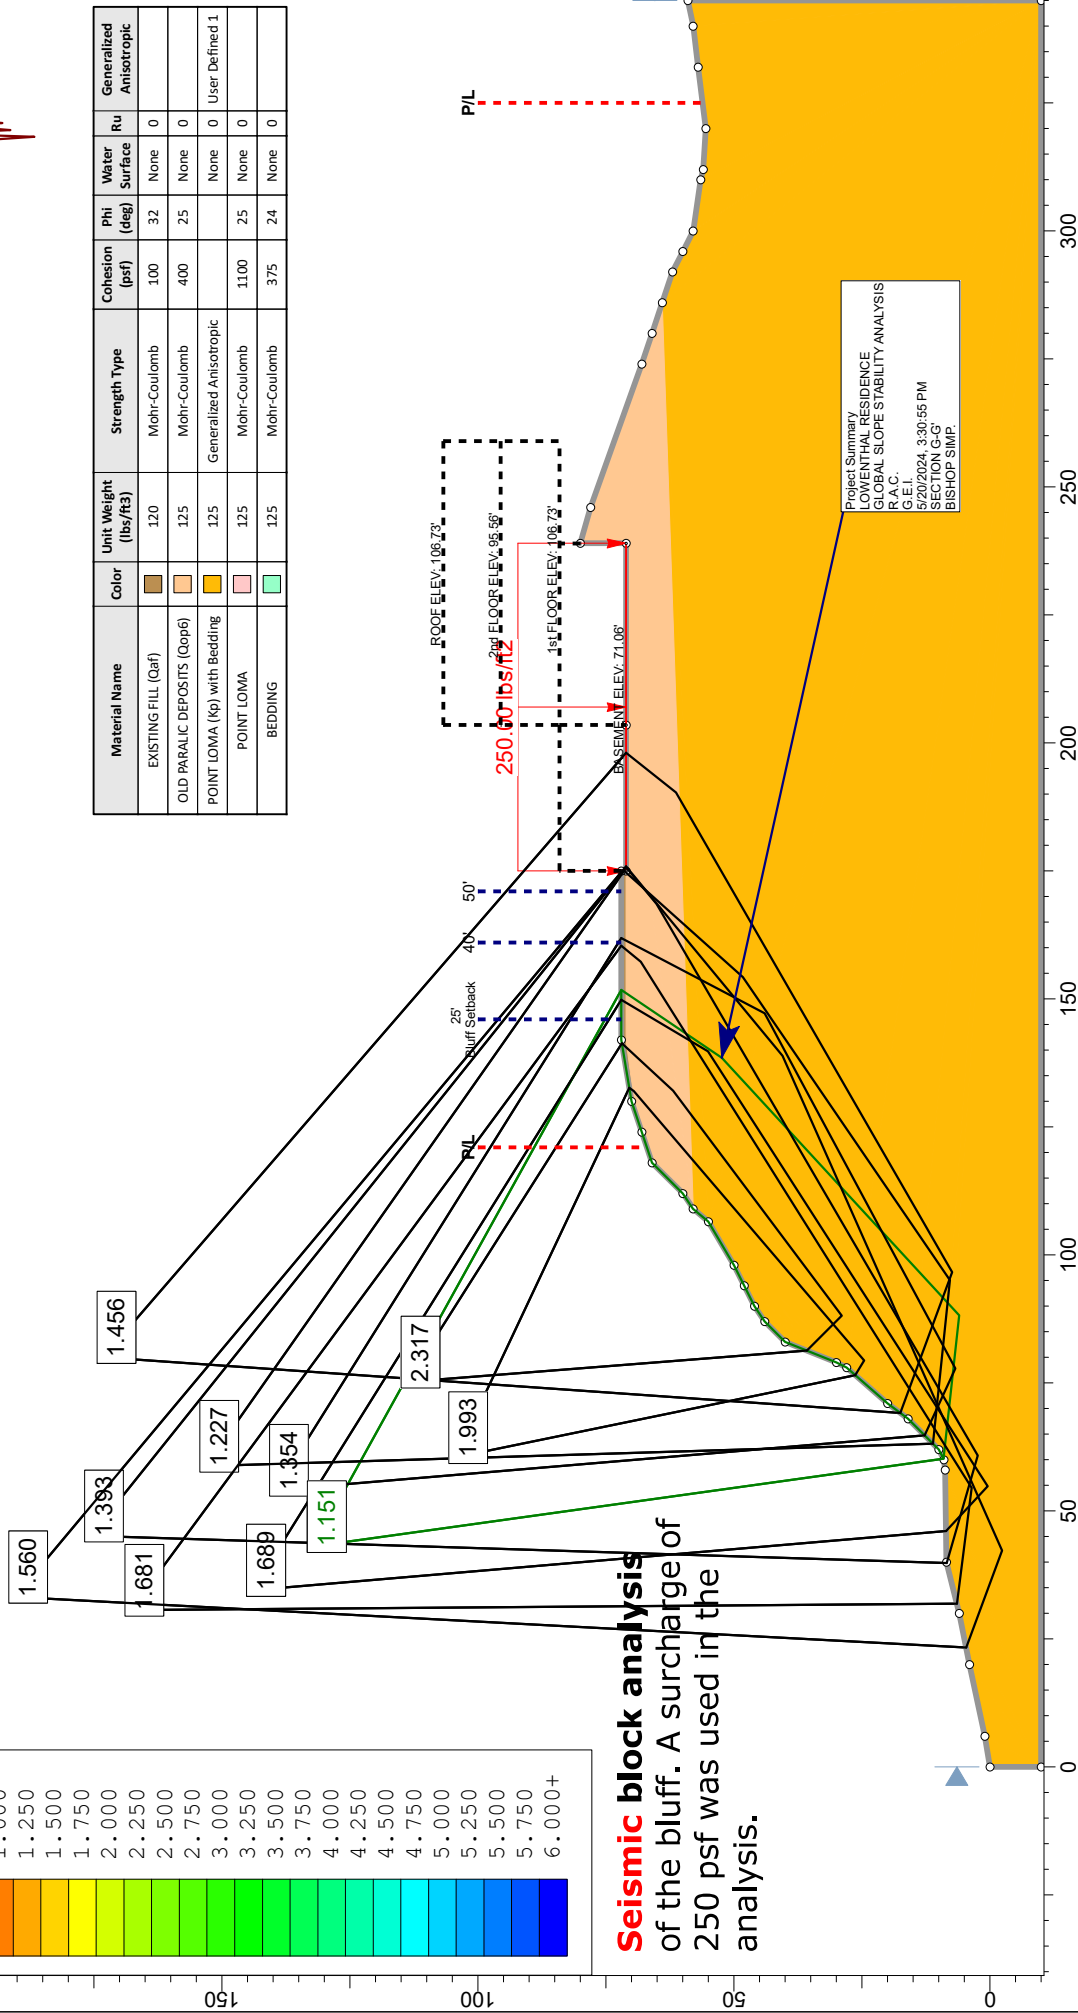
**Seismic block analysis** of the bluff. A surcharge of 250 psf was used in the analysis.
