**REPORT OF PRELIMINARY GEOTECHNICAL INVESTIGATION
AND COASTAL BLUFF EDGE EVALUATION**

Princess Street Coastal Trail
7957 Princess Street
La Jolla, California

JOB NO. 22-13797
28 September 2023

Environmental Center of San Diego

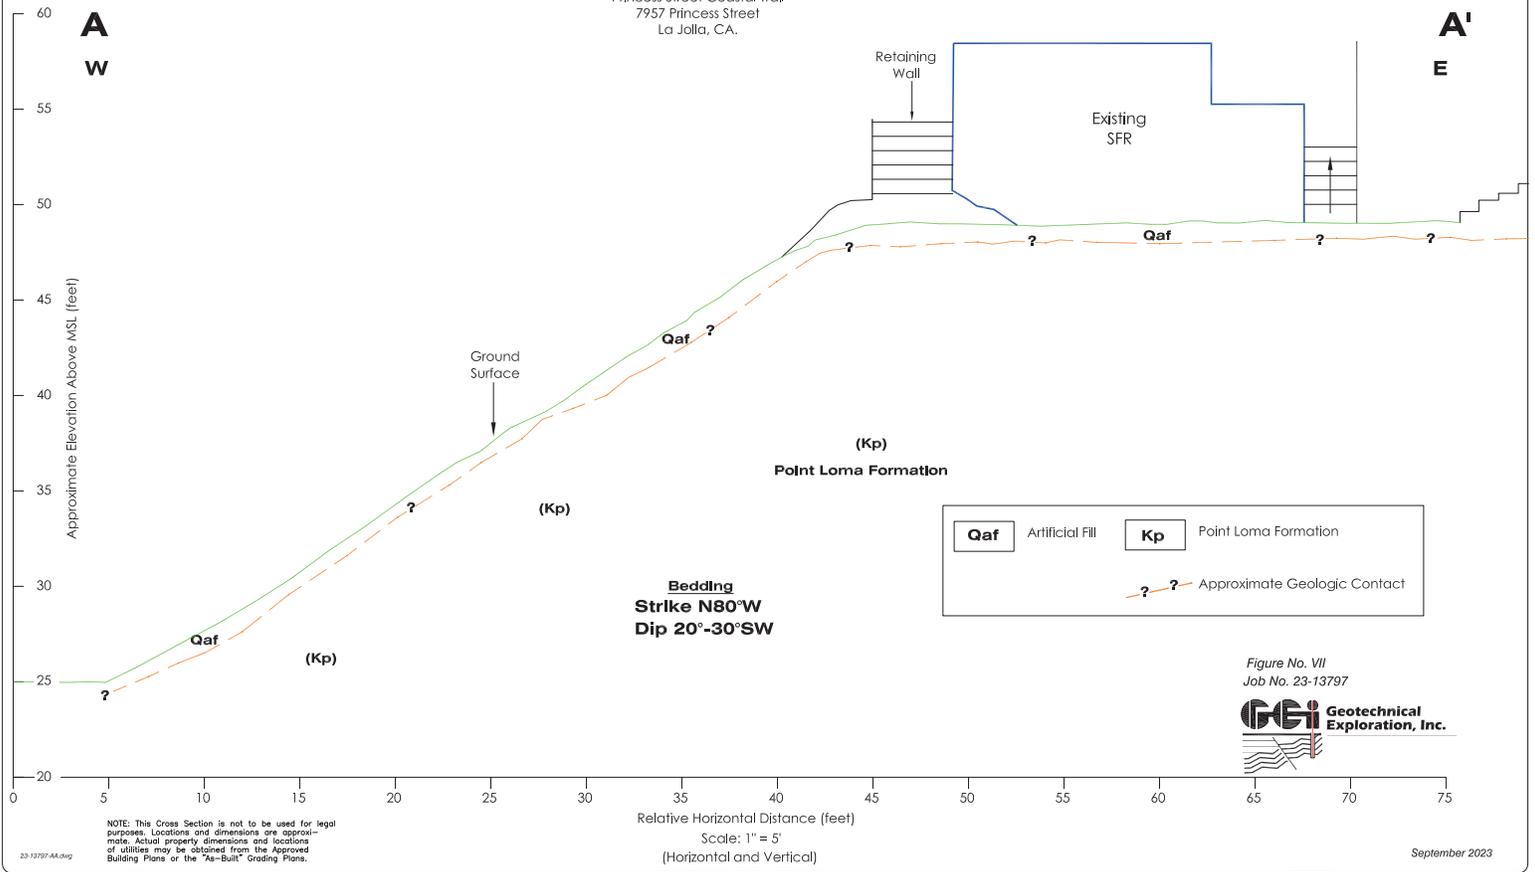
GEOLOGIC CROSS SECTION A-A'

Figure No. V presents an excerpt of the Kennedy and Tan, 2008, geologic map of the general area of the site and Figure No. VI is an excerpt of the geologic hazards map of the area. Geologic cross section A-A' (from the base of the existing concrete stairs to the bottom of the easement) is included as Figure No. VII.

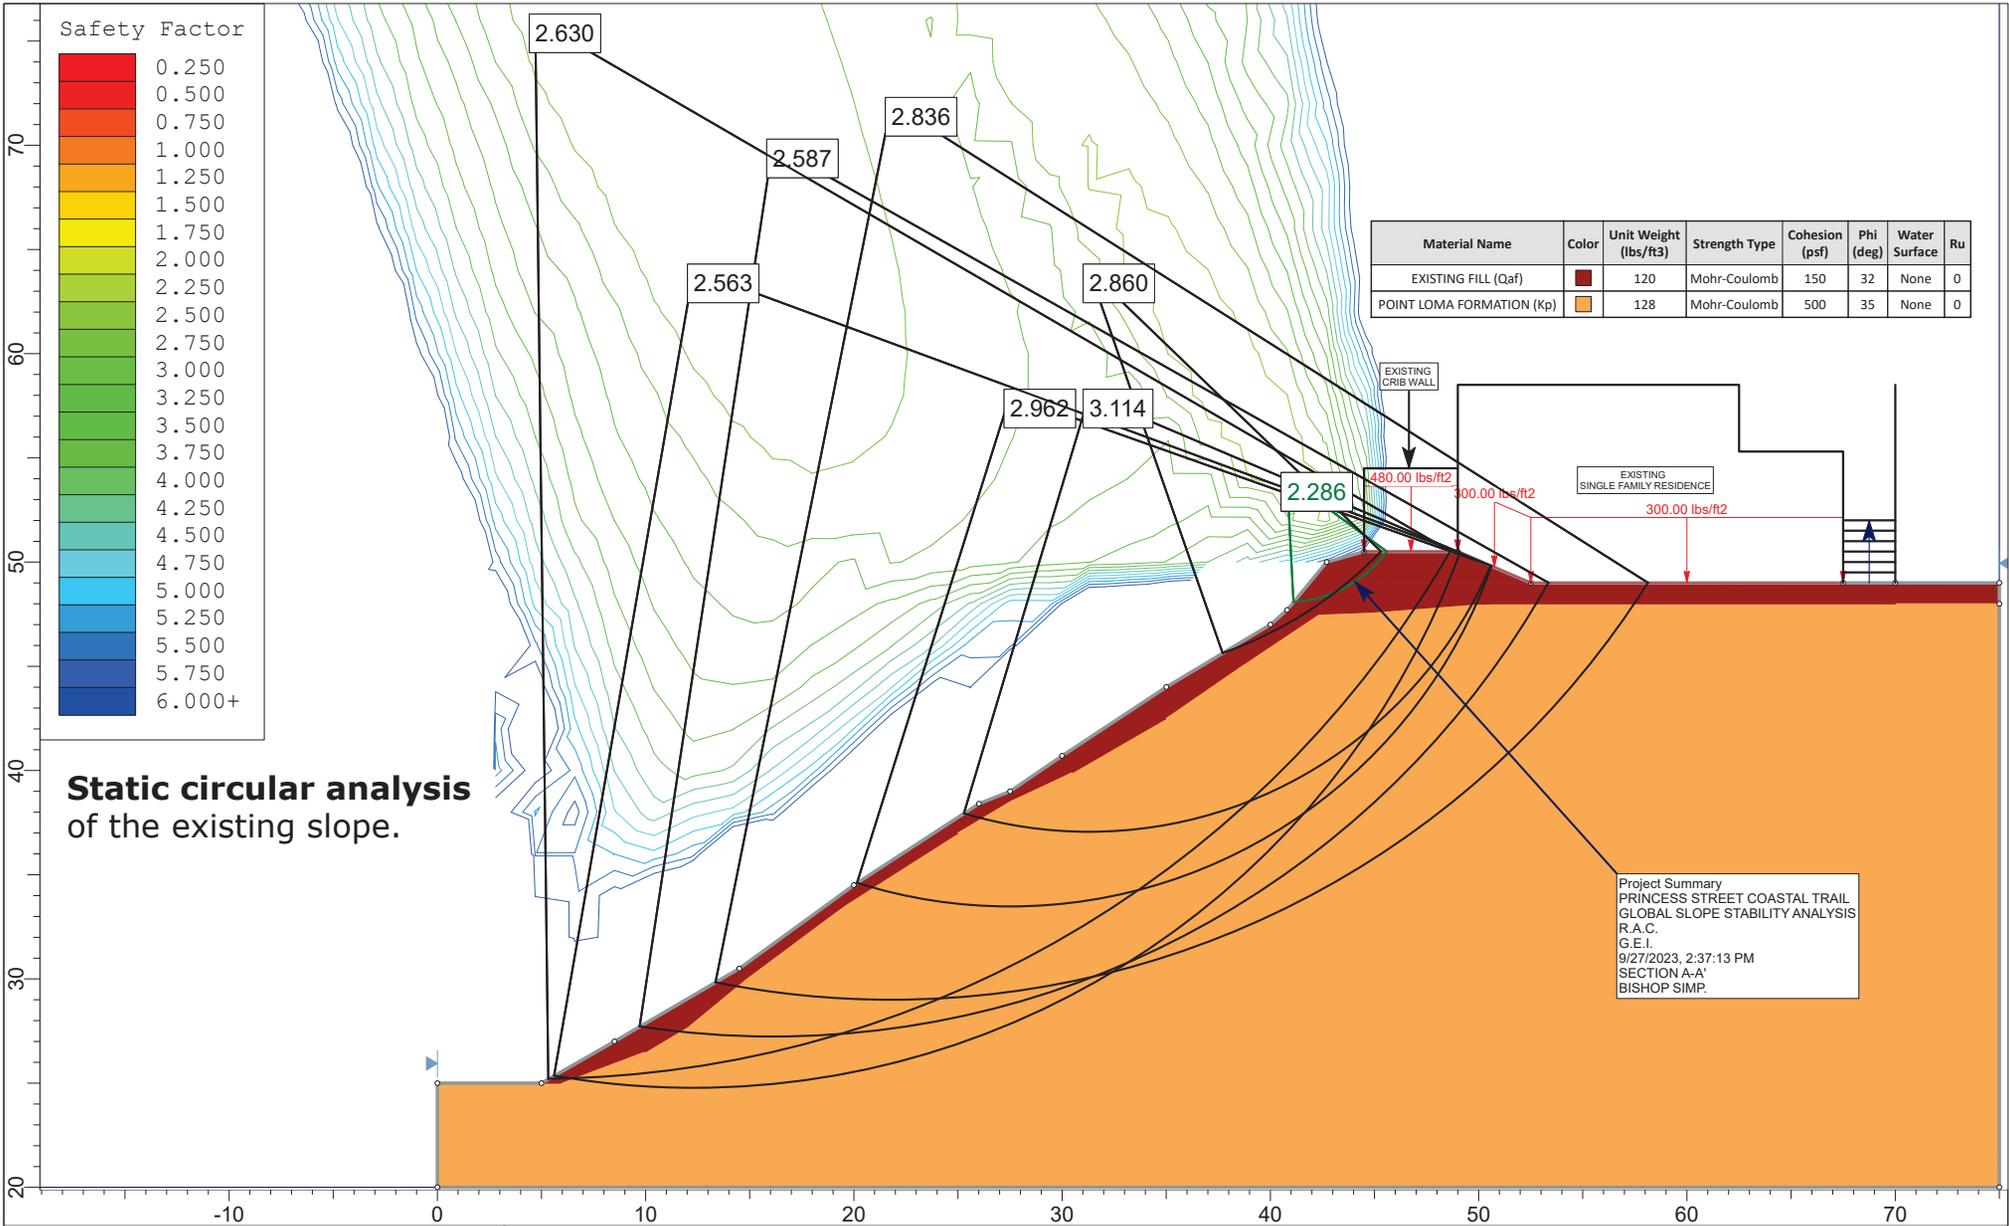
For remediation of the fill wedge slope located in front of the existing crib wall, the soil should be removed and recompactd using an A-B-C slot cut method as not to undermine the existing crib wall. Once recompactd, the surficial slope stability will have a factor of safety greater than 1.50.

Static circular analysis of the existing slope.

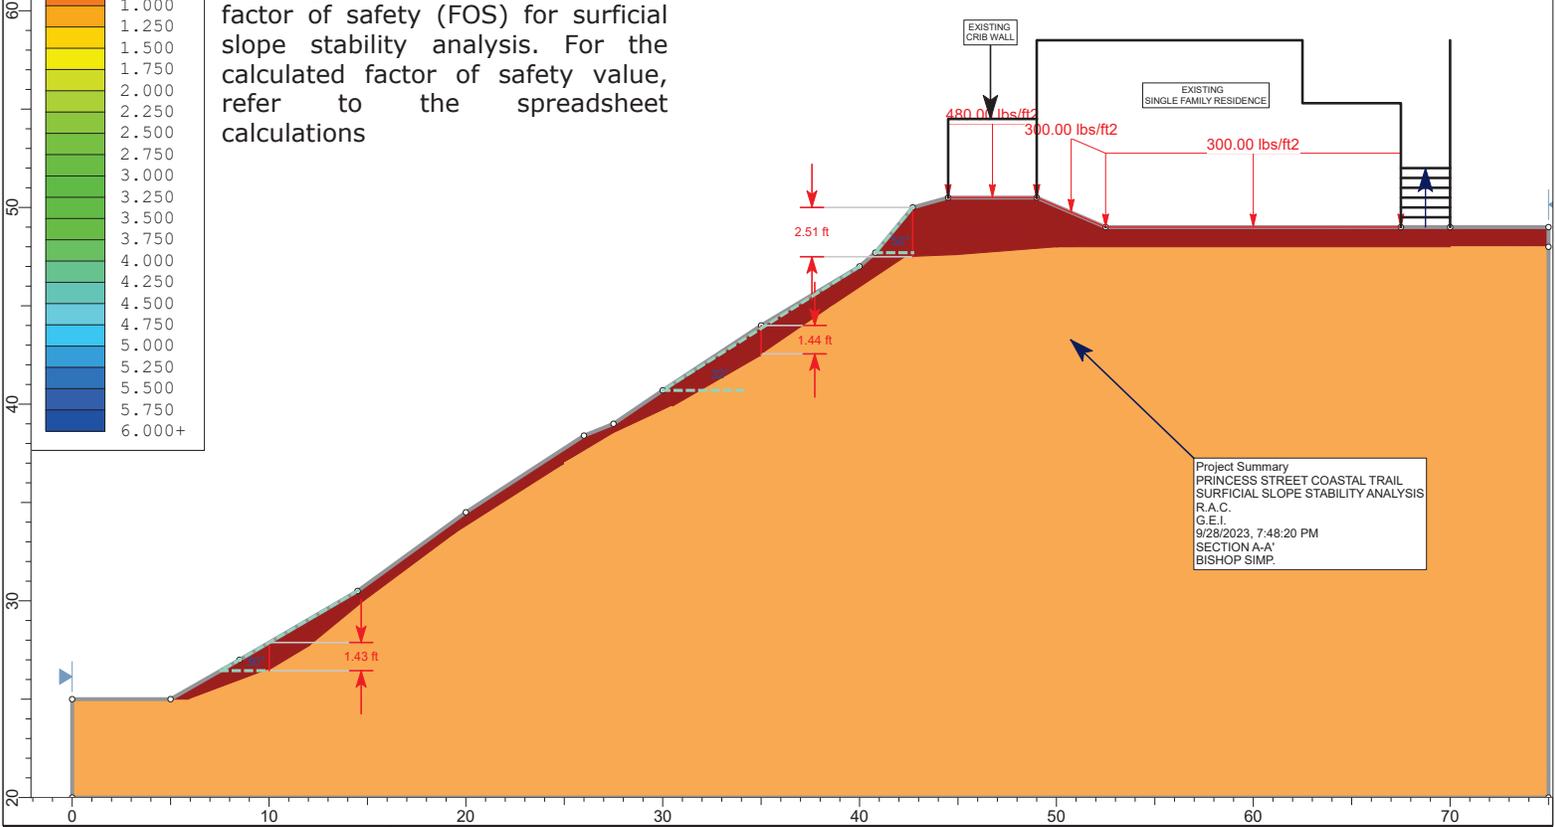
This section shows the analyzed fill thickness and the inclination angle (α) used to determine the factor of safety (FOS) for surficial slope stability analysis. For the calculated factor of safety value, refer to the spreadsheet calculations

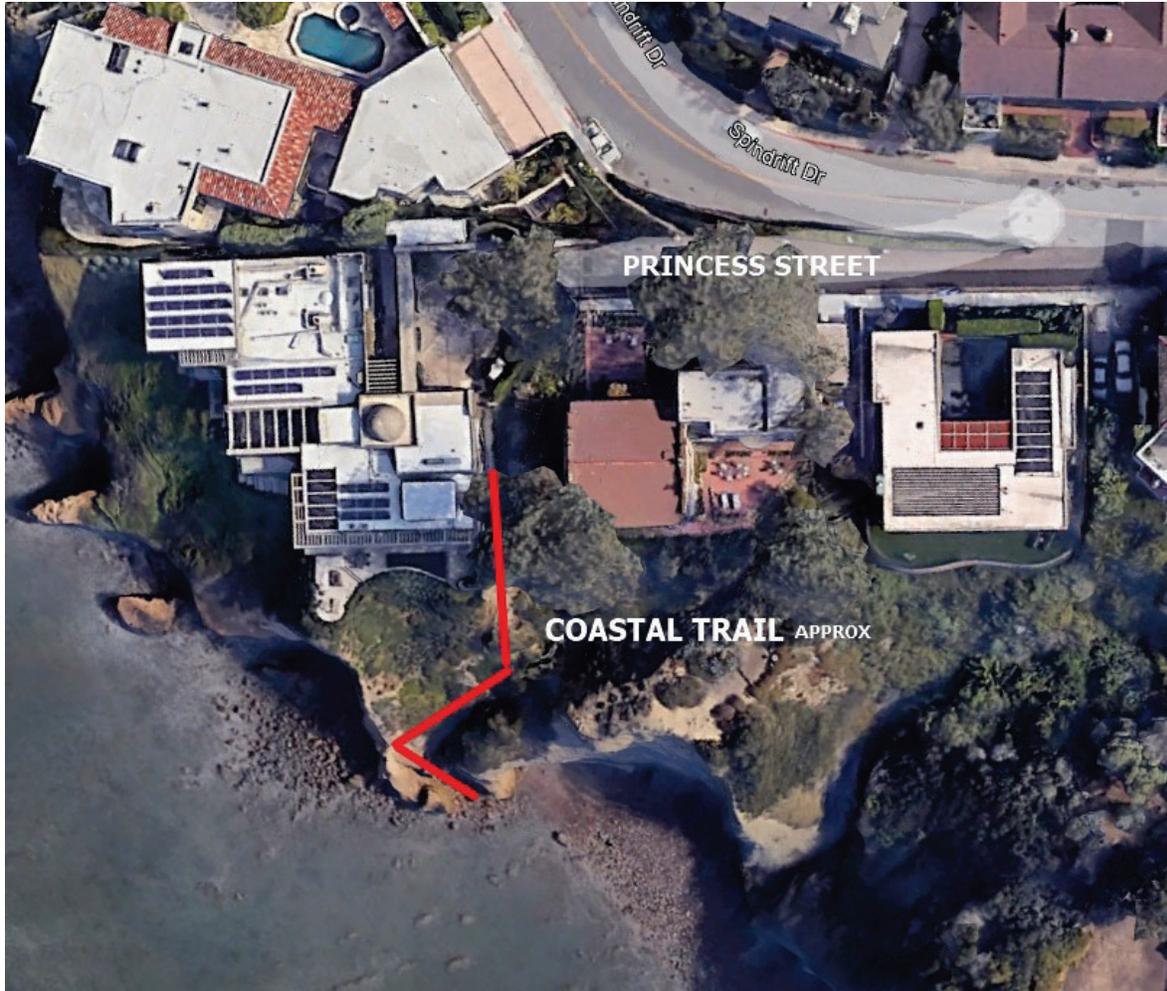
bluff top erosion. The site is in a unique area of bluff/shoreline that is fronted by a broad shore platform and significantly protected by waves from the submarine canyon just offshore. Figure 1 is an aerial photograph of the site taken in 2021 downloaded from the Google Earth. The figure shows the approximate trail location in relation to Princess Street, the bluff, and the shoreline.

Figure 1. Subject trail location, bluff, and shoreline in 2022.

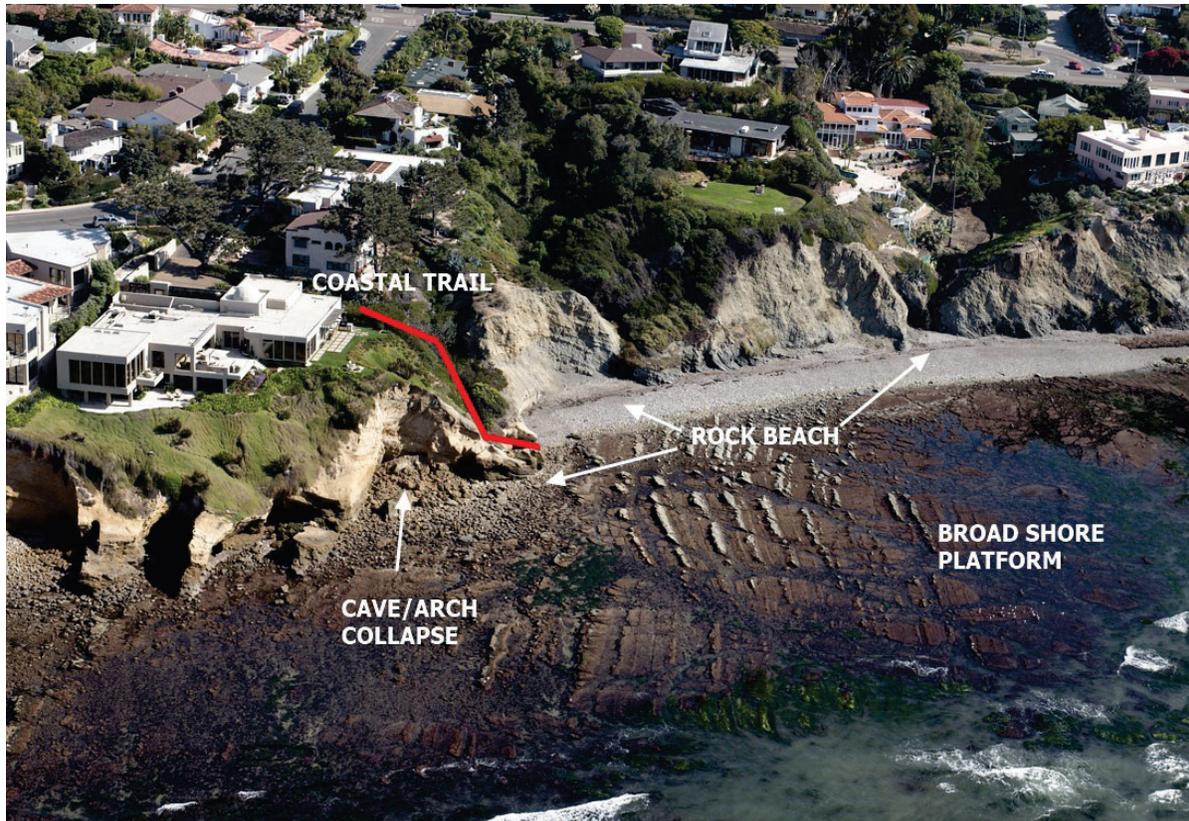
The site is close to an approximate 90 turn in the shoreline to the west . The bedrock below the site is jointed, which over time results in the formation of sea caves and arches. Figure 2 shows the very broad shore platform which significantly limits the size of the wave that reaches near the shoreline. Ocean swell is refracted by the submarine canyon away from this section of shoreline, focusing the waves to Point La Jolla and La Jolla Shores. Figure 2 also shows the irregular bluff toe and bluff face in this area along with a recently failed portion of a cave or arch near the access site.

Figure 2. Site photograph showing the coastal bluff, rock beach, and broad shore platform.

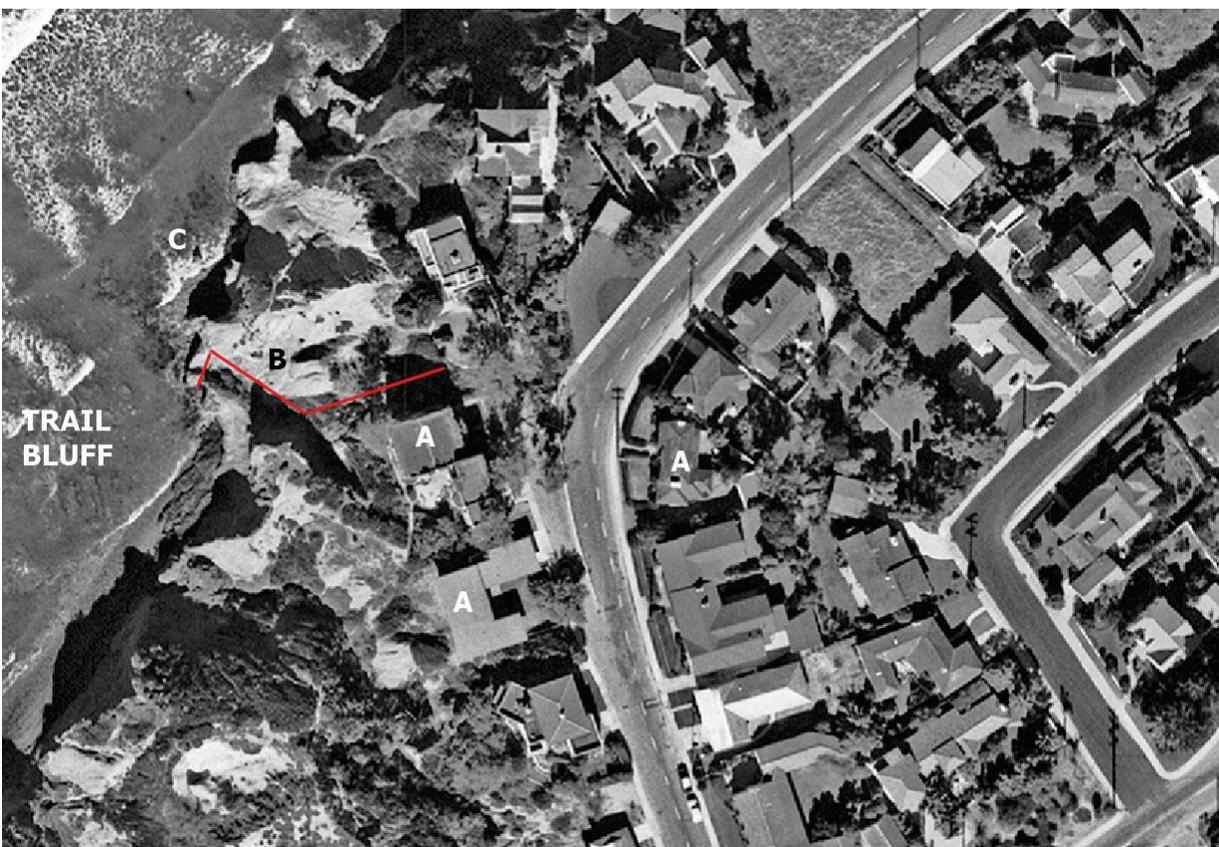
Figure 3. Princess St. Coastal Trail area in November 1952 for comparison to Figure 4.

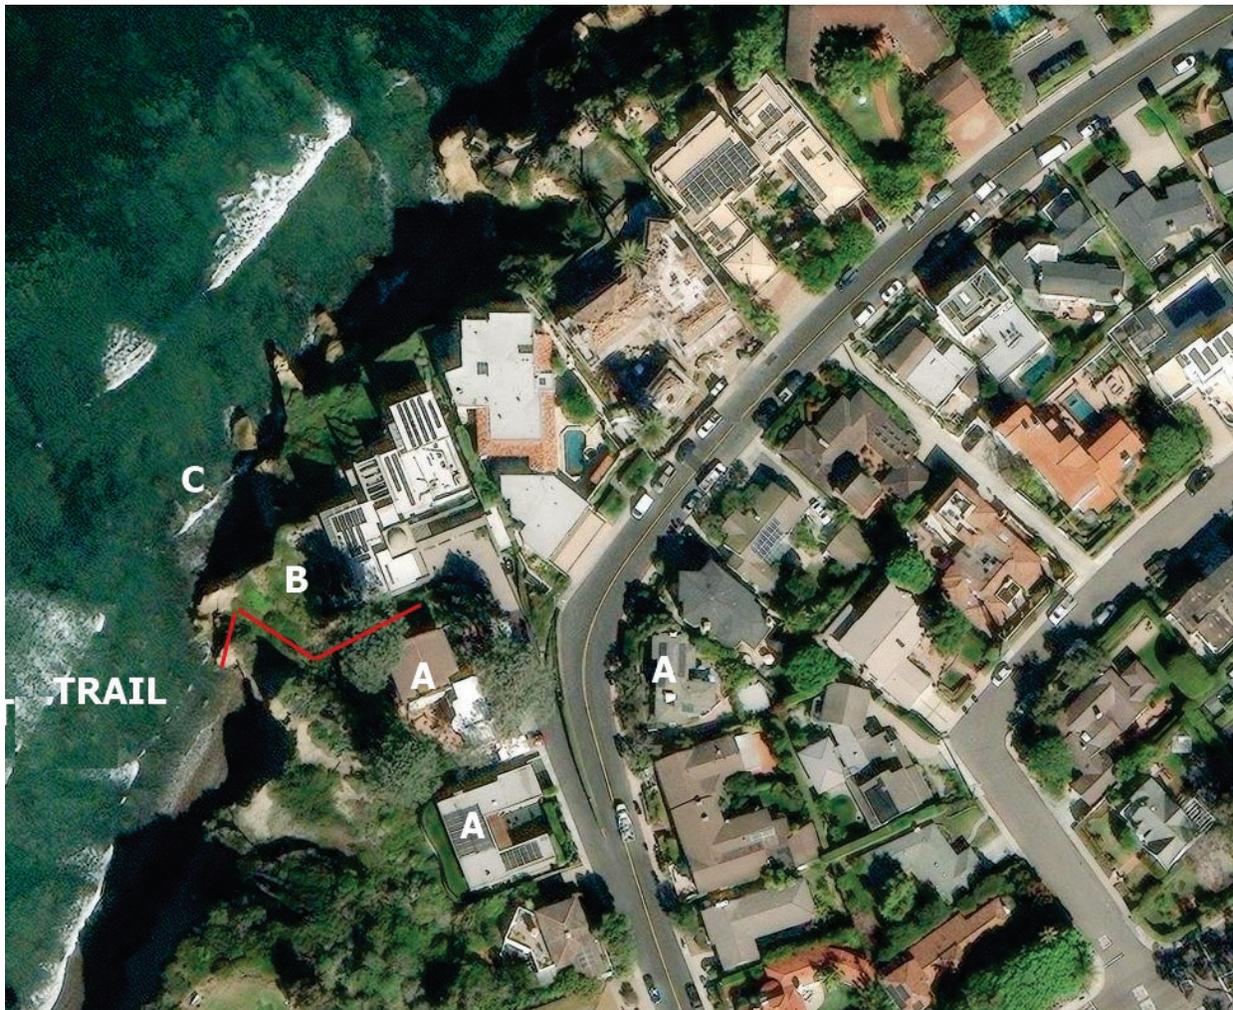
The bluff and shoreline in front of the site have been observed on several occasions in the past five decades during regular visits to La Jolla. Sea cave or arch collapse occurs sporadically but typically these are very local failures do not extend up to the top of the bluff. One of the best ways to estimate shoreline and bluff erosion is by comparing historical aerial photographs. Figure 3 is a vertical aerial photograph of the trail site taken in 1952 downloaded with permission from the University of Santa Barbara Aerial Photograph website (Flight C 18080, Frame 4-25). Figure 4 is a 2021 vertical aerial photograph of the same area as Figure 3. These images can be used to compare changes in the bluff face and shoreline position over the 69 year period between the time the photographs were taken. Because the public streets and some of the individual houses have not moved measurements of the images can be scaled and the distance from the shoreline or bluff to street centerline or other objects can be compared. The areas denoted with an "A" are homes, along with the public street, that have not moved between the 1952 and 2021 images. The area denoted "B" is the actual bluff that the trail is on. This bluff is at an angle of almost 90 degrees to the shoreline and not significantly impacted by marine erosion. The area denoted "C" is the portion of the bluff near the trail that has changed as a result of marine erosion (cave and arch collapse along weak joints in the bedrock). The approximate location of the bluff trail is shown in red in the figures.

Figure 4. Princess St. Coastal Trail area in November 2021 for comparison to Figure 3.
