October 7, 2025

Reference: Tree Survey Letter Report for the Junípero Serra Museum Americans with Disabilities Act (ADA) Improvements Project (WBS# S-15034.02.02; RECON Number 9087-1)

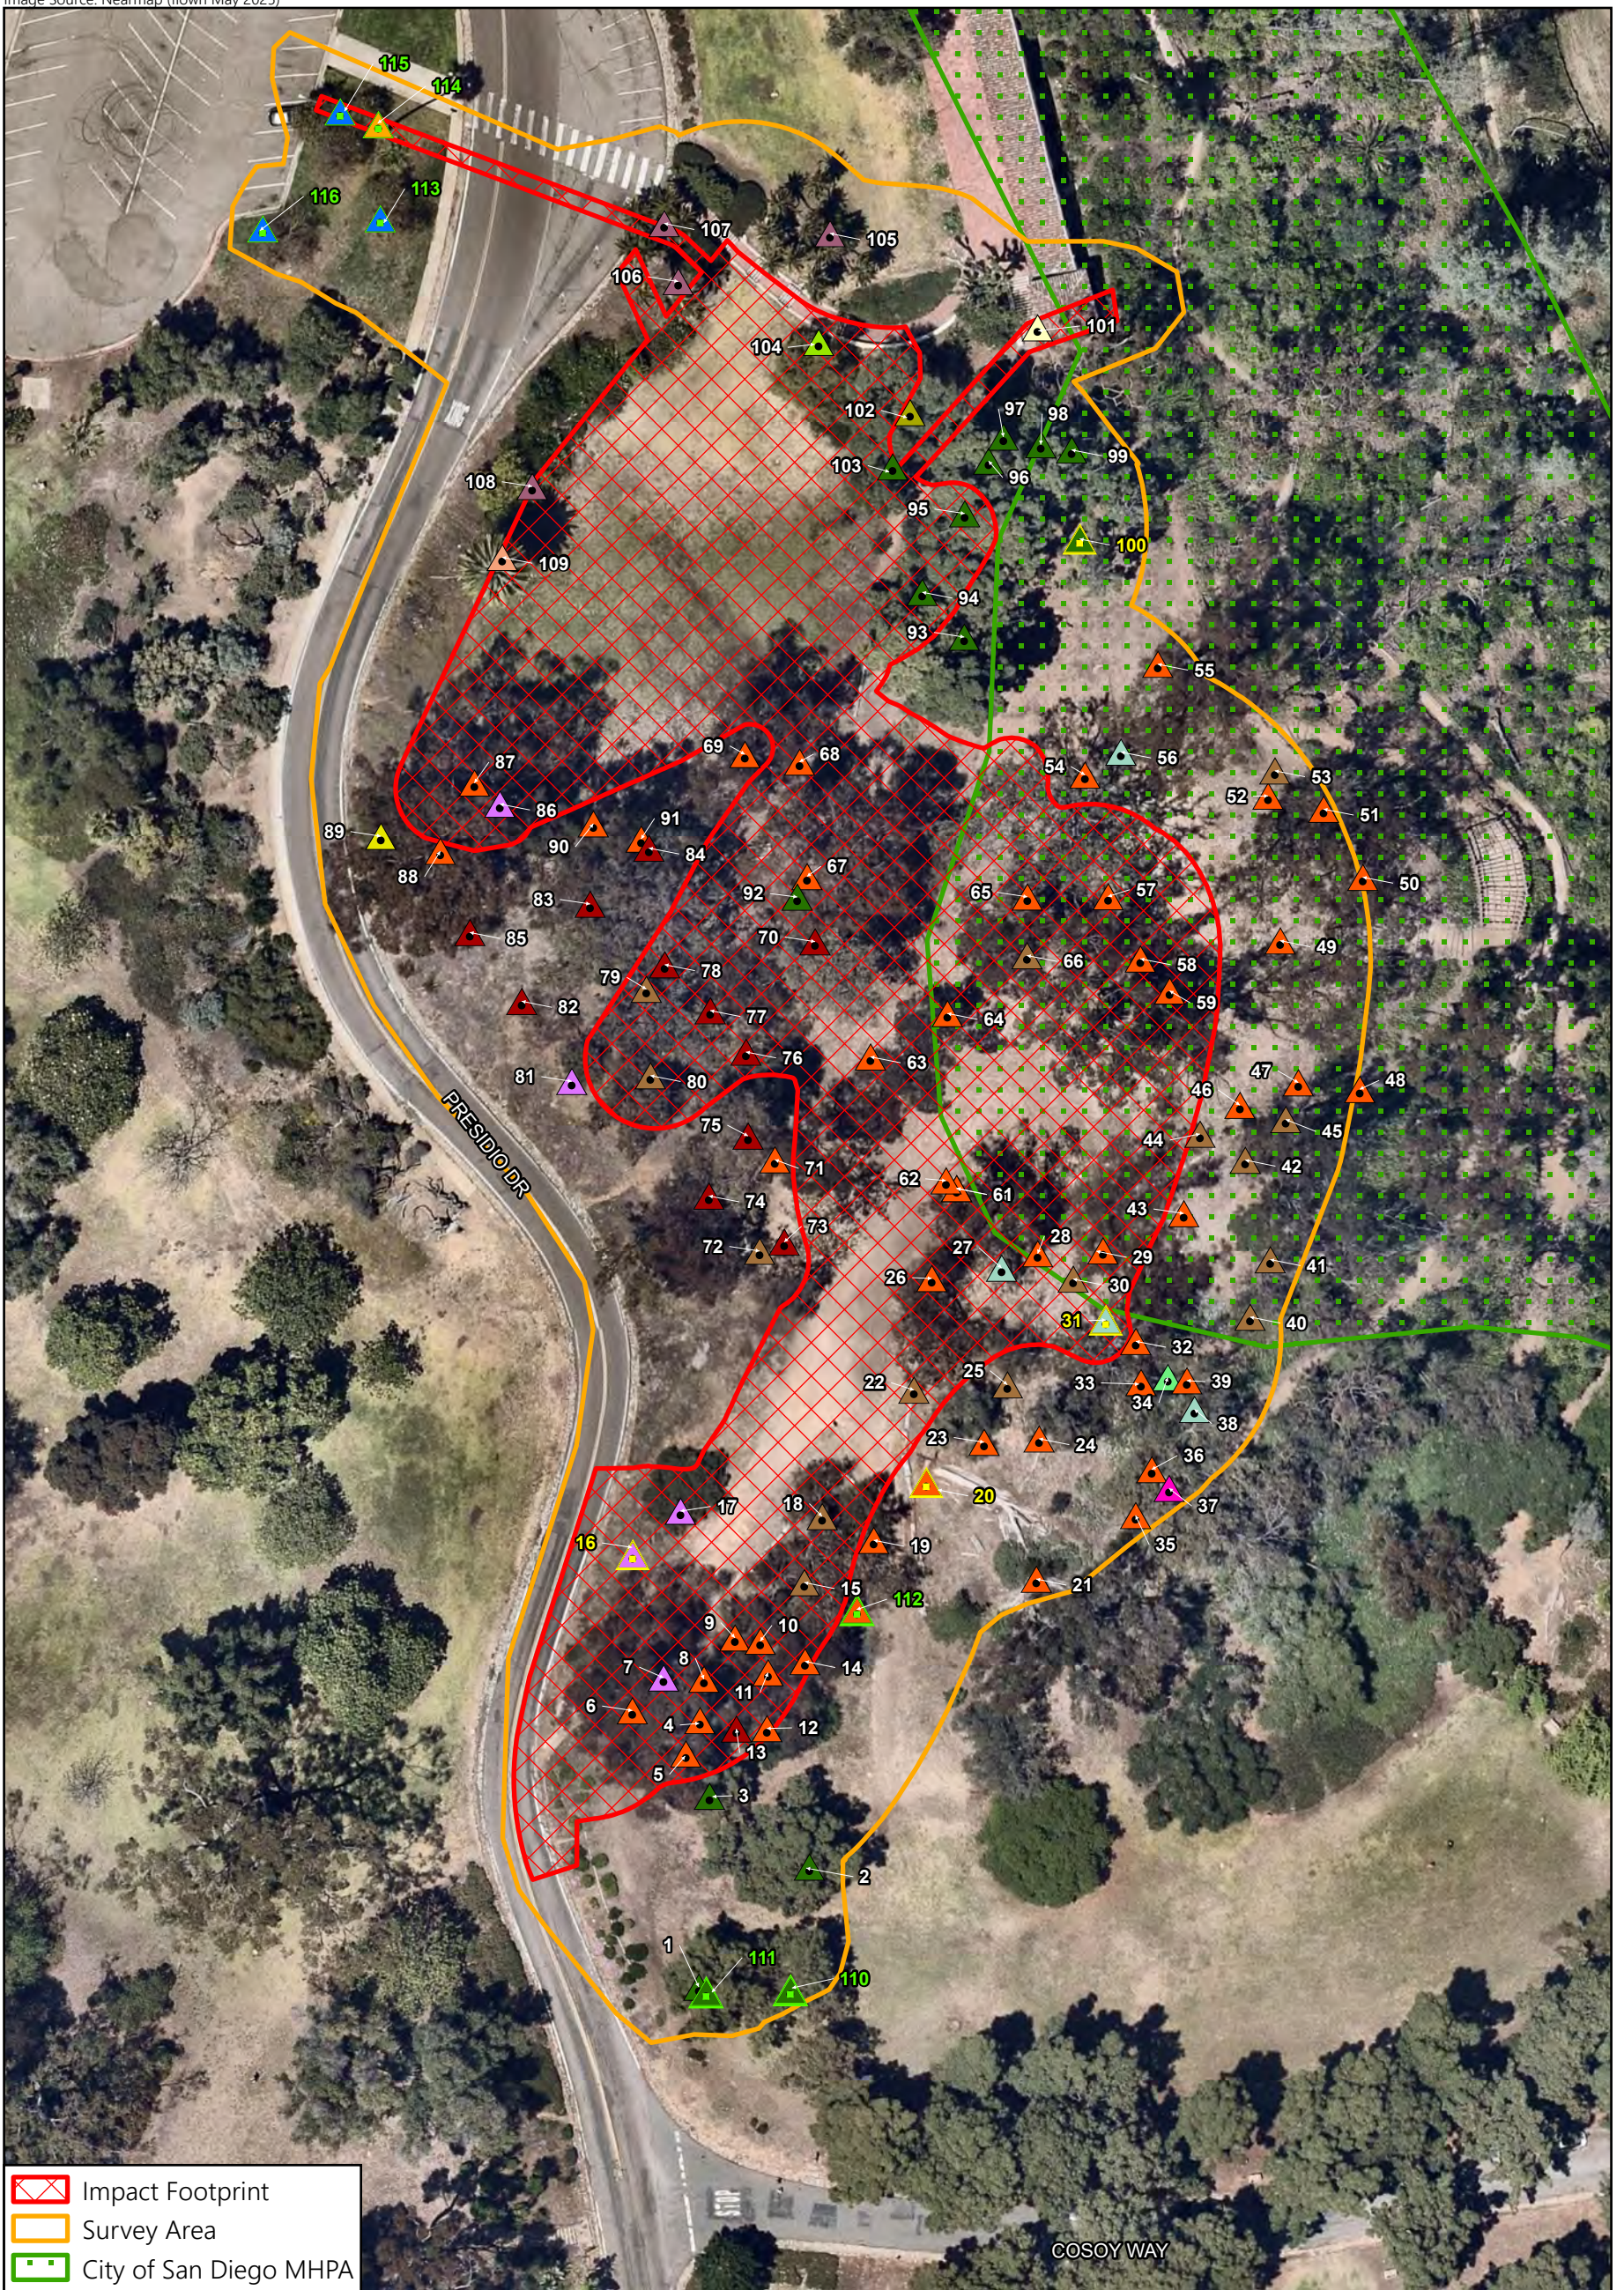
FIGURE 3  
Tree Location Map

In 2021, 109 trees were mapped within the survey area, representing 16 species (see Figure 3). The most common tree species encountered was red gum (*Eucalyptus camaldulensis*). The most common health score was 4, typically due to codominant trunks, or dead branches in the canopy. The average DBH was 14 inches, and the average estimated height was 34 feet.

The majority of the 109 trees that were mapped in 2021 were in similar or better condition in 2024 (see Figure 3 and Attachment 1). A total of four trees naturally died or were removed since 2021 (Tree numbers 16, 20, 31, 100) and seven new trees were mapped in 2024 (Tree numbers 10, 111, 112, 113, 114, 115, 116; see Attachment 1 and Figure 3), for a grand total of 112 trees.

Out of these 112 trees, 53 are located within the project site, including 13 within the MHPA (see Figure 3 and Attachment 1). The trees that naturally died since 2021 included tree number 20 (*Eucalyptus camaldulensis*), which had a health score of 4 in 2021, tree number 31 (*Eucalyptus polyanthemus*), which had a health score of 1 in 2021 and tree

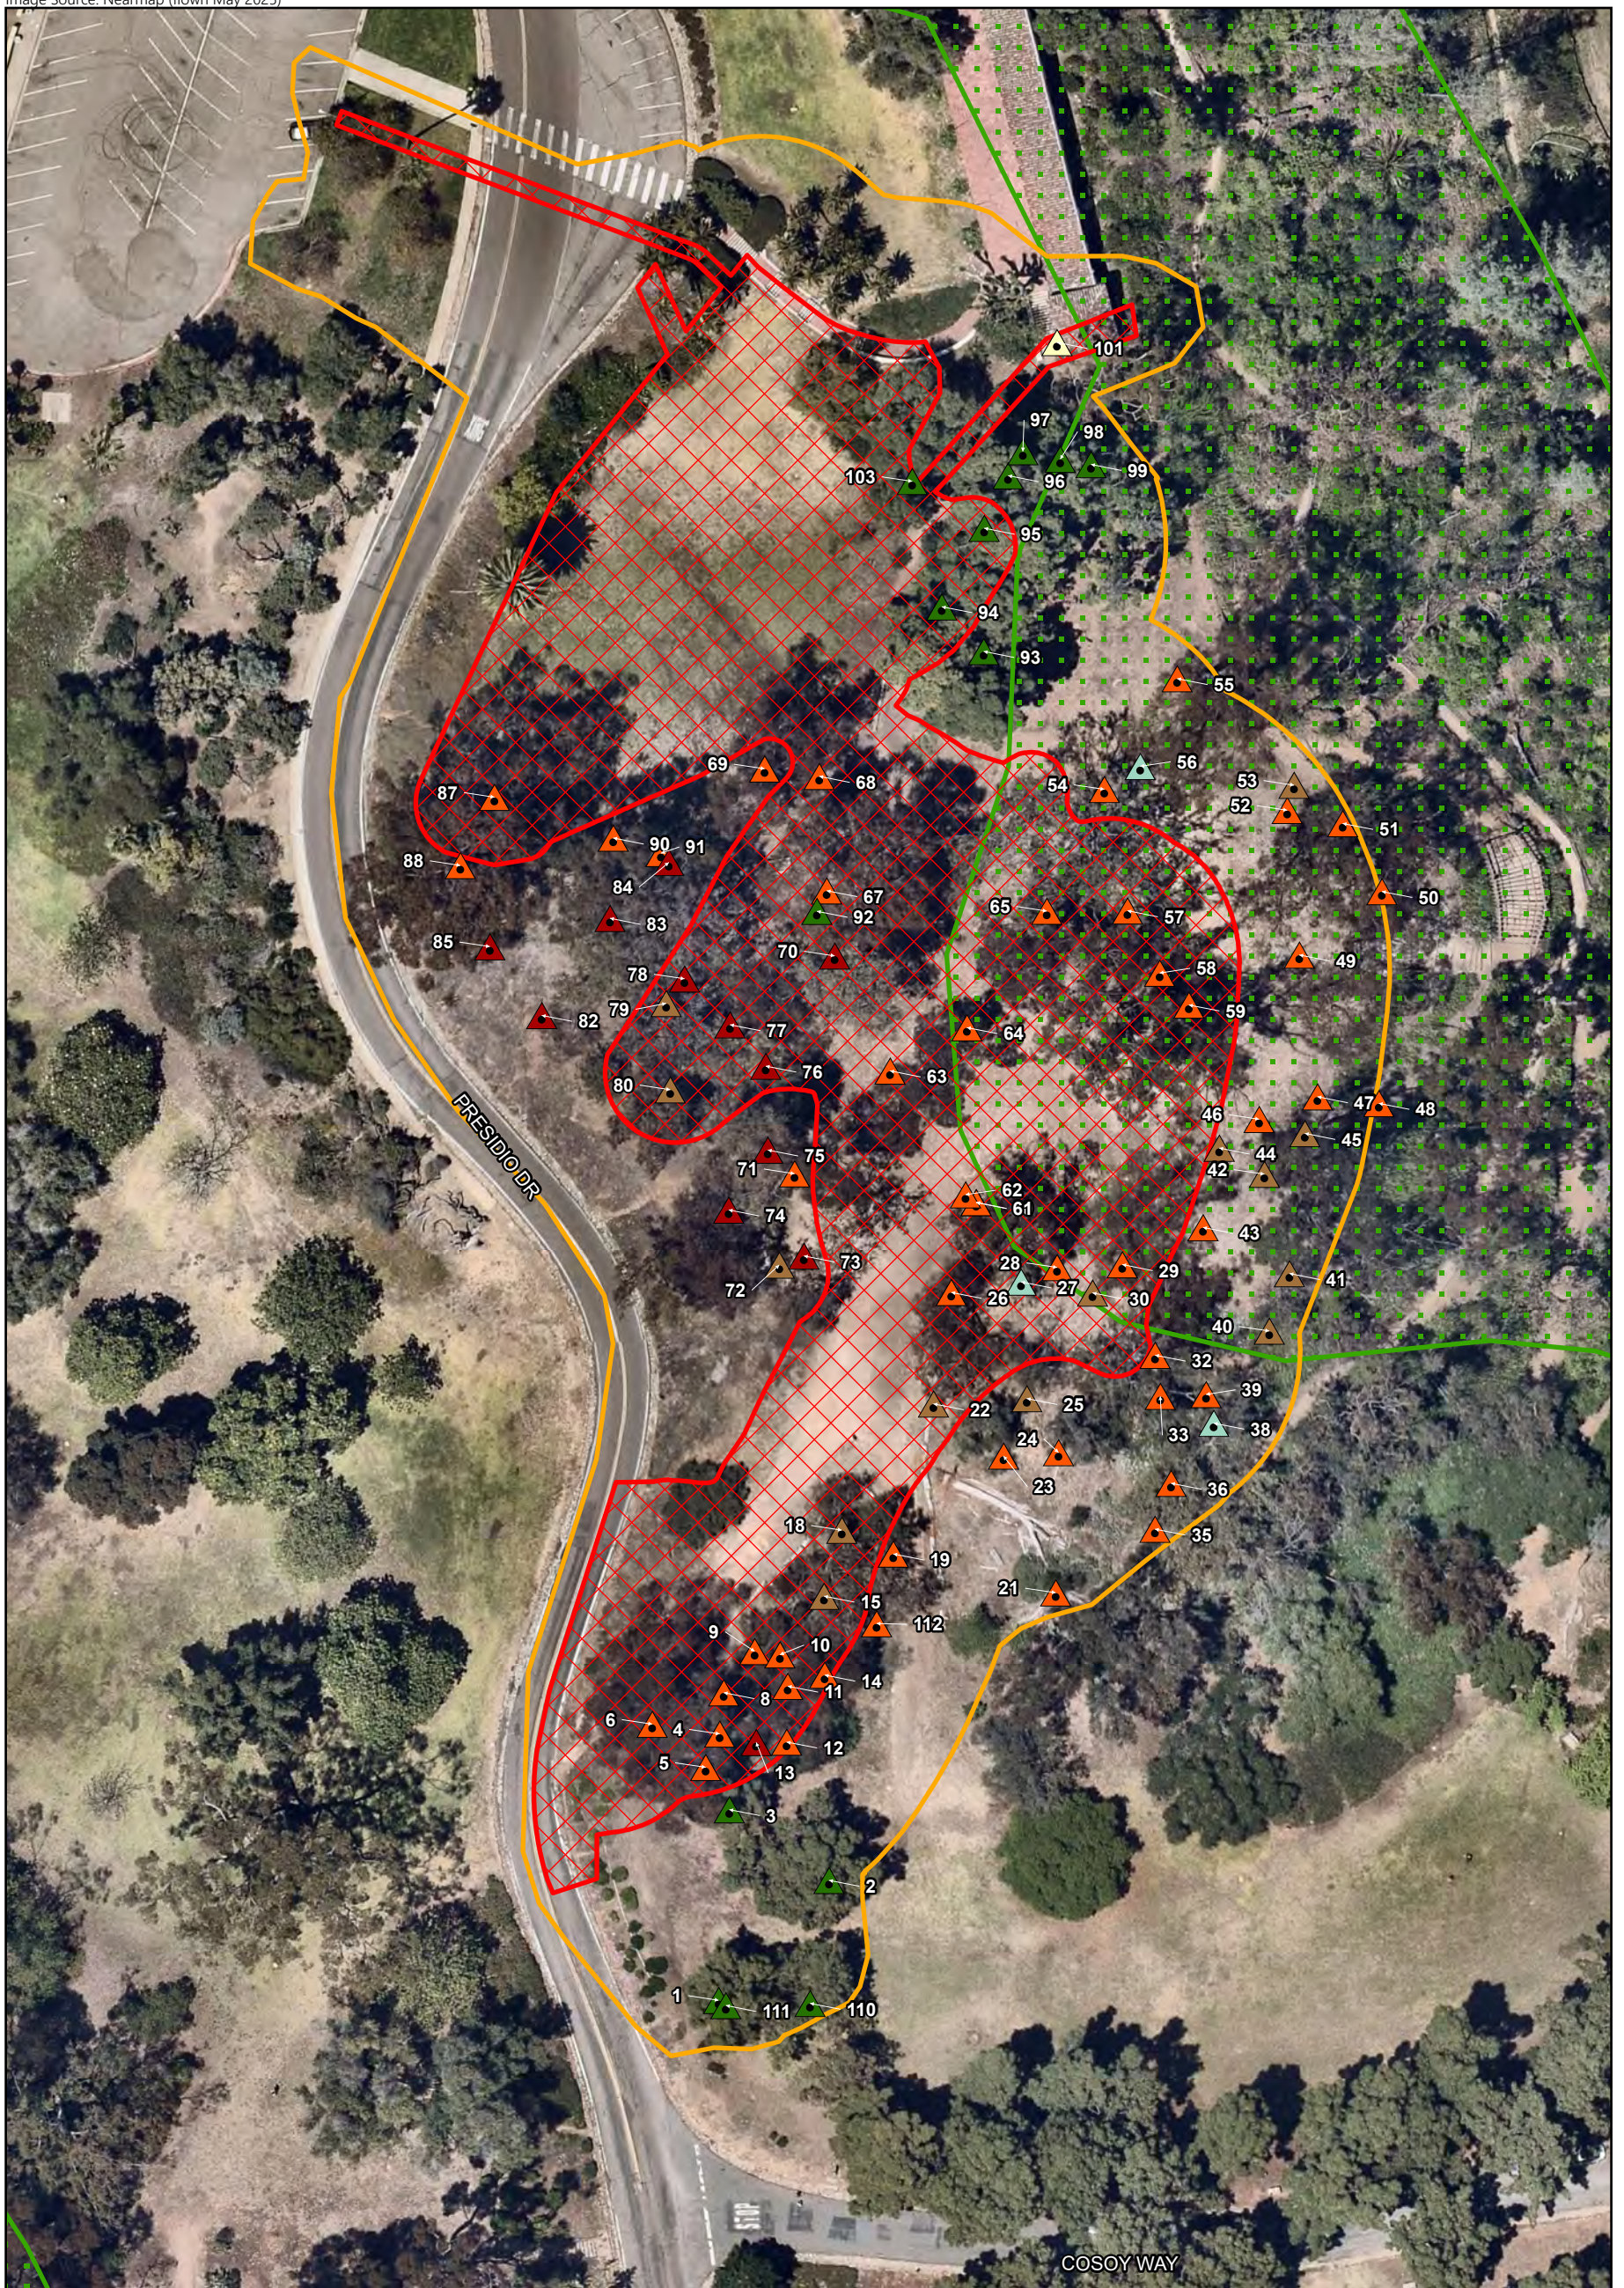
FIGURE 4  
Suitable Monarch Roosting Trees

The proposed project site is known as a winter roosting site for monarch butterfly, and records from the California Natural Diversity Database note that this species roosts in lemon-scented gum (*Eucalyptus citriodora*) and Canary Island pine (*Pinus canariensis*) within the park (California Department of Fish and Wildlife 2024; Xerces Society 2024). For the current analysis, all Canary Island pines and gum (*Eucalyptus* sp.) trees taller than 15 feet with health scores of 3–5 are considered suitable for monarch roosting. Spider gum (*Eucalyptus conferruminata*) is a shrubby plant shorter than most gum trees and is not ideal for monarch roosting. Trees with scores of 1 and 2 are damaged or diseased and have a high likelihood of failure, so they are not considered suitable for monarch roosting in this analysis. Based on these criteria, out of the 112 trees within the survey area, 93 trees are considered suitable for monarch roosting (Figure 4). Of these, 45 trees that are suitable for monarch roosting would be impacted by the project, including 10 trees within the MHPA (Tree numbers 28, 29, 30, 44, 54, 57, 58, 59, 64, and 65). These 45 trees include 39 trees that are located inside the project impact footprint and six trees (Tree numbers 12, 32, 44, 54, 79, and 88) that are located on the edge of the project boundary (within 4 feet of the project boundary). Trees inside the project boundary are expected to be directly impacted by the project, and trees on the edge of the project boundary are expected to be indirectly impacted by ground disturbances near their root zones. The remaining 48 suitable trees for monarch roosting are not within the project boundary or on the edge of the project boundary and, thus, are not anticipated to be impacted.
