REPORT OF GEOLOGIC FAULT INVESTIGATION

Proposed Lee/DeGuzman Residence
1855 Spindrift Drive
La Jolla, California

JOB NO. 22-13755

07 July 2023

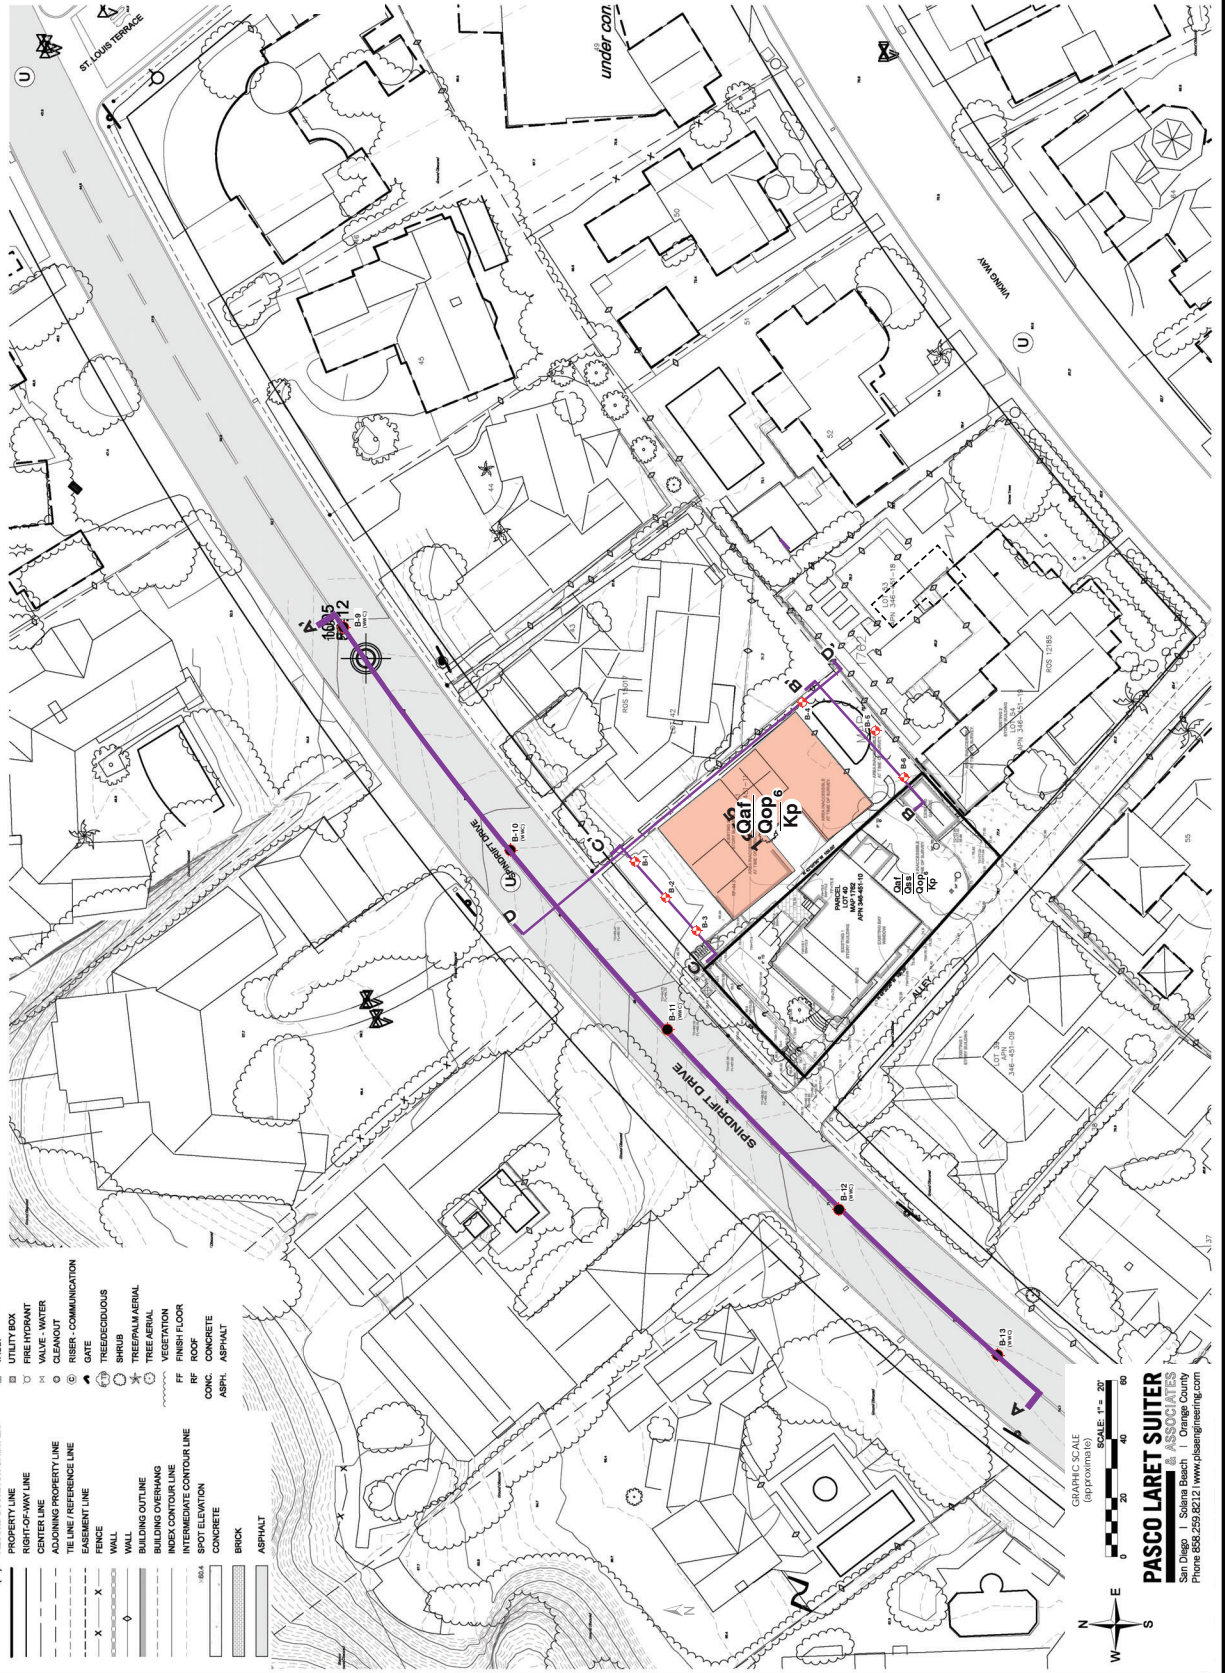
The roughly rectangular-shaped property is approximately 4,609 square feet in size. For the purpose of this report, the front of the site is referred to as facing northwest toward Spindrift Drive and is bordered on the northeast by a similar single-family residence at a lower elevation; on the southeast to the rear of the home by a similar single-family residence at a slightly higher elevation; on the southwest by residences at a higher elevation; and on the northwest by Spindrift Drive at a similar elevation. The site is currently occupied by a three-story, single-family residential structure located centrally on the site, with car parking adjacent to Spindrift at the front and a swimming pool and patio area in the rear, in addition to retaining walls, flatwork, and associated improvements. The site consists of a terraced building pad, ascending to the southeast with building and perimeter and central retaining walls of various heights of approximately 2 to 8 feet (refer to Figure II, Plot Plan and Site-Specific Geology).

Description and Identification of soils (Visual-Manual Procedures) (ASTM D2488-17e1), part of the Unified Soil Classification System (refer to Appendix A). The approximate locations of the borings and cross section locations, along with the geologic units encountered, are shown on the Plot Plan and Site-Specific Geologic Map, Figure No. II.

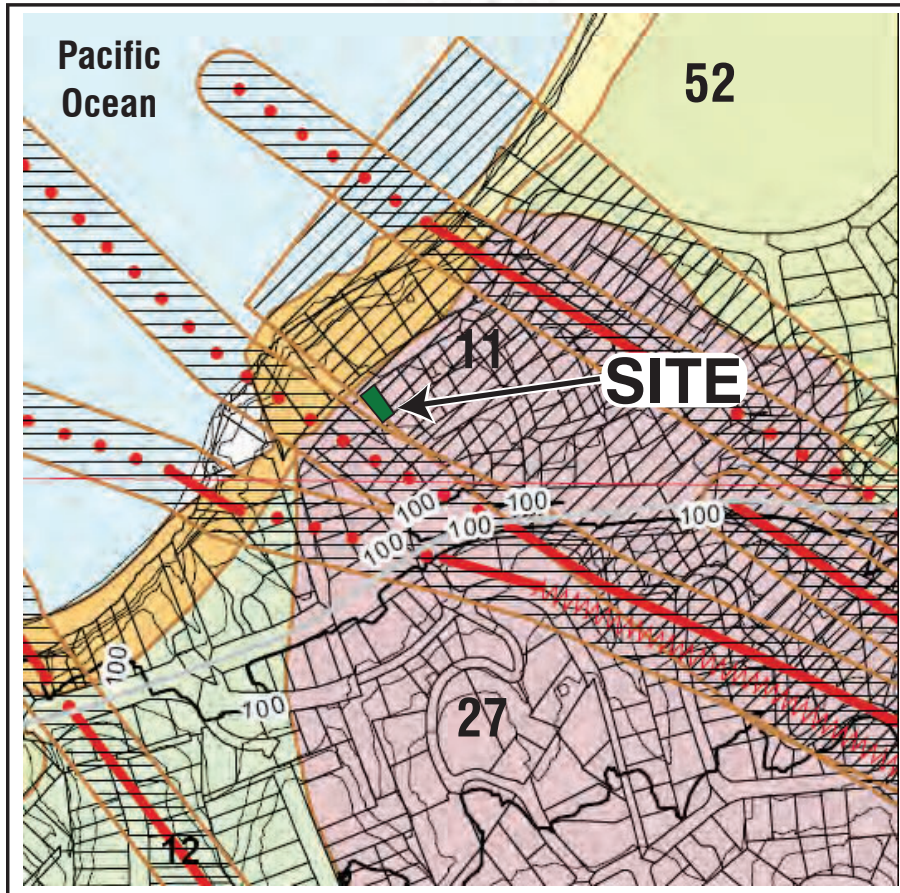
Figure No. III
Job No. 22-13755

Our review of the City of San Diego Seismic Safety Study -- Geologic Hazards Map Sheet 29, dated 2008, indicates that the site is located in two geologic hazard areas designated as Categories (GHC) 11 and 27. An excerpt of the map is included as Figure No. III. Category 11 is identified as a State of California fault zone, described as "*Active, Alquist-Priolo Earthquake Fault Zone.*" Category 27, also a City of San Diego designation, is identified as a slide-prone formation "*Otay, Sweetwater and others.*" The following discusses issues related to faulting. The potential for landsliding is discussed later under Geologic Hazards.

Regarding GHC 27, a "slide-prone" category, it our opinion, based on the property location on very gently sloping terrain and the massive structure and density of the underlying geologic units, the risk associated with "slide-prone" is considered nominal. The additional potential geologic hazards not described in this report will be discussed in our geotechnical report, which will be issued separately.

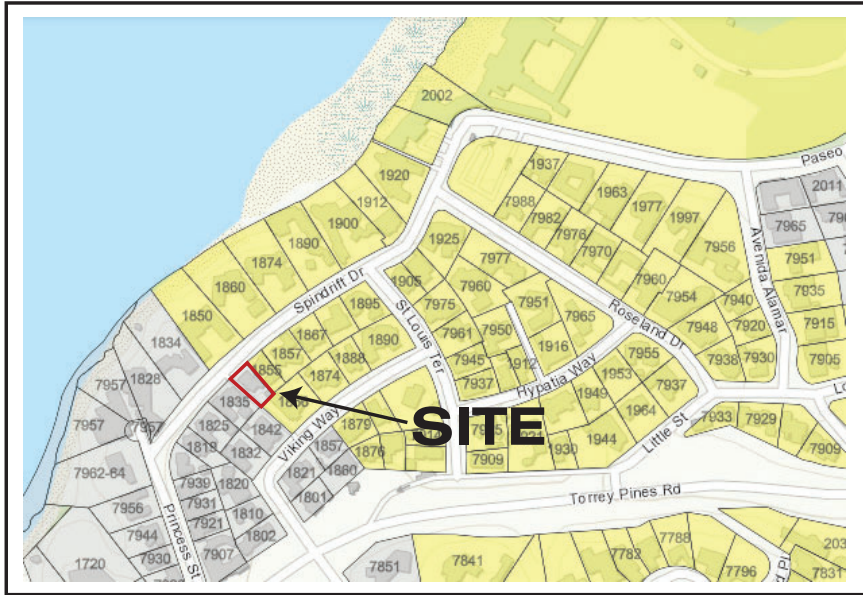
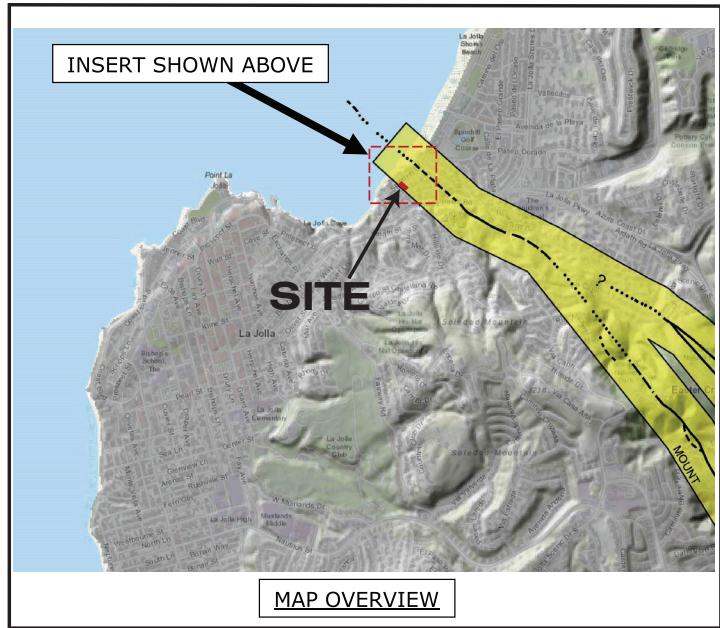
*Lee/De-Guzman Residential Property
 1855 Spindrift Drive
 La Jolla, CA.
 Figure No. IVa
 Job No. 22-13755*

Regarding GHC 11, based on the previous discussions, it is our opinion that there is no significant faulting within the subject property, which is zoned in GHC 11. We provide on Figure No. IVa the properties in the vicinity of 1855 Spindrift Drive Fault Hazard Zone that are included in the State of California Special Studies Report

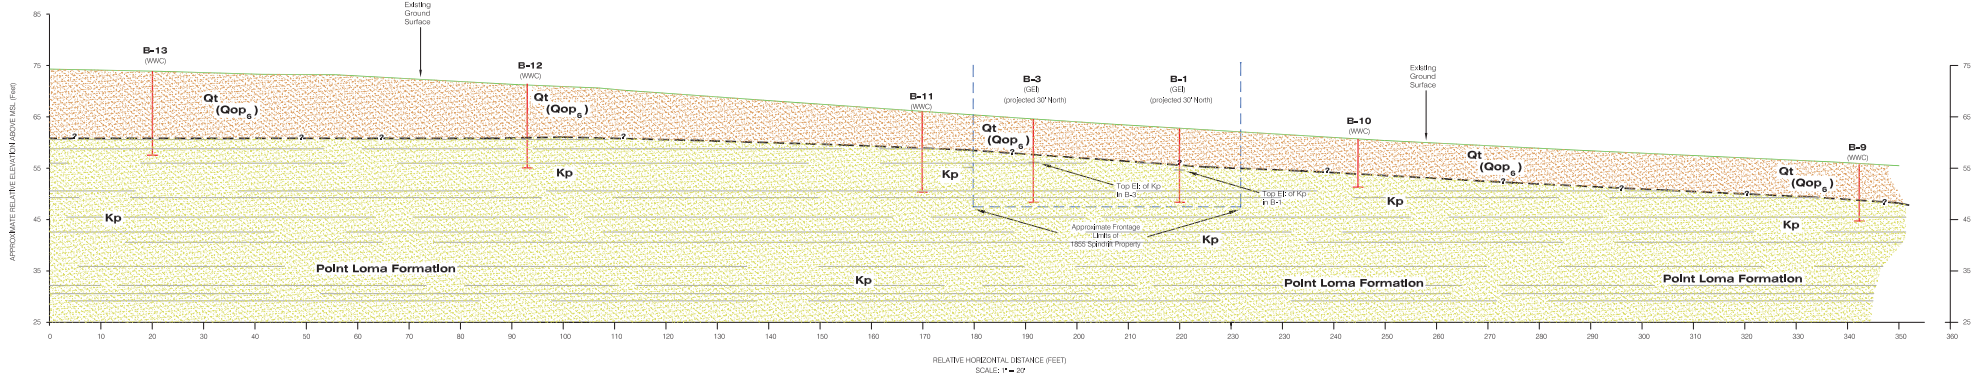
anticipated, elevations of the Point Loma Formation surface are very similar to the elevations noted in the Artim and Streiff borings northwest of and adjacent to the site. Cross section A-A' (Figure No. VIIIa), specifically in the area of Station Nos. 170 through 250 feet, depicts the Artim and Streiff borings and the GEI borings. GEI borings B-1 and B-3 are projected about 30 feet northwest to the Spindrift Drive cross section. The cross section reveals that the elevations of the underlying Point Loma Formation surface are essentially the same on Spindrift Drive and in front of the property and in the rear yard of the home. Figure Nos. VIIIb and VIIIc present cross sections B-B' and C-C' across the rear and front yards, respectively, and Figure No. VIIId presents cross section D-D', drawn perpendicular to B-B' and C-C'. Cross section B-B' includes GEI boring data from the adjacent project at 1851 Spindrift Drive. Review of the cross sections noted above indicates a similar surface elevation of the underlying Point Loma Formation (below the Qop6).
