November 18, 2019

**Letter Report**

Ms. Darlene Walter  
SeaWorld Parks and Entertainment  
500 SeaWorld Drive  
San Diego, California 92109

Subject: 2019 Sewer Capacity Study Update

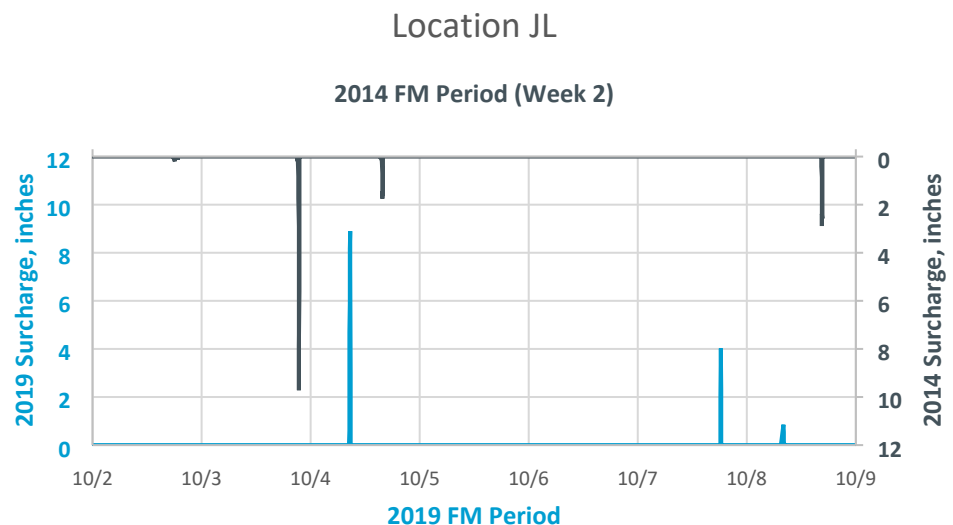
**Figure 1. Comparison of Surcharges at Location JL**

**Location JL.** Location JL is the furthest upstream of the monitoring locations. The 10-inch-diameter mainline enters from the west and exits to the east at roughly the same invert elevation. A third pipe enters at the north from the Shark and Otter area. ADS installed the flow meter in the incoming 10-inch main. Per the 2014 study, surcharging at this location is due to backwatering, not to the capacity of the pipe at this location.

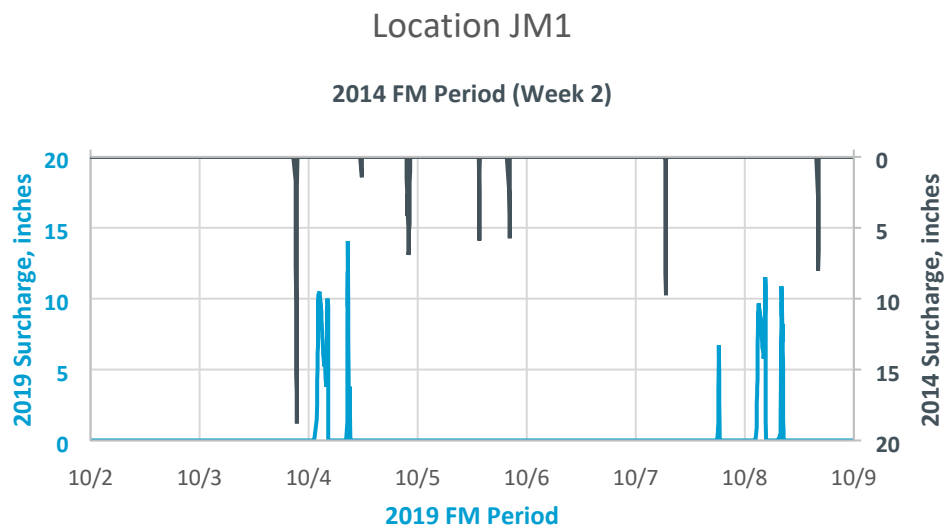
Figure 2 . Comparison of Surcharges at Location JM1

**Location JM1.** Location JM1 is the next downstream location from JL. The 10-inch-diameter mainline enters from the west and exits to the south at roughly the same invert elevation. A third pipe enters at the north from the Cascades area. ADS installed the flow meter in the incoming 10-inch main.

- **Location JM1.** JM1 was impacted by the change in cleaning process at Cascades Flamingo changed from a straight dump to a controlled flow during the draining process. Only five surcharge events occurred during the monitoring period, compared with eight events in 2014. These events can be tied to specific operational activities, specifically backwash occurring at the Main Plant and maintenance activities at the Aquarium, Shark and Otter area, Shipwreck, and Cascades. The surcharge event that occurred during the Cascades pool drop was also accompanied by backwash events at the Main Plant and from a facility called ESO#3 in the maintenance logs.

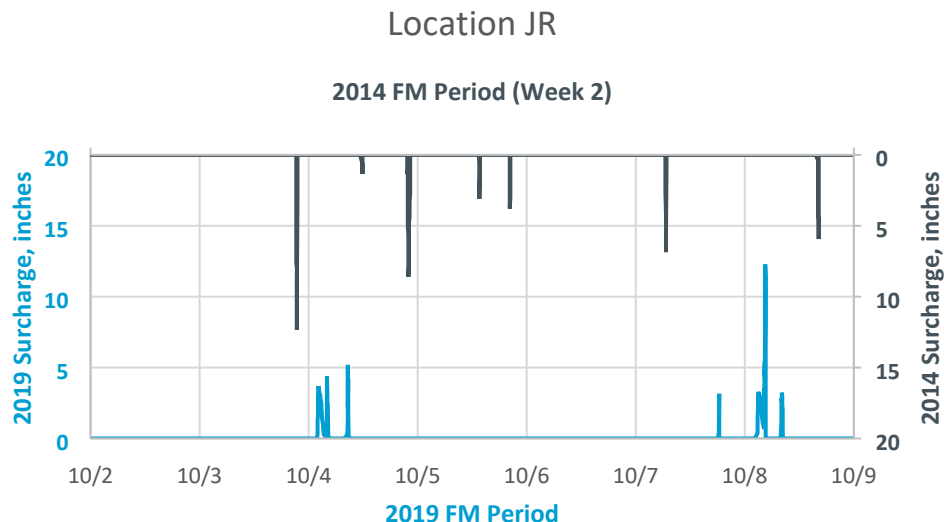
Figure 3. Comparison of Surcharges at Location JR

**Location JR.** Location JR is the next downstream location from JM1. The 10-inch-diameter mainline enters from the north and exits to the south at roughly the same invert elevation. The flow meter was installed in the 8-inch-diameter pipe that enters from the Shipwreck Rapids area to the east. That pipe drops into the manhole approximately 4 to 6 inches above the manhole invert, so the surcharging above the top of the 10-inch-diameter mainline is actually a few inches higher than the value reported for JR.

- **Location JR.** JR was impacted by changes in waterfowl type at West Shipwreck, resulting in a 50 percent reduction in backwashing. Only five surcharge events occurred during the monitoring period, compared with nine events in 2014. These events can be tied to specific operational activities, specifically backwash events occurring at the Main Plant and at Shipwreck.

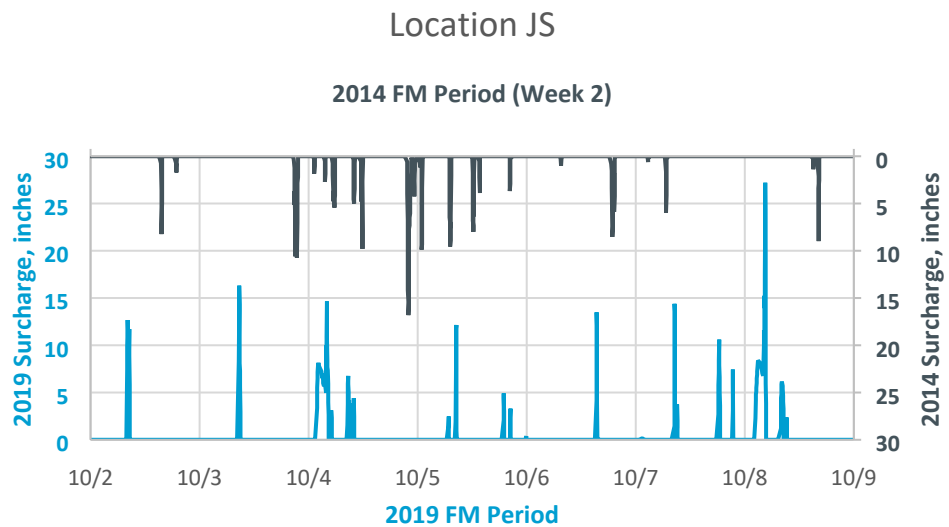
**Figure 4. Comparison of Surcharges at Location JS**

**Location JS.** Location JS is the furthest downstream location. The 10-inch-diameter mainline enters from the north and exits to the south at roughly the same invert elevation. The flow meter was installed in the 6-inch-diameter pipe that enters from the Main Plant area to the west. The top of the 6-inch-diameter pipe is roughly equal to the top of the 10-inch-diameter mainline, so surcharging above the top of the 10-inch main is roughly the same as the reported value.

- **Location JS.** JS was impacted by the reduction in backwash flow rate and duration in backwash operations at the Main Recovery Plant. Although the frequency of surcharging was reduced in comparison to the 2014 study, the typical height of the surcharge at JS was greater in 2019. Reductions in surcharge frequency at this downstream location likely contributed to lower surcharge frequencies observed at upstream manholes. However, this location experiences peak flows from all of the upstream activities, and the 10-inch-diameter main between JX and JS is still a bottleneck in the system. This capacity restriction continues to cause propagation of surcharge upstream, although the impact appears to be somewhat less than it was in 2014.

- Install a SmartCover at Manhole JS. SmartCovers measure remote site water levels in real-time and can give instant feedback about water levels or provide means for automation control to sequence operations, thereby allowing SeaWorld staff to implement measures to prevent SSOs caused by surcharge from maintenance activities on top of storm-induced flows. Consider installing SmartCovers on other manholes as well.
- Notify the City of required repairs to the liner in manhole JZ and to cap the sewer line north of Shark, as noted in the 2014 report.
