# **POINT LOMA OCEAN OUTFALL ANNUAL INSPECTION REPORT**

## **2024**

### **POINT LOMA WASTEWATER TREATMENT PLANT**

DATE: June 30, 2025  
TO: Peter Vroom, Deputy Director Public Utilities Department/EMTS  
FROM: Stephen Cann, Senior Civil Engineer, Public Utilities Department/WWTD  
SUBJECT: Point Loma Ocean Outfall 2024 Annual Inspection Report

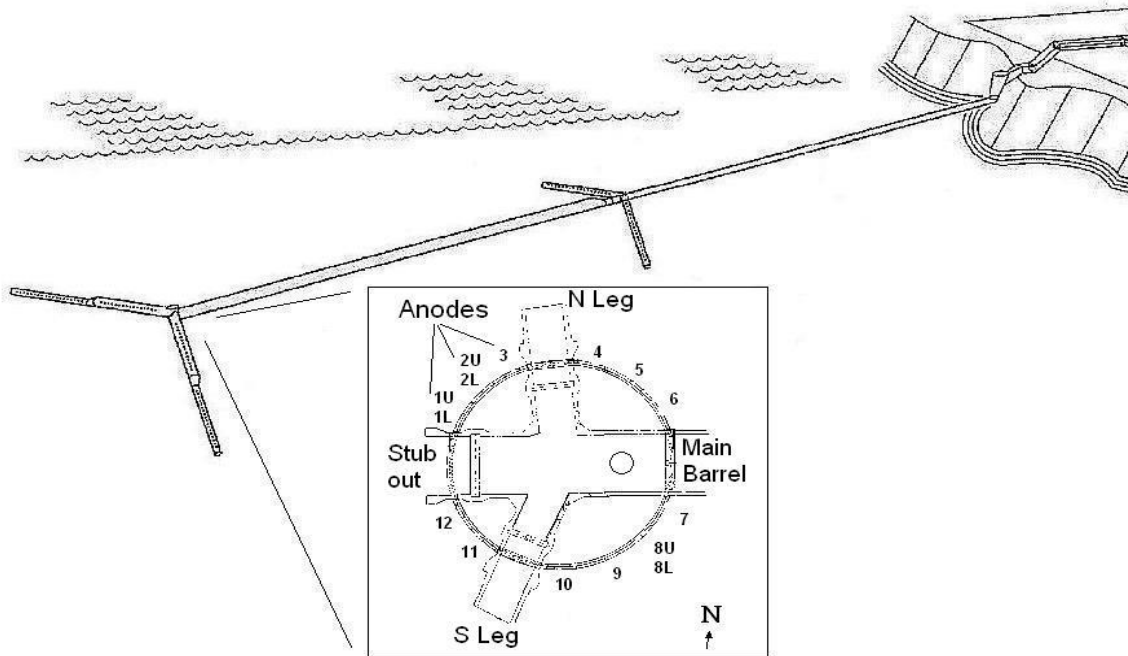
### Appendix B.3

The structure continues to be in overall good condition. A schematic of the twelve pairs of anodes on the New Diffuser Wye is shown in Appendix B.3. Lower anodes 1, 2, and 8, along with its mounting bracket are missing or consumed. The remaining eight lower anodes were thought to have been buried with armor rock during construction, thus no conclusion can be drawn regarding their condition. The protective wrappings on the remaining anodes of the upper ring have loosened over time to varying degrees, which has caused them to become partially active. Localized areas of leaking were observed emanating from the seams of the North and South Leg Gate Cover as well as, the Stubout Gate Cover. This observation is not new and is likely a function of the time of day the survey is being performed and, thus, the accompanying pressure inside the pipe. Effluent continues to leak from different locations on the perimeter of Stubout Gate. However, these leaks are of little consequence, in regard to water quality, as the initial dilution of this low flow effluent escaping is much higher than that of effluent being discharged from the nearby Diffuser Ports.

Cathodic protection structure-to-electrolyte potentials were measured and recorded on the new diffuser wye on May 7, 2024. Measurements were taken at exposed anodes and anode cores as conditions allowed and included anodes 4U, 7U, 8L, and 12U. Measured potentials varied from -0.620 volts to -0.640 volts with an average of -0.630 volts. These measurements indicate that the intermediate wye structure is receiving partial levels of cathodic protection. Due to the low potential measurements, it was decided to unwrap the passive anodes to see if cathodic protection levels improve. A special tool was attached to the ROV and the passive anodes were successfully unwrapped on June 10 and 11, 2025. A total of 10 anodes were unwrapped. The anodes were in various stages of consumption because the protective wrapping had begun to come loose after over 30 years of immersion. Anodes 7U and 8U had approximately 30-40% of their original mass

remaining, anodes 1U, 2U, 5U and 12U had approximately 10-30% of their original mass remaining, anodes 4U, 6U, and 11U had approximately 10% or less of their original mass remaining, and anodes 3U, 9U, and 10U were either completely consumed or missing. A new structure-to-electrolyte potential survey will need to be performed to see if the anode unwrapping has had any beneficial effect on the cathodic protection levels. This new survey can be done in conjunction with next year's ROV video inspection,

Anode Schematic of PLOO extension.
