# **SOUTH BAY OCEAN OUTFALL ANNUAL INSPECTION REPORT 2024**

## **South Bay Water Reclamation Plant**

## **USIBWC South Bay International Wastewater Treatment Plant**

DATE: June 30, 2025  
TO: Peter Vroom, Deputy Director, Public Utilities Department/EMTS  
FROM: Stephen Cann, Senior Civil Engineer, Public Utilities Department/WWTD  
SUBJECT: South Bay Ocean Outfall 2024 Annual Inspection Report

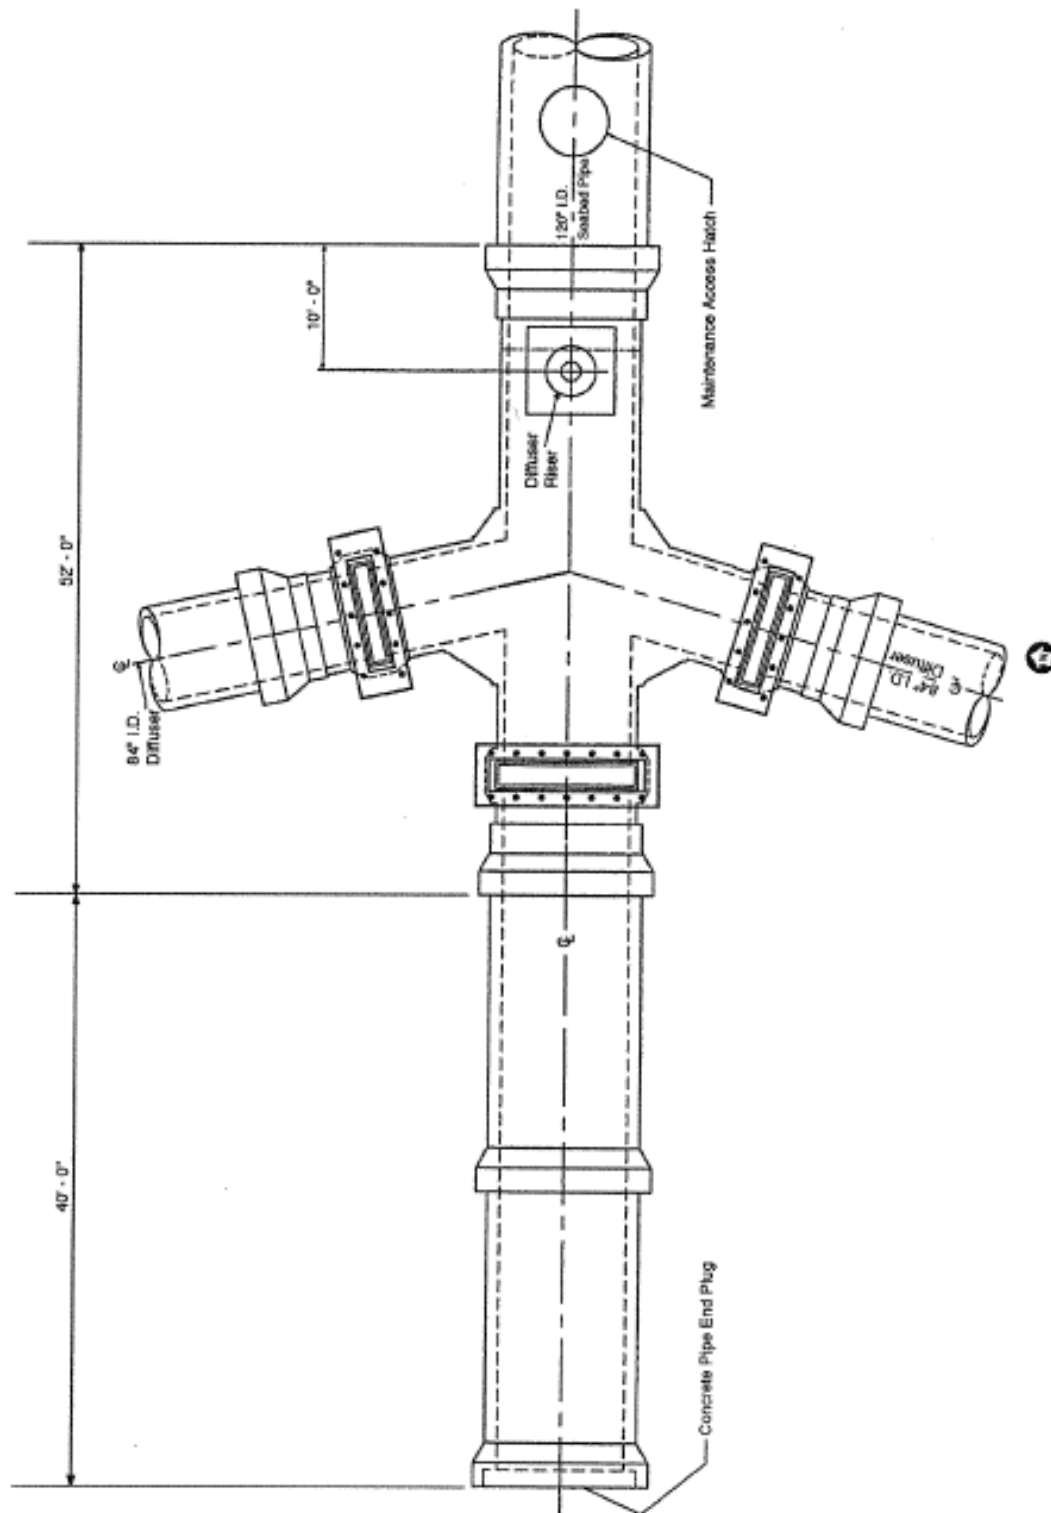
## Appendix A.6

The condition of the Wye was nearly identical to the previous surveys: the gate covers were in good condition, and all were sealed properly except a slight leak on eastern edge of north gate cover. The West edge of offshore gate cover has a gap or crack on the it. The offshore rock pile was generally free of algal coverage, and the ballast coverage was complete with no visible bacterial mat. The single riser located on the WYE; Riser “W” was flowing well.

The Diffuser Wye structure for the SBOO.

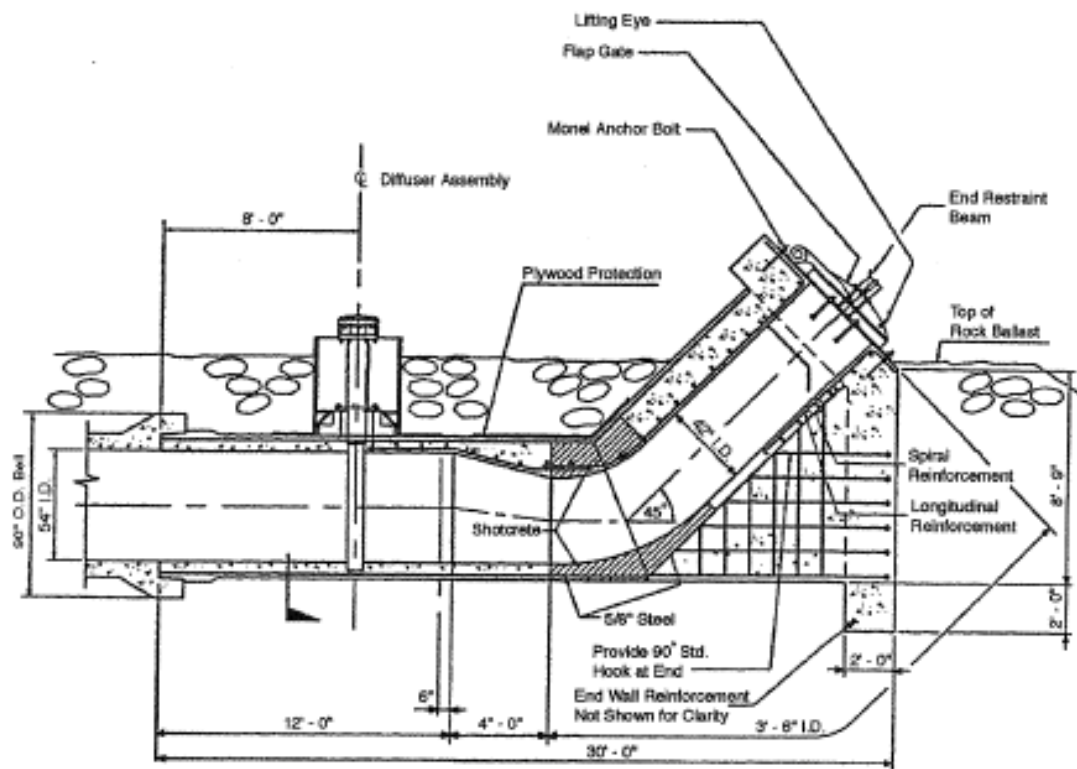
## Appendix A.7

As observed in last year’s survey, the Termination structure and the Flap Gate remained overgrown by algae and invertebrate, but overall, it appeared to be in good condition. The Flap Gate did not exhibit any visible signs of leaking. The anode on the crossbar could not be evaluated because it continues to be obscured by encrusting marine growth. A contract to inspect and clean the active diffuser heads (18 total) occurred in April and May of 2024 which increased the service life and improved the functionality of the diffusers. In this year’s survey, the “clean” active risers, as expected have accumulated some encrusting marine invertebrate and algal growth. Despite this all the active risers, are flowing freely and unobstructed. A summary of the South Bay Ocean Outfall Diffuser Cleaning and Inspection Report was included with the 2023 SBOO outfall inspection report. The inactive Risers were all in good condition and appeared to be sealed properly. The ballast coverage along this structure was unchanged. Some of the Risers are not centered on their shields.

Termination structure found at the end of the SBOO Diffuser Legs.
