# **POINT LOMA OCEAN OUTFALL ANNUAL INSPECTION REPORT**

## **2025**

### **Point Loma Wastewater Treatment Plant**

SUBJECT: Point Loma Ocean Outfall 2025 Annual Inspection Report

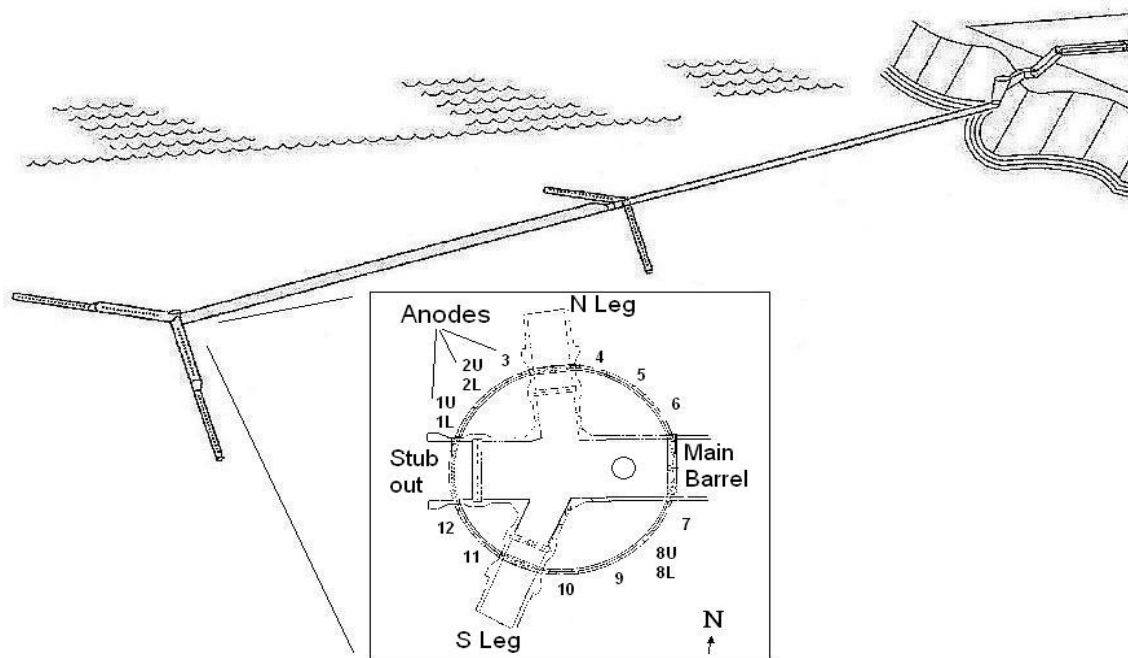
## Appendix B.3

The structure continues to be in overall good condition. A schematic of the twelve pairs of anodes on the New Diffuser Wye is shown in Appendix B.3. Lower anodes 1, 2, and 8, along with its mounting bracket are missing or consumed. The remaining eight lower anodes were thought to have been buried with armor rock during construction, thus no conclusion can be drawn regarding their condition. The protective wrappings on the remaining anodes of the upper ring have loosened over time to varying degrees, which has caused them to become partially active. Localized areas of leaking were observed emanating from the seams of the North and South Leg Gate Cover as

A new structure-to-electrolyte potential survey was performed on April 26, 2026 to see if the anode unwrapping has had any beneficial effect on the cathodic protection levels. Measurements were taken at exposed anodes and anode cores as conditions allowed and included anodes 1U, 1L, 2U, 2L, 3U, 4U, 7U, 5U, 6U, 7U, 8U, 9L, 10U, 11U and 12U. Measured potentials varied from -0.750 volts to -0.810 volts with an average -0.776 volts. This was a significant increase in the structure potentials over last year's average of -0.630 volts. While this increase in protection levels is beneficial and brings the values up to almost fully protected levels, we do not expect that the anodes to provide long term protection because of their present state of consumption. New anodes should be installed within the next three years to provide future protection.

Anode Schematic of PLOO extension.
