# Memorandum

**Date:** March 29, 2016

**Subject:** Post-maintenance Report for the Nestor Creek Channel Emergency  
Maintenance Project – Map 134

**HELIX Proj. No.:** SDD-24.25

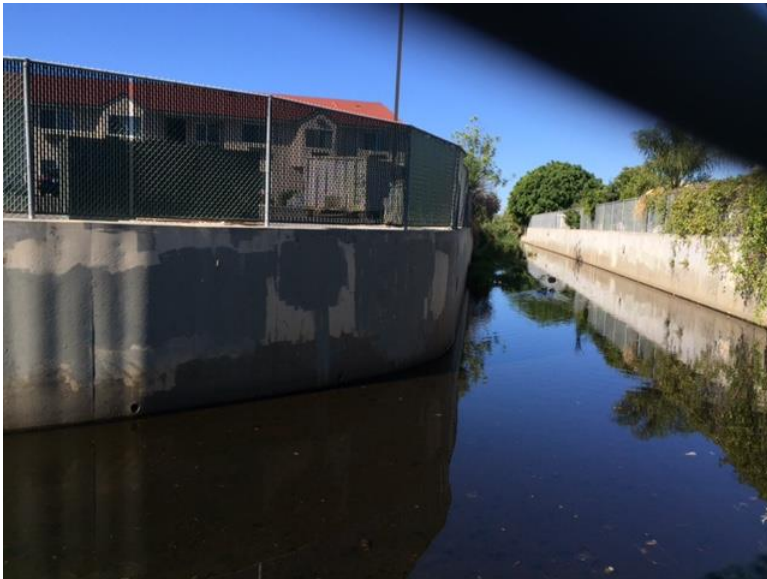
**Photograph 1:** Looking downstream (west) from the center of the concrete lined section of the channel toward the west end of MMP Map 134; Figure 3.

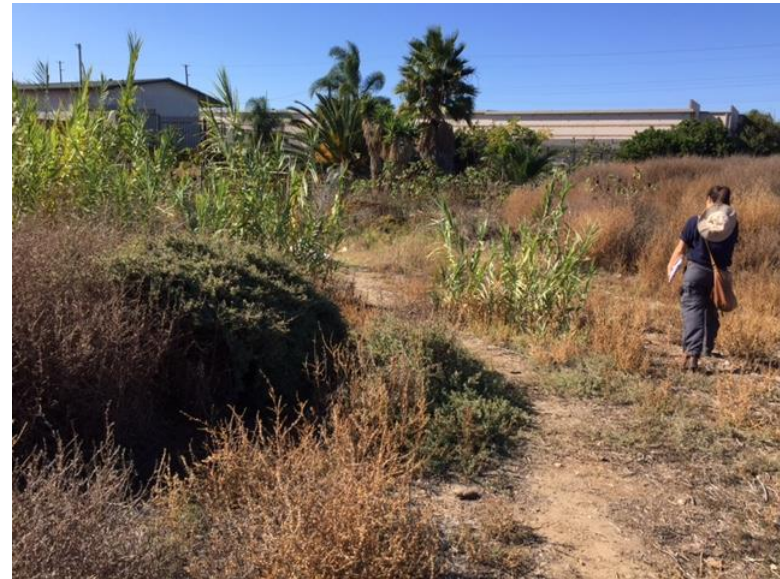
**Photograph 2:** Looking south within the north end of the Access/Staging area in MMP Map 134; Figure 3.

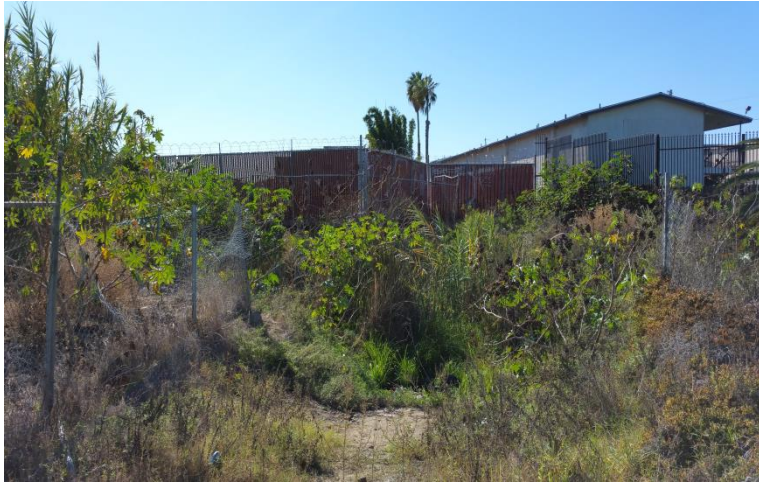
**Photograph 3:** Looking south towards the earthen channel impact area and adjacent properties from the staging area in the northwest end of MMP Map 134; Figure 3.

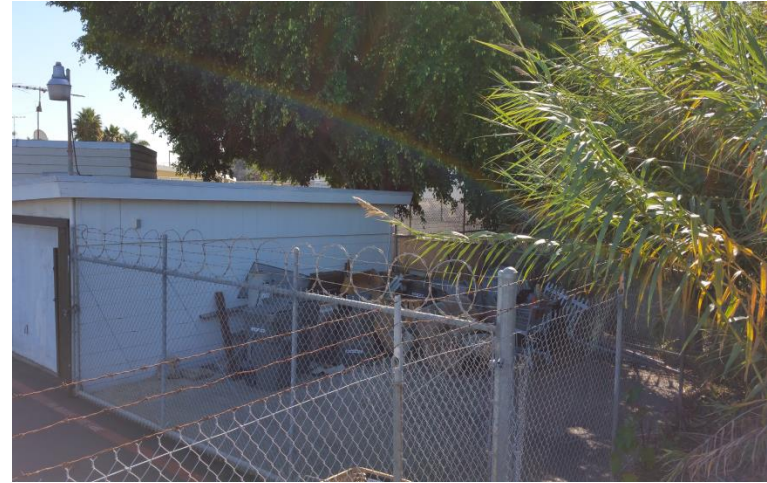
**Photograph 3:** Looking northeast at the properties adjacent to the proposed emergency impact area (see Arundo on right side of photo) at the northwest end of MMP Map 134; Figure 3.

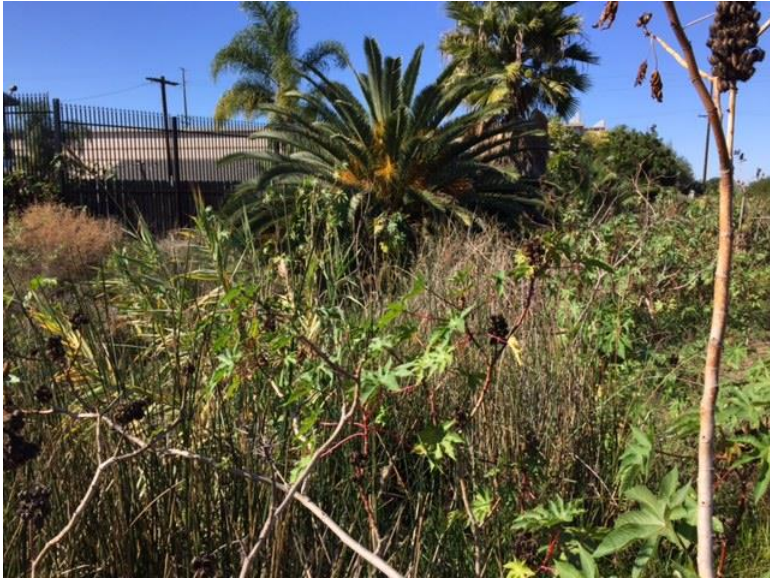
**Photograph 4:** Looking upstream from the northern end of the Access/Staging area towards disturbed freshwater marsh and adjacent properties in MMP Map 134; Figure 3.

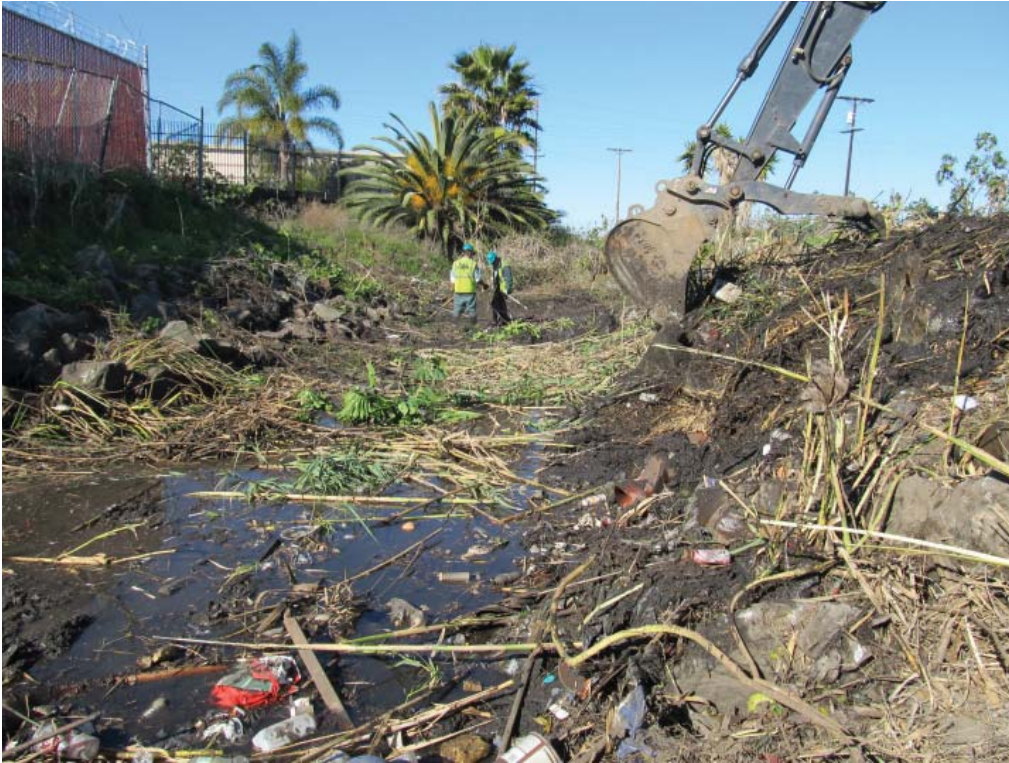
Excavator clearing channel (facing north).  
February 5, 2016

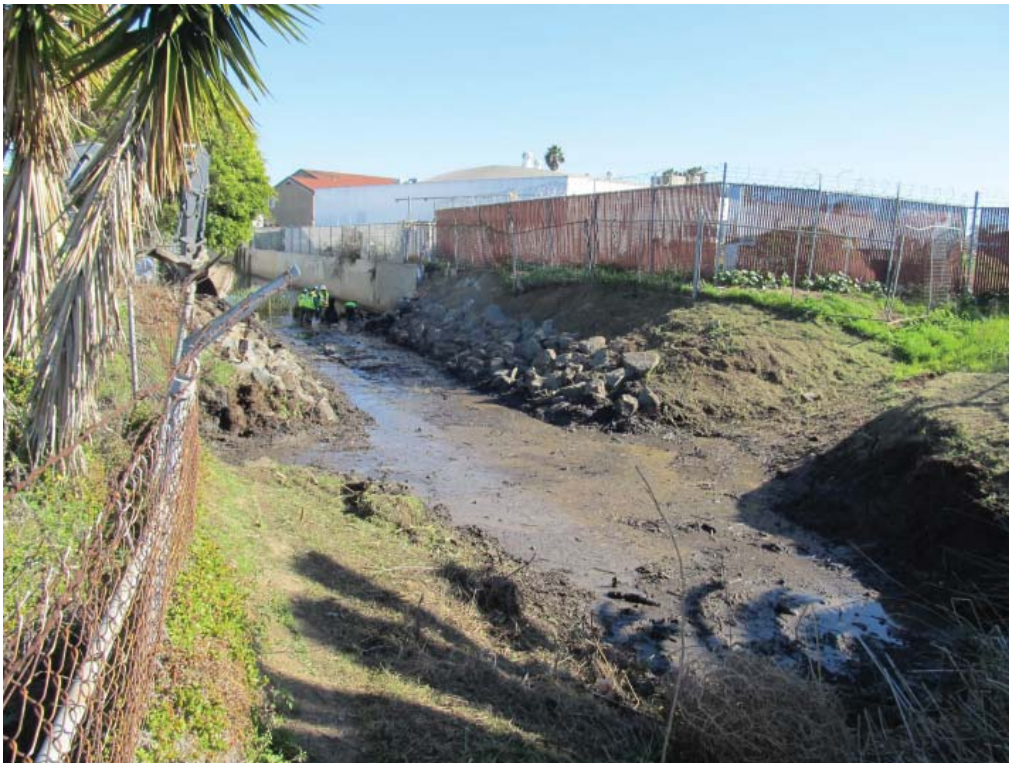
Excavator clearing channel (facing south).  
February 5, 2016

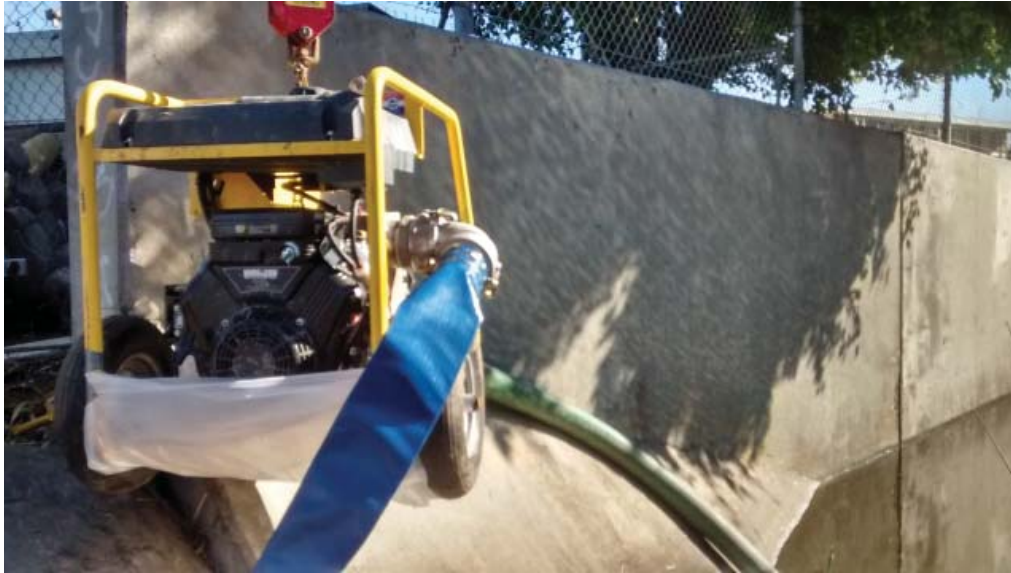
Bypass pump hung above channel.  
February 5, 2016

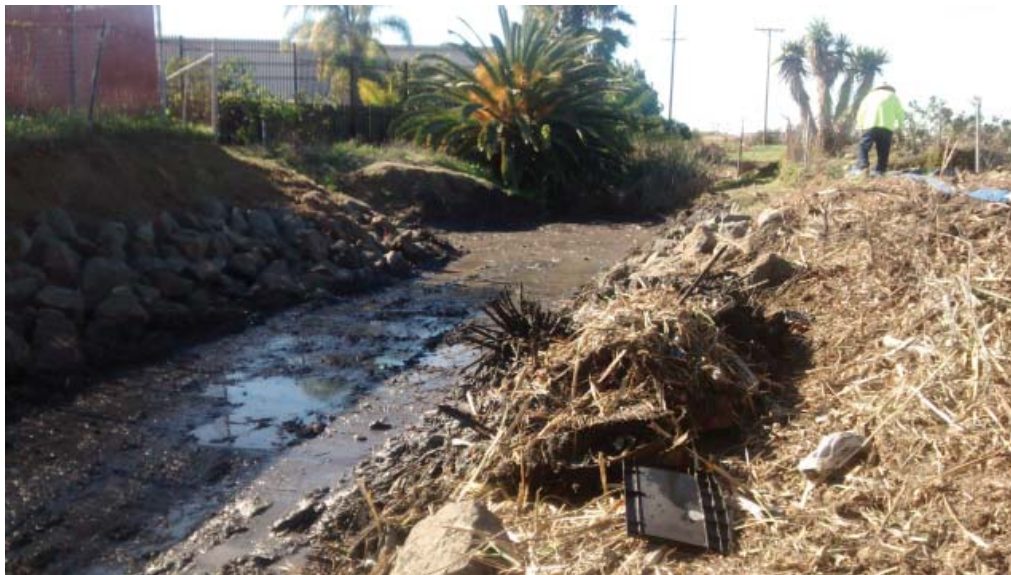
Cleared channel (facing north).  
February 5, 2016

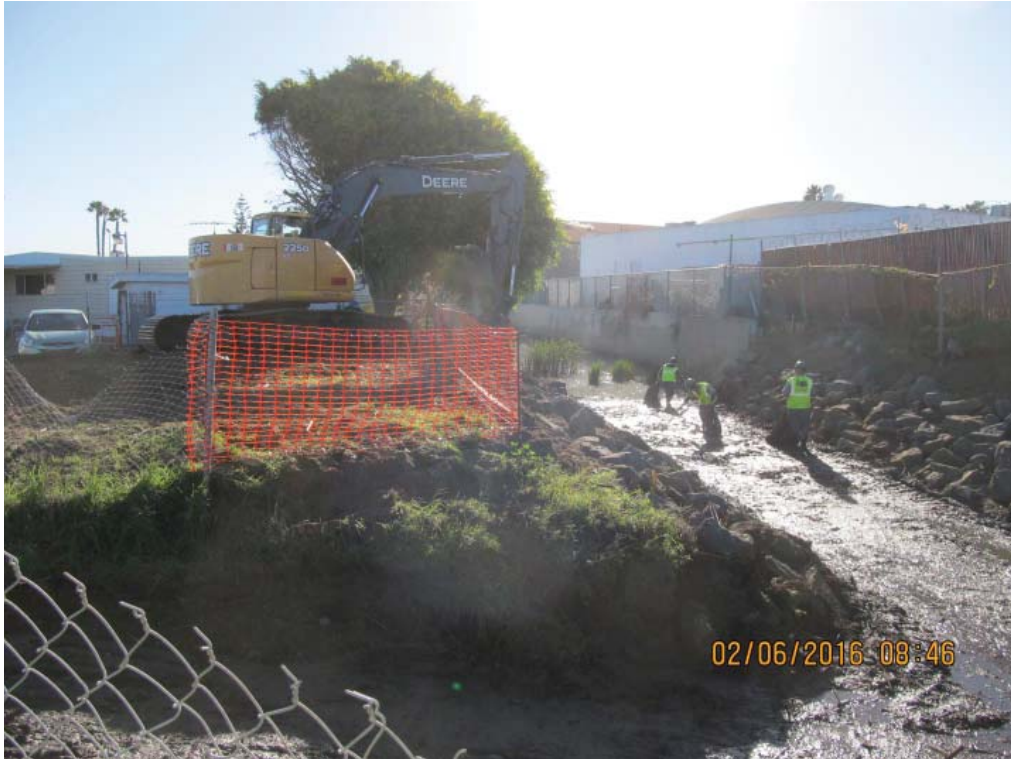
Removal of trash and vegetation from within the channel using hand-held tools.  
February 6, 2016

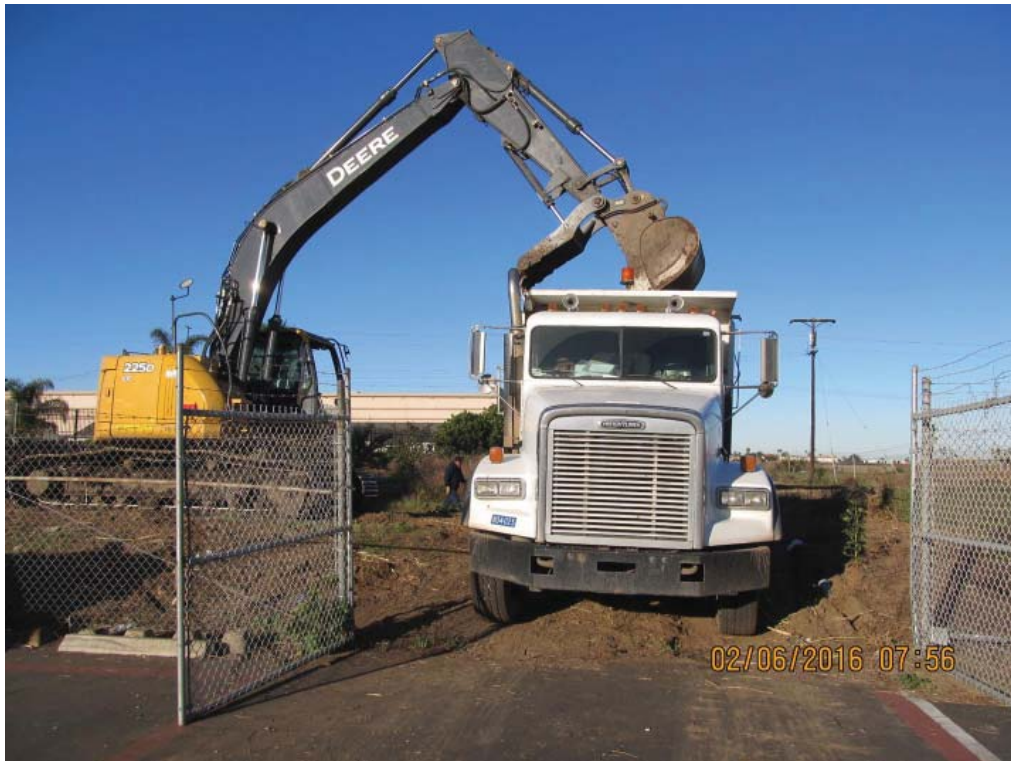
Debris loading into dump truck for removal from site.  
February 6, 2016

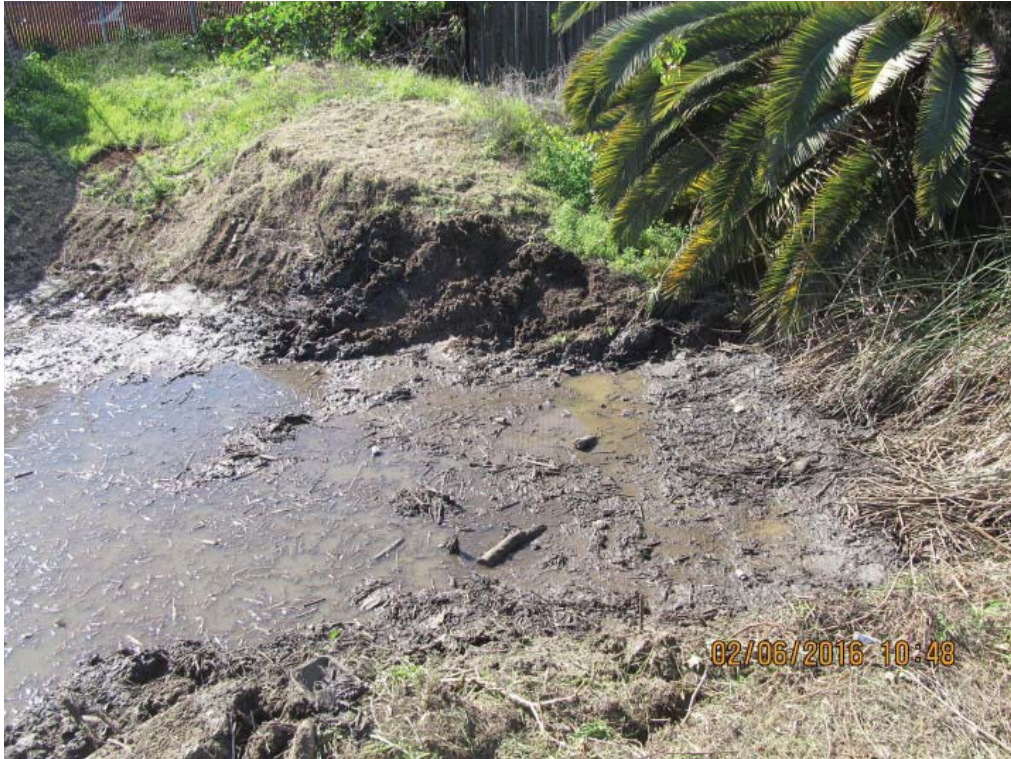
Cleared downstream portion of channel.  
February 6, 2016

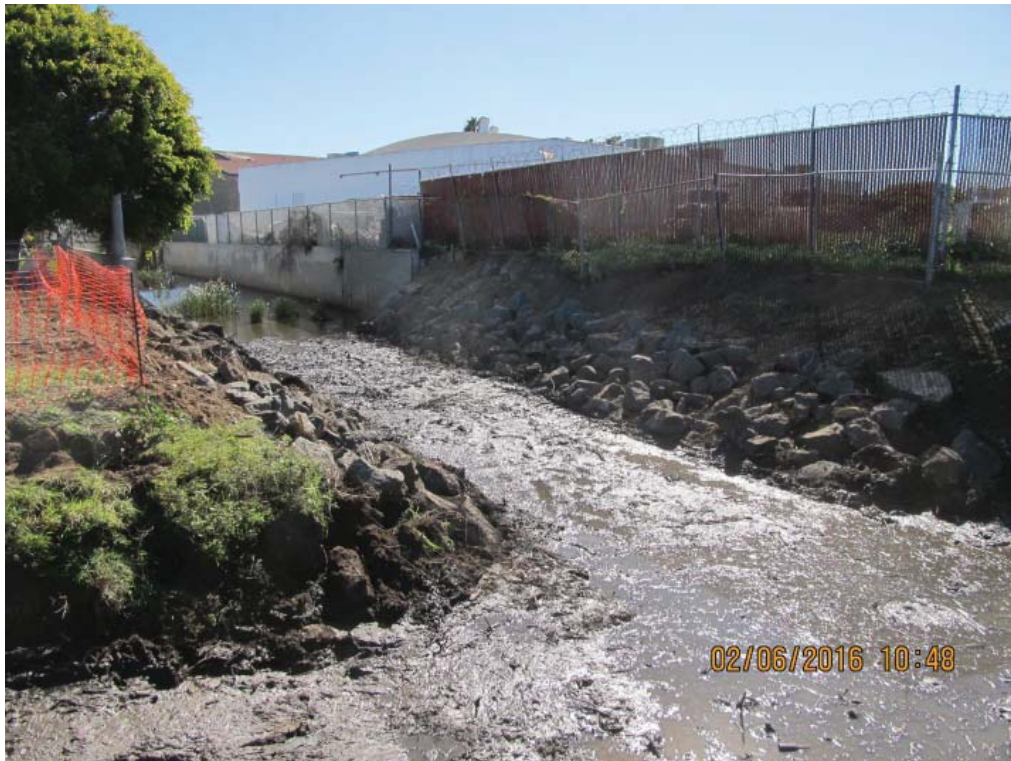
Cleared channel (facing south).  
February 6, 2016
