**GEOTECHNICAL DESKTOP STUDY  
COAST BOULEVARD BETWEEN  
PROSPECT PLACE AND SCRIPPS PARK  
CITY OF SAN DIEGO**

AGE Project No. 185 GS-16-J

October 18, 2019

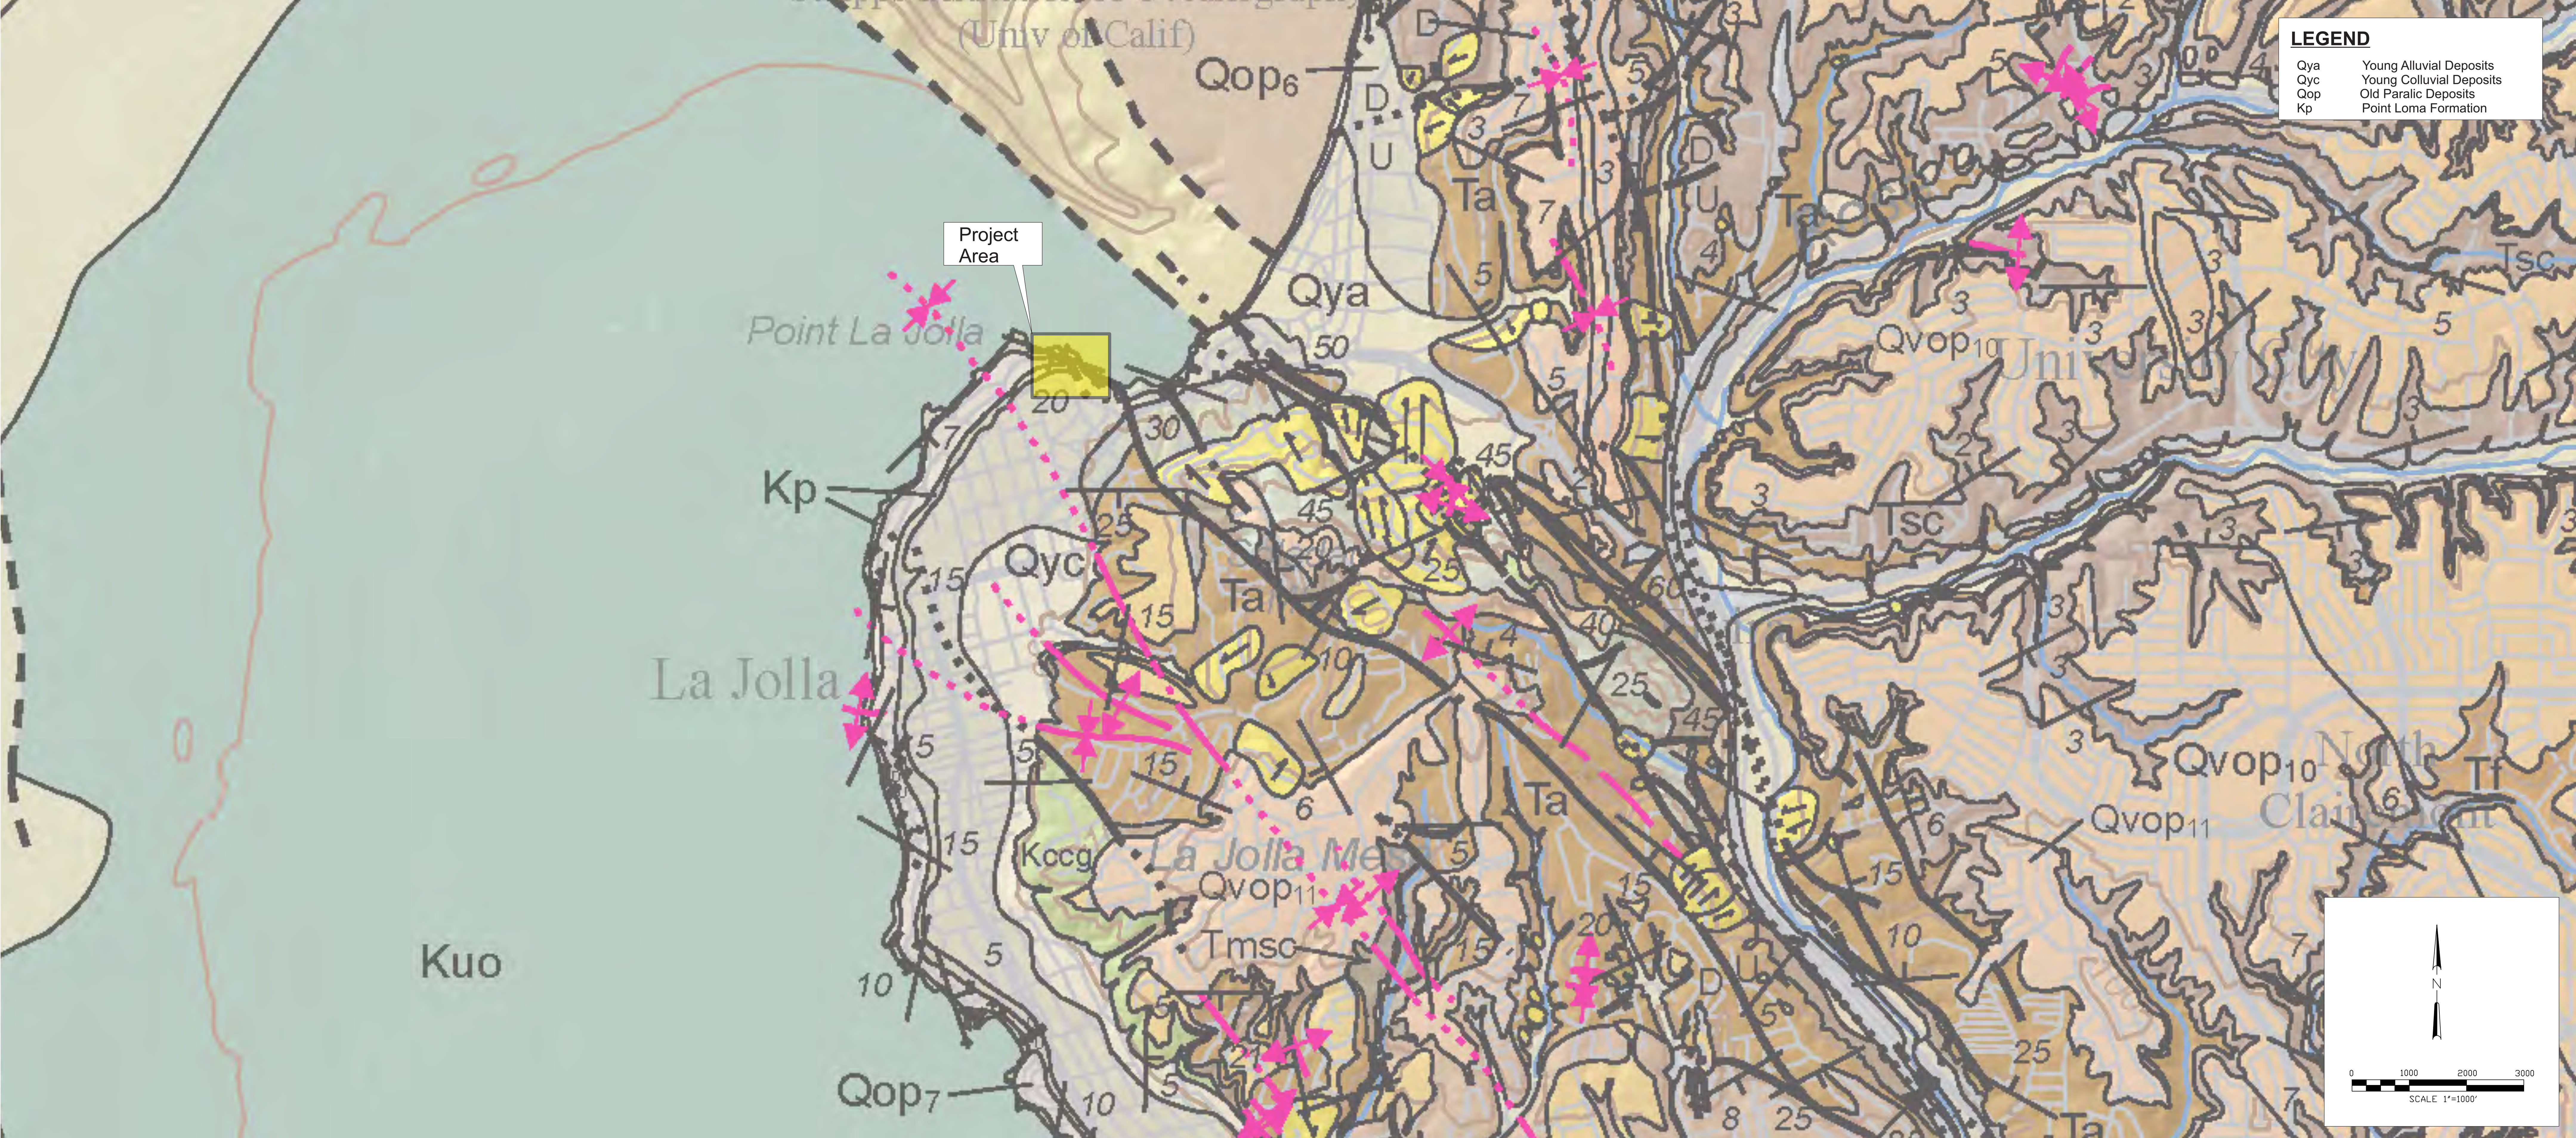
FIGURE 2

For site characterization purposes, the subsurface soil materials in the project study area can be categorized into three geologic units which include (in order of increasing age): fill materials; old paralic deposits unit 6; and Point Loma Formation. A brief description of each unit is presented below. A generalized geologic map of the project study area and surrounding areas is shown on Figure 2.

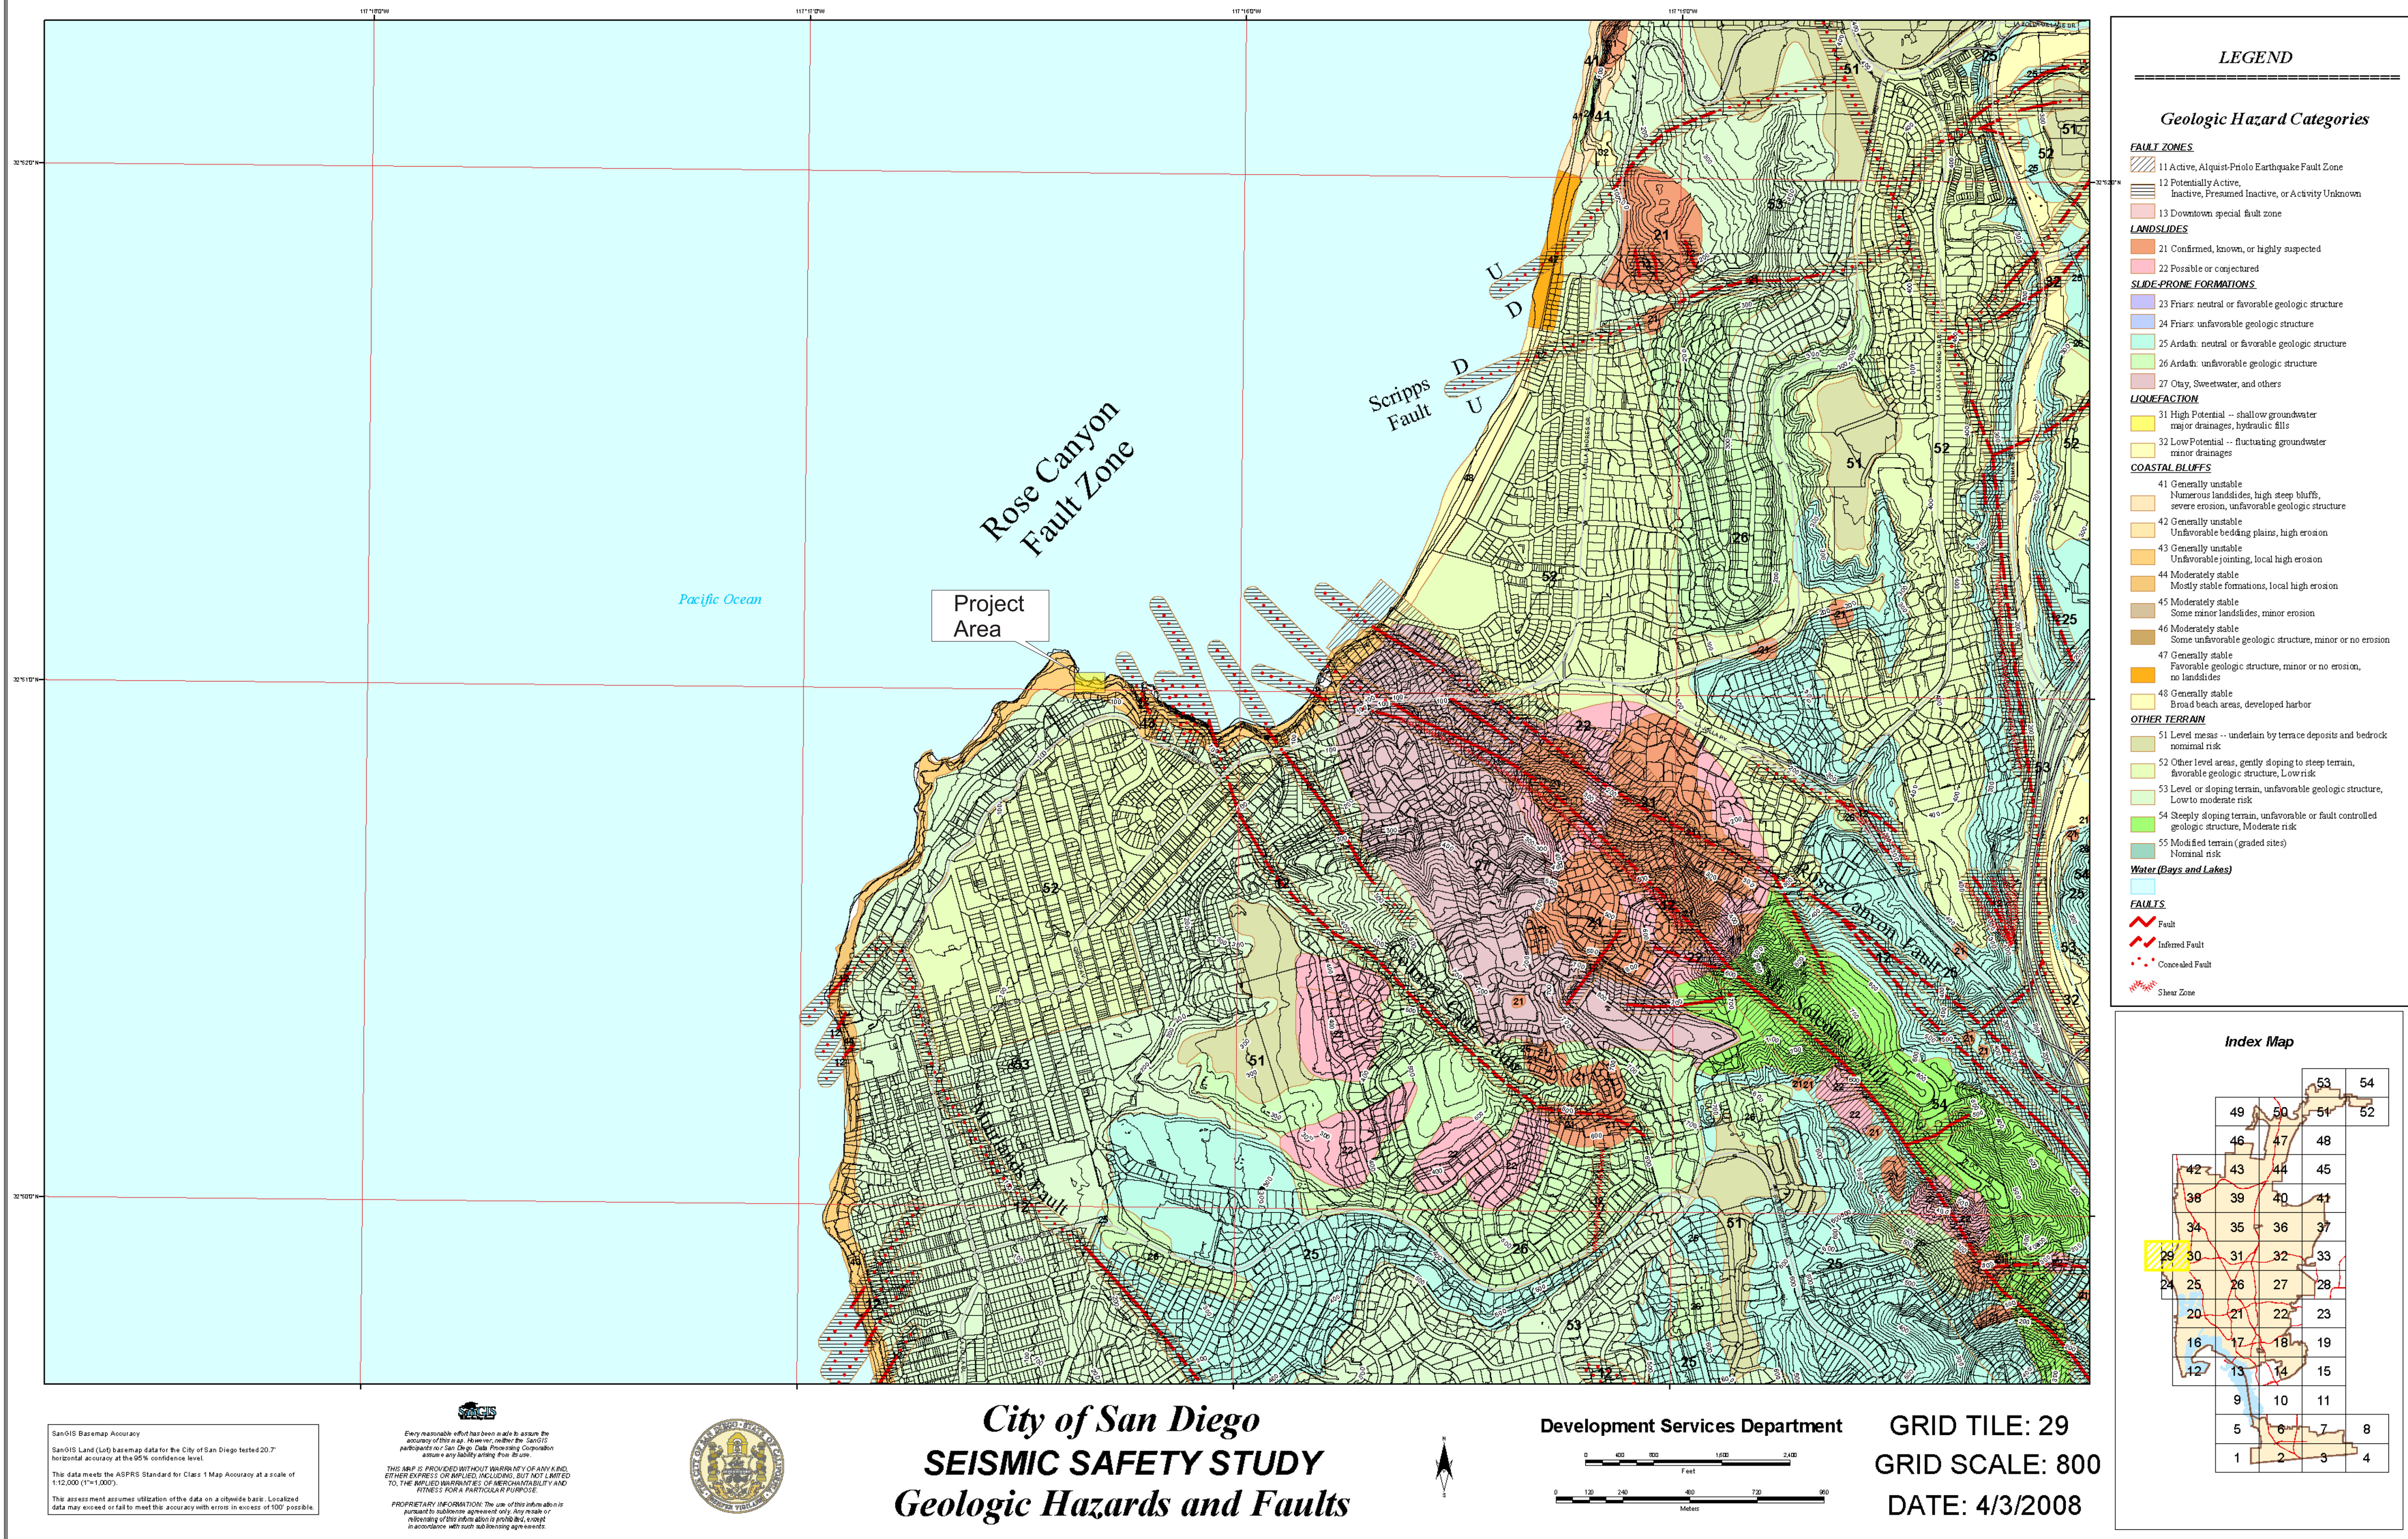
FIGURE 3

A review of the City of San Diego Seismic Safety Study Geologic Hazards and Faults Map Grid 29 (2008) indicates that the project study area is located in an area classified as a Coastal Bluff, Zone 43 - Generally unstable, with unfavorable jointing, and local high erosion. A copy of the map is shown on Figure 3.

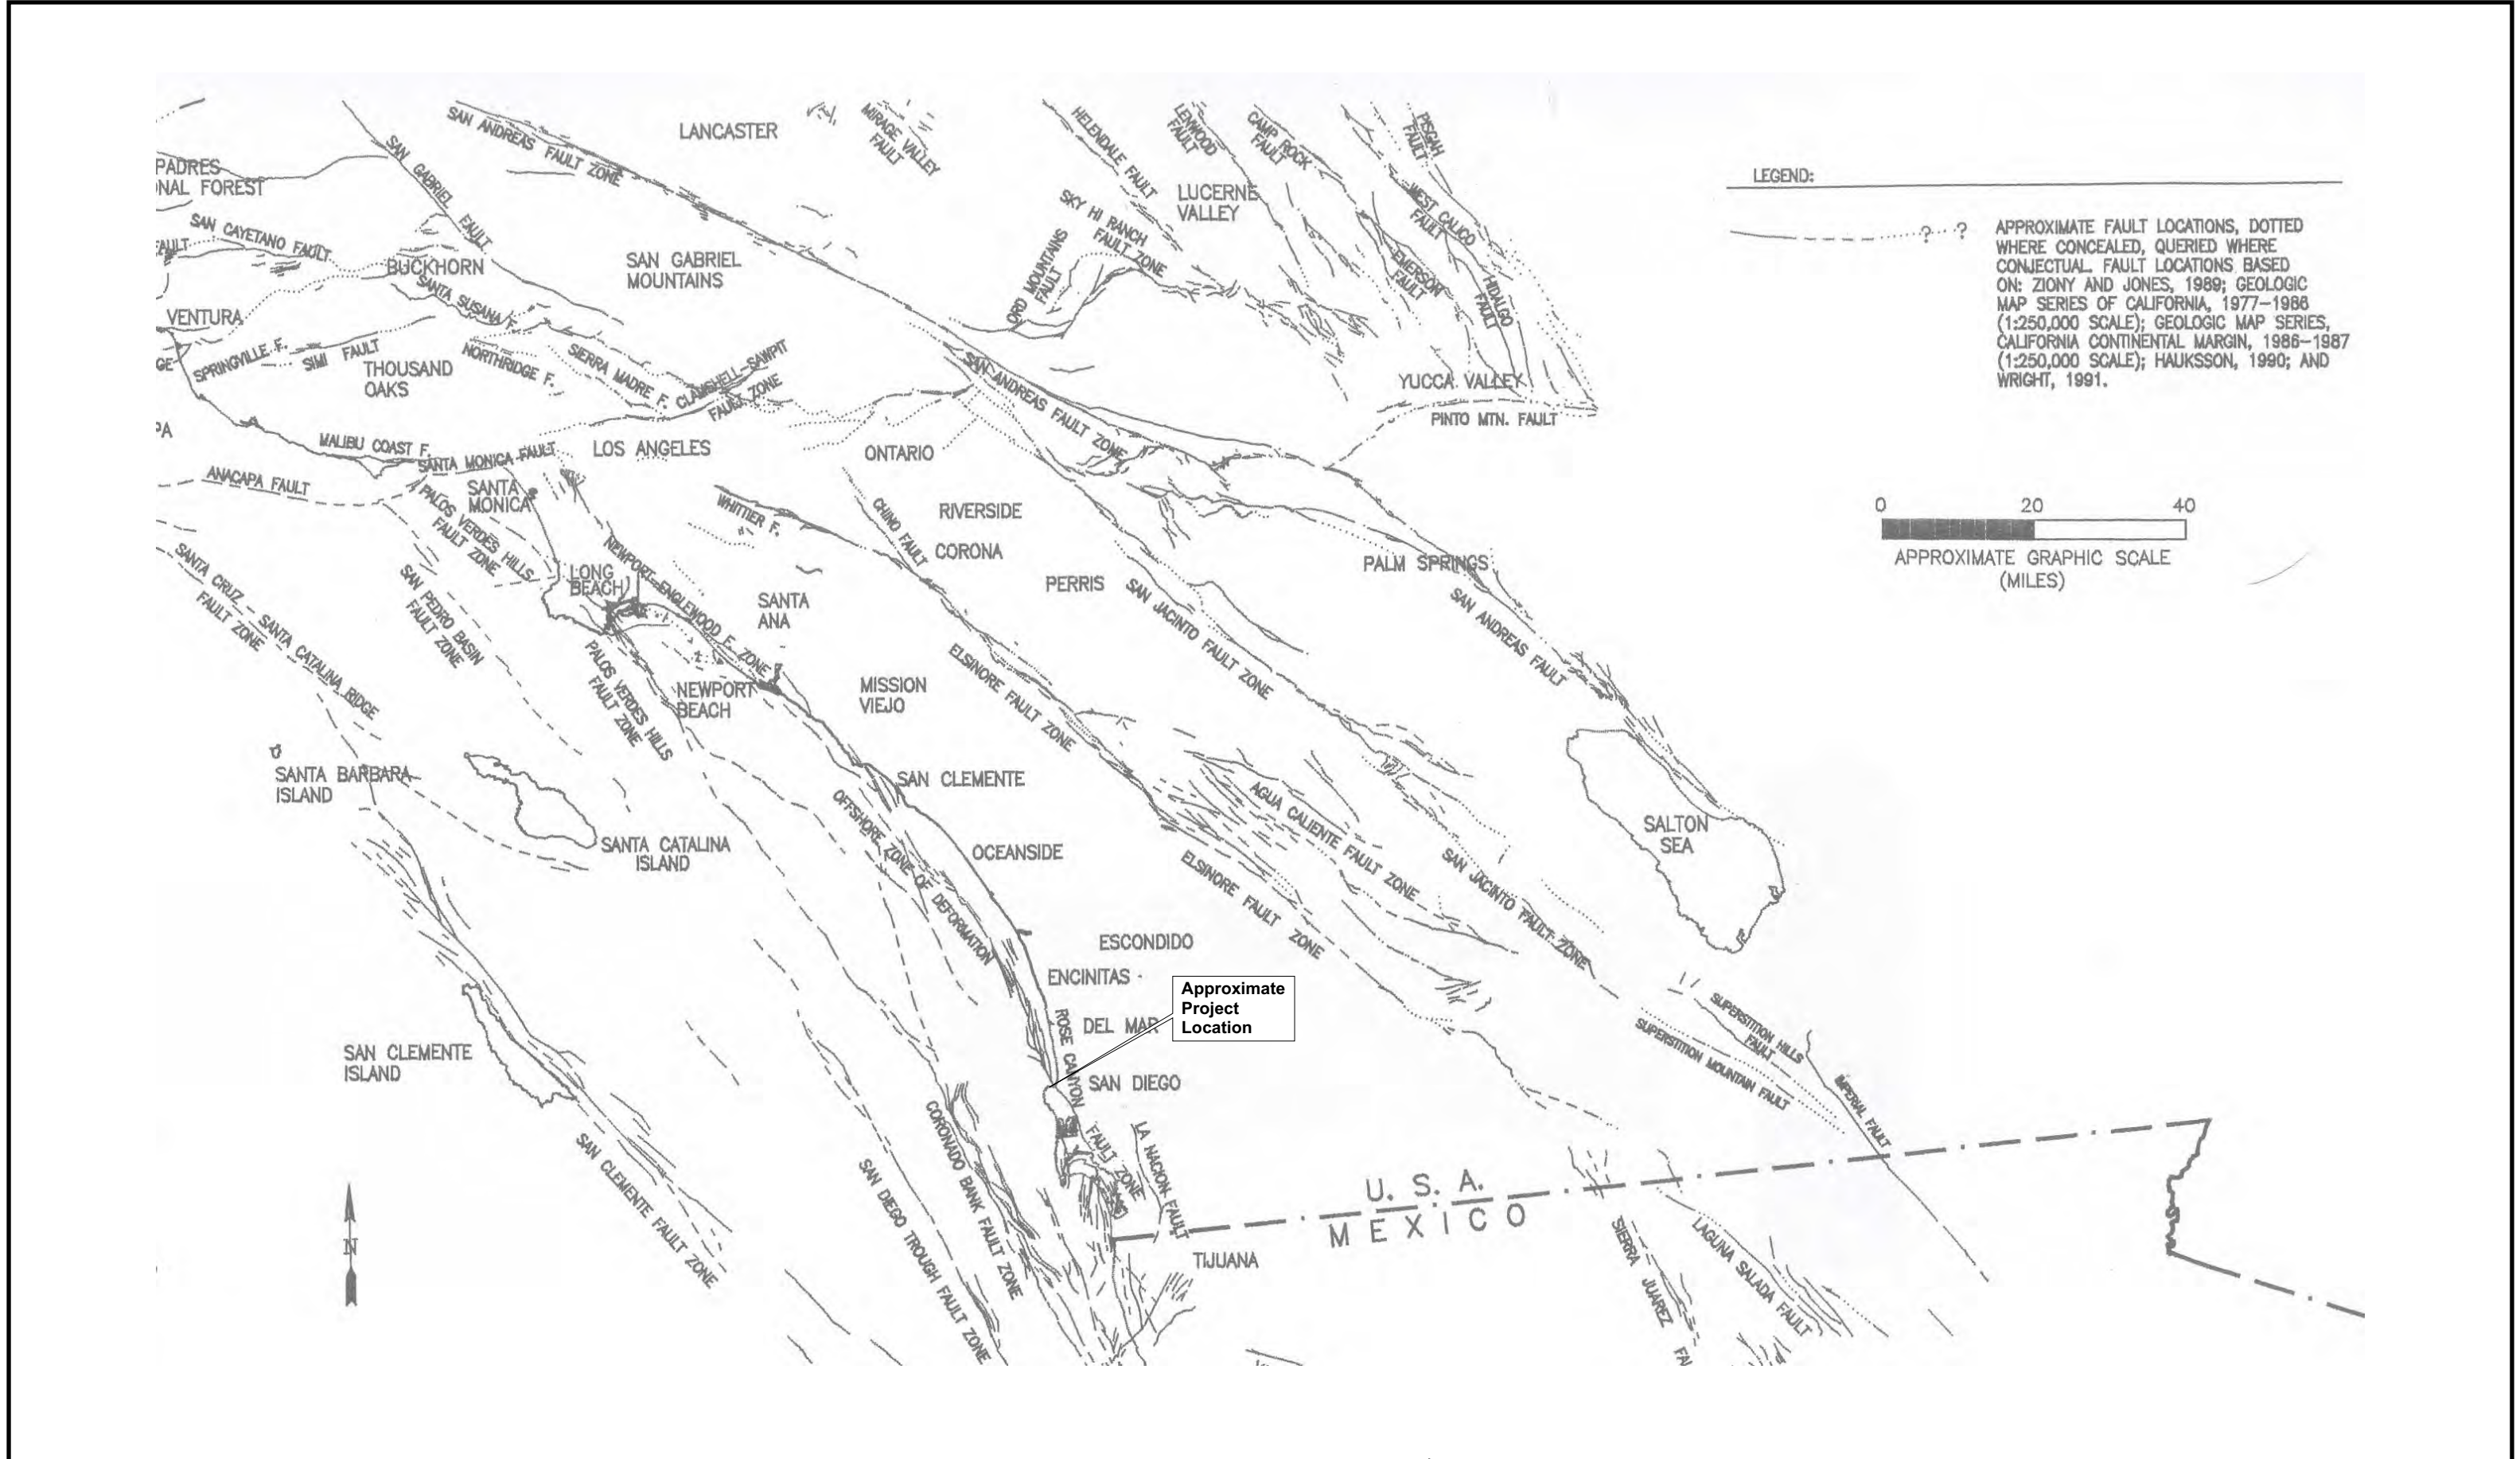
The location of the project study area in relation to the active faults in the region is shown on the Regional Fault Map (see Figure 4). California Department of Transportation ARS Online (V2.3.09) was used to approximate the distance of the closest ten (10) known faults to project study area. A summary of seismic source characteristics for faults that present the most significant seismic hazard potential to the project study area is presented in Table 1 below.

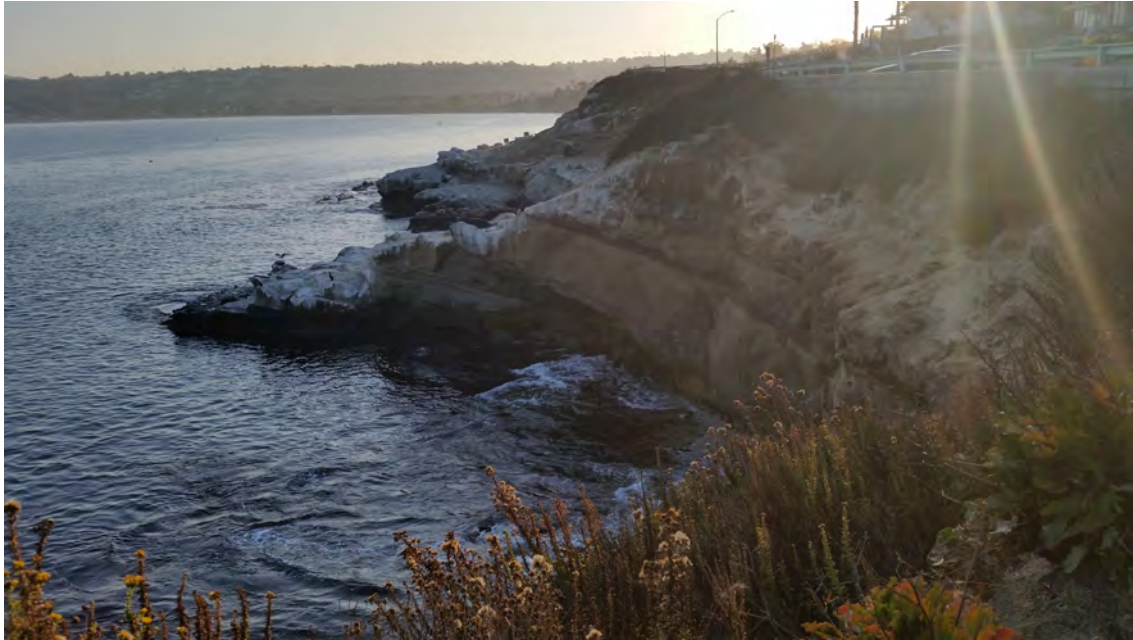
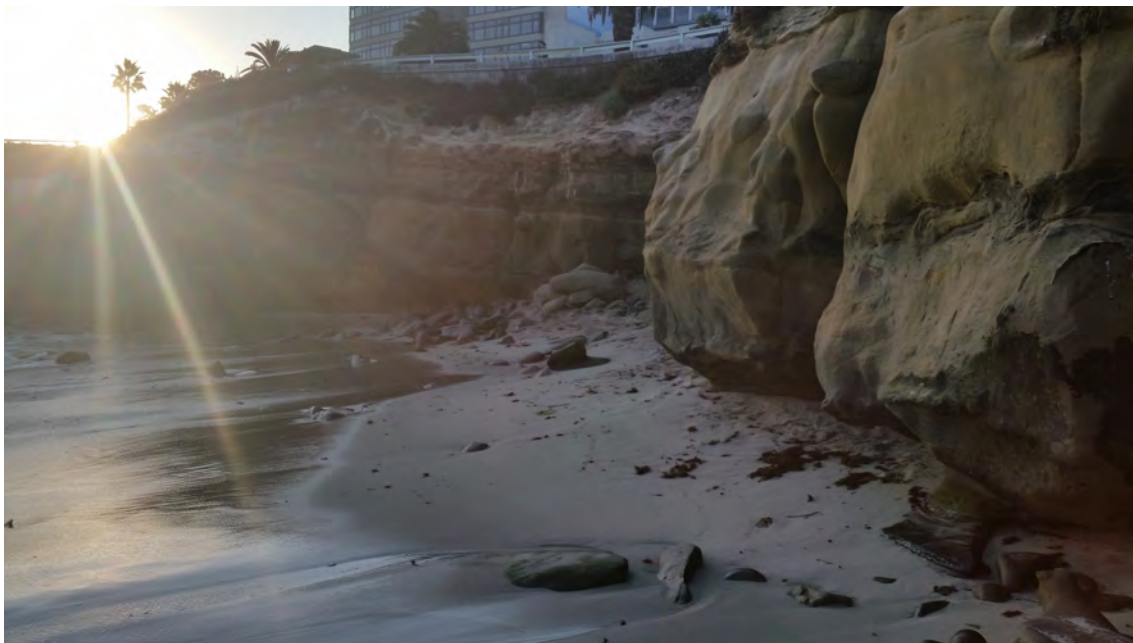
**PHOTOGRAPH A-1**

Bluff erosion and periodic rock falls on the sea cliffs are an ongoing concern along the project alignment. During our site reconnaissance visit we observed undercutting of an approximately 100-foot section of Coast Boulevard at the west end of the study area near Scripps Park. The undercutting is occurring within the Point Loma Formation due to wave and surf activity. Ongoing bluff erosion at this locality may affect Coast Boulevard.

Looking east from Scripps Park toward 10 feet deep undercut below the bluff.

Looking east from the beach at Scripps Park toward 10 feet deep undercut below bluff.

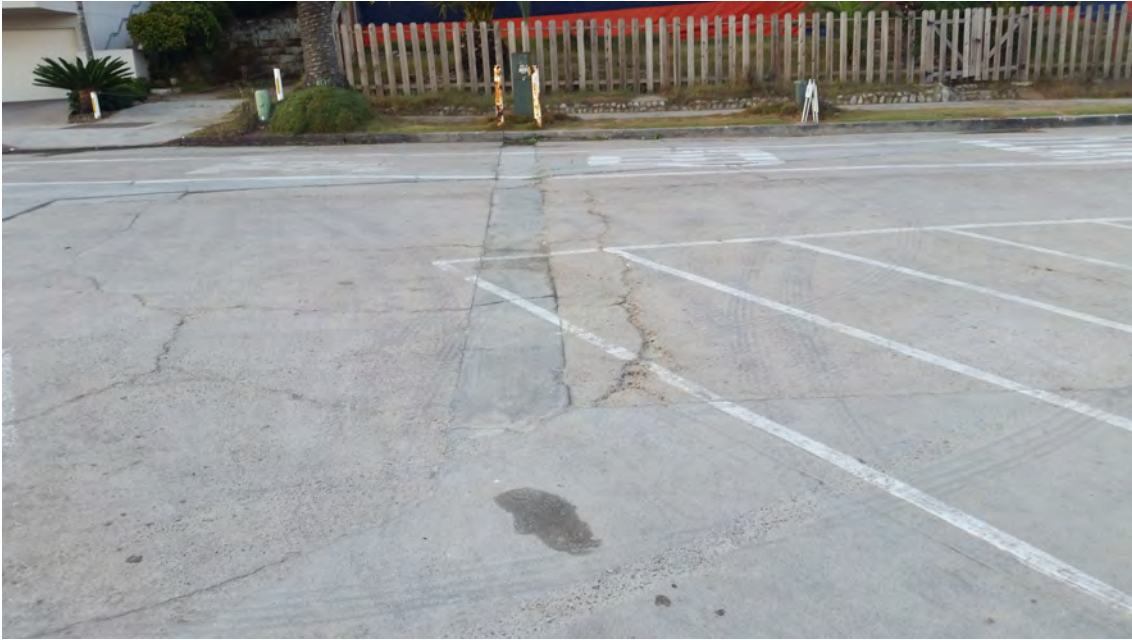
**PHOTOGRAPH A-2**

Existing concrete street pavement to the east and west of the new pavement area displays appreciable cracks and local subsidence that appears to be decades old. Several saw-cut areas of repair extend the length of the street along utility trenches, with a number of saw-cut areas of repair extending crosswise along utility laterals from existing residences. The saw-cut areas of repair are old, and also display cracking damages. Some localized areas of asphalt filling are also present in the street paving.

The cracking and subsidence damages in the street paving are consistent with age and localized subsidence from vehicle wheel loads. Long-term soil movement and disturbance of the subgrade soil materials due to the utility trenching has likely contributed to the paving damages. Given the age of the concrete it is doubtful that the paving is underlain by adequate base materials.

Typical pavement conditions between Scripps Park and Cook's Crack Sea Cave.

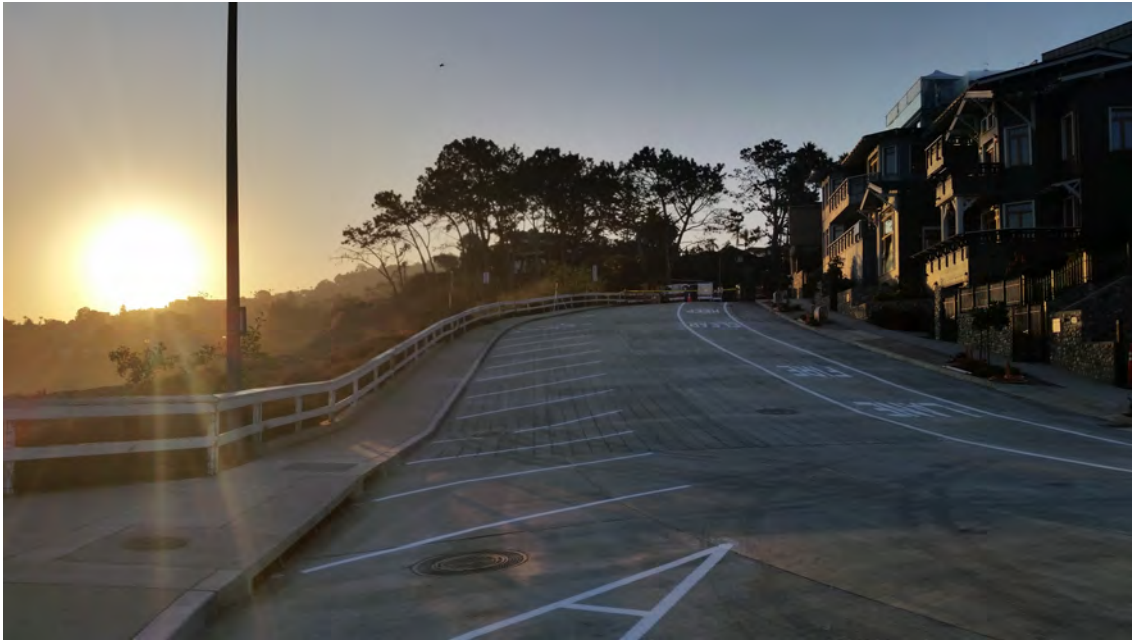
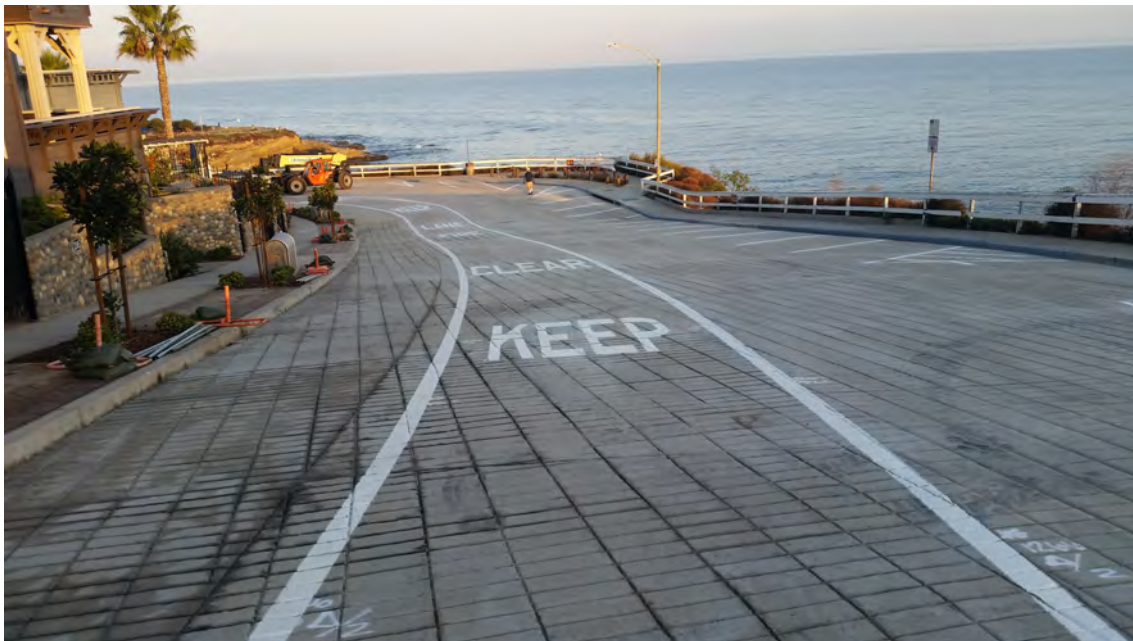
**PHOTOGRAPH A-3**

At the time of our field reconnaissance, the stabilization of the Cook's Crack Sea Cave had been completed, and the installation of the new concrete pavement and sidewalk have been completed. Personnel from Flatiron Construction were in the process of cleaning up the site. Based on verbal information, it is our understanding that approximately 610 cubic yards of slurry was utilized to fill the sea cave.

Looking northeast at the new pavement and sidewalk above Cook's Crack Sea Cave.

Looking southwest at the new pavement and sidewalk above Cook's Crack Sea Cave.

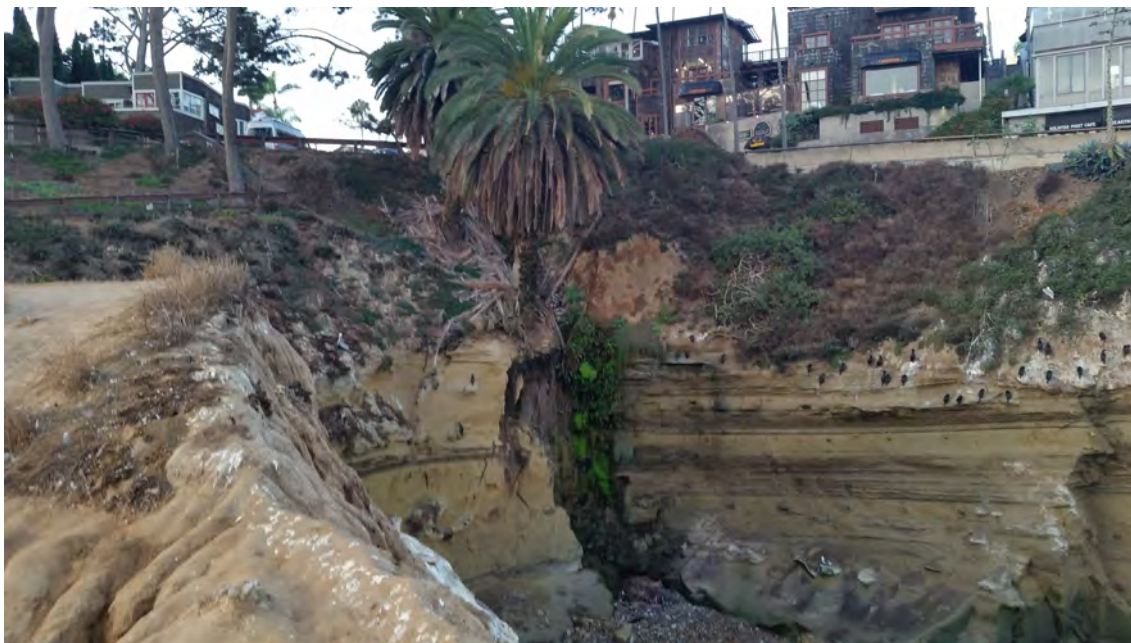
It is also noted that, although AGE's representatives were unable to visually confirm the location of the stormdrain pipeline outlet, erosion due to stormwater runoff was observed on the face of the bluff located below the assumed location of the stormdrain outfall.

Bluff erosion due to stormwater runoff was observed in the area below the assumed location of the stormdrain outfall. However, since the scope of work for the proposed project does not increase the drainage area of the existing stormdrain system, the proposed project is not anticipated to increase the erosion rate of the face of the bluff beneath the outfall.

Looking south from promontory by Sunny Jim Cave at bluff erosion from storm drain outfall.
