Mission Trails Regional Park Master Plan Update
Hazardous Materials/
Unexploded Ordnance (UXO) Review

GHD Inc.

May 2016

Client: U.S. Army Corps of Engineers
Location: Tierrasanta Project Area, San Diego, California
Photograph Dates: November 16 - 20, 2006

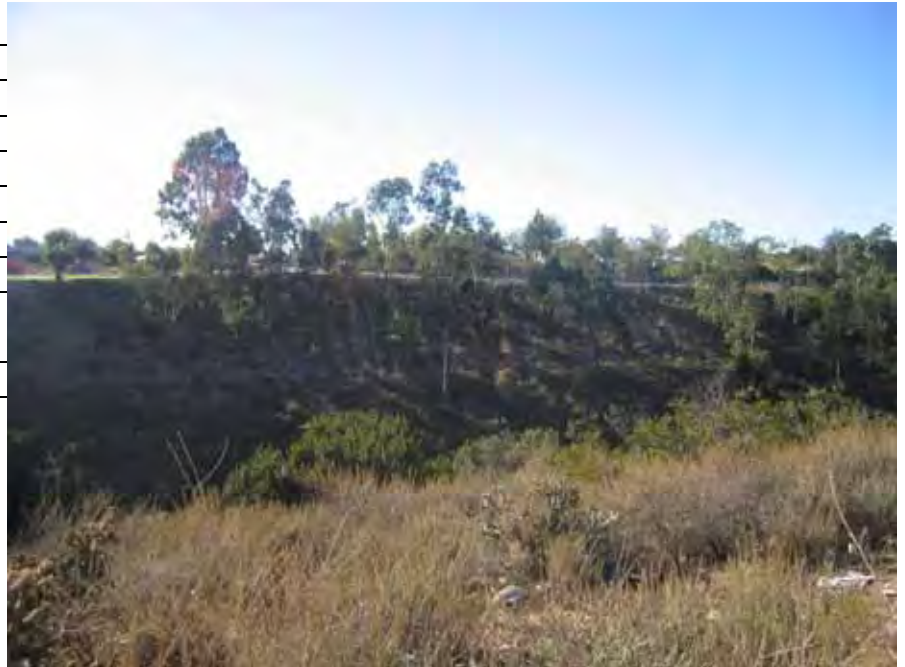
Erosion on eastern side of Santo Road

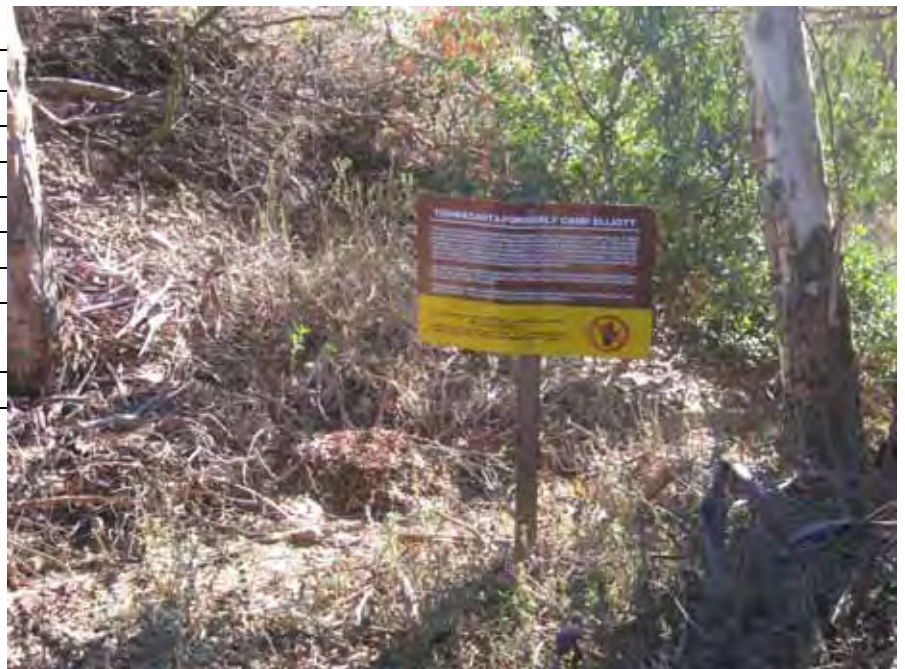
Photograph No. 2

MEC warning sign at Roadrunner Park.

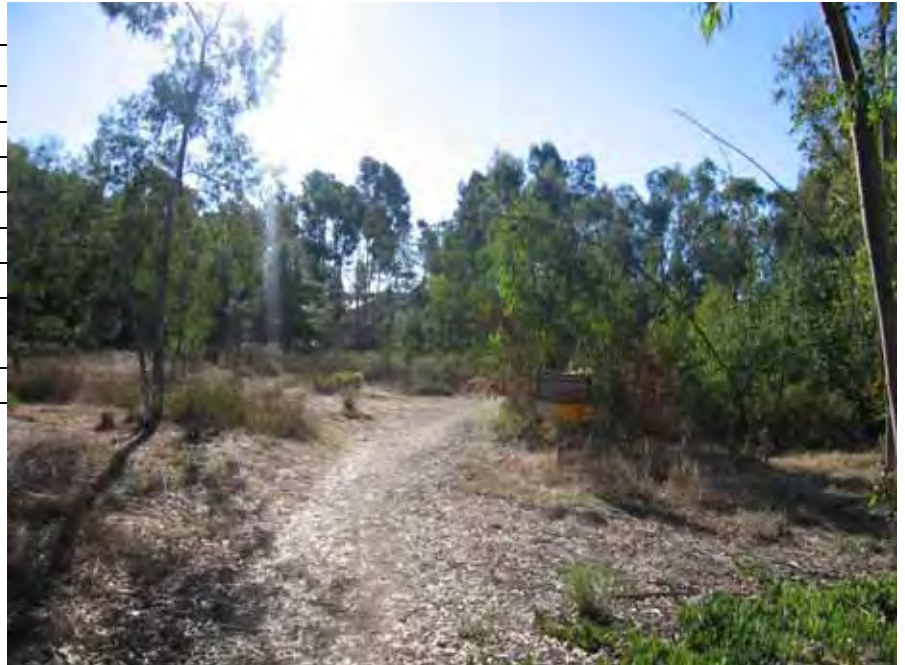
F-2M. Good vegetation; some evidence of burning; minor vandalism to sign.

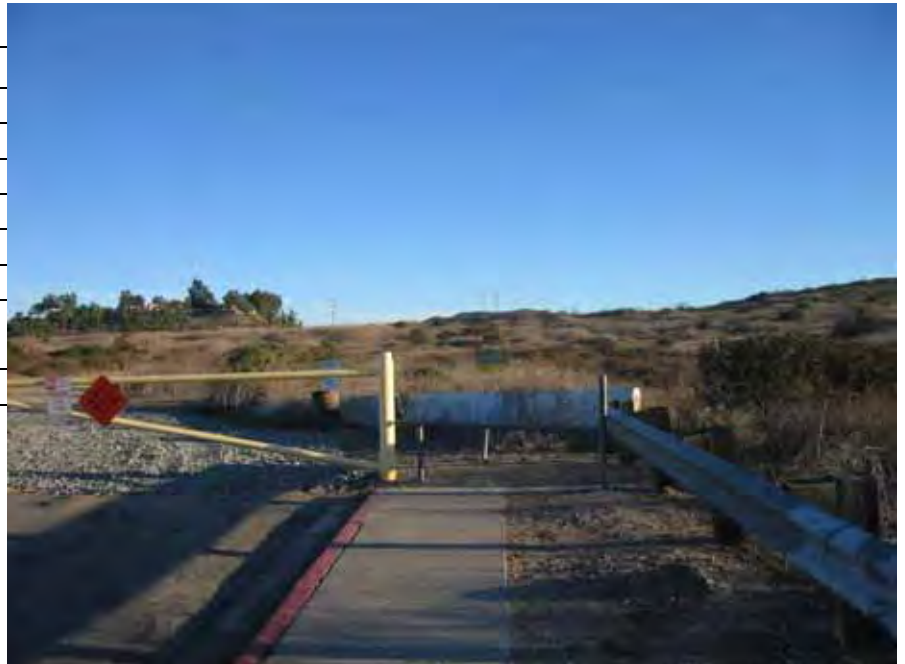
E-2 in background. Park entrance end of Colina Dorada Dr. Area burned in fire, fully recovered, good vegetation. MEC sign in good condition.

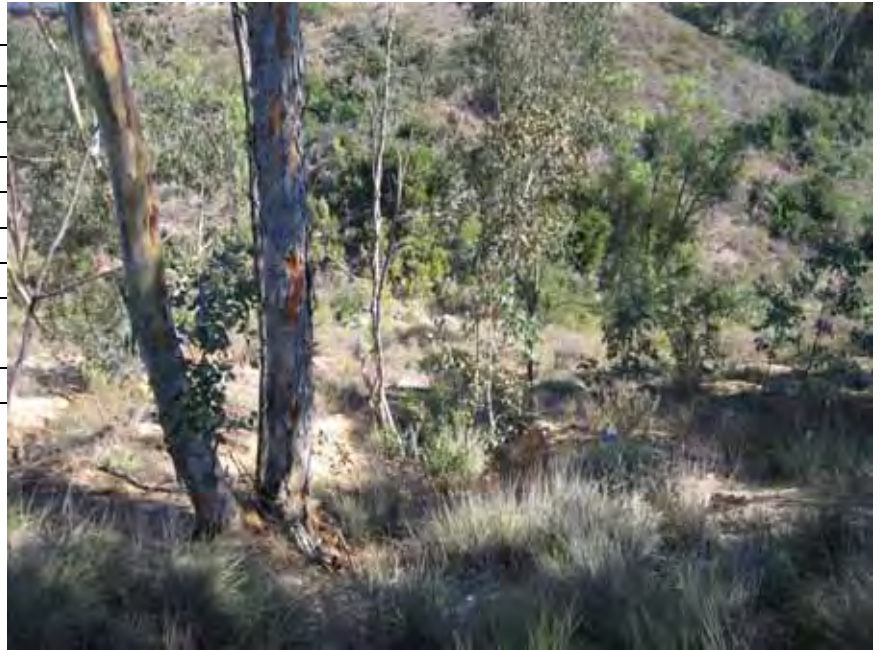
F-1. Area did not burn in fire, better vegetation. Erosion improved.

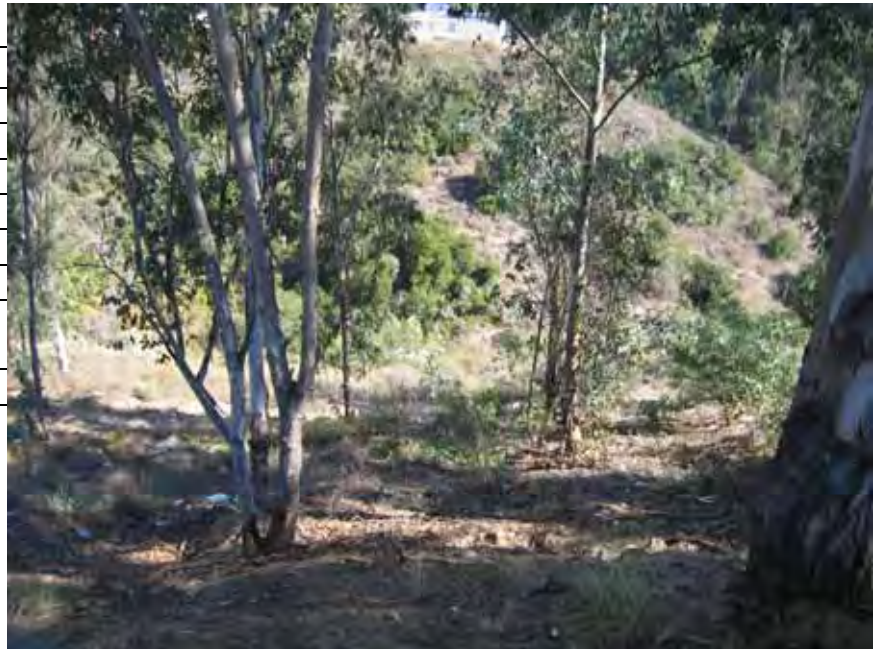
**Photograph No. 52**

F-1. Area did not burn in fire, better vegetation. Erosion improved. Same area as above.

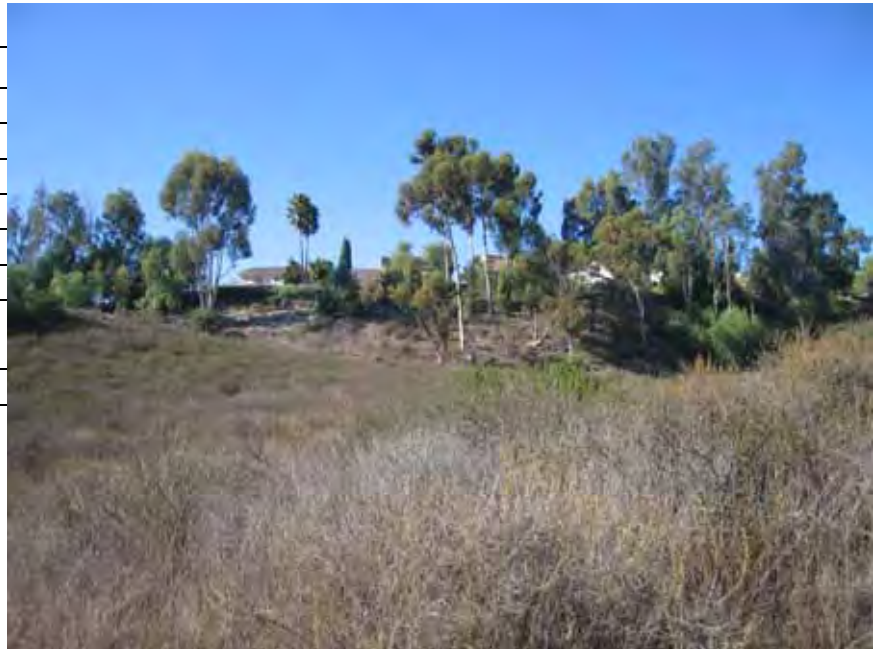
F-5N. Area burned in fire, vegetation recovered. Previous minor erosion on slope below house better, more vegetation.

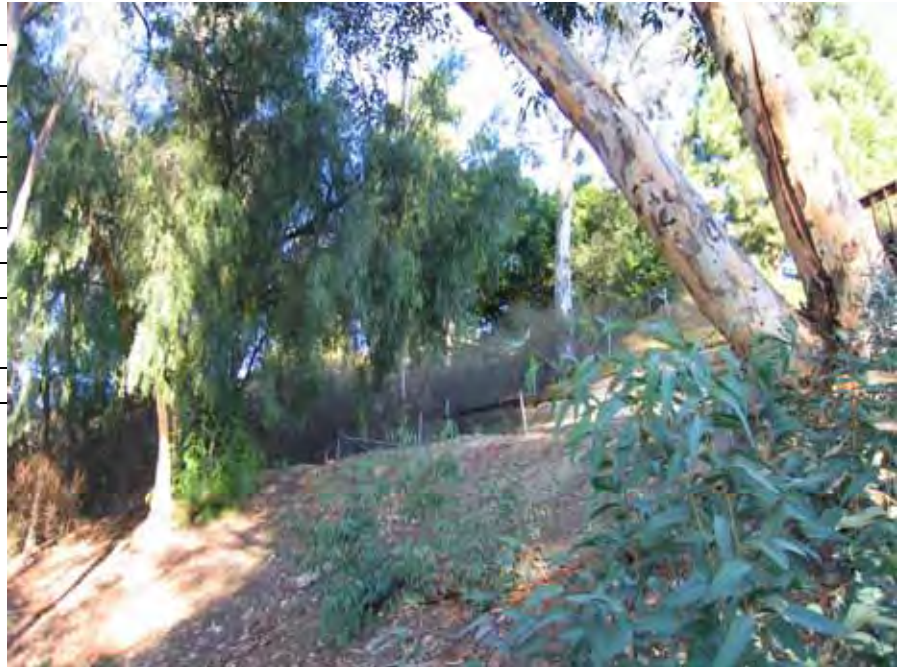
F-5N. Previous minor erosion on slope below house unchanged. This area of F-5N did not burn.

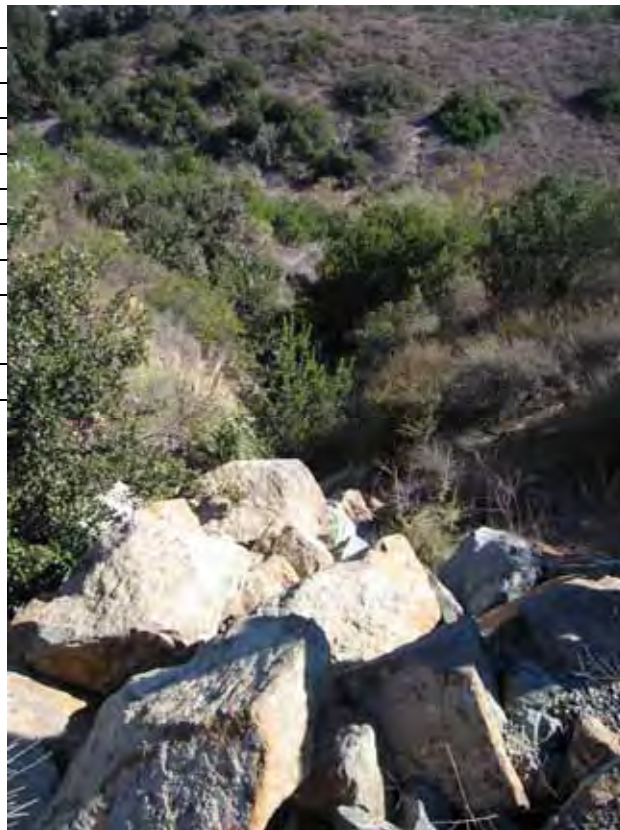
F-1. Looking down large gully now repaired.

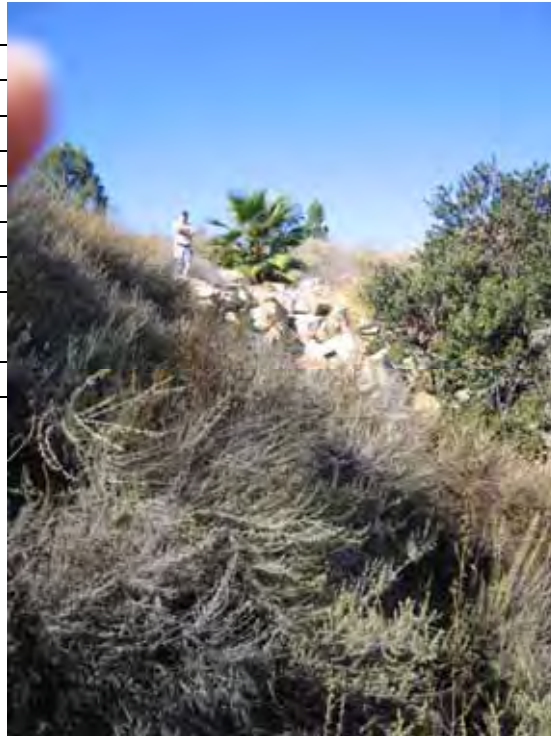
F-1. Large gully now repaired.
