INDIVIDUAL WATER QUALITY ASSESSMENT REPORT

Site Name/Facility:	San Carlos Channel
Master Program Map No.:	54
Date:	May 15, 2018
Civil Engineer (name, company, phone number):	N/A
Register Civil Engineer Number & Expiration Date (place stamp here):	N/A

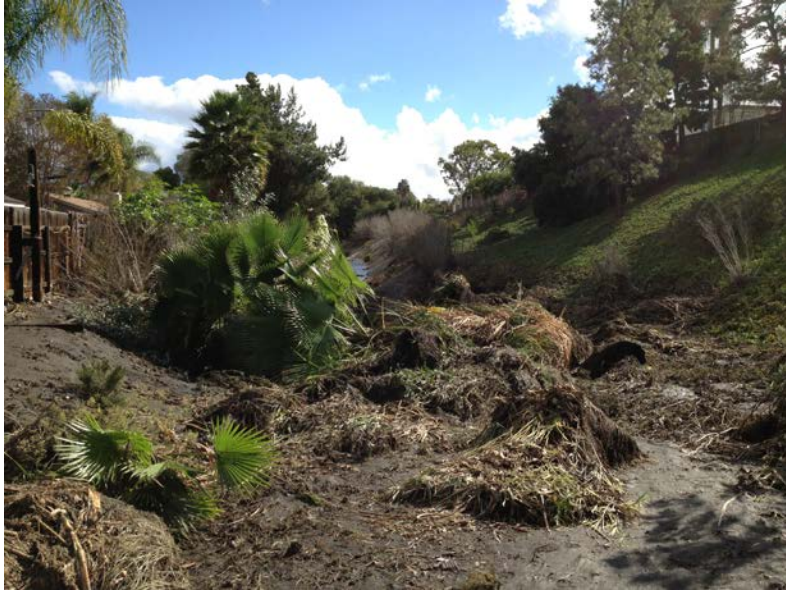
Photo 1. General condition of the San Carlos Channel and adjacent area, on 11/1/2014 after initial storm, prior to work beginning and prior to second storm began.

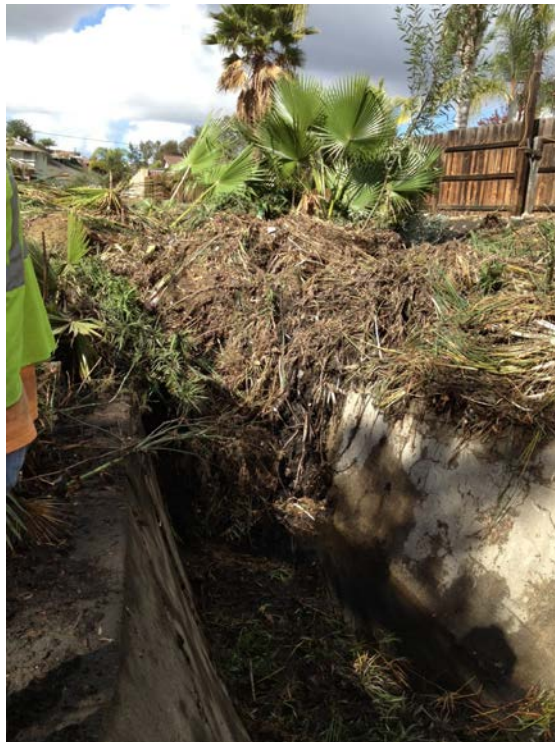
The emergency maintenance was performed in two phases. The first phase was required to remediate flooding caused by a clog in the culvert beneath Cowles Mountain Boulevard. The clog was formed by vegetation within the Beaver Lake section becoming dislodged by a high rainfall event, and accumulating at the entrance to the culvert. The second phase was conducted to remove remaining vegetation within the channel further upstream of the Cowles Mountain Boulevard channel to prevent a re-occurrence of a clog.

Photo 2. Condition of opening to culvert on 11/1/2014 after initial storm, prior to work beginning and prior to second storm began.

The first phase began on November 1, 2014 within the Beaver Lake and Golf Course sections, and was completed on November 8, 2014. The initial work to clear the culvert was conducted with a Gradall and backhoe from the area above the culvert entrance. In addition, vegetation and sediment were removed for a distance of approximately 180 feet within a concrete channel downstream of the culvert. In order to preclude a similar problem from occurring in the future, vegetation was cut and removed by hand from the sloped sections along the entire length of the Beaver Lake section of the channel. The excavated material was taken to an approved disposal site. Approximately 158 tons of material was removed from the channel.

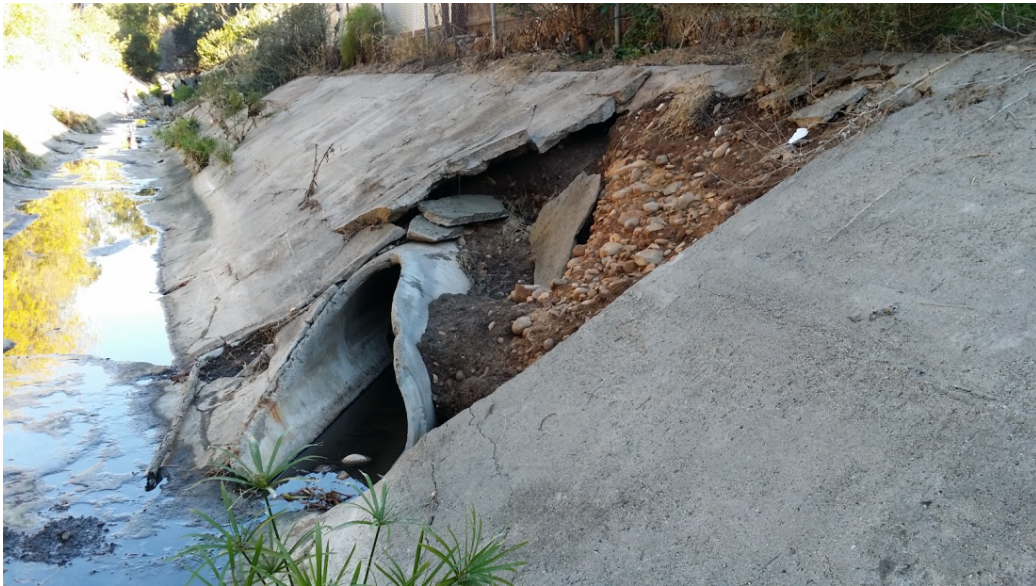
Photo 3. Condition of upstream portions of San Carlos Channel on 11/6/2014 after rain event. Note the concrete panels that have broken off and washed down into the channel.

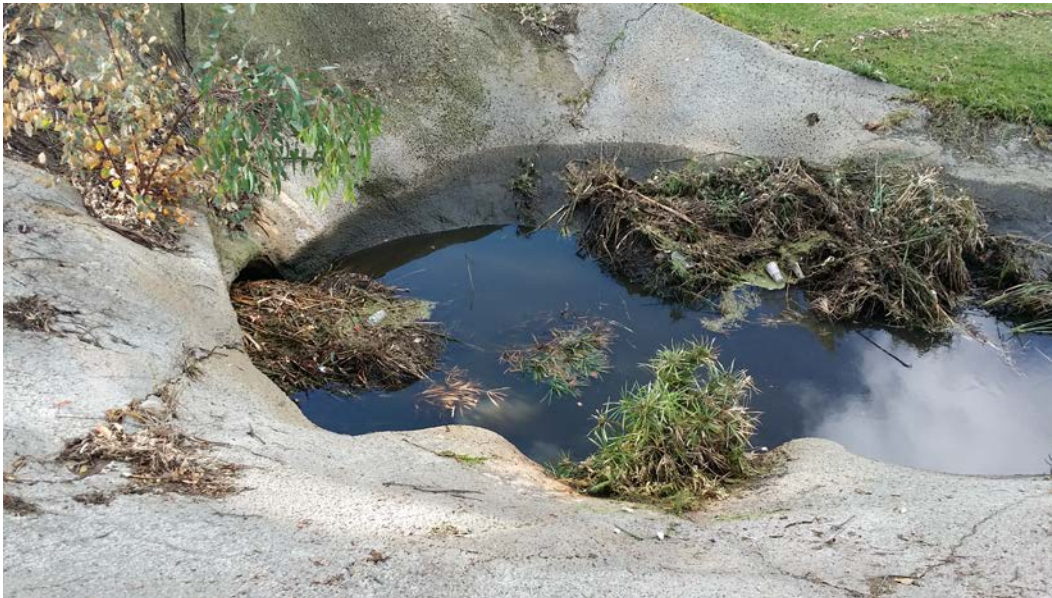
Photo 4. Condition of channel east of Cowles Mountain Blvd after first rain event on 11/1/2014, prior to emergency maintenance commencing, looking at outlet to culvert.

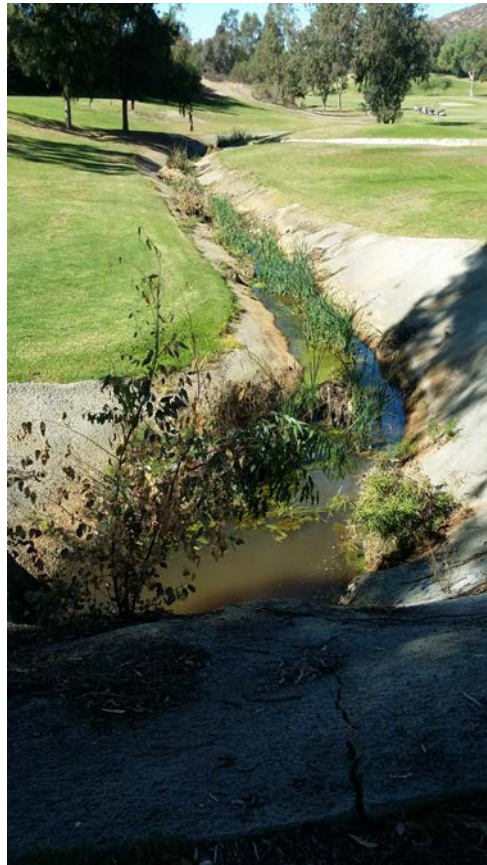
Photo 5. Condition of channel east of Cowles Mountain Blvd prior to emergency, 10/30/2014, looking west of culvert.

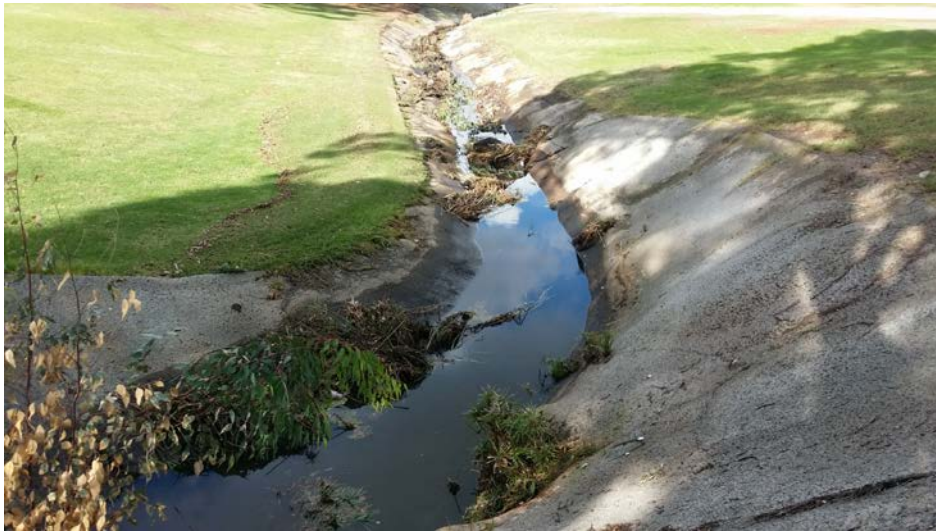
Photo 6. Condition of channel west of Cowles Mountain Blvd after rain event on 11/1/2014, prior to emergency maintenance commencing.

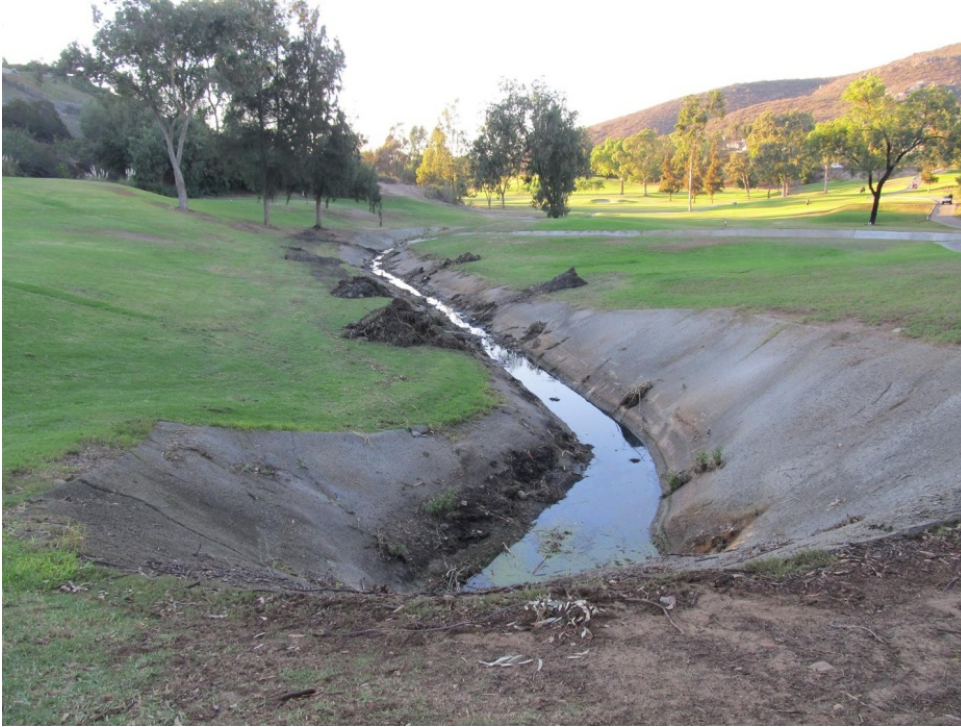
Photo 7. Condition of channel west of Cowles Mountain Blvd after emergency maintenance activities commenced.
