UPDATED HAZARDOUS MATERIAL TECHNICAL STUDY

Otay Mesa Community Plan Update San Diego, California

Project No. 09721-06-02
October 11, 2012

Subject: OTAY MESA COMMUNITY PLAN UPDATE
SAN DIEGO, CALIFORNIA
UPDATED HAZARDOUS MATERIALS TECHNICAL STUDY

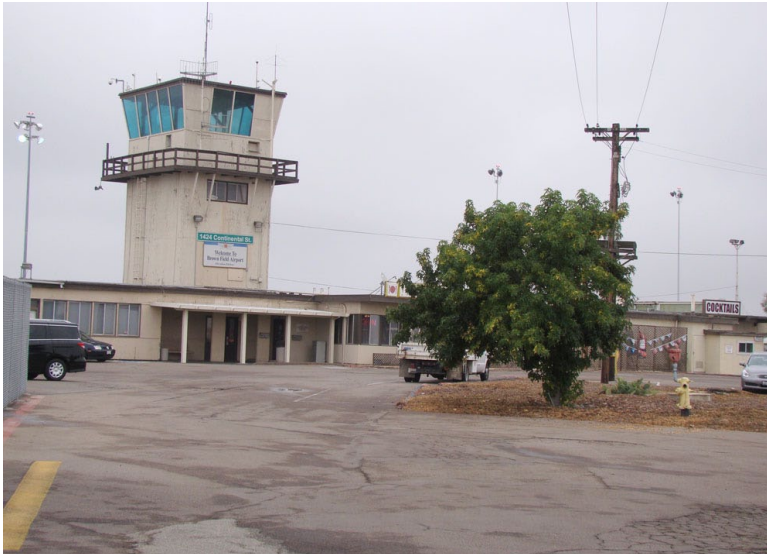
Photo No. 1 Area 1 - Administration and control tower building at 1424 Continental Street in the central portion of the Brown Field operations area (Map ID 2)

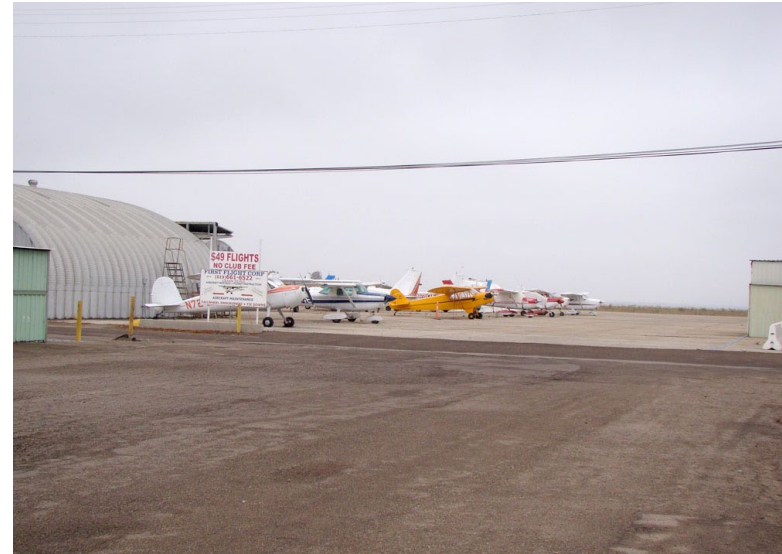
Photo No. 2 Area 1 - Hangars and private planes in northwestern portion of the Brown Field operations area (Map ID 2)

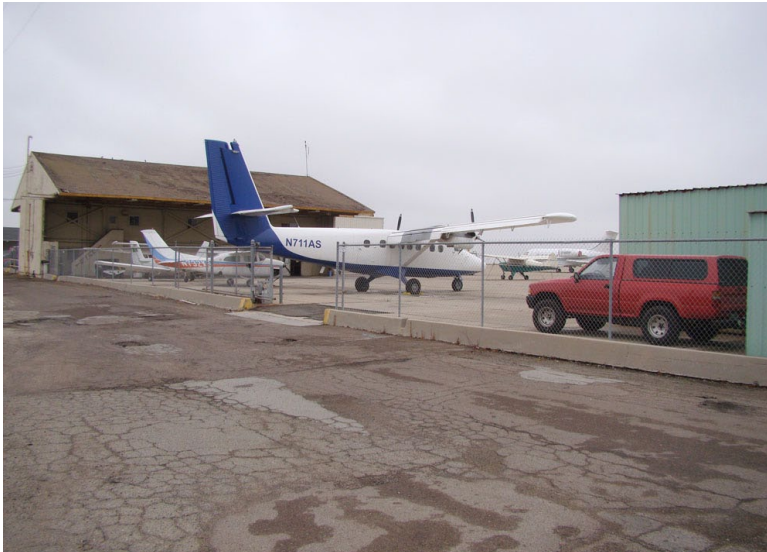
Photo No. 3 Area 1 - Hangar in northern portion of the Brown Field operations area (Map ID 2)

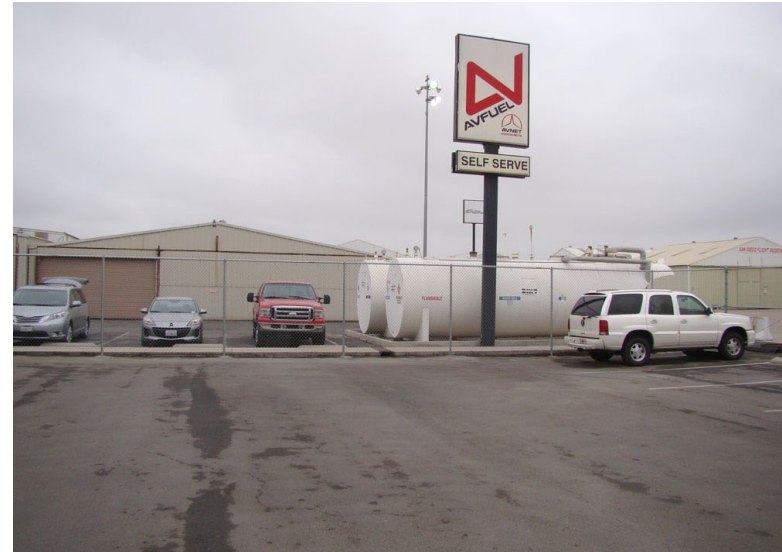
Photo No. 4 Area 1 - ASTs containing jet fuel north of the administration and control tower building in the Brown Field operations area (Map ID 2)

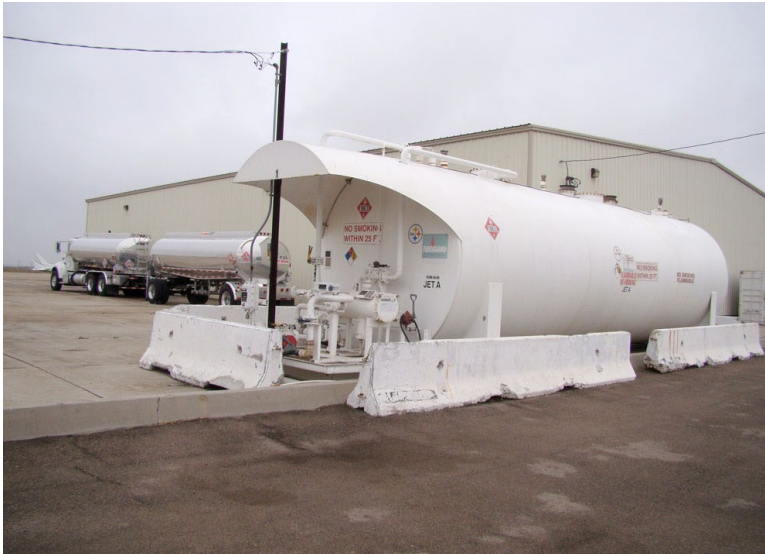
Photo No. 5 Area 1- ASTs containing jet fuel south of the hangars in the Brown Field operations area (Map ID 2)

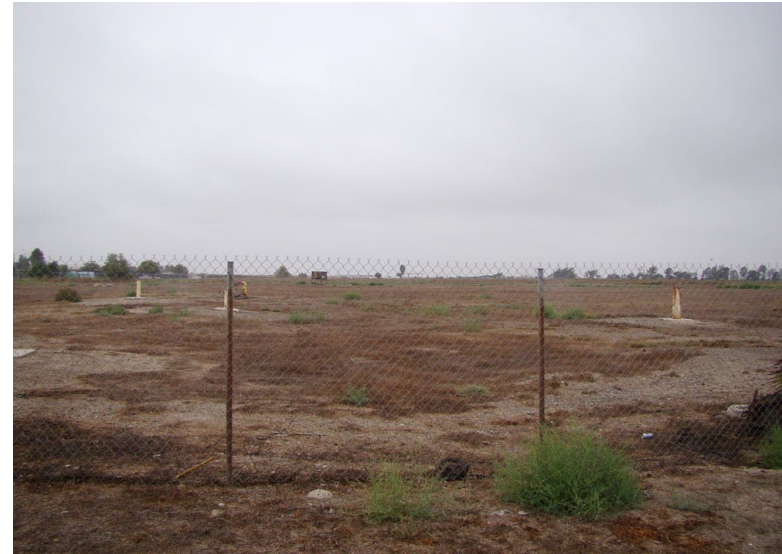
Photo No. 6 Area 1 - Former fuel farm west of the Brown Field operations area (Map ID 2)

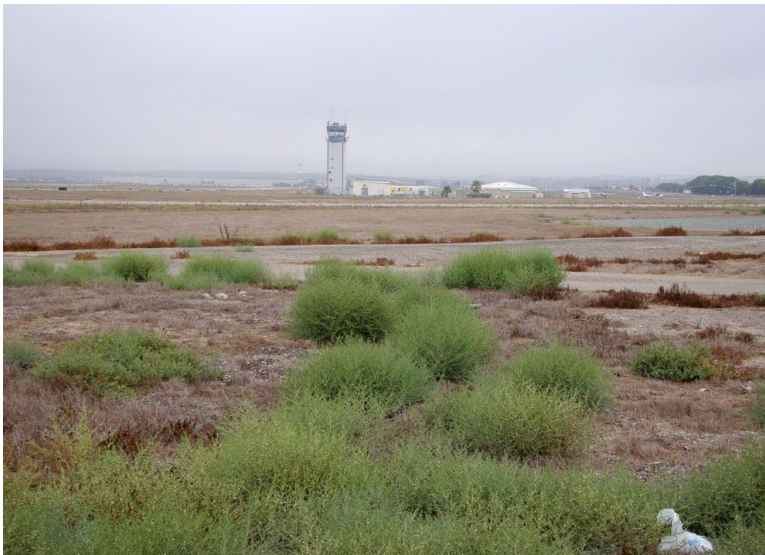
Photo No. 7 Area 1 - Runways and control tower east of the Brown Field operations area (Map ID 2)

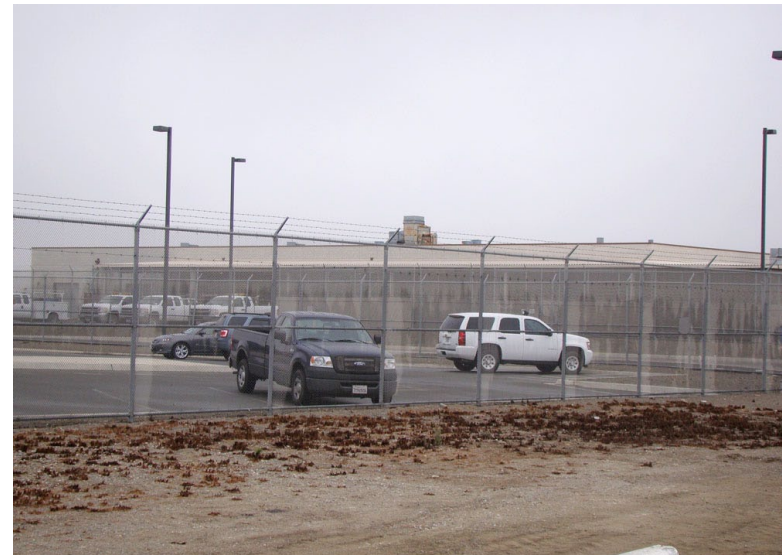
DEH records reviewed for our 2007 HMTS regarding Case No. H37776-001 indicated that an assessment conducted in 1998 identified 3,000 cubic yards of lead-containing soil at this facility. Additional assessment in 2000 found that at least 3,500 cubic meters of soil at the three firing ranges contained high concentrations of lead, antimony, arsenic, copper, molybdenum, and zinc. Excavation, characterization, and disposal of the impacted soil were recommended to mitigate the former facility.

Photo No. 8 Area 1 - U.S. Border Patrol Maintenance Facility north of Pogo Row that currently occupies the western portion of the former U.S. Border Patrol Pistol Range (Map ID 3)

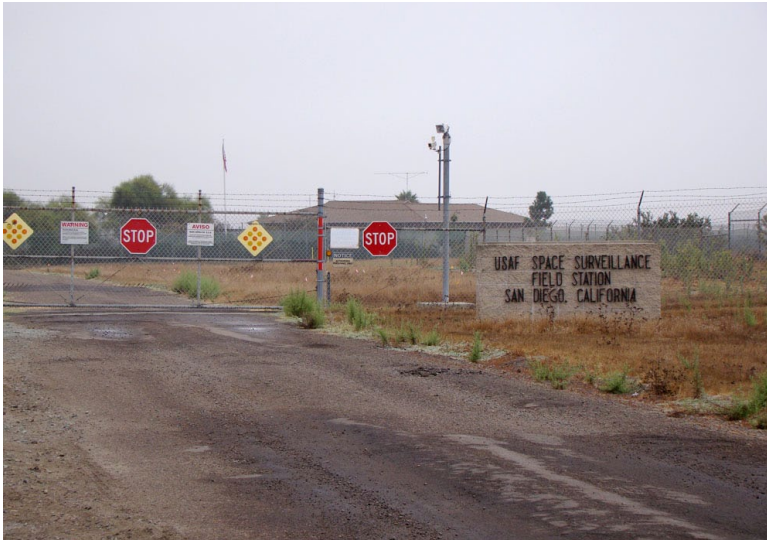
Information available on EnviroStor indicates that the eastern portion of this facility is currently occupied by the San Diego Space Surveillance Station (SDSSS) and that assessment is ongoing to evaluate former munitions installations that were operated by the U.S. Navy, prior to use of the facility by the U.S. Border Patrol. A Remedial Investigation/Feasibility Study (RI/FS) Workplan was prepared

Photo No. 9 Area 1 – San Diego Space Surveillance Station north of Pogo Row that currently occupies the eastern portion of the former U.S. Border Patrol Pistol Range (Map ID 3)

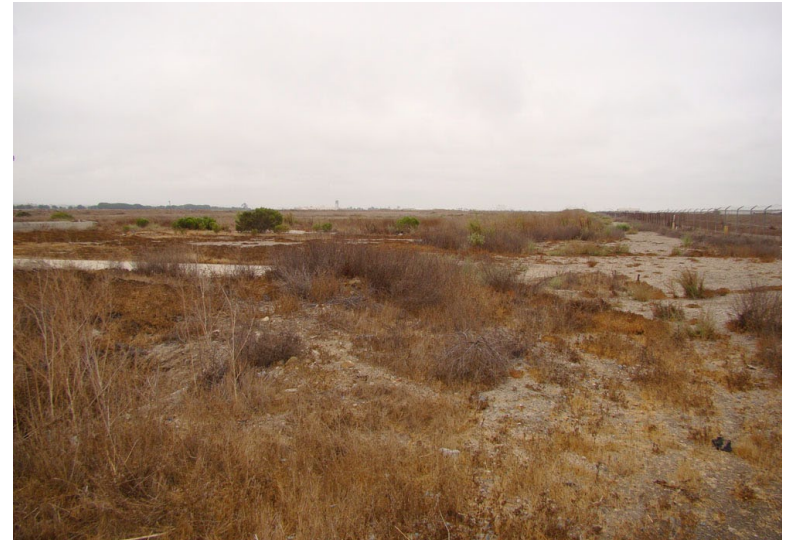
Documents at the County LEA that we reviewed as part of our 2007 HMTS indicate that this facility began operating 1994, is approximately 26 acres in size, and was classified as a composting facility. The facility is not located on an existing or closed landfill and, reportedly, only “green” and “woody” materials (i.e., materials which are derived from plant material) were accepted at the facility. During a routine inspection conducted on July 26, 2006, by City LEA staff, the following observation was noted: “Vehicular fluids and leaking batteries were spilled onto soil west of vehicular maintenance area and

This facility does not appear on any database that reports unauthorized releases of hazardous substances and is not referenced on GeoTracker. This suggests that the unauthorized hazardous waste release incident was minor and did not warrant the opening of a DEH case.

Photo No. 10 Area 1 – Former Organic Recycling West property at 1202 La Media Road (Map ID 5)

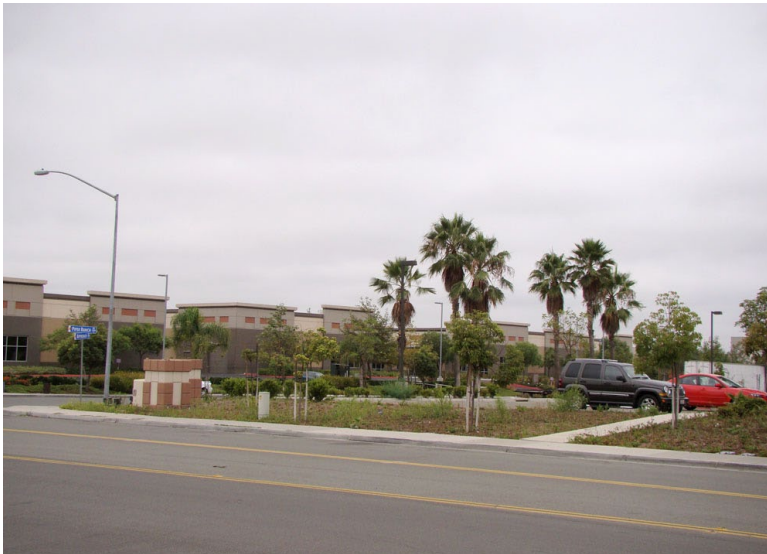
Photo No. 11 Area 1 – Former Piper Ranch property west of Piper Ranch Road that has been redeveloped as a business park (Map ID 6)

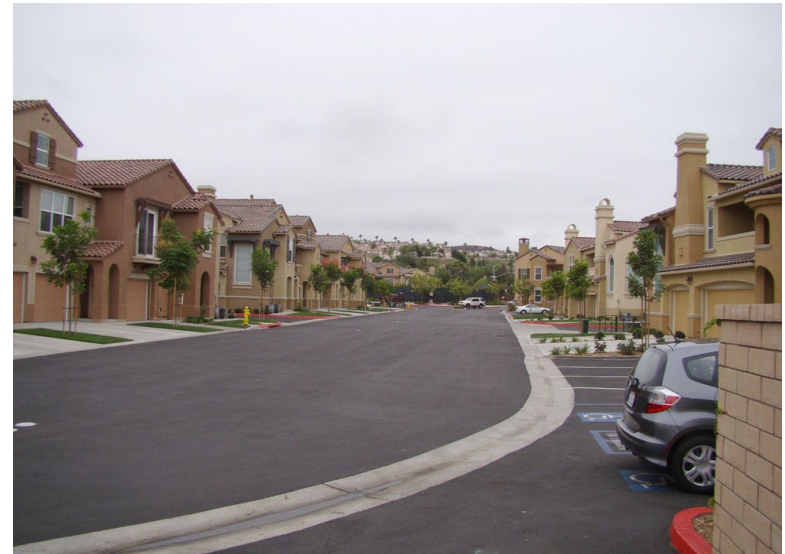
Documents that we reviewed at the County LEA as part of our 2007 HMTS indicate that this property is located north of the intersection of Dennery Road and Red Fin Lane. Reportedly, approximately 5,000 cubic yards of burn ash deposits, originating from the Shinohara II Burn Site (Map ID 9 and adjacent to the north of this property), are present over an approximately 0.5-acre area in the northwestern portion of this property. In a letter dated October 25, 2006, the County LEA approved a plan to construct a 2-foot-thick vegetative soil cap over the areal extent of the burn ash deposits.

Information available on EnviroStor indicates that Pardee Homes entered into a Voluntary Cleanup Agreement (VCA) with the DTSC in 2005 for review and opinion on potential health risks to future occupants of a proposed residential community due to the proximity of the Shinohara II Burn Site. Based on a health risk assessment prepared in 2005, the DTSC indicated that the Shinohara II Burn Site does not pose a significant health threat to future residents of the proposed residential community provided the following conditions are met:

- 1) The Shinohara II Burn Site will continue to remain undisturbed and covered with vegetation.
- 2) The DEH or other appropriate regulatory agency will provide oversight of any future disturbance to the burn site soils to ensure that potential dust migration will be controlled to protect the health of residents in the adjacent residential community.

Information available on EnviroStor indicates that the VCA case was closed in January 2006. At the time of our 2007 HMTS, grading was being conducted at the property as part of redevelopment.

Photo No. 12 Area 1 – Former Dennery Ranch property north of the intersection of Dennery Road and Red Fin Lane that has been redeveloped with single-family homes (Map ID 7)

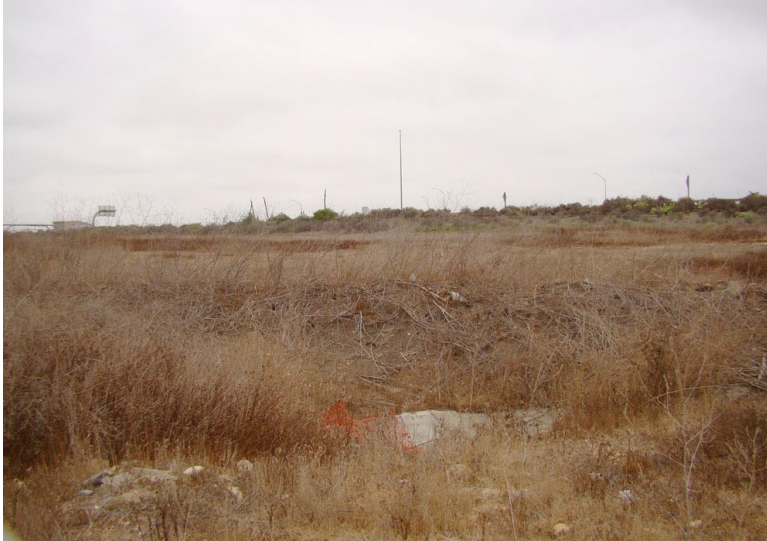
Photo No. 13 Area 1 – Vacant property southeast of the Southbay Expressway Operations Center at 1129 La Media Road (Map ID 10). An abandoned underground storage tank was encountered and removed during grading of this property in 2007

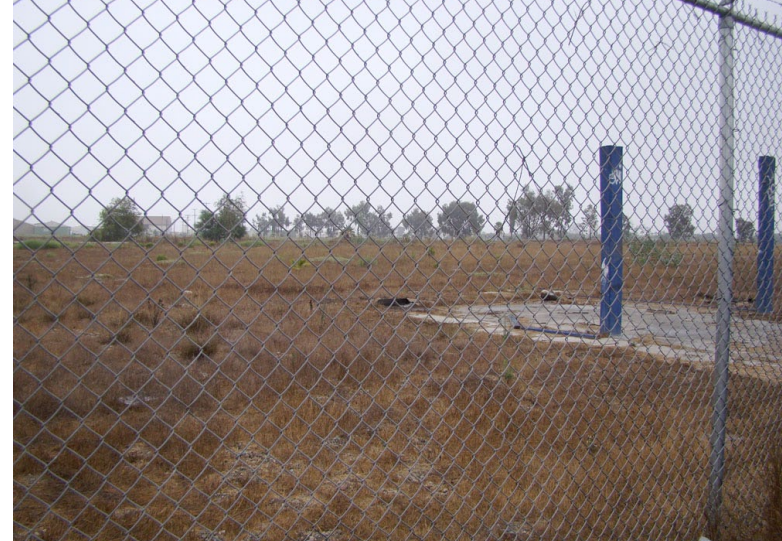
Photo No. 14 Area 1 - Vacant land west of the former fuel farm at Brown Field previously occupied by auto sales lots and Rohr Engine Test Facility (Map ID 11)

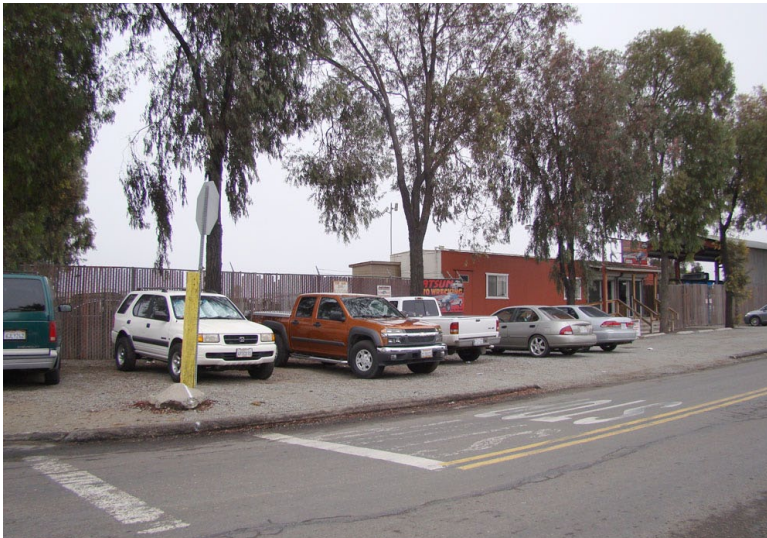
Information available in regulatory databases (Section 3.1) and on GeoTracker indicates that DEH Case No. H39789-001 is associated with this facility. This case was opened in April 2012 as a result of submittal of a Phase I Environmental Site Assessment (ESA) prepared in 1995 by Geocon and a compliance letter prepared in April 2012 by Brash Industries to the DEH for review through the Voluntary Assistance Program. During the 1995 Phase I ESA, stained concrete and soil was observed in various areas of the facility, and batteries and engines were observed on the ground. It was

recommended that the areas of staining be further investigated to determine the extent of potential impacts to underlying soils.

The April 2012 compliance letter describes best management practices (BMPs) that were implemented at the facility to minimize current and future discharges to soil and surface waters, including storing engines off the ground, use of concrete pads with berms for auto dismantling, and storing hazardous waste in a covered space with an impervious floor. The letter also describes the observations from a site reconnaissance conducted in March 2012 by Brash Industries during which no oil spills of significance were noted and no hydrocarbon sheen was observed in puddles of standing water from recent rainfall. Based on this information, Brash Industries concluded that the concerns of petroleum hydrocarbon contamination of the soil have no basis and that no significant damage to the environment has occurred from the staining observed during the 1995 Phase I ESA.

Representatives of DEH inspected the facility on May 16, 2012, and noted that asphalt was observed under the work areas, engines were located on pallets staged on concrete, and the facility was clean and organized. Based on their inspection, the DEH concurred that the BMPs implemented decreased the likelihood of an illegal discharge to the environment. However, DEH review of their inspection records for the facility revealed multiple violations between 1996 and 2007 where oil/fuel spills/stains were noted. In combination with the observations noted in the 1995 Phase I ESA, the DEH concluded that petroleum-impacted soil likely remains at shallow depths (up to of depths 5 feet) in various locations at the facility. As such, the DEH noted they are unable to provide a closure letter without assessment of the extent of petroleum impacts. The DEH did note that they have no objection to the continued use of the facility as an auto recycler provided that they are notified prior to surface grading or proposed changes in land use.

Photo No. 15 Area 1 – Auto Recycling facility at 980 Otay Valley Road (Map ID 12)

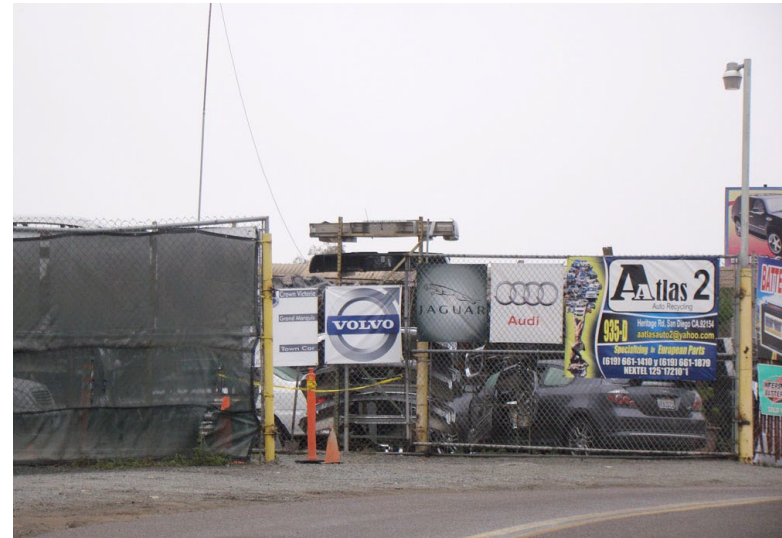
Photo No. 16 OLA Imports and Exports at 935 Heritage Road (Map ID 14)

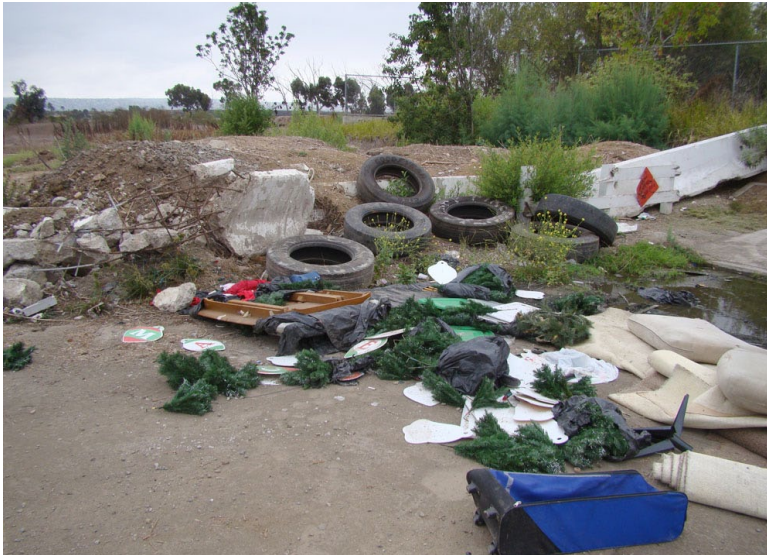
City LEA conducted periodic inspections of the site from 1999 through 2001 and observed “evidence of historical surface dumping that had been largely cleaned up.” Subsequently, the City LEA recommended a “zero inspection frequency” for the site in a letter dated January 3, 2002. Reportedly, City LEA representatives no longer conduct inspections of this property.

Photo No. 17 Area 2 – Various debris observed at the northern entrance to the Dillons Trail Site (Map ID 15) at the southern termination of Caliente Avenue

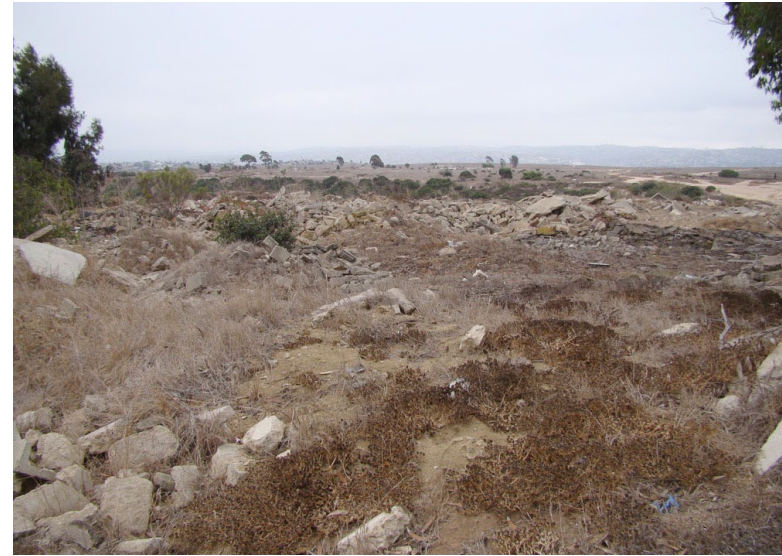
Photo No. 18 Area 2 – Concrete debris observed in the central portion of the Dillons Trail Site (Map ID 15)

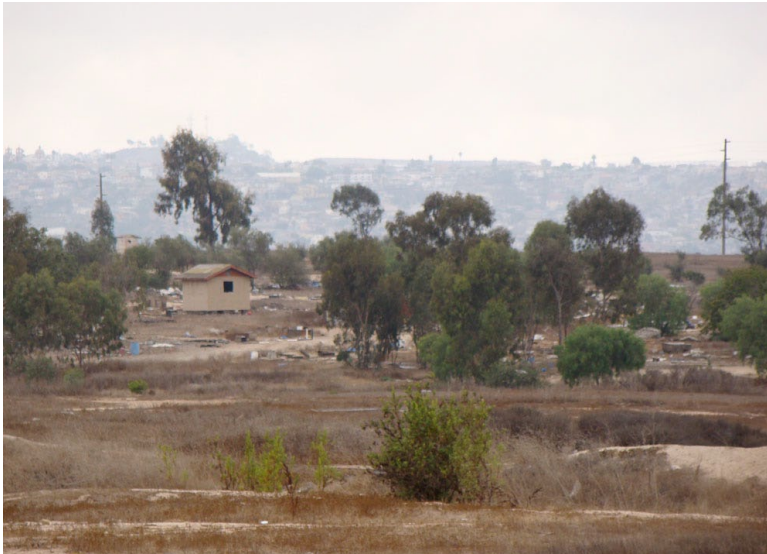
Photo No. 19 Area 2 – Abandoned structures and debris observed southwest of the main trail through the Dillons Trail Site (Map ID 15)

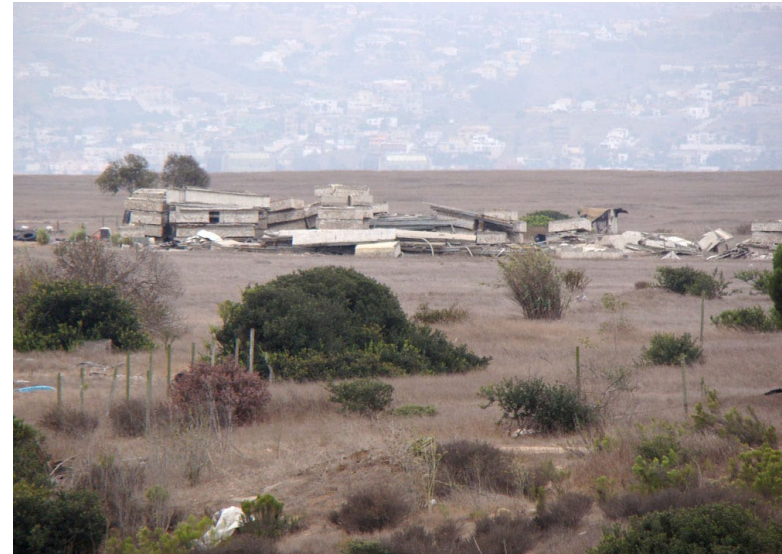
Photo No. 20 Area 2 – Abandoned structures and debris observed southeast of the main trail through the Dillons Trail Site (Map ID 15)

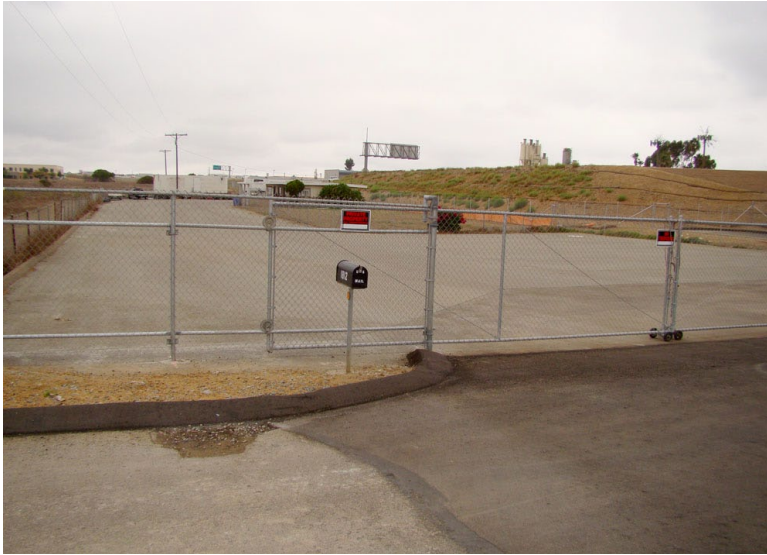
Photo No. 21 Area 3 – Barnhart and Dantzler Property (Map ID 16) located west of the northern termination of Cactus Road

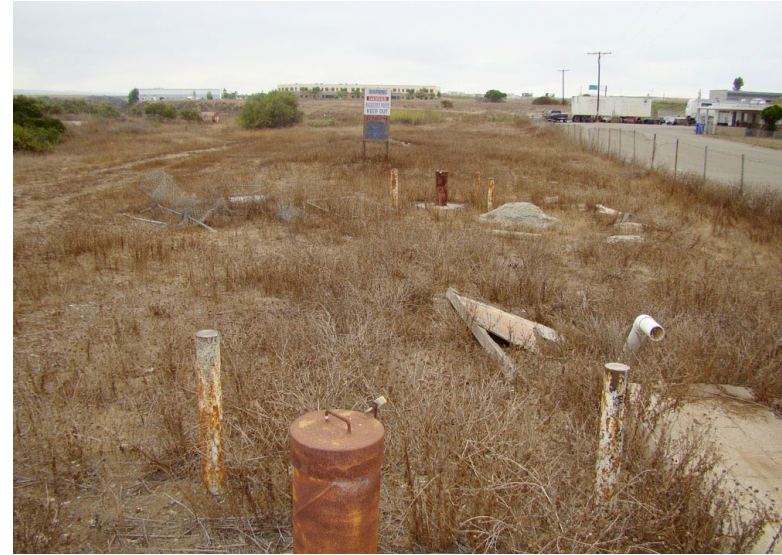
Photo No. 22 Area 3 – Sesi Property (Map ID 17) located adjacent to the south of the Barnhart and Dantzler Property

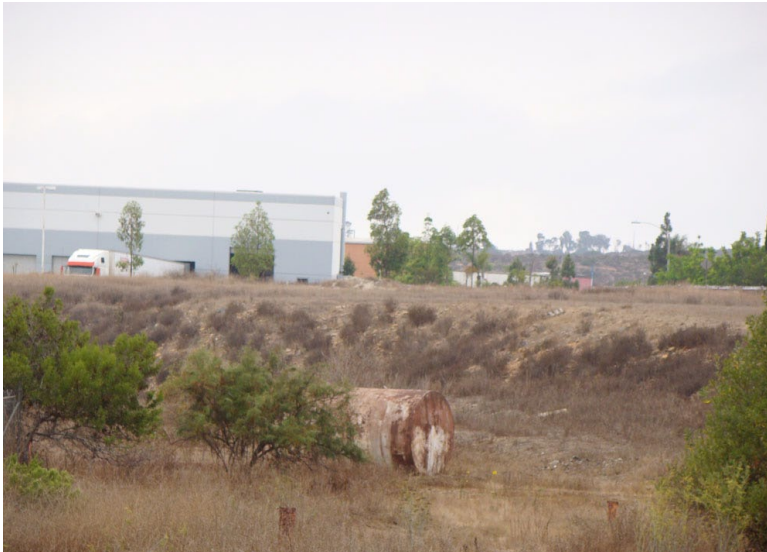
Photo No. 23 Area 3 – Abandoned aboveground storage tank observed in the western portion of the Sesi Property (Map ID 17)

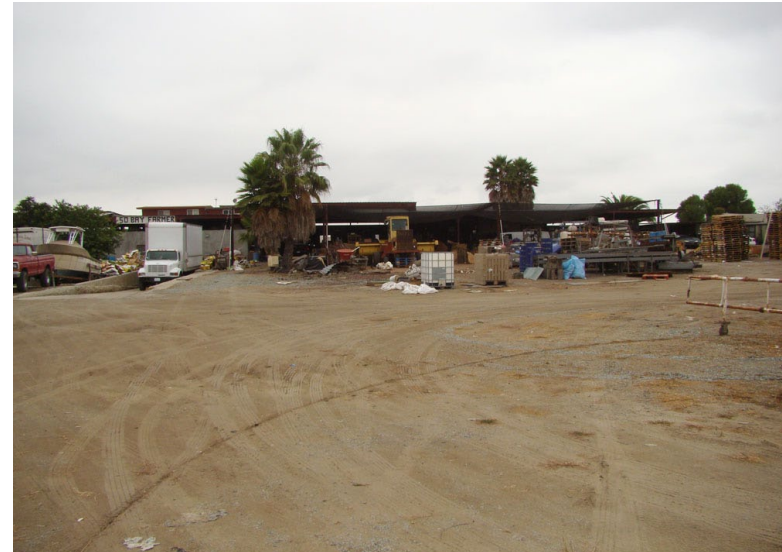
Photo No. 24 Area 3 – Packing and distribution area in the central portion of the Martinez Ranch Compound at 2160 Cactus Road (Map ID 18).

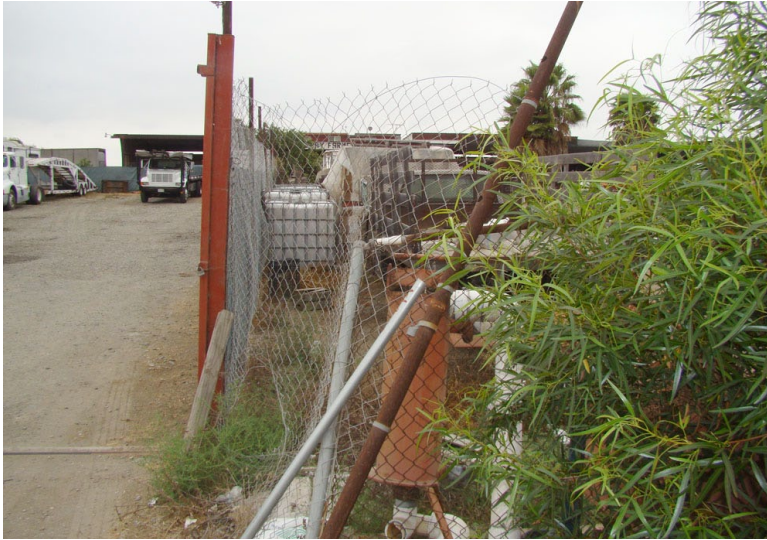
Photo No. 25 Area 3 – Fertilizer storage tanks observed in the packing and distribution area in the central portion of the Martinez Ranch Compound (Map ID 18)

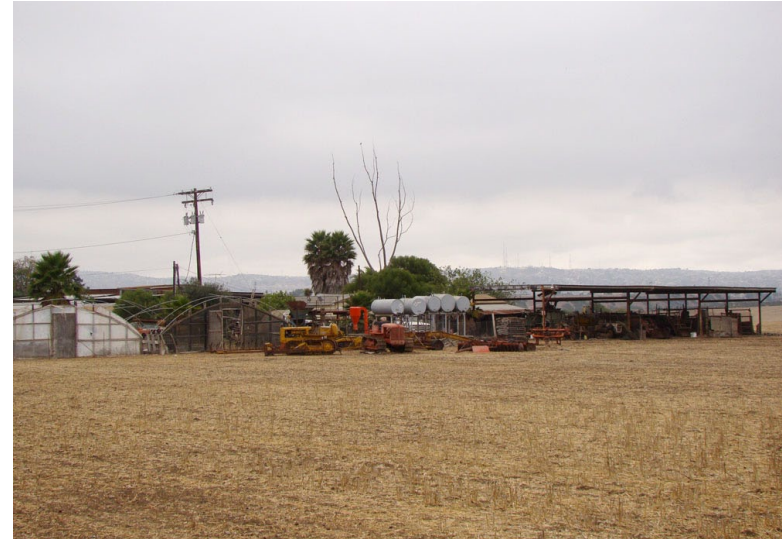
Photo No. 26 Area 3 – Diesel aboveground storage tanks observed in the northern portion of the Martinez Ranch Compound (Map ID 18)

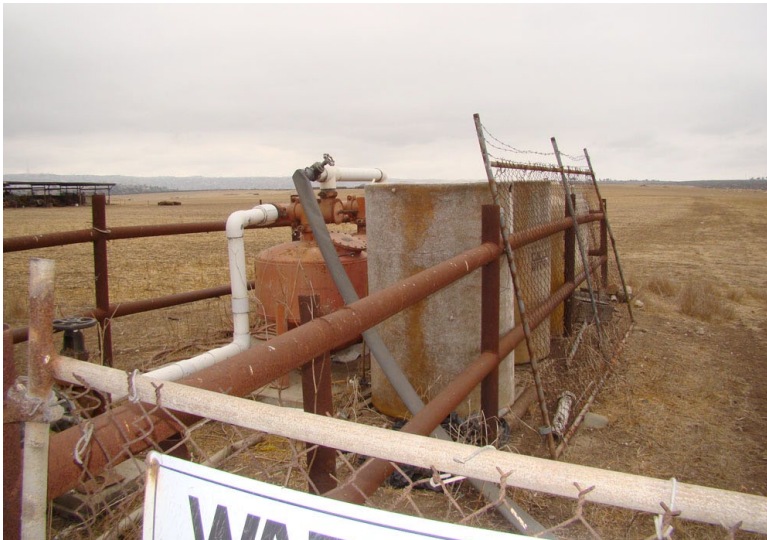
Photo No. 27 Area 3 – Fertilizer aboveground storage tanks observed in the northeastern portion of the Martinez Ranch Compound (Map ID 18)

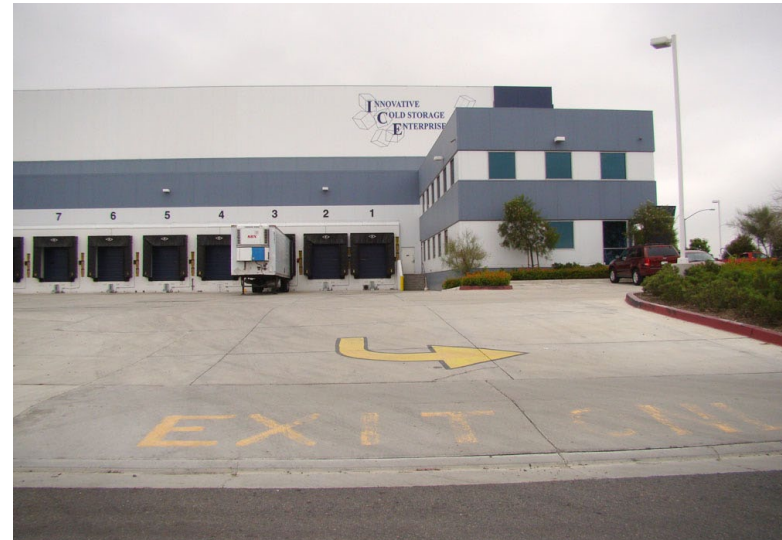
Photo No. 28 Area 3 – Former Martinez Outdoor Storage at 2770 Martinez Ranch Road currently occupied by Innovative Cold Storage Enterprises (Map ID 20)

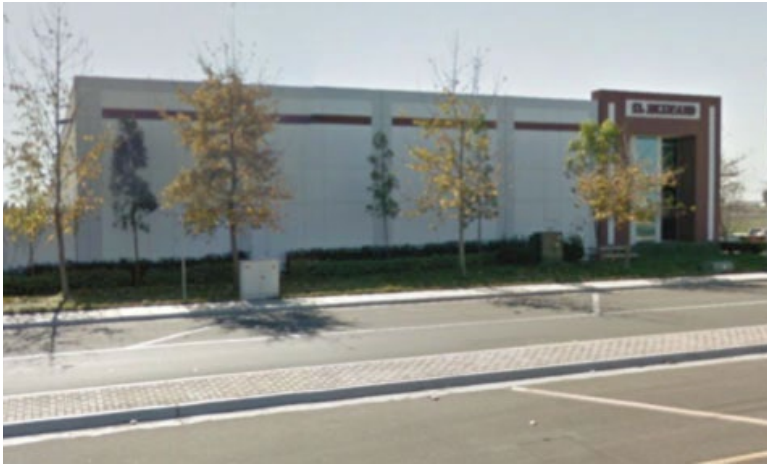
Photo No. 29 Area 4 – Northern portion of Britannia Boulevard Property at 2133 Britannia Boulevard, currently occupied by a business park (Map ID 21)

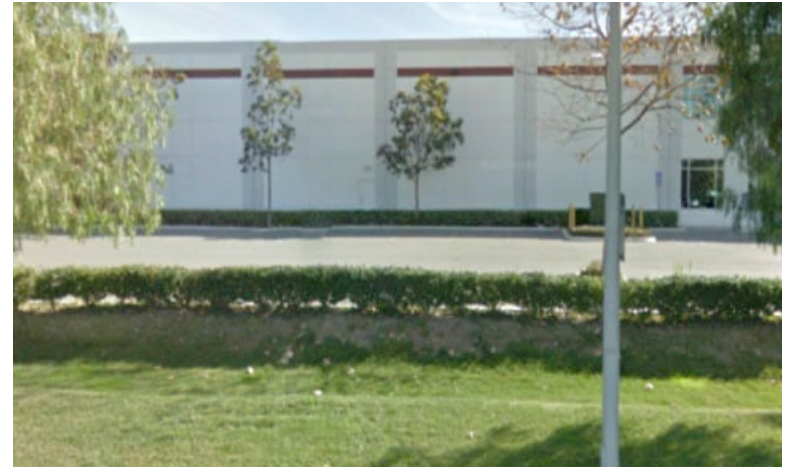
Photo No. 30 Area 4 – Southern portion of Britannia Boulevard Property at 2133 Britannia Boulevard, currently occupied by a business park (Map ID 21)

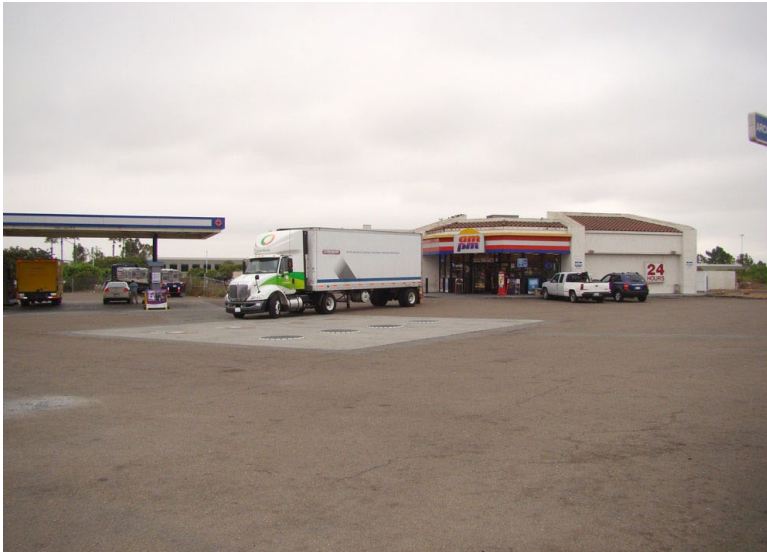
Photo No. 31 Area 5 – Arco Service Station at 2510 Otay Center Road (Map ID 22)

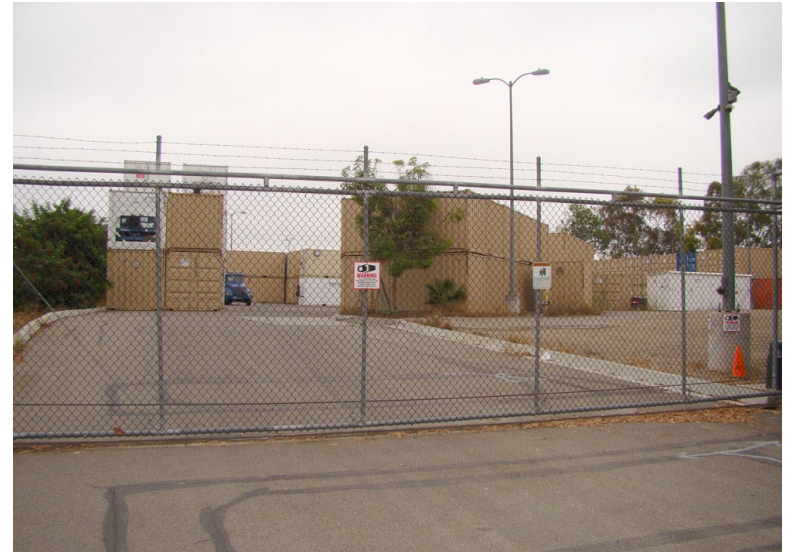
Photo No. 32 Area 6 – Air Liquide Industrial at 9955 Via De La Amistad (Map 23)
