SUBJECT: RESPONSE TO 1<sup>ST</sup> PLANCHECK COMMENTS ON THE DRAFT MASTER MAINTENANCE PROGRAM (MMP) MAP 70 AND 76 AUBURN CREEK CHANNEL INDIVIDUAL WATER QUALITY ASSESSMENT (IWQA) REPORT DATED MARCH 30, 2017 (RICK ENGINEERING COMPANY JOB NUMBER 17204-L)

## INDIVIDUAL WATER QUALITY ASSESSMENT REPORT

**Site Name/Facility:** Auburn Creek Channel  
**Master Program Map No.:** Maps 70 and 76  
**Date:** March 30, 2017; Revised April 28, 2017  
**Civil Engineer (name, company, phone number):** Jayne Janda-Timba  
Rick Engineering Company  
5620 Friars Road  
San Diego, California 92110  
(619) 688-1448  
**Register Civil Engineer Number & Expiration Date (place stamp here):** RCE # 70649  
Exp. 06/2017

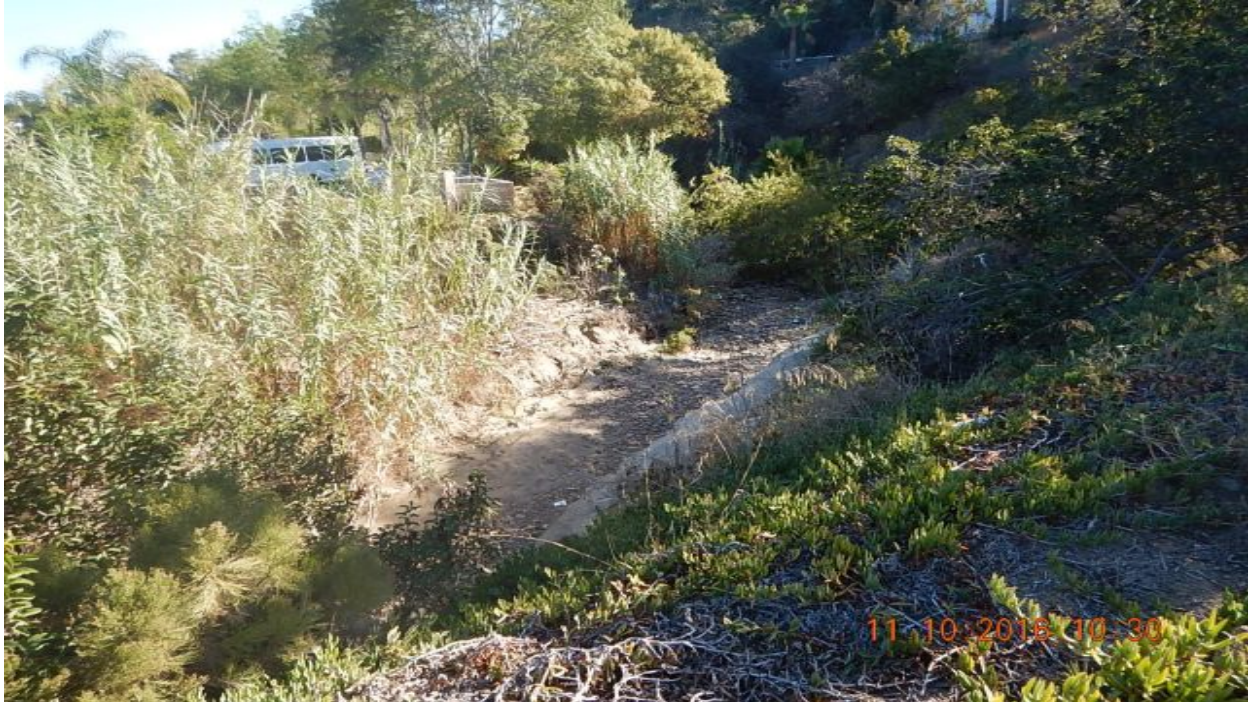
Downstream portion of Auburn Creek Channel Reach 1 facing east along Spillman Drive. No dry weather flows and dense vegetation was observed in Reach 1.

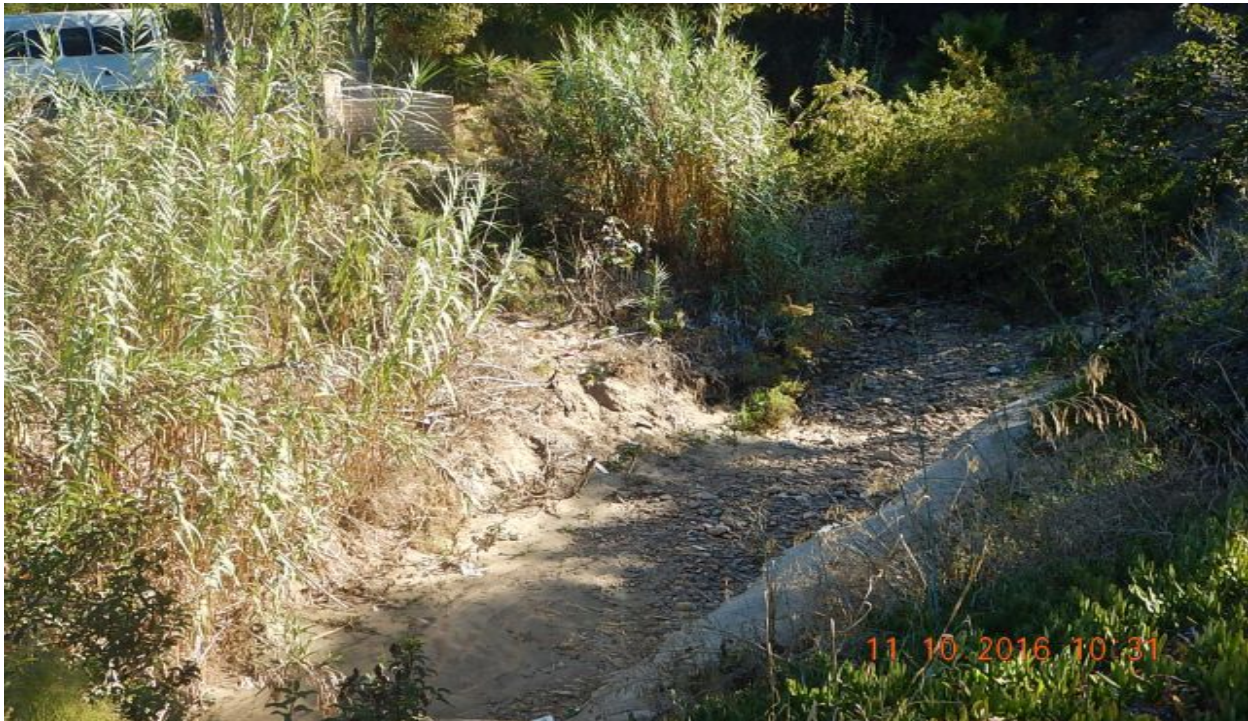
2.

Downstream portion of Auburn Creek Channel Reach 1 facing east along Spillman Drive. No flowing water was observed in Reach 1.

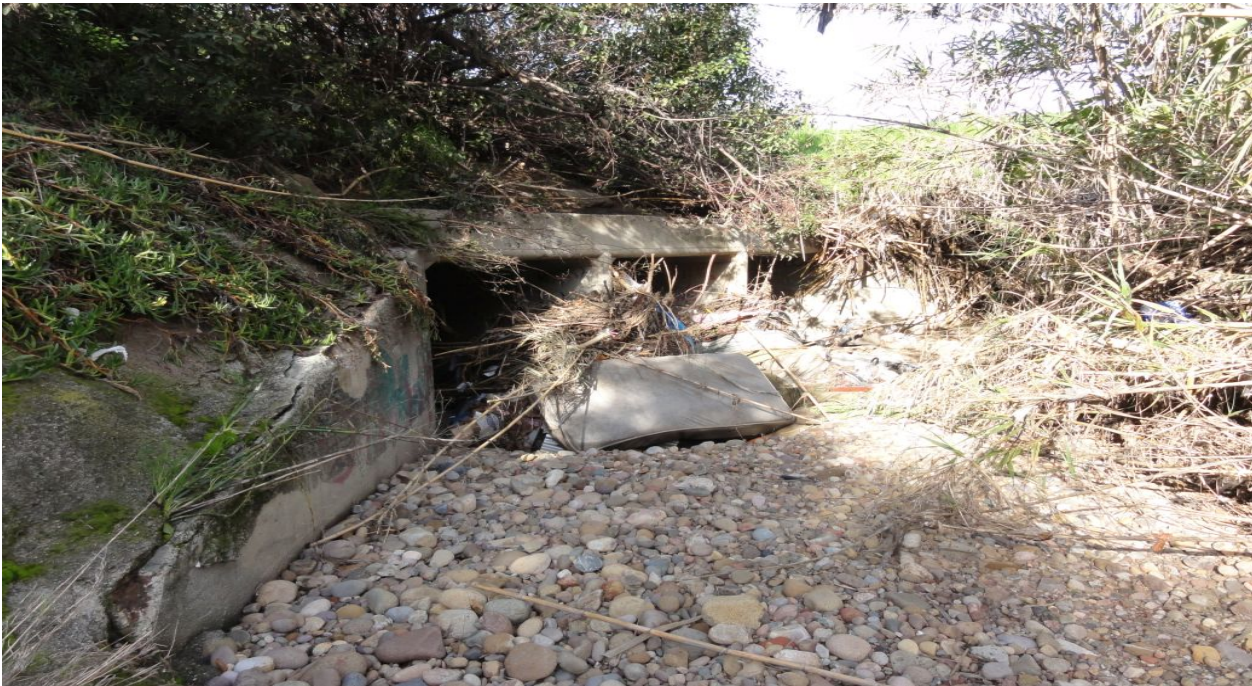
3.

Downstream portion of Auburn Creek Channel Reach 1 facing west (downstream) at the triple 6-ft. by 6-ft. box culvert under Spillman Drive. No flowing water was observed in Reach 1.

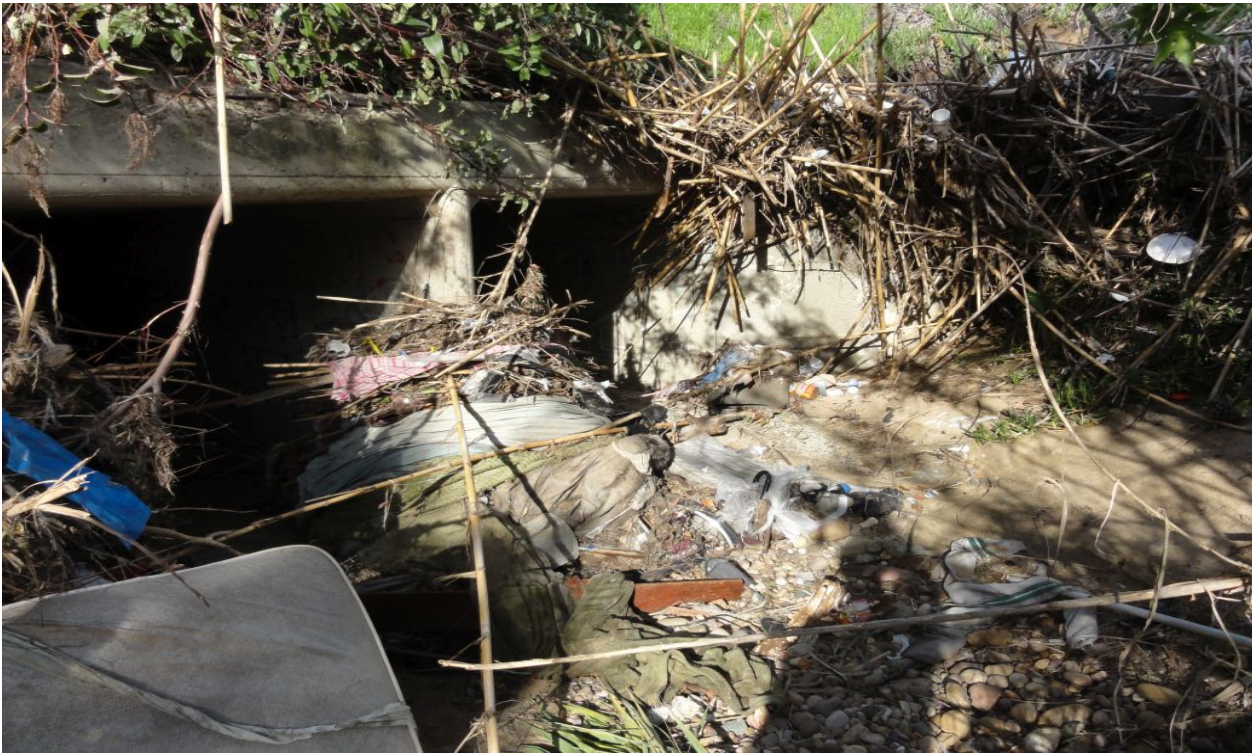
4.

Reach 1 is bound from the downstream end by an existing triple 6-ft. wide by 6-ft. high box culvert under Spillman Drive and extends approximately 150-ft. upstream. Reach 1 is earthen and trapezoidal through the reach, having a bottom width of approximately 15-ft., a minimum depth of approximately 11-ft., a grouted rip-rap southern side slope of 1.5-ft. horizontal to 1-ft. vertical (1.5H:1V), and an earthen northern side slope of 1.5H:1V. The dimensions of the channel were determined during the site visit performed on February 3, 2017, in conjunction with the cross sectional geometry based on 2014 LIDAR contours. As observed during the site visit performed on February 3, 2017, Reach 1 contains approximately 1 ft. of sediment deposition. The existing downstream 6-ft. wide by 6-ft. high box culvert under Spillman Drive is approximately 50% clogged by trash, debris, and sediment.

Downstream portion of Auburn Creek Channel Reach 1 facing west (downstream). Photo shows 50% clogging of box culvert. No flowing water was observed in Reach 1.

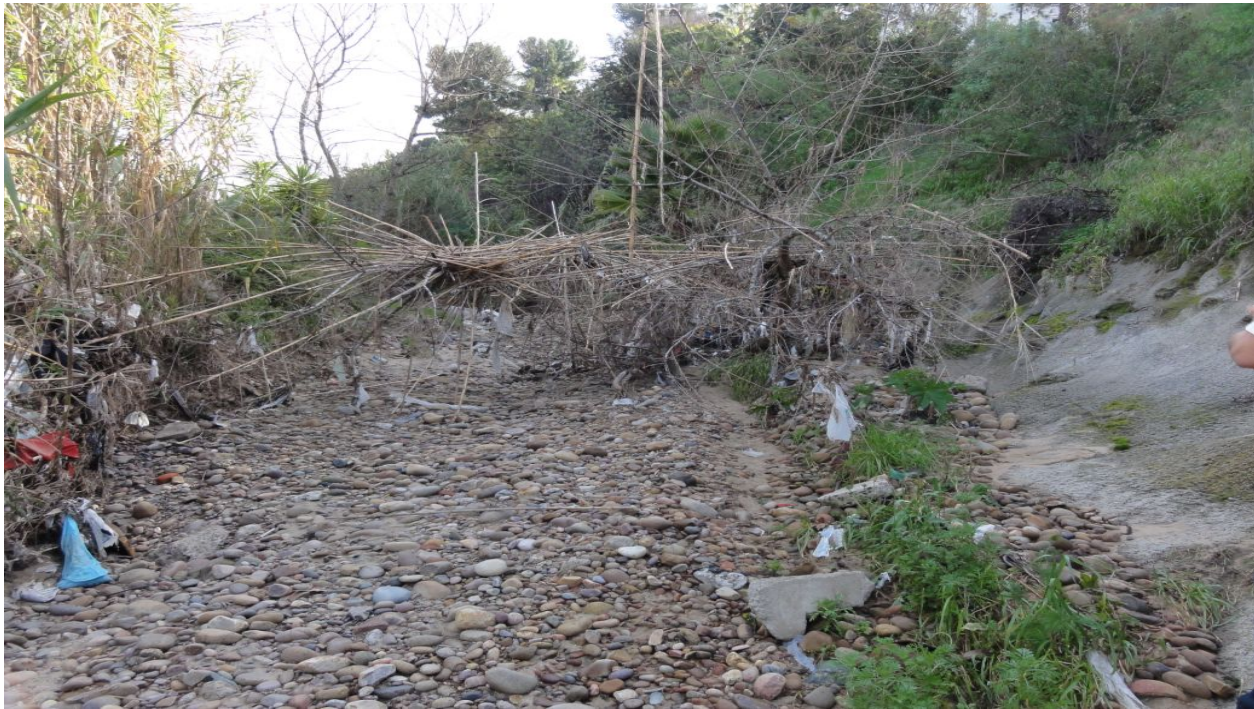
5.

Upstream portion of Auburn Creek Channel Reach 1 facing east (upstream). No flowing water was observed in Reach 1.

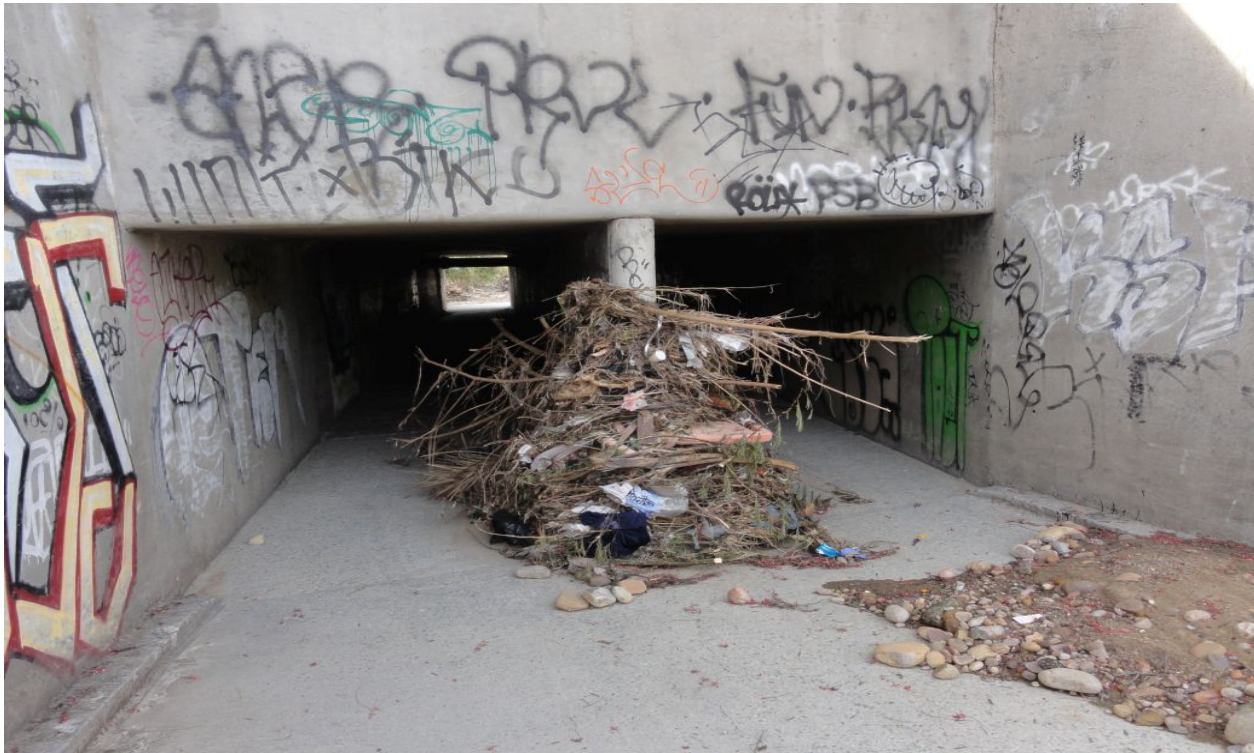
6.

Downstream portion of Auburn Creek Channel Reach 5 facing southwest (downstream) at the 6-ft. by 6-ft. double box culvert. No flowing water was observed in Reach 5.

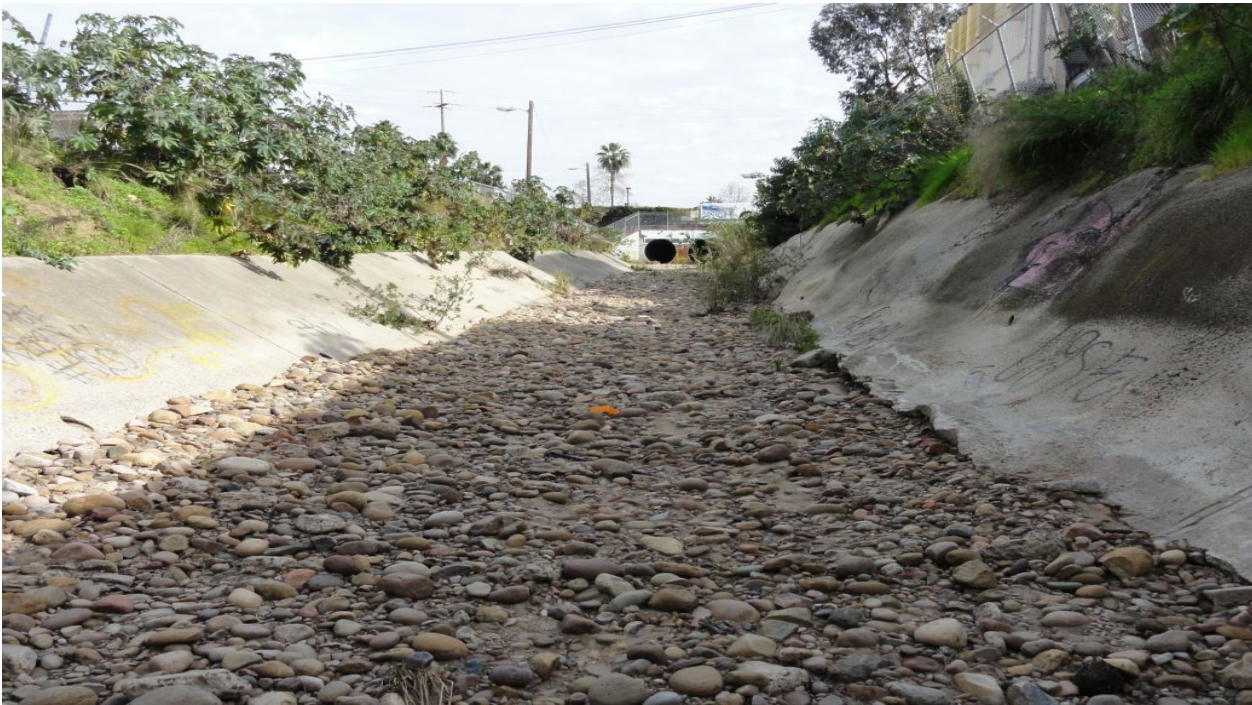
7.

Middle portion of Auburn Creek Channel Reach 5 facing northeast (upstream). No flowing water was observed in Reach 5.

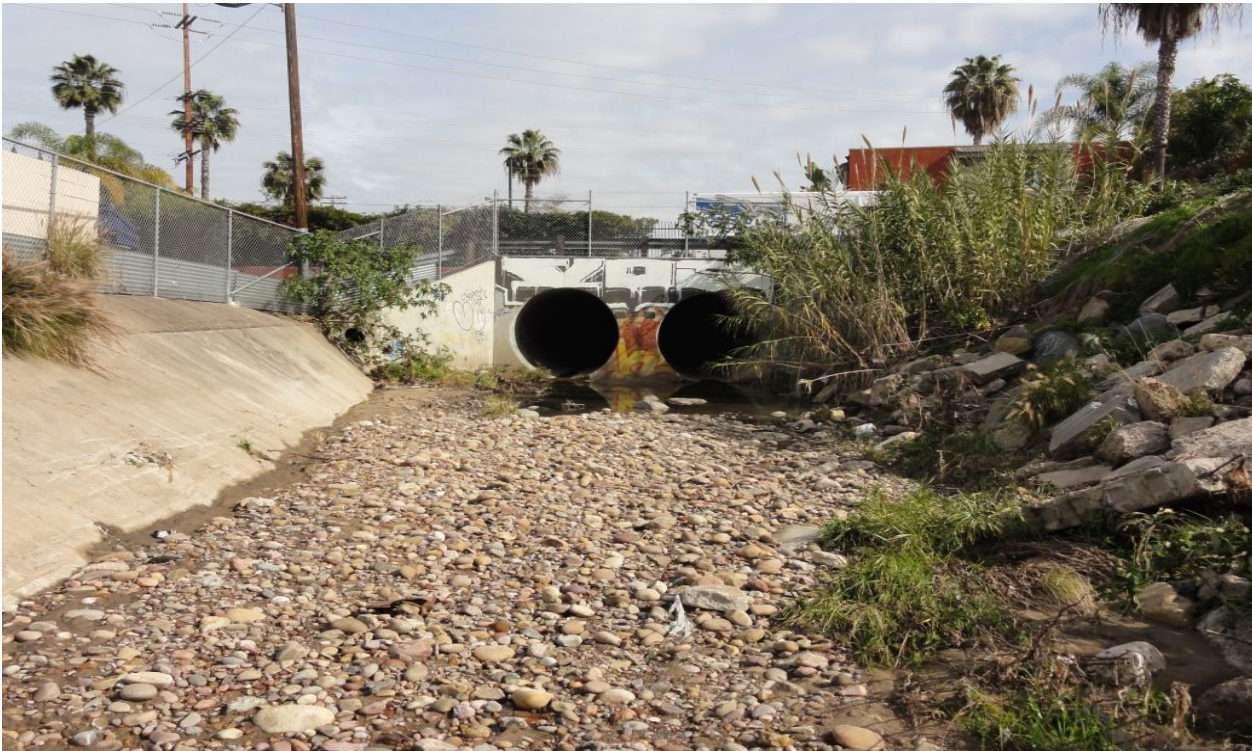
8.

Upstream portion of Auburn Creek Channel Reach 5 facing northeast (upstream) at the 74'' double concrete pipe culvert. No dry weather flows and ponded water was observed in Reach 5.

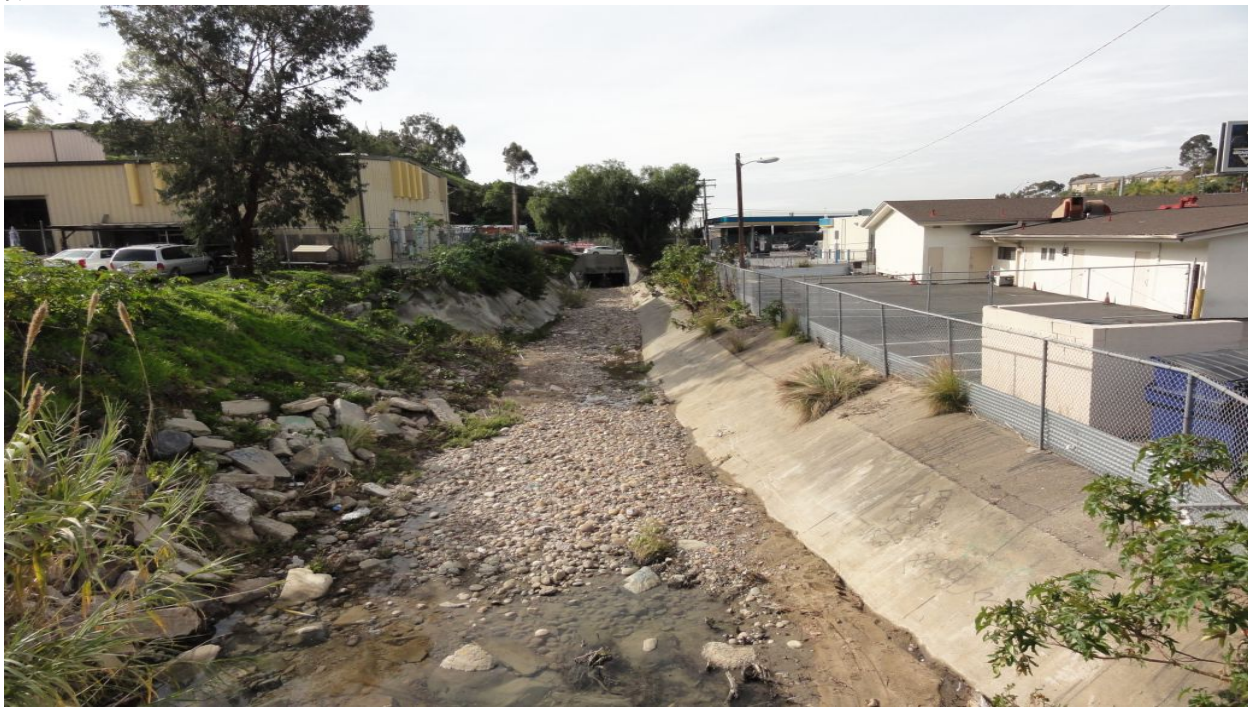
9.

Auburn Creek Channel Reach 5 facing southwest (downstream). No dry weather flows and ponded water was observed in Reach 5.

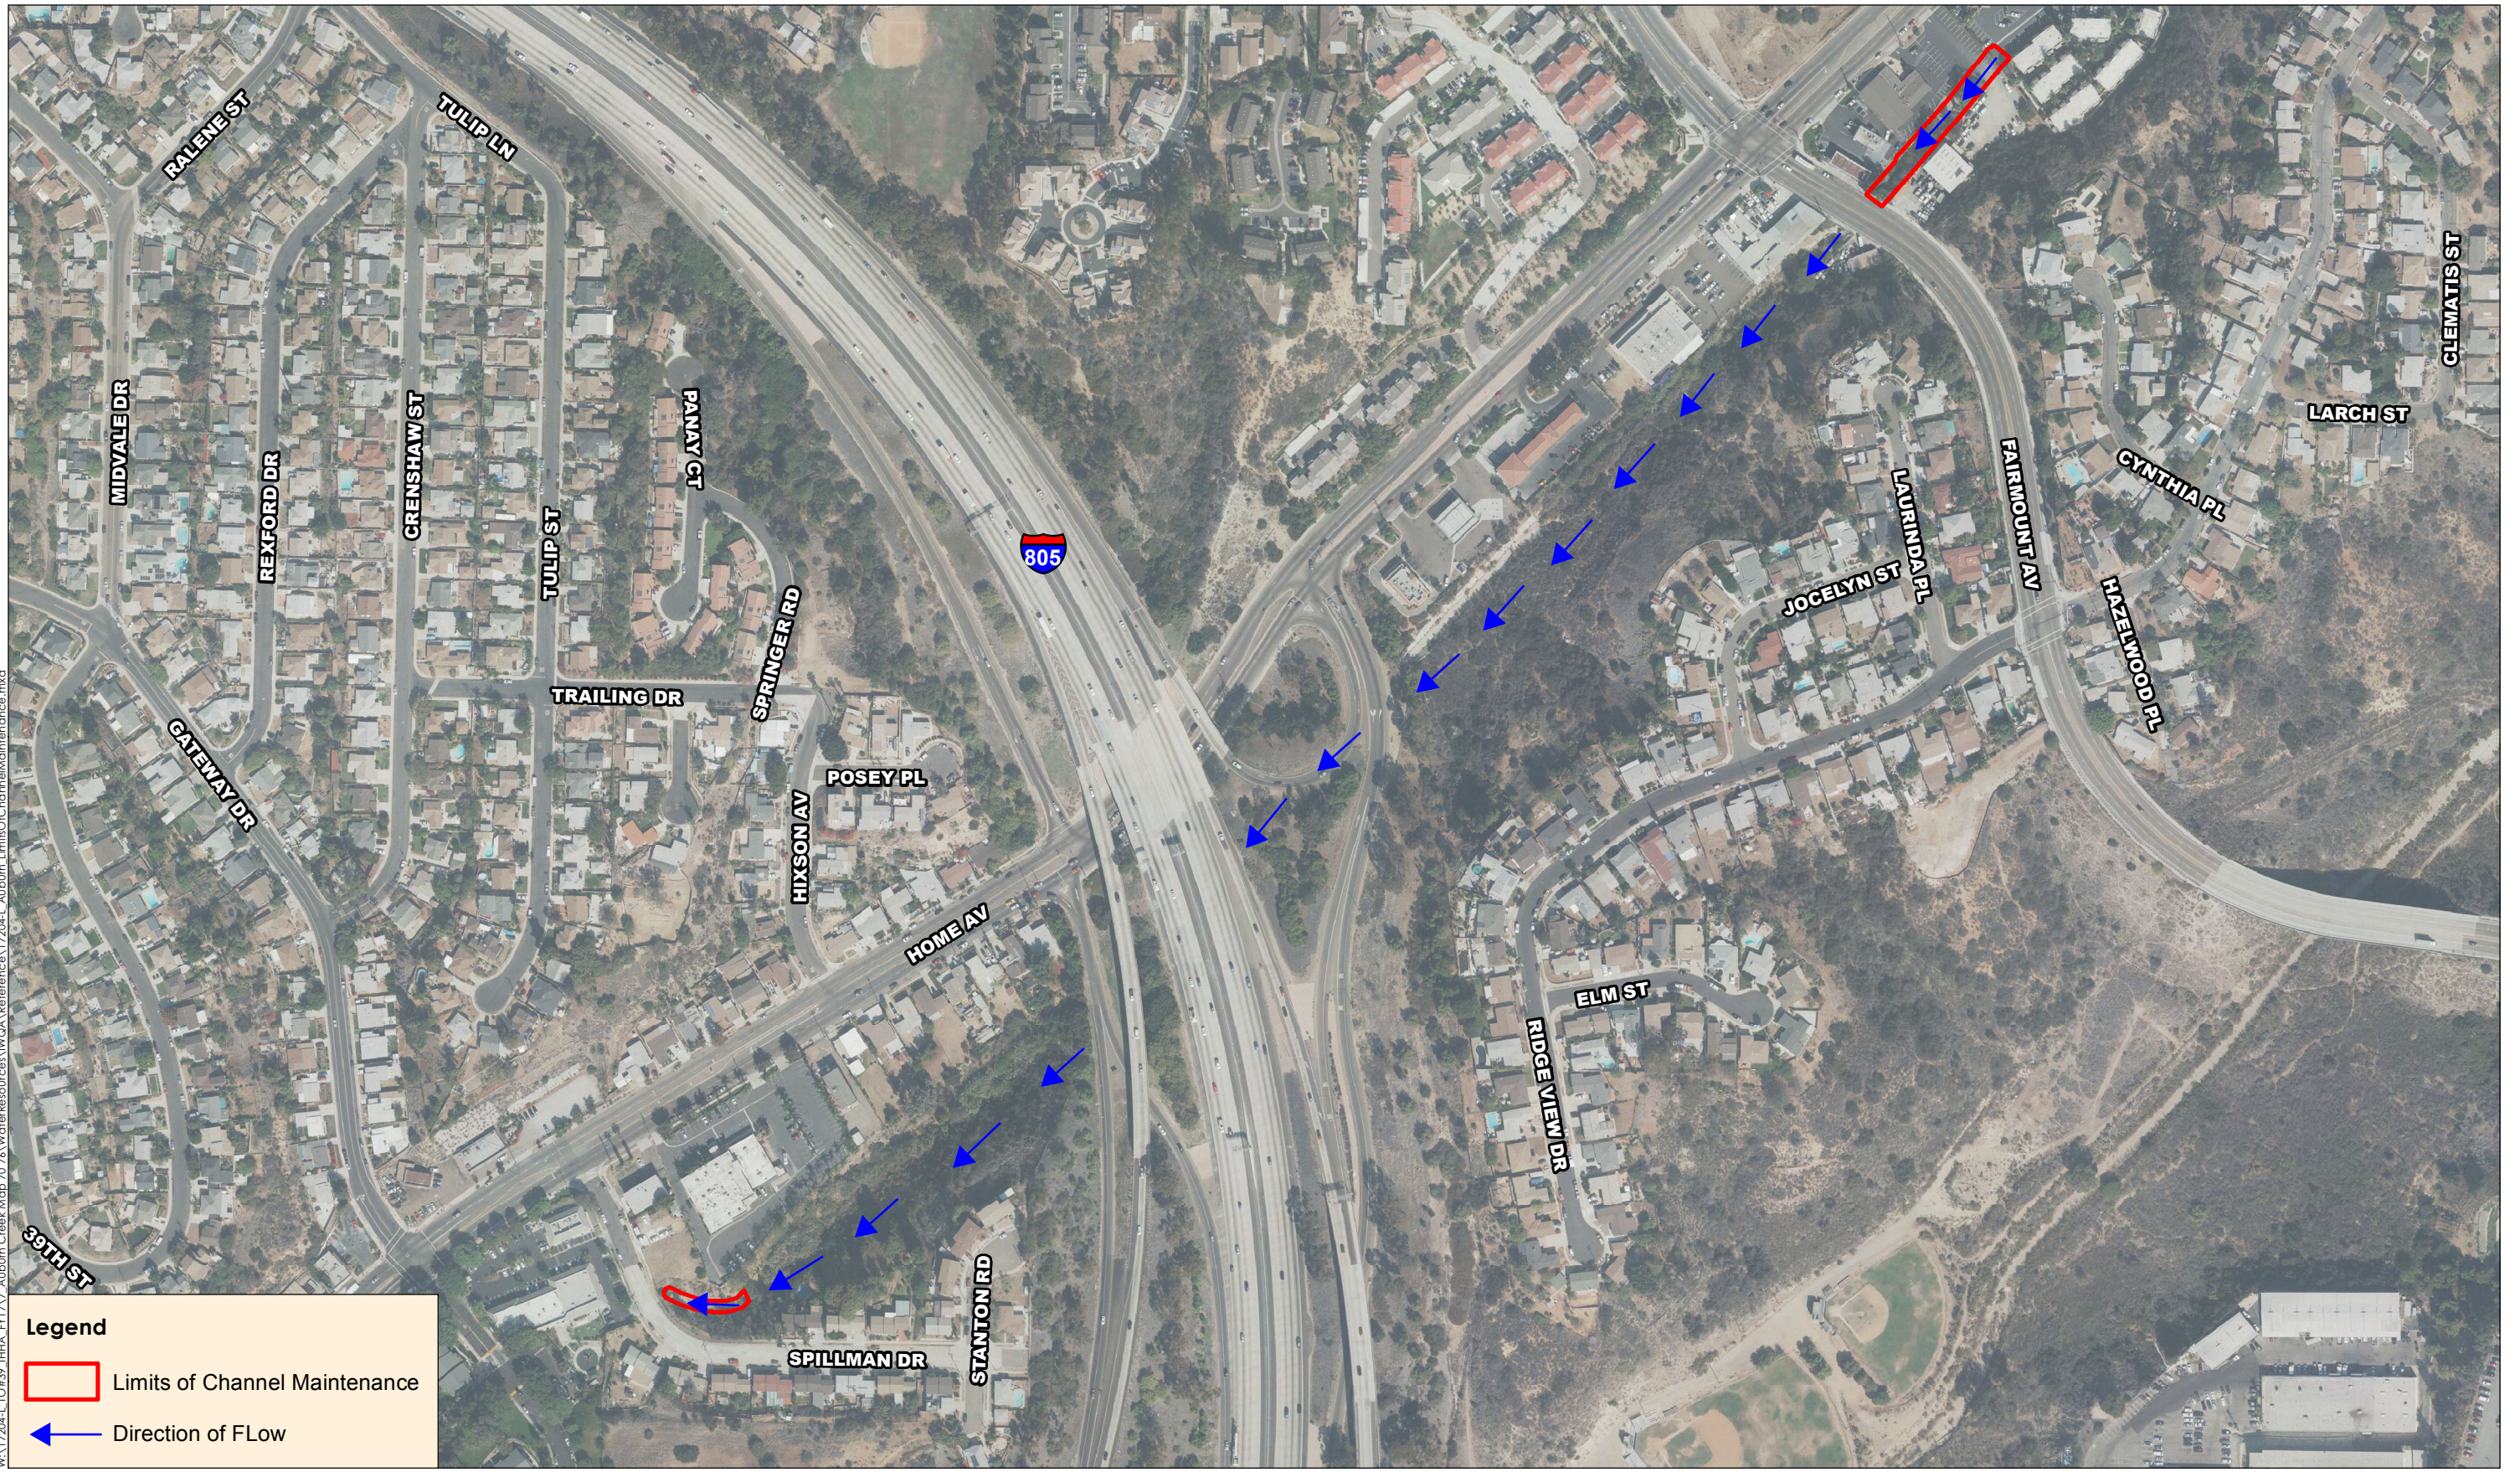
**Figure 3 - IWQA Limits of Channel Maintenance for Auburn Creek Channel MMP Maps 70 and 76**

Pursuant to the email dated April 27, 2017 from the City of San Diego, there were no comments to the Auburn Creek IWQA. However, Figure 3 – Limits of Channel Maintenance for Auburn Creek Channel MMP Maps 70 and 76, Figure 4 – Hydraulic Workmap, and Figure 5 – Photo Locations Map have each been revised to remove the culvert under Fairmont Avenue from the limits of channel maintenance.

Pursuant to the MMP, the Individual Hydrologic and Hydraulic Assessment (IHHA) recommends the limits and amount of maintenance for each channel. The IHHA Report for Auburn Creek Channel consists of five reaches (Reach 1, 2, 3, 4, and 5). Pursuant to the IHHA, it should be noted that only Reach 1 and Reach 5 are proposed for maintenance.

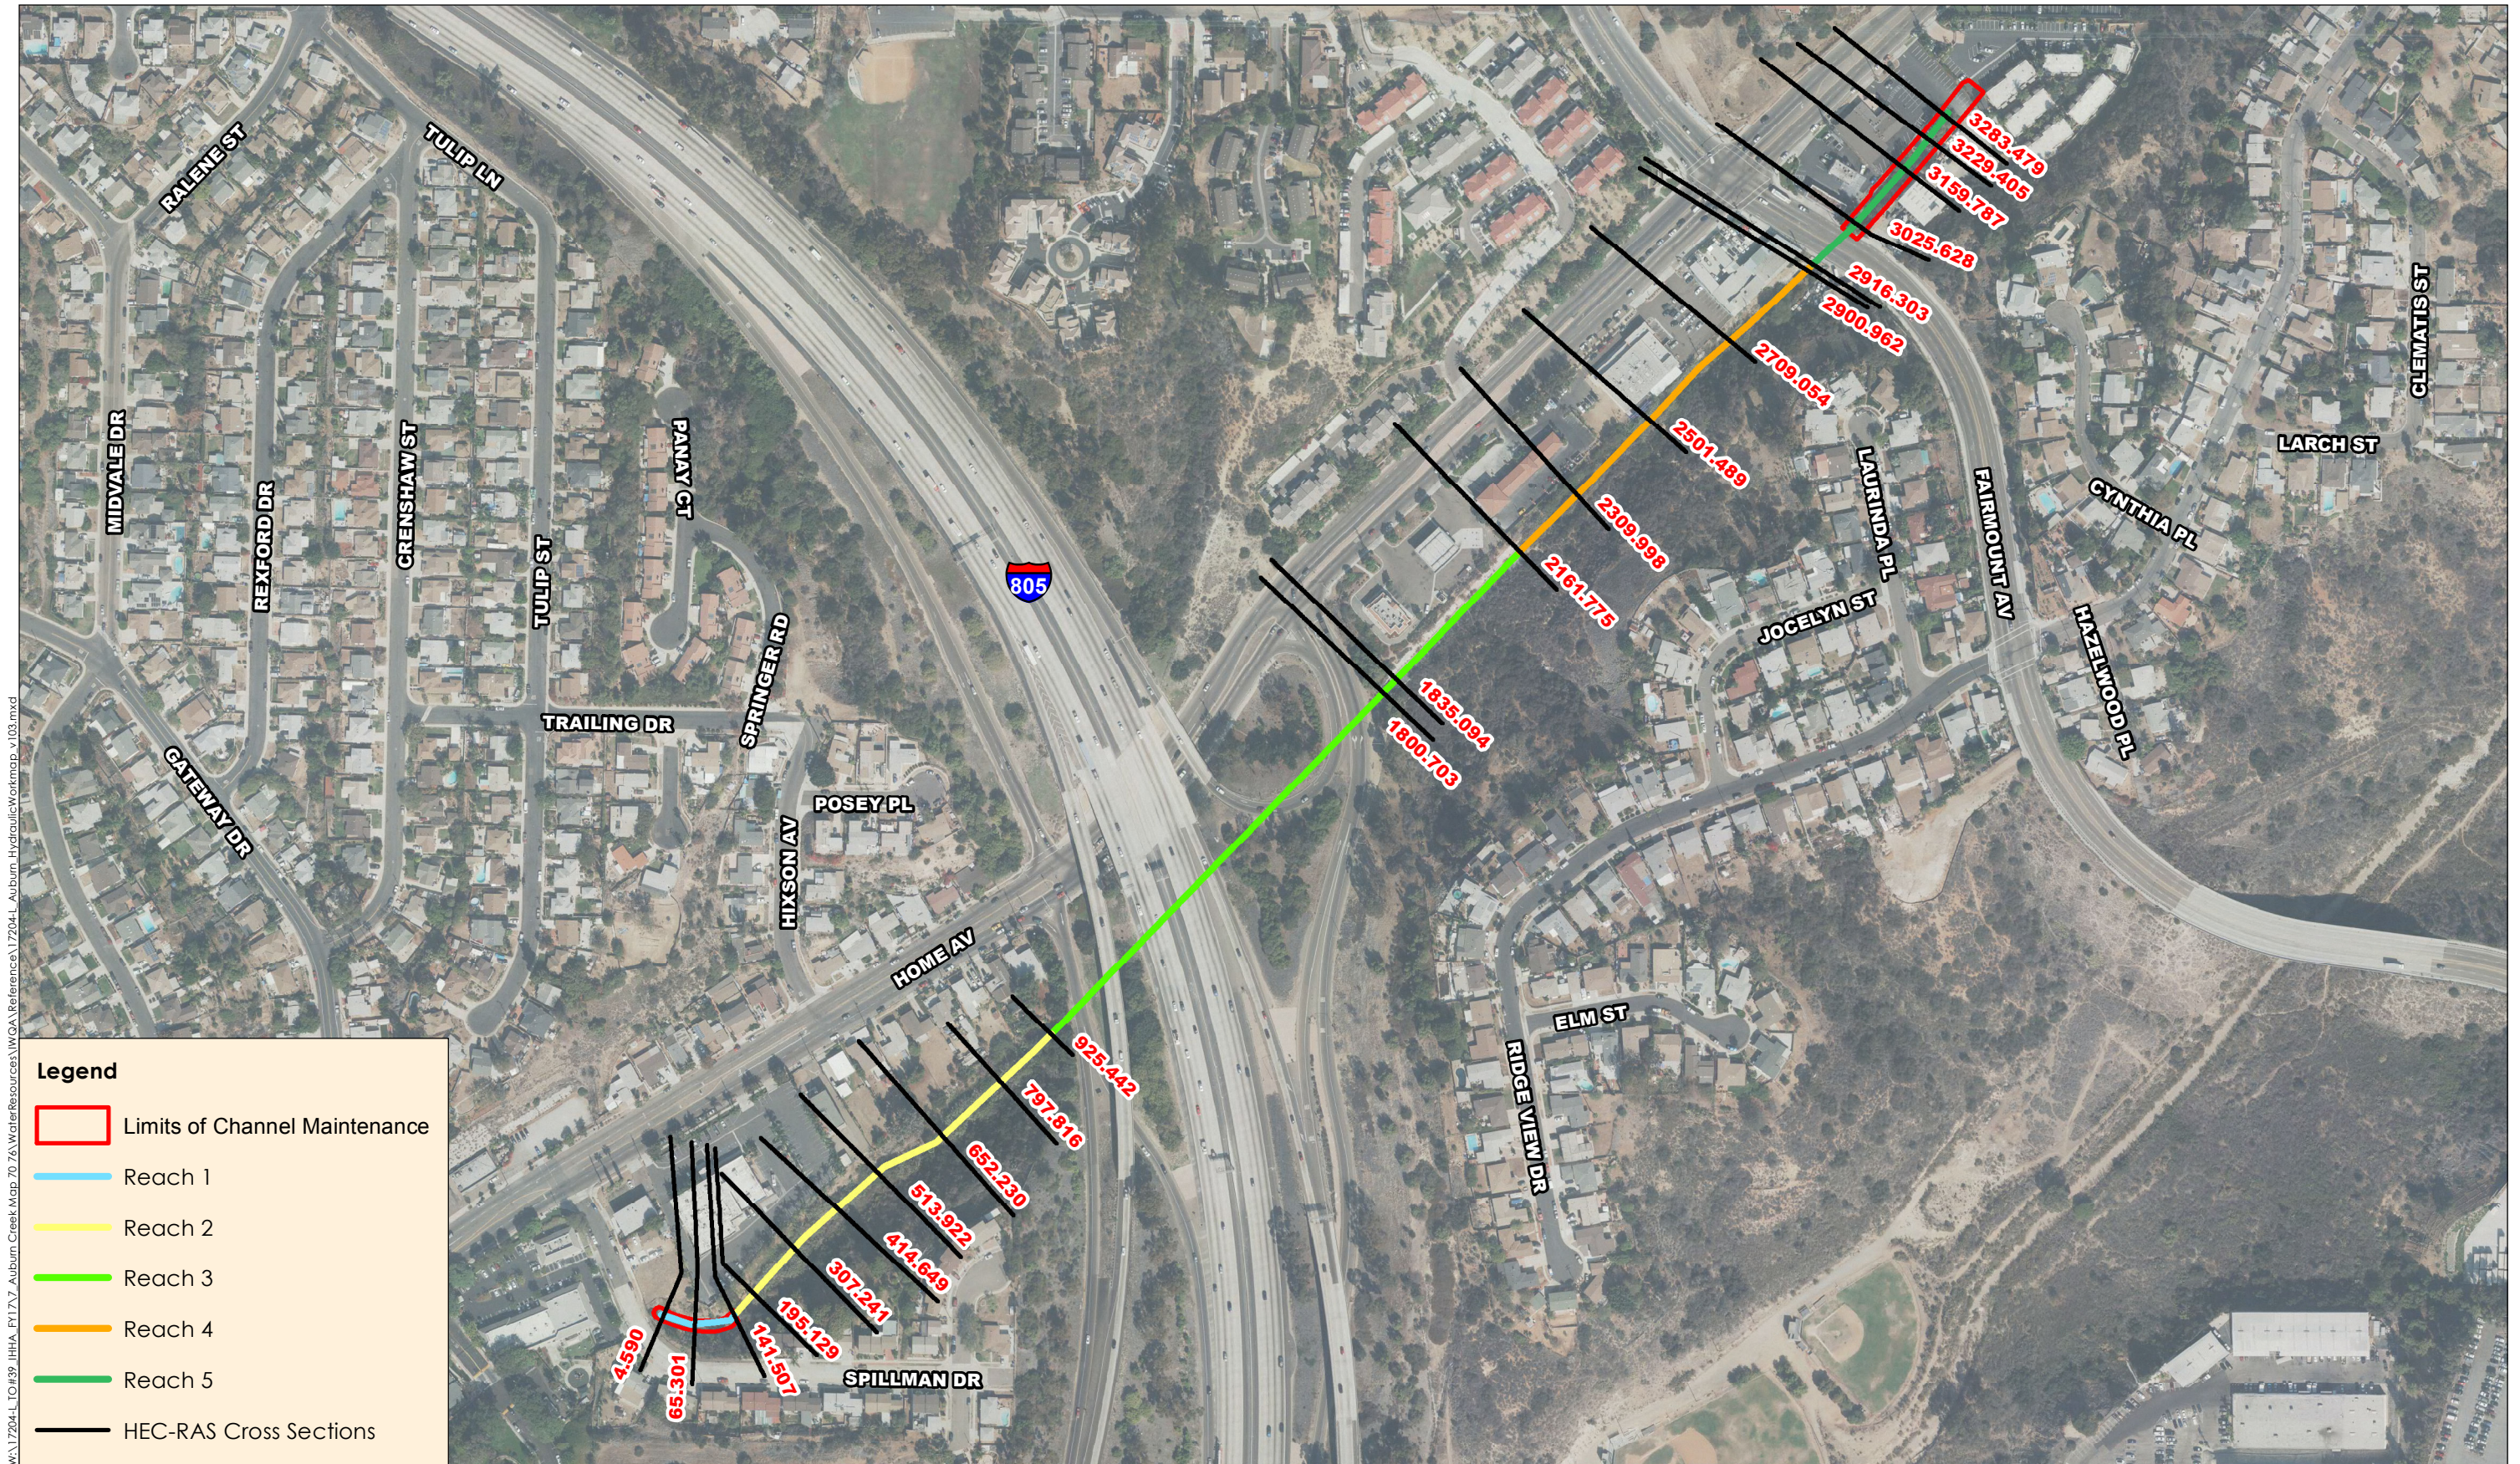
### Auburn Creek Channel - Figure 4 - Hydraulic Workmap

- Reach 1: HEC-RAS Cross-sections 4.590 to 141.507
- Reach 5: HEC-RAS Cross-sections 2916.303 to 3283.479
