INDIVIDUAL WATER QUALITY ASSESSMENT REPORT

Site Name/Facility: Montezuma Channel
Master Program Map No.: Map 66
Date: April 11, 2017
Civil Engineer (name, company, phone number): Jayne Janda-Timba
Rick Engineering Company
5620 Friars Road
San Diego, California 92110
(619) 688-1448
Register Civil Engineer Number & Expiration Date (place stamp here): RCE # 70649
Exp. 06/2017

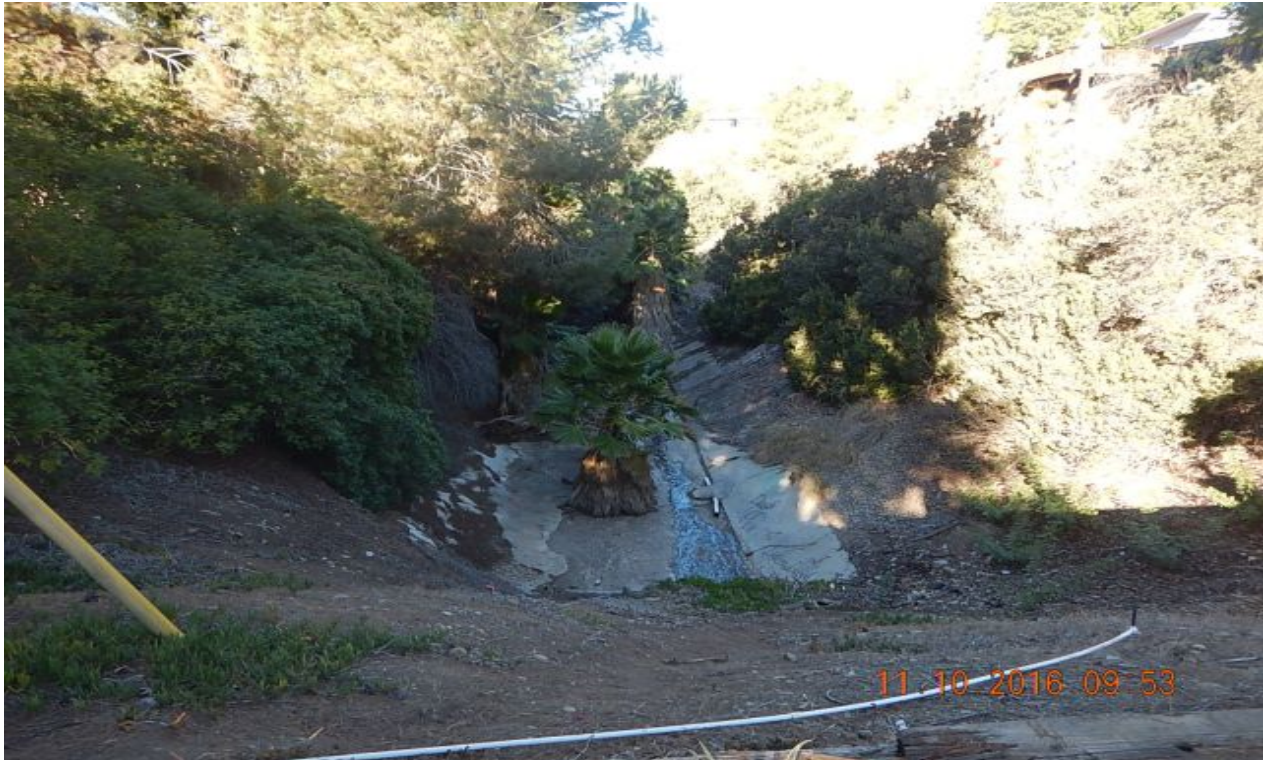
1.

Downstream end of Montezuma Channel Reach 3 with no dry weather flows observed (only pockets of standing water). Facing west along 54th Street.

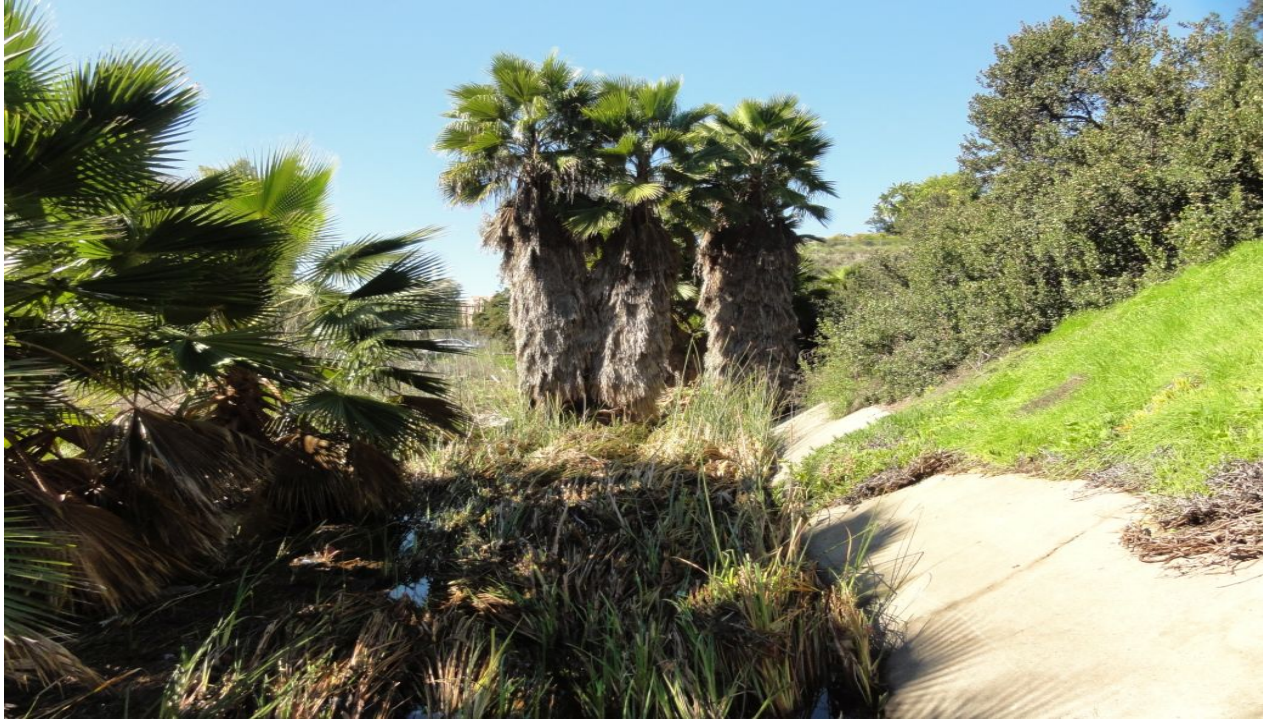
Upstream end of Montezuma Channel Reach 2 facing west. Standing water and dense vegetation was observed in Reach 2. No flowing water was observed.

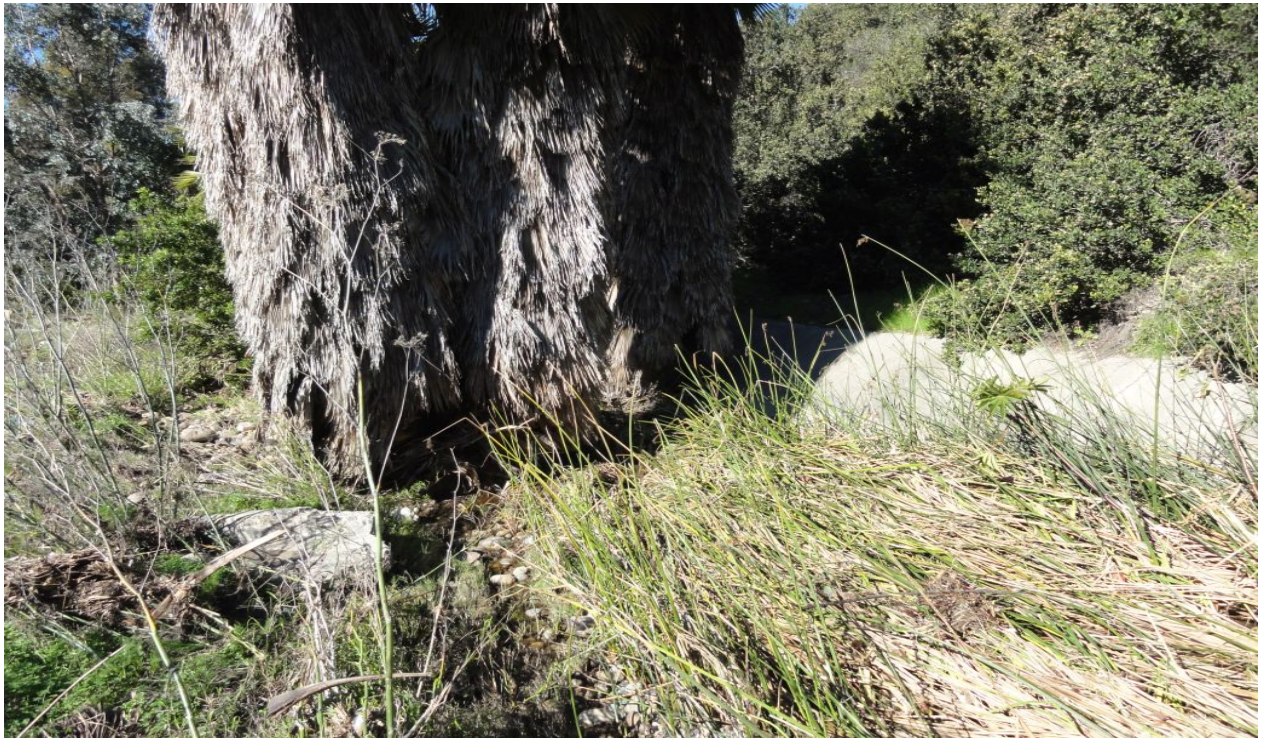
3.

Upstream end of Montezuma Channel Reach 2 facing north. No dry weather flows and dense vegetation was observed in Reach 2.

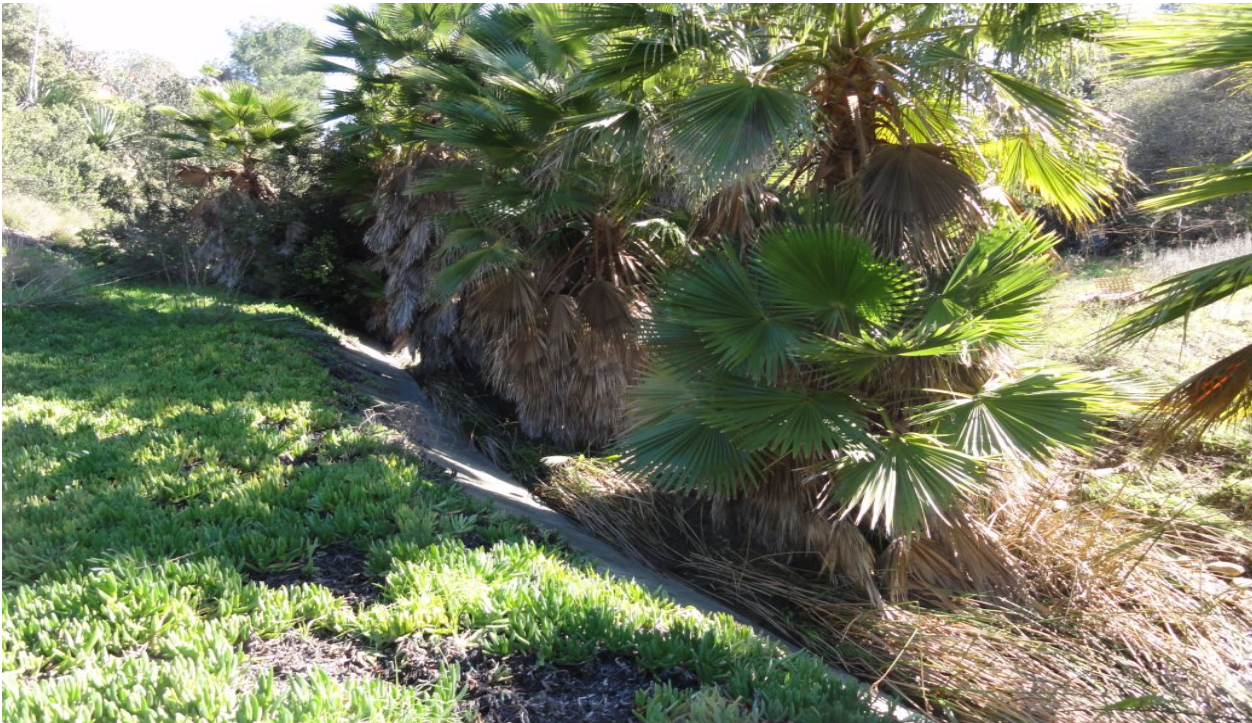
4.

Downstream end of Montezuma Channel Reach 2 facing east. No dry weather flows and dense vegetation was observed in Reach 2.

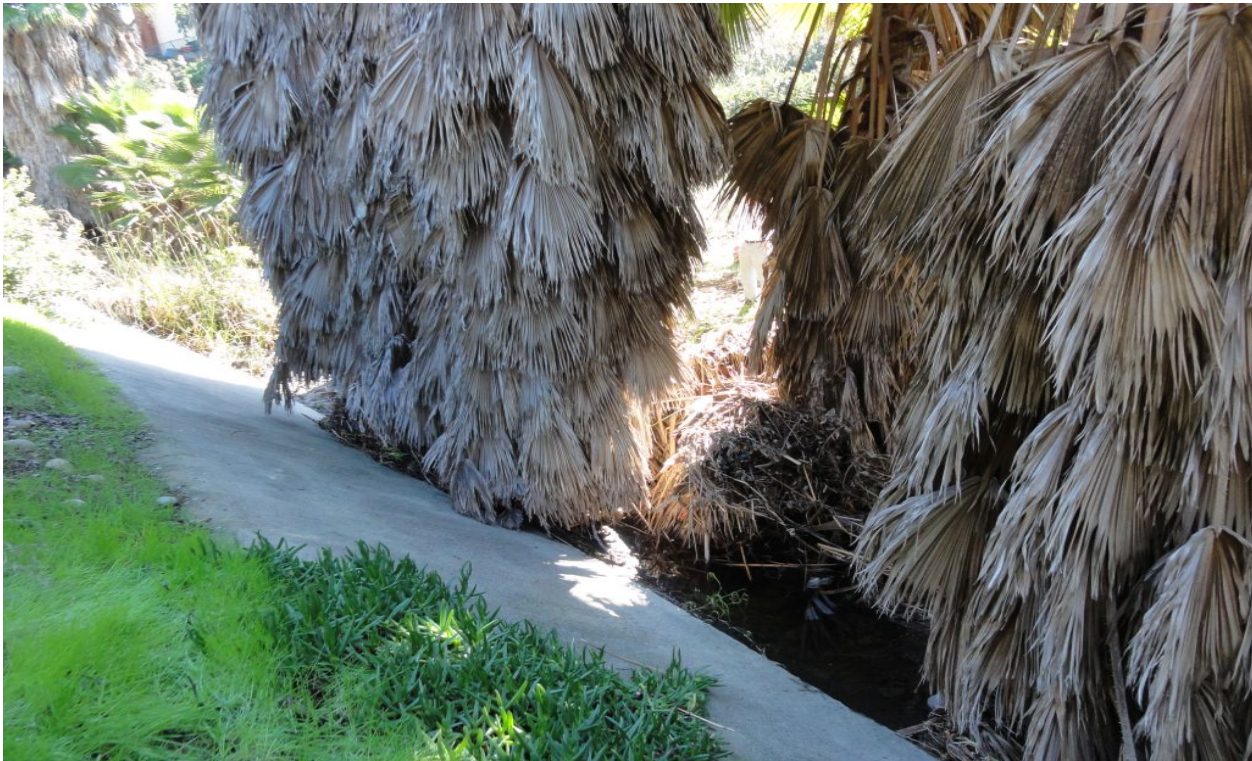
5.

Upstream end of Montezuma Channel Reach 2 facing southeast. Standing water and dense vegetation was observed in Reach 2. No flowing water was observed.
