## MAINTENANCE ACTIVITY REPORT

**Site Name/Facility:** Reservoir Drive Channel

**PEIR Map No:** 64a

**Date:**                      **Start:** 11-28-2014                      **Completion:** 11-28-2014

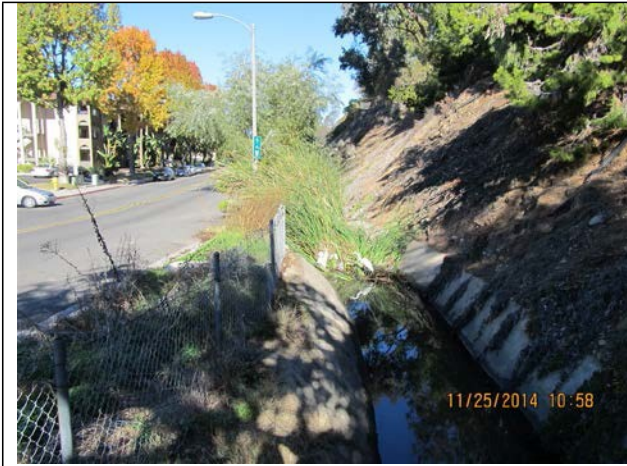
Photo 1

Photo 1: Looking downstream (north) from outfall pipe, before maintenance (11/25/2014).

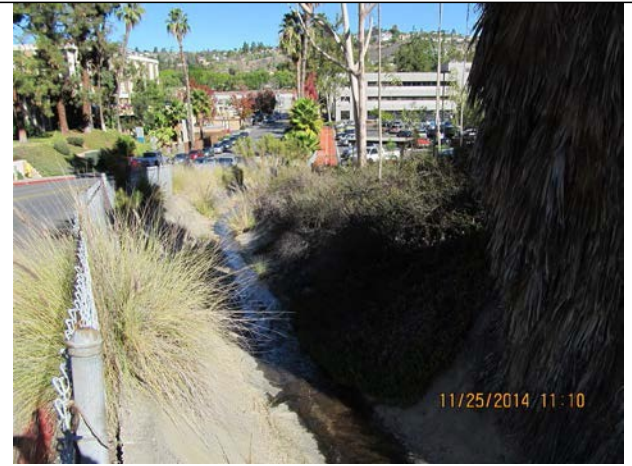
Photo 2

Photo 2: Looking downstream (north) towards inlet pipe, before maintenance (11/25/2014).

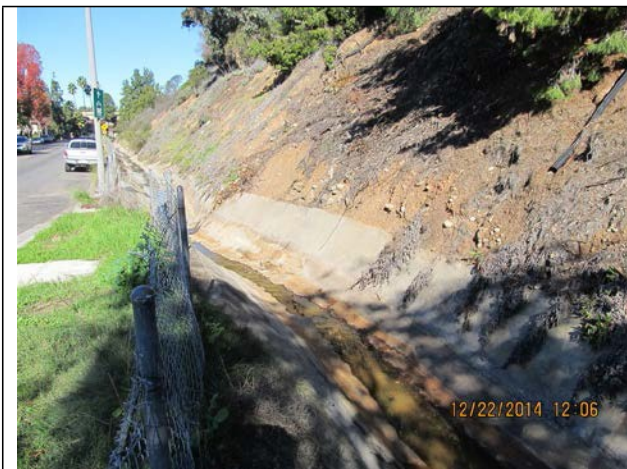
Photo 1a

Photo 1a: Looking downstream (north) from outfall pipe, after maintenance (12/22/2014).

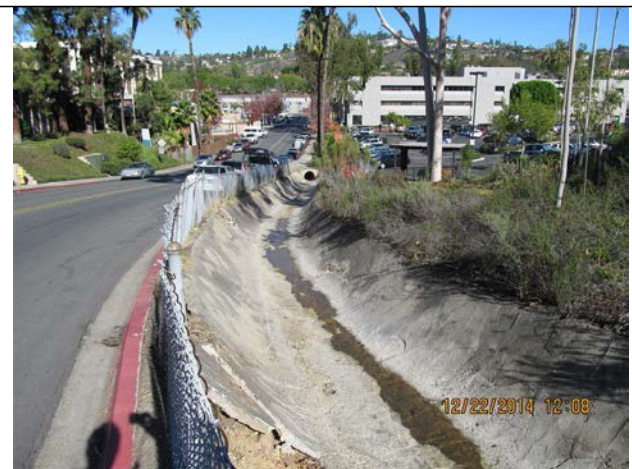
Photo 2a

Photo 2a: Looking downstream (north) towards inlet pipe, after maintenance (12/22/2014).
