101 ASH STREET

BUILDING CONDITION ASSESSMENT

FINAL REPORT

PREPARED BY KITCHELL

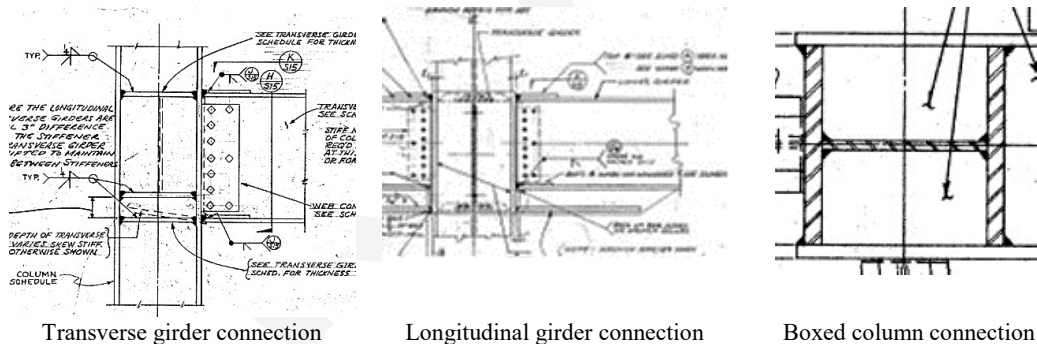
Figure 5. Connection details

- *Structural configuration.* The building is regular in plan, with no re-entrant corners or vertical off-sets. Regular buildings have performed well in past earthquakes.
- *Redundancy.* Steel moment frames are used at each gridline connection
- *Reinforced Moment connections.* As seen in Figure 5, in the transverse direction, cover plates are used for top and bottom flange. In the longitudinal direction, bottom haunches are used for the girders. This type of detailing is more ductile than WUF connection and serves to move the plastic hinging and yielding away from the critical beam-to-column joints. In the longitudinal direction, the girders are attached to box plates welded to column flanges. This is a superior connection than welding girders to the column webs.

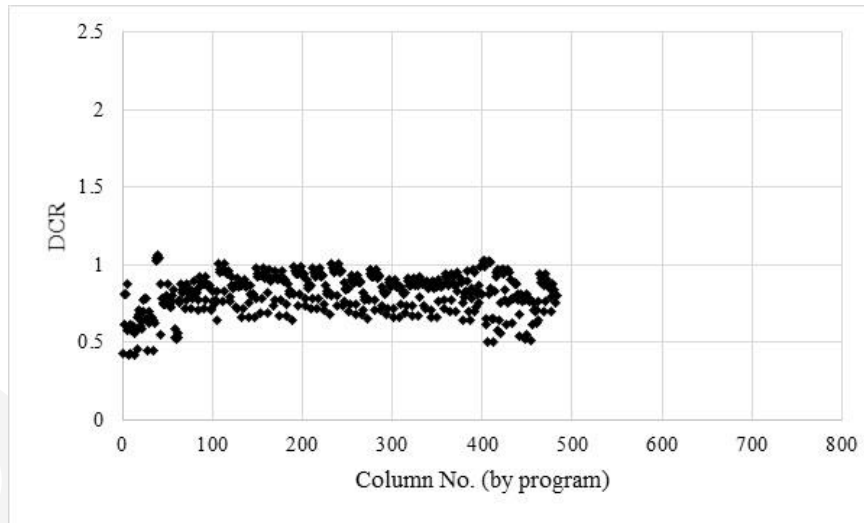
Figure 8. Performance of columns, existing BSE 1E

Figure 8 presents the performance of columns at BSE-1E. Note the following:

- Connections meet ASCE 41-17 requirements
- DCR values are less than or close to unity. In other words, columns remain elastic (damage free).

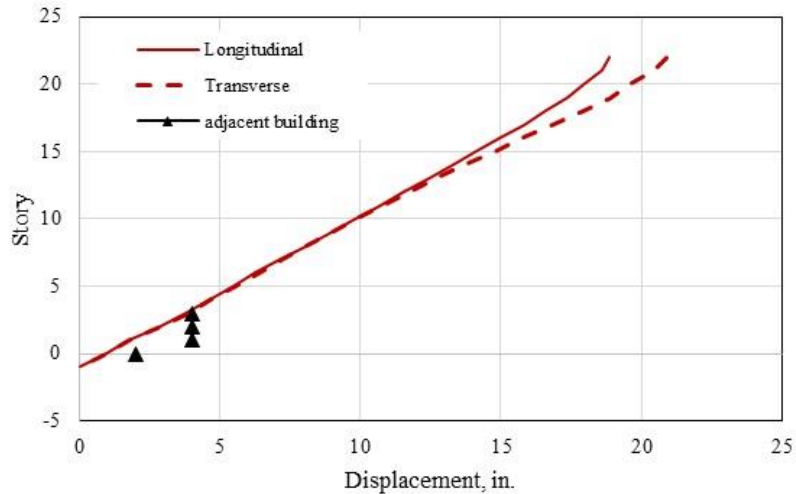
Figure 10. Floor displacements, existing BSE 1E

Figure 10 presents the computed floor displacements. Note that the seismic gap provided is adequate and thus no pounding is anticipated.

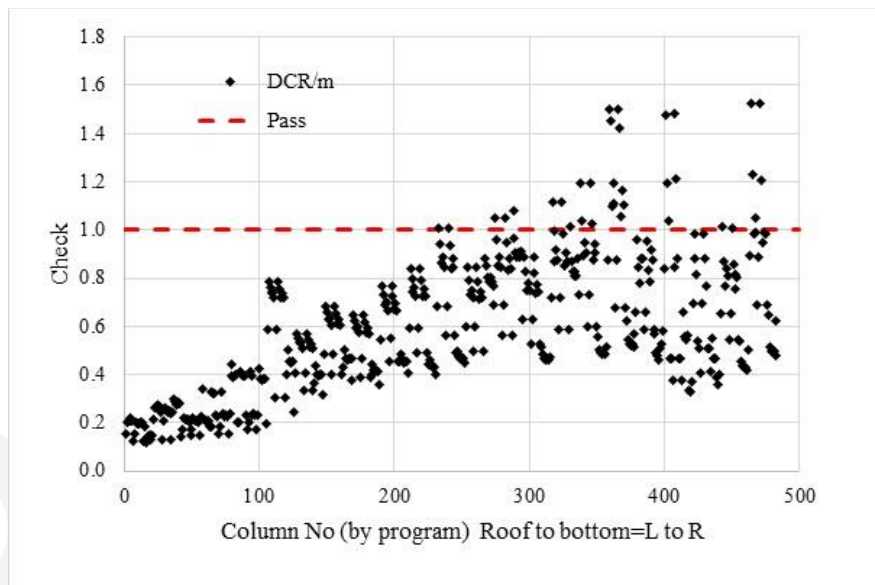
Figure 12. Performance of columns, existing BSE 2E

Figure 12 presents the performance of columns at BSE-2E. Note the following:

- Columns do not meet ASCE 41-17 requirements

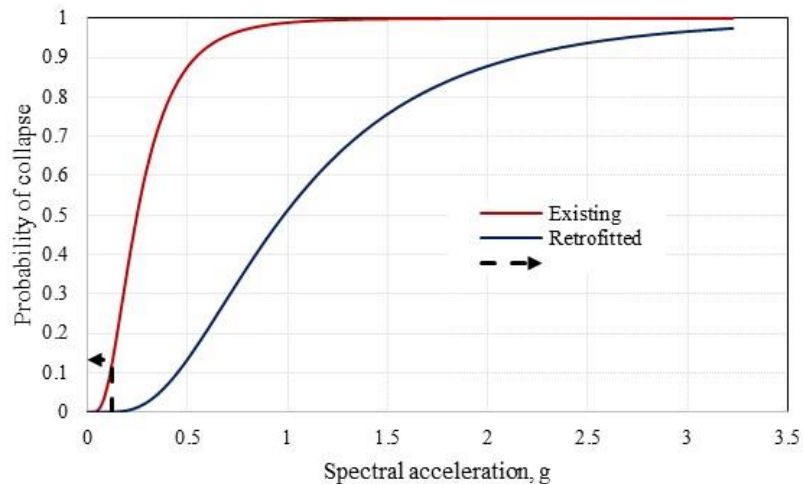
Figure 27. Probability of collapse

The input for analysis consisted of the structural responses discussed in the earlier sections of this report. Figure 27 presents the probability of collapse at a rare 975-year return earthquake. The existing structure has collapse probability of 13%, but retrofit with dampers reduce this to less than 1%.
