**STORM WATER CHANNEL  
MAINTENANCE PROGRAM PRIORITIZATION**  
September 13, 2016

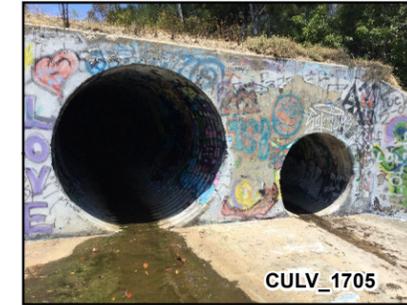
CHAN\_3392

- Maintenance Priority: **HIGH**
- Channel Prioritization Score: **88.8 out of 100**
- Capacity Prior to Maintenance: **less than 2-year storm event**
- Capacity After Maintenance (As-built Capacity) : **25-year storm event**
- Clogging Potential: **MEDIUM**
- Approximate Invasive Vegetation Coverage: **HIGH**
- Approximate Native Vegetation Coverage: **LOW**
- Surrounding Area: **Residential**
- Infrastructure Failures: **NONE**
- Site Evaluation Date: **May 15, 2016**
- Notes/Comments: **Channel has dense arundo growing near downstream culvert. Arundo and channel are right next to residential houses and fencing.**

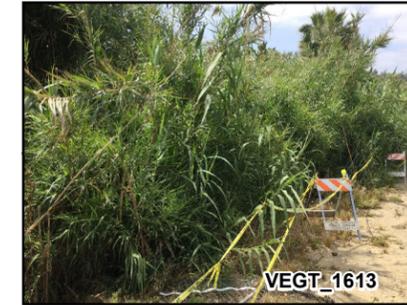
CHAN\_3171

- Maintenance Priority: **HIGH**
- Channel Prioritization Score: **80.6 out of 100**
- Capacity Prior to Maintenance: **less than 2-year storm event**
- Capacity After Maintenance (As-built Capacity): **50-year storm event**
- Clogging Potential: **MEDIUM**
- Approximate Invasive Vegetation Coverage: **HIGH**
- Approximate Native Vegetation Coverage: **LOW**
- Surrounding Area: **Residential**
- Infrastructure Failures: **NONE**
- Site Evaluation Date: **May 11, 2016**
- Notes/Comments: **Channel is adjacent to residential houses. Channel inlet and outlet could not be found due to dense vegetation and sediment deposition.**

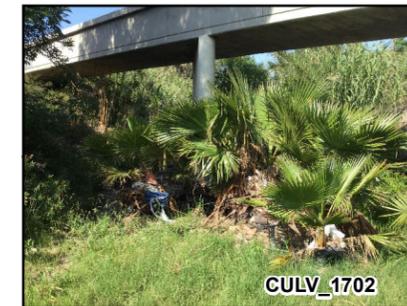
CHAN\_3381

- Maintenance Priority: **MEDIUM**
- Channel Prioritization Score: **78.6 out of 100**
- Capacity Prior to Maintenance: **less than 2-year storm event**
- Capacity After Maintenance (As-built Capacity): **5-year storm event**
- Clogging Potential: **MEDIUM**
- Approximate Invasive Vegetation Coverage: **HIGH**
- Approximate Native Vegetation Coverage: **LOW**
- Surrounding Area: **Residential**
- Infrastructure Failures: **NONE**
- Site Evaluation Date: **June 2, 2016**
- Notes/Comments: **Channel has dense vegetation and sediment deposited within the channel. Channel has invasive vegetation (palm trees and arundo) growing in it.**

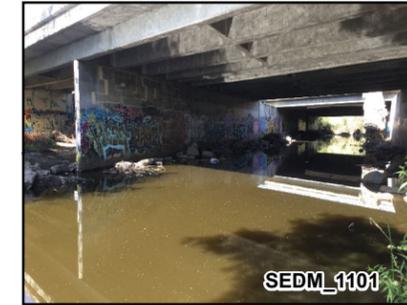
CHAN\_3462

- Maintenance Priority: **MEDIUM**
- Channel Prioritization Score: **75.3 out of 100**
- Capacity Prior to Maintenance: **2-year storm event**
- Capacity After Maintenance (As-built Capacity) : **2-year storm event**
- Clogging Potential: **MEDIUM**
- Approximate Invasive Vegetation Coverage: **LOW**
- Approximate Native Vegetation Coverage: **HIGH**
- Surrounding Area: **Commercial**
- Infrastructure Failures: **NONE**
- Site Evaluation Date: **June 16, 2016**
- Notes/Comments: **Channel narrows drastically once it goes underneath Avenida Del Rio. Channel has high potential to flood Fashion Valley parking structure due to structure being so low and channel being narrow in this area.**

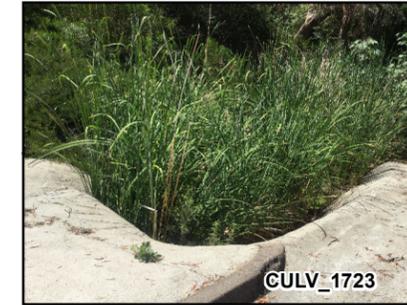
CHAN\_3509

- Maintenance Priority: **LOW**
- Channel Prioritization Score: **63.6 out of 100**
- Capacity Prior to Maintenance: **less than 2-year storm event**
- Capacity After Maintenance (As-built Capacity) : **less than 2-year storm event**
- Clogging Potential: **HIGH**
- Approximate Invasive Vegetation Coverage: **MEDIUM**
- Approximate Native Vegetation Coverage: **MEDIUM**
- Surrounding Area: **Residential**
- Infrastructure Failures: **NONE**
- Site Evaluation Date: **June 17, 2016**
- Notes/Comments: **Inlet to desilting basin is 75% clogged with tullies. The trash fence around the outlet is full of dead vegetation and sediment deposition.**

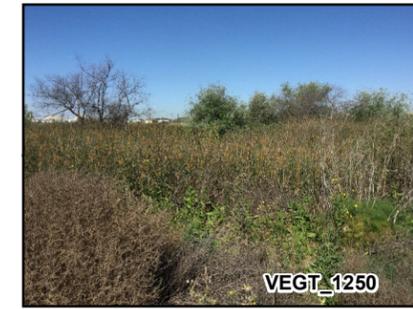
CHAN\_1786

- Maintenance Priority: **LOW**
- Channel Prioritization Score: **54.4 out of 100**
- Capacity Prior to Maintenance: **less than 2-year storm event**
- Capacity After Maintenance (As-built Capacity): **less than 2-year storm event**
- Clogging Potential: **HIGH**
- Approximate Invasive Vegetation Coverage: **LOW**
- Approximate Native Vegetation Coverage: **HIGH**
- Surrounding Area: **Industrial**
- Infrastructure Failures: **NONE**
- Site Evaluation Date: **April 18, 2016**
- Notes/Comments: **Channel is full of vegetation. Potential for flooding is high, and flooding would impede traffic into Mexico.**
