TEXT CLARIFICATION
COASTAL EROSION ASSESSMENT AND
CAVE SOLUTION FEASIBILITY ANALYSIS
COAST BOULEVARD AND COOK'S CRACK SEA CAVE
SAN DIEGO, CALIFORNIA

COASTAL EROSION ASSESSMENT AND
CAVE SOLUTION FEASIBILITY ANALYSIS
**COAST BOULEVARD AND
COOK'S CRACK SEA CAVE**
SAN DIEGO, CALIFORNIA

Project No. 2086B
June 17, 2019

GEOTECHNICAL SURVEY & EVALUATION
COOK'S CRACK SEA CAVE
SAN DIEGO, CALIFORNIA

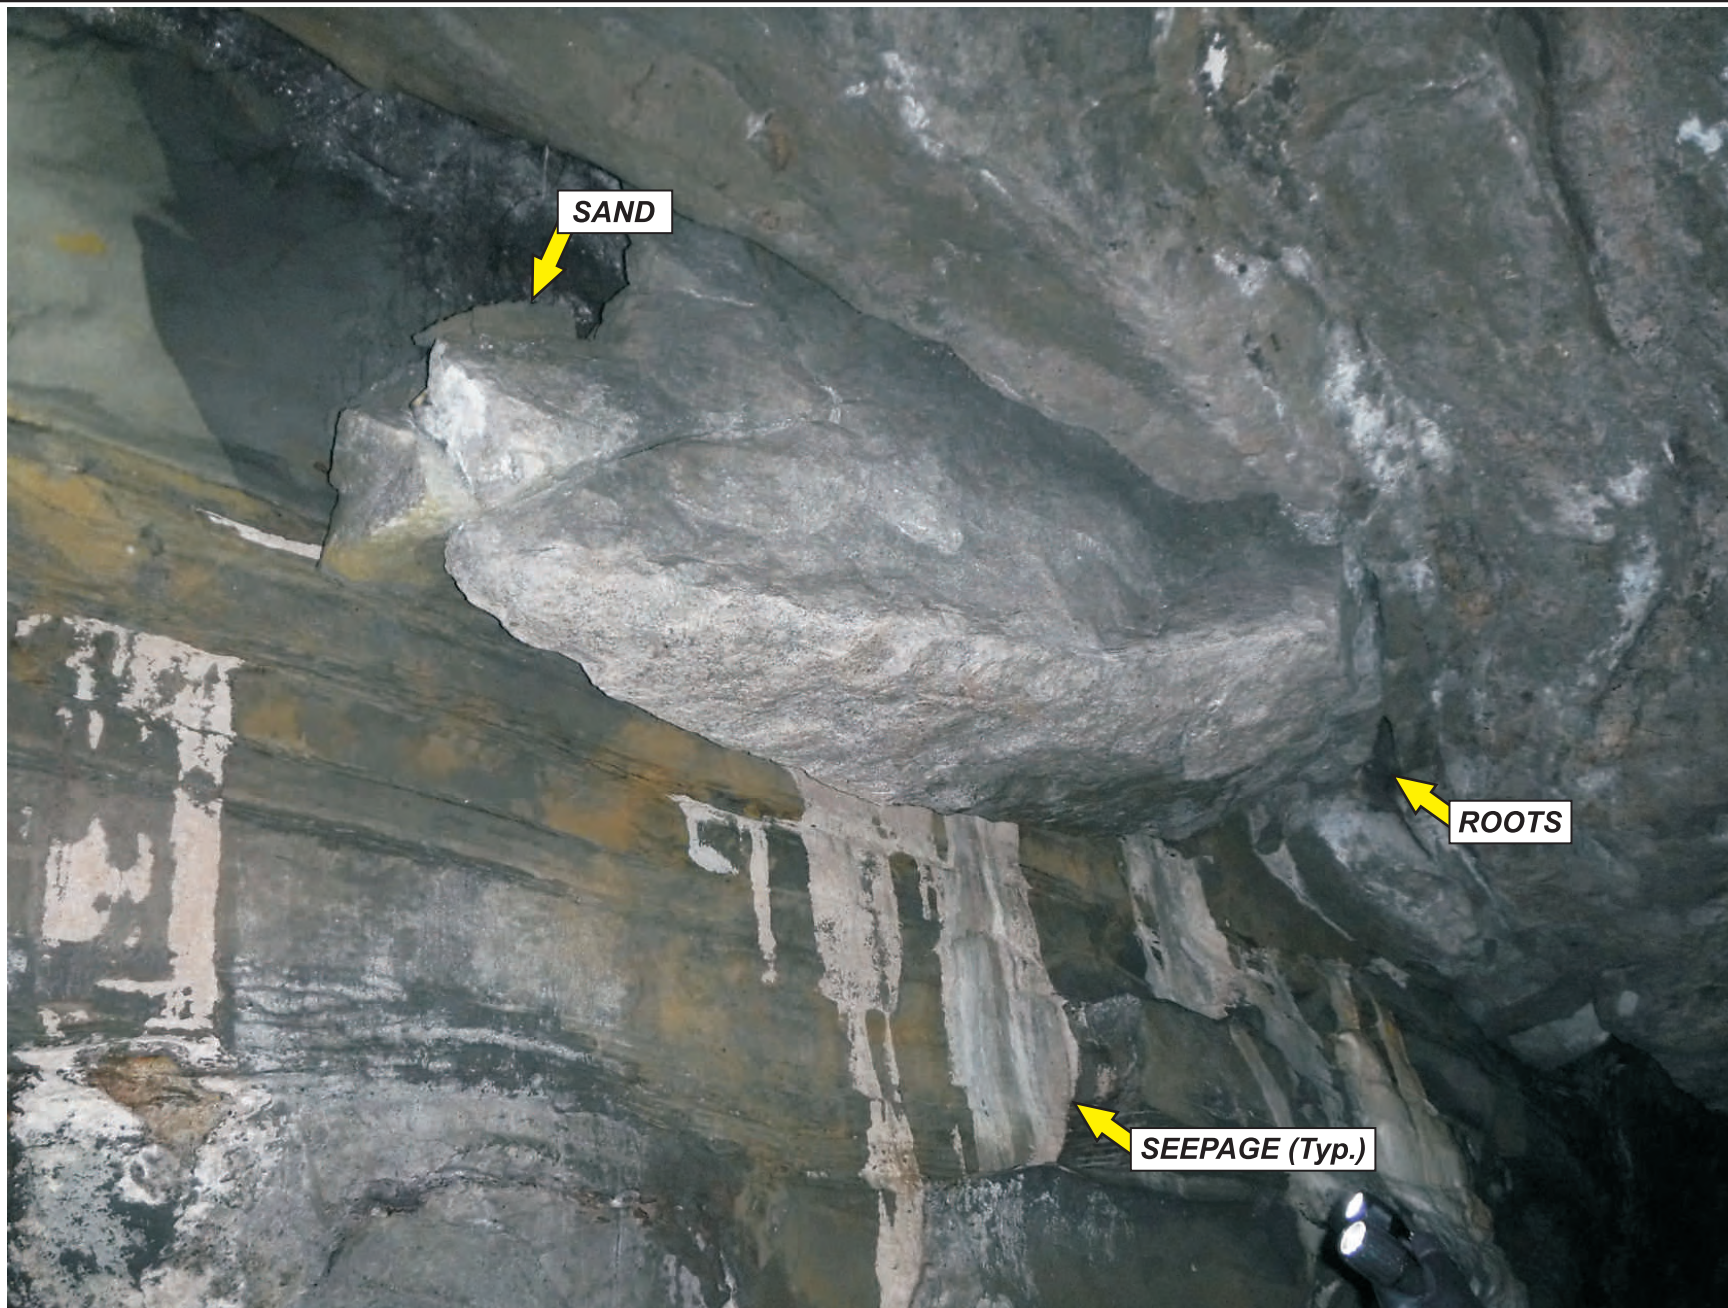
PHOTO NO.:
3

As we discussed today during our presentation, and as shown on Photo 3 of our June 17 report, this possibly 5,000-pound block that has become dislodged within the adjacent fault joints, along with both the groundwater and overlying terrace deposits that are now falling from the roof, creates a very unstable condition, and this block could in fact, collapse at any time. Moreover, any seismic tremor, or even a break of the City's water main that runs over the roof of the sea cave, could cause an imminent and catastrophic collapse. We have attached Photo 3 from our June 17, 2019, report to remind the reader that this overhanging block, although temporarily wedged into the parallel joint sets associated with this fault, could fall out at any time, thereby completely removing support for the overlying loose and friable terrace deposits. The relatively substantial seepage

exposed in the sidewalls of the cave (visible in Photo 3) is an additional cause for concern, as the seepage, along with the failure of the block, could trigger an immediate and catastrophic collapse, resulting in a rather large linear sinkhole into which a vehicle or pedestrian could fall, possibly resulting in serious injury.

The words used in our June 17 report, namely, "within a few years," was a measured description of the urgency to stabilize the site, and should not have been construed to suggest that there is **not** a very real concern that this collapse could occur at any time, and particularly after a small seismic tremor or waterline break.

As discussed in our June 2018 report, based on the results of our mapping, observations, and engineering analyses, it is our opinion that within a few years, there is a high probability of collapse of additional supporting roof rock resulting in the formation of voids or sinkholes under Coast Boulevard, causing damage to the street and utilities that overlie the Cook's Crack Sea Cave and/or injury or death due to a vehicle or pedestrian falling into a sinkhole. Based on our studies, the most feasible alternative would be to seal and infill the sea cave.

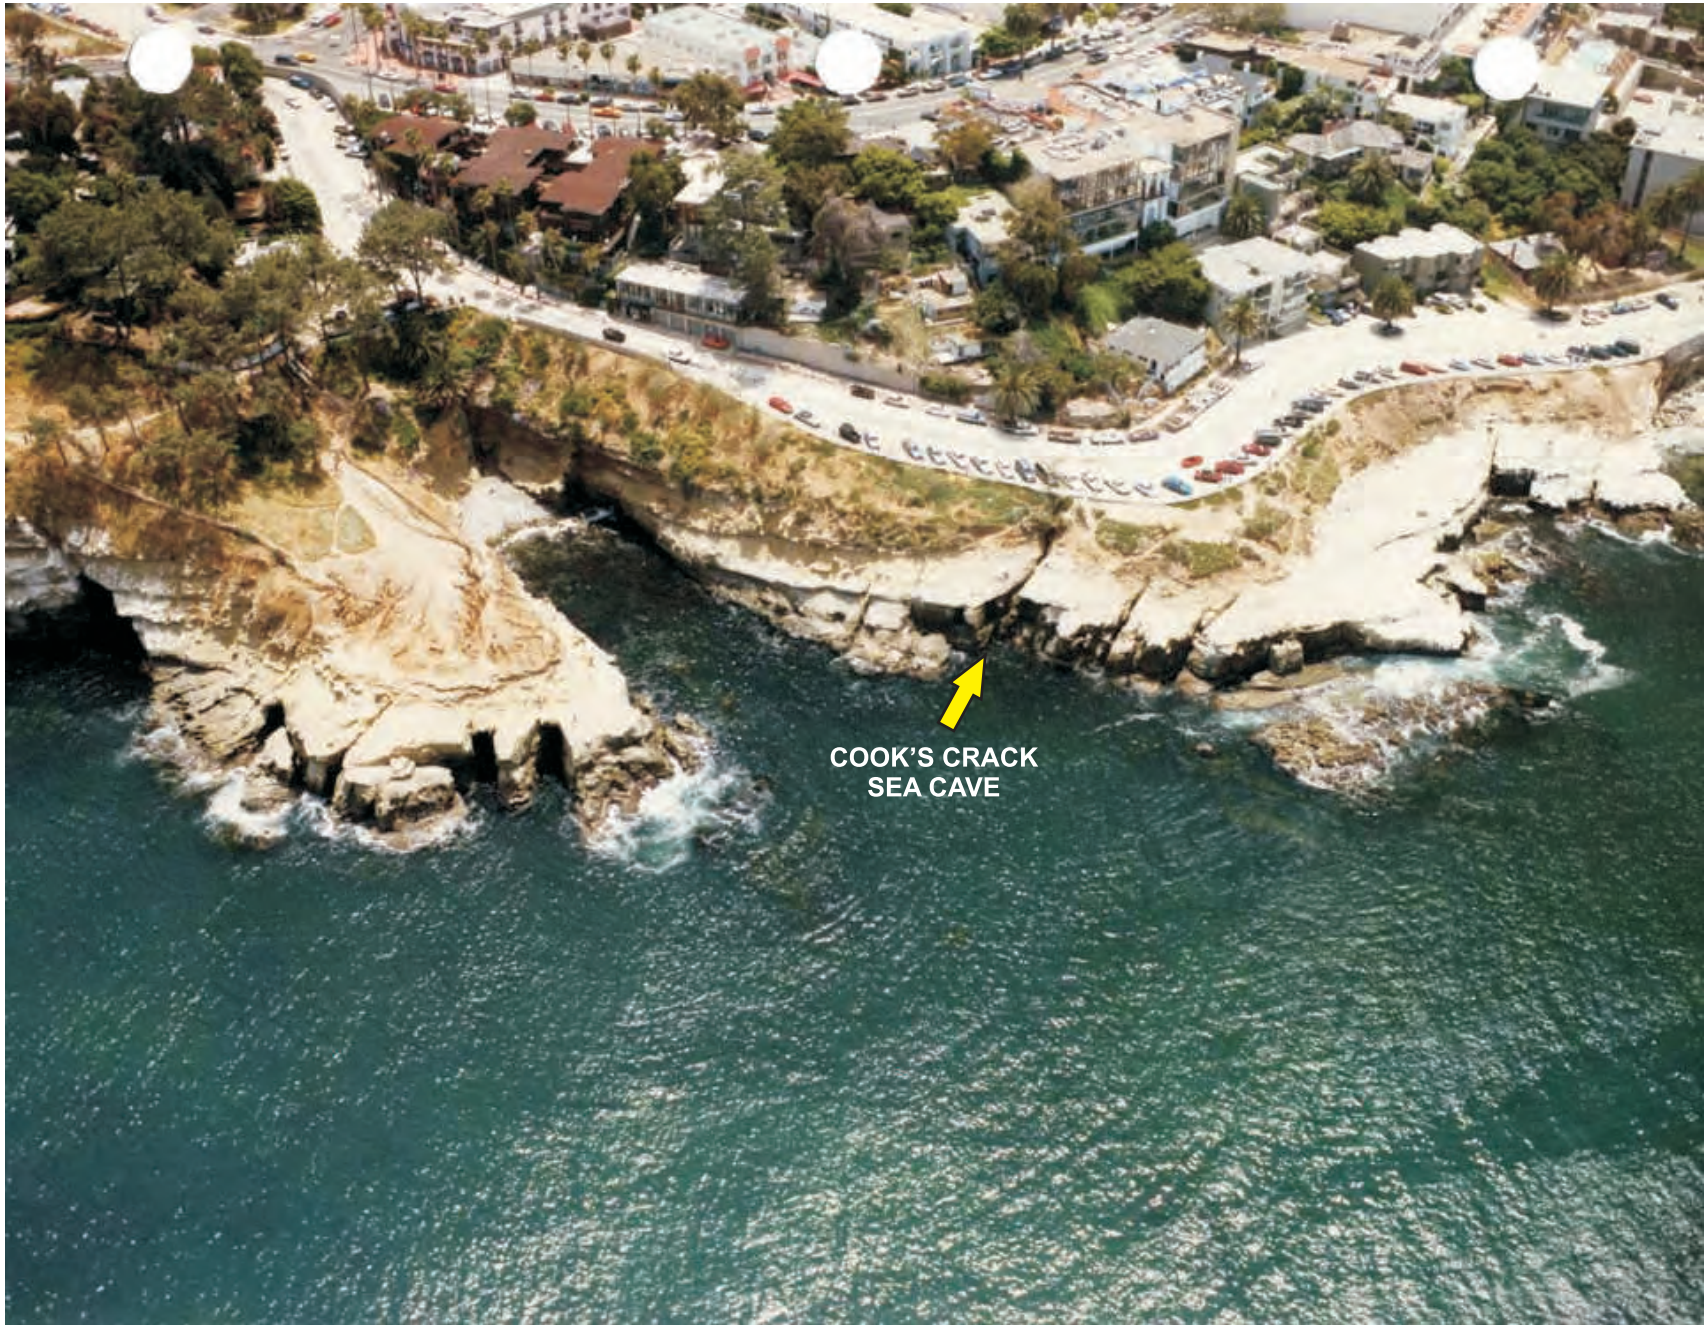
As indicated on Photo 1, the Cook's Crack Sea Cave is located on a cliffed section of the La Jolla shoreline, with the bathymetry immediately fronting the sea cave, although somewhat variable, around -3 feet MLLW. Photo 4, taken during our survey during a tidal low with the water level at about -0.2 foot MLLW, shows an indentation into the cliffed shore face of about 9 feet prior to actually entering the 4½-foot-wide mouth of the sea cave that is still not visible in Photo 4. The width of this indentation is also about 9 feet, and provides

We anticipate that the contractor would fill the cave in relatively horizontal lifts, and after the tops of the geobags have been reached, the exposed seaward face of the open jointed roof of the Cook's Crack Sea Cave (see Photo 1) would then be architecturally shaped to blend in with the surrounding formational bedrock to recreate the architectural appearance of the faulted roof rock. Once the cave is filled, the ten to twelve 4-ton rocks could be lifted back out of the mouth of the cave, returning the cliffed section to that shown in Photo 4.

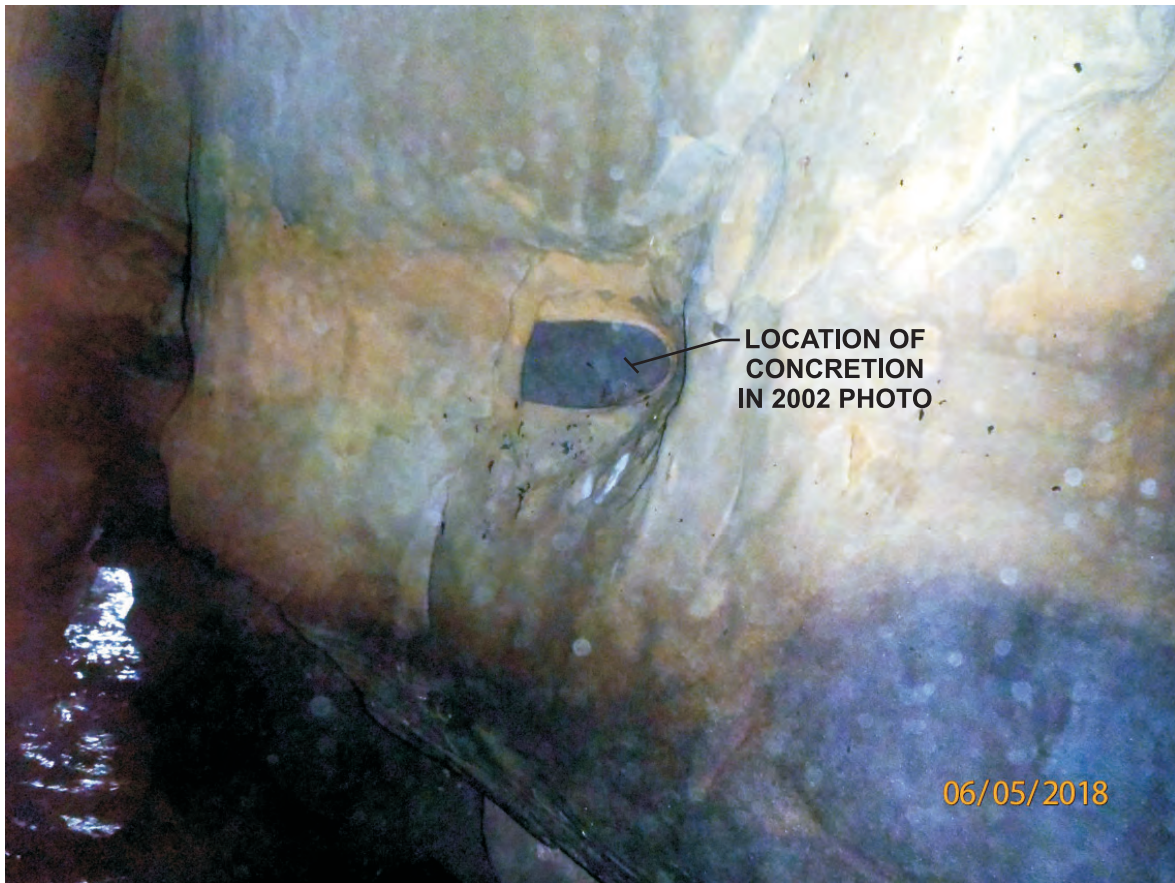
PHOTO 2: NOTE LARGE CONCRETION IS GONE, AND WALLS HAVE ERODED BACK AND WIDENED.

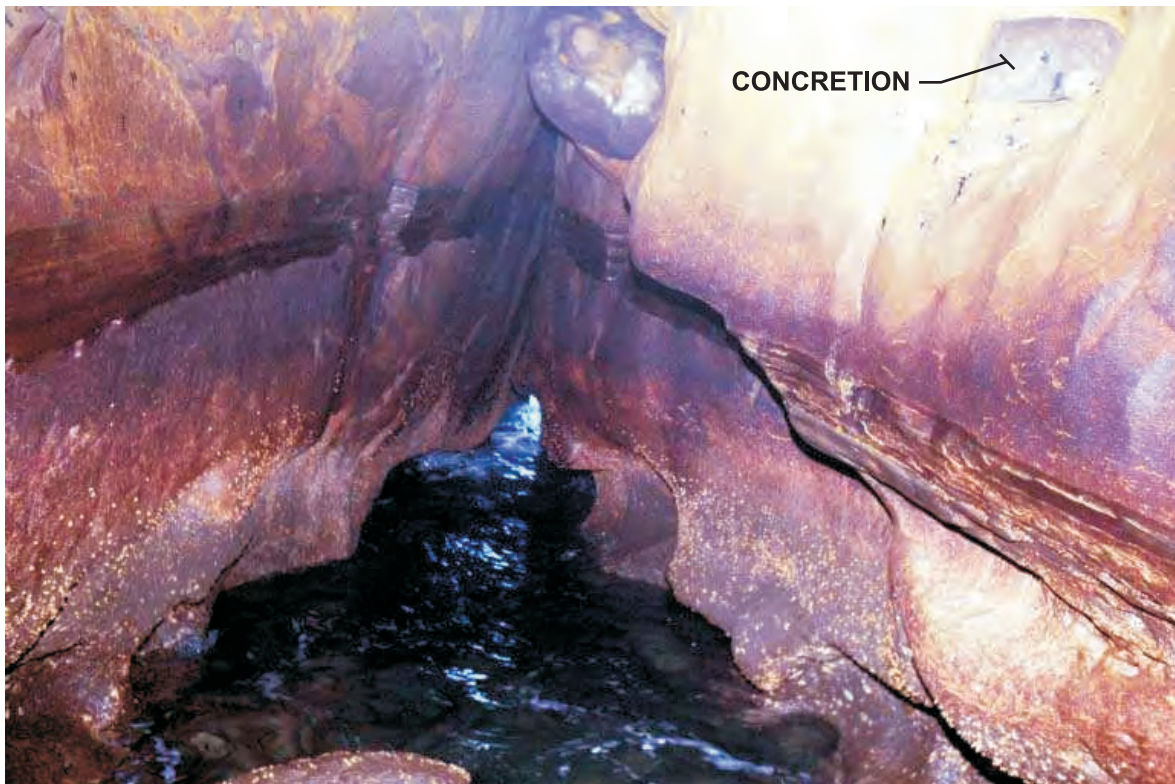
PHOTO 2A: (2002) LOOKING OUT. NOTE EXISTING CONCRETION AT UPPER EDGE OF PHOTO.

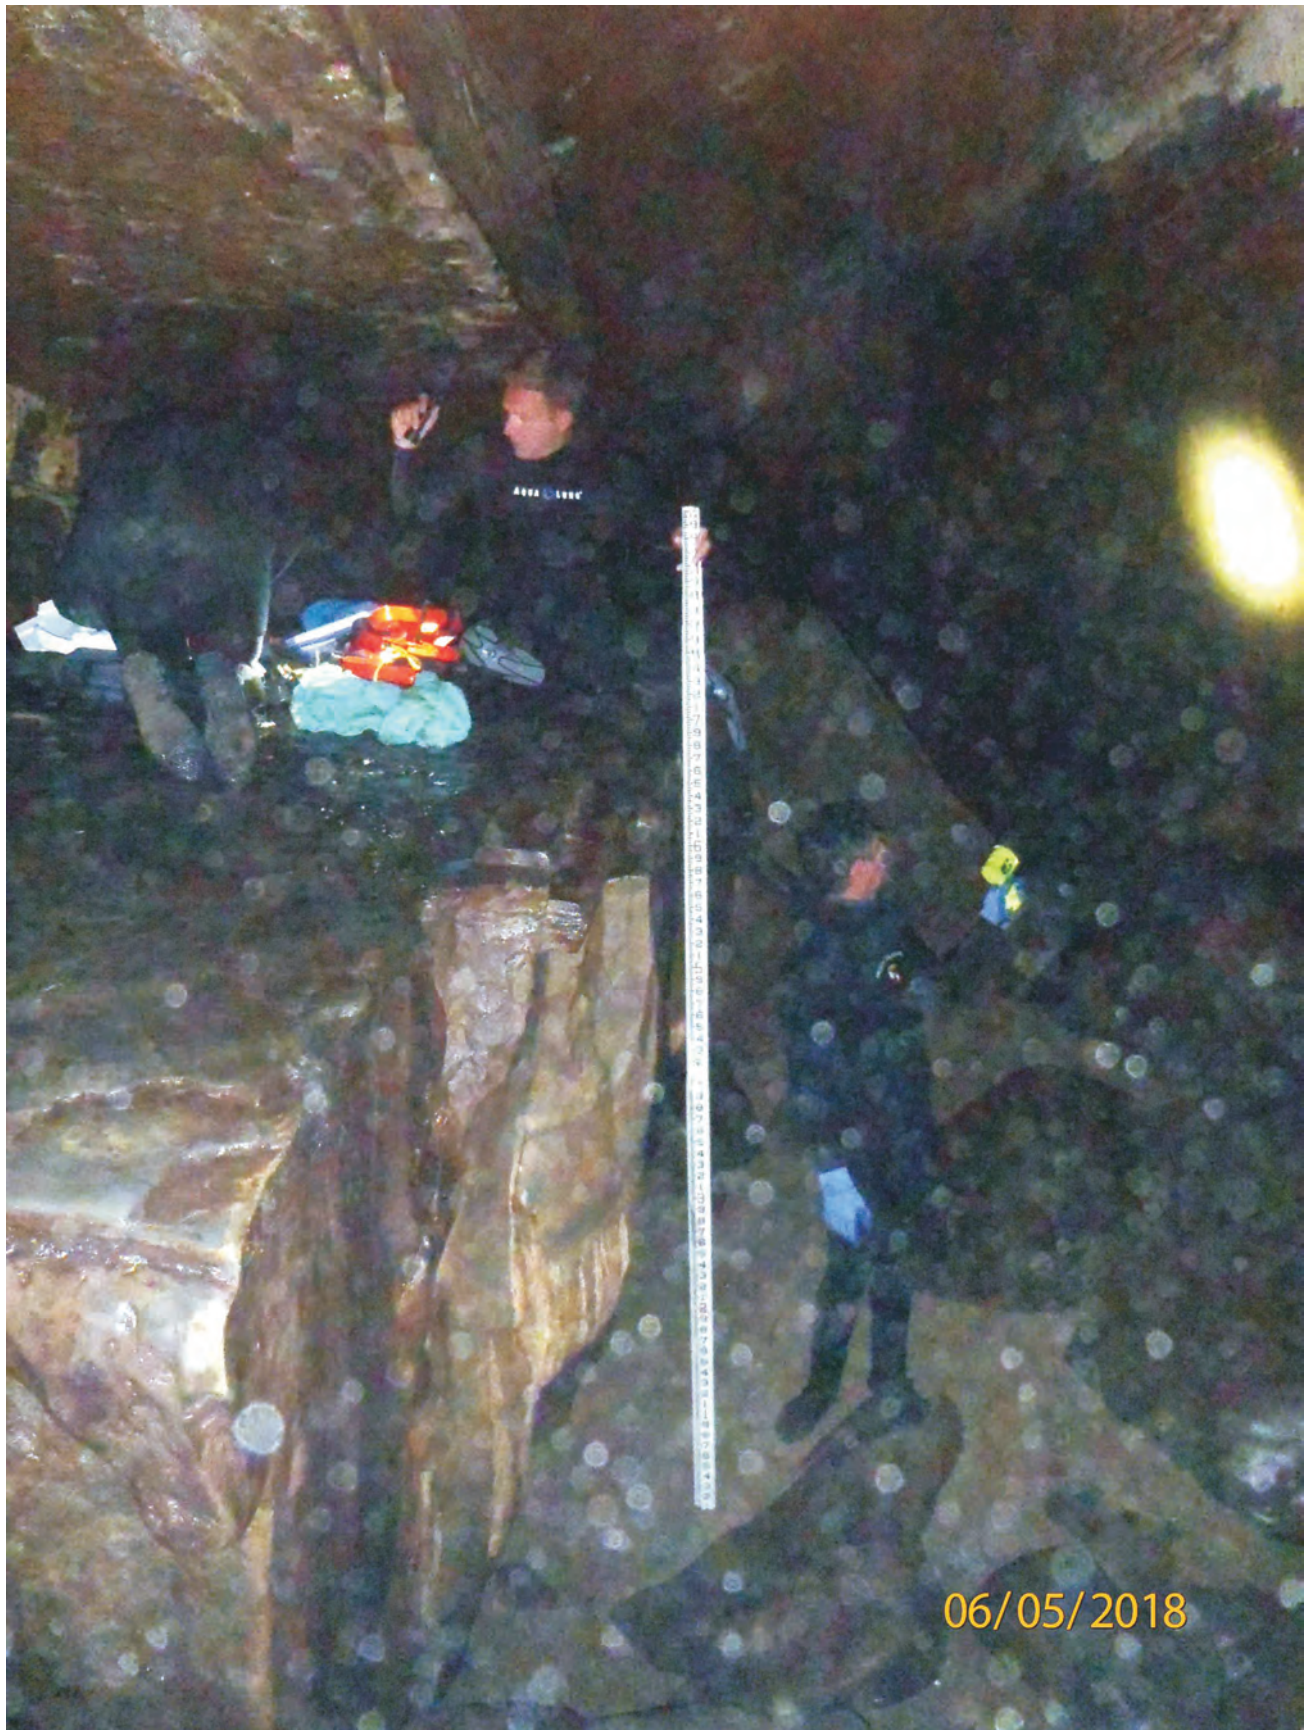
PHOTO 3: MAIN BLOCK SEEN IN 2002 SURVEY STILL MOSTLY INTACT. A CAVITY HAS DEVELOPED, UNDERMINING THE SOUTHERLY SIDE OF THE BLOCK.

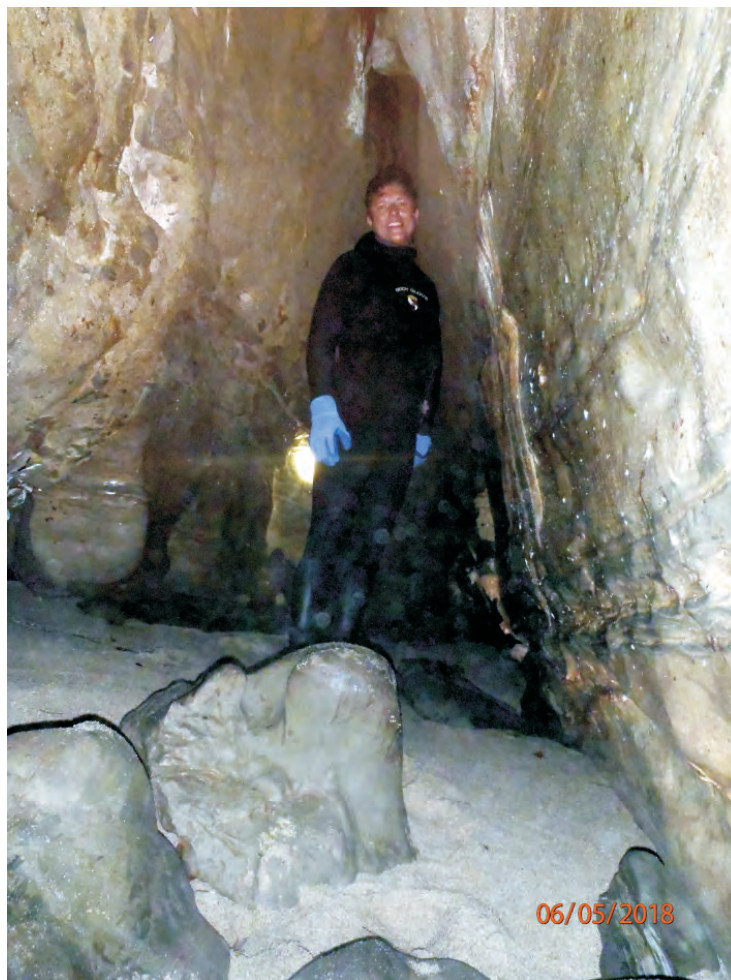
PHOTO 4A:
NOTE SAND LEVEL HAS DROPPED 1.5 TO 5 FEET.

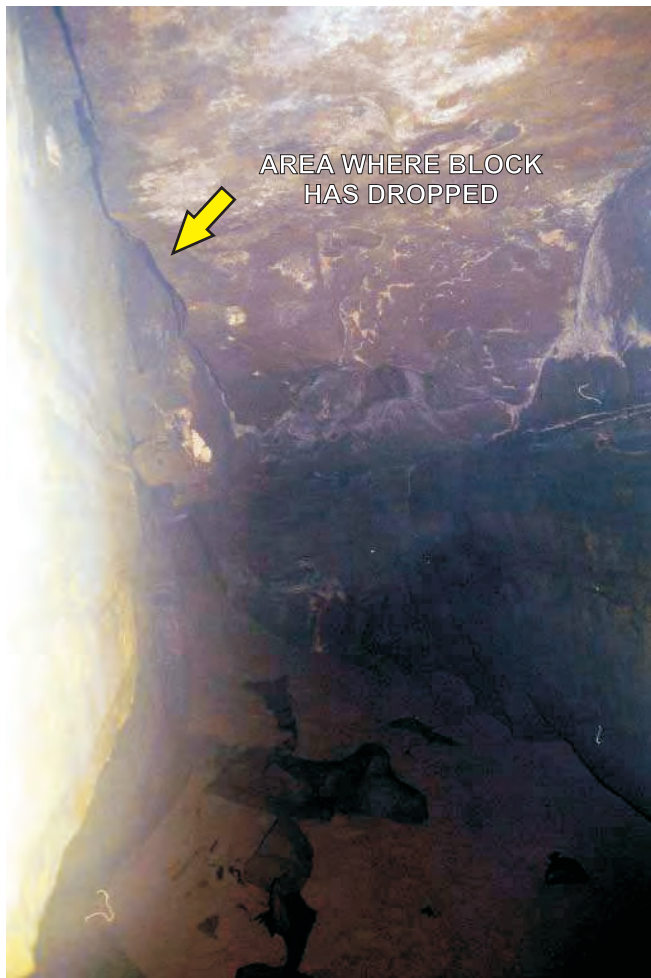
*PHOTO 5: (2002) NOTE AREA PRIOR TO RECENT ROOF
BLOCK FAILURE.*

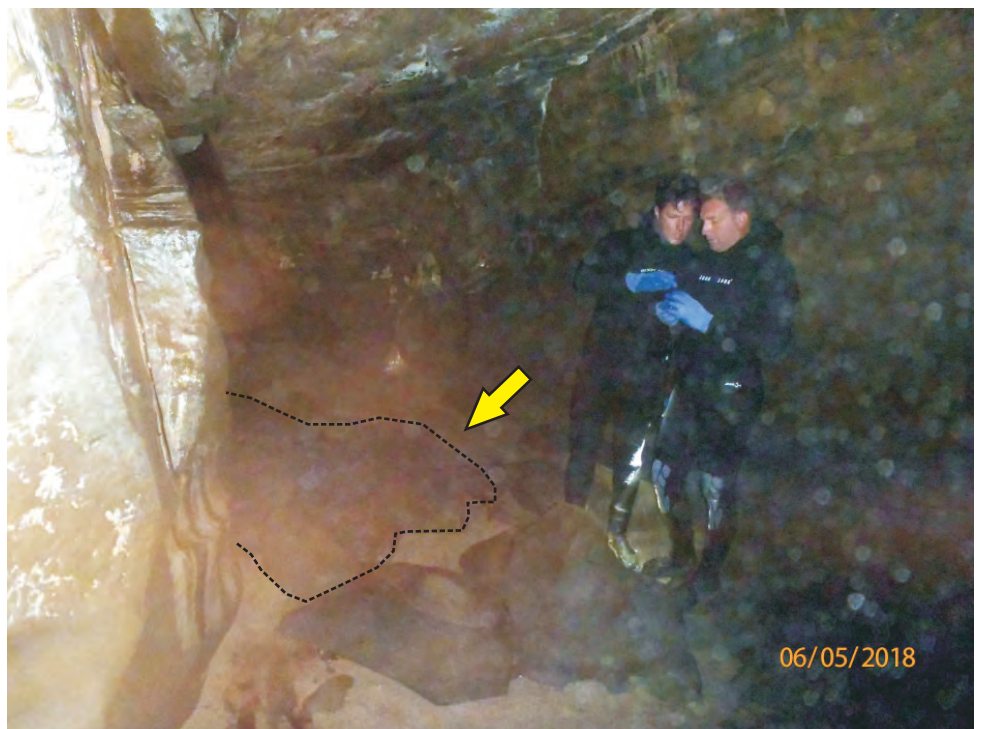
PHOTO 5A: NOTE APPARENT RECENT ROCK DEBRIS (ARROW).

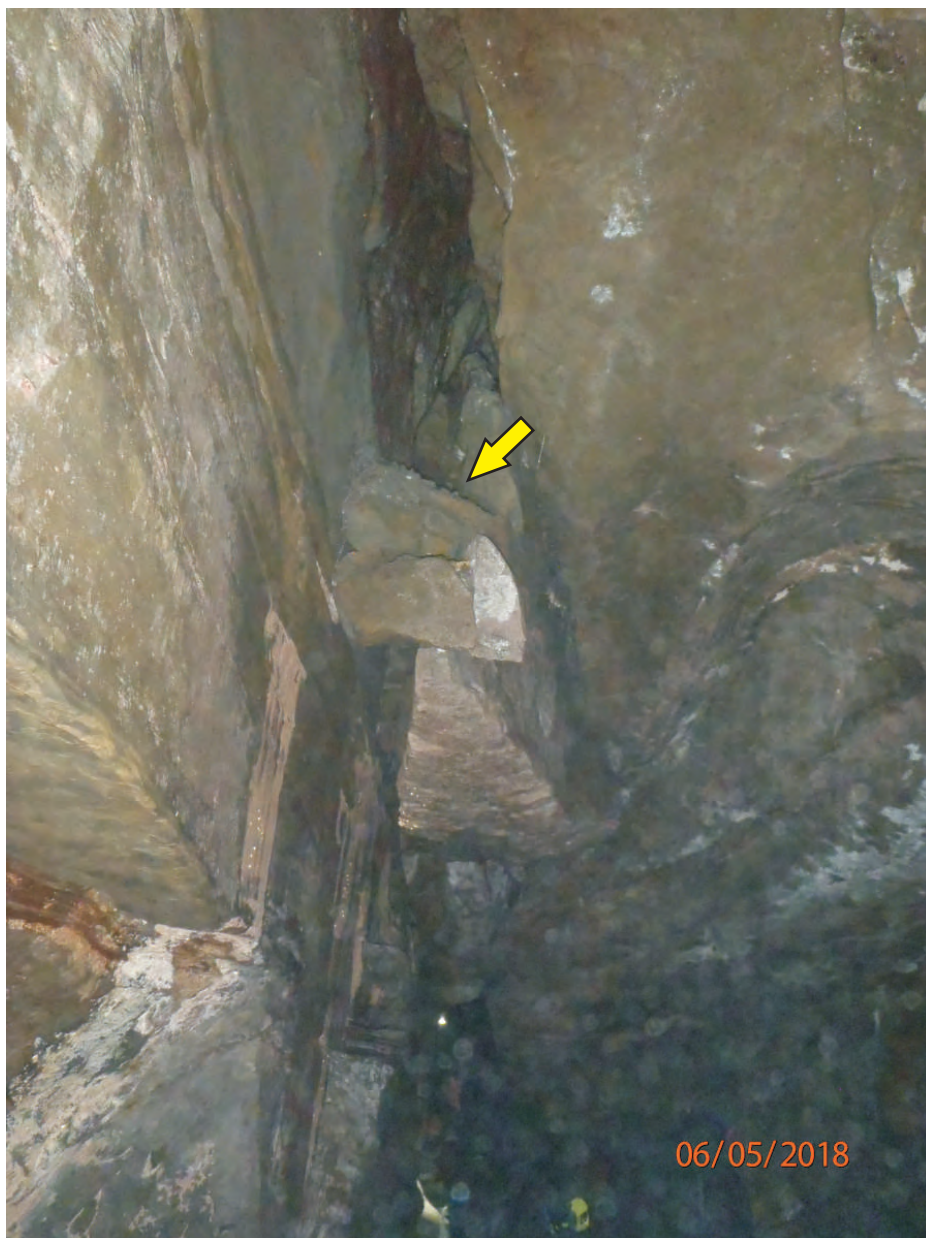
PHOTO 6: ARROW INDICATES DOWN DROPPED BLOCK. NOTE SAND ON TOP OF BLOCK.

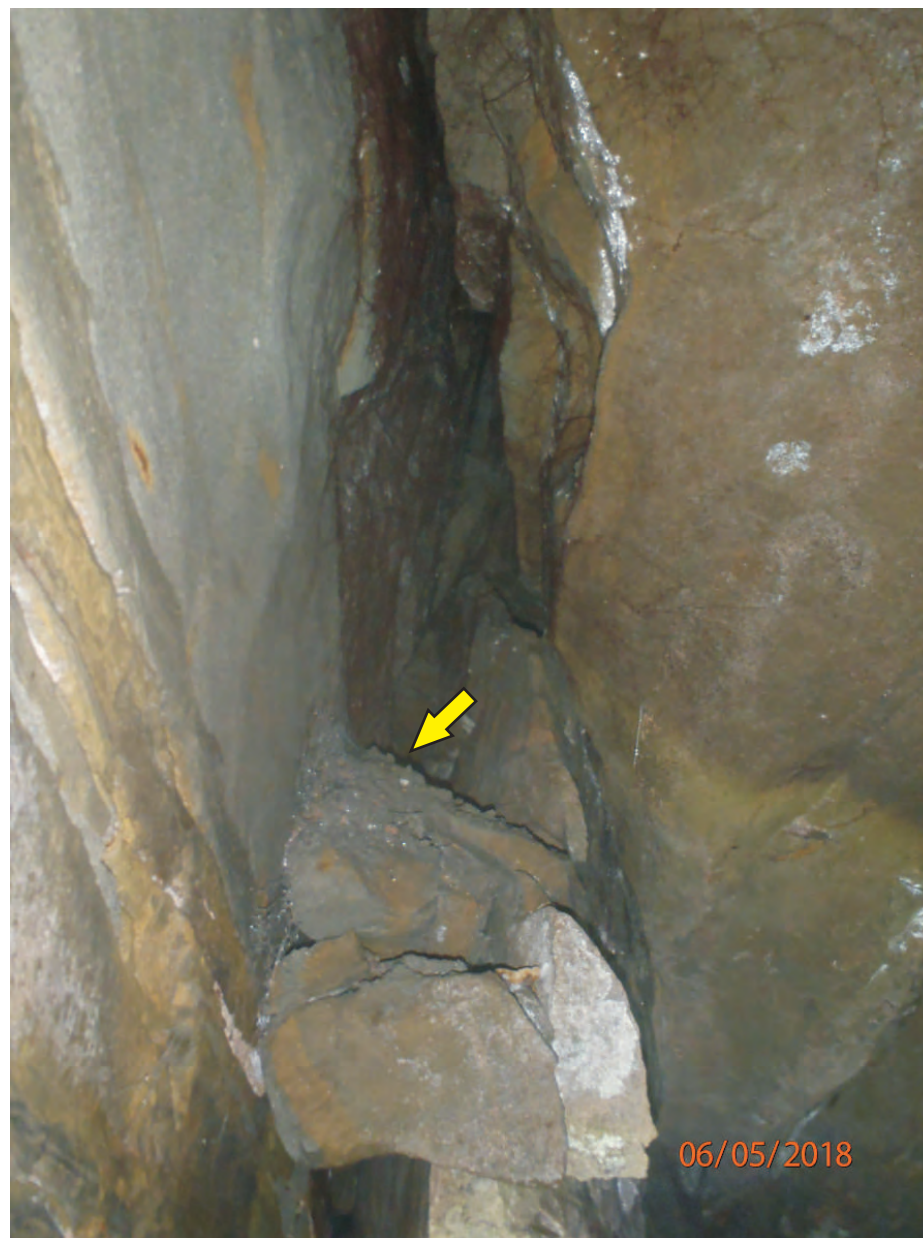
PHOTO 6A: NOTE SAND PIPING FROM OVERLYING TERRACE DEPOSITS (ARROW).
