**REPORT OF PRELIMINARY GEOTECHNICAL
INVESTIGATION**

Davidson Residential Development
811-827 Coast Boulevard South
La Jolla, California

JOB NO. 20-12787
24 September 2020

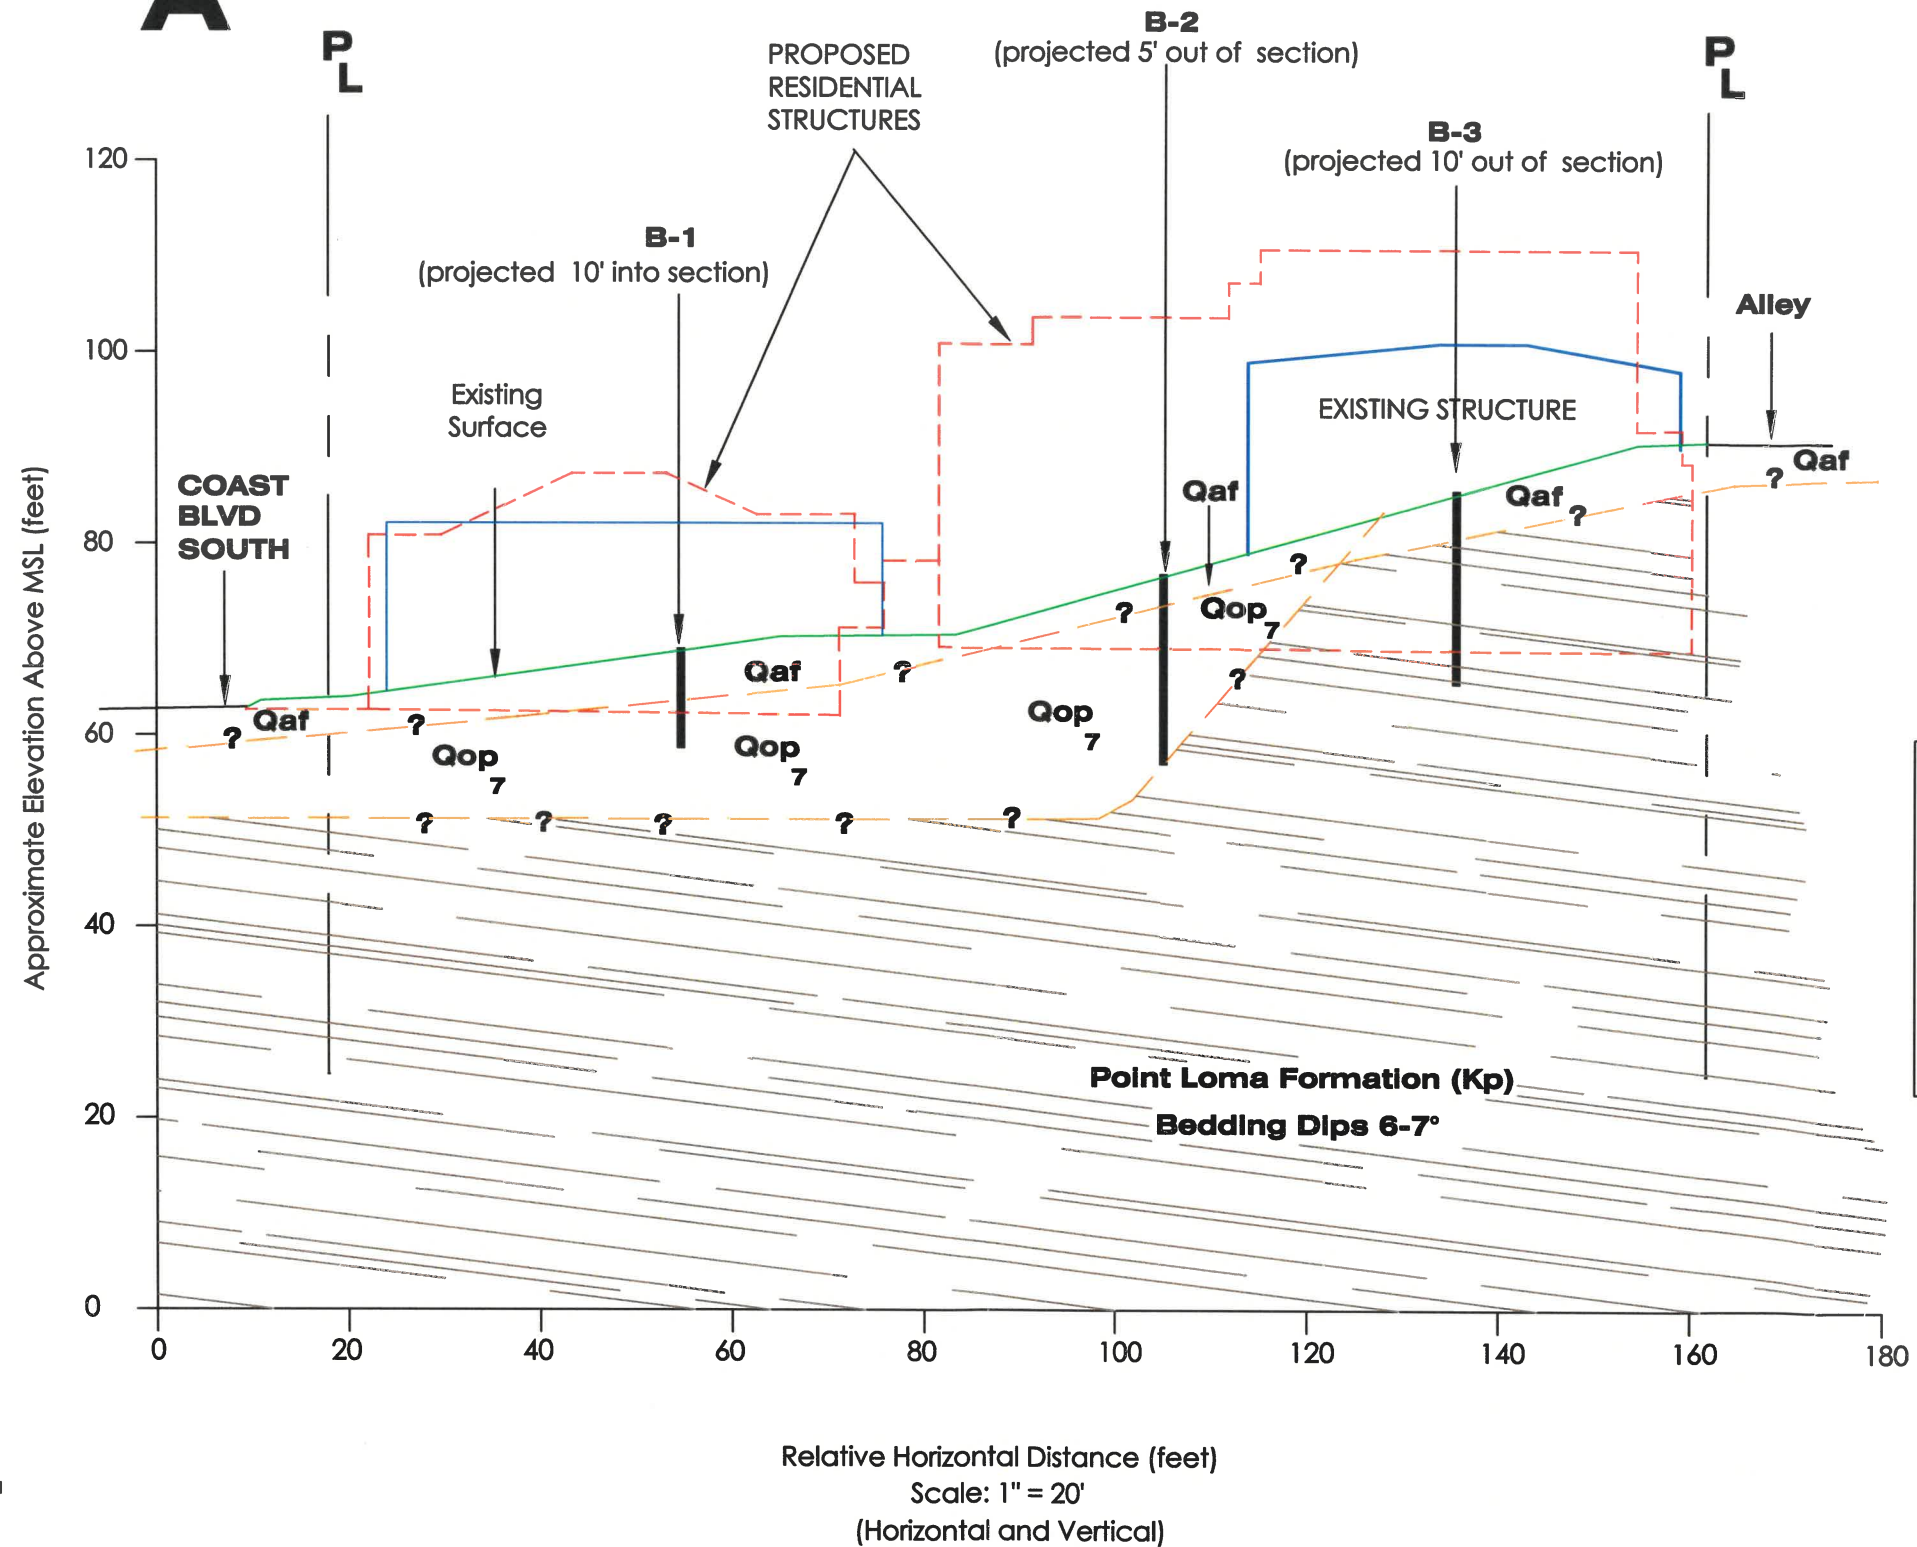
CROSS SECTION A-A'

Regional geologic structure was correlated by using information obtained in our exploratory borings and the mapped geology of the La Jolla area. The geologic contact between the Old Paralic Deposits and the Point Loma Formation is an unconformity. The basal contact of the Old Paralic Deposits is near horizontal, at an elevation of approximately 52 feet above MSL in the northwestern portion of the site. The inland edge of the marine terrace bench occurs in the eastern area of the site, where the Point Loma formation was observed to be directly underlying the fill soils. For greater understanding of the geologic structure, refer to Figure Nos. IIB-c, the Geologic Cross Sections.

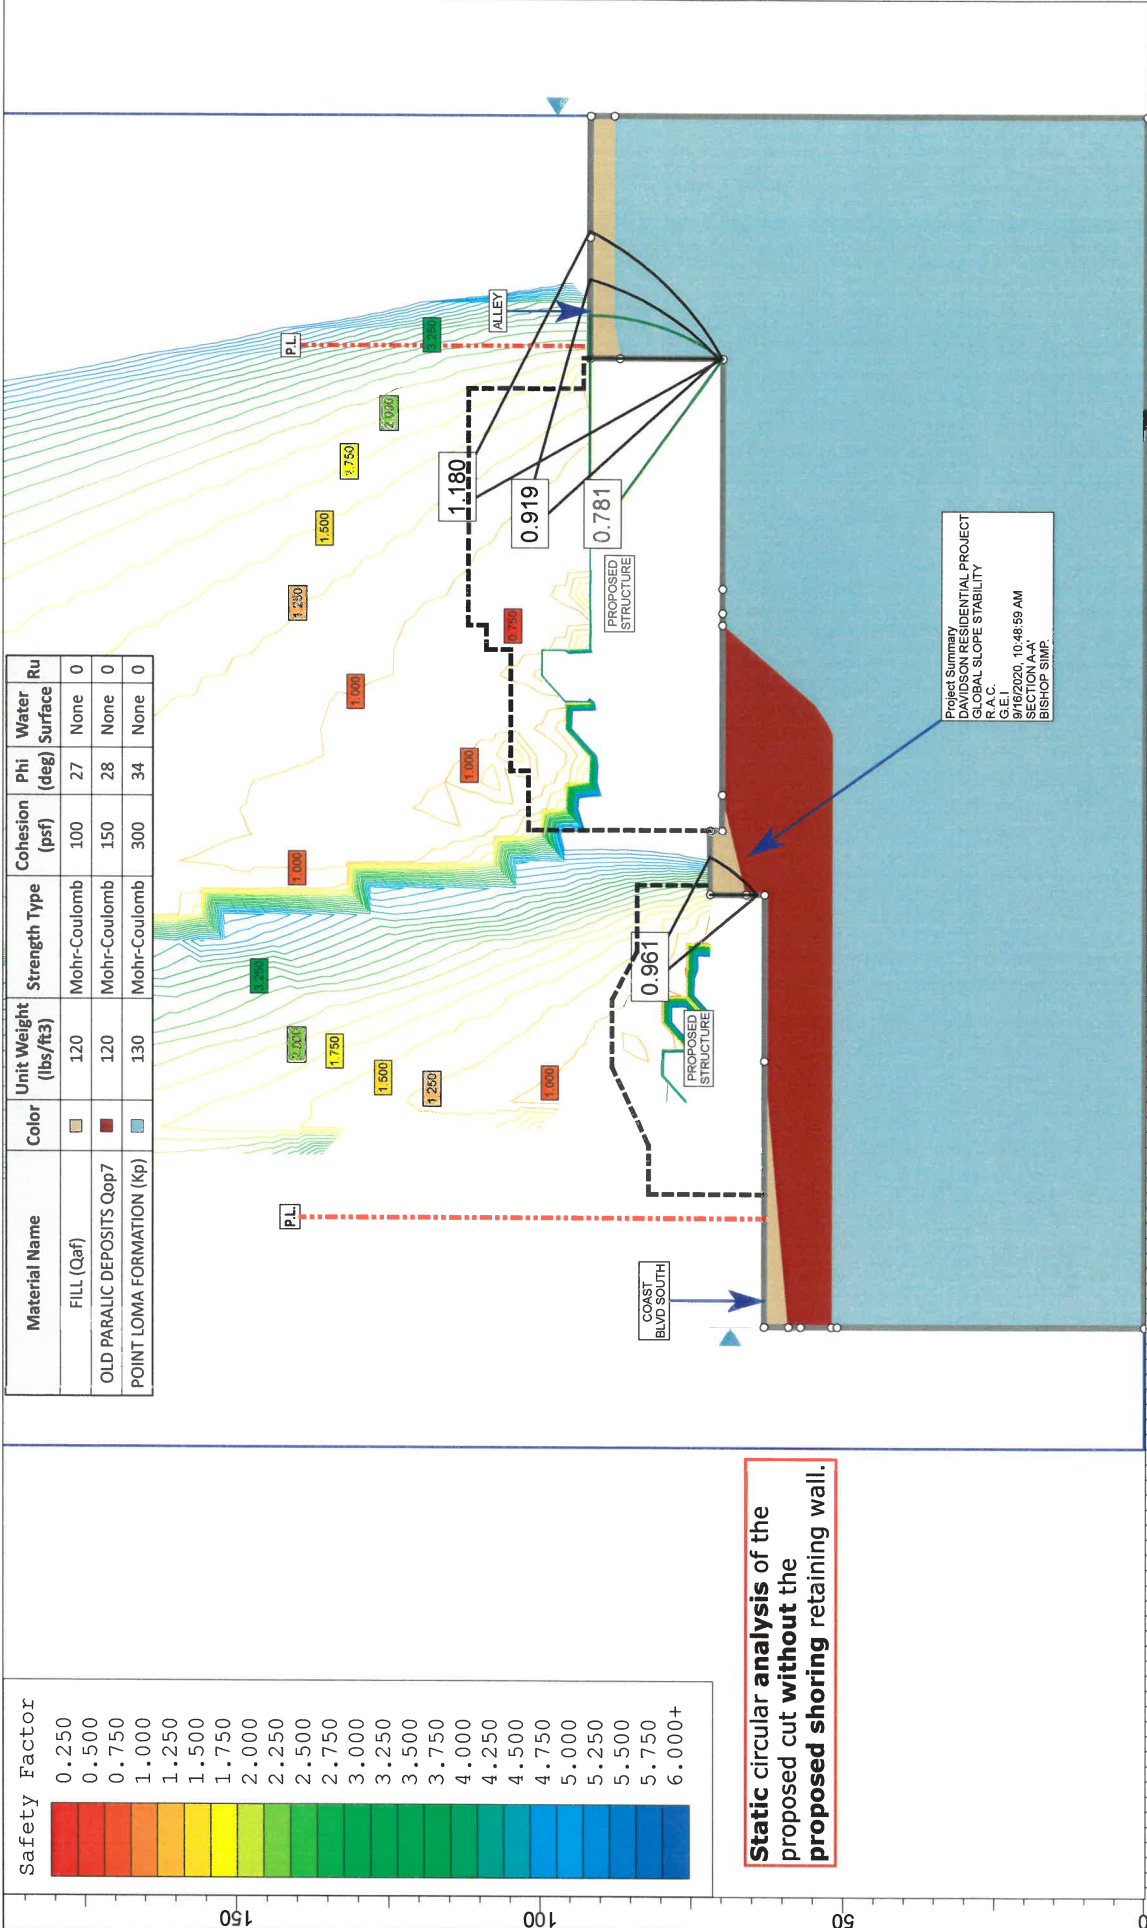
Static circular analysis of the proposed cut without the proposed shoring retaining wall.

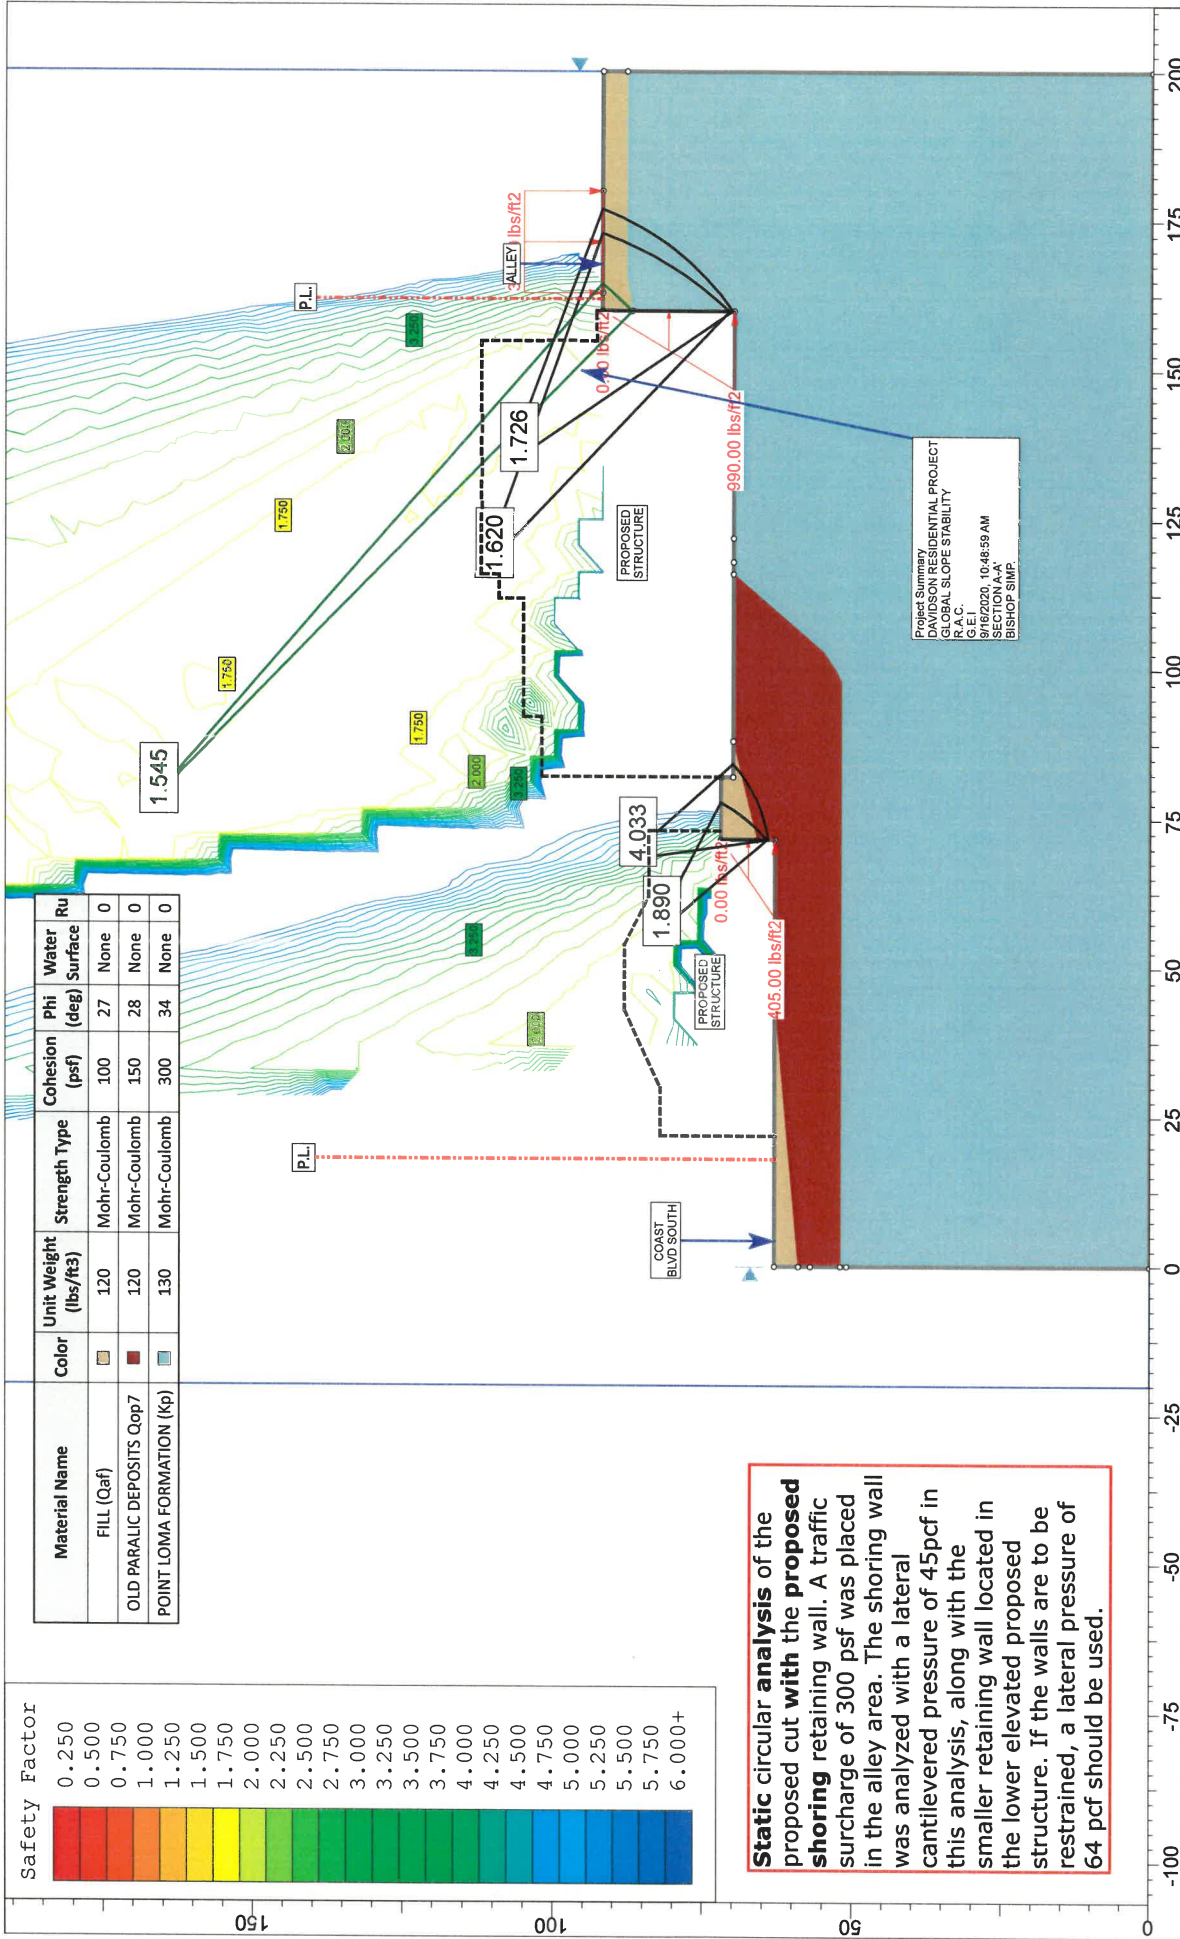
Static circular analysis of the proposed cut with the proposed shoring retaining wall. A traffic surcharge of 300 psf was placed in the alley area. The shoring wall was analyzed with a lateral cantilevered pressure of 45pcf in this analysis, along with the smaller retaining wall located in the lower elevated proposed structure. If the walls are to be restrained, a lateral pressure of 64 pcf should be used.

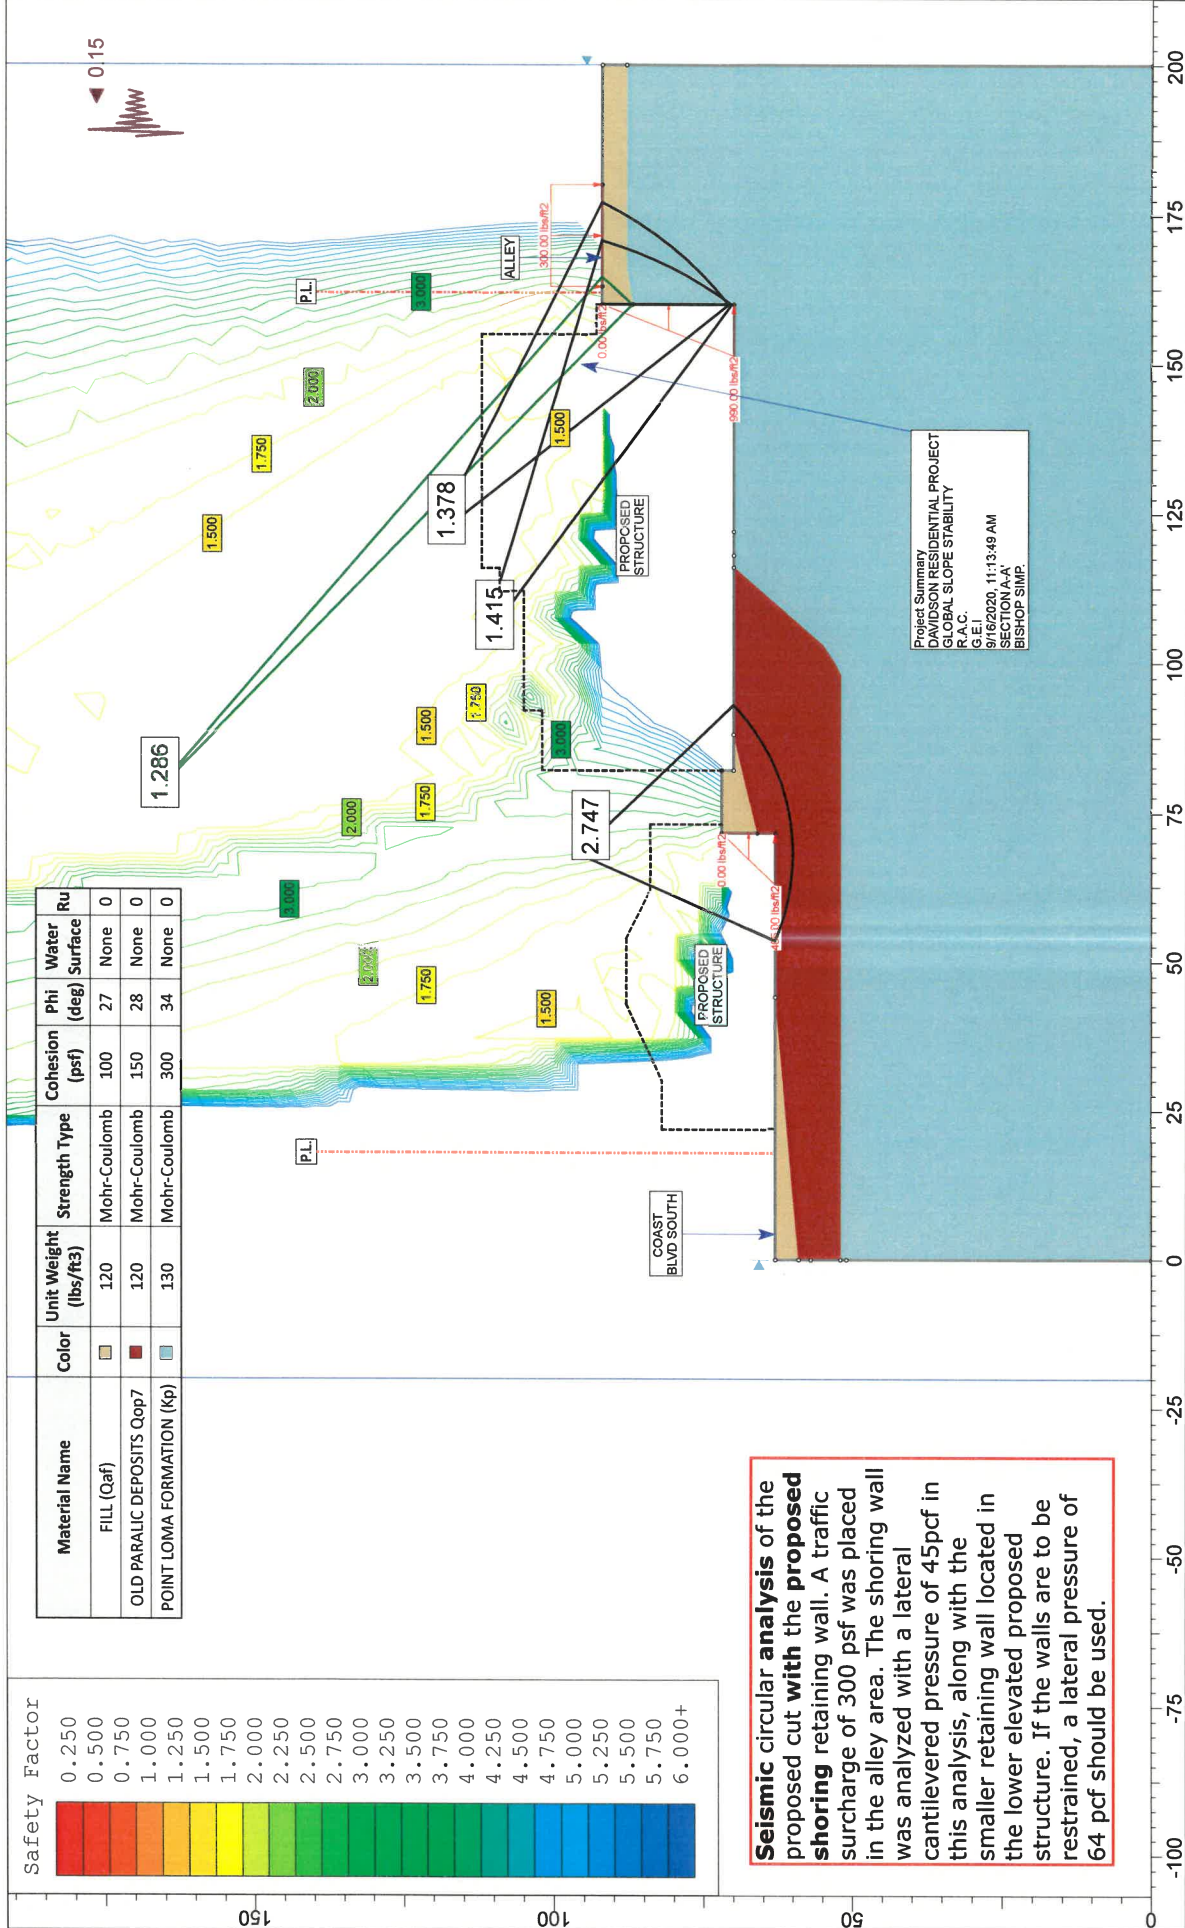
Seismic circular analysis of the proposed cut with the proposed shoring retaining wall. A traffic surcharge of 300 psf was placed in the alley area. The shoring wall was analyzed with a lateral cantilevered pressure of 45pcf in this analysis, along with the smaller retaining wall located in the lower elevated proposed structure. If the walls are to be restrained, a lateral pressure of 64 pcf should be used.

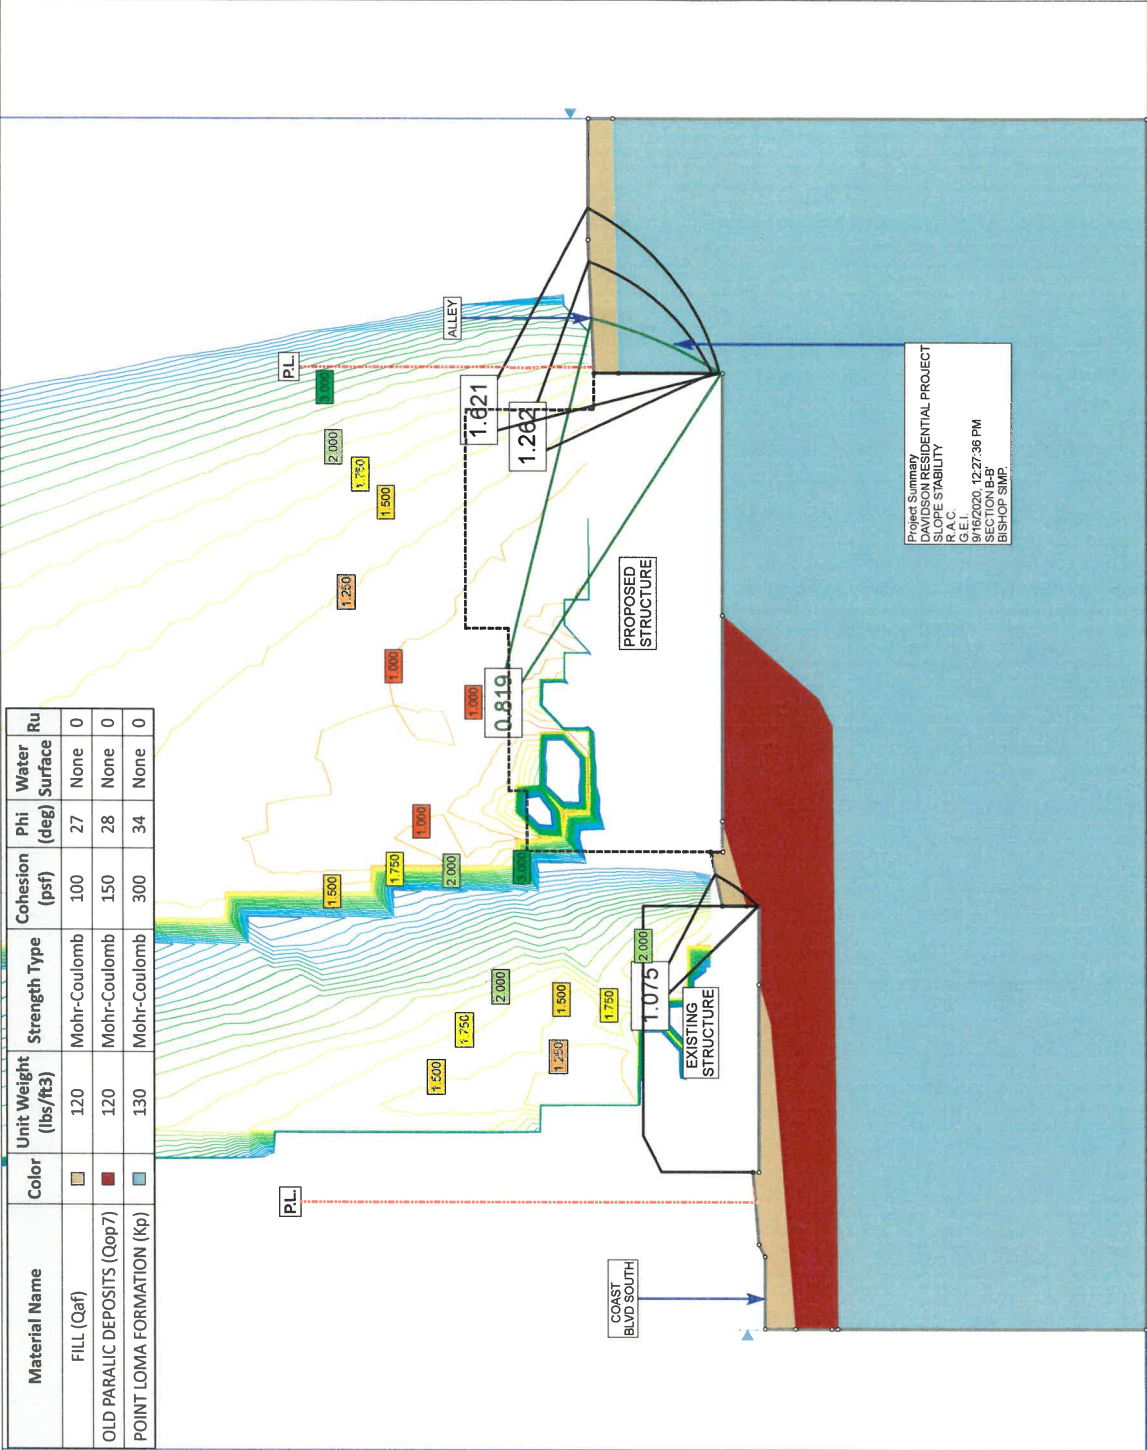
Static circular analysis of the proposed cut without the proposed shoring retaining wall.

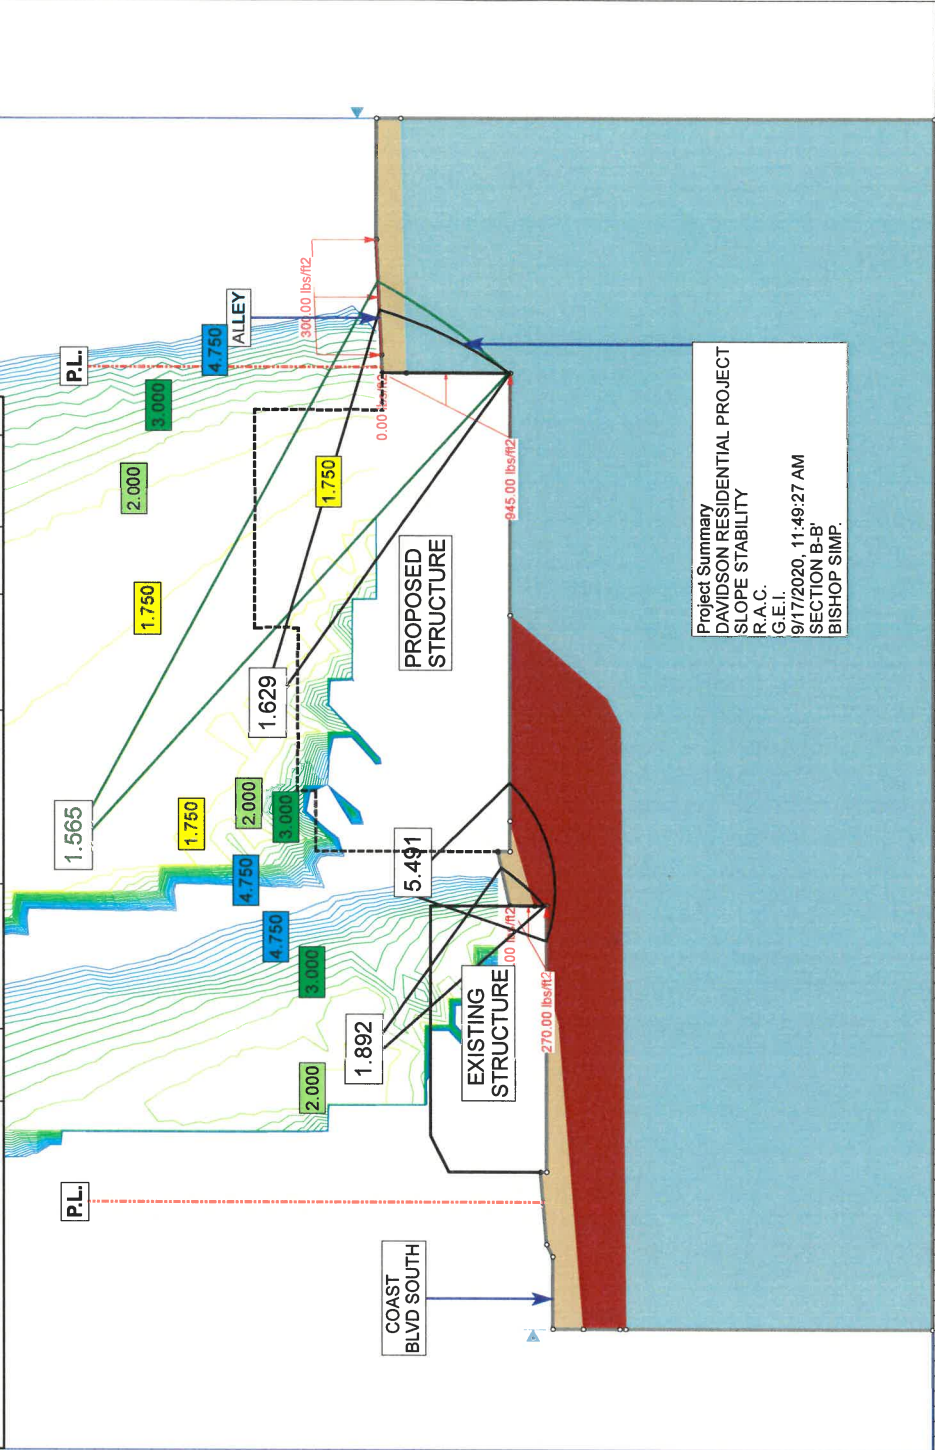
Static circular analysis of the proposed cut with the proposed shoring retaining wall. A traffic surcharge of 300 psf was included in the alley. The proposed shoring wall was analyzed with a lateral cantilevered triangular pressure of 45 pcf in this analysis. A similar load was assumed for the existing structure retaining wall. If the shoring wall is to be restrained, a lateral pressure of 64 pcf should be used.

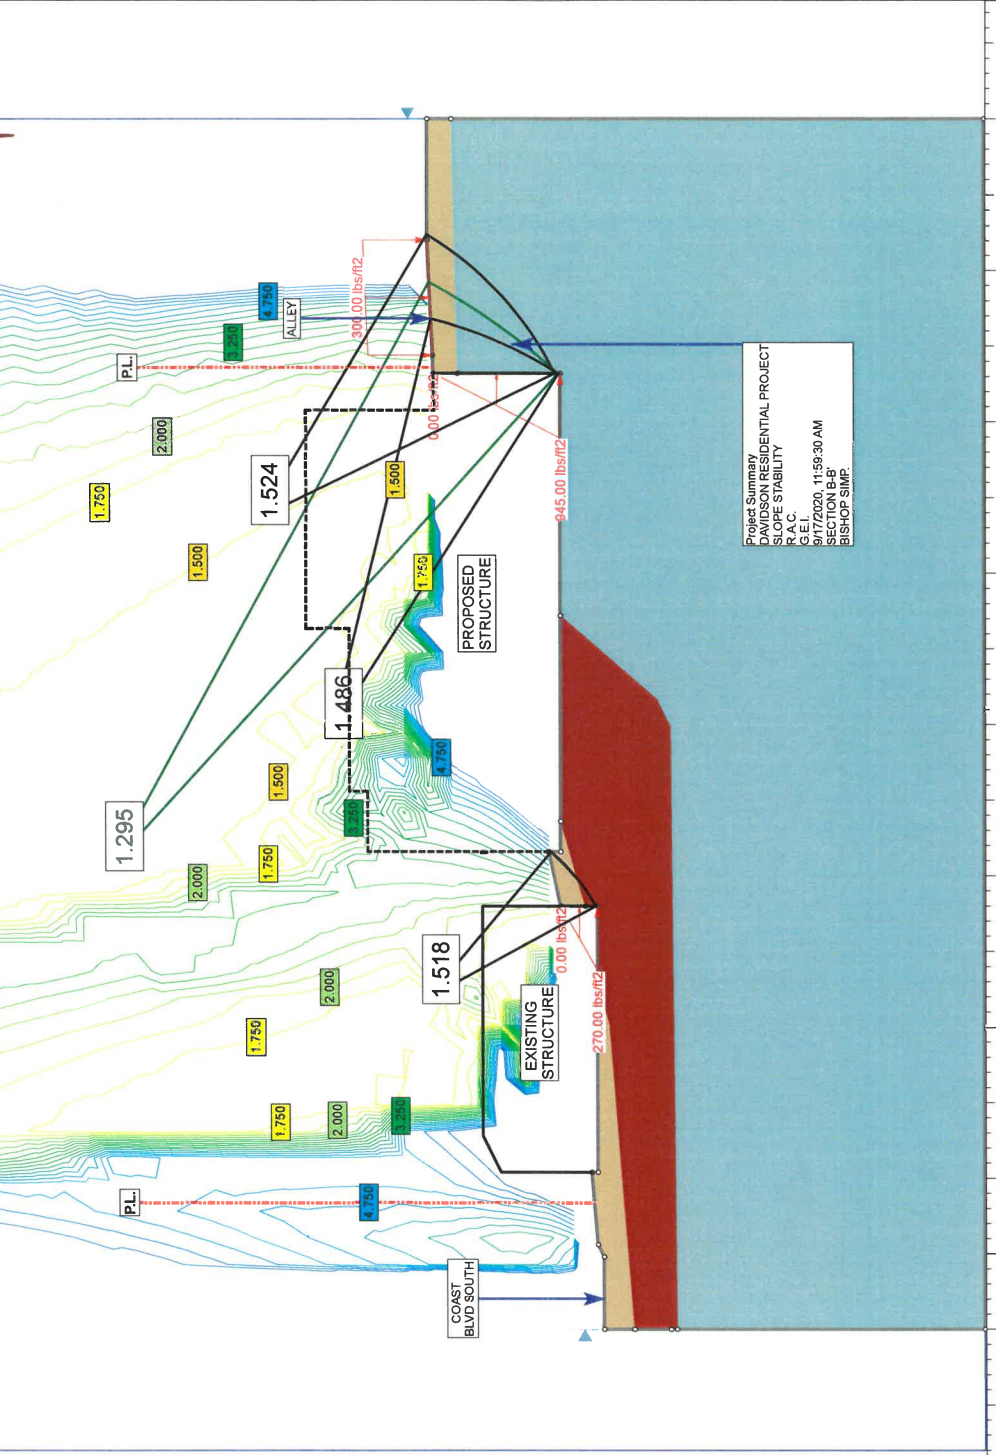
Seismic circular analysis of the proposed cut with the proposed shoring retaining wall. A traffic surcharge of 300 psf was included in the alley. The proposed shoring wall was analyzed with a lateral cantilevered triangular pressure of 45 pcf in this analysis. A similar load was assumed for the existing structure retaining wall. If the shoring wall is to be restrained, a lateral pressure of 64 pcf should be used.
