SUBJECT: **ITEM 5 – Vulcan Steam Room and Sauna**

**STRUCTURAL EVALUATION REPORT  
FOR BUILDING LOCATED AT:**

**For 805 W. Cedar Street  
San Diego, CA. 92101**

**Date: May 13, 2020**

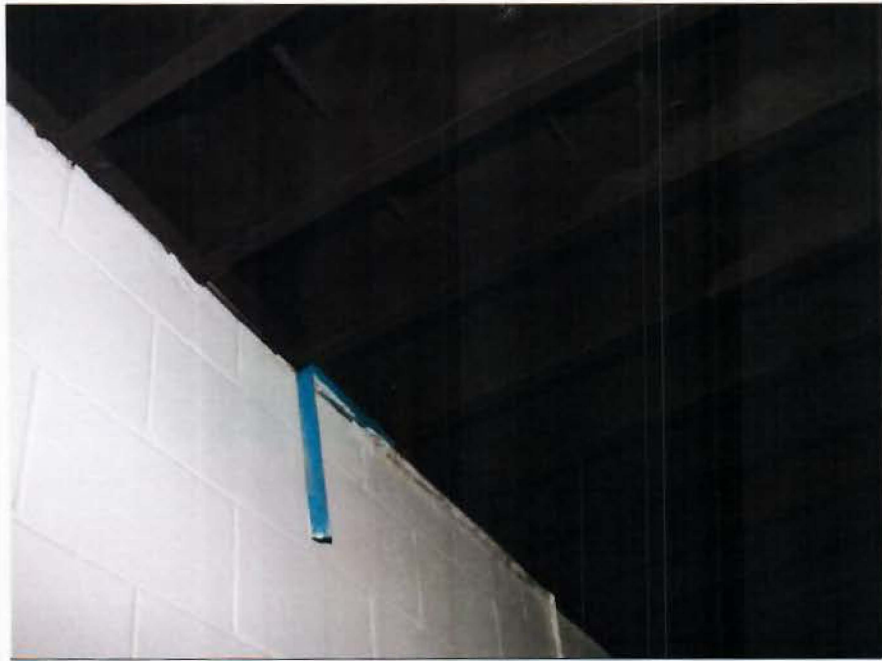
For the lateral resisting system of the building all the exterior walls are concrete with a flexible diaphragm for the roof system. The roof diaphragm should tie back to the top of the concrete walls to create out of plane stability to the walls. Due to heavy weight of the concrete walls, the roof diaphragm should be designed as a high-strength diaphragm to support top of all concrete walls and prevent any out of plane instability in seismic events. Currently there is no tie back connection between the existing roof trusses and the walls in both parallel or perpendicular conditions to concrete walls. *See Appendix A, Images #1, #2.*

The exterior CMU wall may collapse/detach in out of plane direction due to seismic event since there is no tie back connection to the walls.

The existing structure meets this requirement. Inadequate structural resistance to horizontal forces, because the heavy CMU walls are not tie back to the roof diaphragm and roof diaphragm is not constructed to capture out of plane loads from the concrete walls.

Image #1 shows the joist perpendicular to CMU wall  
Without any tie connection to two story CMU wall

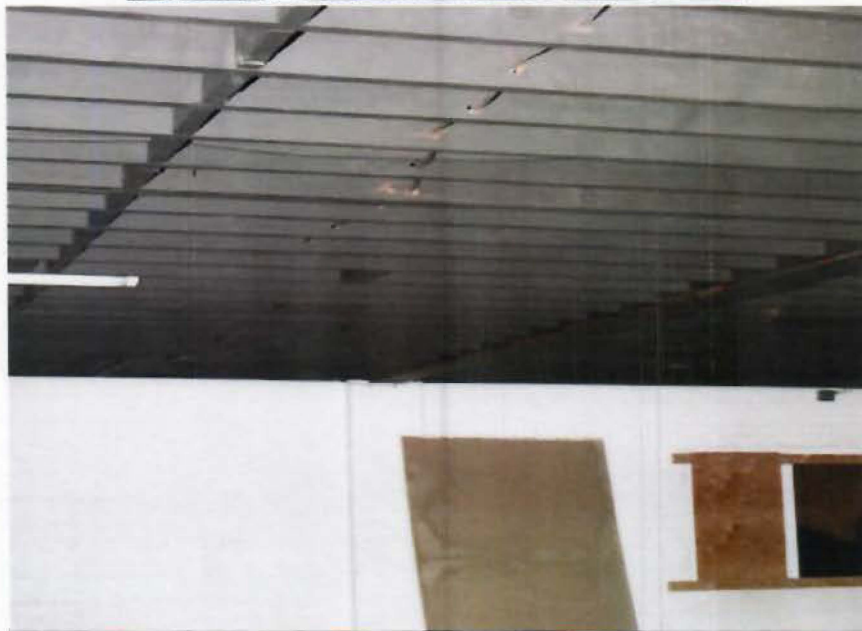
Image #2 shows the joist parallel to CMU wall  
Without any tie connection to two story CMU wall

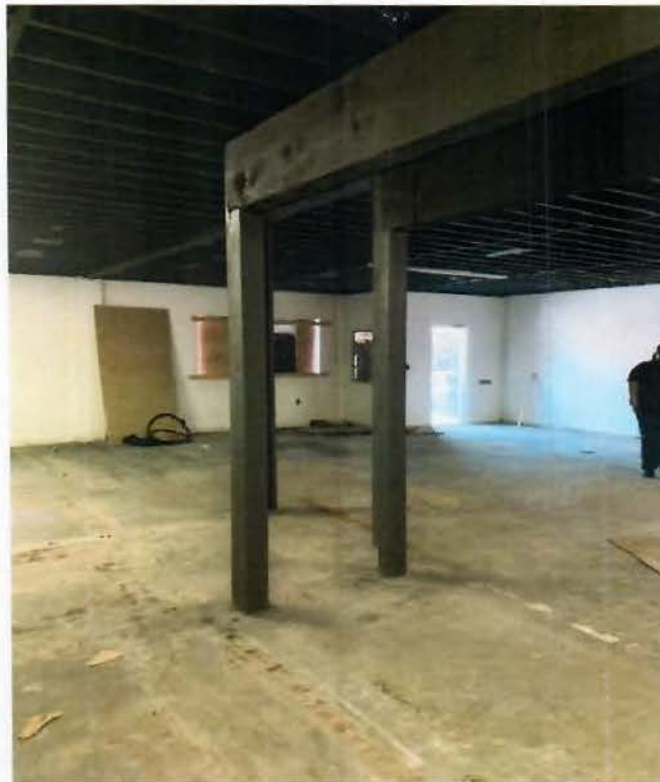
The existing roof framing system is a flexible diaphragm which is supported at the middle with a concrete beam, which usually is required to be braced with the diaphragm at the compression side. The existing flexible diaphragm will not provide the fully braced concrete beam. Part of the roof framing is deteriorated due to water damage. The floor framing is composed of 2x members which are supported at the center of the building with either a steel beam or wood beam. The wood beam is under supported with a double 2x4 posts for the 16 ft span beam. This is under designed, please see the attached calculation under *Appendix B*. Also, there is a portion of the floor framing in the center of the building which does not have any support and the joists are spliced creating an unsafe condition that will result in the floor system failure when live loads are applied to it. *See Appendix A Images #3, #4, #5 and #6.*

Image #3 shows the floor joist supported with wood beam which support with 2-2x6 stud

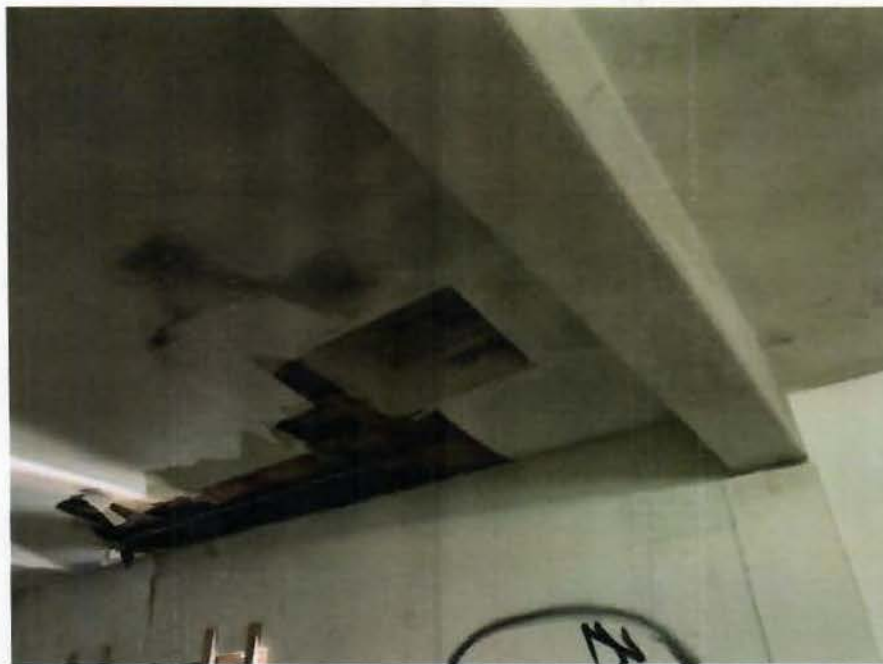
The flooring at some areas is defected due to water damage and faulty construction. See Appendix A, Images #4, #7.

Images #4 shows the concrete beam support the flexible diaphragm and deterioration of the roof framing

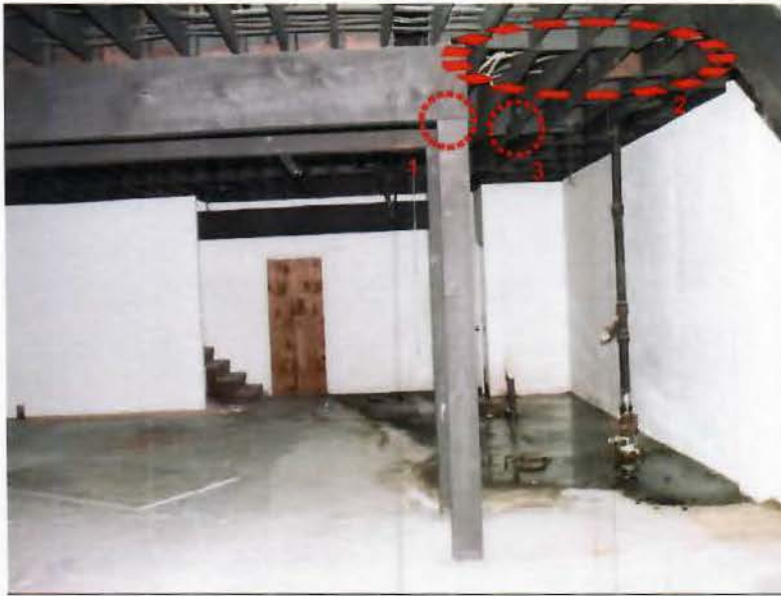
Image #5 show the portion of the floor with out any support at the middle with spliced joist

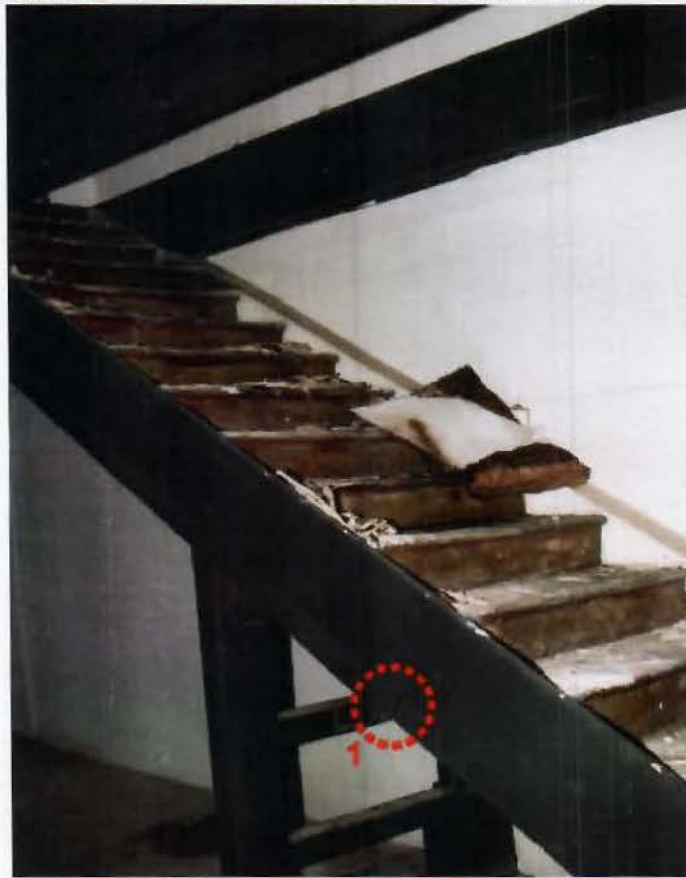
There is one stair case inside the building which is poorly constructed and damaged and unsafe to serve as a portion of the means of egress. The construction of the staircase is inadequate to support the live loads applied to the structure.

Image #6 shows the stairs case with splice at the stringer and deteriorated wood

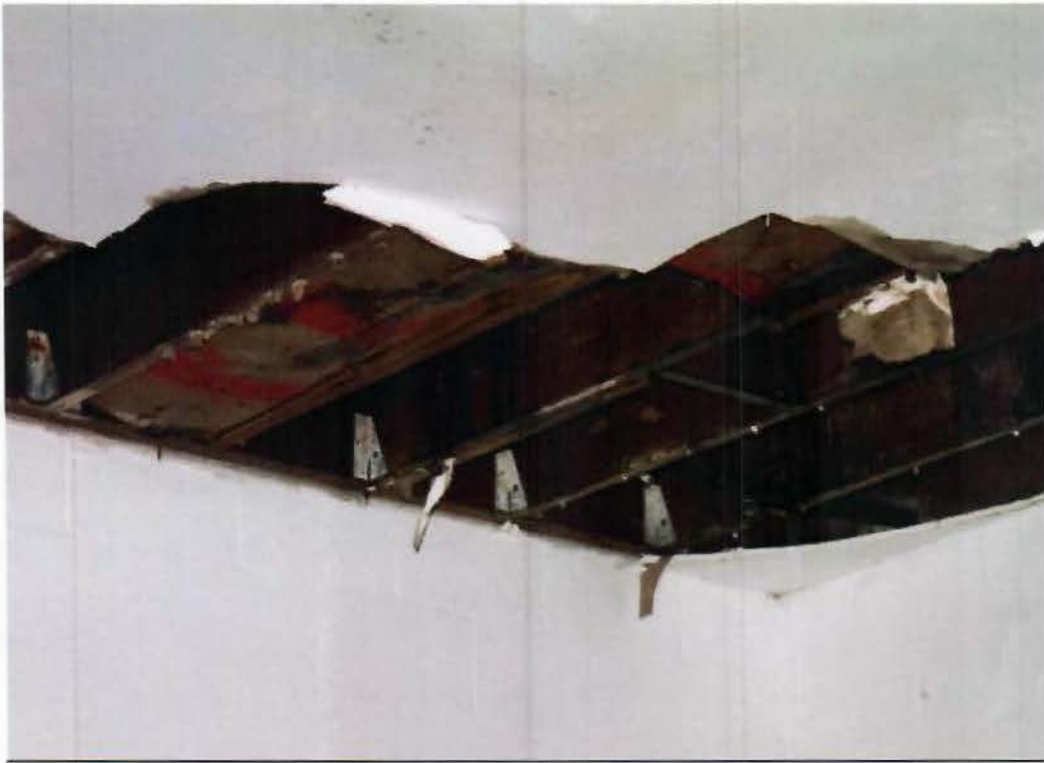
Image #7 shows the roof framing deteriorated wood as well as notched joist

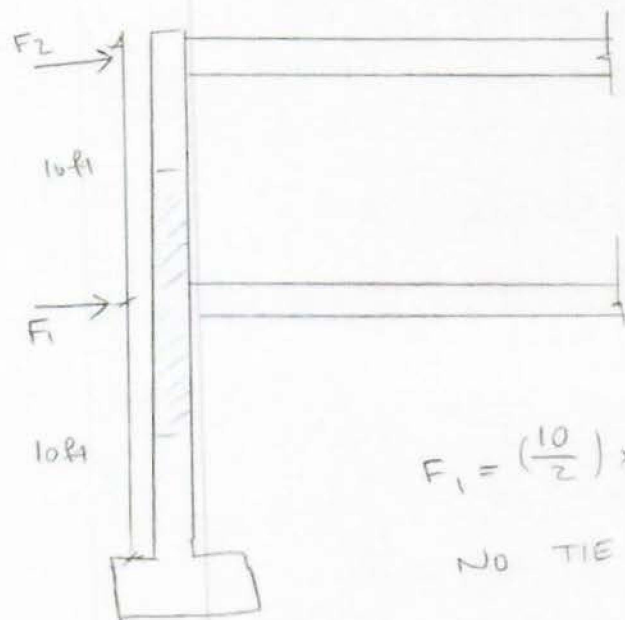
NO TIE - OUT OF PLANE PROVIDED

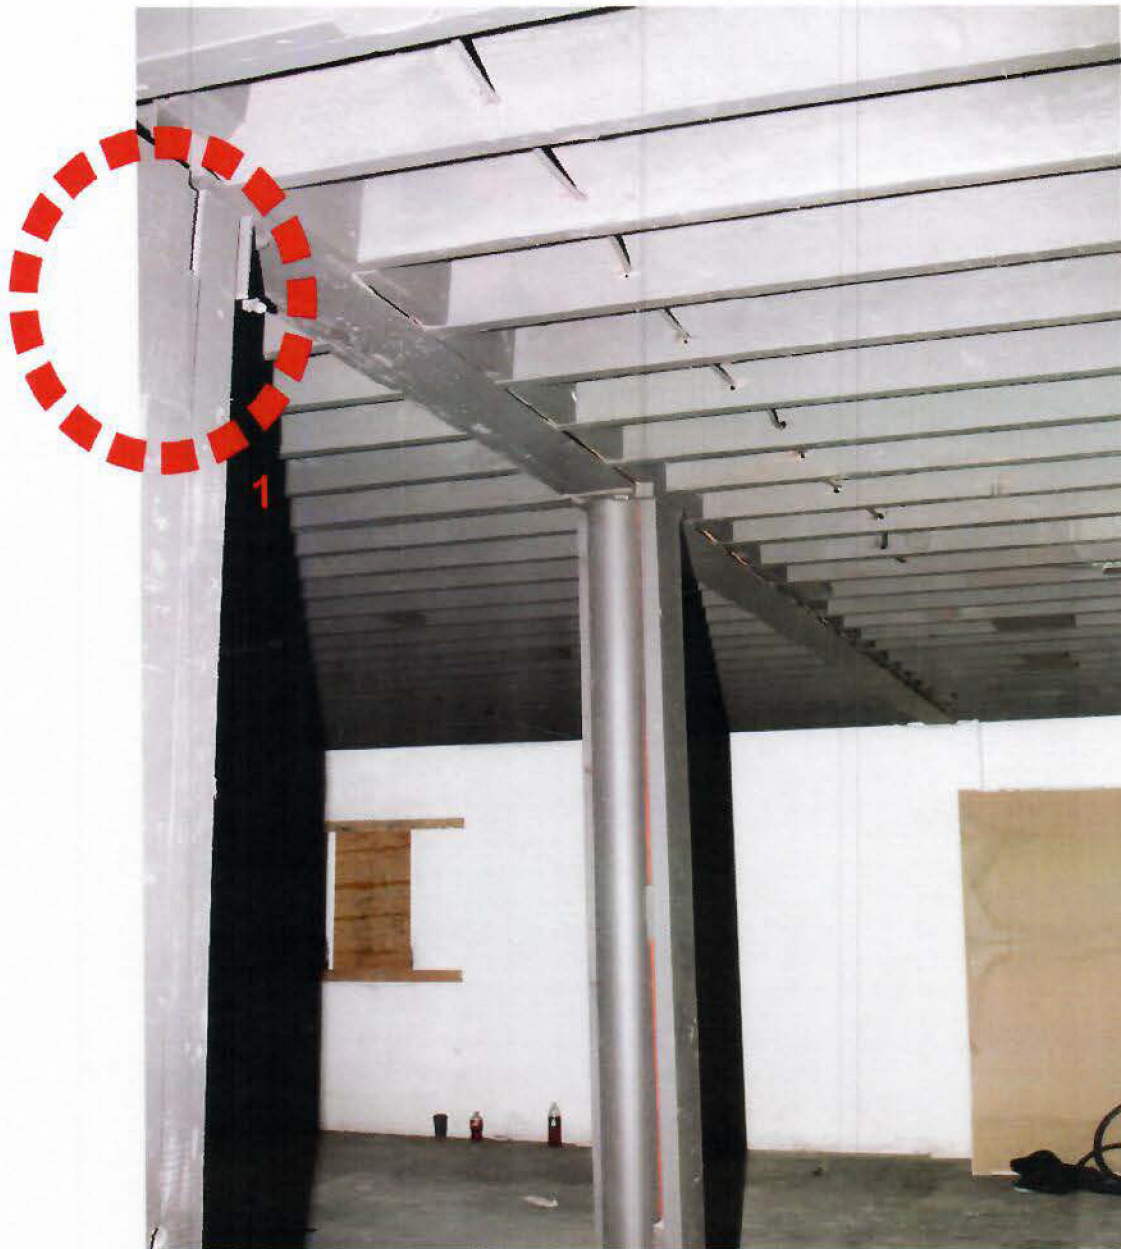
1ST FLOOR

1. INSUFFICIENT BEAM POST CONNECTION WITH NO HARDWARE. BEAM TOE-NAILED TO POST.

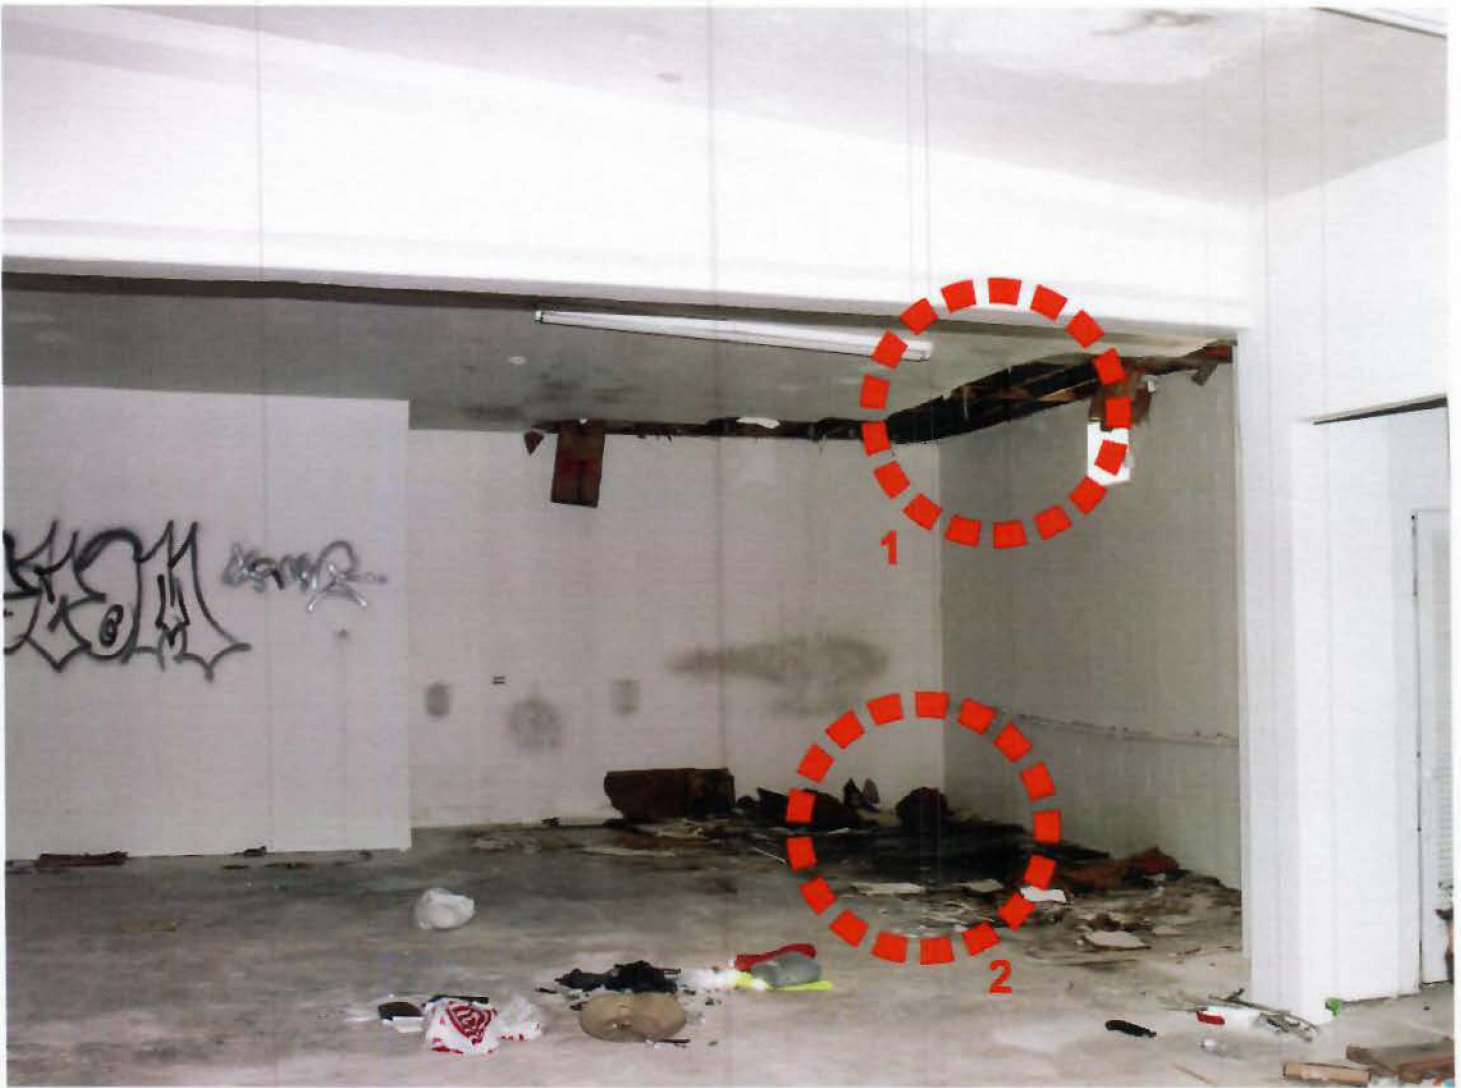
- 1. WATER DAMAGED ROOF FRAMING MEMBERS**
- 2. WATER DAMAGE AT FLOOR. FLOOR JOISTS AND PLYWOOD DIAPHRAGM HAVE INCURRED SUBSTANTIAL DAMAGE.**

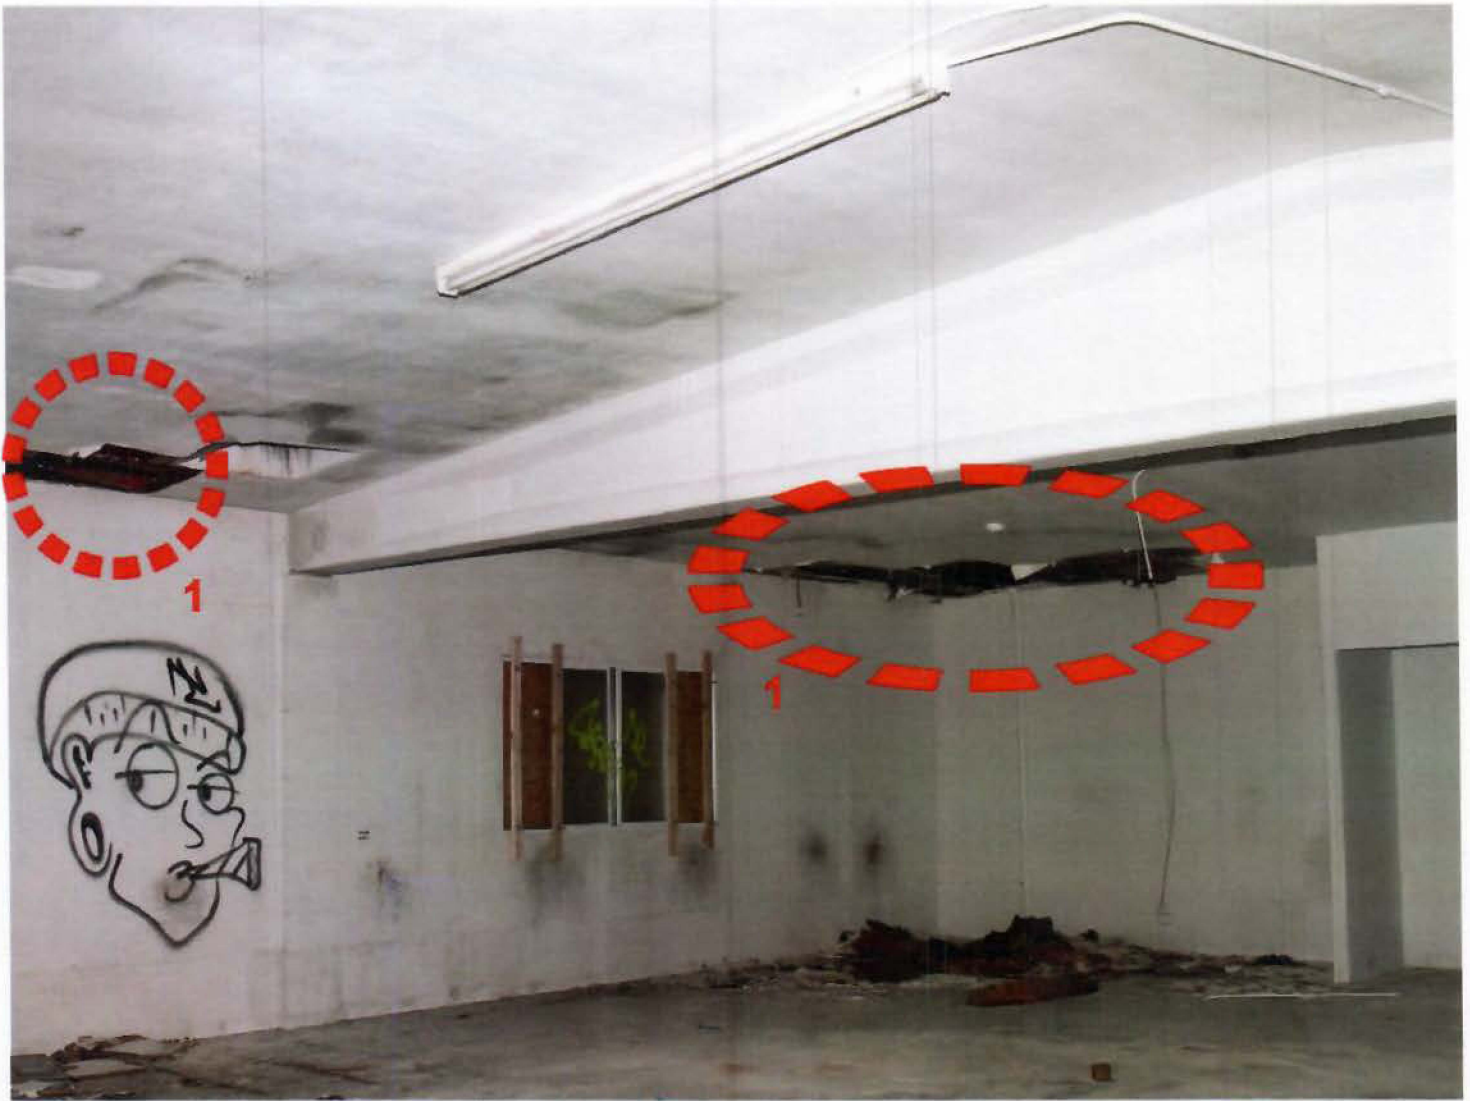
# **INTERIOR CEILING**

1. WATER DAMAGED ROOF FRAMING MEMBERS

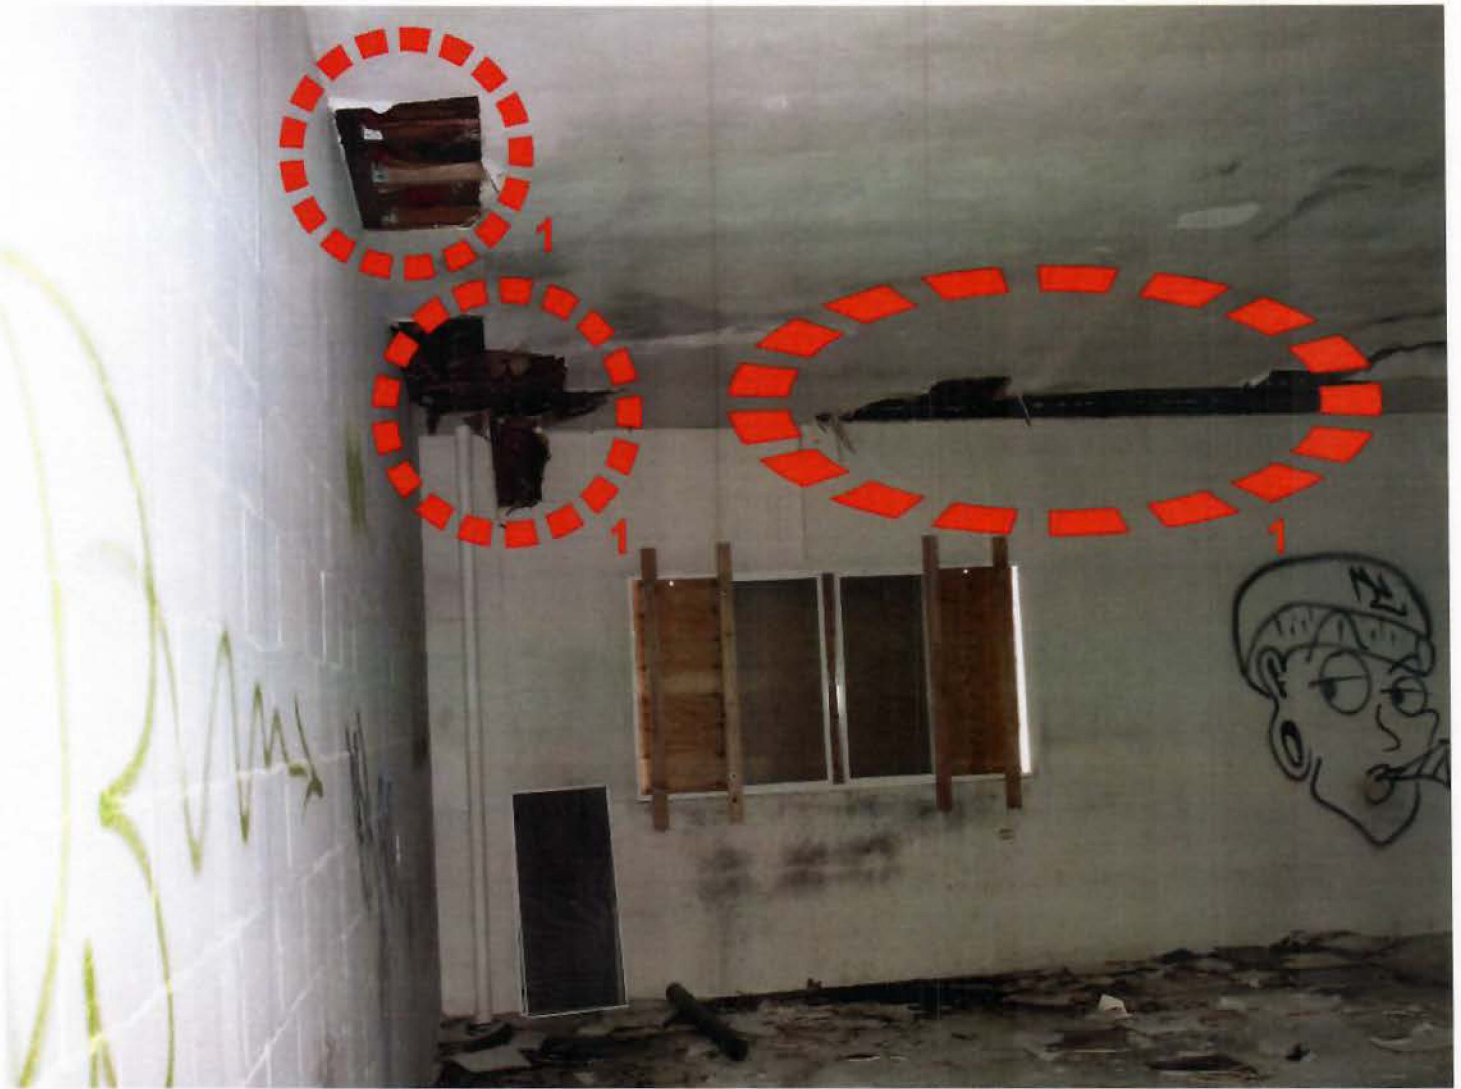
1. WATER DAMAGED ROOF FRAMING MEMBERS
