HISTORICAL RESOURCES TECHNICAL REPORT

HENRY B. JONES HOUSE

4040 FIFTH AVENUE, SAN DIEGO, CA 92103

May 23, 2017

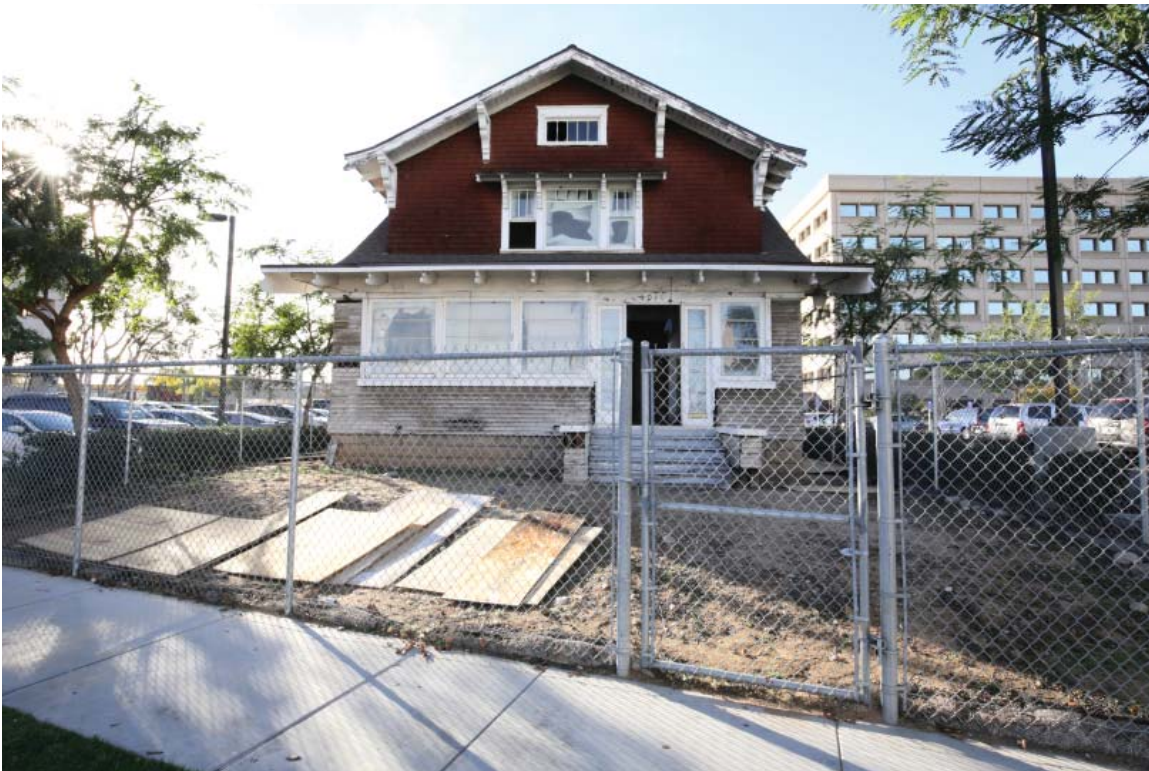
Figure 3-1: View of the east façade from Fifth Avenue.

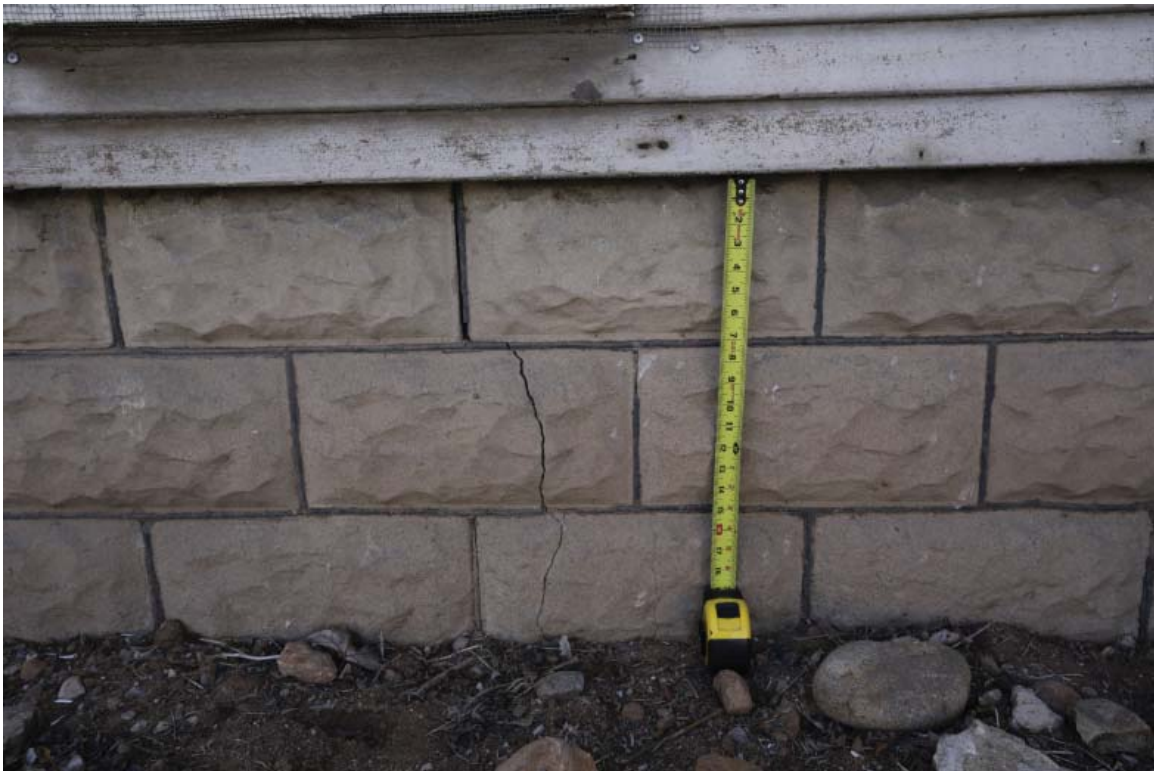
Foundation: The perimeter foundation walls of the Henry B. Jones House include rough-faced cast-concrete blocks around the perimeter of the building. The floor structure above is wood. The foundation walls appear to be in fair condition.

Figure 3-5: View of the perimeter foundation walls. The blocks are rough-faced cast concrete blocks with beaded mortar joints.

4. The non-original CMU foundation walls will be transported to the new site. Reconstruction will incorporate salvaged or new CMU's with a matching faux-stone finish.

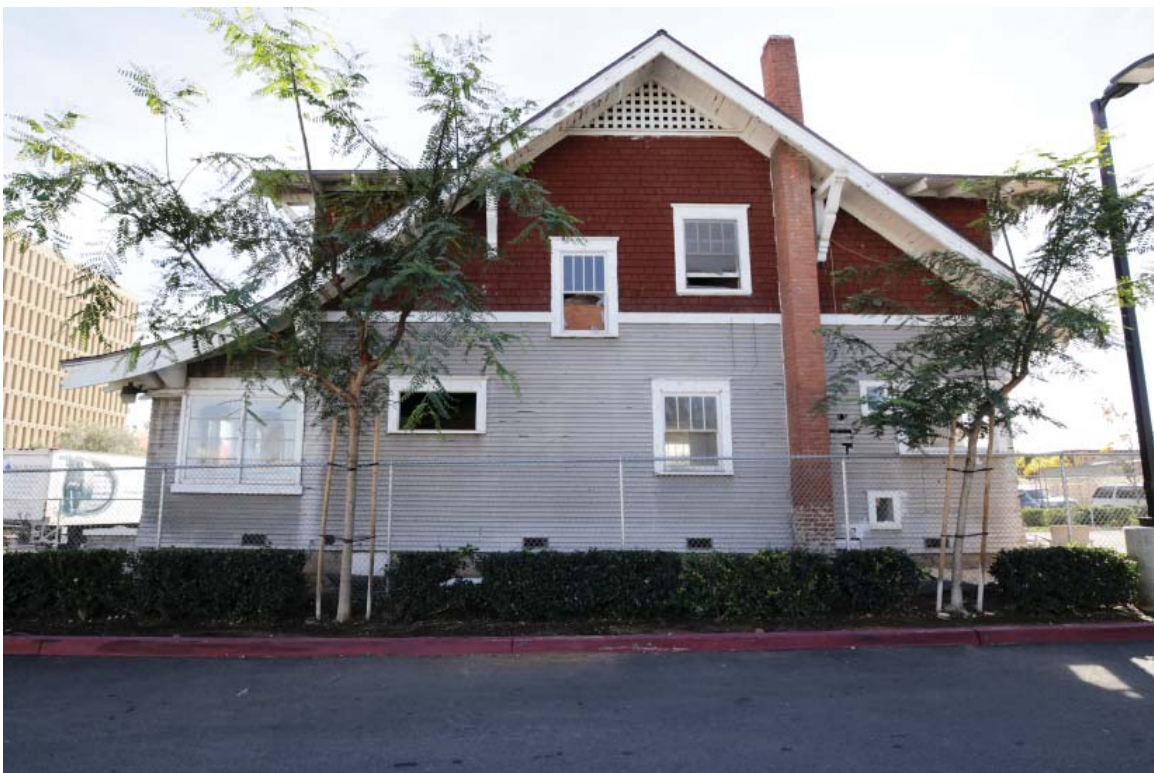
Figure 3-6: View of the north façade. Note the curved roof slope. The north chimney is not original.

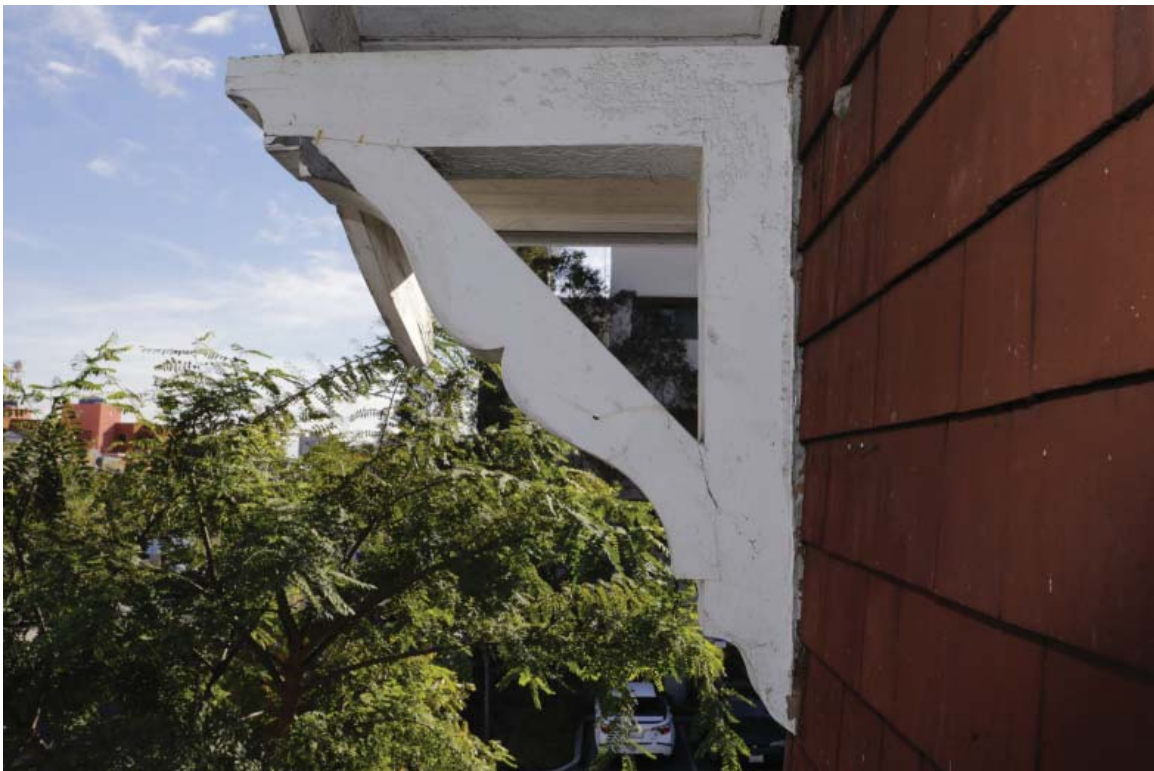
Figure 3-8: A typical wood eave bracket with a decorative profile.

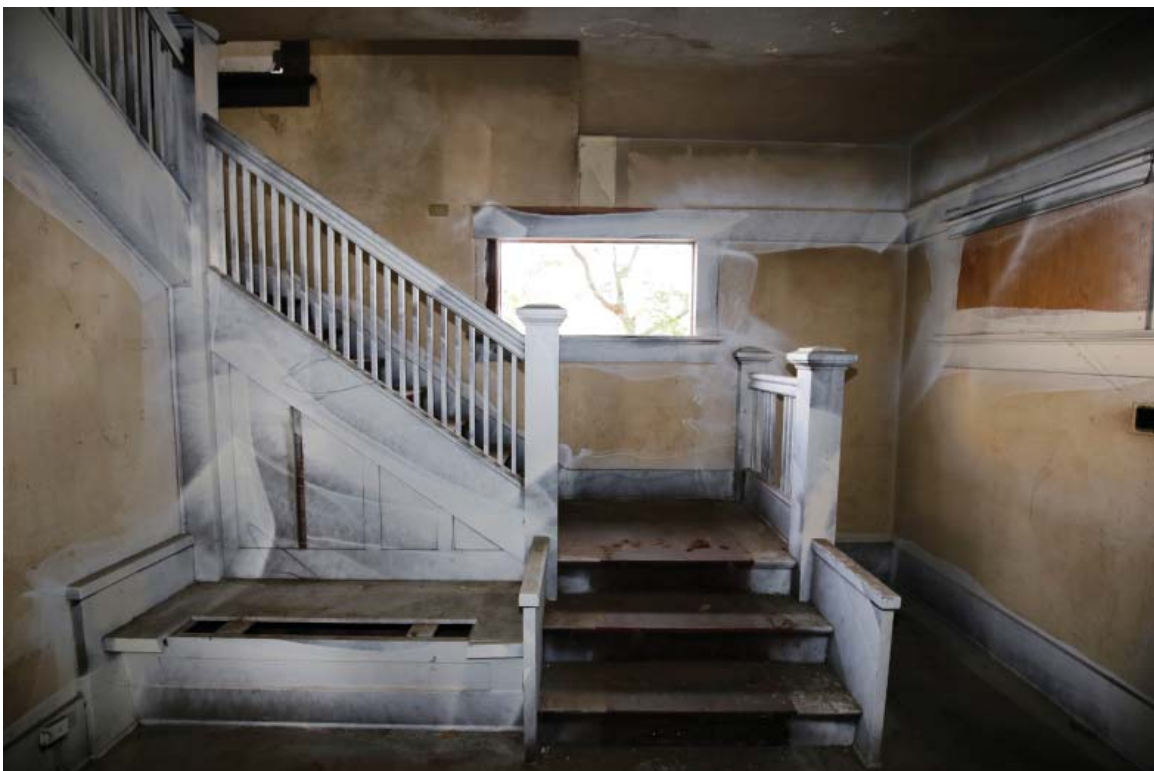
Figure 3-14: View of the foyer and stairs. Much of the stained and varnished woodwork has been sprayed with a white primer for unknown reasons.

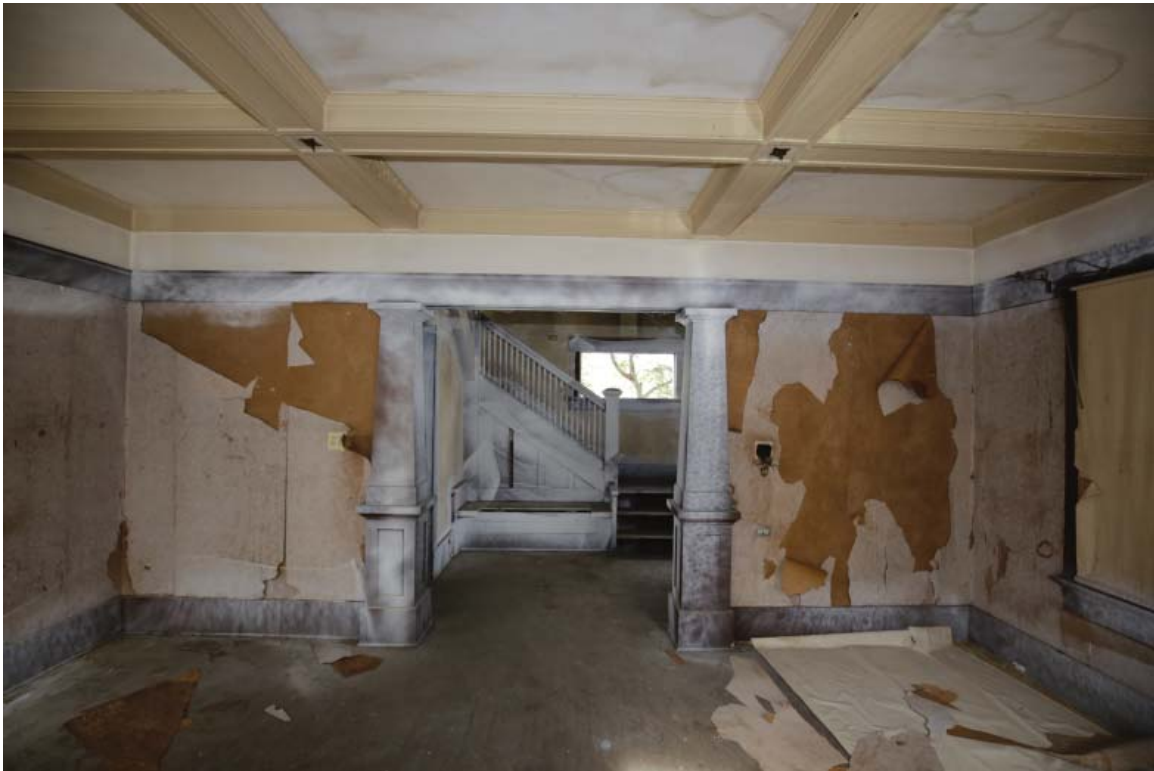
Figure 3-15: The living room, looking north to the stair. Note the decorative posts framing the doorway.

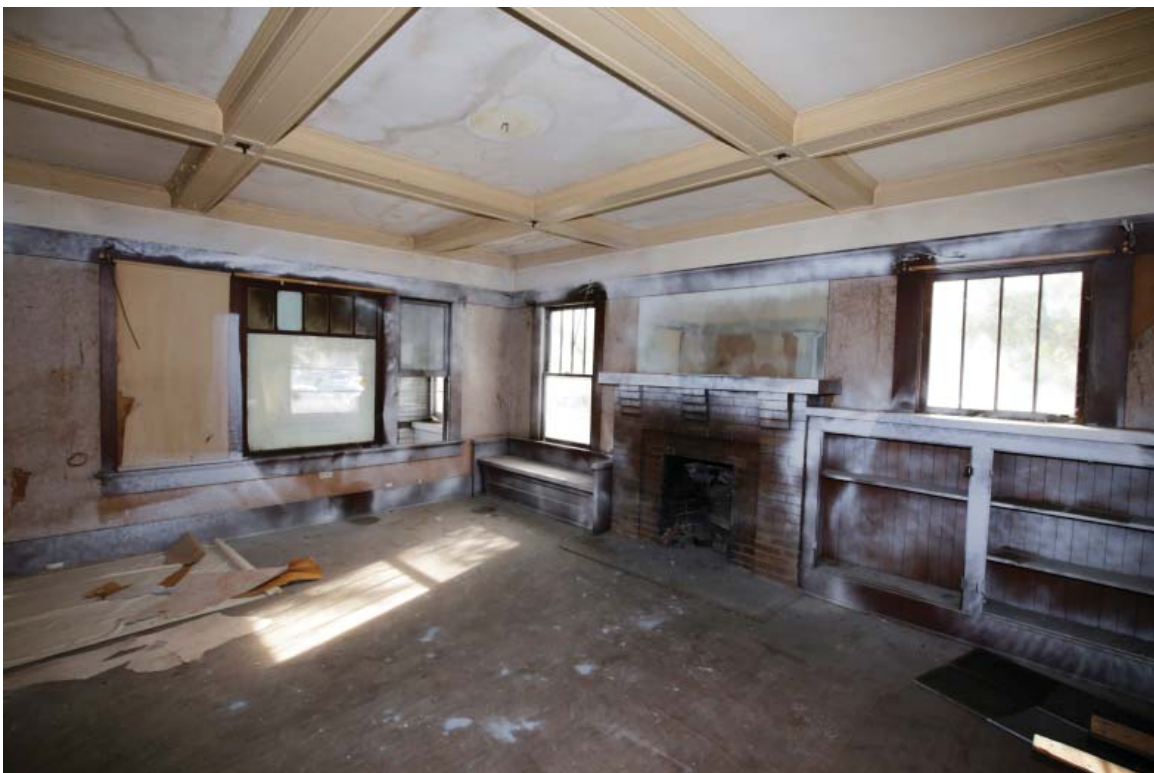
Figure 3-16: Looking southeast in the living room. Note the fireplace and beamed ceiling.

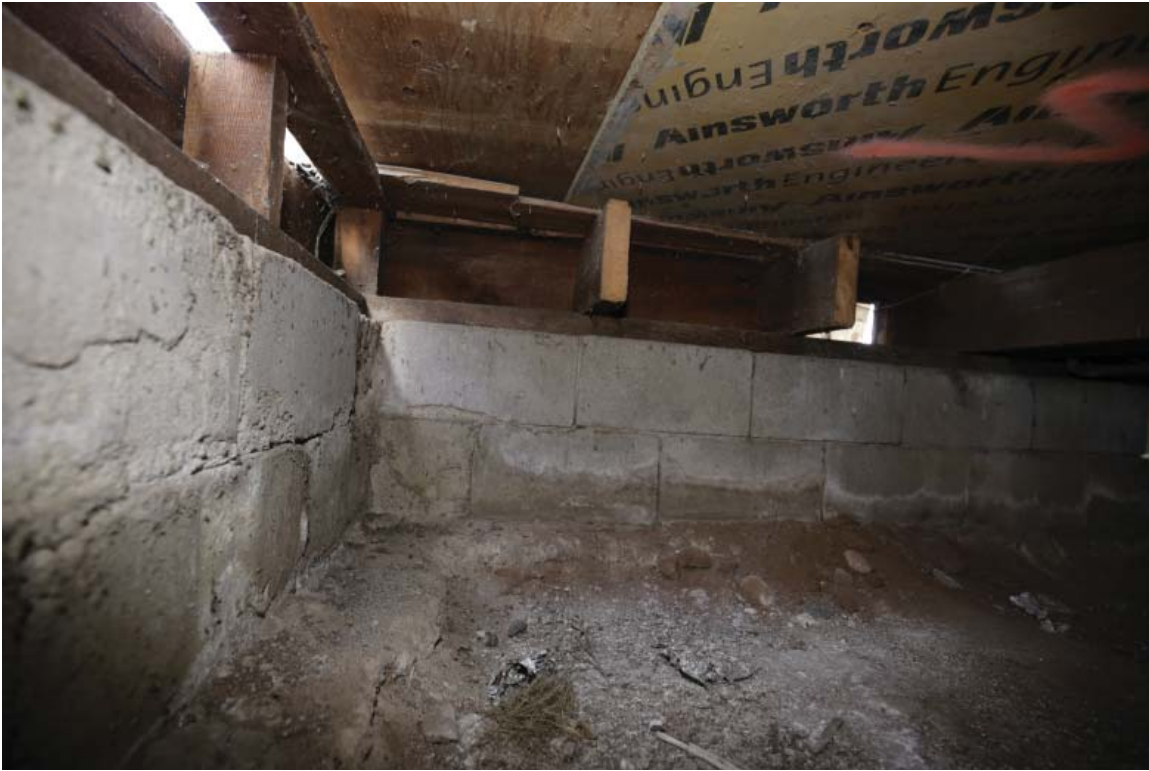
Figure 3-23: The northwest corner of the foundation from the crawl space. Note the cut floor joists where the flooring was removed.

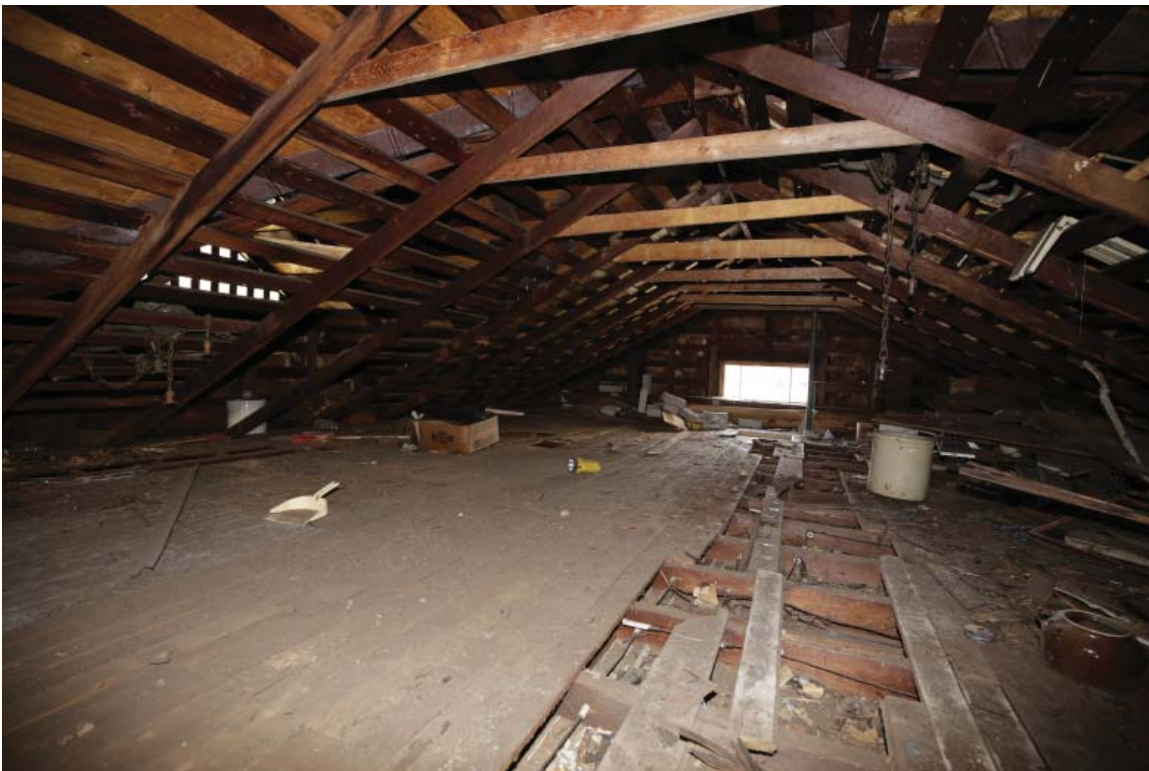
Figure 3-24: View of the attic, looking west.

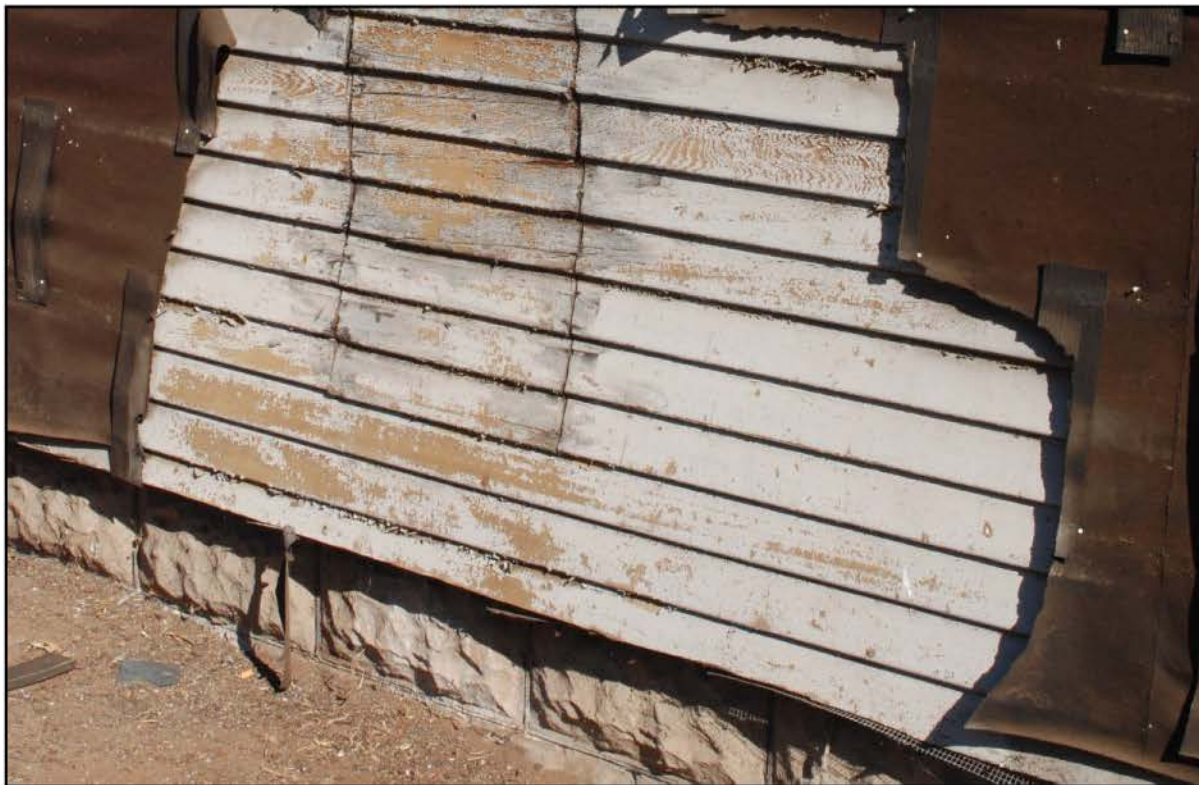
Photograph 6
Probable Original
Clapboard and
Shingles under
Tarpaper

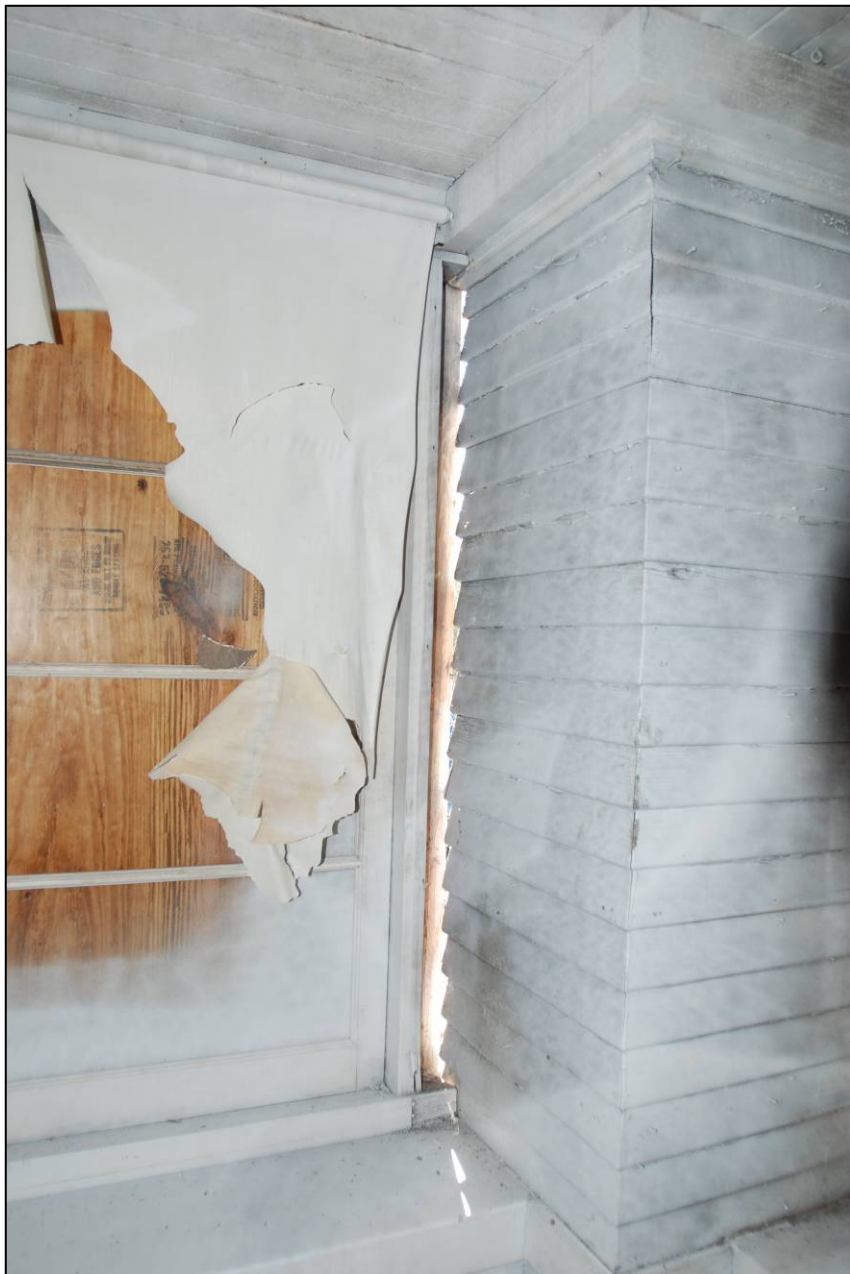
Photograph 11
Interior View of
Porch Window
Showing gap
Between
Window Frame
and Porch
Clapboard

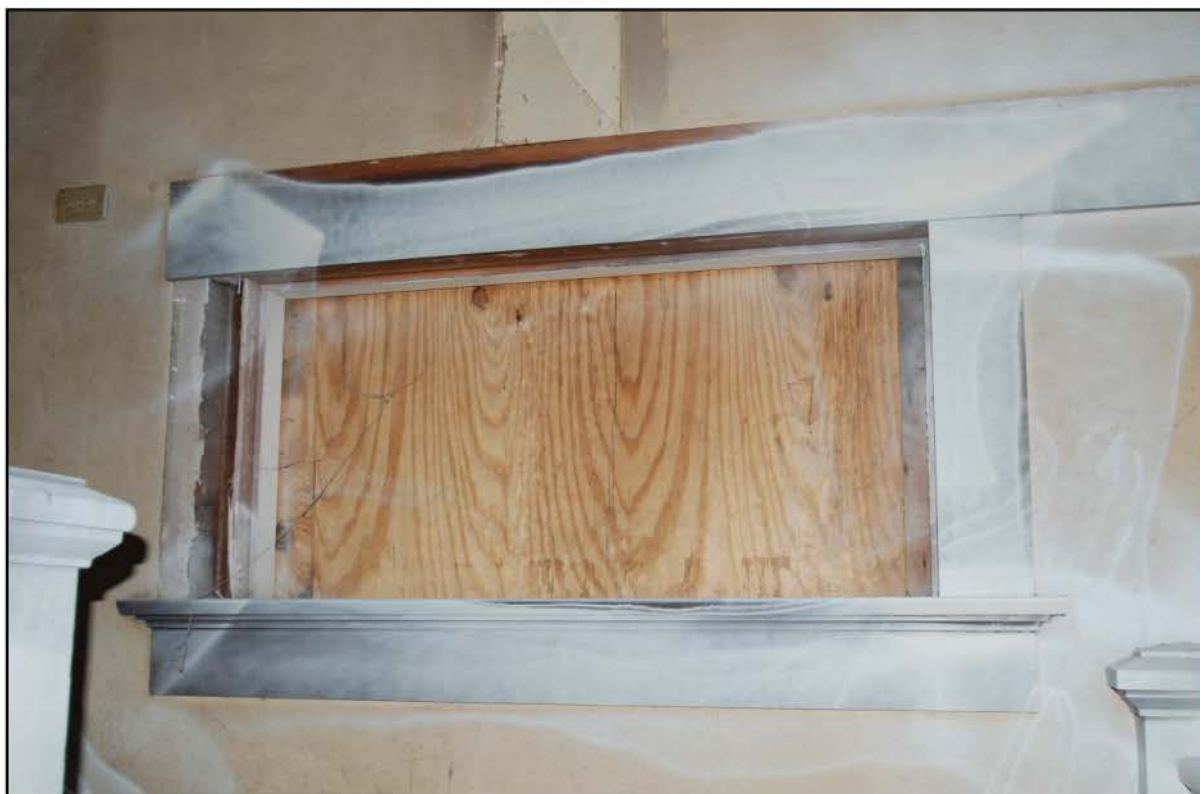
Photograph 15
North Side Window
2, Interior Shot,
Showing Missing
Sash

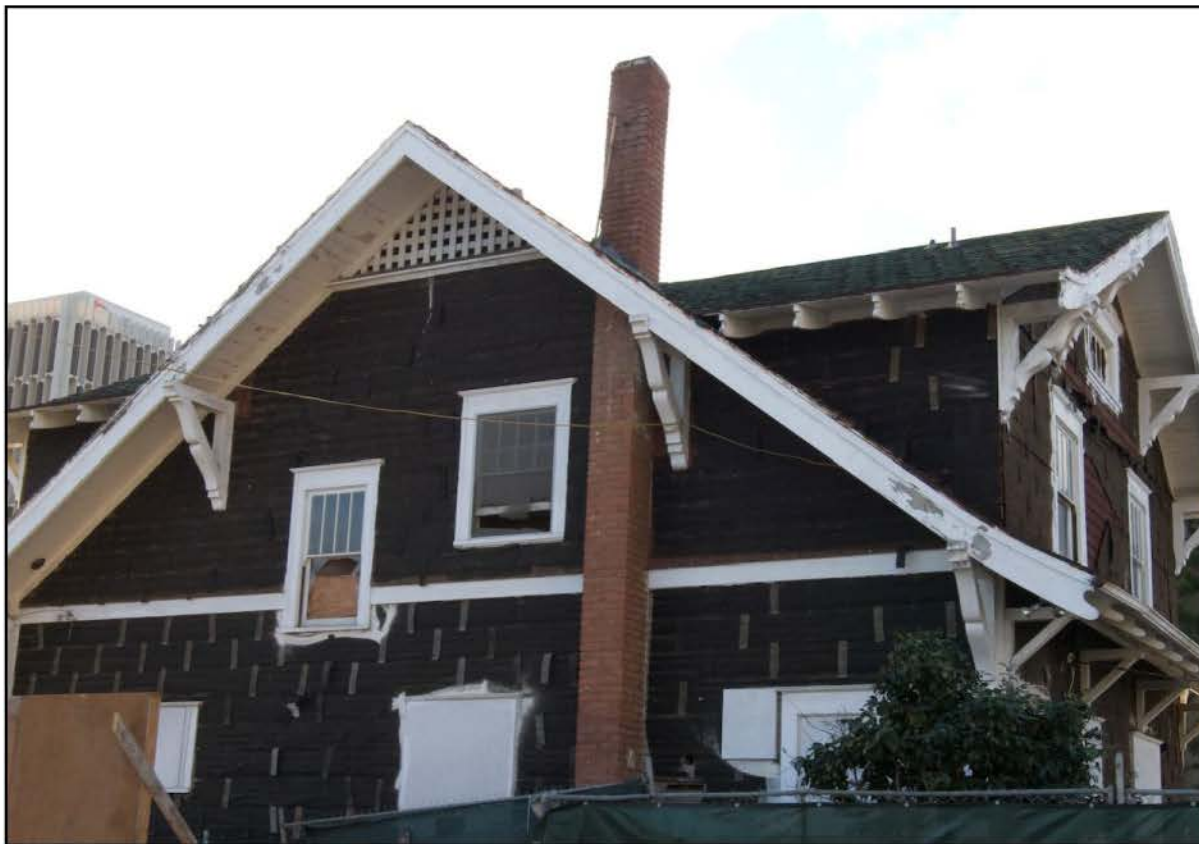
Photograph 18
Northeast
Corner of
House, Showing
Small Chimney
on North Wall

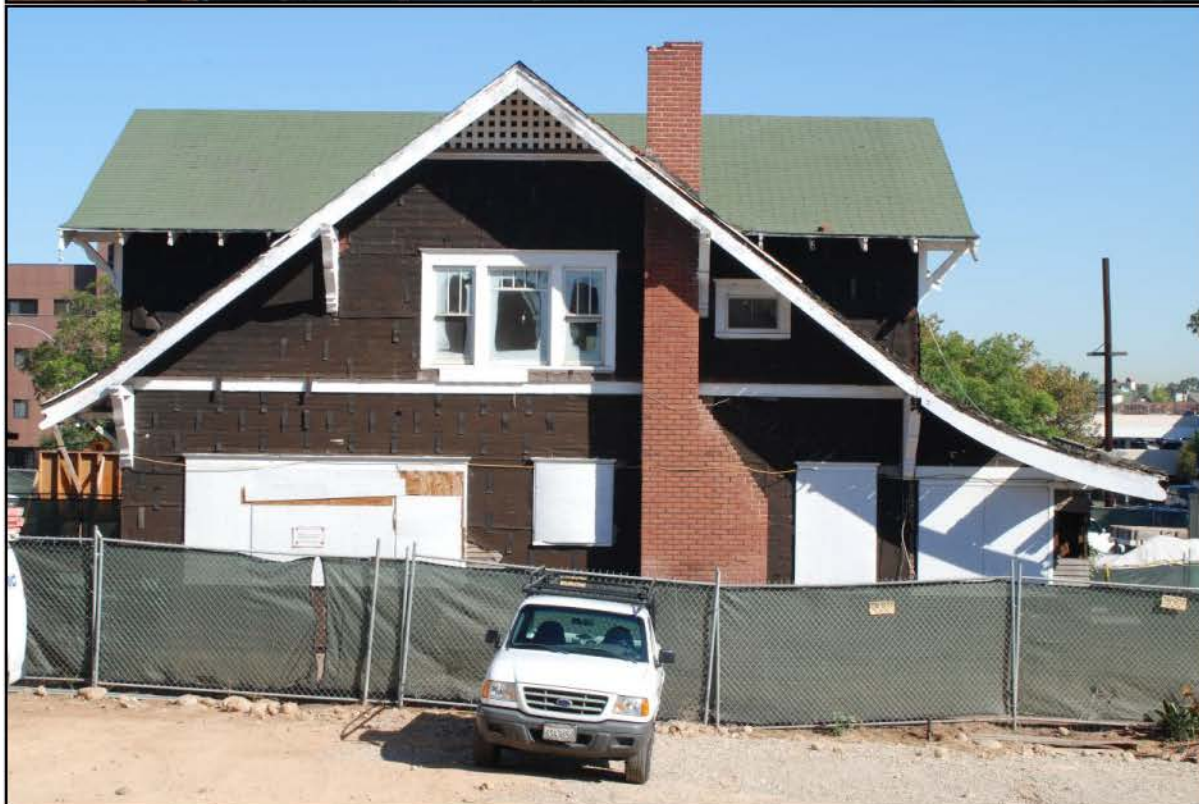
Photograph 19
South Side of
House, Showing
Window
Arrangement and
Chimney

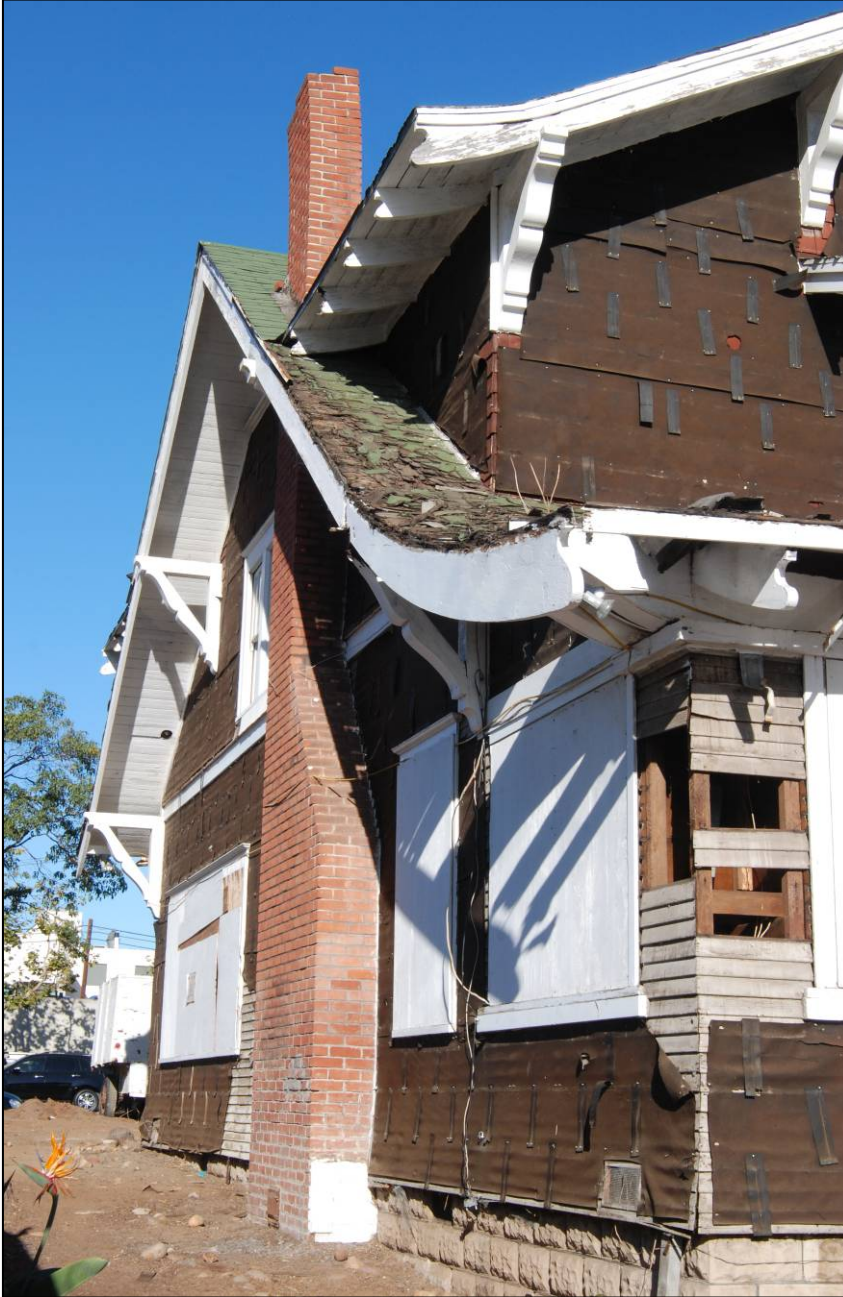
Chimneys: The Henry B. Jones House originally had one brick masonry chimney at the south façade. The original brick masonry chimney is offset to the front of the gable peak and is built of red brick with black mortar. The chimney is leaning at the top and is in fair to poor condition and may need to be replicated.

Photograph 24
Chimney on South Side

3. Some items will need to be dismantled prior to the relocation. These include the non-original CMU foundation walls, both brick chimneys, parts of the fireplace, and the front steps and wing walls.

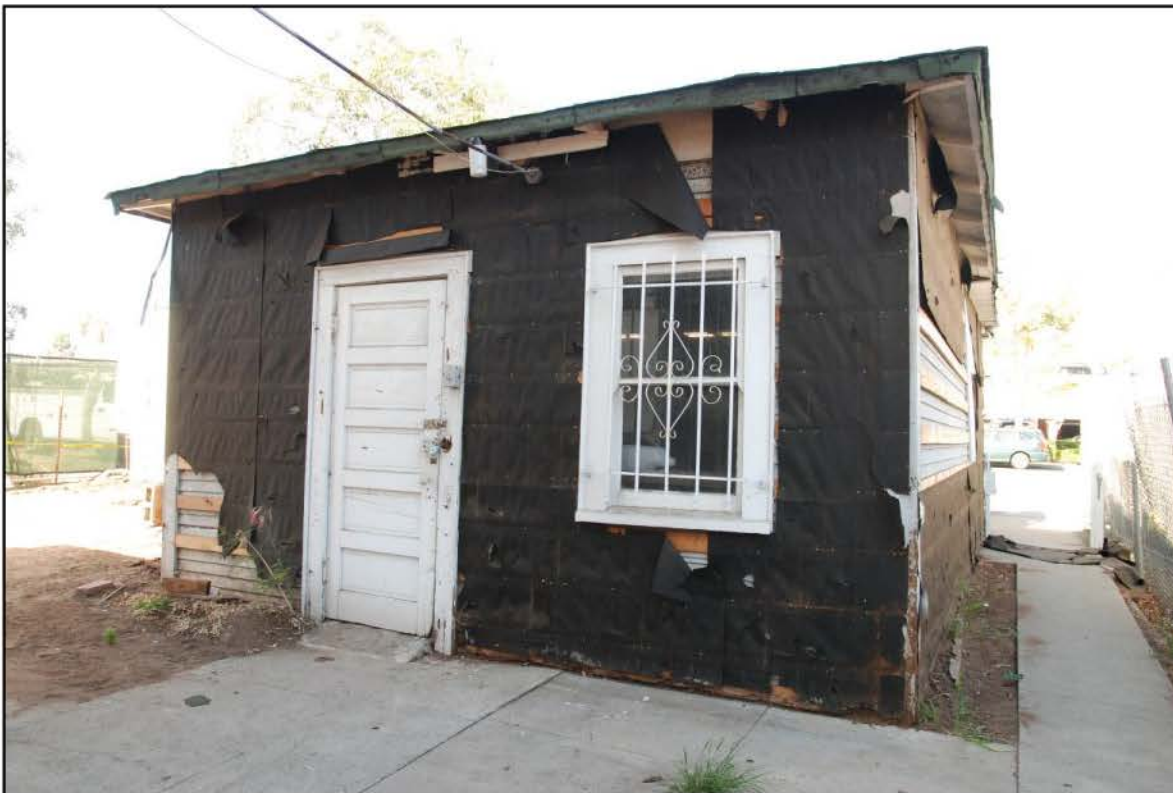
Photograph 29
East Side of
Garage, Current
Condition. Note
Different Style of
Window Casing
