SUBJECT: JUNE 2010 SITE INSPECTION: WEST MIRAMAR LANDFILL, SAN DIEGO COUNTY

Landfill Inspection Report

Name of Facility: West Miramar Landfill
Owner: MCAS Miramar
Operator: City of San Diego
Facility Address: 5180 Convoy Street, S.D.
RB Inspector: Amy Grove

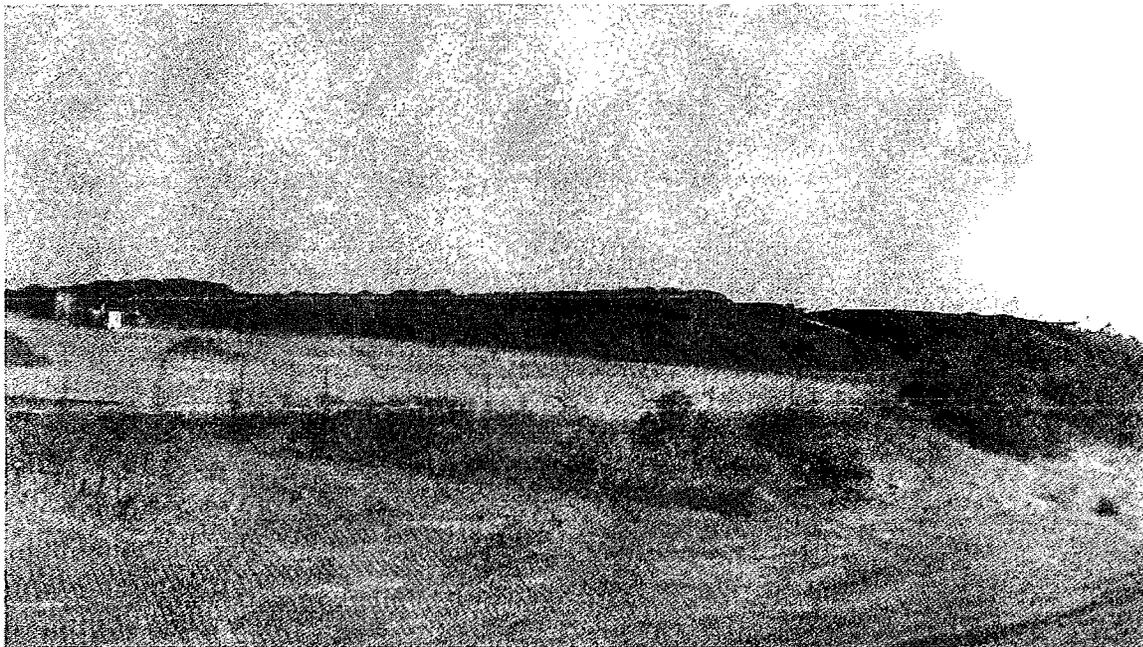
Photo 2: This area is used for composting green waste. The site uses wind rows for drying and maintaining the area.

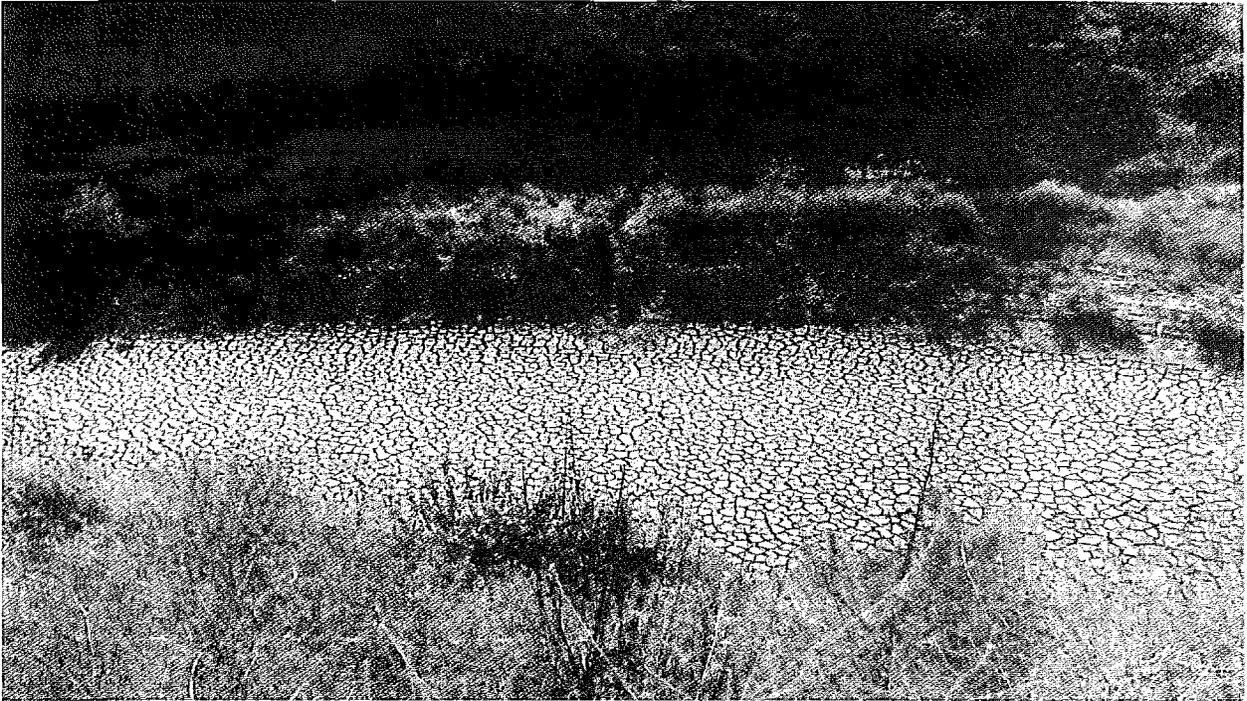
Photo 3: Photo of the main desiltation basin. The City will perform a clean out of the earthen basin prior to the start of the rainy season, if needed.

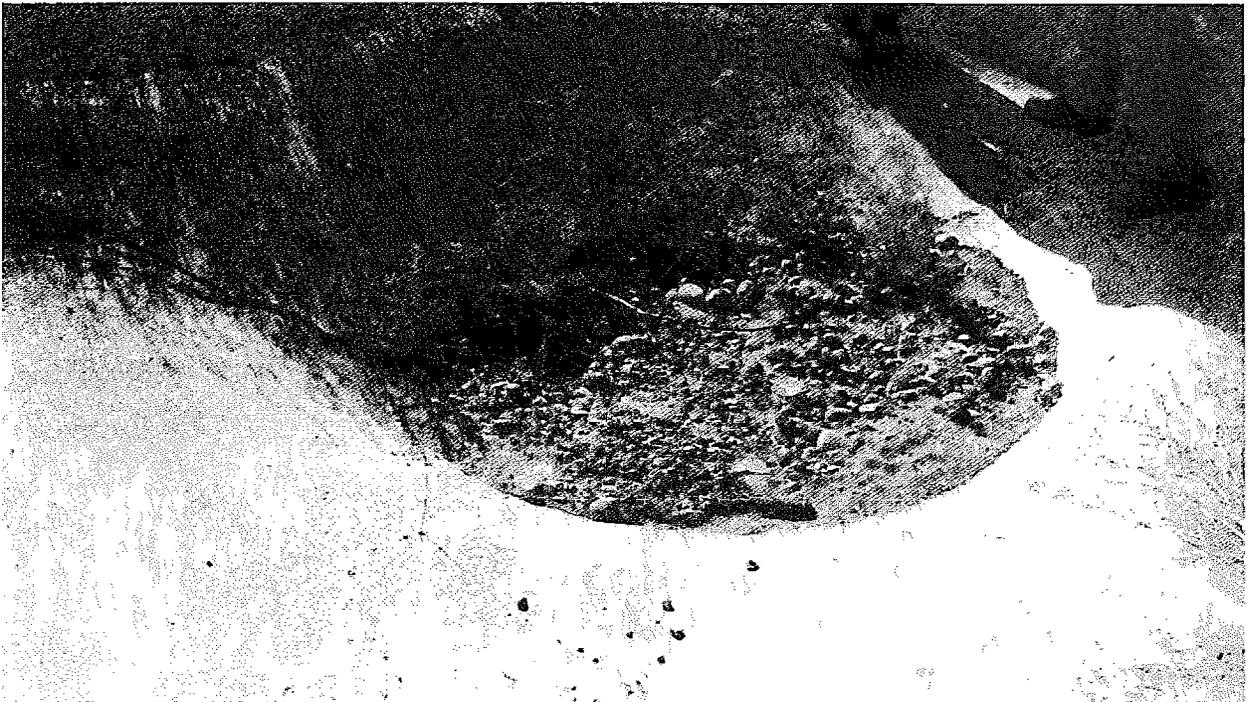
Photo 4: Photo of a perimeter drain culvert. The culvert drains to the main desiltation basin. The City will perform a clean-out of the drain prior to the start of the rainy season.
