August 9, 2010

*Re: 6004 Muirlands Drive, La Jolla, Substantial Modifications & Changes--Lack Of Original Integrity*

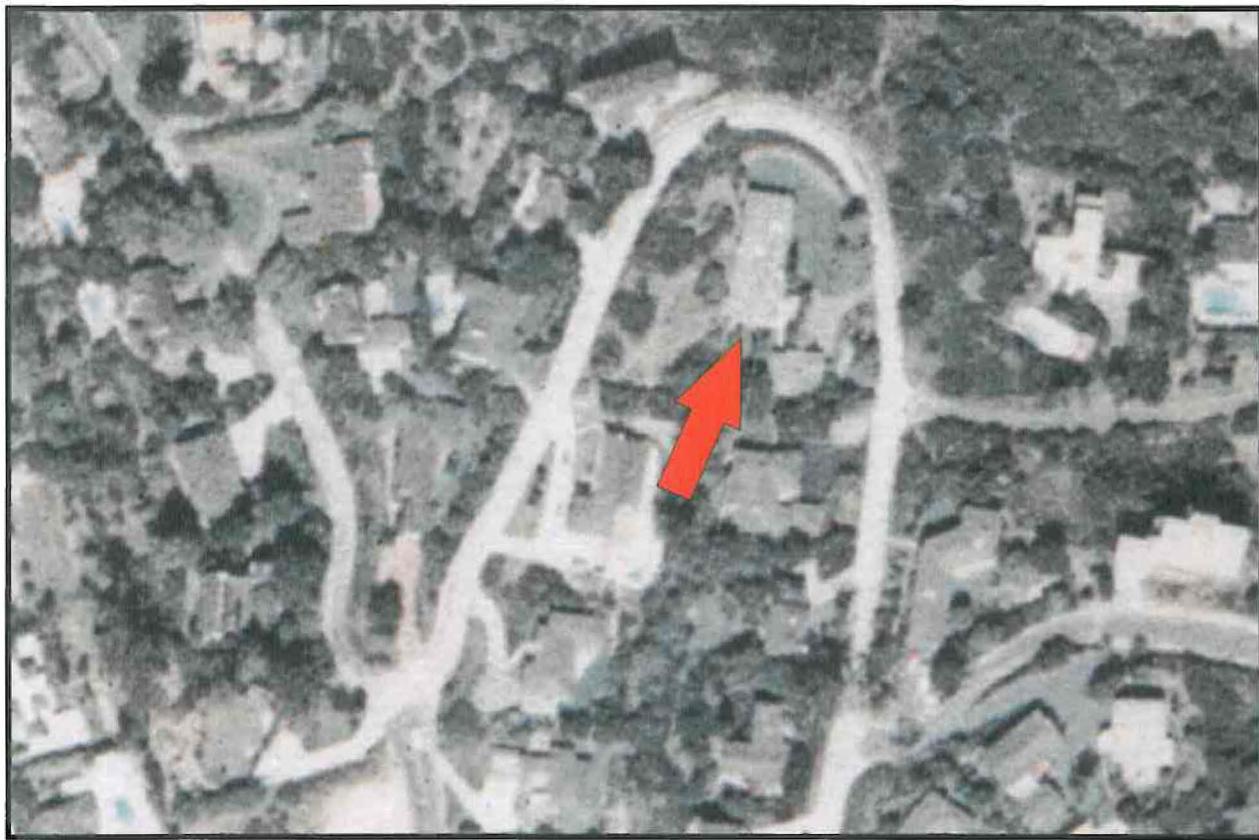
The effect of the lot split was to produce a virtually non-existent, non-usable rear (backyard) area for the Property. The wide rear yard expanse (“a deep setback” identified in the HRB Staff Report, Number HRB-10-031, July 16, 2010), an important element to the Modern Ranch ideal of social entertainment, which originally characterized the Property, has therefore been completely removed and the entire character of the lot has been altered. The westerly home constructed on the newly created lot is literally less than 10 feet from the rear of the residence and any sense of an estate lot or setting forever ruined. (*See presented photos for further background, Item #1, Photos A-D*).

Photo A - 1970 aerial photo showing 6604 Muirlands home centered in a large estate lot pre-lot split.

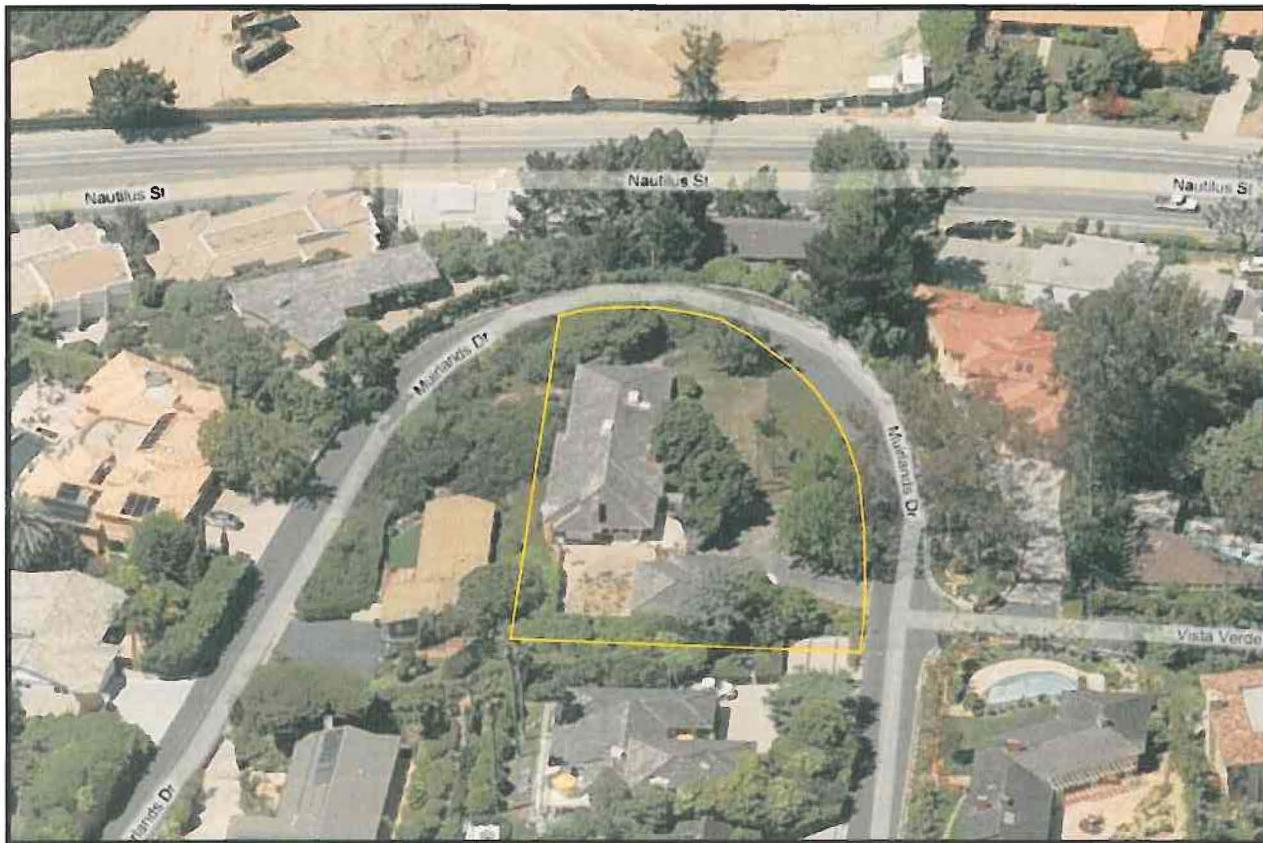
Photo B - Current aerial photo showing the lot post-lot split and the new home to the west 10' from the home.

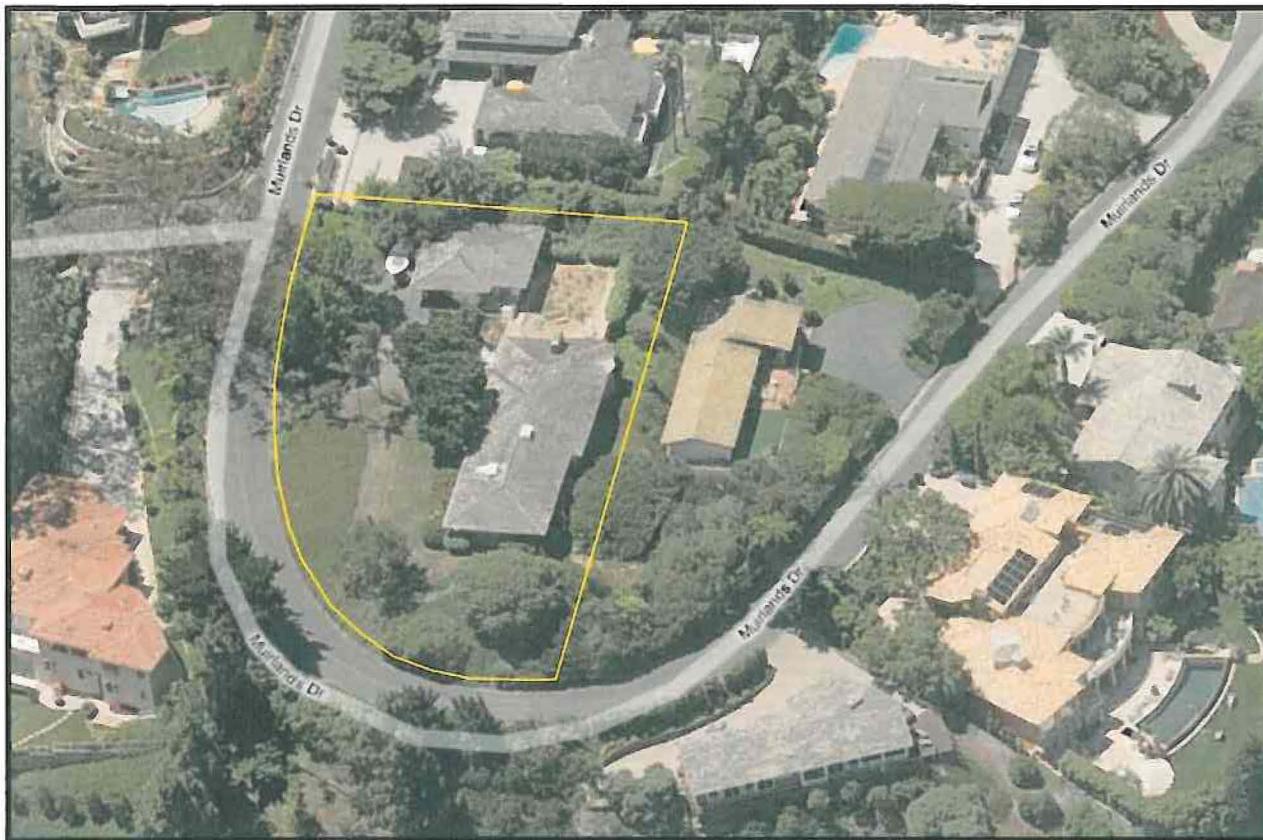
Photo C - Current aerial photo showing the westerly home and it's proximity to 6604 Muirlands Residence.

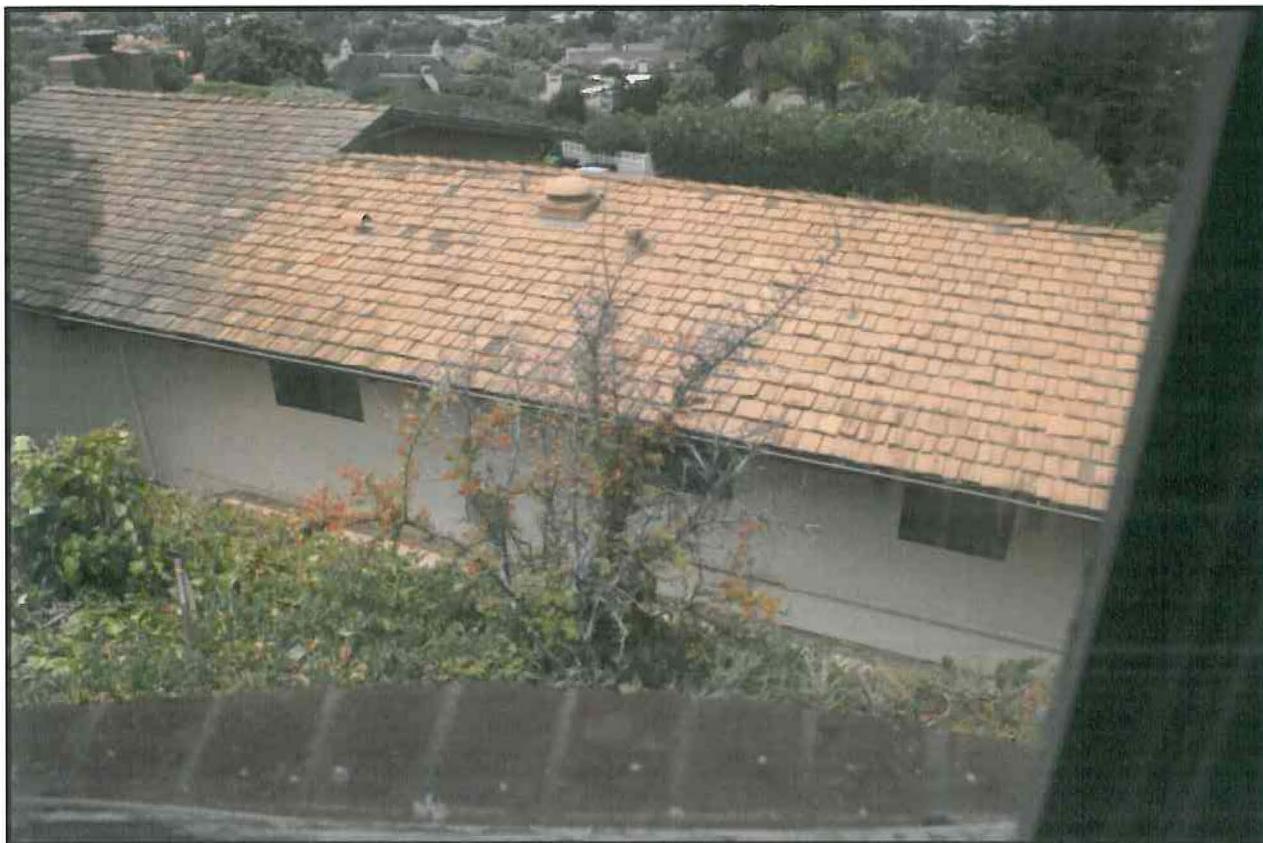
Photo D - Photo from 6604 Residence Kitchen showing proximity of post-lot split adjoining home.

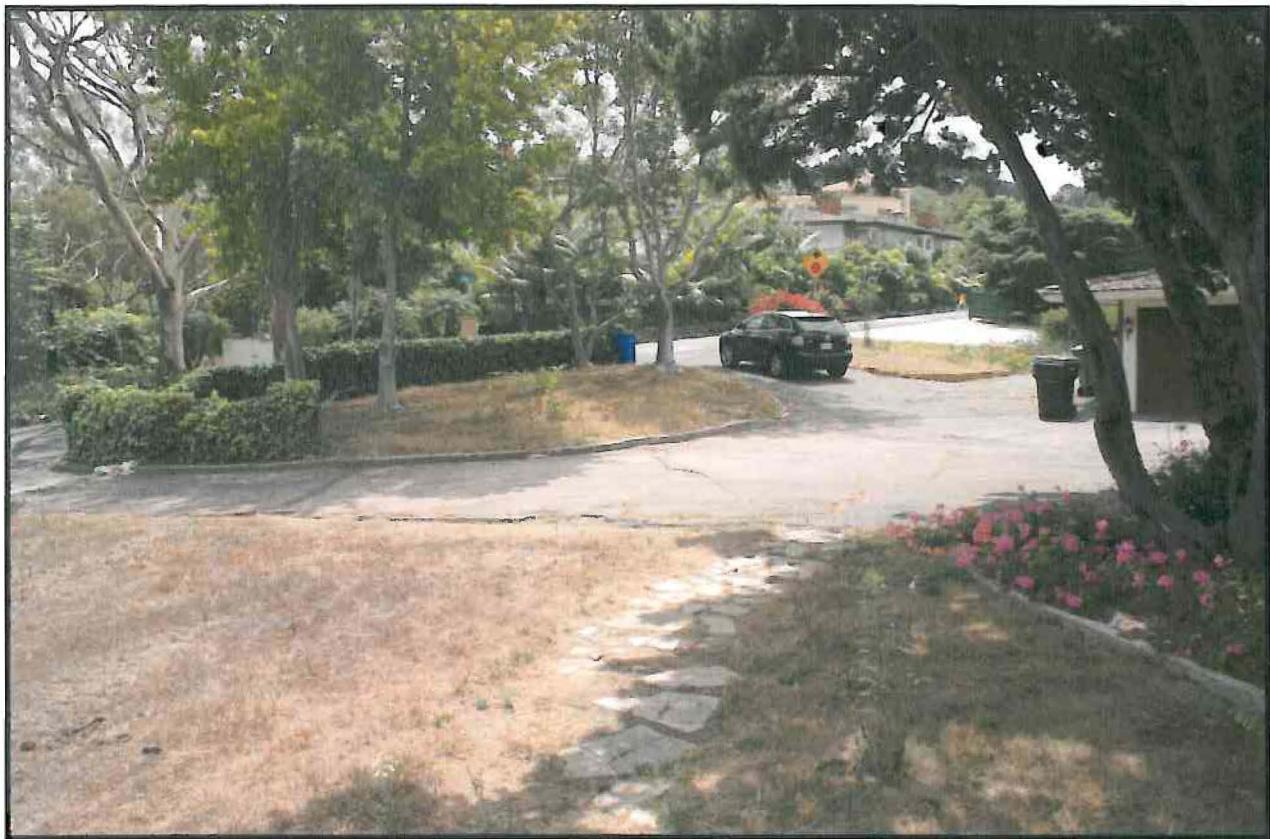
The aerial photographs from 1966 and 1970 depict the Site as having driveway-access from Muirlands Drive along the eastern side of the Property. The photographs clearly show that access to the Property from Muirlands Drive occurred only by virtue of a *single, linear driveway*. Sometime after 1970, the driveway was modified to create an extension or “roundabout” which emptied further southeast into Muirlands Drive. Once this was accomplished, the driveway had been transformed. According to the HRB Staff Report, what now resulted was a “motor court (circular drive leading to the garage).” The effect of this modification was to create a non-original, false feature. According to the HRB Staff Report, such a feature is “indicative of Custom Ranch homes.” (*See presented photos for further background, Item #2, Photos A-F*).

Photo A - Current photo of circular driveway at 6604 Muirlands Drive Residence.

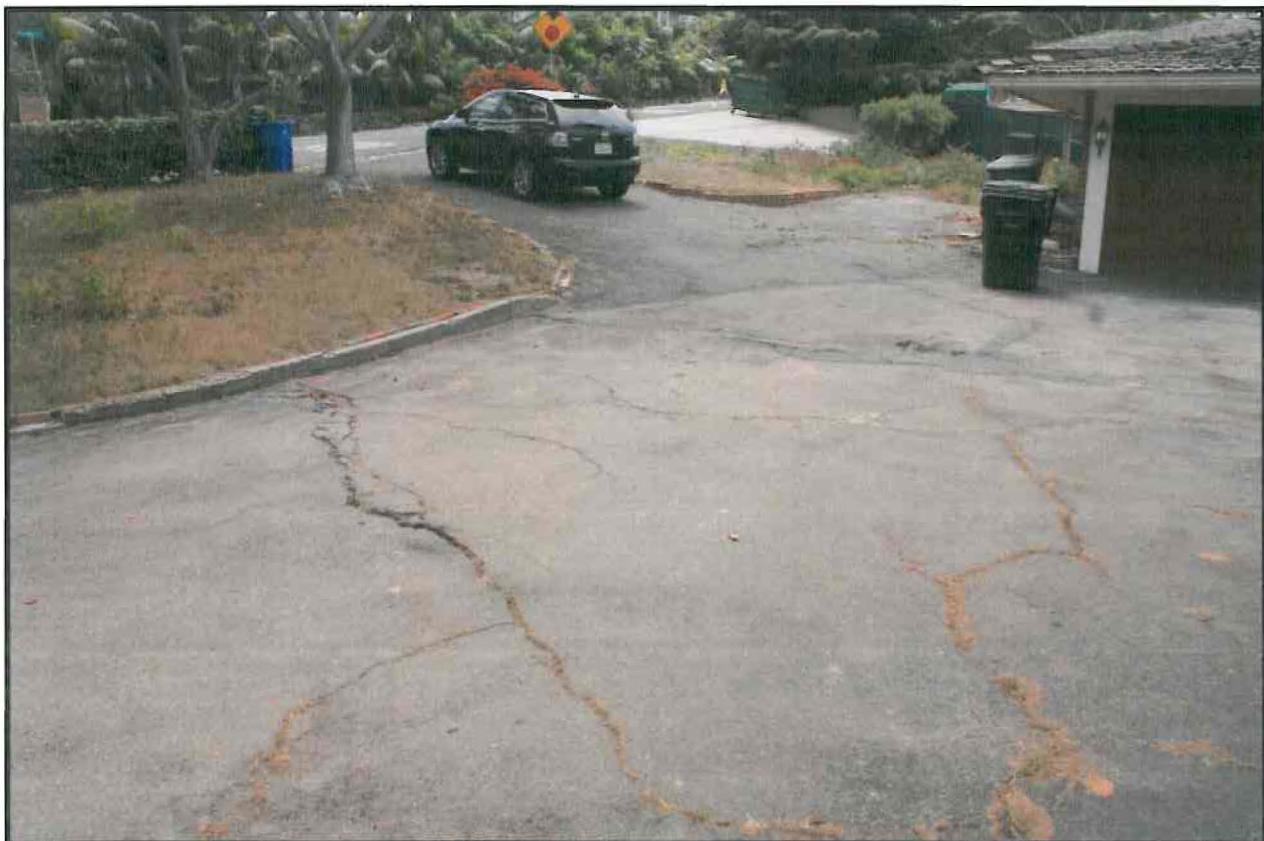
Photo B - Current photo showing new circular drive addition and break in original brick/block border.

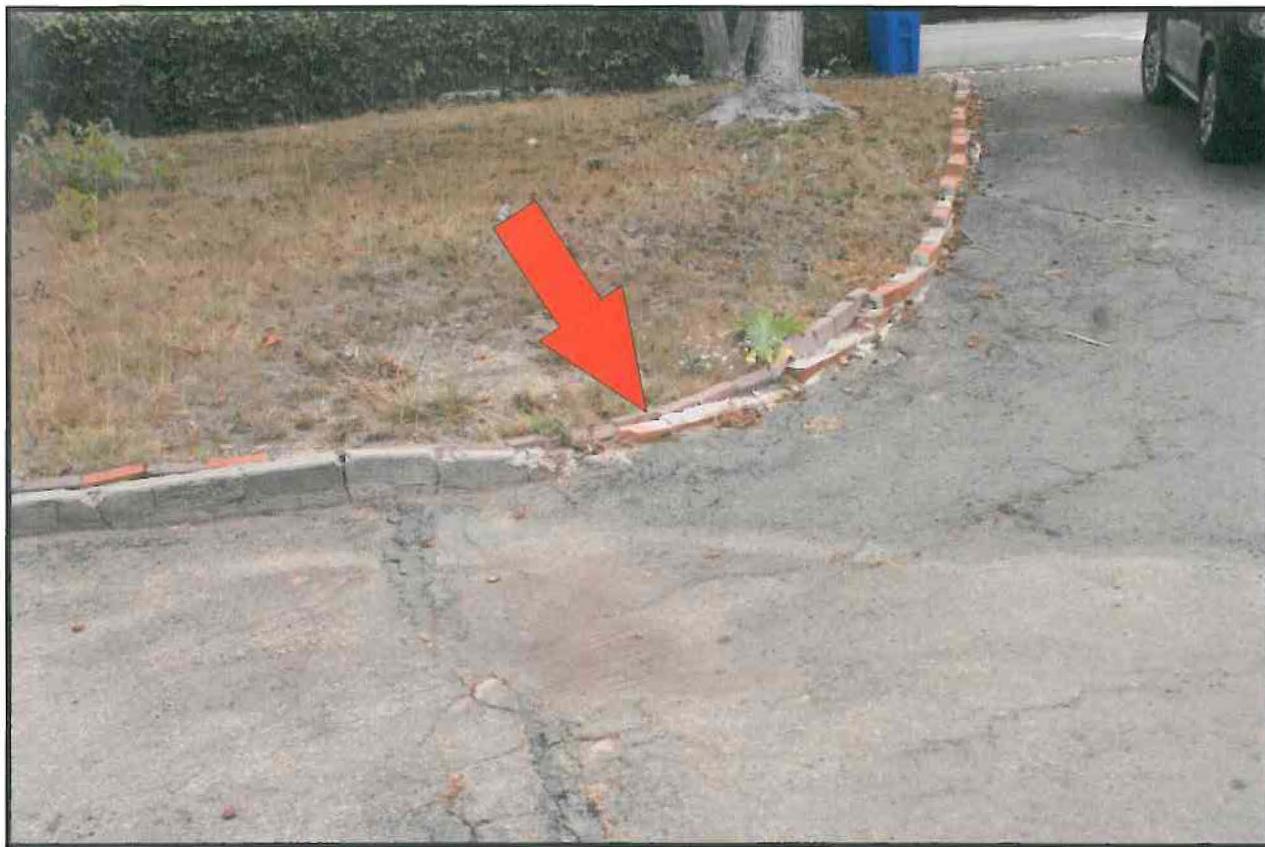
Photo C - Photo depicting termination of original border next to added new border

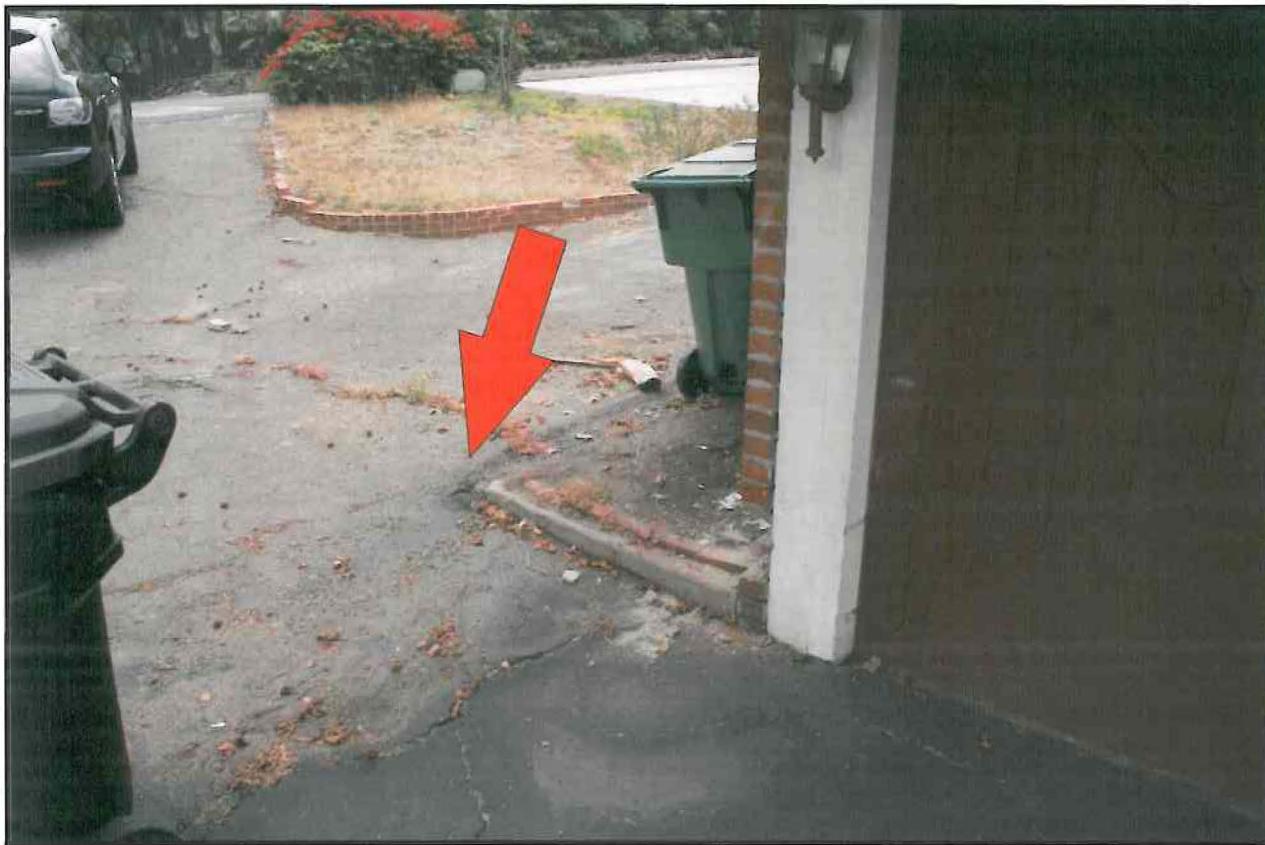
Photo D - Photo showing original driveway border buried under added circular driveway addition.

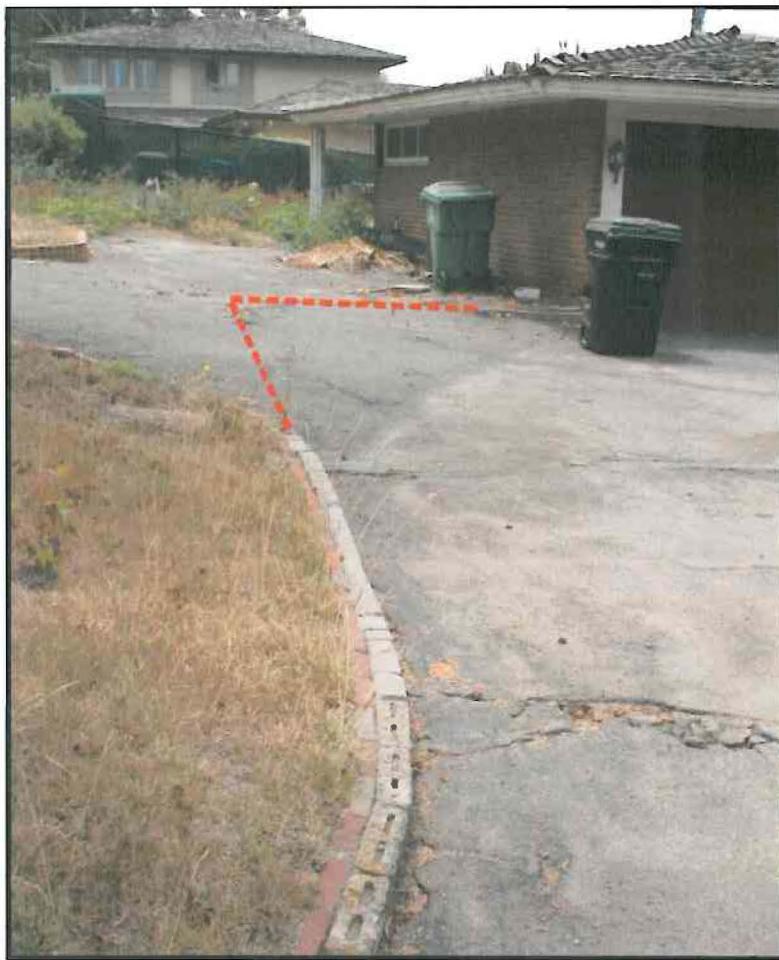
**Photo E** - Photo showing dashed original location of non-circular driveway location

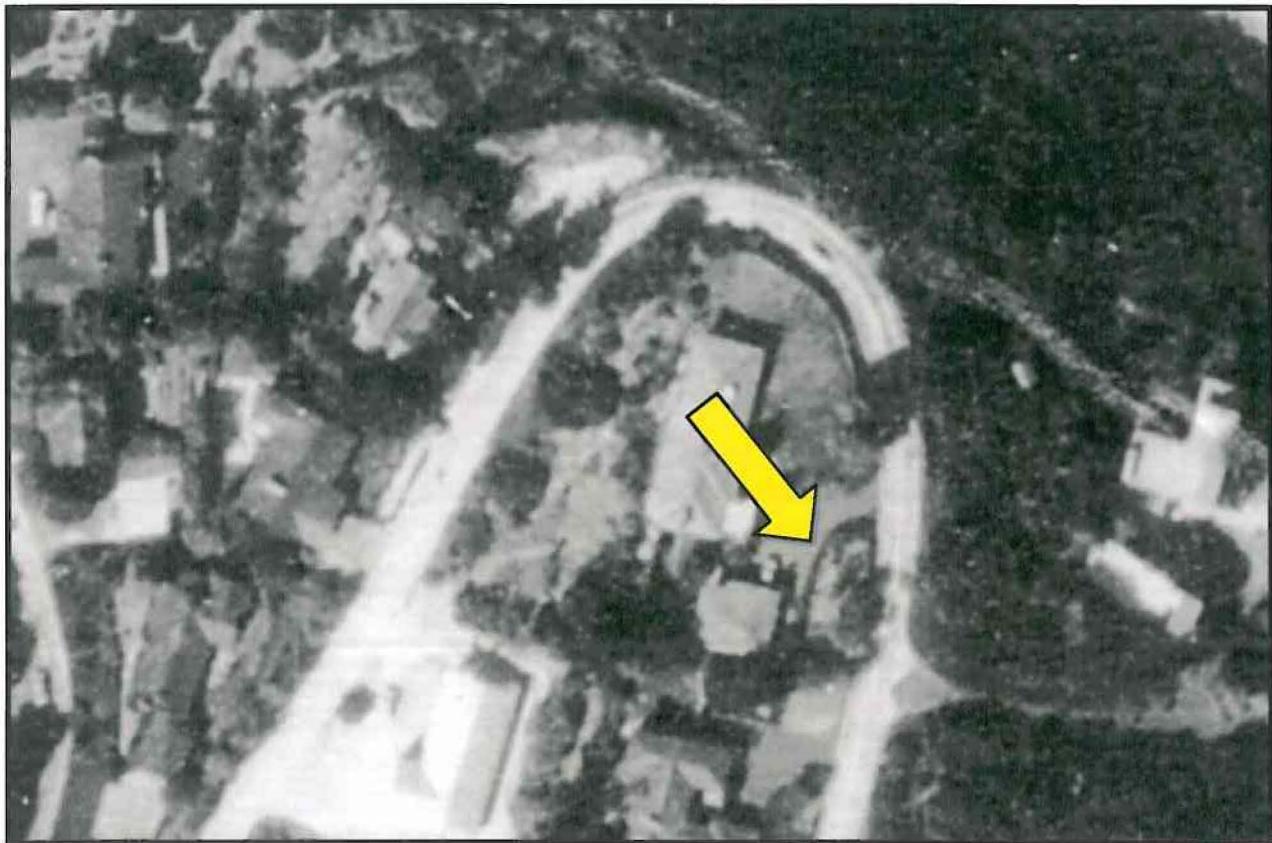
**Photo F** - 1966 Aerial Photo showing original (non-circular) driveway configuration

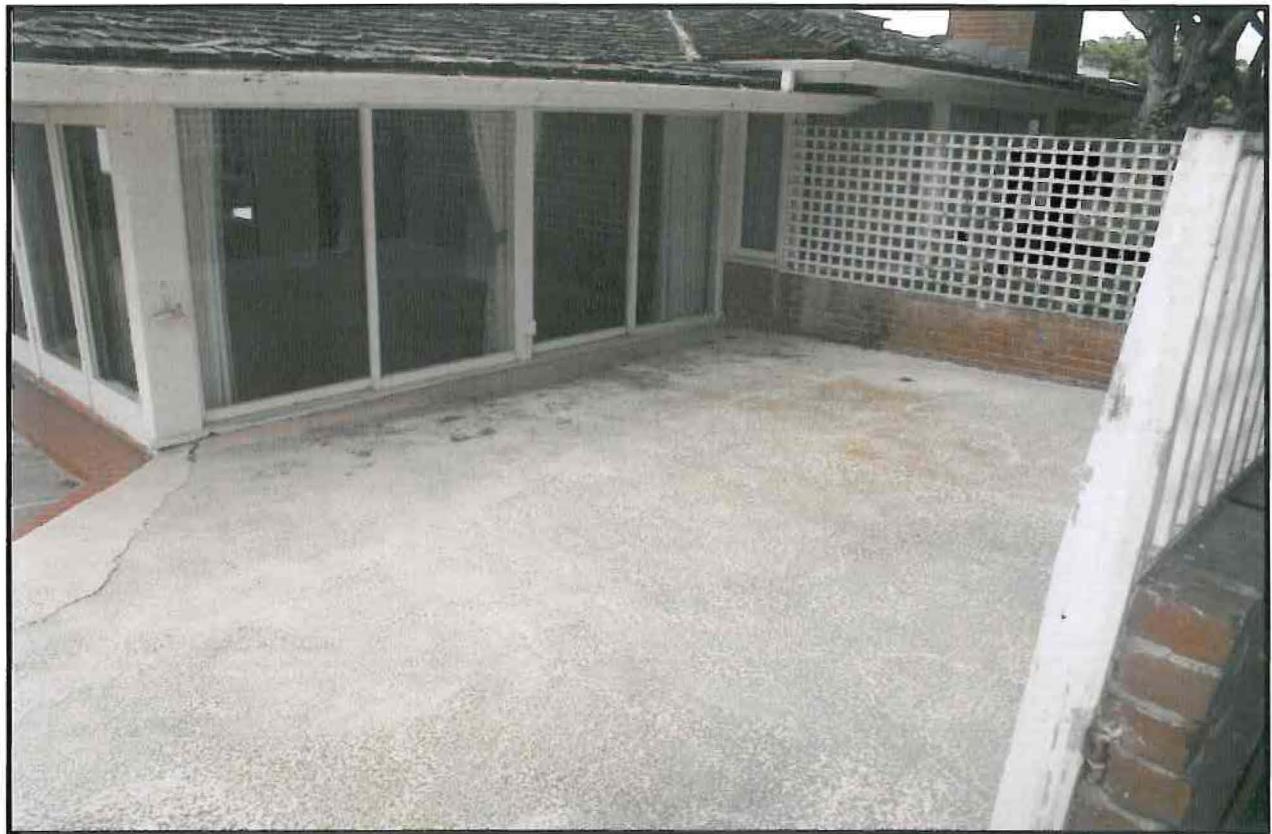
However, at an unknown date, the southeastern corner patio area was enclosed by the addition of a new stem wall, glass windows, and doors. This has been documented with extensive forensic investigation which shows that the slab for this area was not poured with the home slab; the walls in the patio space are the exact same vertical T&G siding on the rest of the house (now covered with paneling); the presence of a barbecue which would never have been built inside the home; the red concrete scored patio surface is the same surface from the other outdoor patio; and the presence of asphalt sealer under what would have been the door threshold to this outdoor patio.

The effect of this patio enclosure was to modify and alter an open patio area which was originally used for recreational gatherings, again an important element to the Modern Ranch ideal of social entertainment. Further, and perhaps more importantly, this patio area identified in the HRB Staff Report as located on the “south end” to complete the “[s]prawling floor plan” (a character defining feature of the Custom Ranch style) of the home was modified, thereby changing the configuration of the original floor plan, altering the relationship with the northern porch area, and resulting in a substantial change to the appearance and massing of the front façade. (*See presented photos for further background, Item #3, Photos A-H*).

Photo A - Photo showing enclosed patio area at front southern corner of the home.

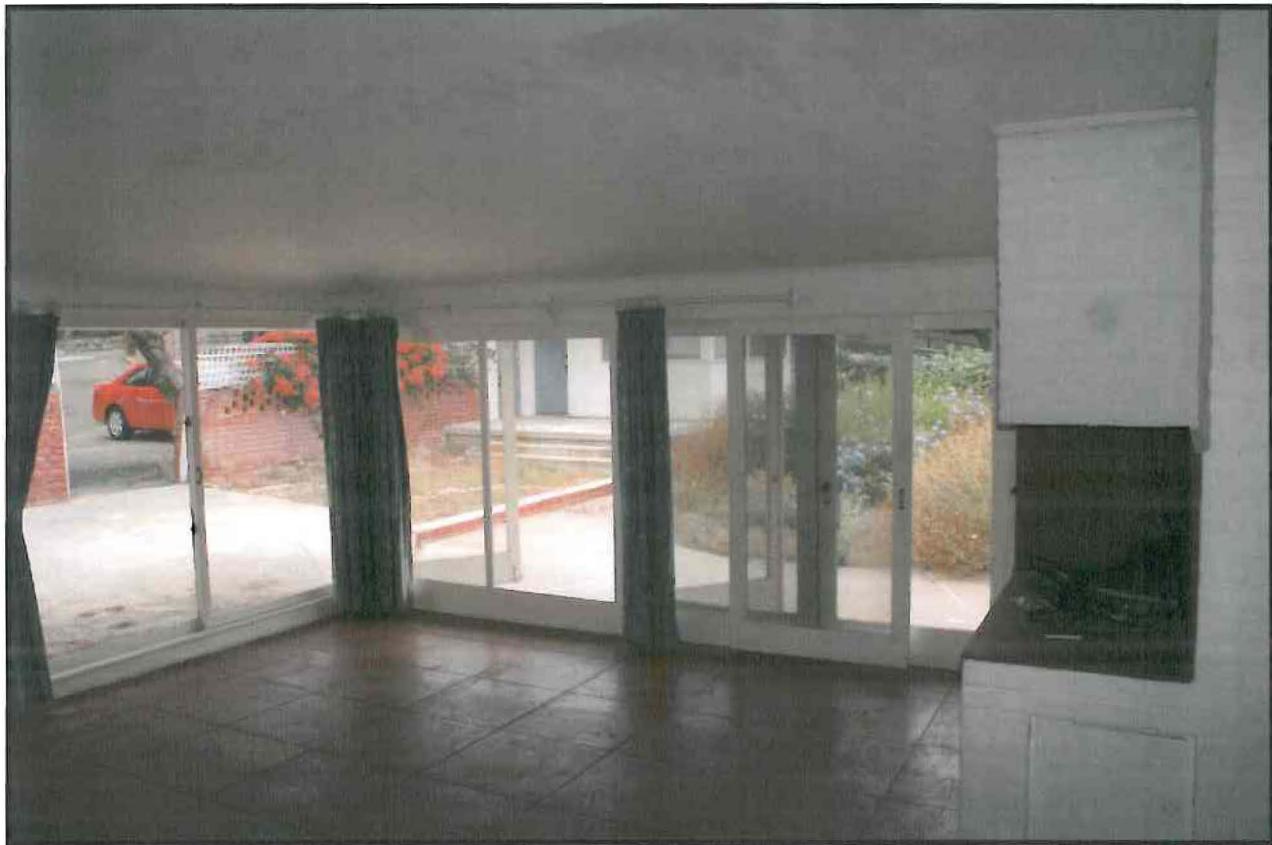
Photo B - Photo of interior or former open patio deck enclosed in 1956

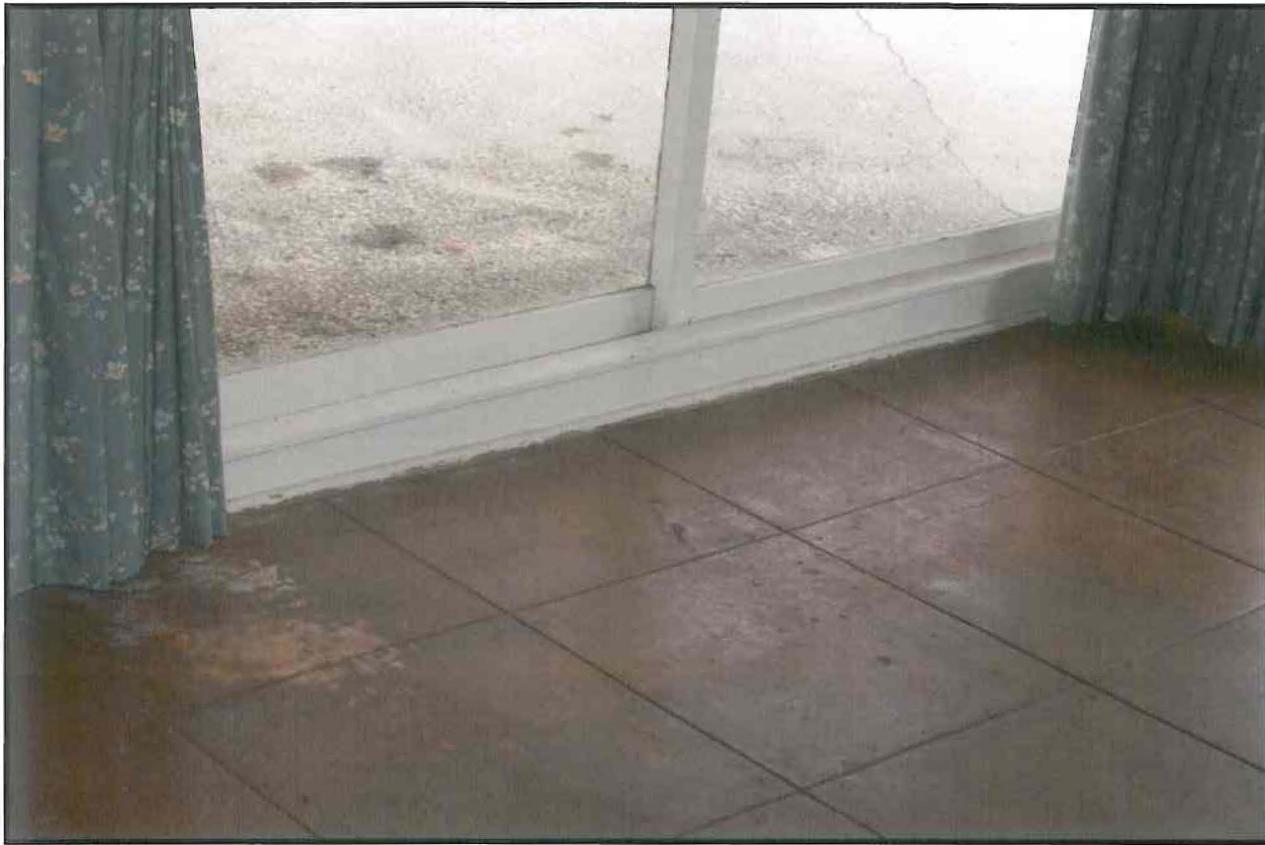
Photo C - Photo showing original scored and colored concrete patio now enclosed - note slope of floor.

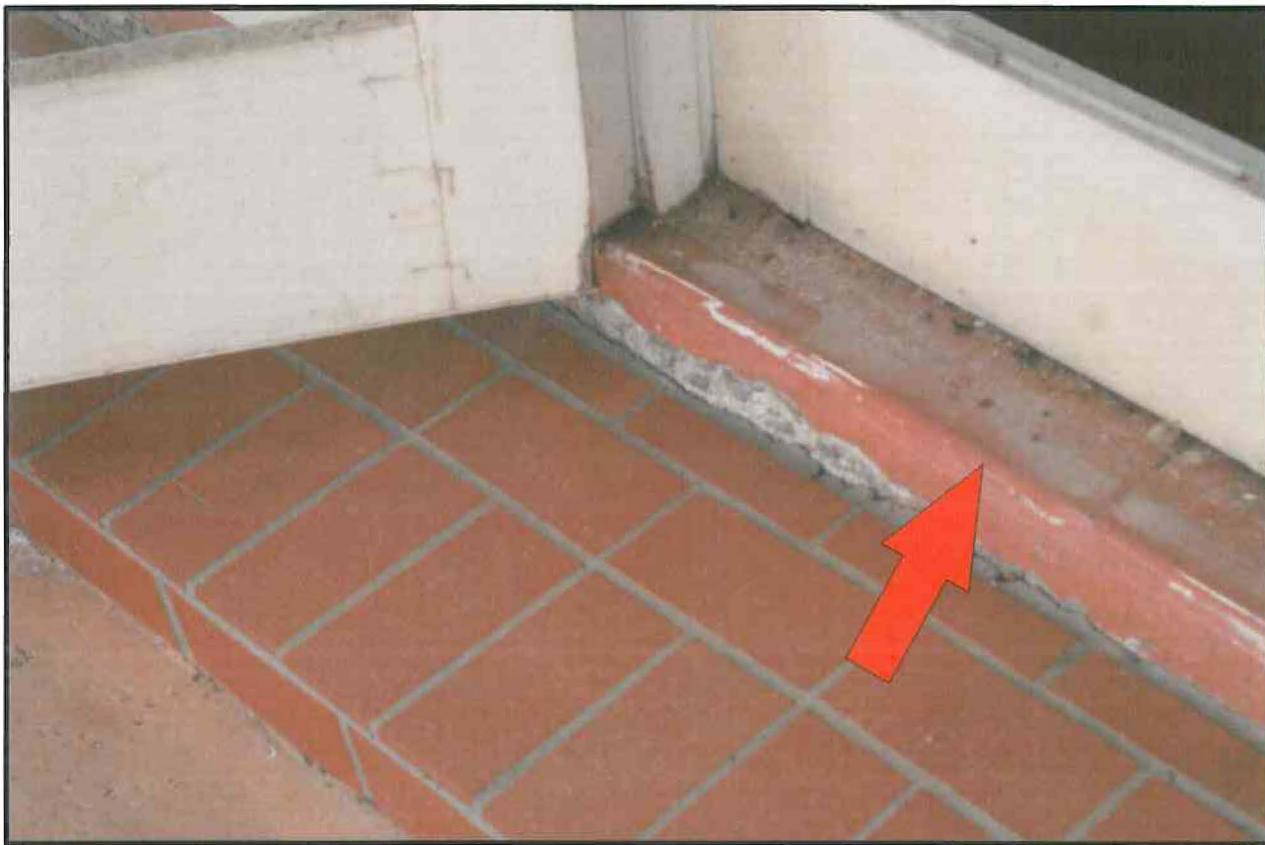
Photo D ~ Photo showing original patio edge in red concrete with wood doors place on top.

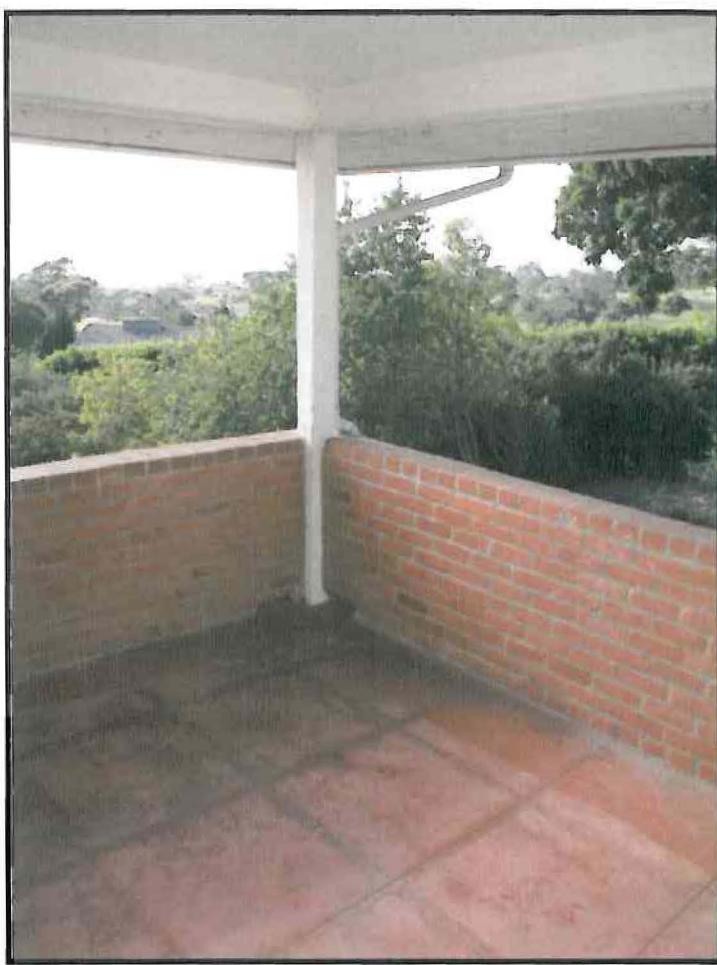
Photo E - Reference photo showing exactly the same scored red concrete at northwestern open patio.

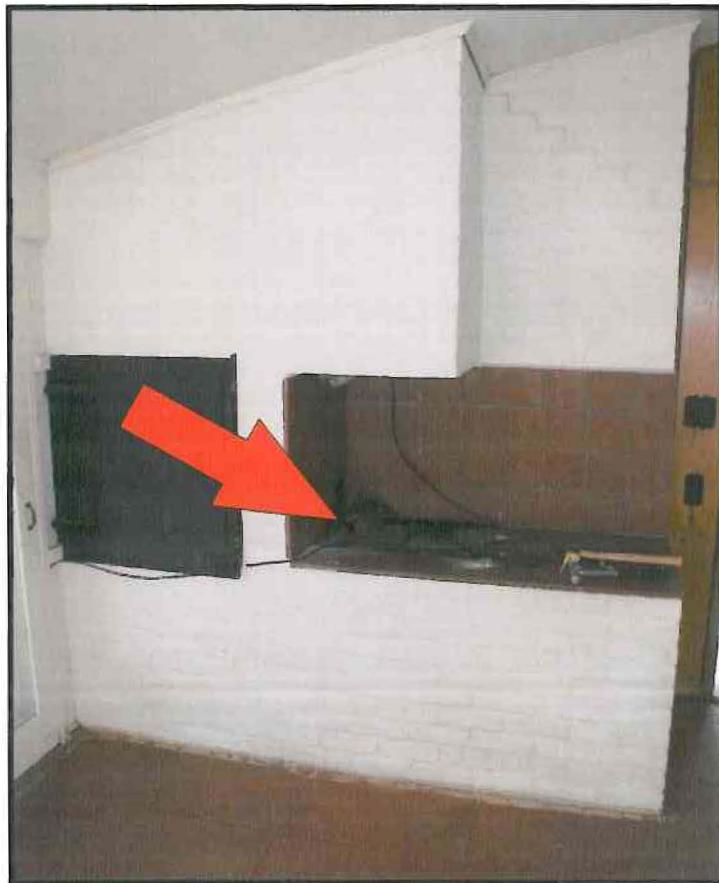
Photo F - Photo showing exterior barbeque located at now enclosed patio without full exhaust covering even.

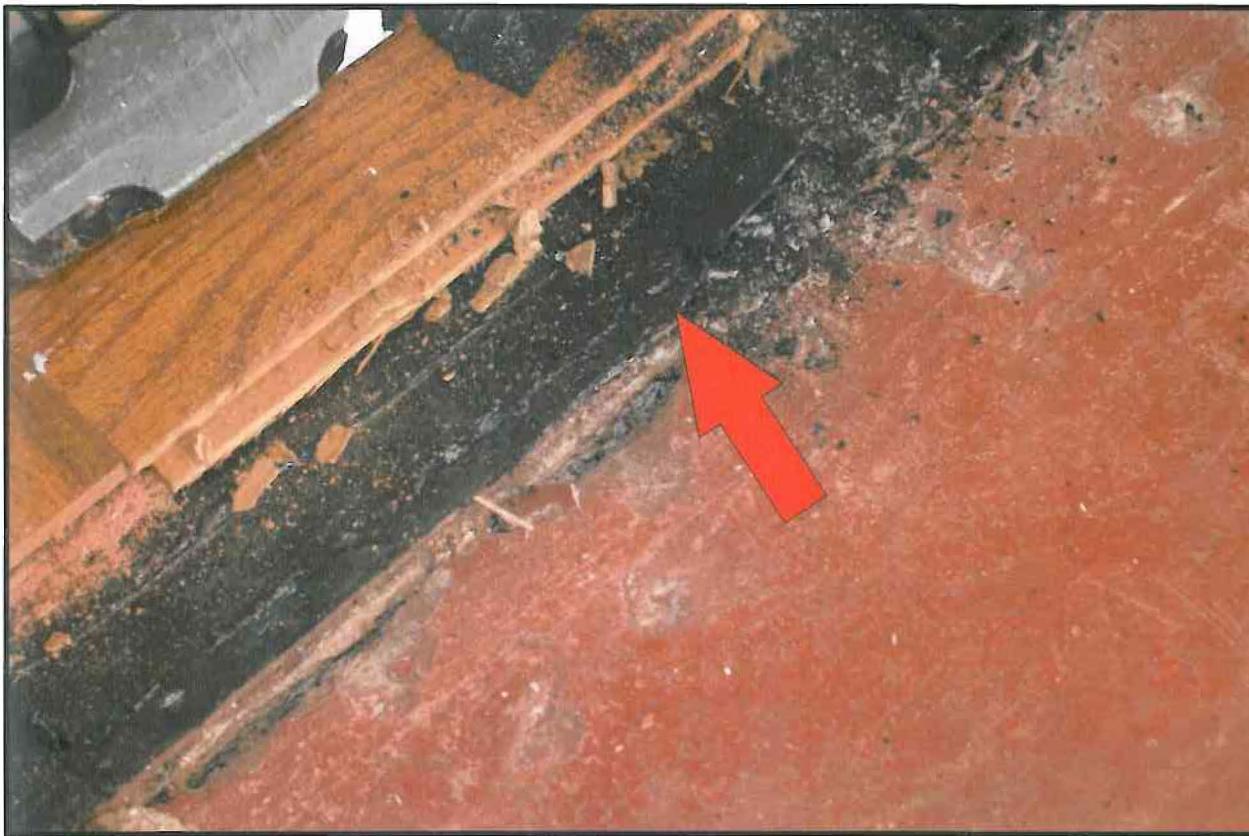
Photo G - Photo of threshold between Living Room and patio showing asphalt sealer to former exterior door.

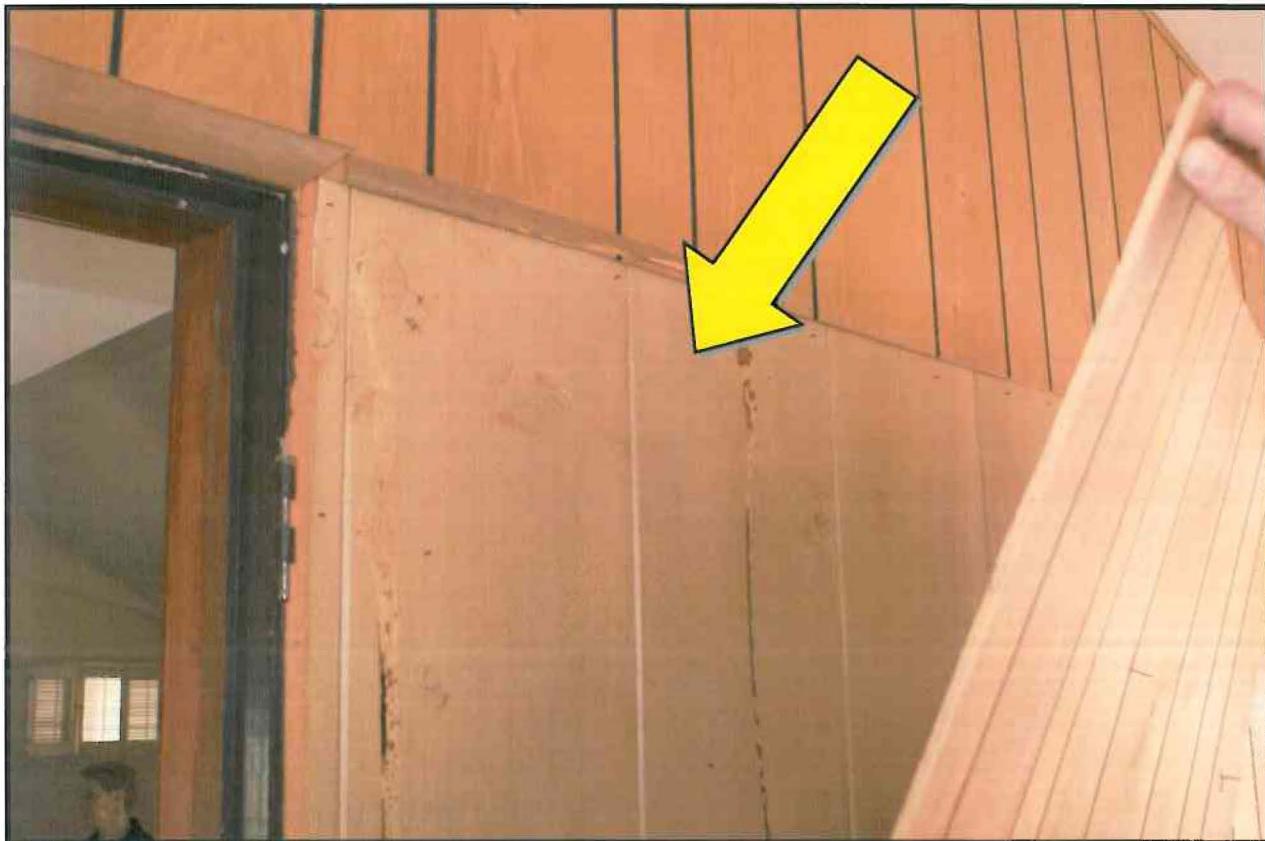
Photo H - Photo showing exterior vertical T & G siding behind paneling in former patio room .

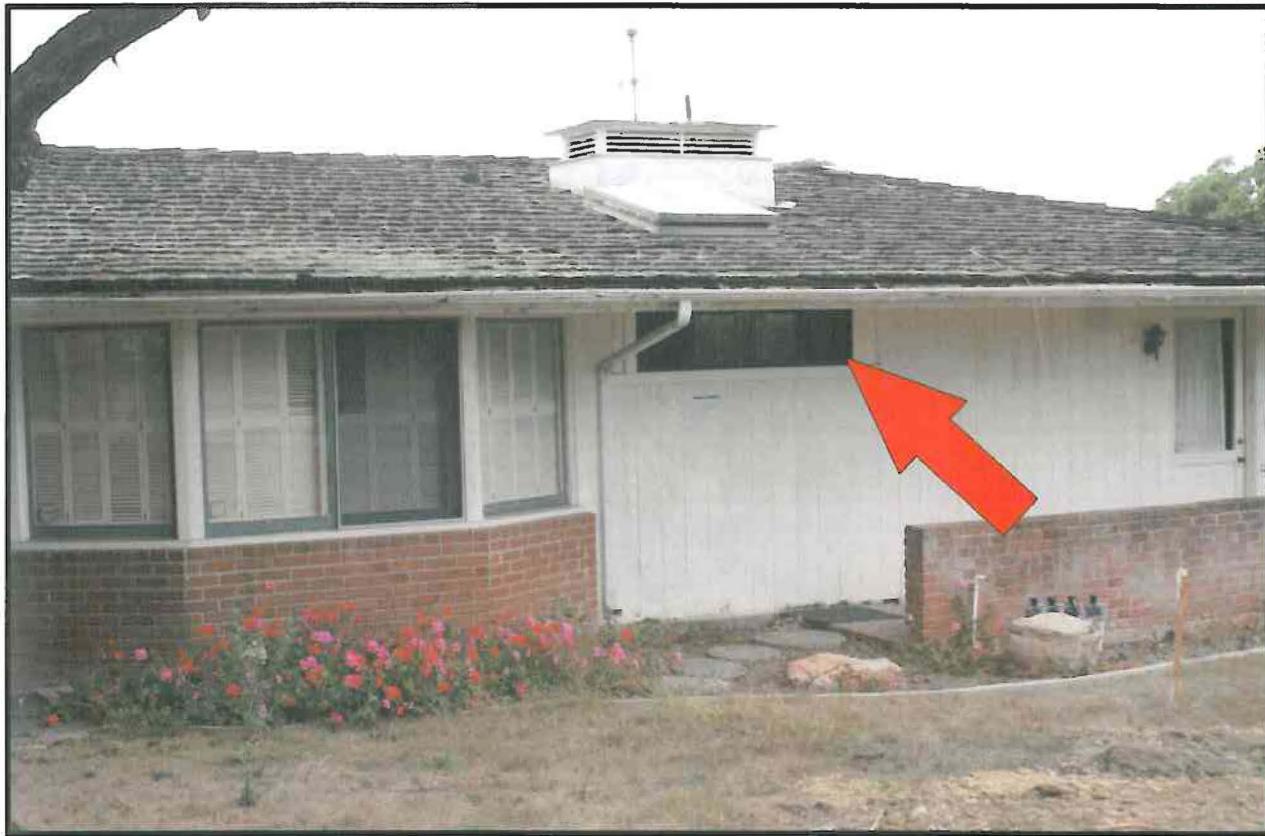
According to a previous property owner, Mr. Collins Haines (see attached sworn Declaration of facts), in or about 1978, a “smaller” bathroom window along the east elevation (master bathroom area) was changed to a “larger” window as part of a substantial bathroom remodel. The current metal window along this elevation is, therefore, not original. Recent extensive forensic examination and analysis supports this fact and demonstrates further that the window size, framing, and exterior materials along this elevation are also not original, and were altered at least two times in the past (given the multiple generations of framing inside the wall and the replacement of the entire exterior siding in this area as well as the pouring of a new foundation in this area). The investigation into the interior framing of the Master Bathroom indicates that the current window is narrower by at least 2'-0" from the originally installed window and probably at least 9" taller as well. Again, this further significantly alters the front façade appearance and leaves a substantial section further lacking integrity.<sup>1</sup> (*See presented photos for further background, Item #4, Photos A-J*).

Photo A - Photo showing location of front facade window replaced with aluminum window.

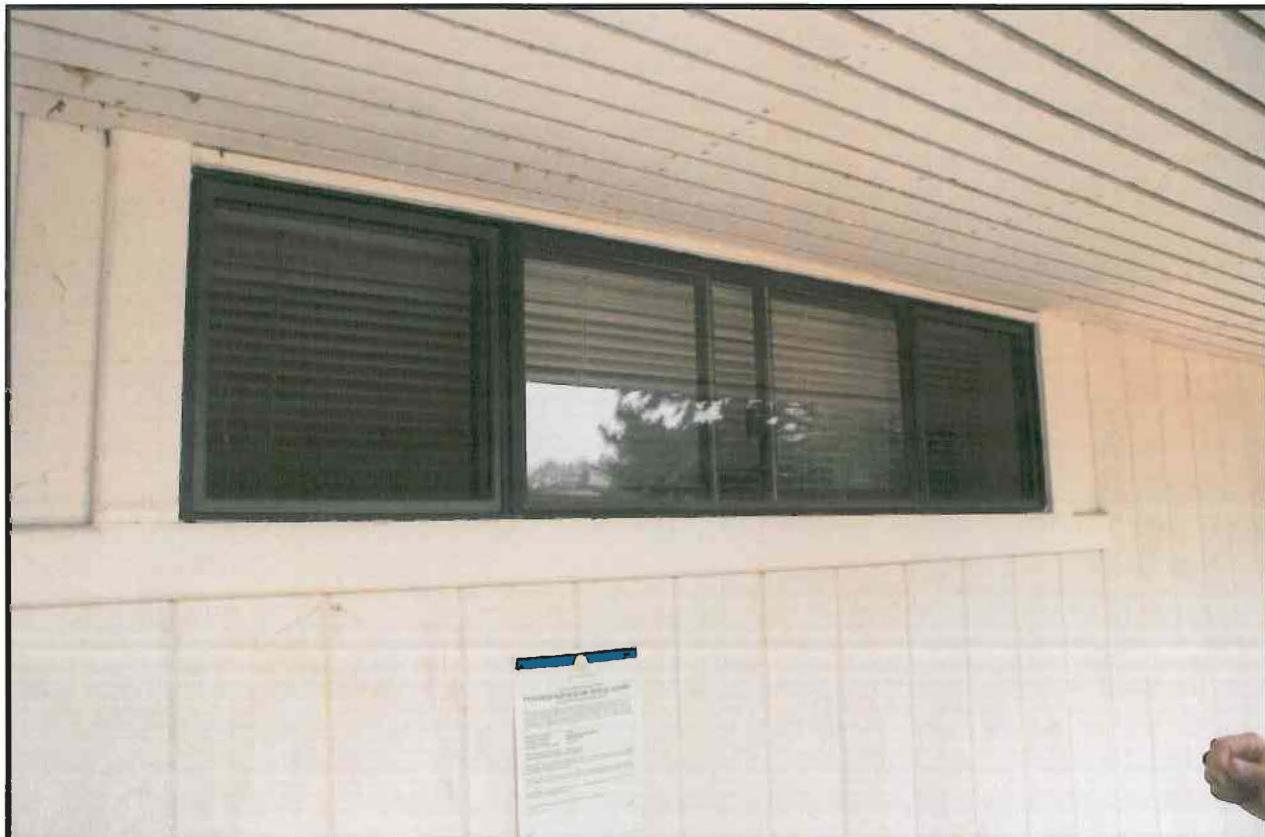
Photo B - Close up showing aluminum replacement window.

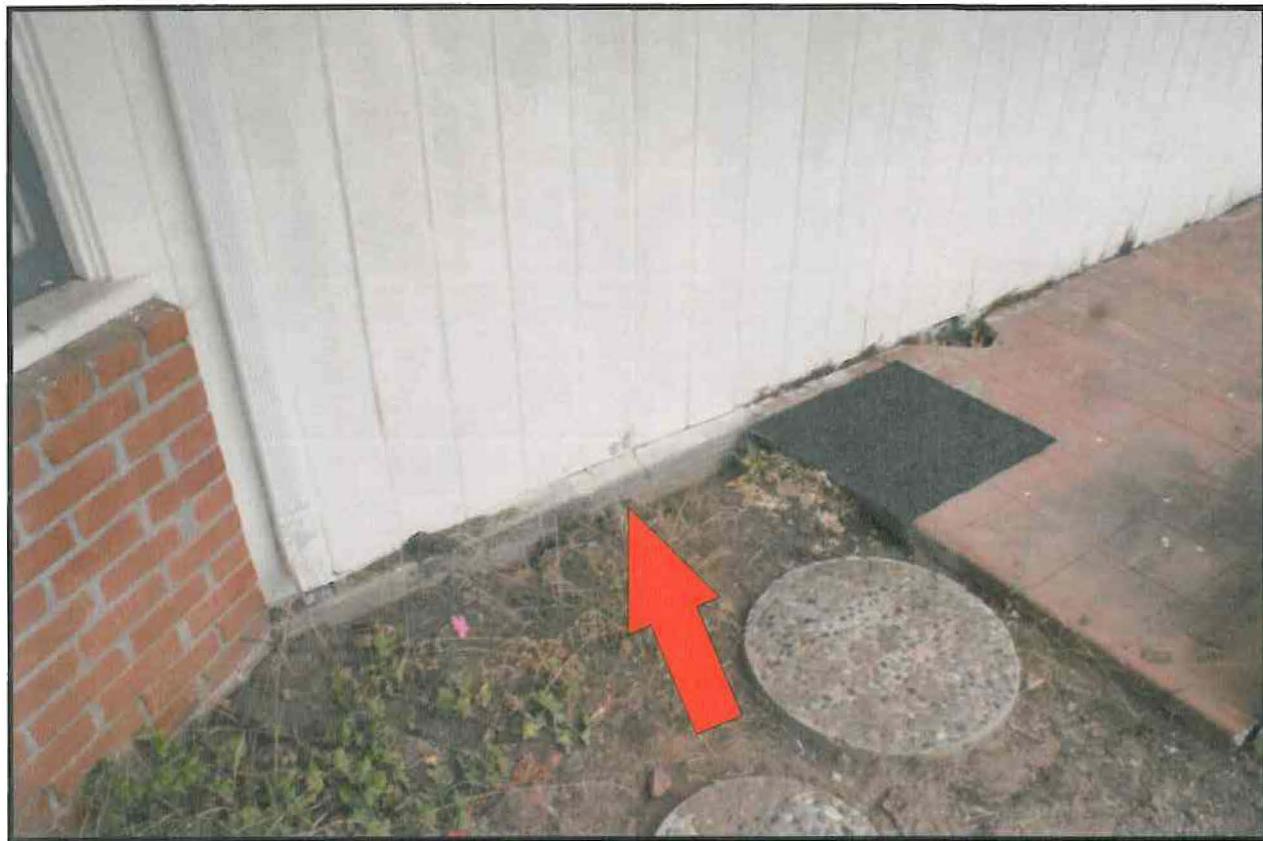
Photo C - Photo showing area of new foundation under replaced window (see color of concrete).
