August 9, 2010

*Re: 6004 Muirlands Drive, La Jolla, Substantial Modifications & Changes--Lack Of Original Integrity*

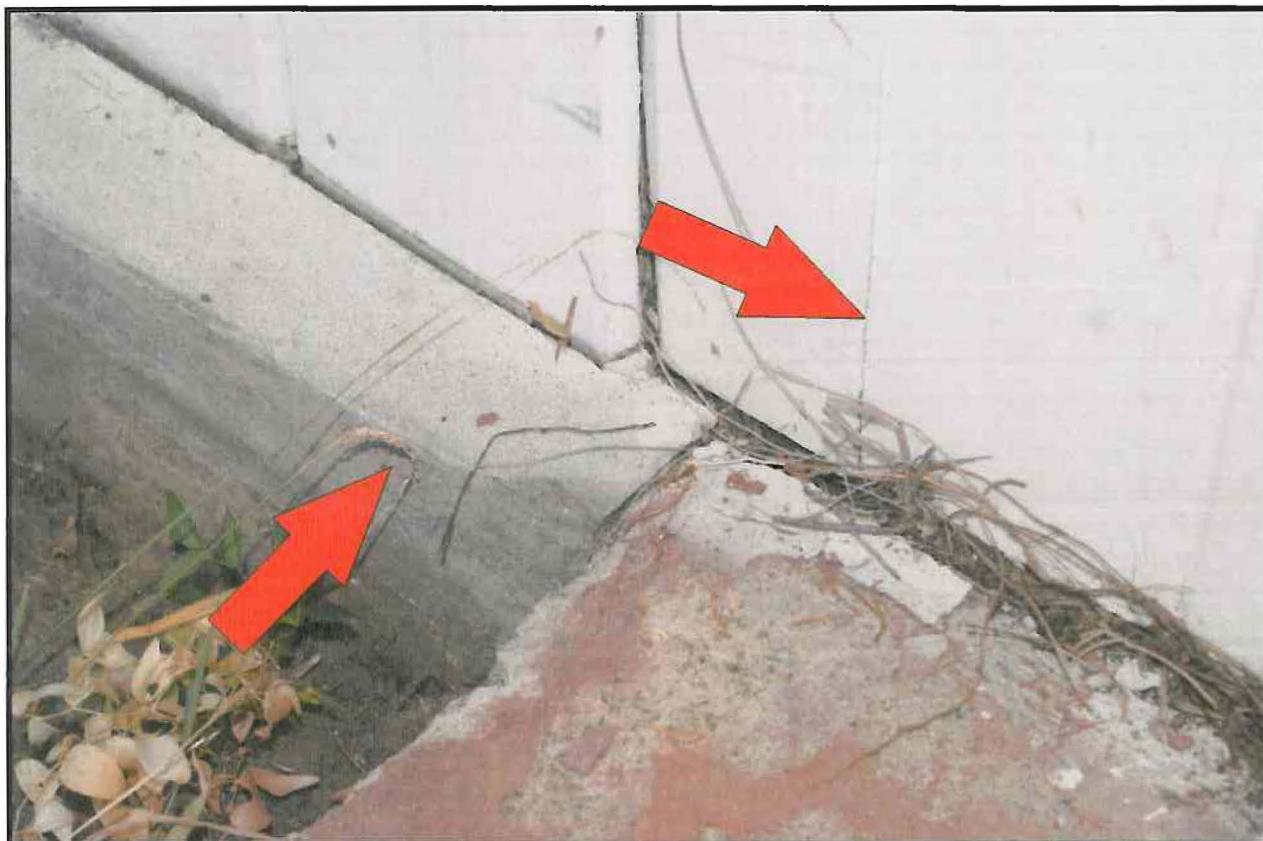
Photo D - Photo showing clear evidence of new foundation and vertical joint in T&G siding.

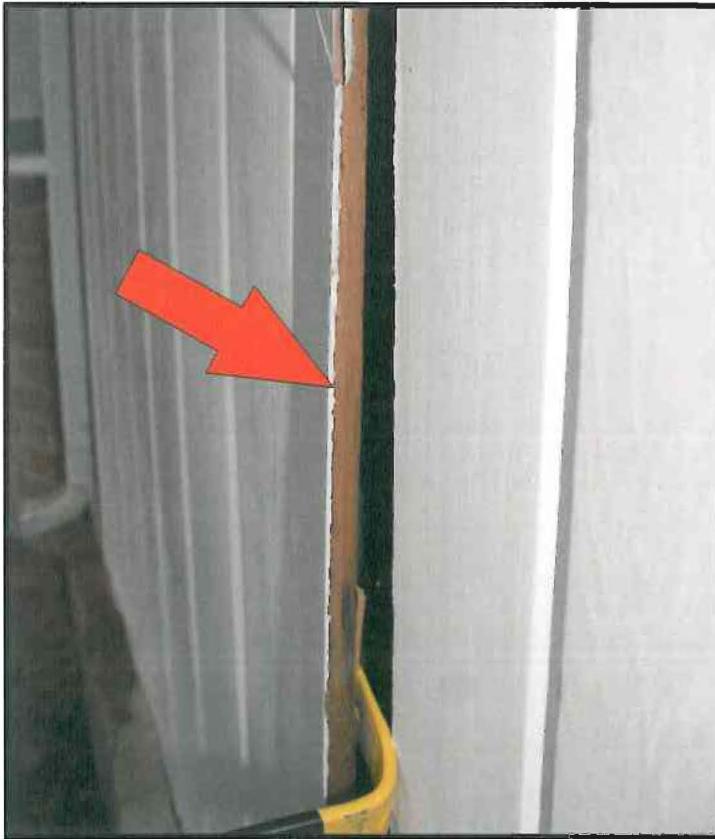
Photo E - Photo showing 45 degree mitre joint mid span on vertical T&G for replaced area of siding under window

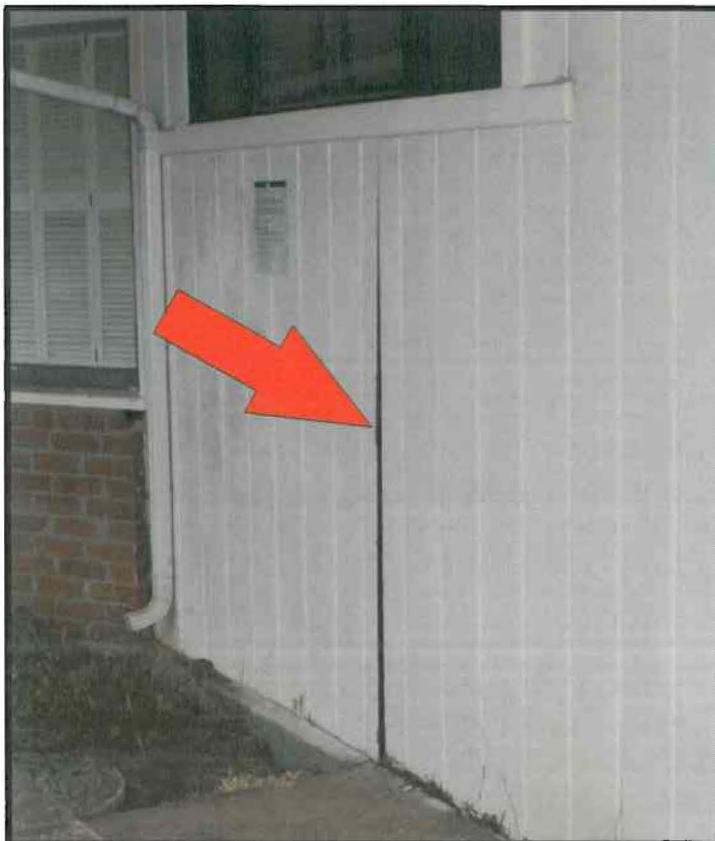
Photo F - Photo clearly showing splice joint in siding under replace window above new foundation

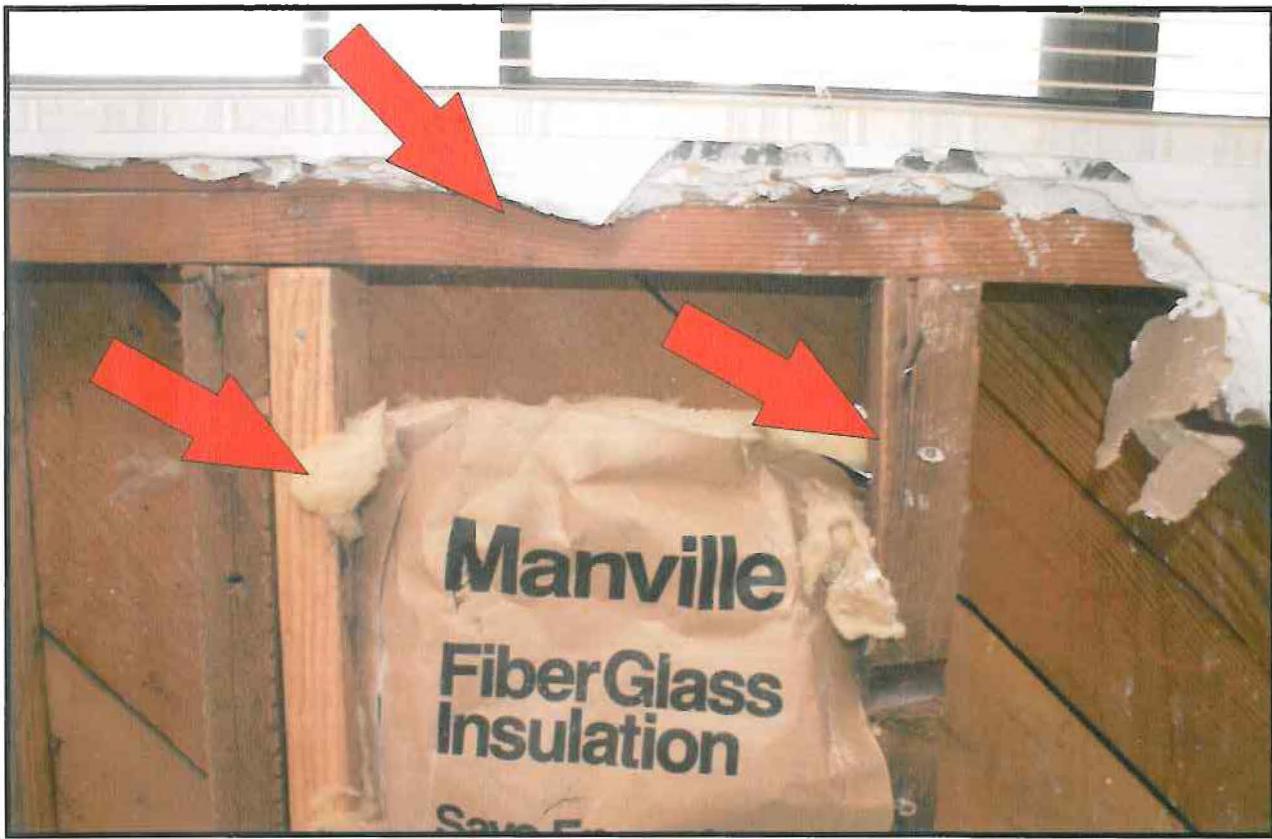
Photo G - Photo clearly showing at least 3 generations of framing lumber at replaced window

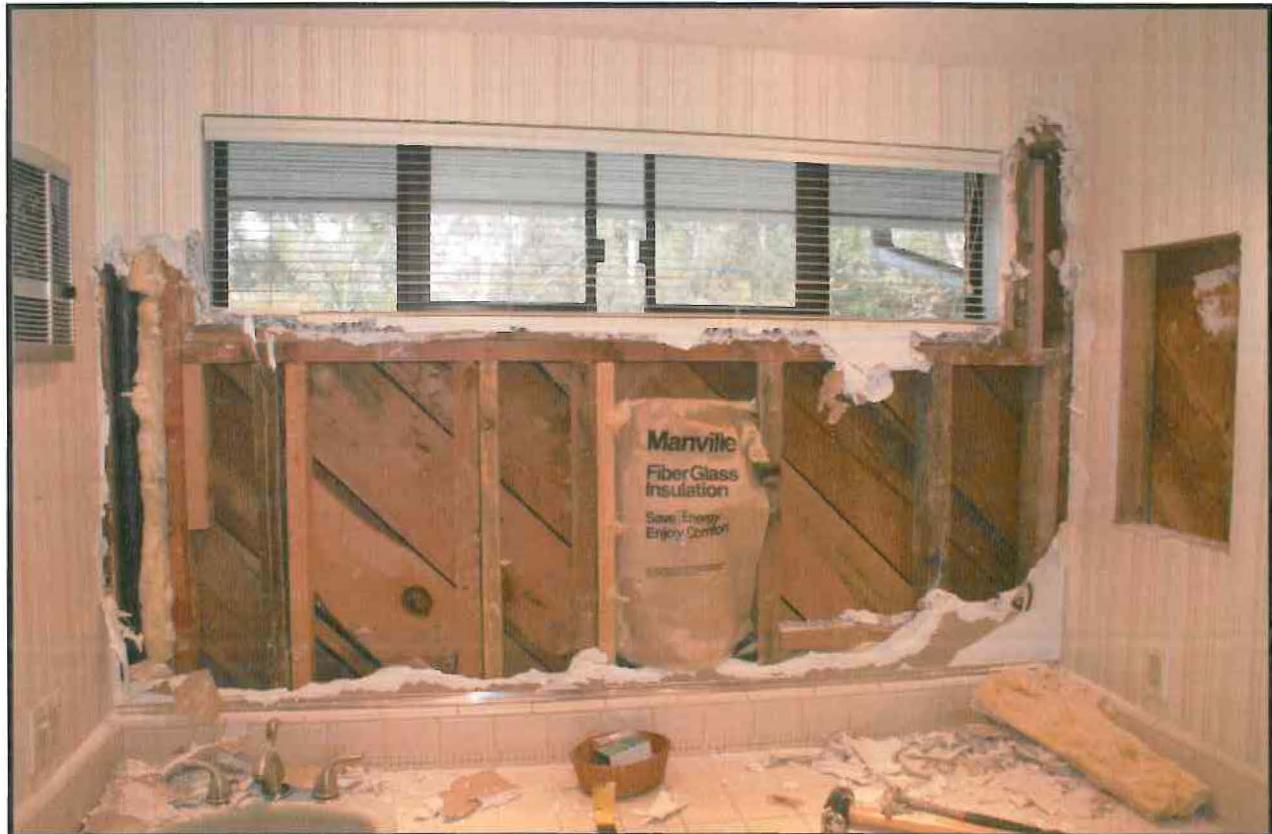
Photo H - Photo clearly showing complete re-framing at replaced window

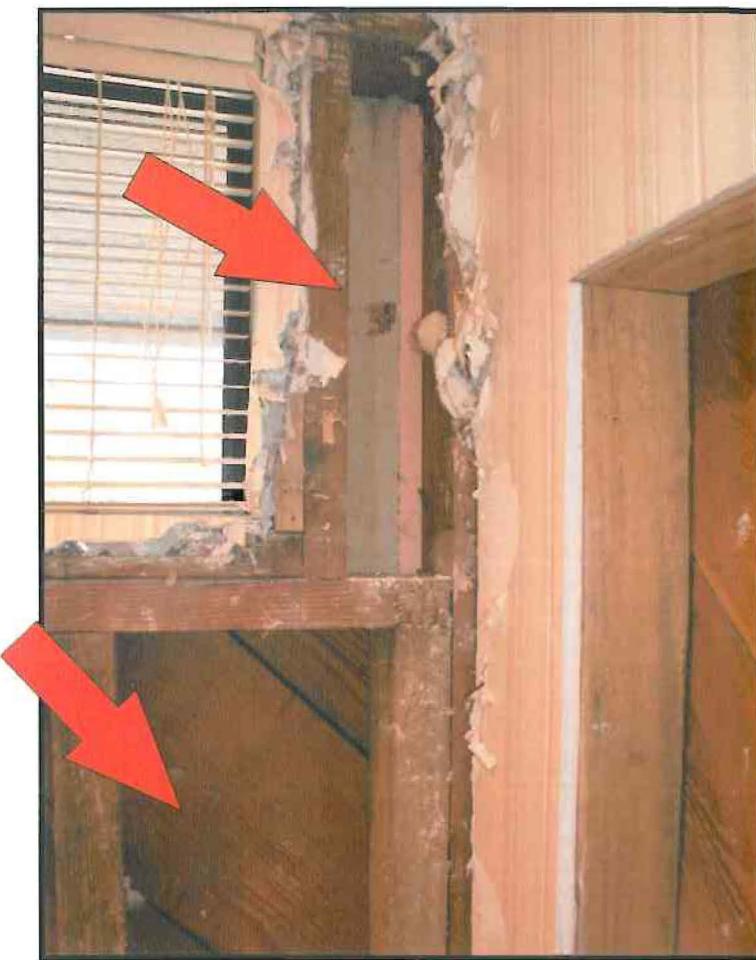
**Photo I** - Photo clearly showing re-framing of side and bottom at replaced window and new skip sheathing

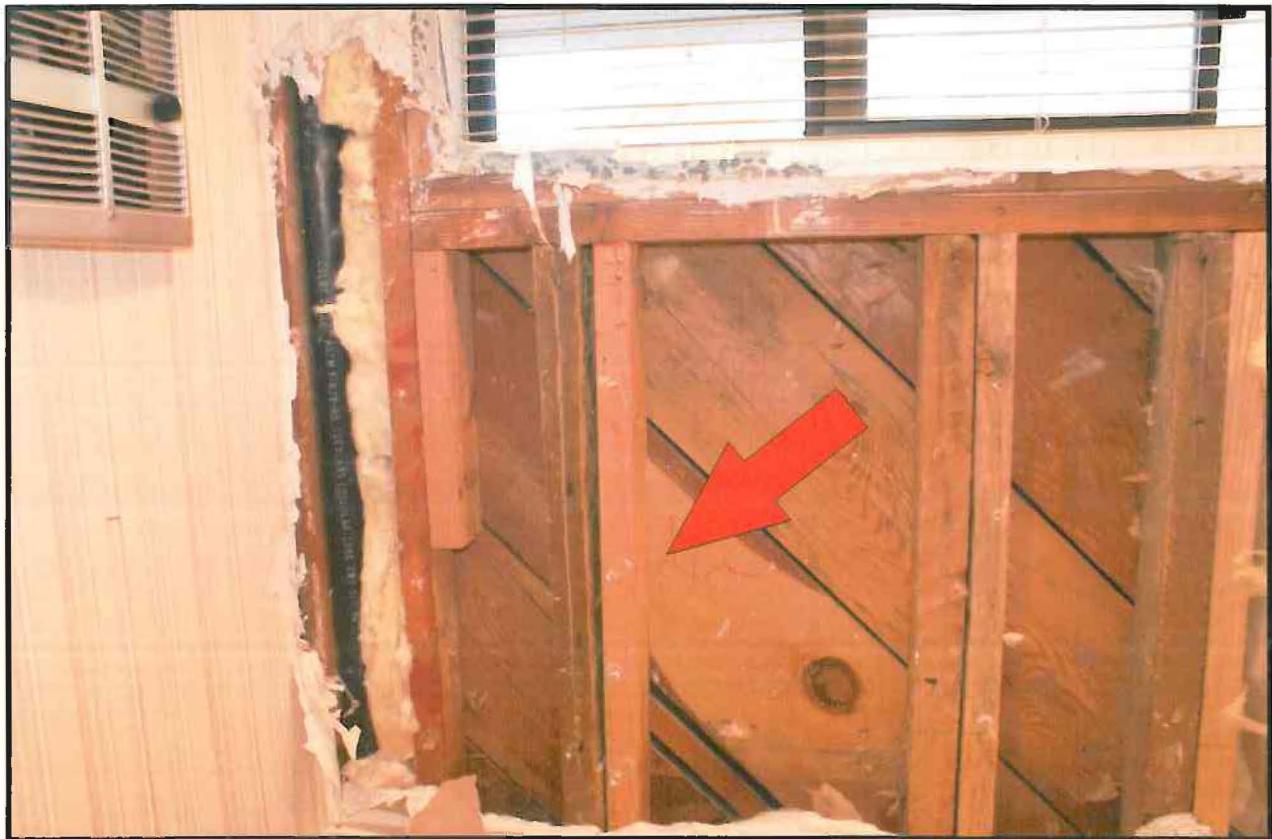
**Photo J** - Photo clearly showing re-framing of side and bottom at replaced window and new skip sheathing

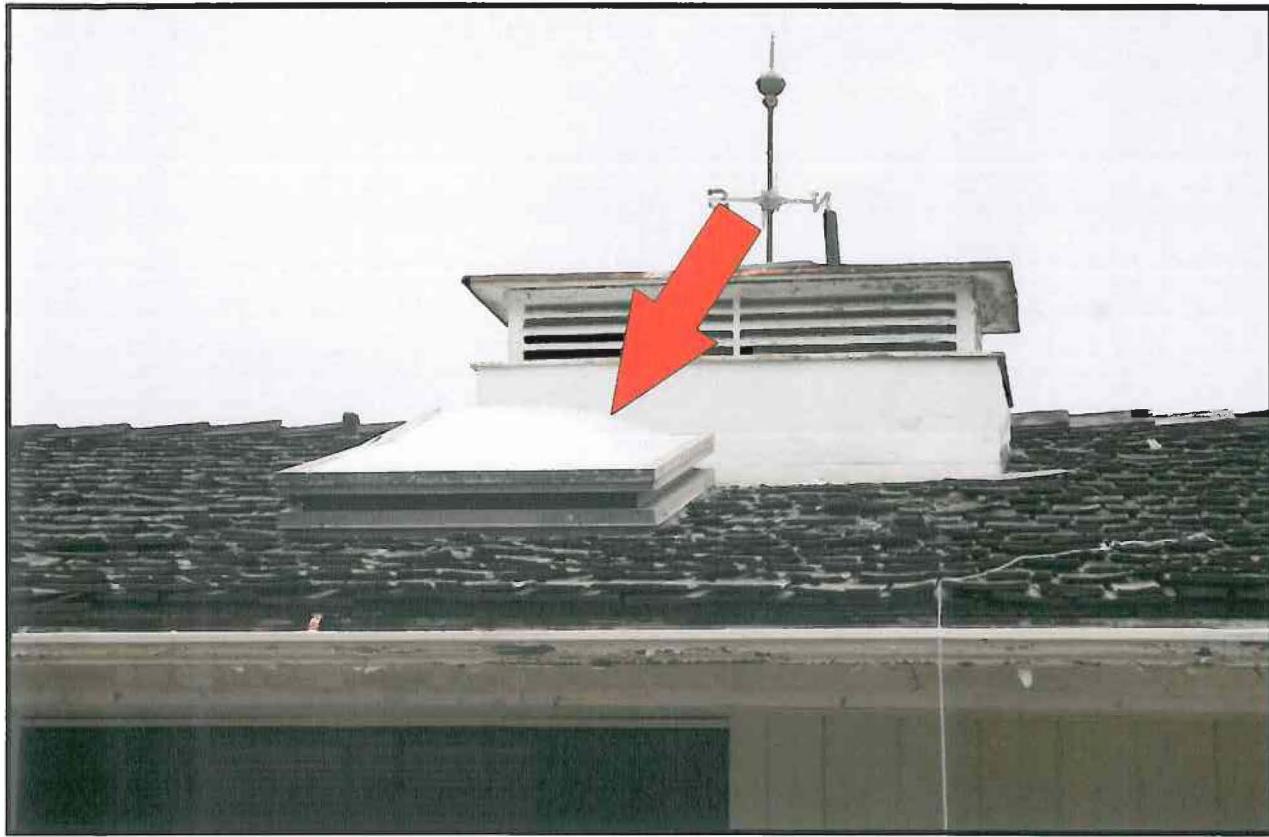
According to Mr. Haines’ signed Declaration, in or about 1978, a skylight was installed over the master bedroom bath “requiring modifications to the roof.” It is not known precisely how the roof itself was modified, but again, a large 48” by 48” white plastic domed skylight was installed

over the Master Bath footprint in plain view on the front facade further eroding the integrity of the façade. (*See presented photo for further background, Item #5, Photo A*).

Photo A - Photo showing 4 foot square plastic dome skylight installed at front facade over bathroom.

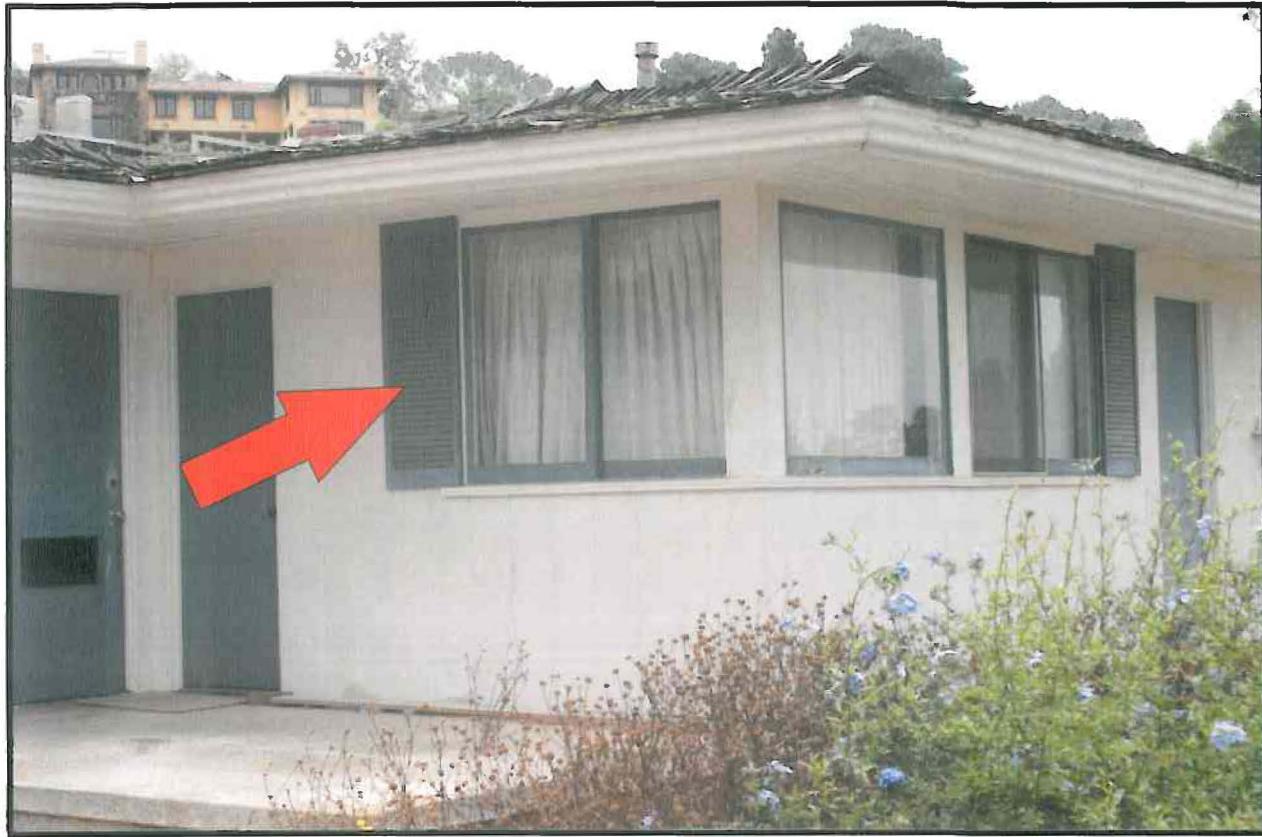
Further, inspection of the two wood shutters on the garage appears to have been added as an afterthought and may not be original to the design. From a design perspective, the “shutters” themselves are only located on one side of the windows and even the width of the shutter represents only approximately 30% of width of the window itself. In any event, the presence of a mere two wood shutters, completely out of scale and proportion, cannot be regarded as any meaningful character defining feature of the Custom Ranch style, as cited in the HRB Staff Report. (*See presented photo for further background, Item #6, Photo A*).

Photo A - Photo showing the only 2 shutters on the home which are not true shutters but tacky ornament.

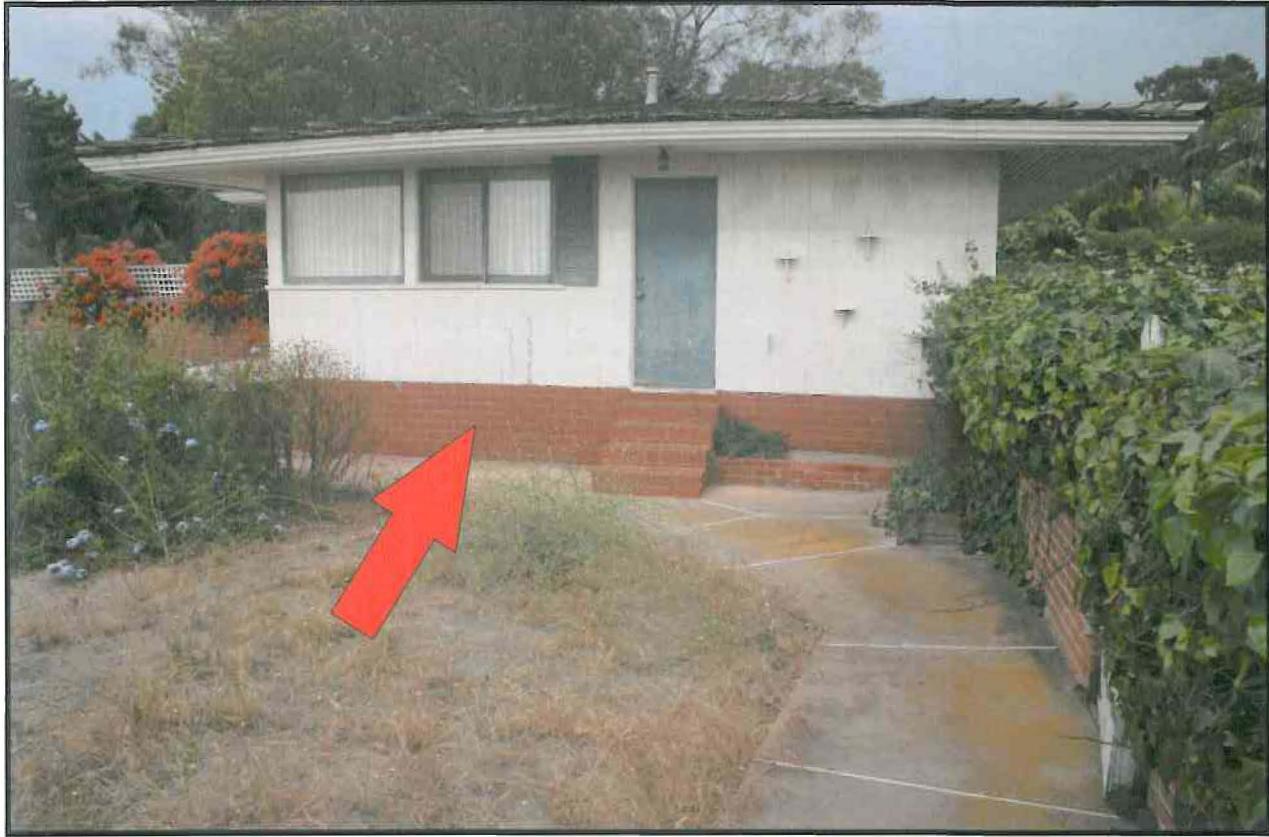
Recent extensive forensic examination and analysis has revealed the garage wall cladding is not brick at all. The brick on the entire garage facing the courtyard living spaces is, in fact, brick tile veneer. This was apparently added at some point in time and is not original based on the look, installation method and style of the  $\frac{1}{4}$ ” thick tiles. (*See presented photos for further background, Item #7, Photos A-B*).

Photo A - Photo showing applied non-original “brick” veneer to garage

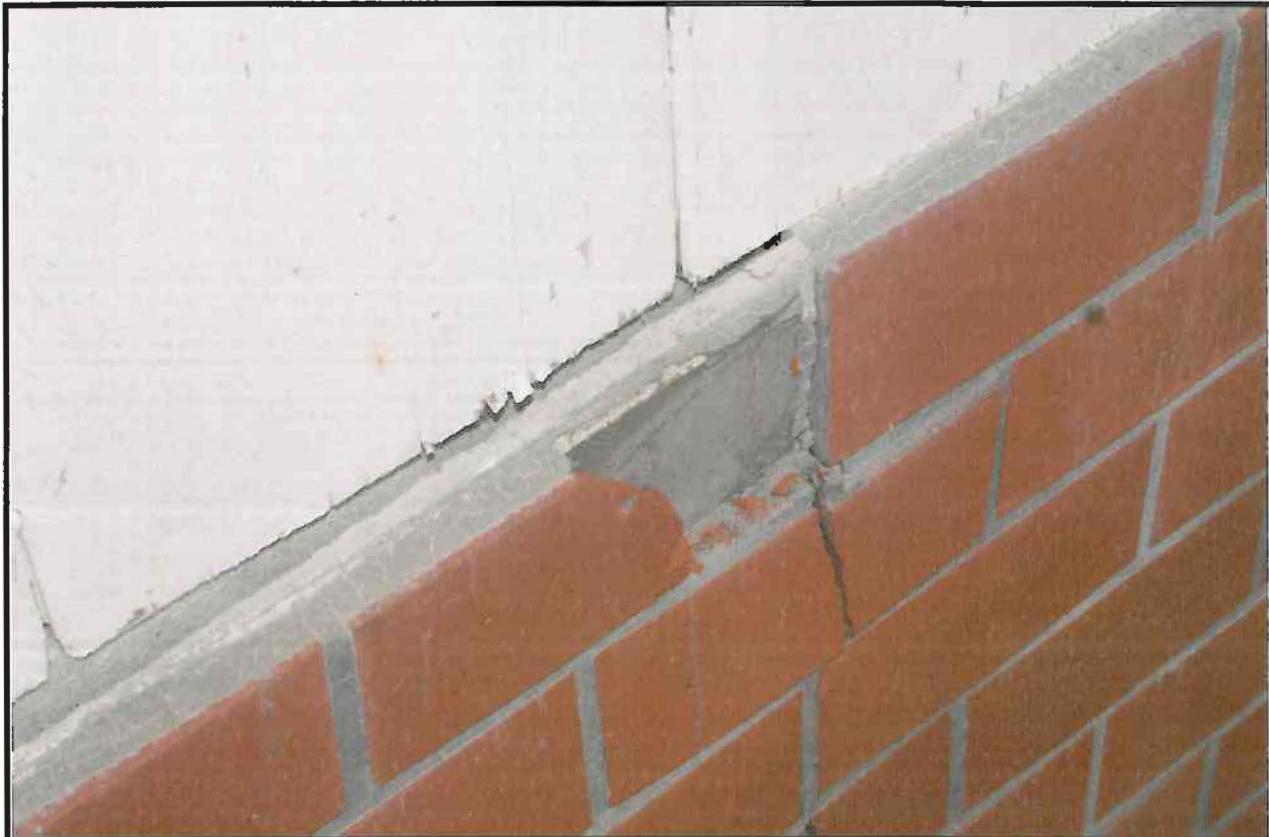
Photo B - Photo showing applied non-original “brick” veneer to garage.

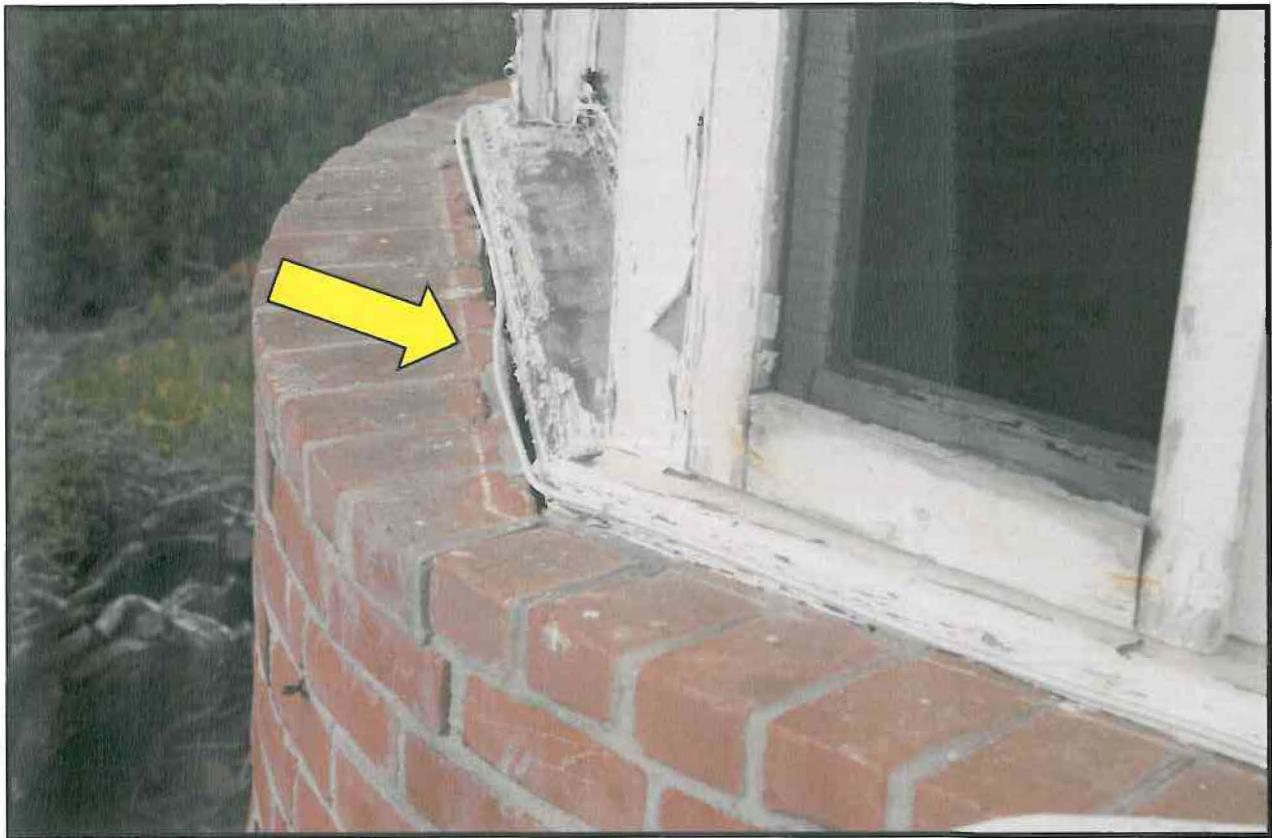
Recent extensive forensic examination and analysis has revealed Haines' statements to be true. From examination, the brick along two entire sections of the west façade have been totally replaced and are not original. Additionally, the replaced brick from the 1980s has now also extensively failed and has either cracked or significantly shifted and moved to a point where it is not structurally sound. (*See presented photos for further background, Item #8, Photos A-B*).

Photo A - Photo showing replaced brick at Kitchen area at rear facade.

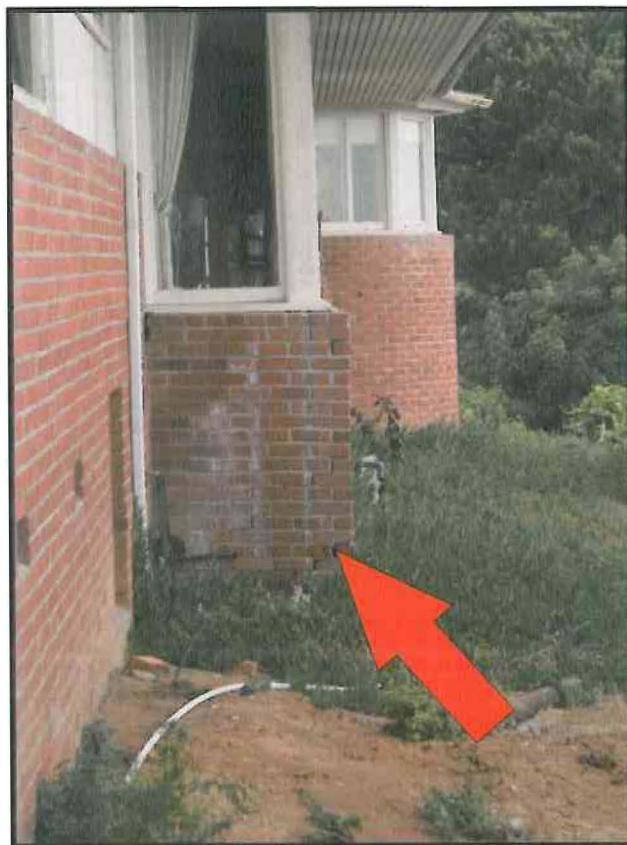
Photo B - Photo showing replaced brick at rear facade.

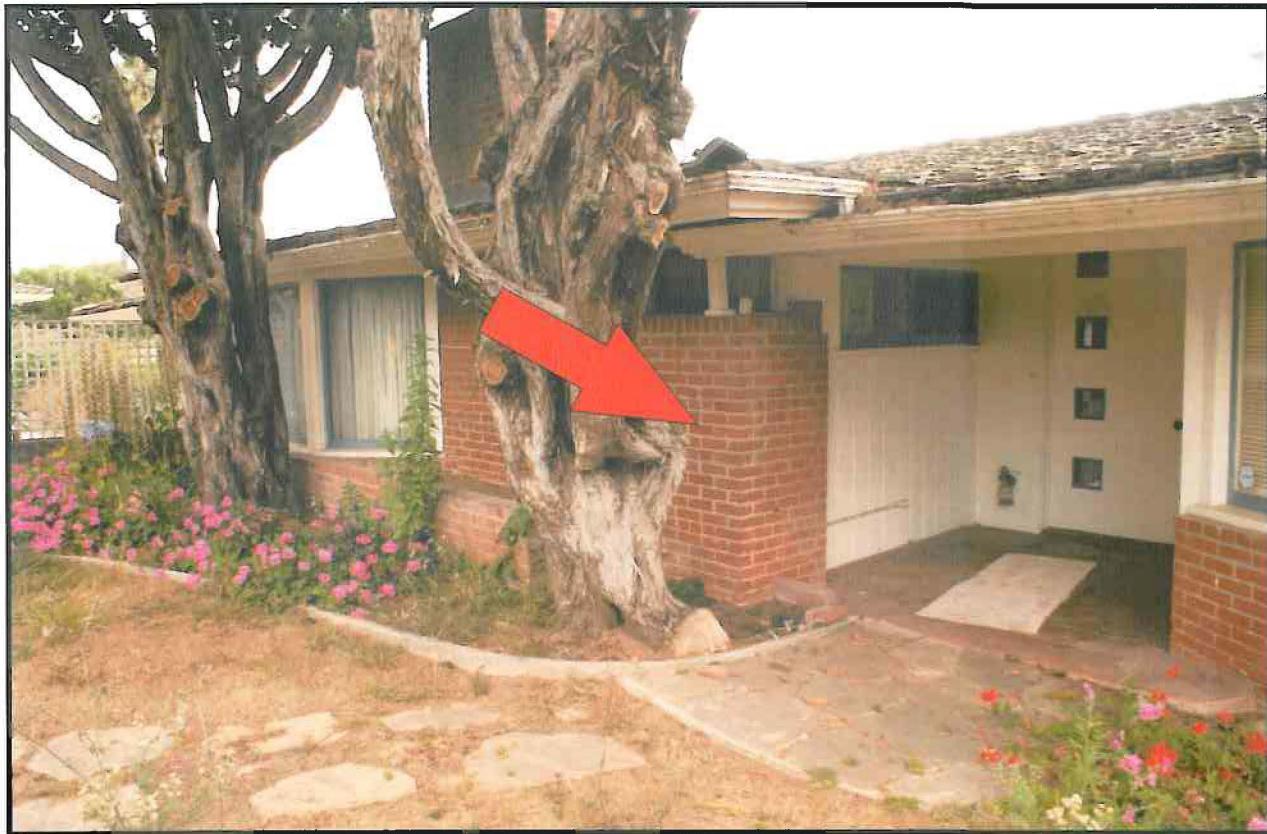
Additionally, and more importantly, in-depth inspection and forensic investigation further indicates that the brick exterior located along the main, front façade of the residence (east elevation), at the bay window and entry fireplace, are also not original. The brick is placed in a fashion with the vertical wood siding behind the brick cladding, indicating it was added after the fact. At a minimum, it reflects an incredibly poor method of construction and a method of attachment void of any craftsmanship. The addition of non-historic brick at these areas of the Property clearly does not represent a character defining feature as cited by the HRB Staff Report as “[e]xtensive use of...brick throughout the house.” (*See presented photos for further background, Item #9, Photos A-D*).

Photo A - Photo showing brick area adjacent to fireplace

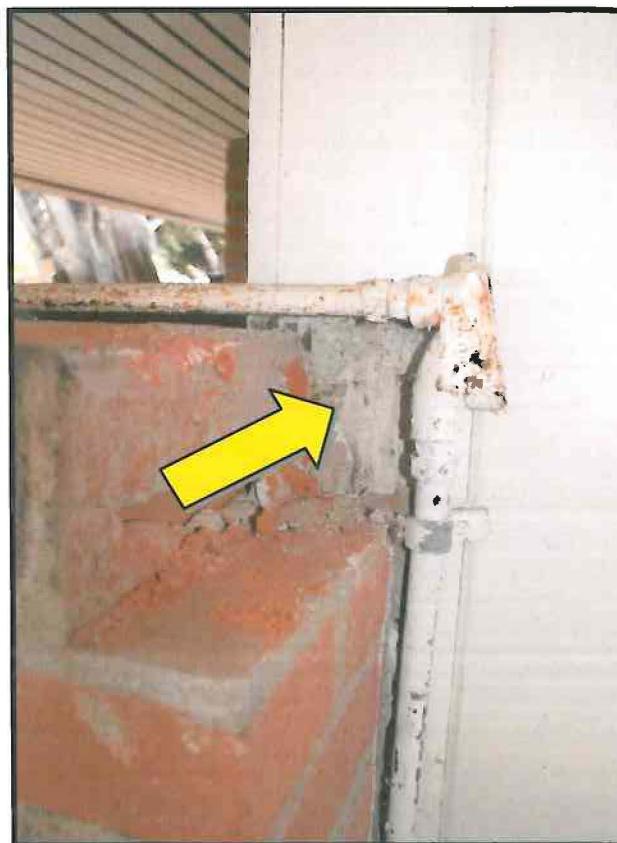
Photo B - Photo of brick at entry area showing wood siding behind the brick .

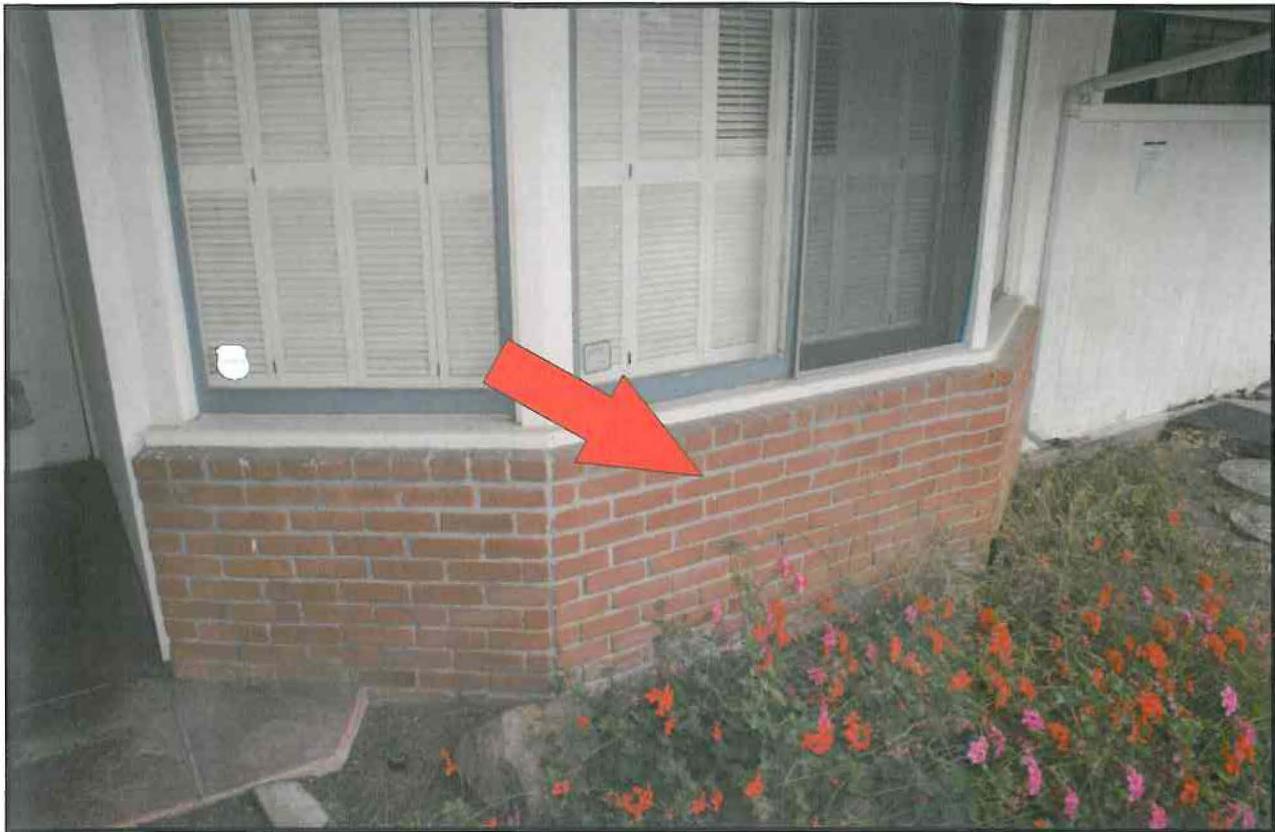
Photo C - Brick cladding at bay window on front facade

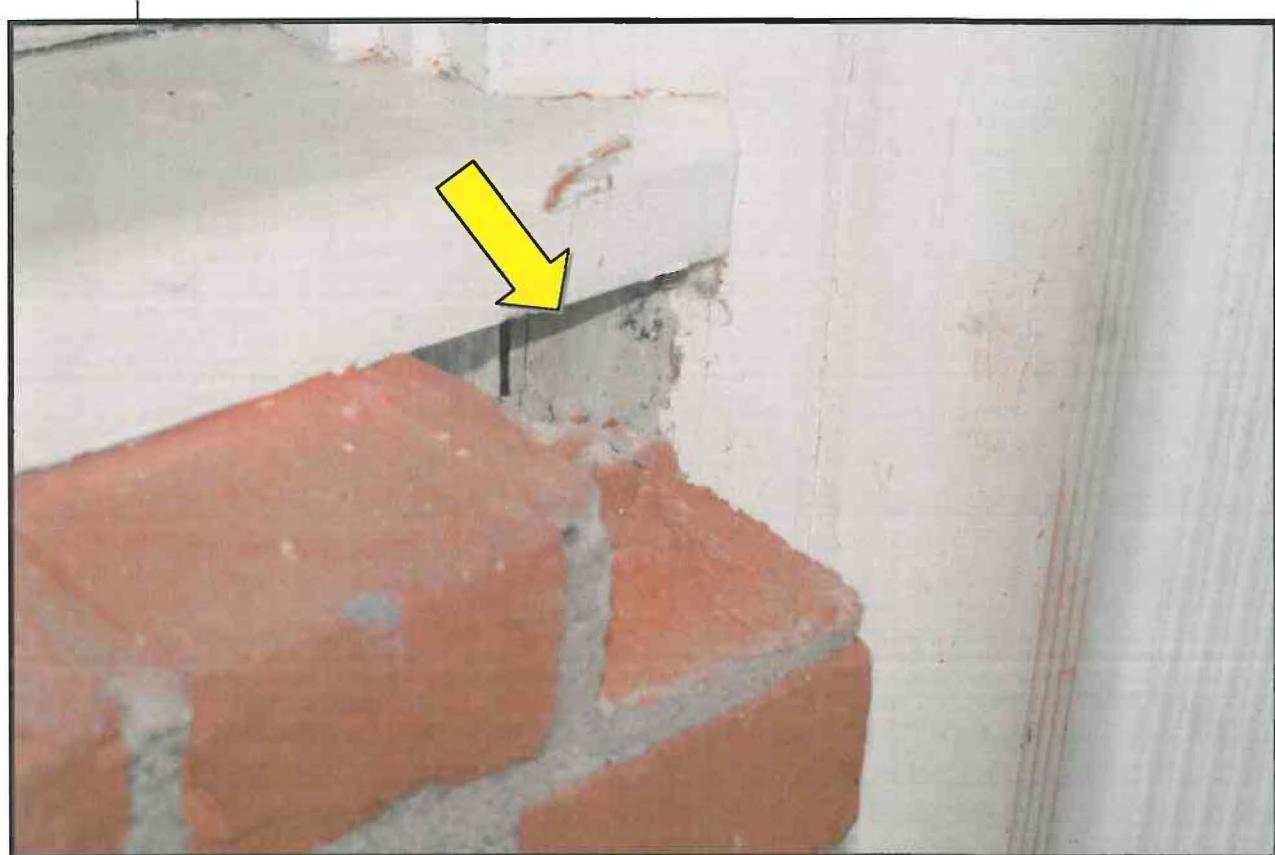
Photo D - Photo showing wood siding installed behind brick cladding

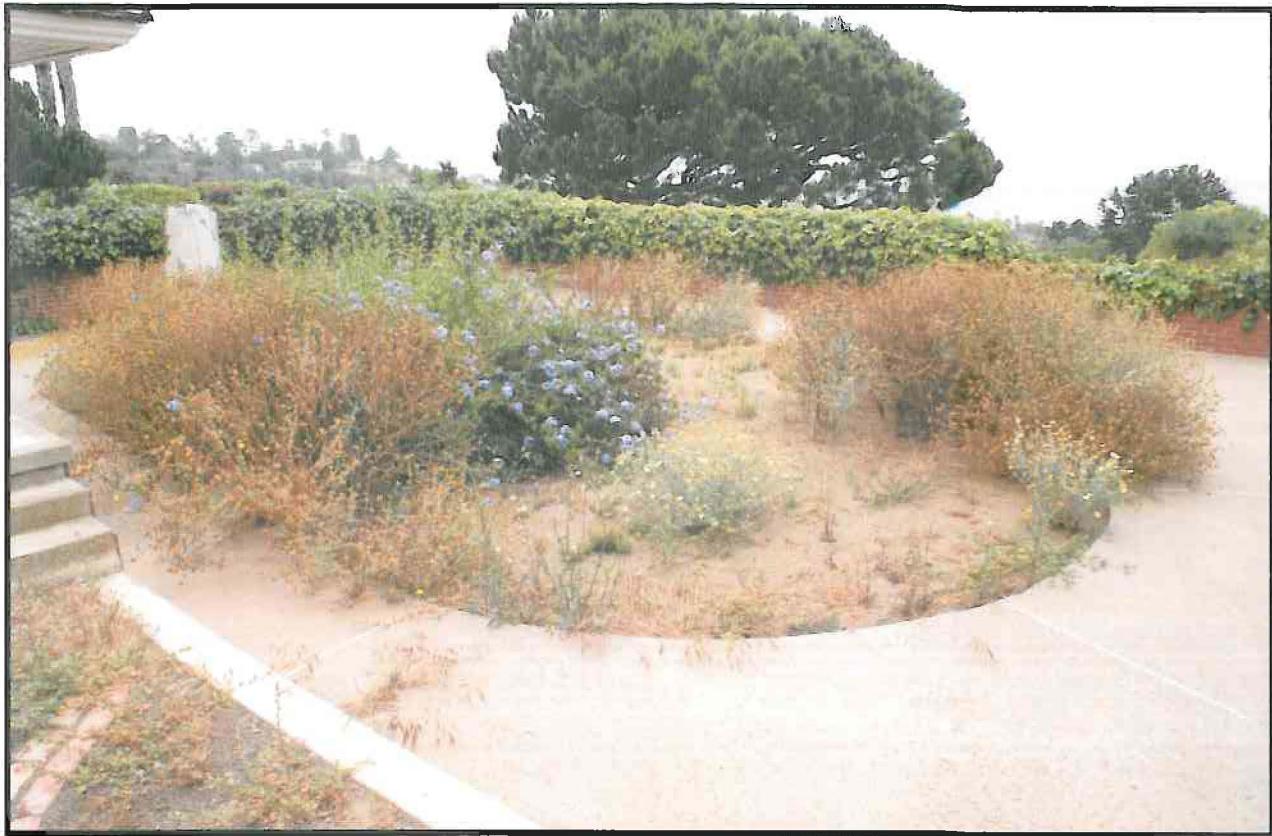
According to Mr. Haines' signed Declaration, in or about 1975, “a swimming pool was installed in the backyard. The entire patio was replaced.” The area referenced by this statement is located along the south side of the residence. Further, according Mr. Haines, “[i]n the early 2000's, the pool was dismantled [i.e. in-filled]. Given that this was the main outdoor living area for the home, this entire area has undergone significant and complete renovations at least twice in its existence. (*See presented photo for further background, Item #10, Photo A*).

Photo A - Photo showing location of pool that was added and later removed on main entertaining space.

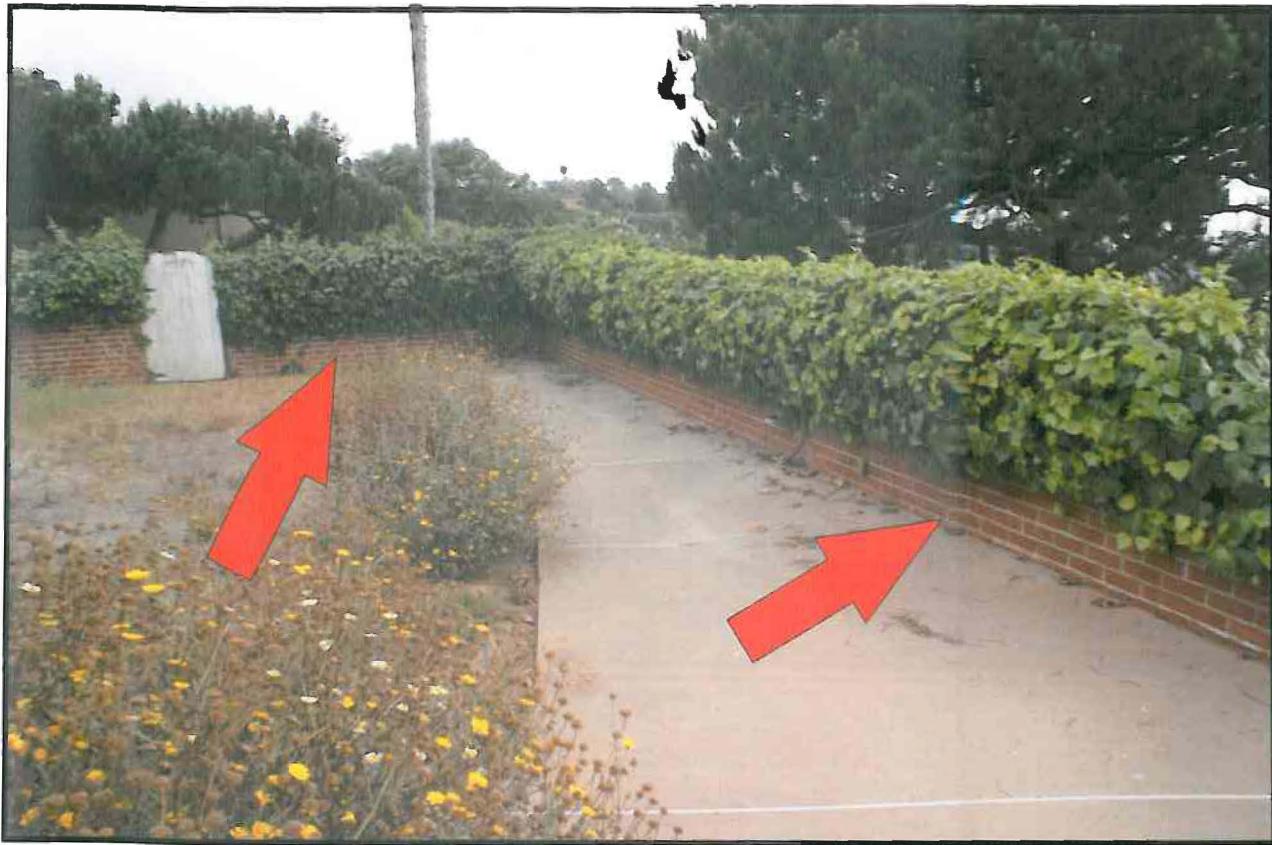
Mr. Haines' signed Declaration also has indicated that around 1978 “a reinforced retaining wall was installed on the west side of the pool.” Recent extensive forensic examination and analysis has substantiated this claim and found that the entire westerly patio wall adjacent to the main outdoor living area is not original and was added in 1978 with new brick cladding that does not match the original brick of the home.

Photo A - Photo of new site walls and retaining walls added .

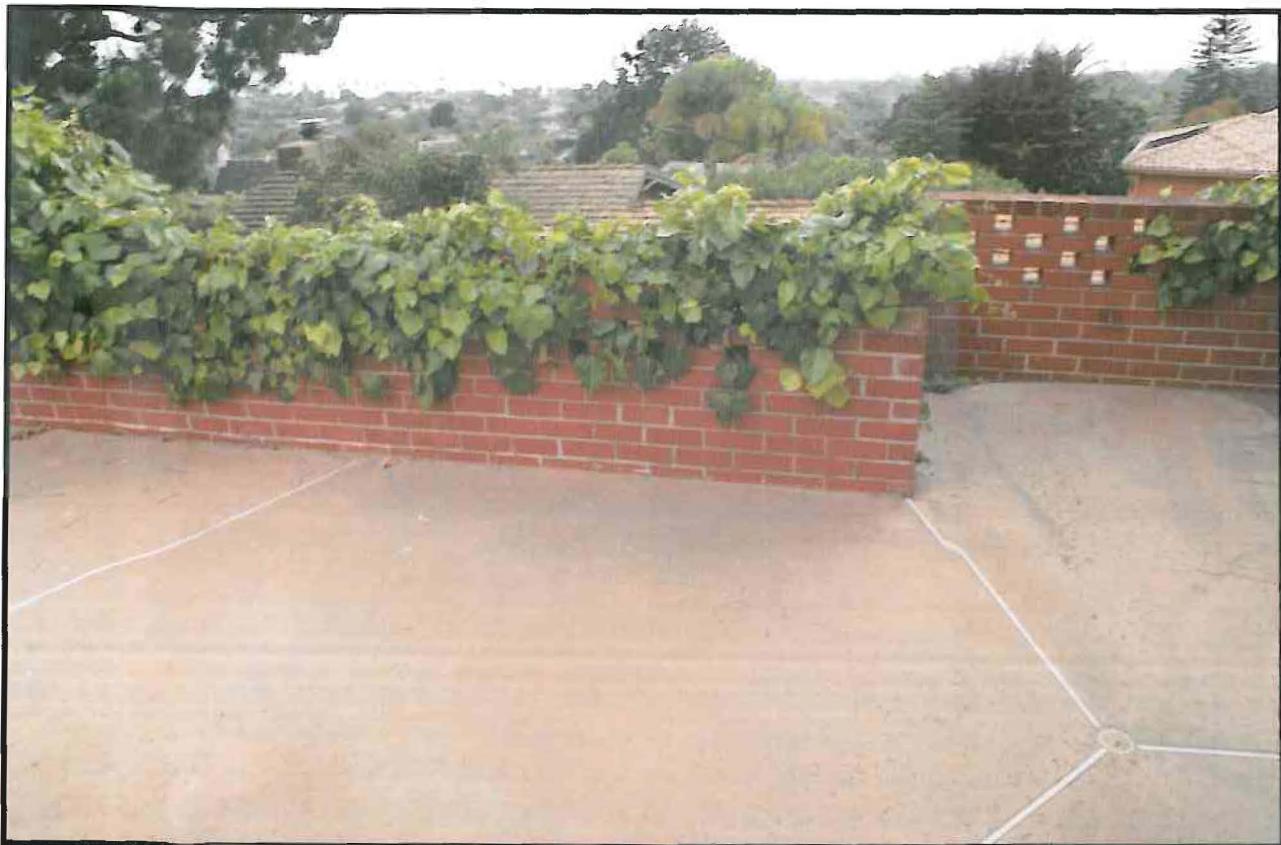
Photo B - Photo of added site retaining walls in new brick

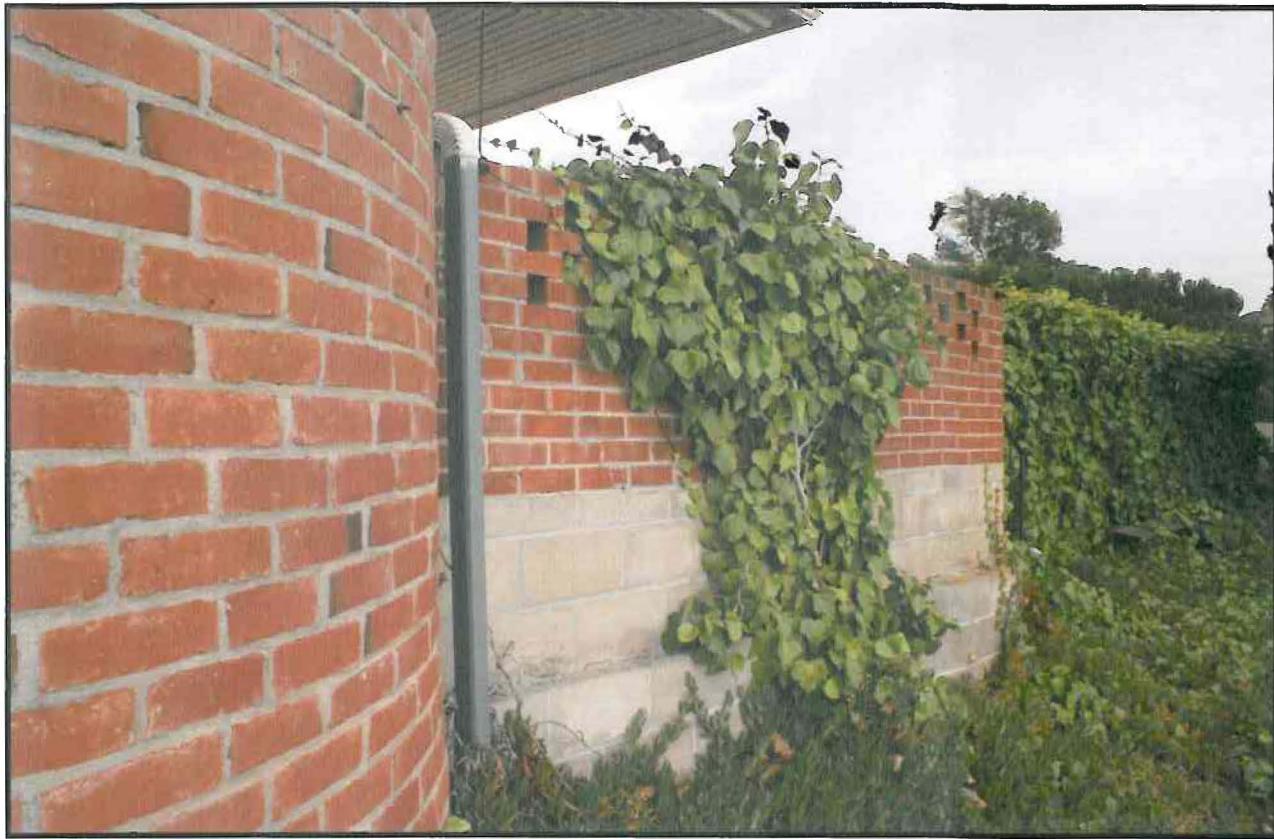
Photo C - Photo showing new block site retaining walls and mis-matched brick

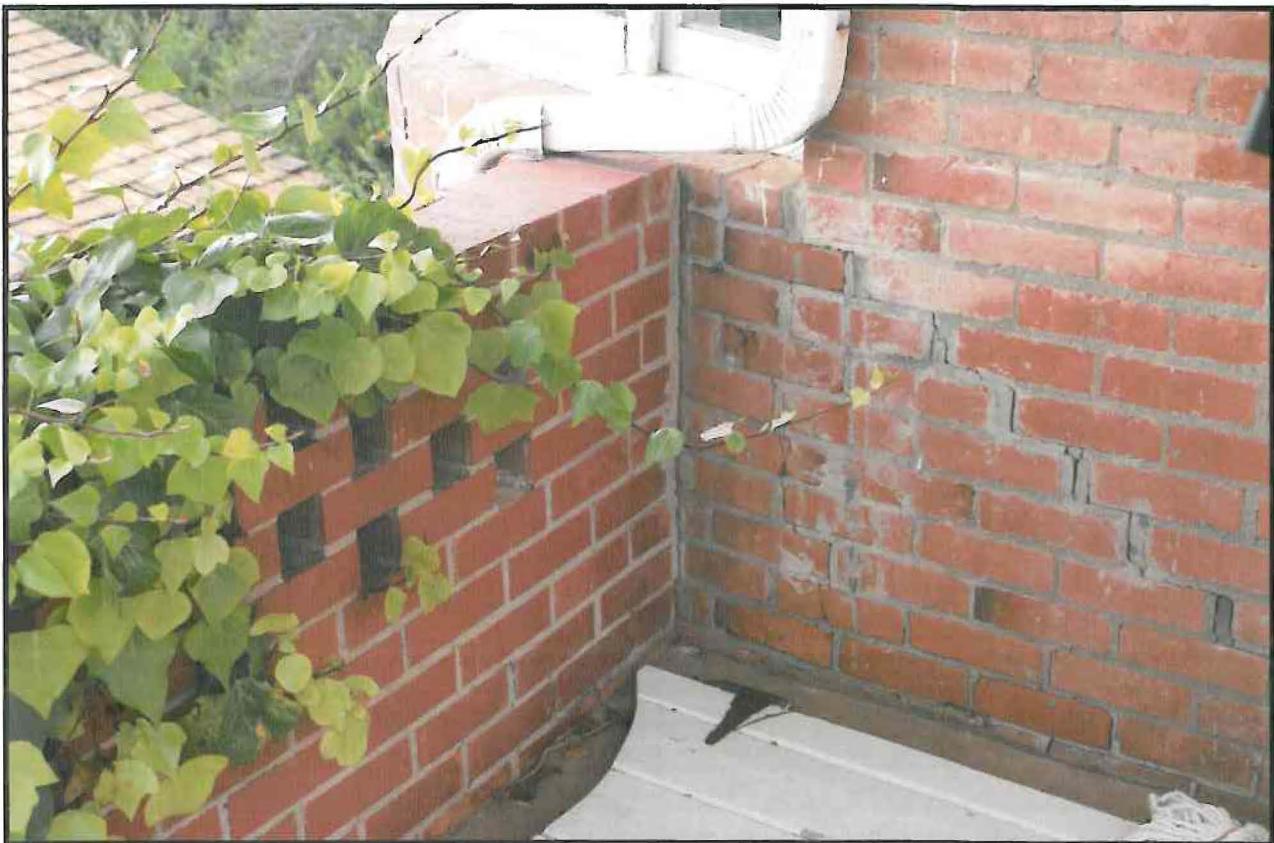
Photo D - Photo showing mis-matched brick at new site retaining walls to house.
