August 9, 2010

*Re: 6004 Muirlands Drive, La Jolla, Substantial Modifications & Changes--Lack Of Original Integrity*

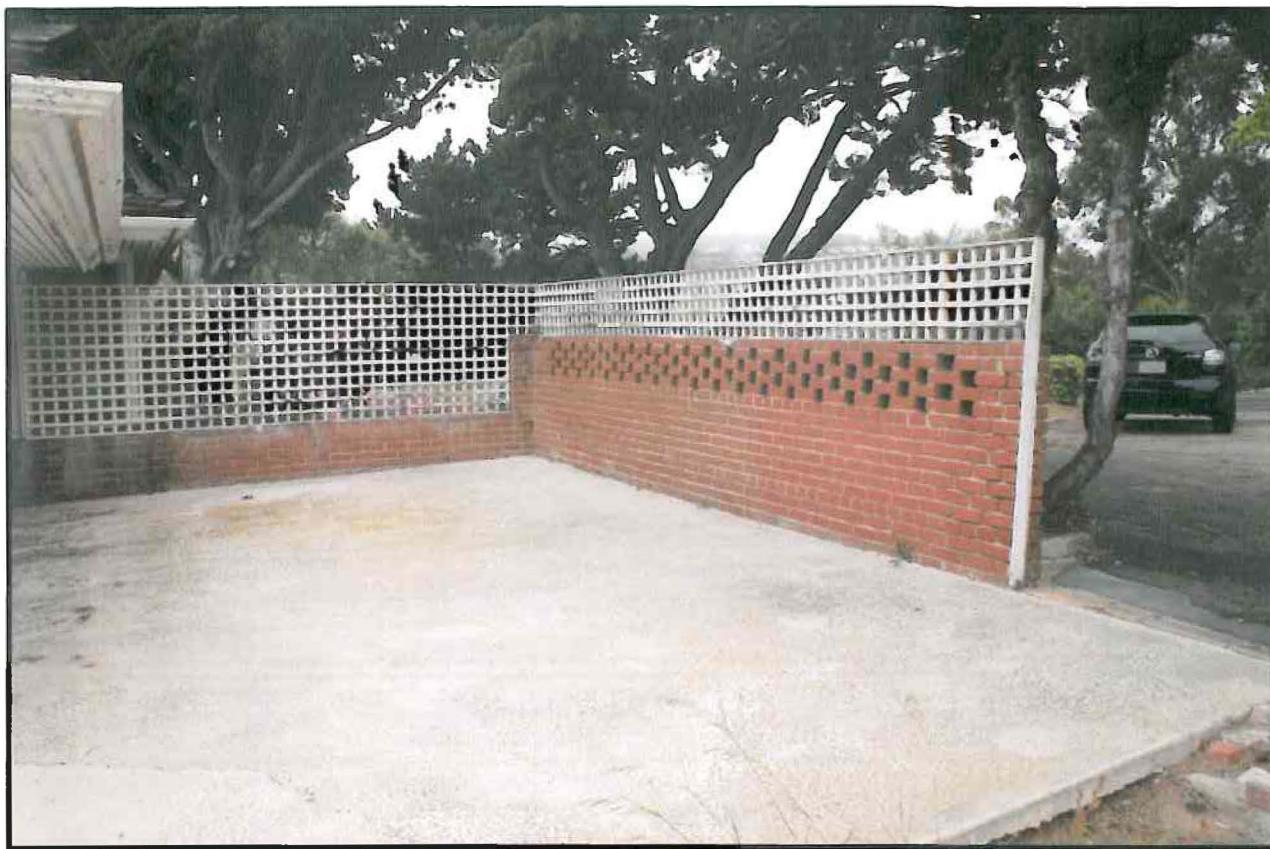
Recent extensive forensic examination and analysis has confirmed this and in fact, the front façade brick walls which are visible to the street, as well as the fence to the main outdoor entertaining area, have been rebuilt several times. No less 6 (six) types of brick are visible in this area.

Photo A - Photo showing added and remodeled brick site wall visible to front elevation

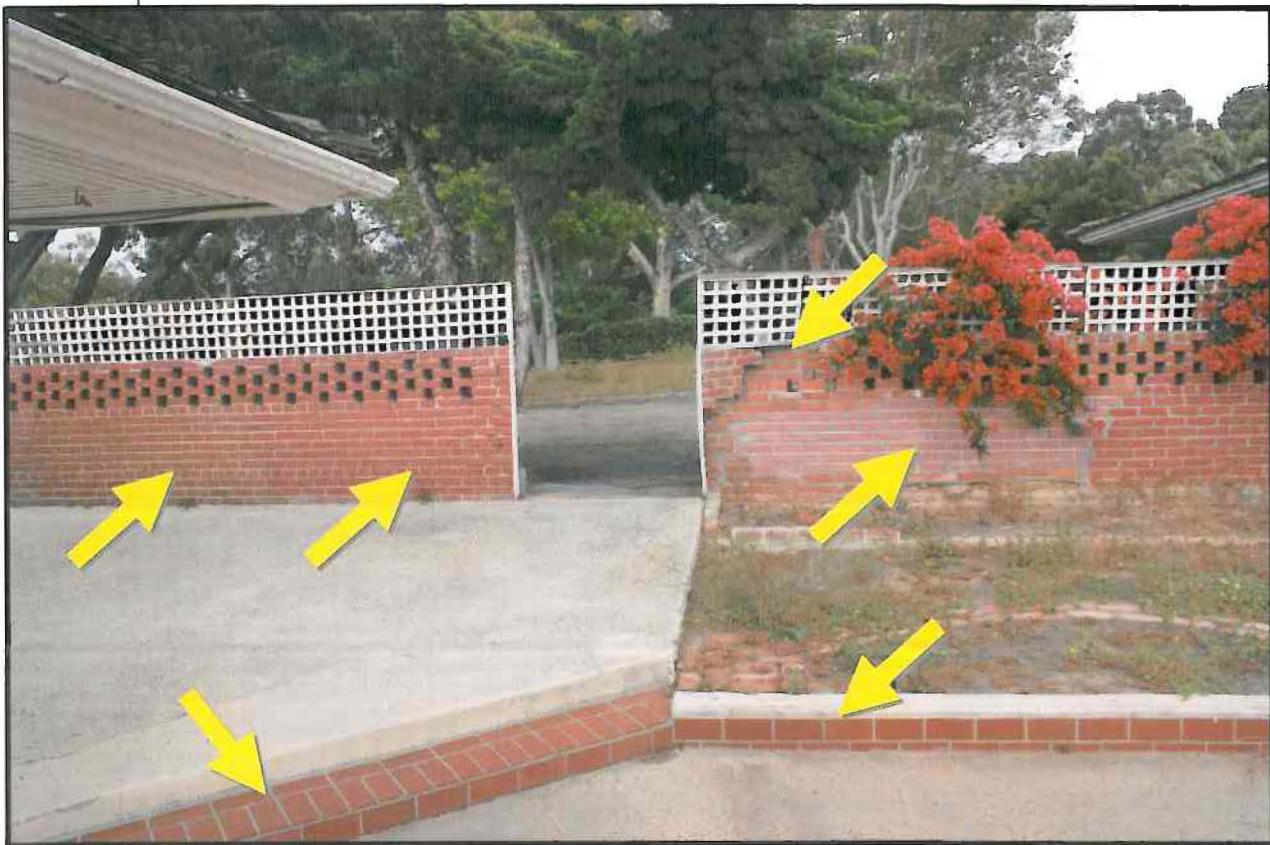
Photo B - Photo from main entertaining space showing no less than 6 brick styles.

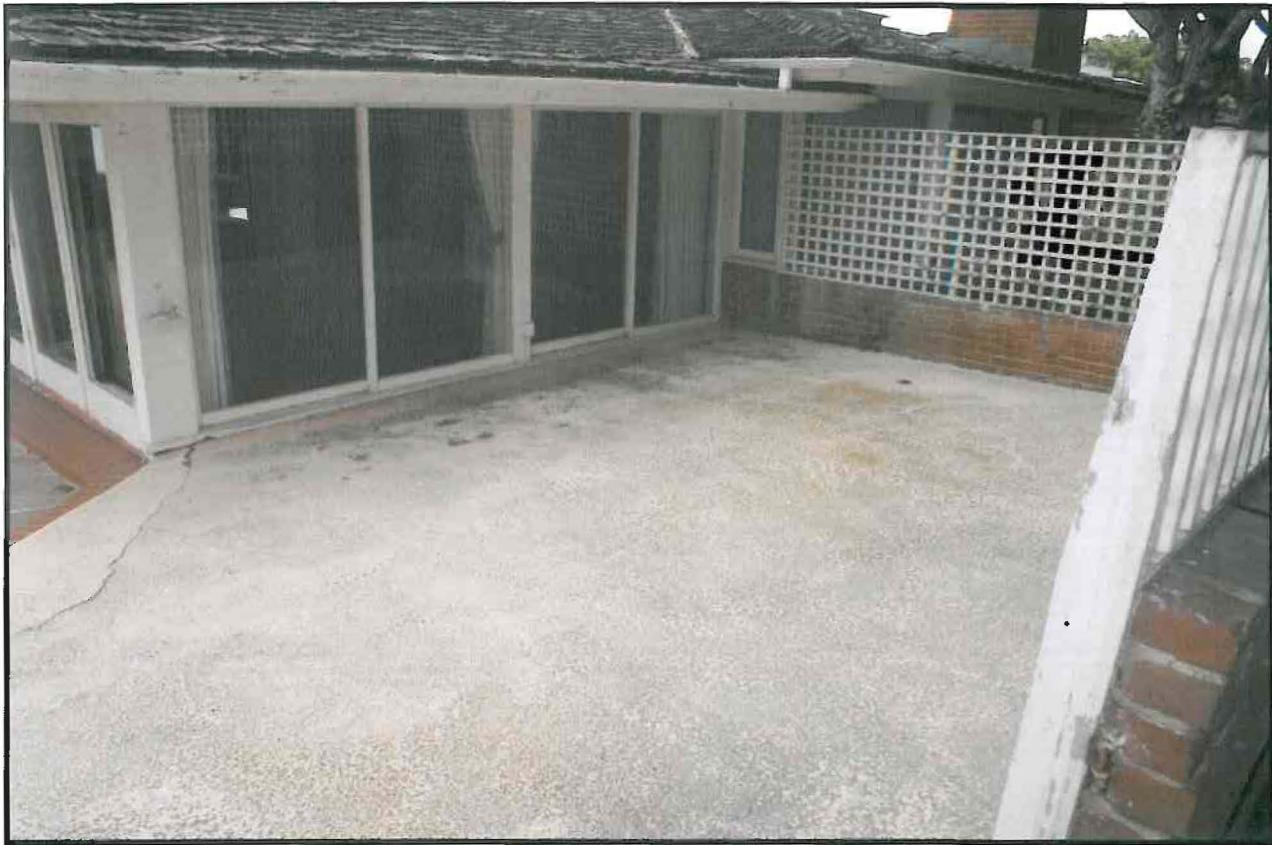
Forensic investigations have revealed that the patio to the east of the enclosed open patio is also new. The slab appears to have been poured after the patio was enclosed and was done to correct a serious site drainage issue. The slab is finished with a pool deck coating (cool-deck) and is poured literally right to the top of the stem wall of the patio enclosure wood framing, and slopes to the south to direct all the water around the house. The slab was literally poured against the wood framing and sill of the new patio enclosure walls, and reflects a further erosion of any original integrity for both the outdoor living areas and front elevation. (*See presented photos for further background, Item #13, Photos A-D.*)

Photo A - Photo showing new concrete patio and finish installed to keep water from flooding home.

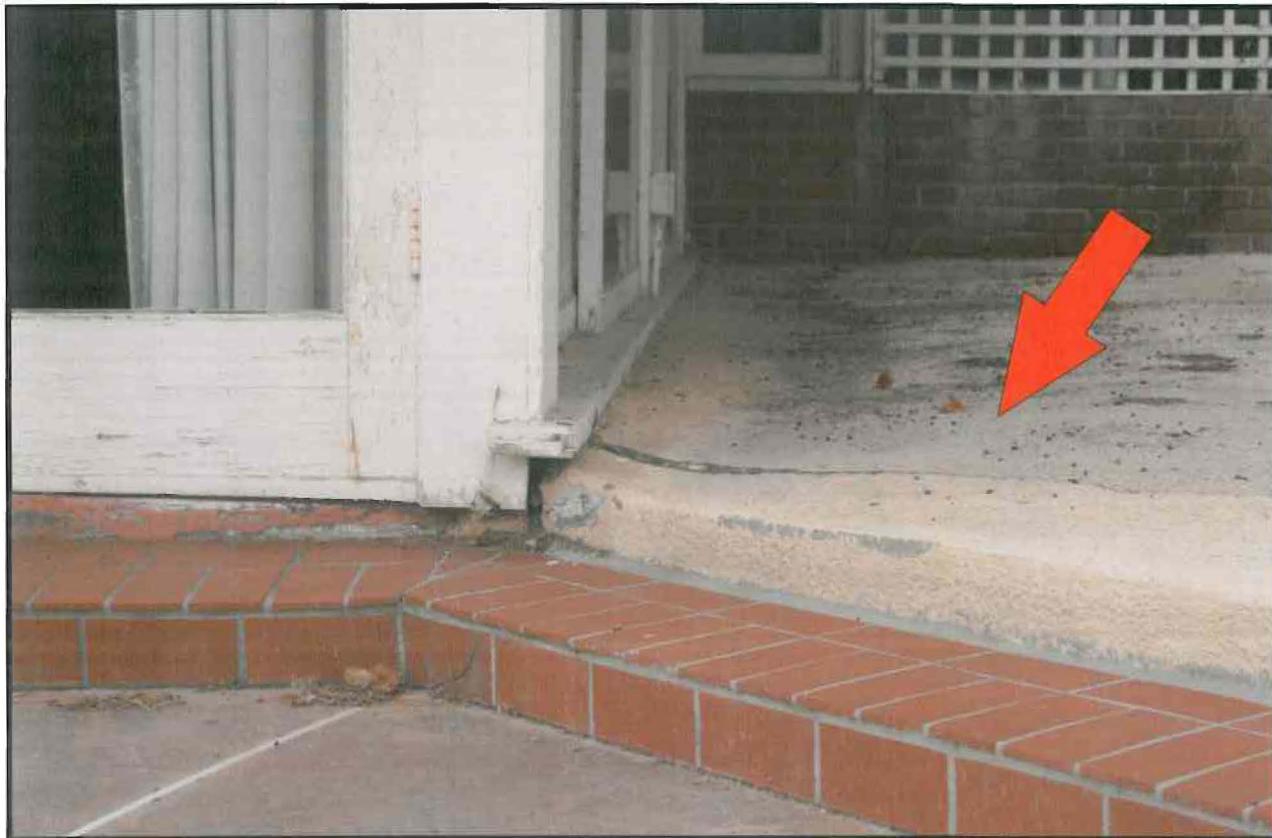
Photo B - Photo showing new concrete patio and finish installed to keep water from flooding home.

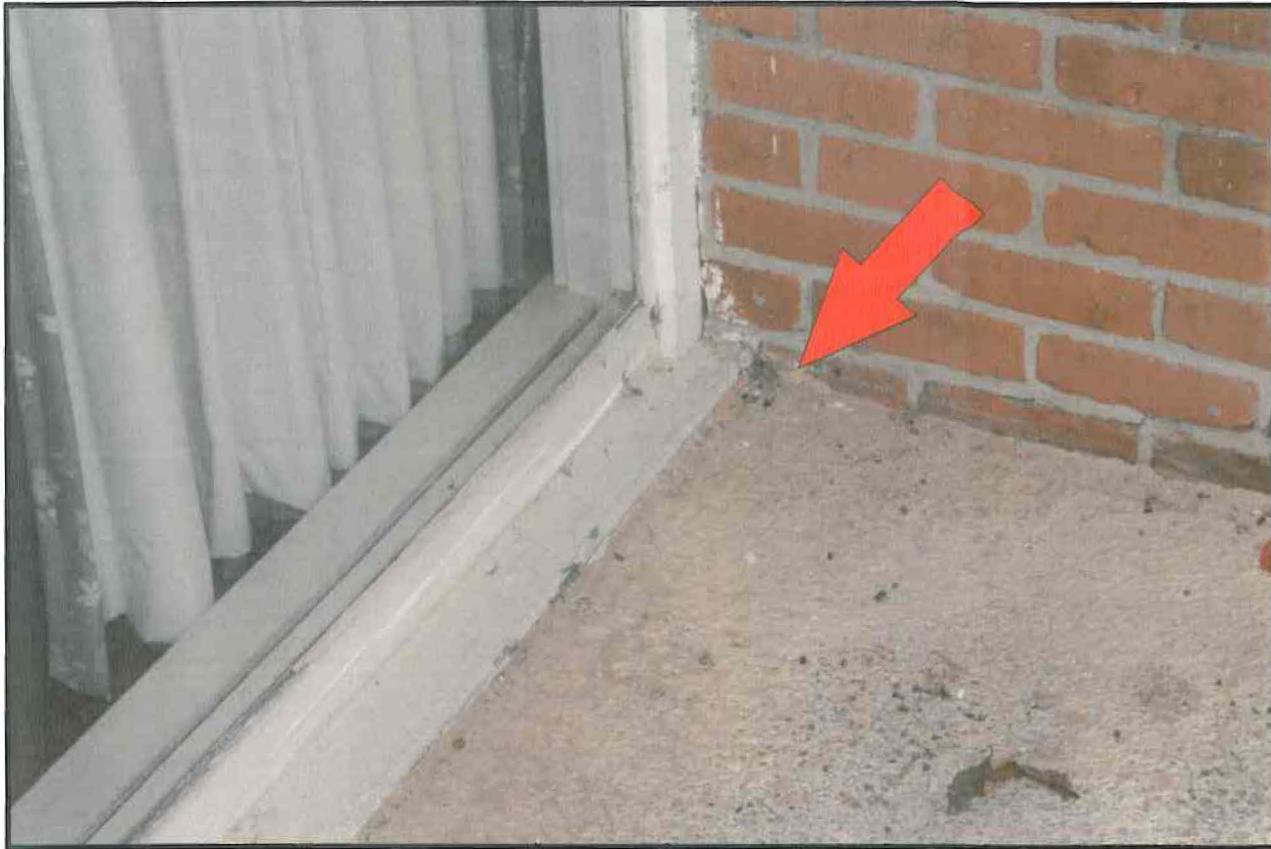
Photo C - Photo showing new concrete patio poured to top of added wood window sill.

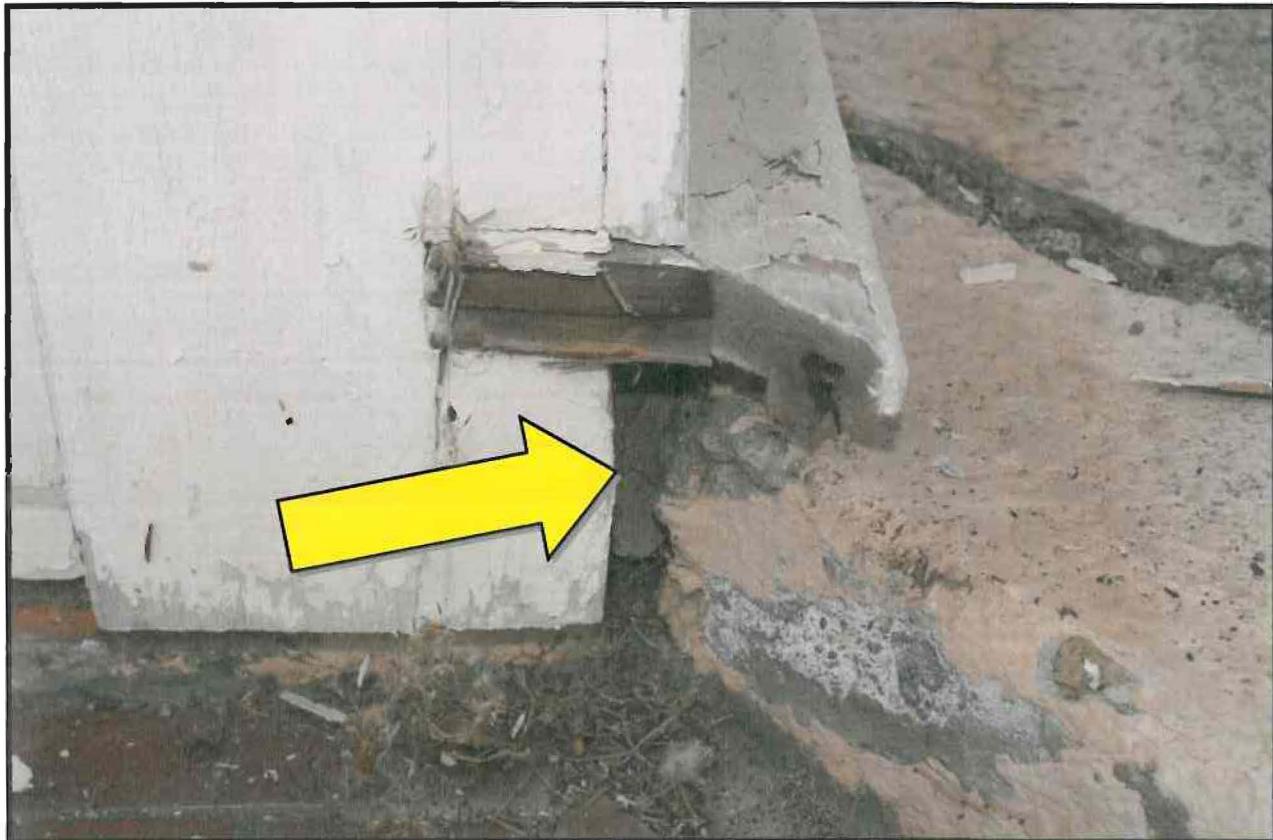
Photo D - Photo showing new concrete patio slab poured and encasing wood sill for added window
