August 9, 2010

*Re: 6004 Muirlands Drive, La Jolla, Substantial Modifications & Changes--Lack Of Original Integrity*

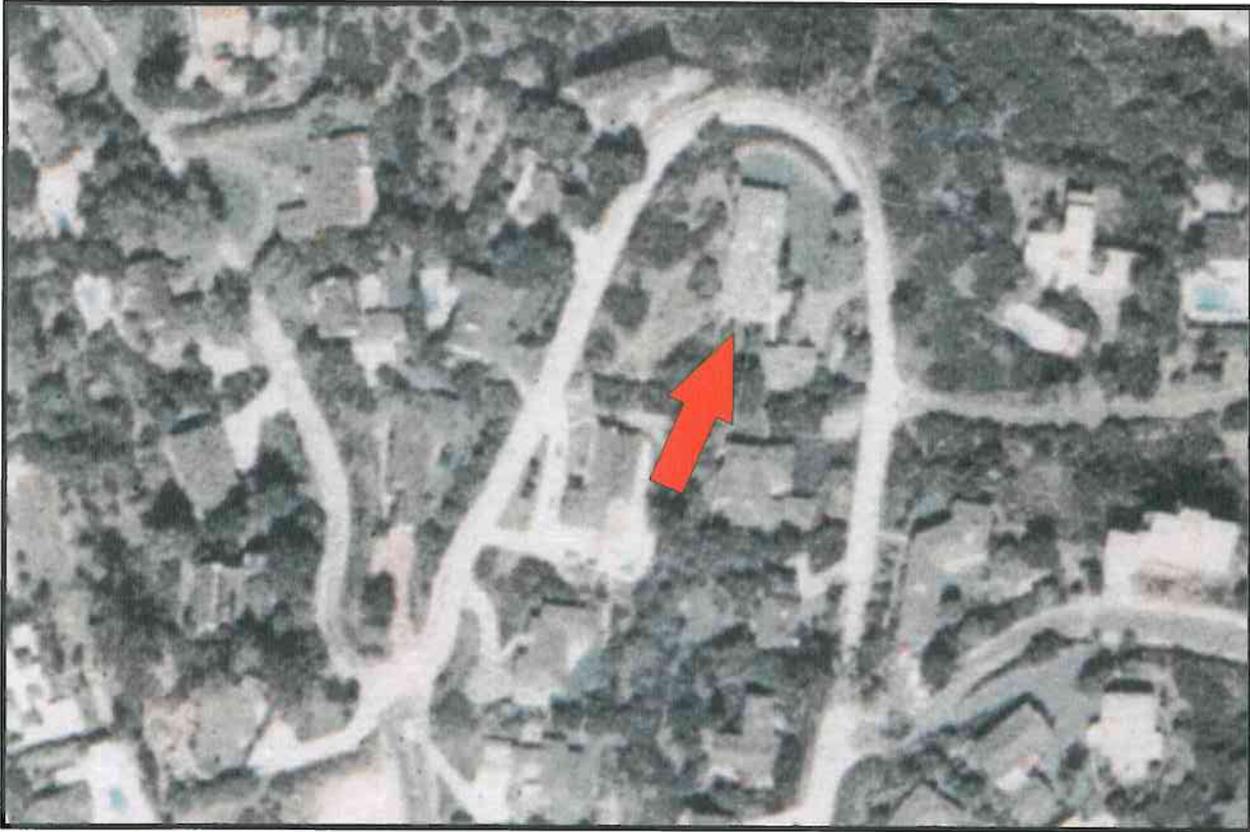
The effect of the lot split was to produce a virtually non-existent, non-usable rear (backyard) area for the Property. The wide rear yard expanse (“a deep setback” identified in the HRB Staff Report, Number HRB-10-031, July 16, 2010), an important element to the Modern Ranch ideal of social entertainment, which originally characterized the Property, has therefore been completely removed and the entire character of the lot has been altered. The westerly home constructed on the newly created lot is literally less than 10 feet from the rear of the residence and any sense of an estate lot or setting forever ruined. (*See presented photos for further background, Item #1, Photos A-D*).

Photo A - 1970 aerial photo showing 6604 Muirlands home centered in a large estate lot pre-lot split.

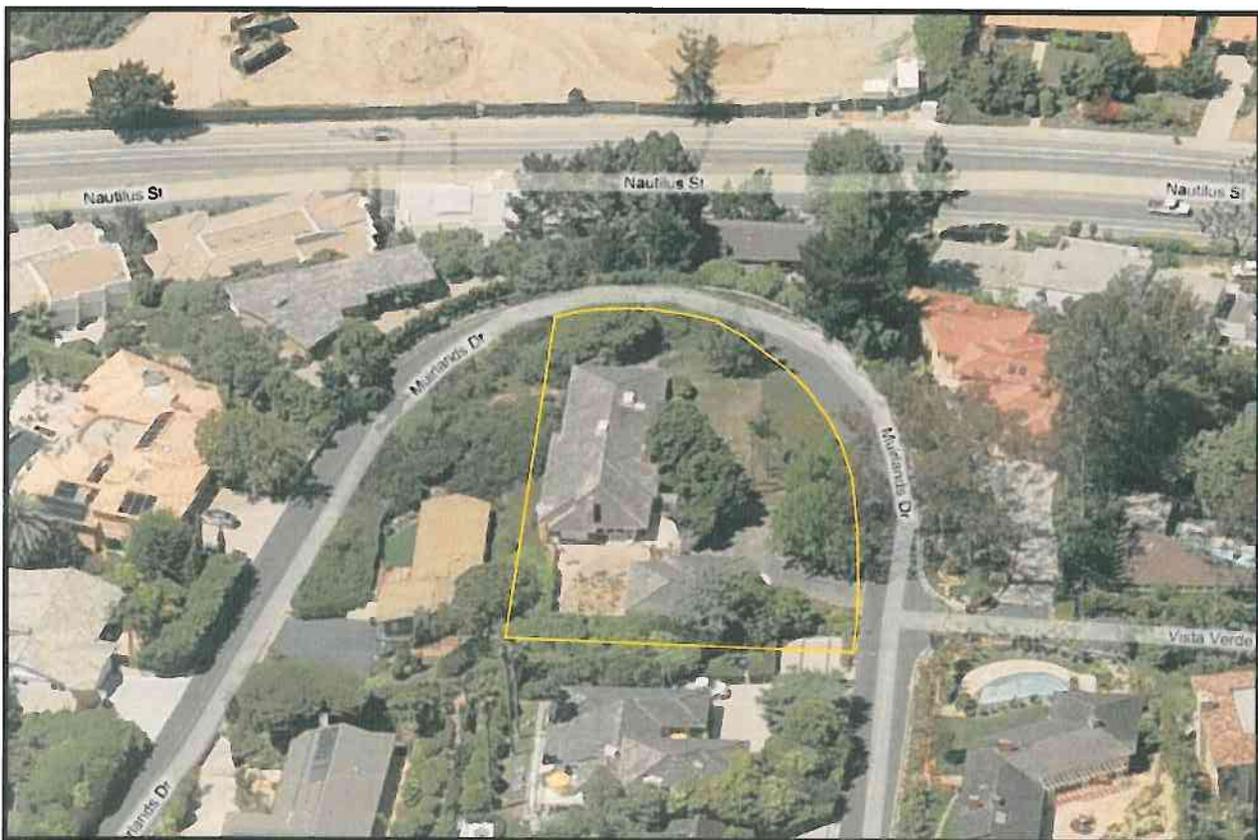
Photo B - Current aerial photo showing the lot post-lot split and the new home to the west 10' from the home.

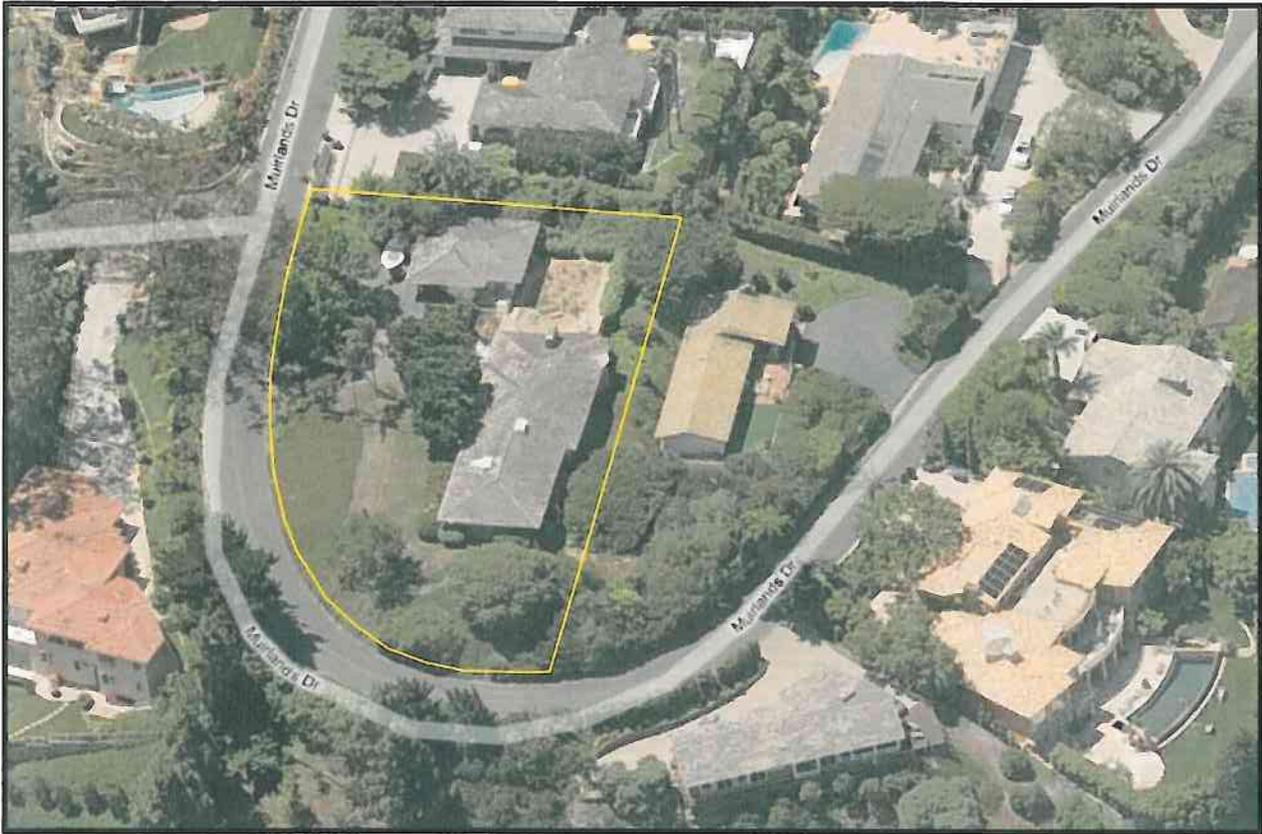
Photo C - Current aerial photo showing the westerly home and it's proximity to 6604 Muirlands Residence.

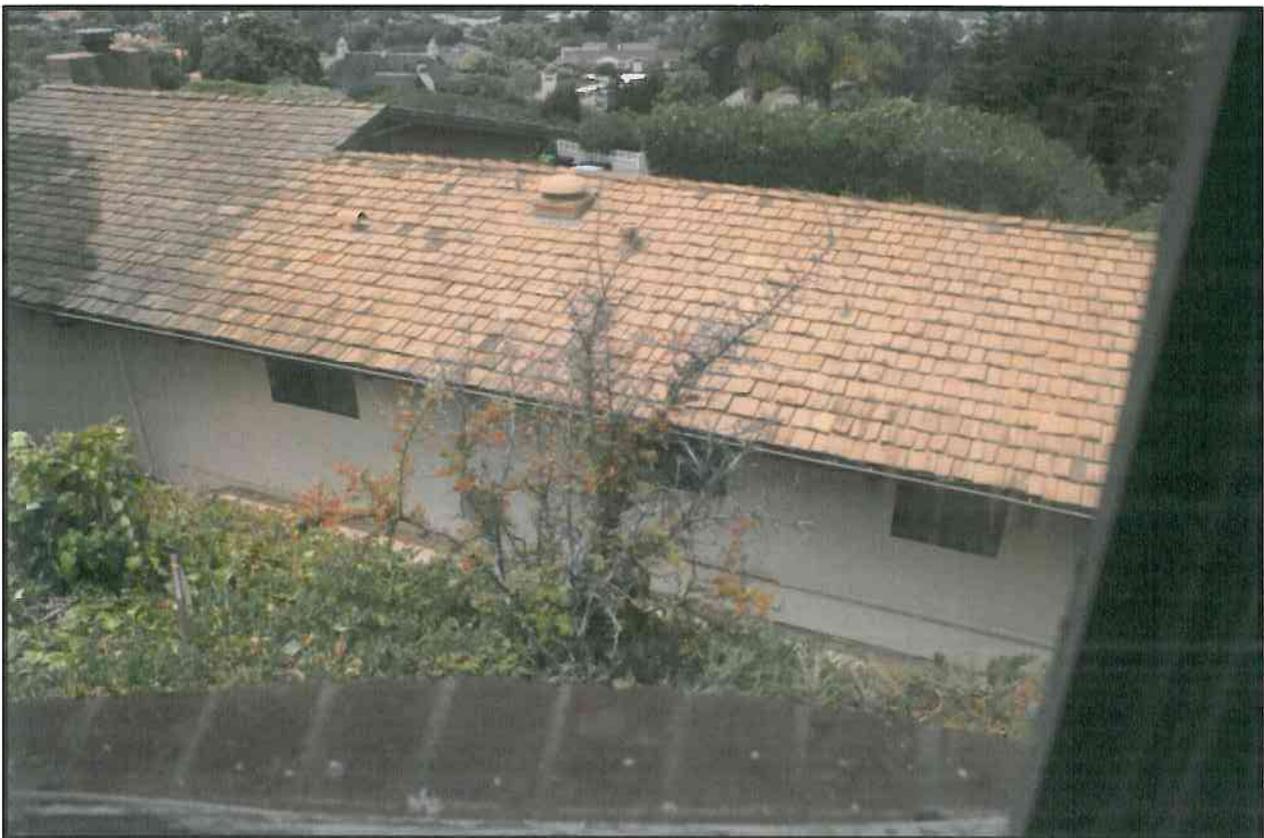
Photo D - Photo from 6604 Residence Kitchen showing proximity of post-lot split adjoining home.

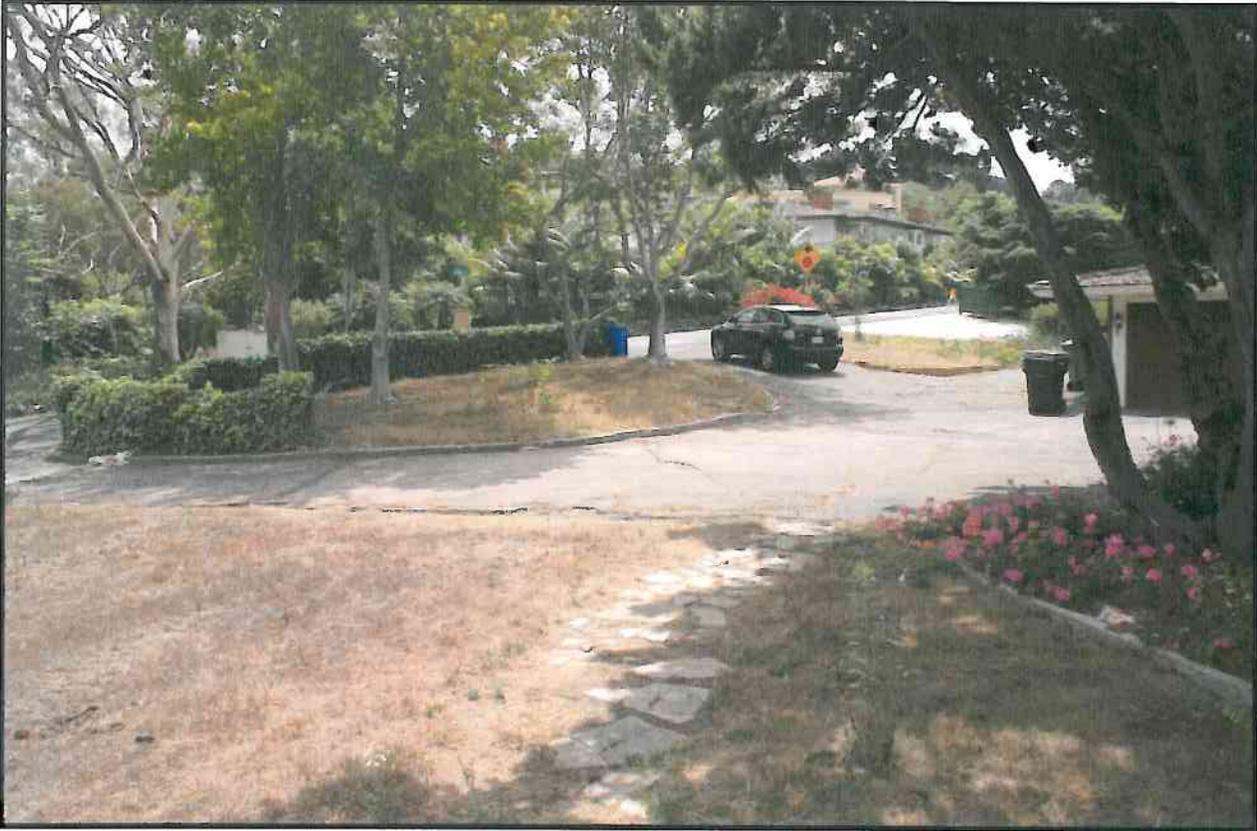
The aerial photographs from 1966 and 1970 depict the Site as having driveway-access from Muirlands Drive along the eastern side of the Property. The photographs clearly show that access to the Property from Muirlands Drive occurred only by virtue of a *single, linear driveway*. Sometime after 1970, the driveway was modified to create an extension or “roundabout” which emptied further southeast into Muirlands Drive. Once this was accomplished, the driveway had been transformed. According to the HRB Staff Report, what now resulted was a “motor court (circular drive leading to the garage).” The effect of this modification was to create a non-original, false feature. According to the HRB Staff Report, such a feature is “indicative of Custom Ranch homes.” (*See presented photos for further background, Item #2, Photos A-F*).

Photo A - Current photo of circular driveway at 6604 Muirlands Drive Residence.

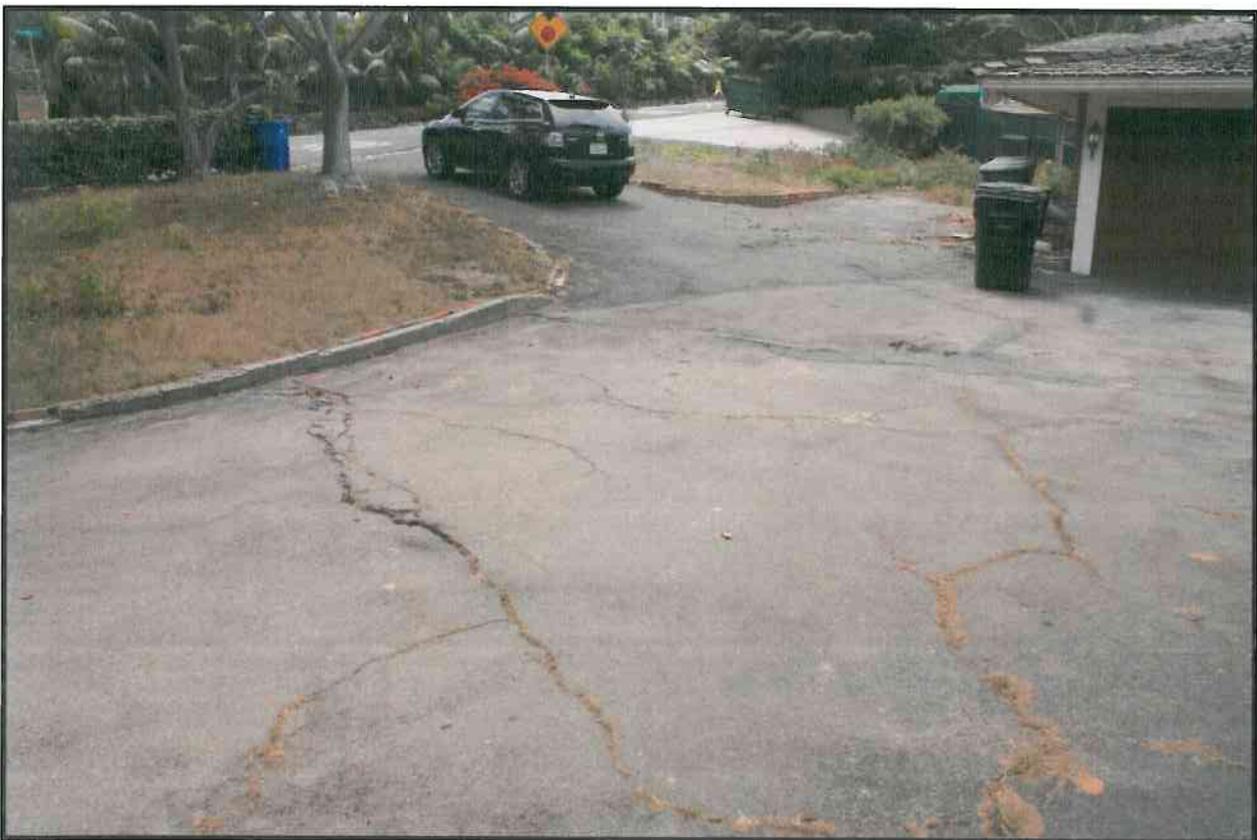
Photo B - Current photo showing new circular drive addition and break in original brick/block border.

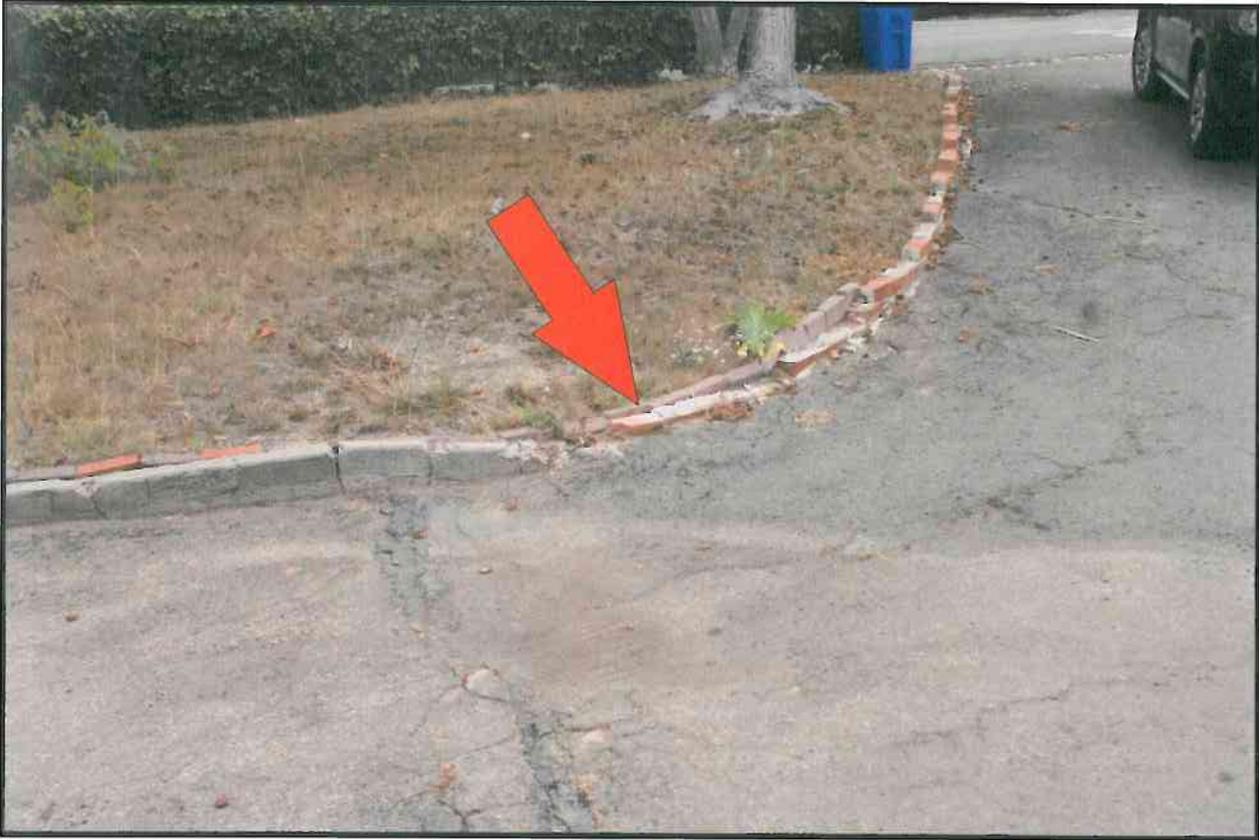
Photo C - Photo depicting termination of original border next to added new border

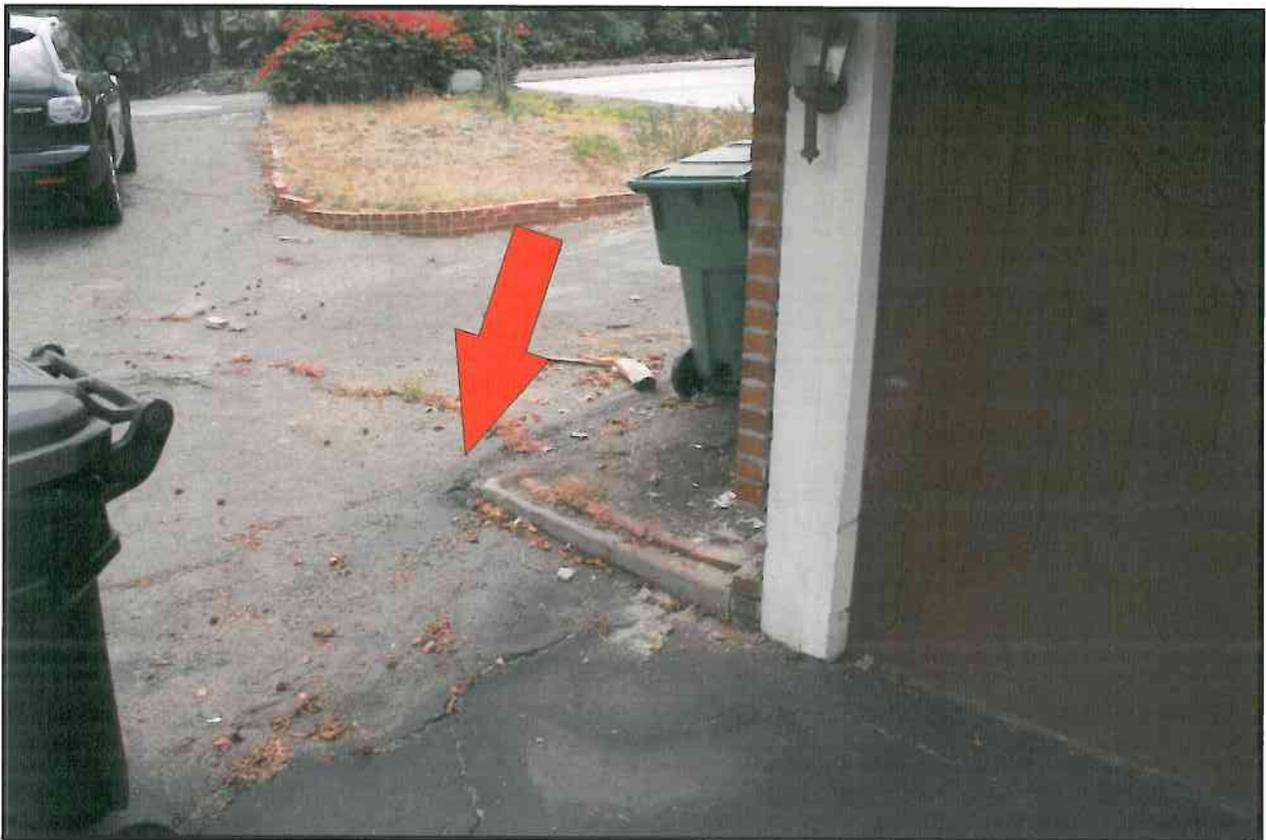
Photo D - Photo showing original driveway border buried under added circular driveway addition.

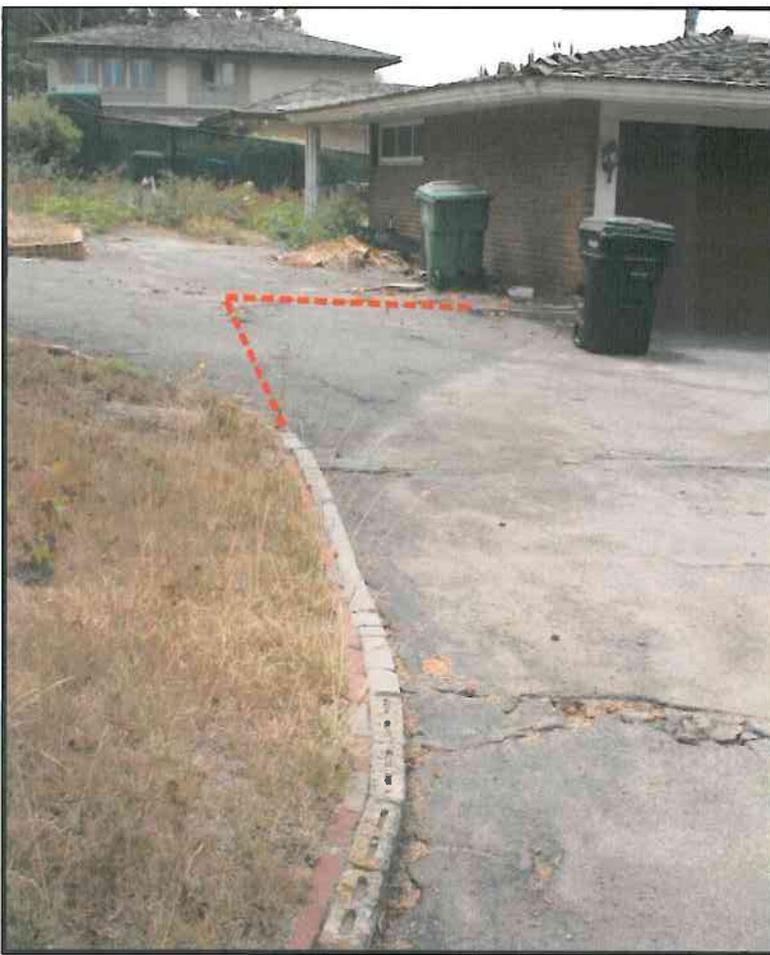
**Photo E** - Photo showing dashed original location of non-circular driveway location

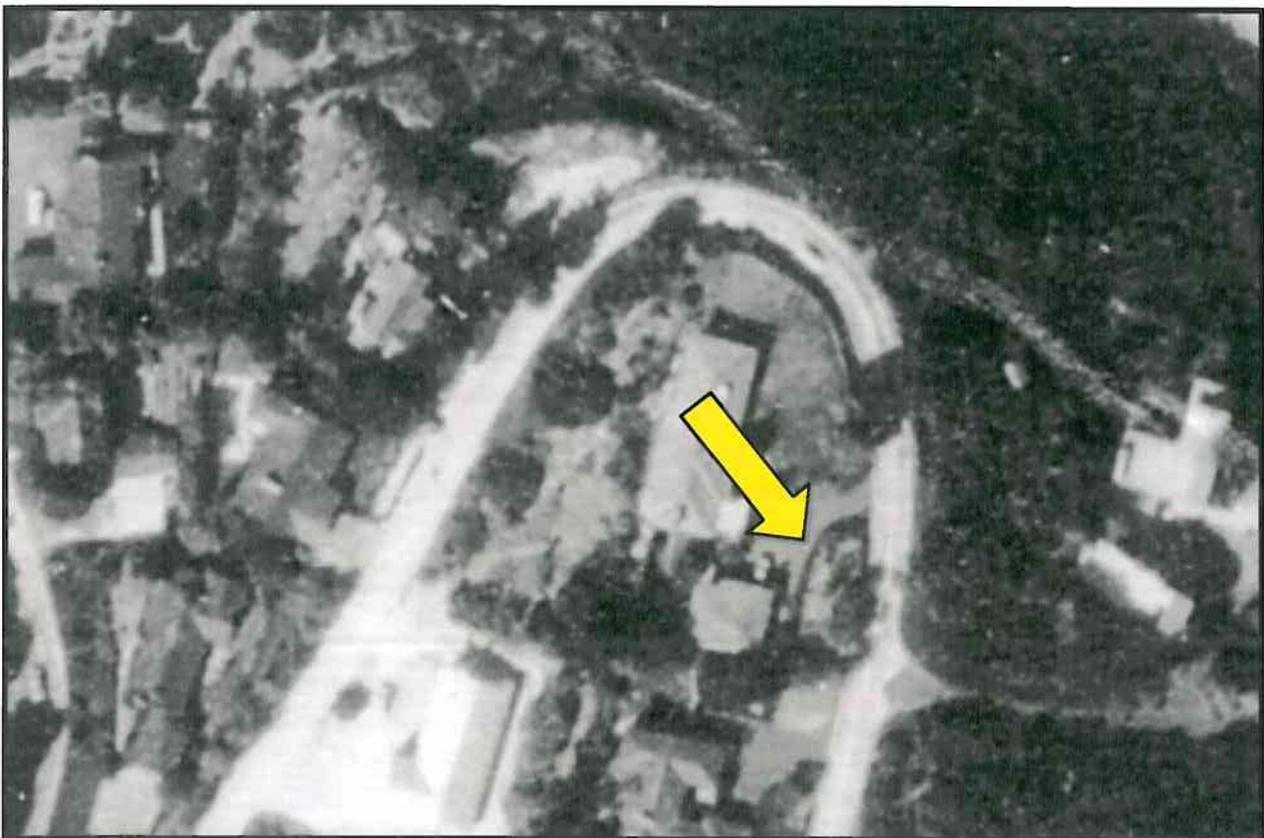
**Photo F** - 1966 Aerial Photo showing original (non-circular) driveway configuration

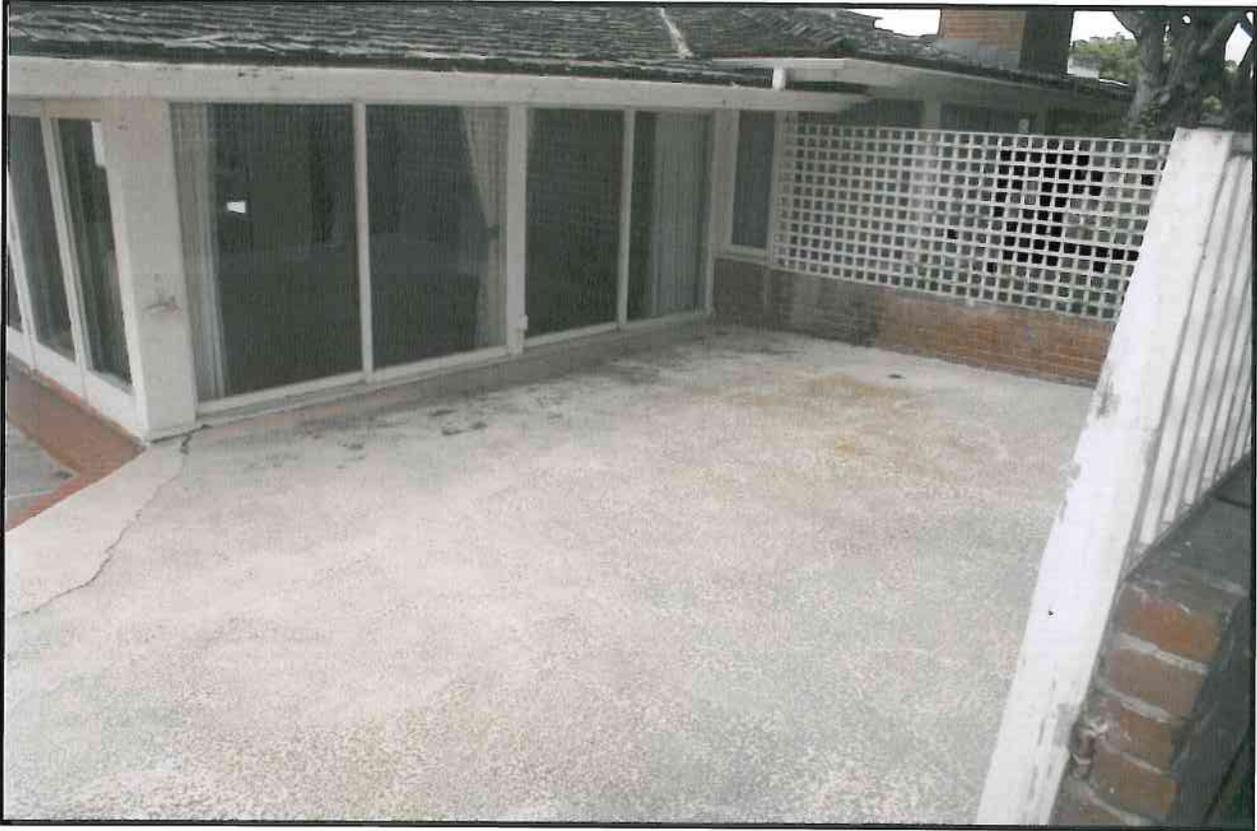
However, at an unknown date, the southeastern corner patio area was enclosed by the addition of a new stem wall, glass windows, and doors. This has been documented with extensive forensic investigation which shows that the slab for this area was not poured with the home slab; the walls in the patio space are the exact same vertical T&G siding on the rest of the house (now covered with paneling); the presence of a barbeque which would never have been built inside the home; the red concrete scored patio surface is the same surface from the other outdoor patio; and the presence of asphalt sealer under what would have been the door threshold to this outdoor patio.

Photo A - Photo showing enclosed patio area at front southern corner of the home.

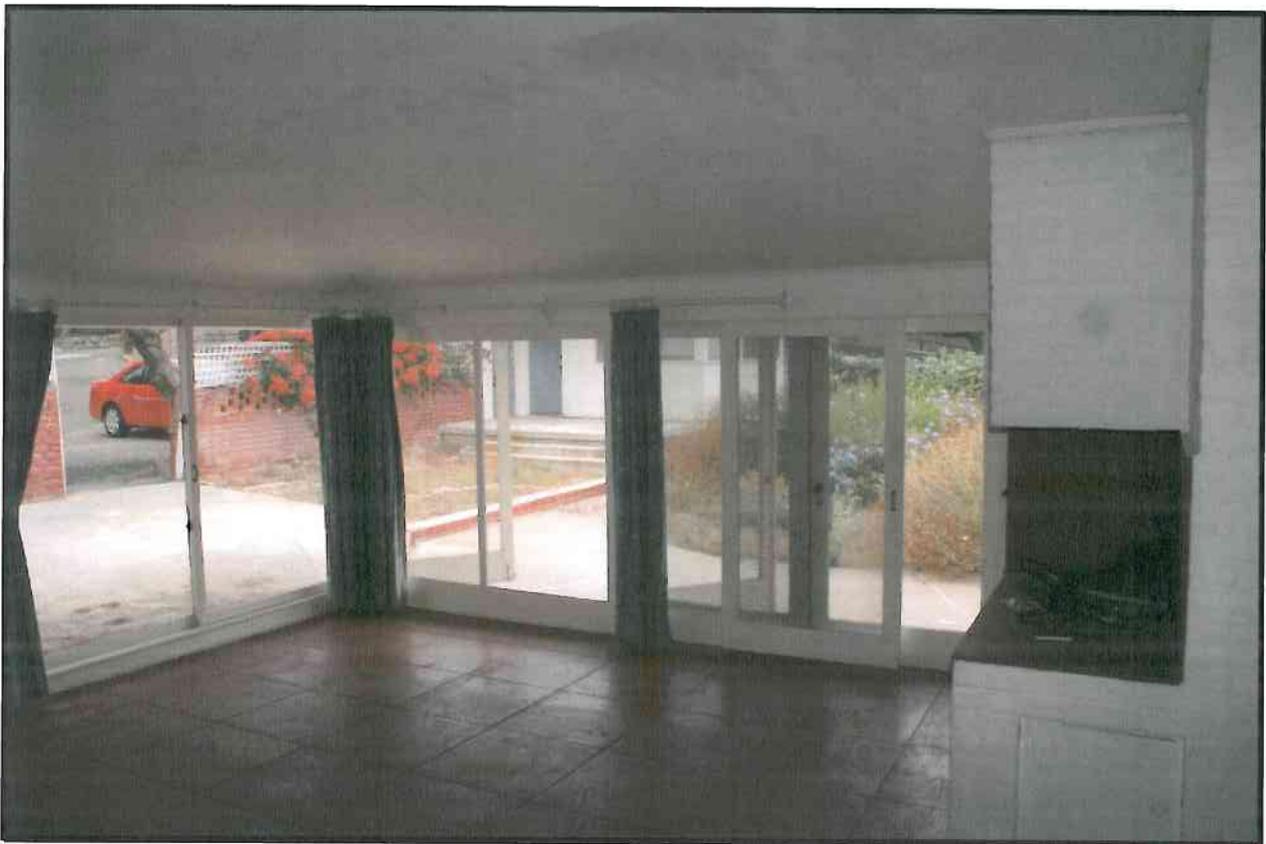
Photo B - Photo of interior or former open patio deck enclosed in 1956

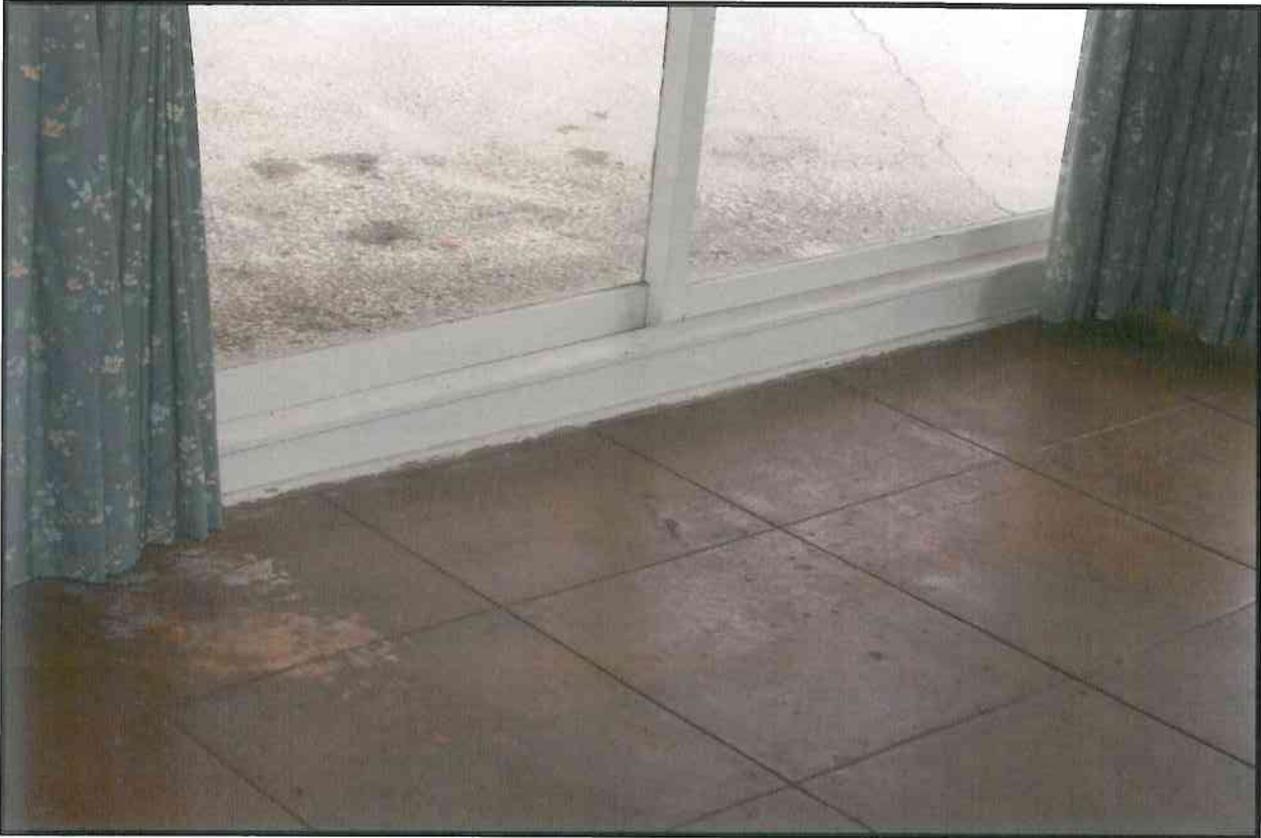
Photo C - Photo showing original scored and colored concrete patio now enclosed - note slope of floor.

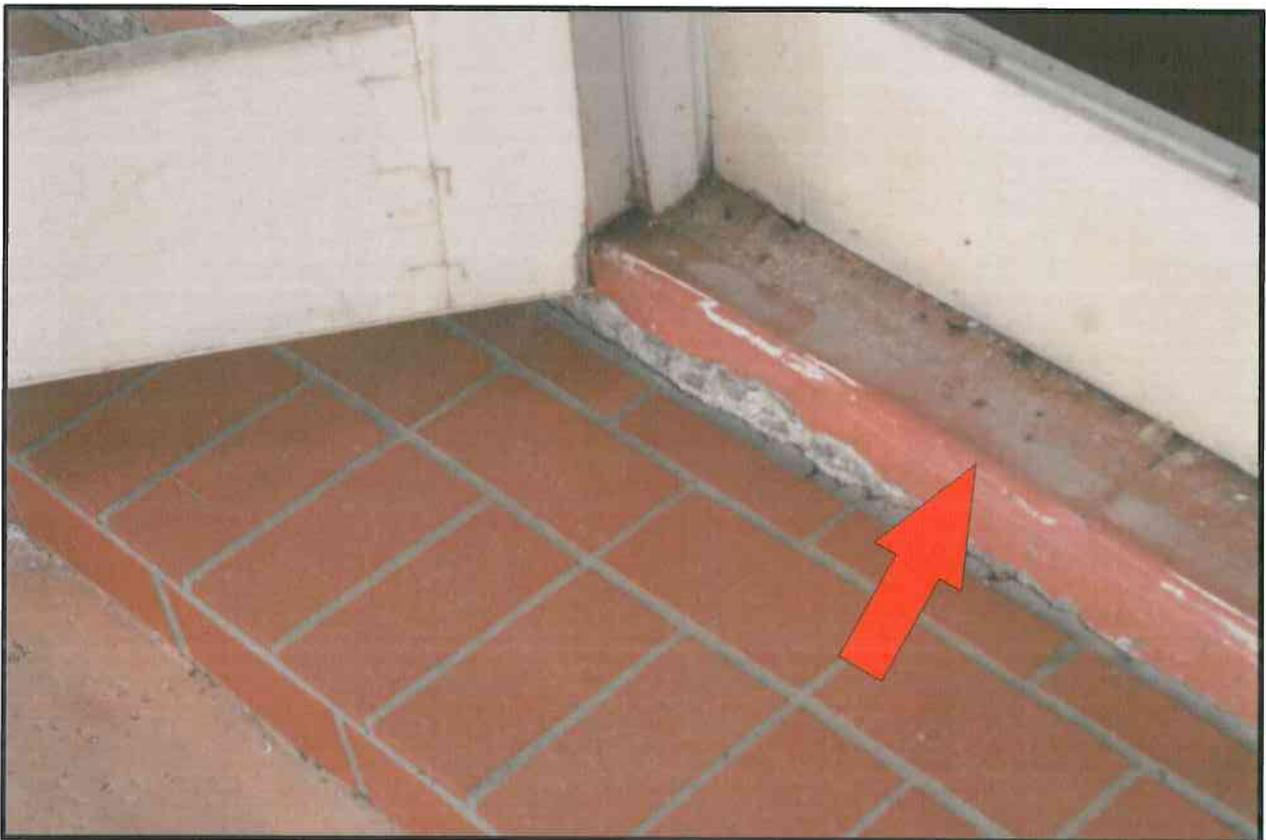
Photo D ~ Photo showing original patio edge in red concrete with wood doors place on top.

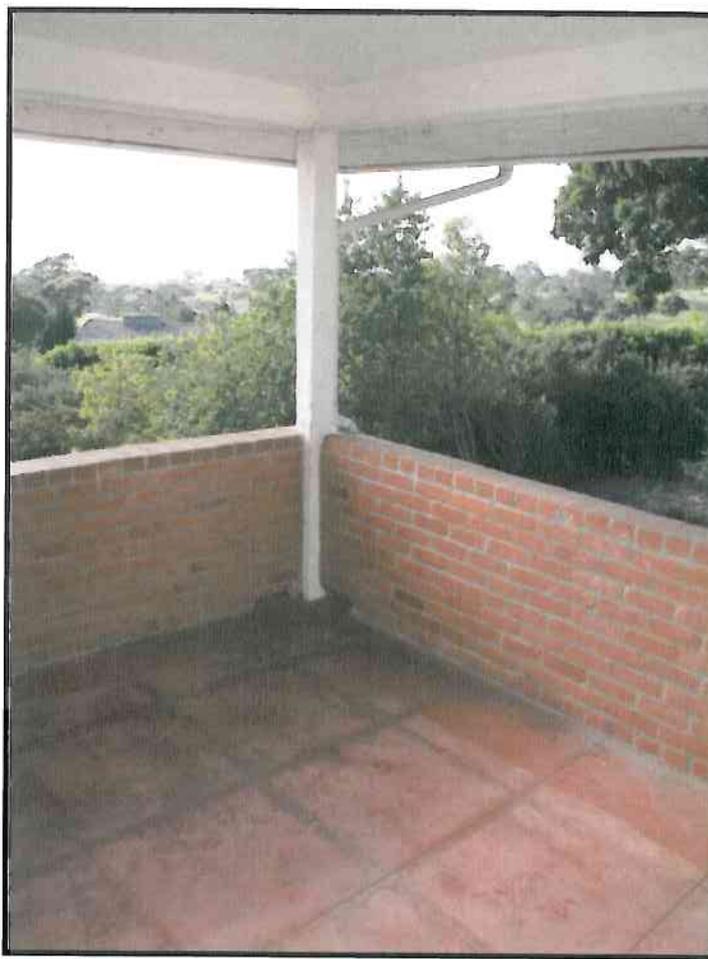
Photo E - Reference photo showing exactly the same scored red concrete at northwestern open patio.

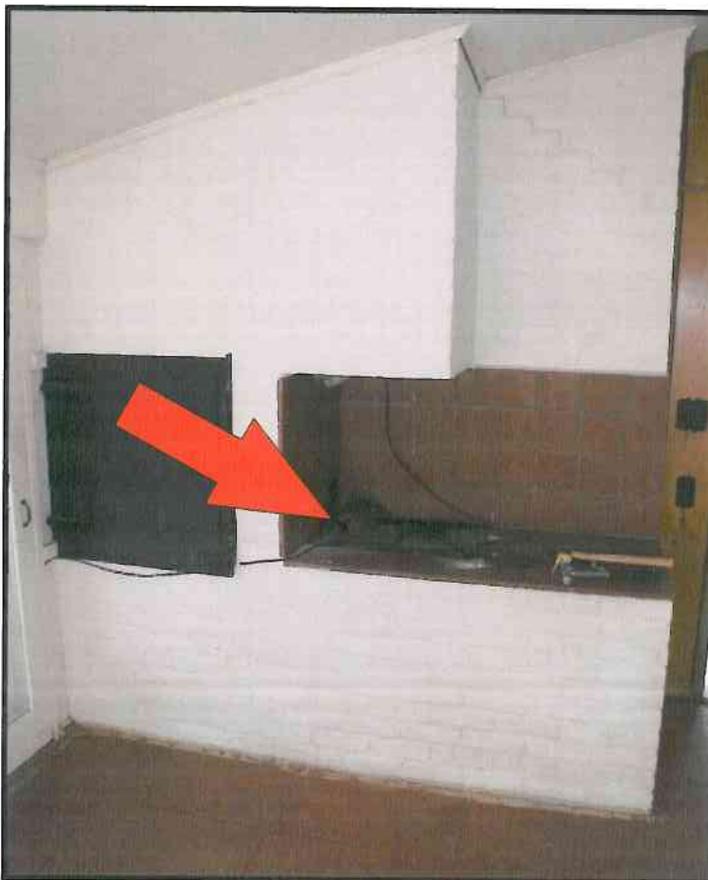
Photo F - Photo showing exterior barbeque located at now enclosed patio without full exhaust covering even.

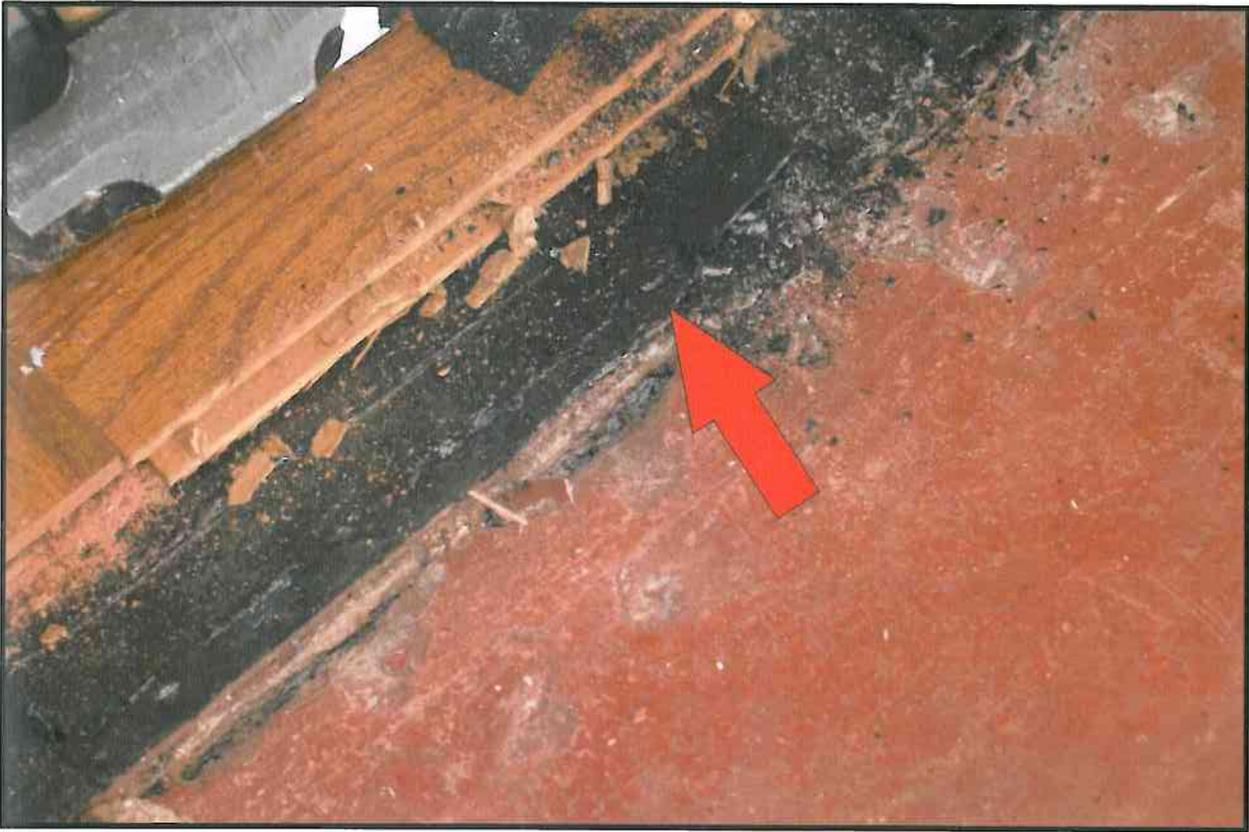
Photo G - Photo of threshold between Living Room and patio showing asphalt sealer to former exterior door.

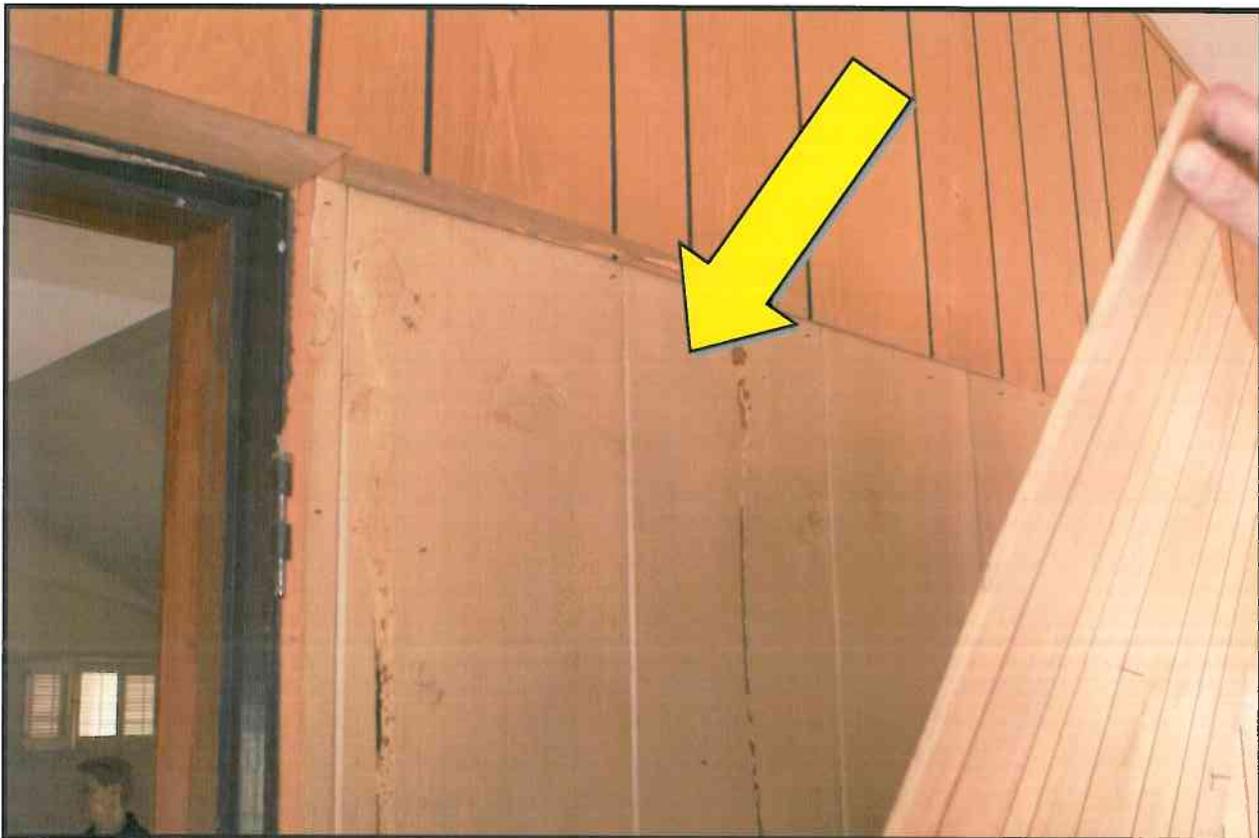
Photo H - Photo showing exterior vertical T & G siding behind paneling in former patio room .

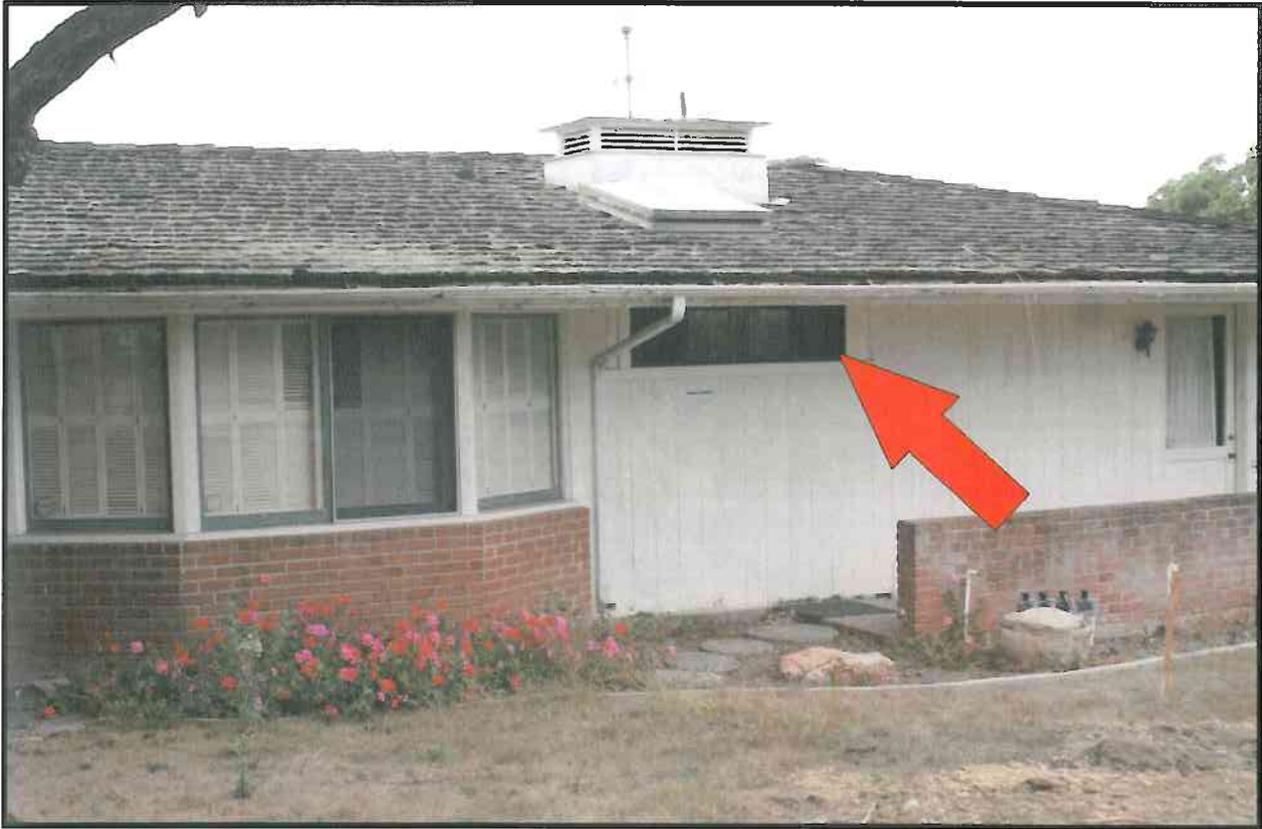
According to a previous property owner, Mr. Collins Haines (see attached sworn Declaration of facts), in or about 1978, a “smaller” bathroom window along the east elevation (master bathroom area) was changed to a “larger” window as part of a substantial bathroom remodel. The current metal window along this elevation is, therefore, not original. Recent extensive forensic examination and analysis supports this fact and demonstrates further that the window size, framing, and exterior materials along this elevation are also not original, and were altered at least two times in the past (given the multiple generations of framing inside the wall and the replacement of the entire exterior siding in this area as well as the pouring of a new foundation in this area). The investigation into the interior framing of the Master Bathroom indicates that the current window is narrower by at least 2’-0” from the originally installed window and probably at least 9” taller as well. Again, this further significantly alters the front façade appearance and leaves a substantial section further lacking integrity.<sup>1</sup> *(See presented photos for further background, Item #4, Photos A-J).*

Photo A - Photo showing location of front facade window replaced with aluminum window.

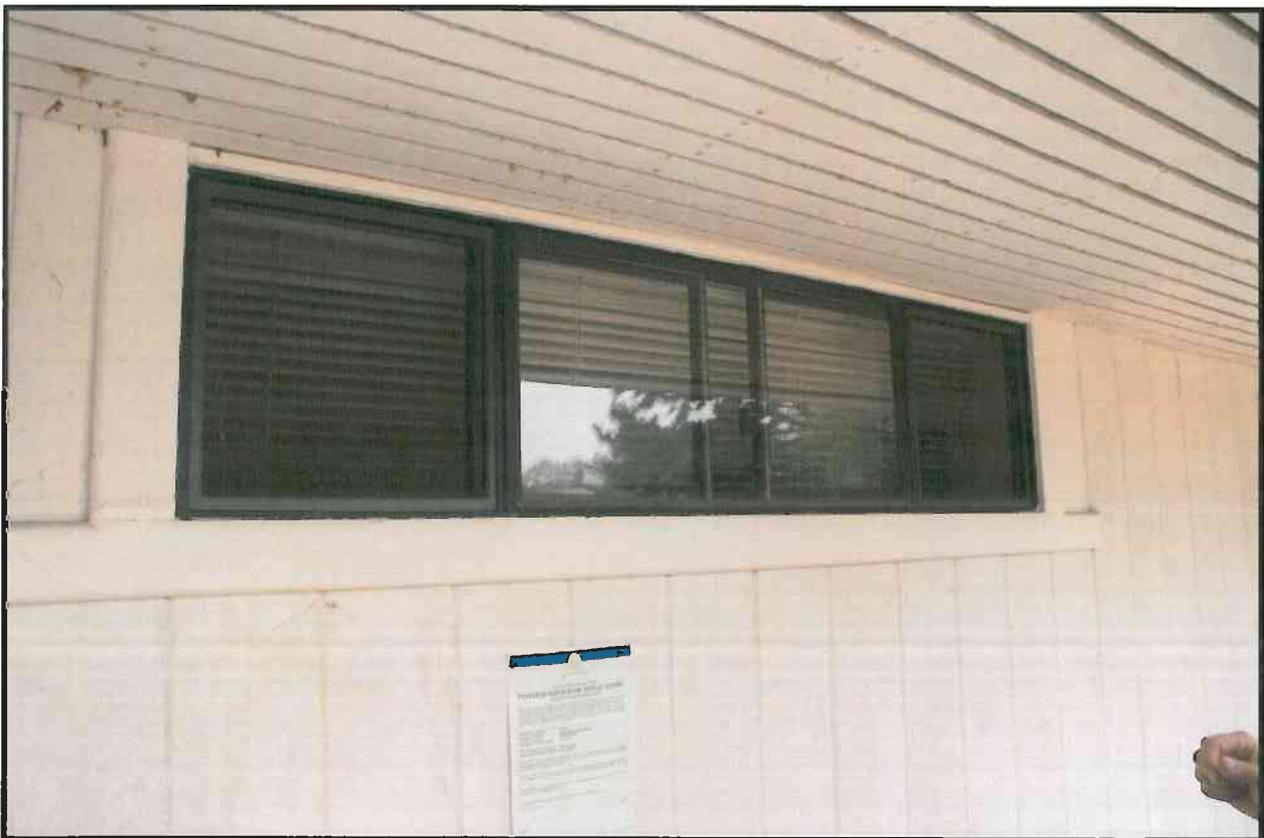
Photo B - Close up showing aluminum replacement window.

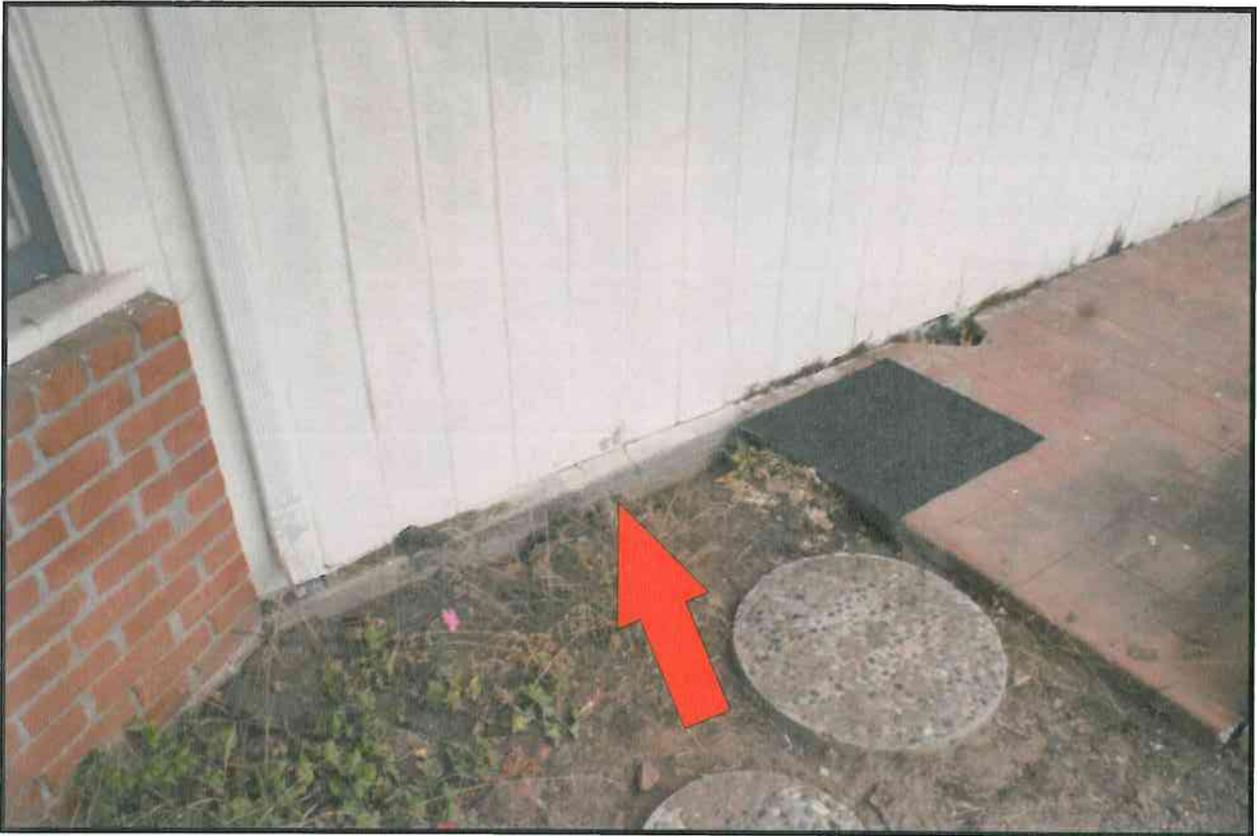
Photo C - Photo showing area of new foundation under replaced window (see color of concrete).
